## NATIONAL TRANSPORTATION SAFETY BOARD

### Group Chairman's Factual Report

## AIR TRAFFIC CONTROL

ERA13LA042

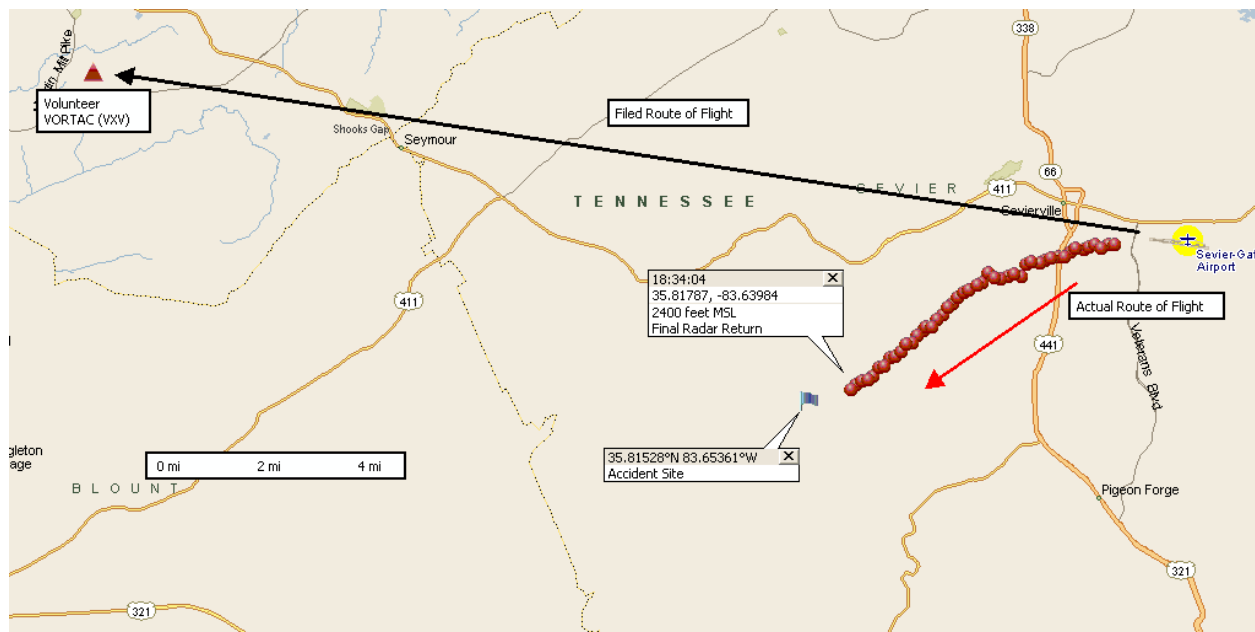
Figure 1: Radar flight track of N4478F indicated by red dots. Filed route of flight indicated by a black arrow. Actual route of flight indicated by a red arrow. Accident site indicated by a blue flag. The Volunteer VORTAC, indicated by a red triangle, is located 18 miles west of GKT. Radar source was the TYS Airport Surveillance Radar (ASR) located at 35 48 44N / 084 00 35W.

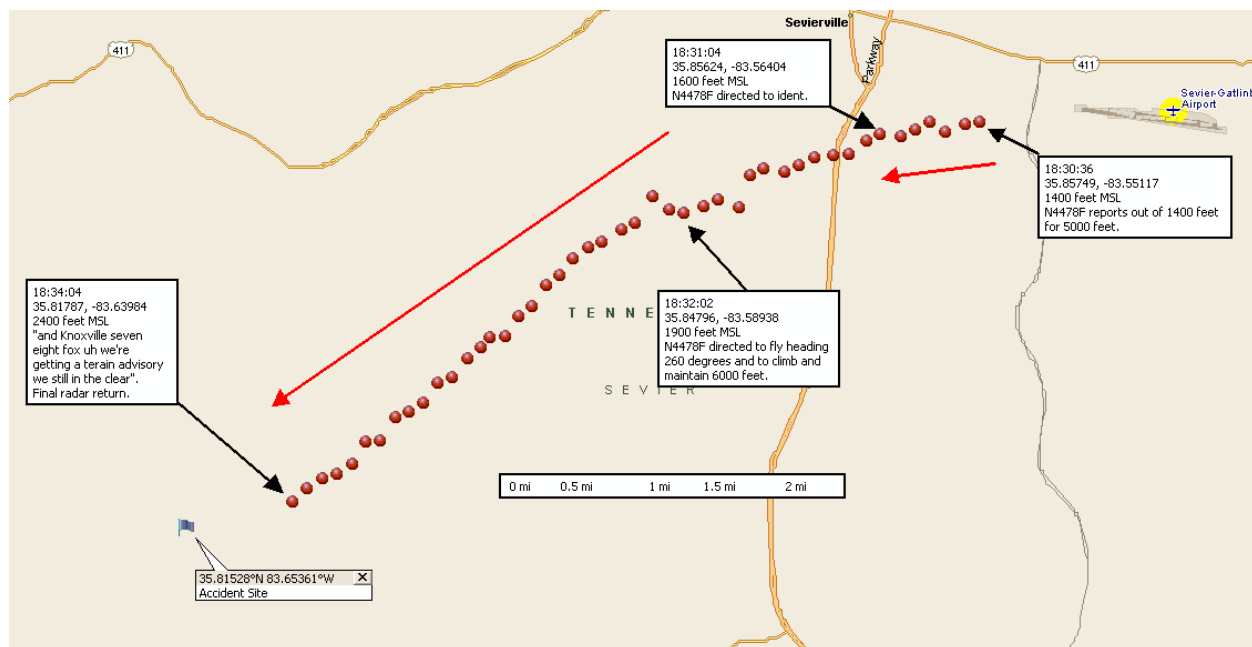
Figure 2: Radar flight track of N4478F indicated by red dots. Route of flight indicated by red arrows. Accident site indicated by a blue flag. Departure airport, GKT, indicated by an aircraft symbol highlighted in yellow.
