U.S. Department  
of Transportation  
**Federal Aviation  
Administration**

Damage report Accident Number ERA13LA060

**Aircraft** was a 1963 Beech 35-B33 Debonair serial # CD-628 aircraft registration # N8519M issued to; Westchester Flying Club  
Address: [REDACTED] Purchase NY, 10577-0254  
Date of registration issue: July 23, 1986 Expires November 30, 2014  
Airworthiness certificate category: Standard-Utility  
Airworthiness certificate issued: replacement 05-13-1963

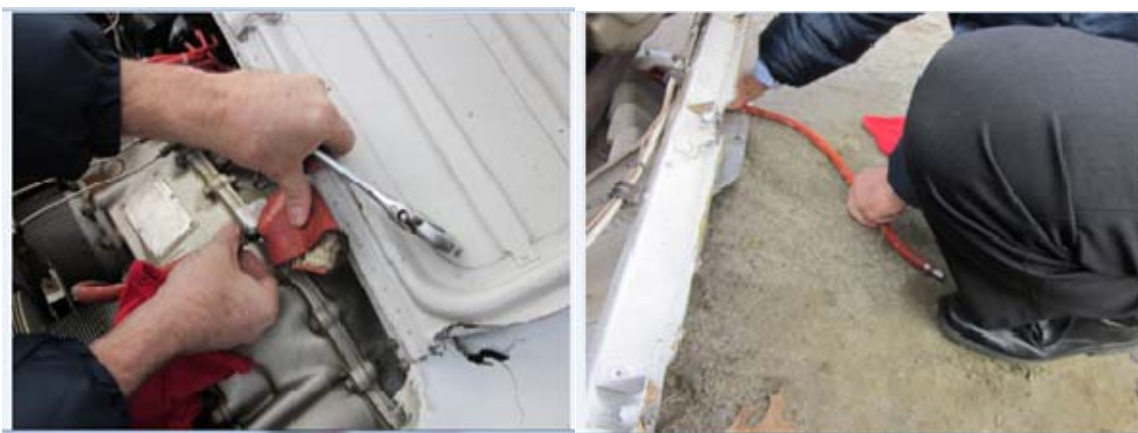
1467/1478 Removed fuel line from the fuel Control Unit to the Fuel Flow Transducer- removed line- no residual fuel found in line.

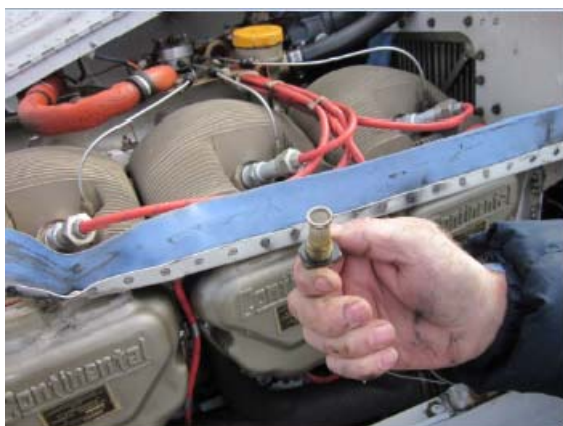
1476 Removed Fuel Control Inlet Screen - no residual fuel, Screen was clean.

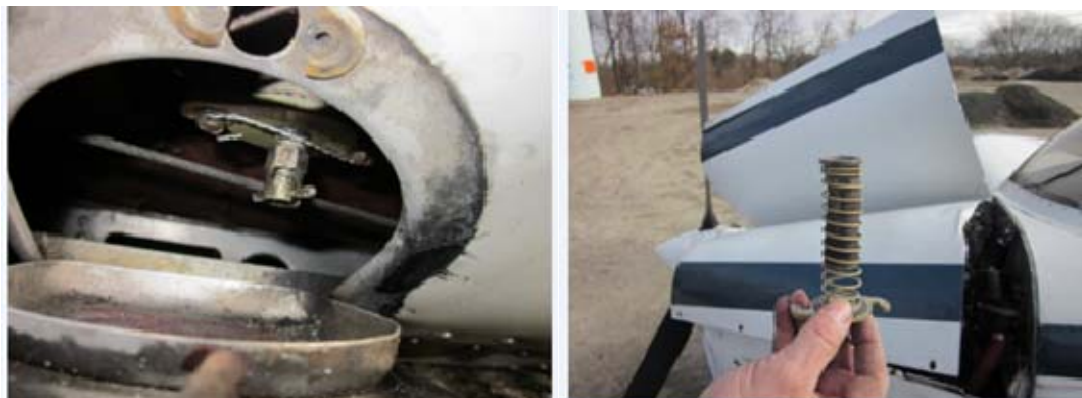
1480/1483 Removed main fuel screen - normal residual fuel found (fuel was getting to fuel selector valve). Screen was found clean

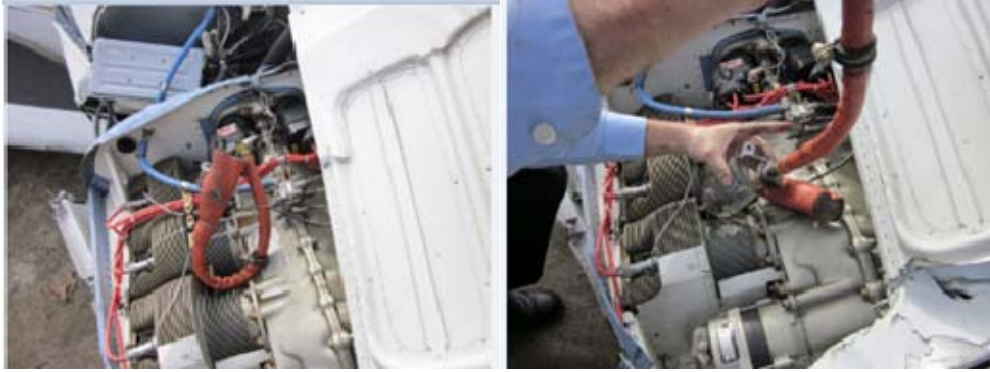
1488/1490 Removed fuel line from the fuel manifold valve to the Fuel Flow Transducer - removed line- no residual fuel found in the transducer or the fuel line.

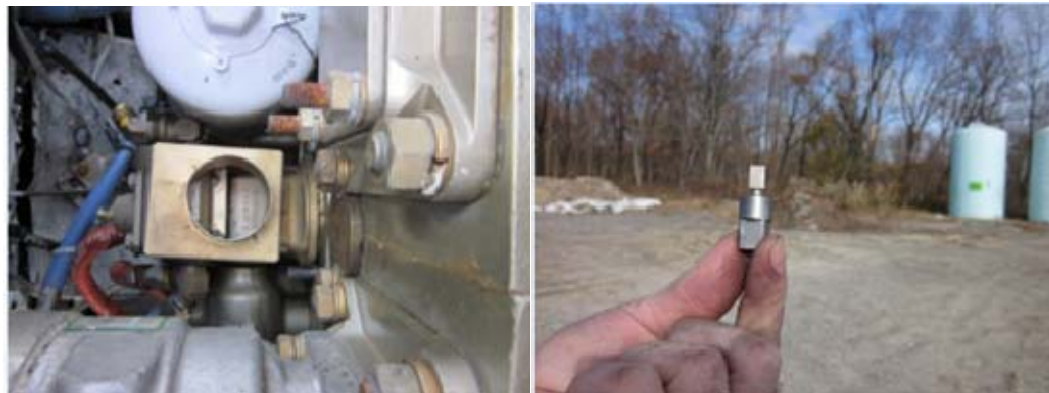
1491/1492 removed engine driven fuel pump, removed and inspected drive coupler – intact and serviceable. Turned pump – pump turned free. On November 21st the engine was in a position that the propeller could be turned, the engine turned freely and a check was performed at that time to check that the engine drive for the fuel pump was turning.

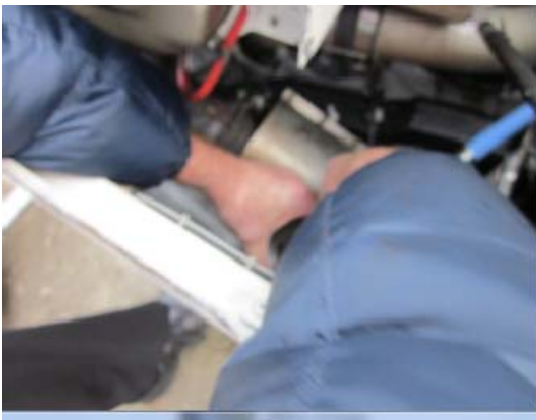
1473 Removed fuel line from the firewall connection to the engine driven fuel pump - no residual fuel found in line.

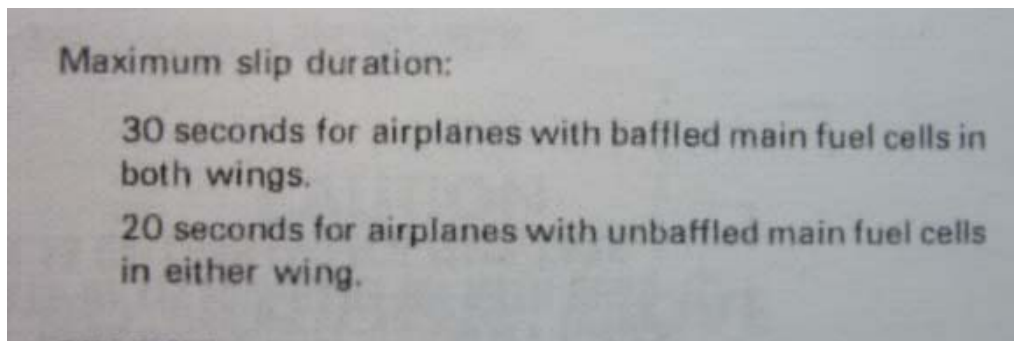
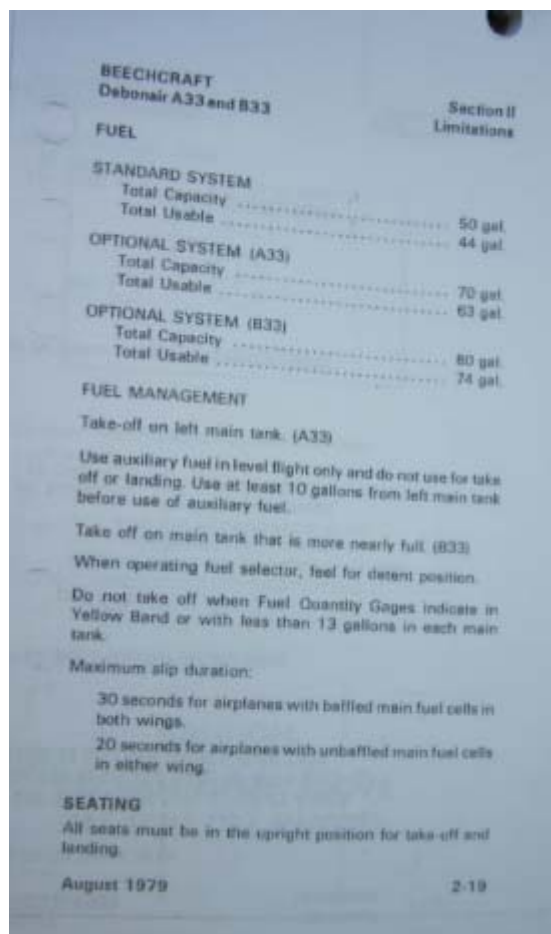
The right and left tank are unbaffled, the second limitation of 20 seconds would coincide with the configuration of this aircraft.

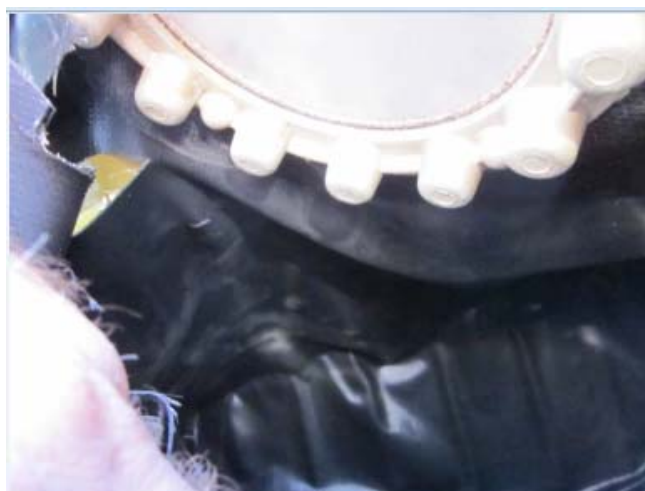
An Internal inspection of the left tank was conducted, no baffle is installed, this brings the maximum slip duration down to 20 seconds vs. 30 seconds for a baffled tank. An inspection of the right tank was not accomplished.

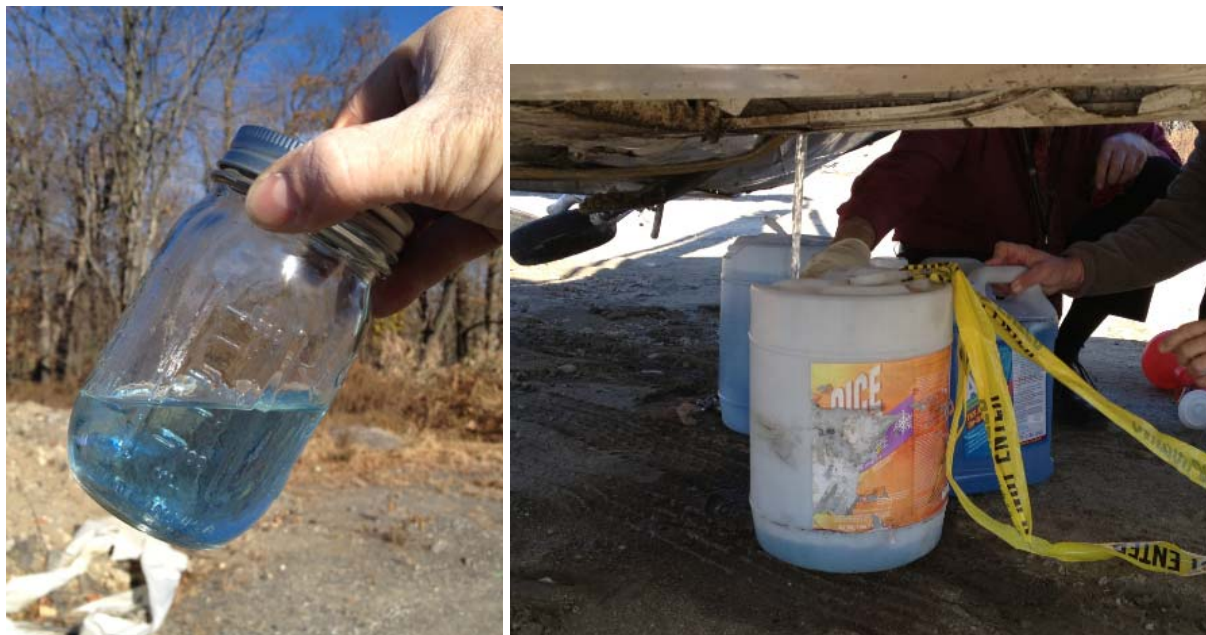
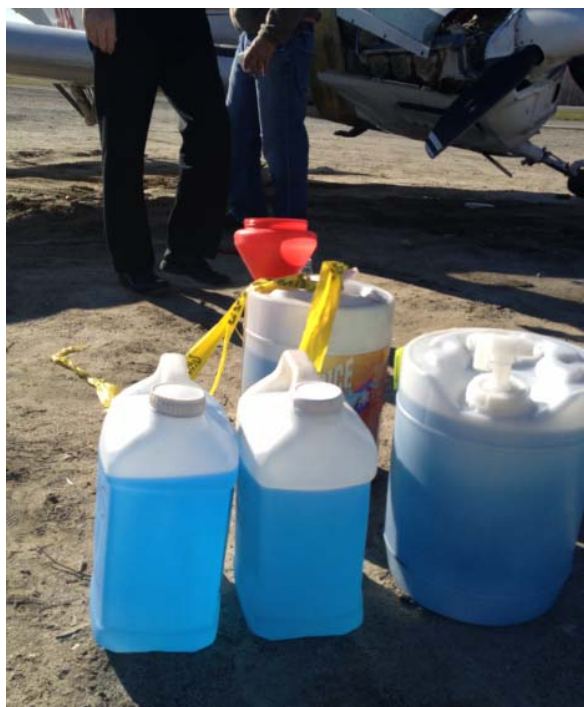
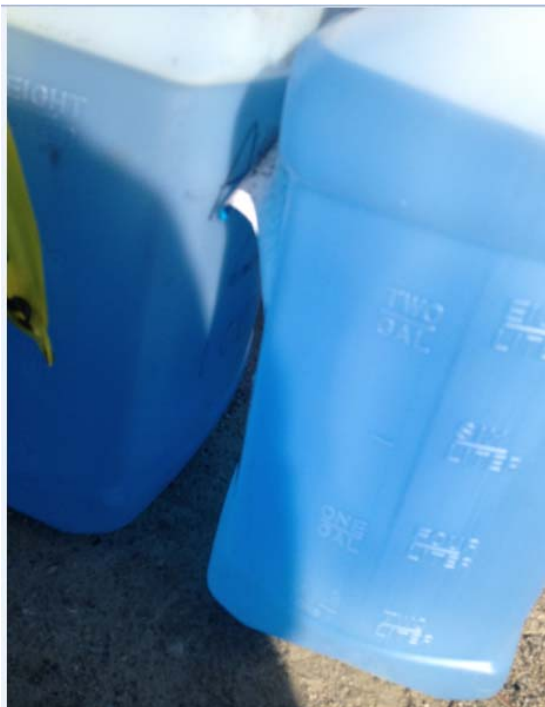
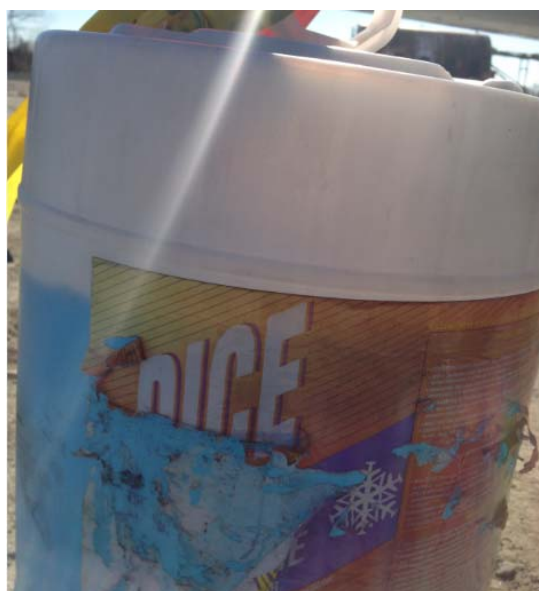
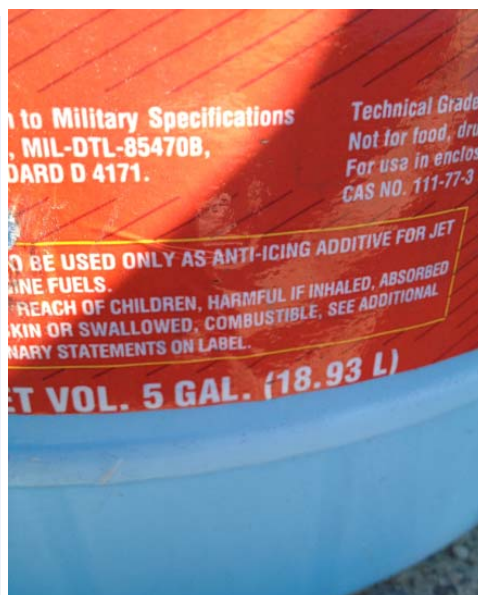
Following the sampling of the right fuel tank, was the defueling of the right tank. The sump drain valve was removed, and total fuel removed from the left tank was approximately 14 gallons. Below are photographs to document the defueling, after the fuel quantity was documented the waste product was returned to Panorama FBO HPN for waste fuel processing.

Below is a set a photograph pertinent to the sampling and defueling of aircraft N8519M

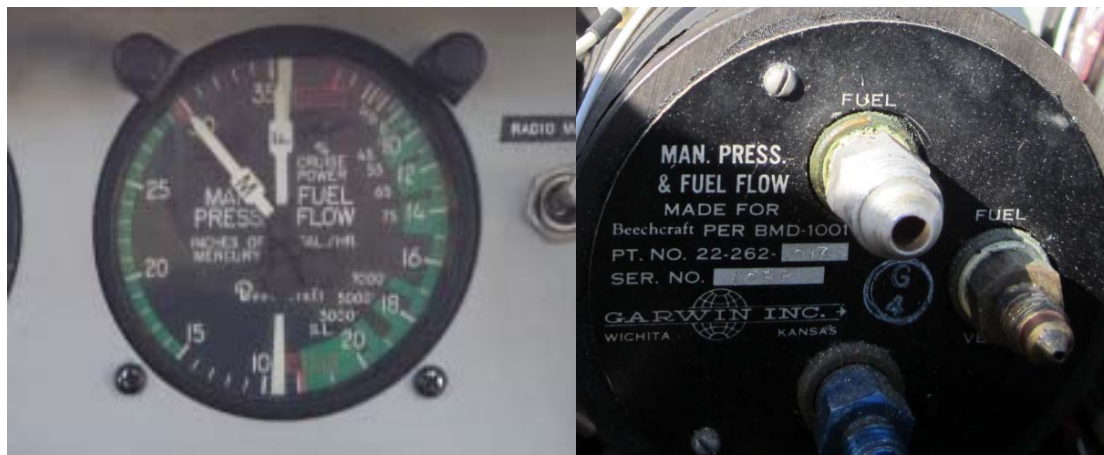
The instrument panel mounted fuel flow gauge installed is not the proper for the IO 520, the gauge only shows indication to 22 gallon per hour, and the fuel flow gauge for the IO-520 would indicate fuel flow up to 26 gallon per hour. The aforementioned data is per D'Shannon STC SA2200SW IO 520 CONVERSION.

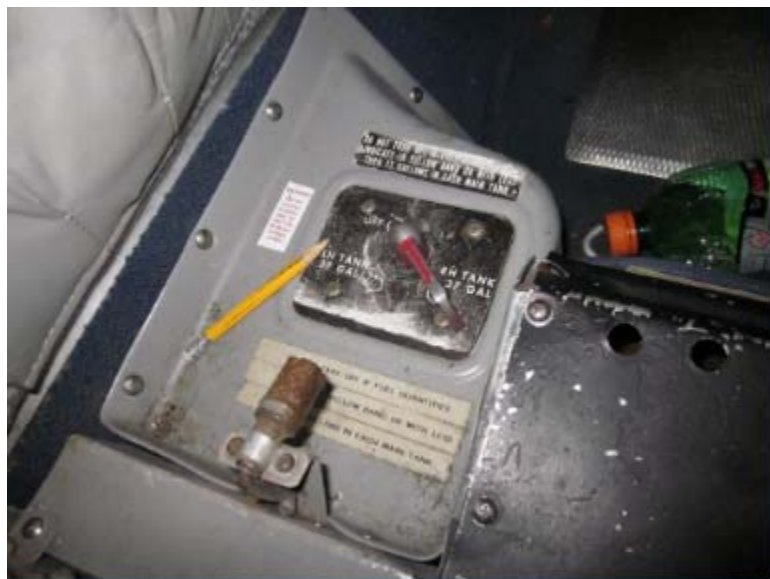
The picture below shows the position of the Fuel Shutoff Valve. It is in the OFF position. According to the pilot, it was placed OFF post- accident. The placard below the valve requires additional research.

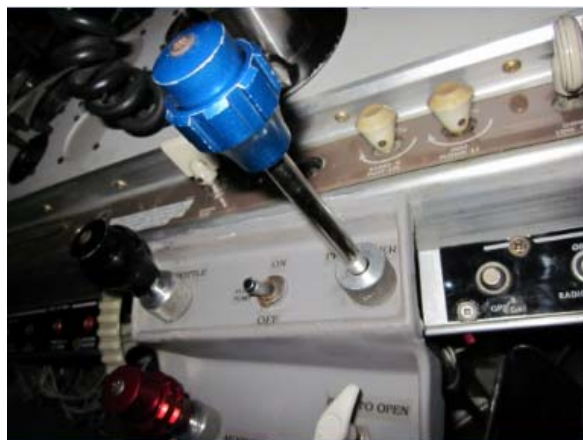
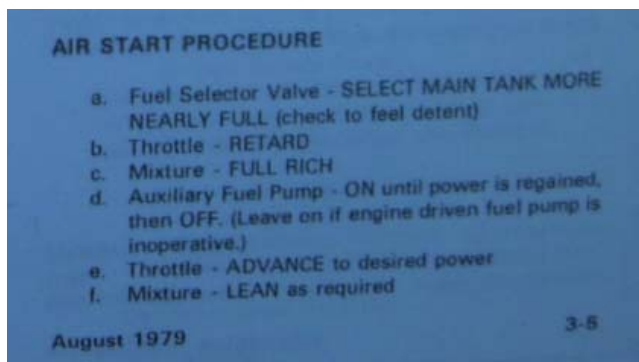
Pictured below is the auxiliary fuel pump, that should be ON for an attempted restart of a failed engine as per the POH.

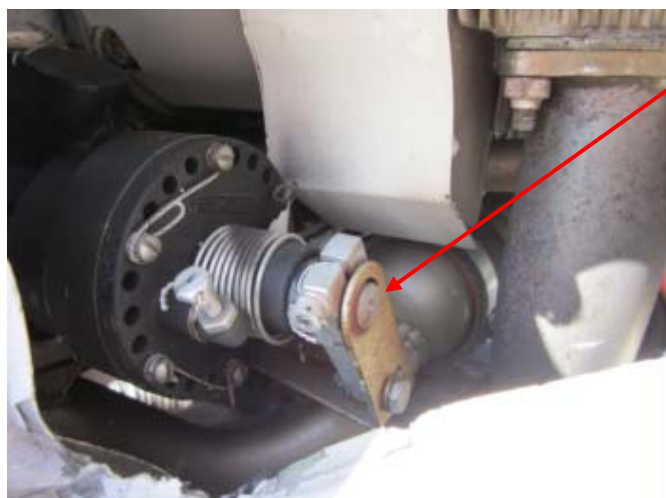
The Blue lever is the Prop Controller, this would normally be placed FULL IN for landing. There was continuity to the propeller governor and operable.

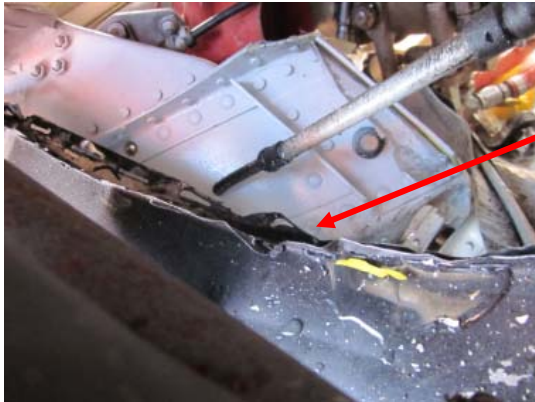
The RED handle is pushed full in which is the FULL RICH position. This is the position that it is expected to be in for this phase of flight. This control was severed during impact.

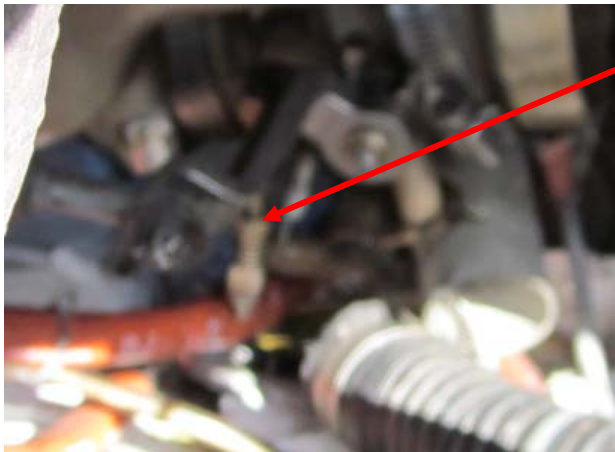
The Throttle has the black control. The current position that it is placed is what would be expected. An attempted restart would show an intermediate position. There was continuity to the Fuel Control Unit and operable.
