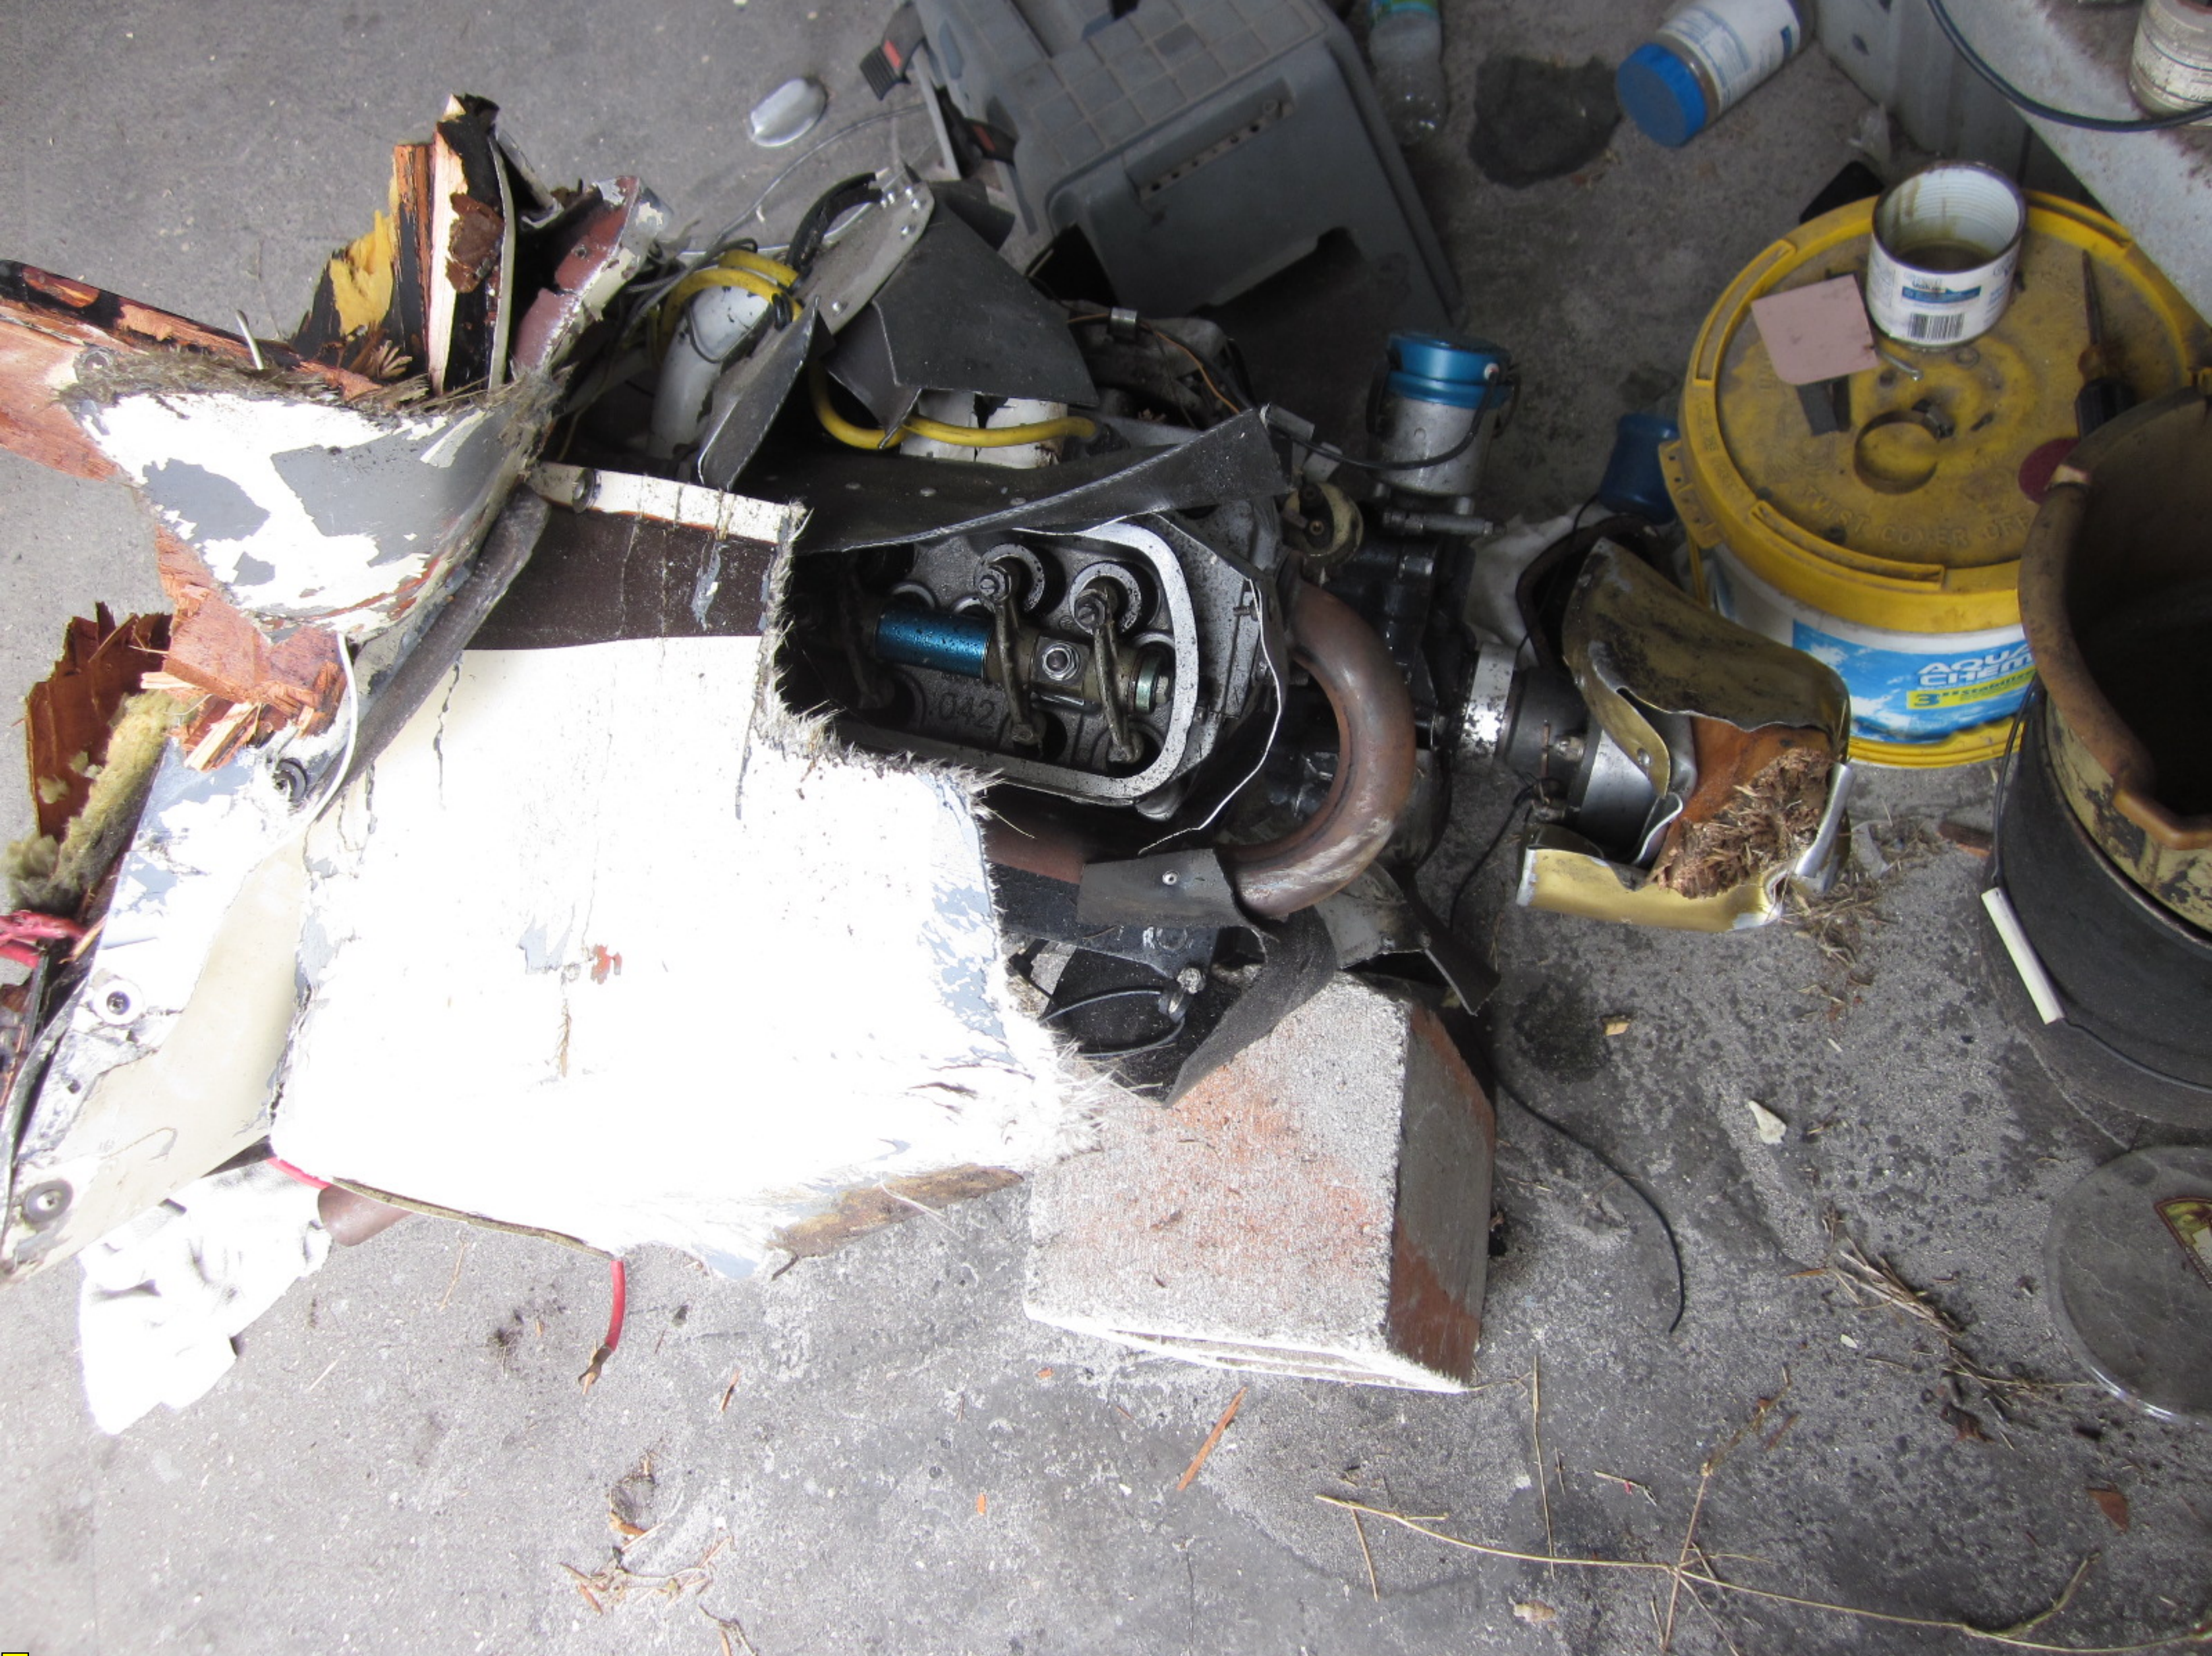
Photo 1: Digital Photograph Provided by FAA. View Depicting the Engine Assembly During the Postaccident Investigation.
