Rotech Flight Safety Ltd. 6235 Okanagan Landing Road

## **INVESTIGATION REPORT**

| <b>Date of accident:</b> | March 16 2013 | <b>NTSB file number:</b> | ERA13LA171 |

| <b>Aircraft Make:</b> | Aerolite | <b>Aircraft registration:</b> | N2549W |

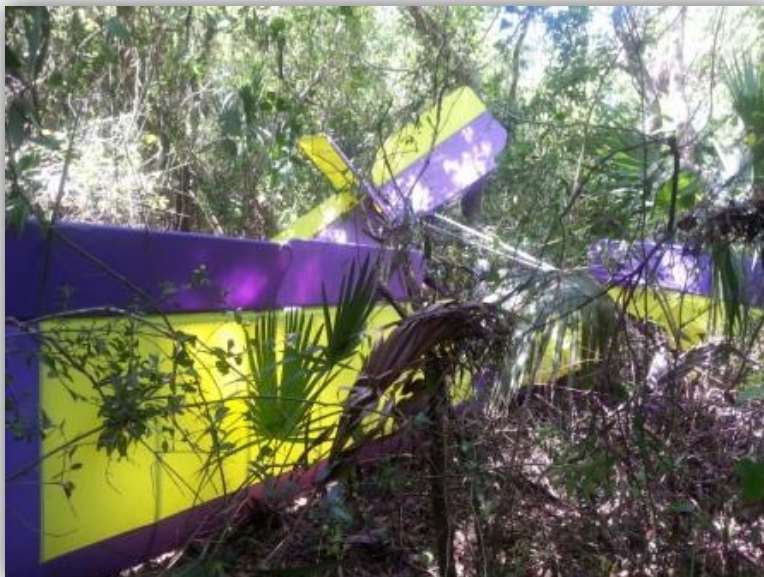
Examination of the airplane by the local authorities revealed that it came to rest in a heavily wooded area, and exhibited substantial damage. The airplane will be recovered for further examination at a later date.

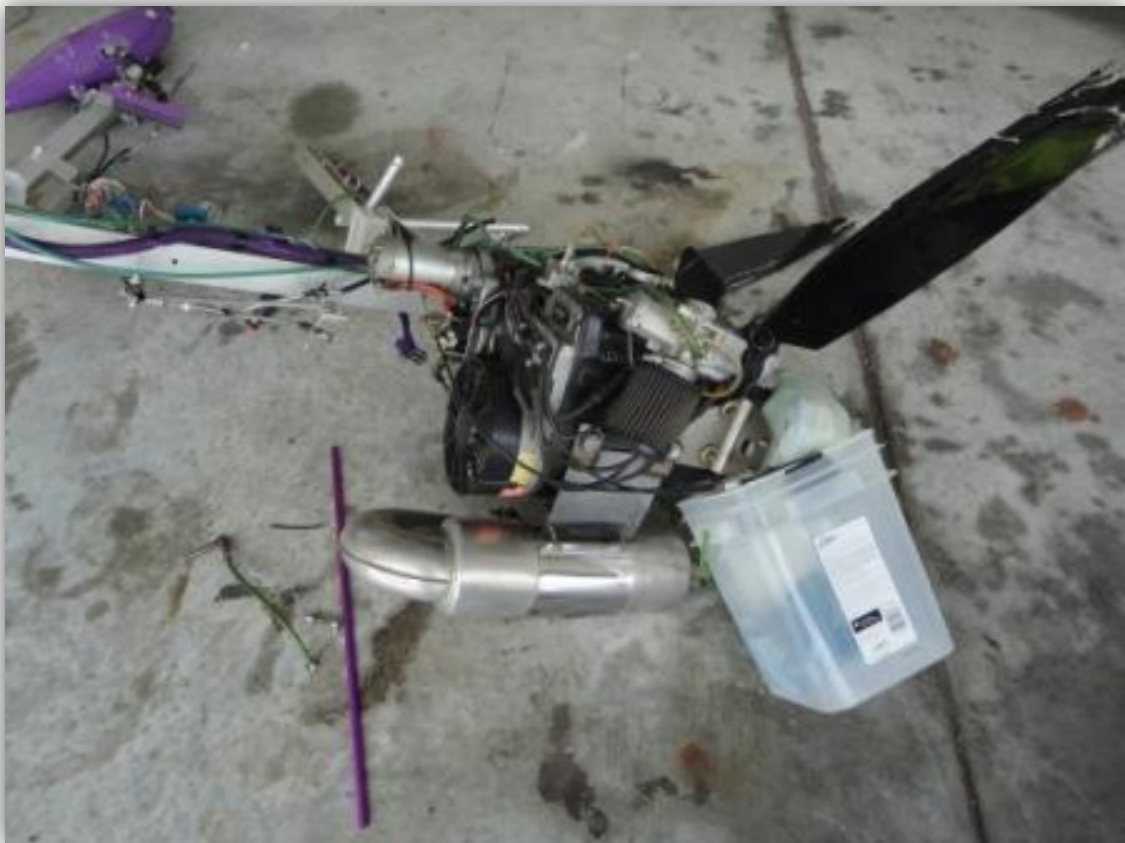
The engine was found sitting on the hanger floor and attached to partial remains of the aircraft and engine mount.

Two of the three propeller blades were present but sustained sever impact damage. Signs of rotation was seen on the remaining blades. One of the propeller blades was broken off at the route and was not available for inspection.

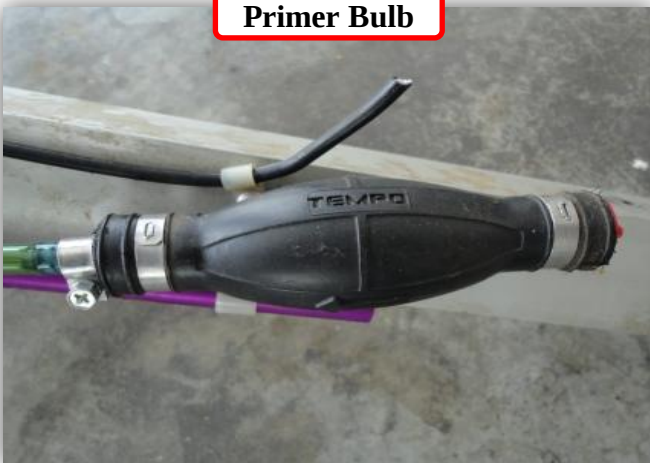
**Primer Bulb**

The fuel system was equipped with a primer bulb and a primer plunger. The fuel system was found breached between the primer bulb and fuel tank. A liquid that was constant with fuel was found contained within the fuel lines.

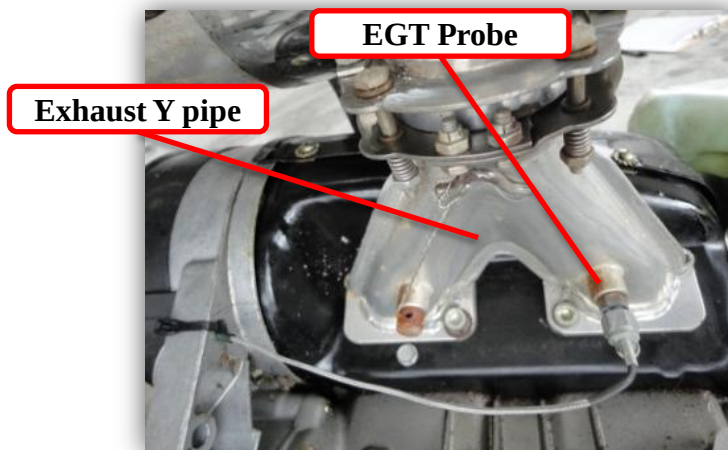
Examination into the engine exhaust gas monitoring system revealed that the engine was only equipped with one EGT probe on the PTO (power take off) cylinder.

Having only one EGT probe monitoring one cylinder exhaust gases would only provide limited information on the running condition of the engine.

In the Rotax installation manual section **10) Exhaust system**, subsection **10.3) Exhaust gas temperature (EGT)** page 10-2, it states "Exhaust gas temperature will give the most rapid response in the event of improper mixture, pre-ignition or detonation. Ideally the exhaust temperature should be measured about 100mm (4 in) from the piston, with separate sensors for each cylinder."

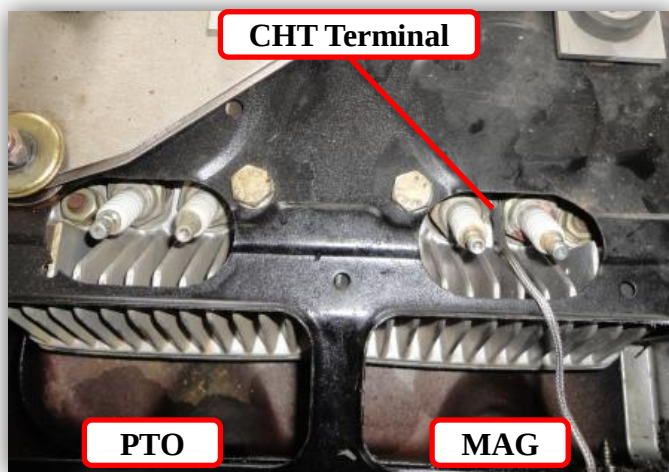
Having only one CHT terminal monitoring one cylinder head temperature would only provide limited information on the running condition of the engine.

In the Rotax installation manual section **20) Connections for Instruments, page 20-1** It states the location and connection for the CHT sensor terminal and states one each per cylinder fastened by one spark plug.

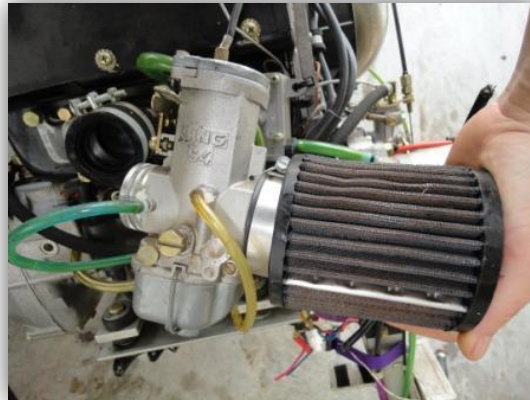
Inspection into the carburetor and intake system revealed that this Rotax engine was not equipped with a carburetor heat system.

In the Rotax installation manual section **16) Carburetor** subsection **16.1) Carburetor air intake**, it states that “If the aircraft is to be operated in climatic conditions where carburetor icing is likely to occur, a heating system must be fitted.”

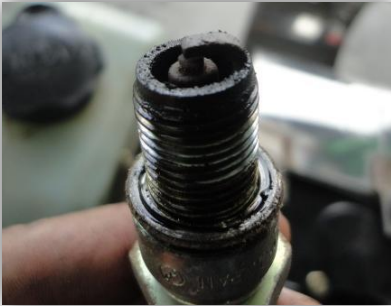
- LB05EZ Spark plug cap with resistor in good physical condition
- NGK B8ES Spark plug without resistor
- Black electrode with heavy oil deposits on the electrodes and insulator. In the Rotax maintenance manual section **11) Maintenance of the various systems**, subsection **11.7) Inspection of spark plugs** it states " On engines with single carburetor, one sooty spark plug usually indicates a bad plug or faulty ignition system. If both plugs are sooty with oil deposits, carburetion and air system should be checked.
- The electrode gap was .021 (Not within specs) (.016 - .018 electrode gap limitation)

Rotax maintenance manual section **10.2) Maintenance schedule** it states that inspection of the spark plugs should be carried out every 12.5 hours of operations and replaced every 25 hours. (See Appendix A for the Rotax Maintenance schedule)

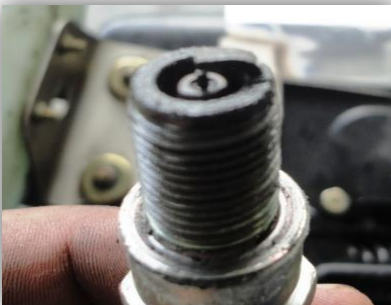
#### PTO (power take off) # 2 Spark Plug & Cap

- LB05EZ Spark plug cap with resistor in good physical condition
- NGK BR8EV fine electrode spark plug with resistor and removable threaded cap (**Non conforming spark plug**)
- Black electrode with heavy oil deposits on the electrodes and insulator. In the Rotax maintenance manual section **11) Maintenance of the various systems**, subsection **11.7) Inspection of spark plugs** it states " On engines with single carburetor, one sooty spark plug usually indicates a bad plug or faulty ignition system. If both plugs are sooty with oil deposits, carburetion and air system should be checked.
- The electrode gap was .019 (Not within specs) (.016 - .018 electrode gap limitation)

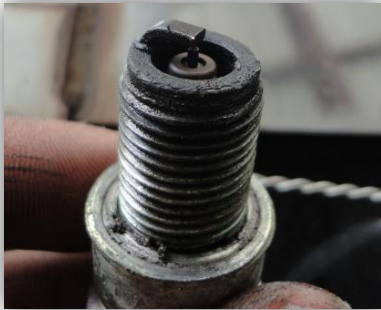
- LB05EZ Spark plug cap with resistor in good physical condition
- NGK BR8EV fine electrode spark plug with resistor and removable threaded cap (**Non conforming spark plug**)
- Black electrode with heavy oil deposits on the electrodes and insulator. In the Rotax maintenance manual section **11) Maintenance of the various systems**, subsection **11.7) Inspection of spark plugs** it states “ On engines with single carburetor, one sooty spark plug usually indicates a bad plug or faulty ignition system. If both plugs are sooty with oil deposits, carburetion and air system should be checked.
- The electrode gap was .020 (Not within specs) (.016 - .018 electrode gap limitation)

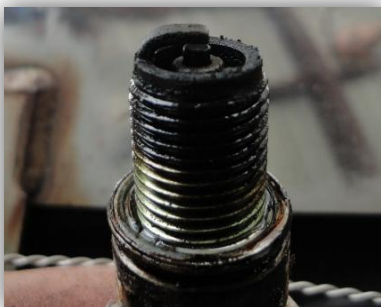
#### MAG (Magneto) # 4 Spark Plug & Cap

- LB05EZ Spark plug cap with resistor in good physical condition
- NGK B8ES Spark plug without resistor
- Black electrode with heavy oil deposits on the electrodes and insulator. In the Rotax maintenance manual section **11) Maintenance of the various systems**, subsection **11.7) Inspection of spark plugs** it states “ On engines with single carburetor, one sooty spark plug usually indicates a bad plug or faulty ignition system. If both plugs are sooty with oil deposits, carburetion and air system should be checked.
- The electrode gap was .018 (within specs) (.016 - .018 electrode gap limitation)

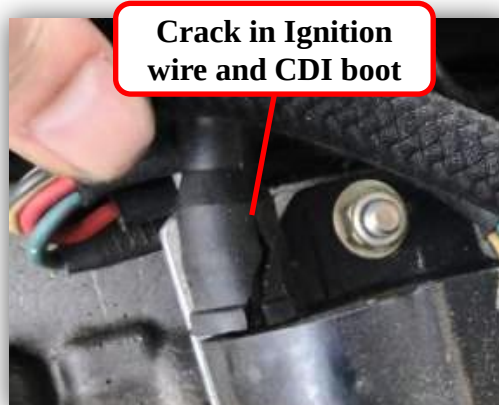
A cracked boot was found on the # 4 MAG spark plug ignition wire. This boot is to protect the contacts from the elements. Rotax maintenance manual section **10.2) Maintenance schedule** it states that checking of the ignition system is to be done every 25 hours. (See Appendix A for the Rotax Maintenance schedule)

Rotax maintenance manual section **11.9) Check of the ignition system** states to “ Verify all electrical connections for good contact and ensure there are free of corrosion. Inspect the wiring for wear, damage and corrosion.

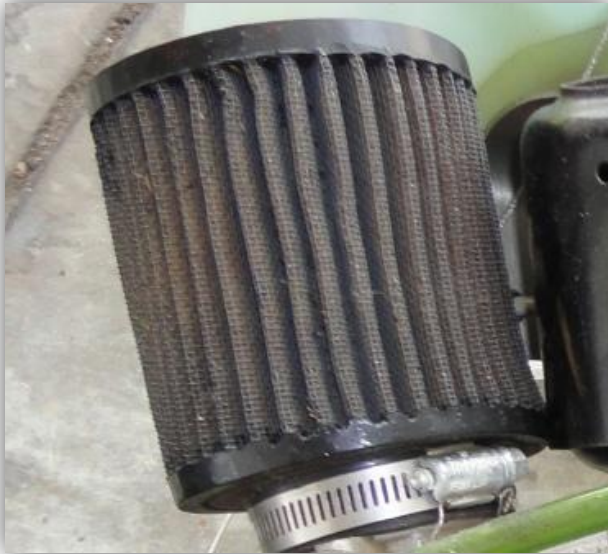
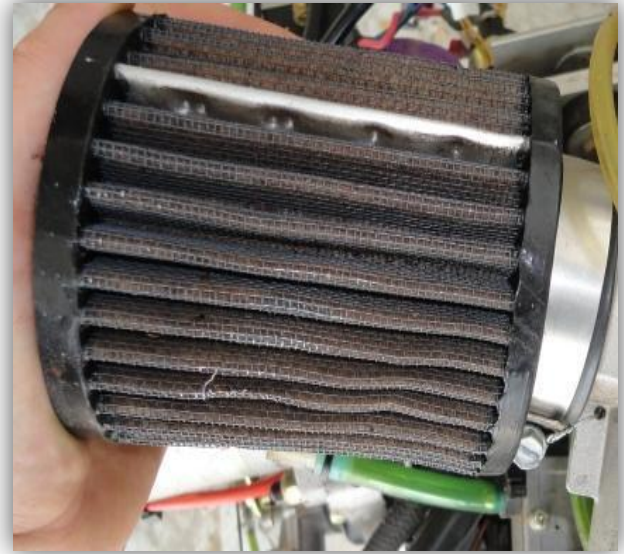
The air filter was examined for condition and conformity. The air filter was found to be dirty which would affect the overall performance of the engine.

In the Rotax operators manual section **10.3.2) Daily checks**, it states **WARNING:** Repair as necessary all discrepancies and shortcoming before flight. It also states to Verify security and condition of intake silencer and air filter.

- Leaking oil injection lines were found at the intake manifold connection. This would effect the overall effectiveness of the lubrication system.
- Dirty air cleaner was found installed on the engine that could effect the overall performance of the engine.

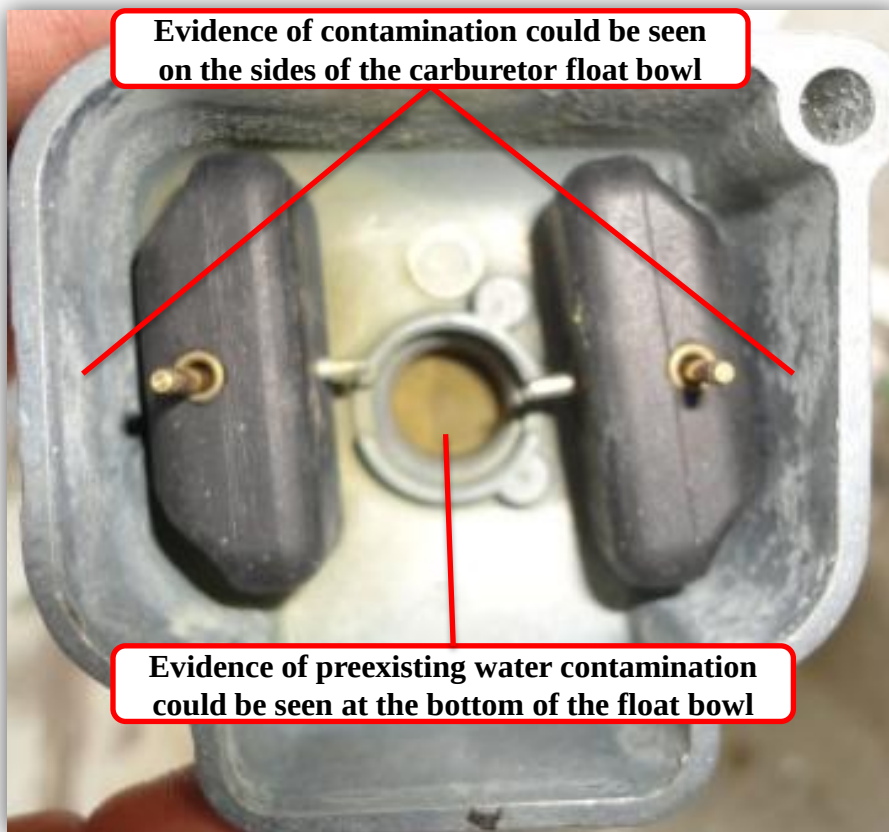
The carburetor float bowl was removed and examined for contamination and proper components. The float bowl had no fuel contained inside but evidence of fuel contamination could be seen through the float bowl. The float bowl gave off an odor of old stale fuel.

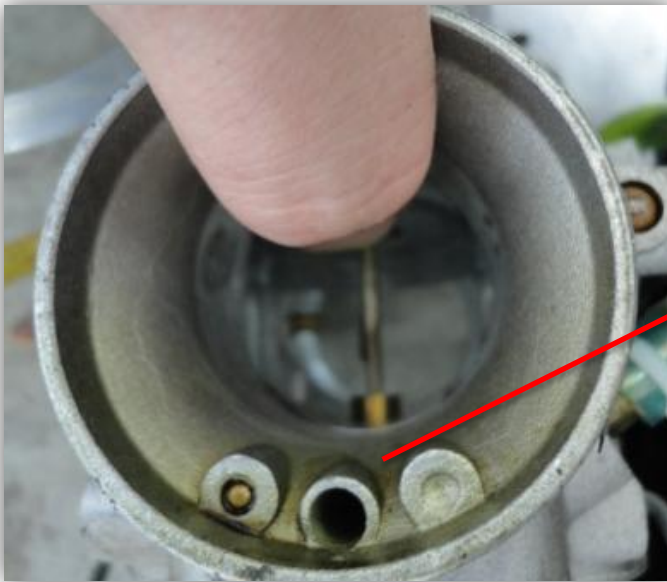
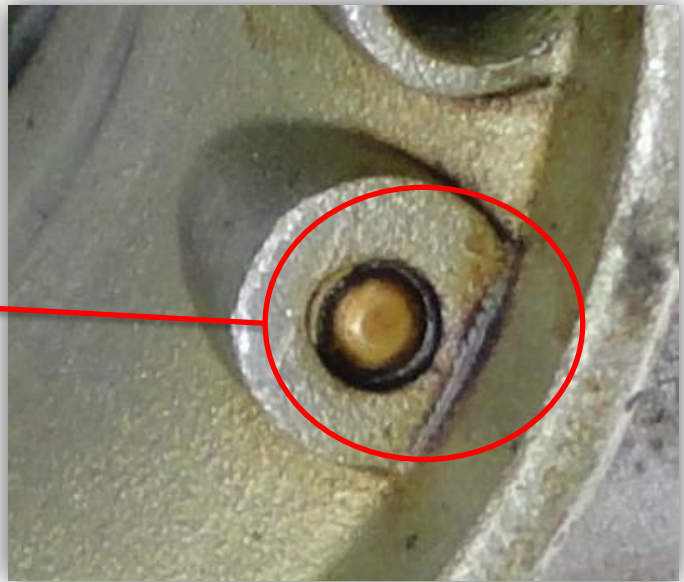
**Yellow staining and buildup of material**

The intake of the carburetor was examined for condition and contamination. Yellow staining and a build up of material was found in the intake of the carburetor. This is signs of poor fuel quality and improper of air filtration.

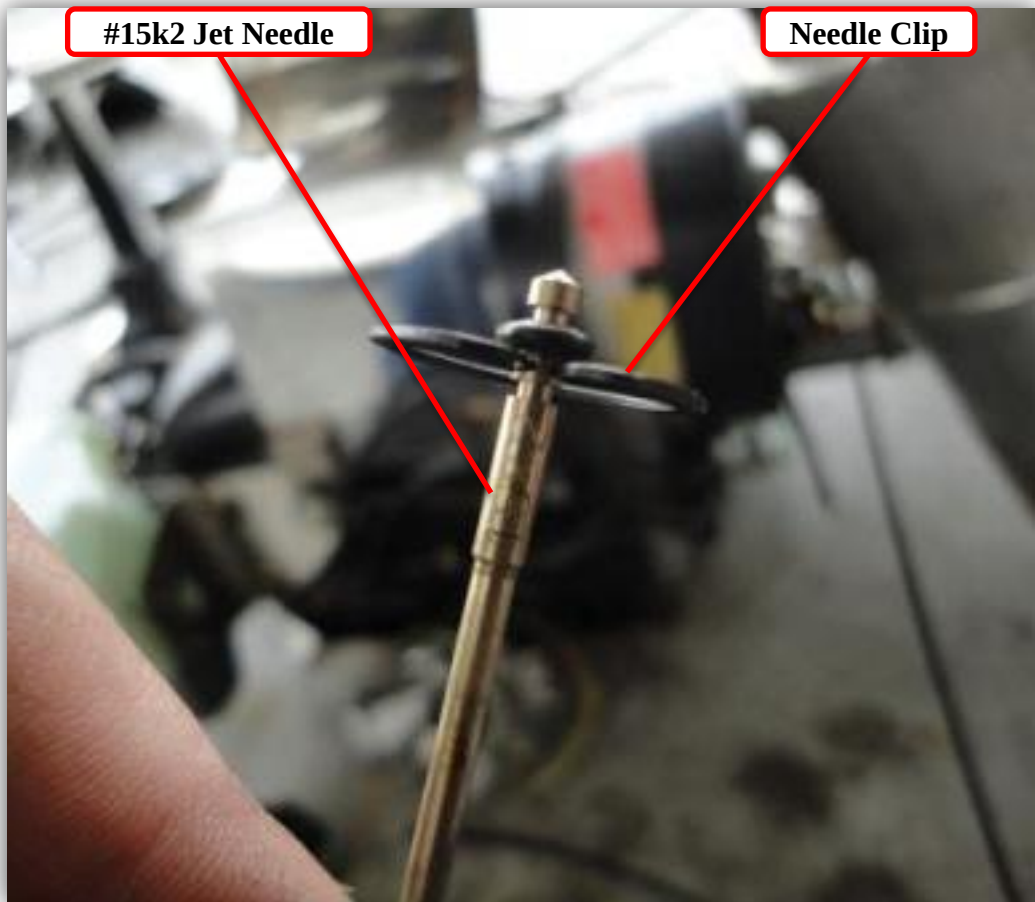
The jet needle was the stock number 15K2 with the needle clip in the stock number 3 position. It was found installed correctly and in good overall condition.

No anomalies were found with the jet needle.

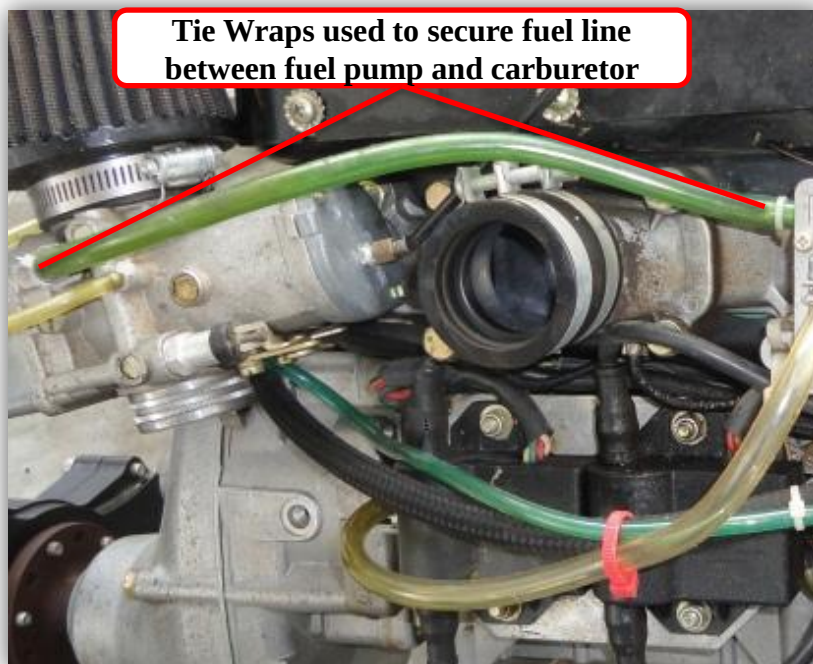
**Tie Wraps used to secure fuel line  
between fuel pump and carburetor**

The fuel lines were examined for condition, security and proper routing. The fuel line from the fuel pump to the carburetor was secured with tie wraps. In the Rotax repair manual section **10.2.5) Elimination of air leaks in the fuel line:** It states that "Some commercial clips are often not very satisfactory on small pipes, as they tend to tighten up oval, creating a possible leak. "Crimp on" clips can be unsatisfactory if incorrectly applied, and are difficult to remove for servicing. Replace all doubtful fuel line clamps with good quality approved ones." Rotax recommended clips are P/N 938 195 which are a spring type clamp.

- Incorrect fuel line connection clamps (Tie Wraps) were found installed on the fuel system that could allow air to be introduced into the fuel system.

Replace all doubtful fuel line clips with good quality approved ones. Quick release type connectors can cause air leaks, and also produce flow restrictions and possible blockage sites - likewise fuel tap connections and glands. If the fuel tank is below the engine, it is best to leave the fuel tap turned on all the time - use it only in an emergency.

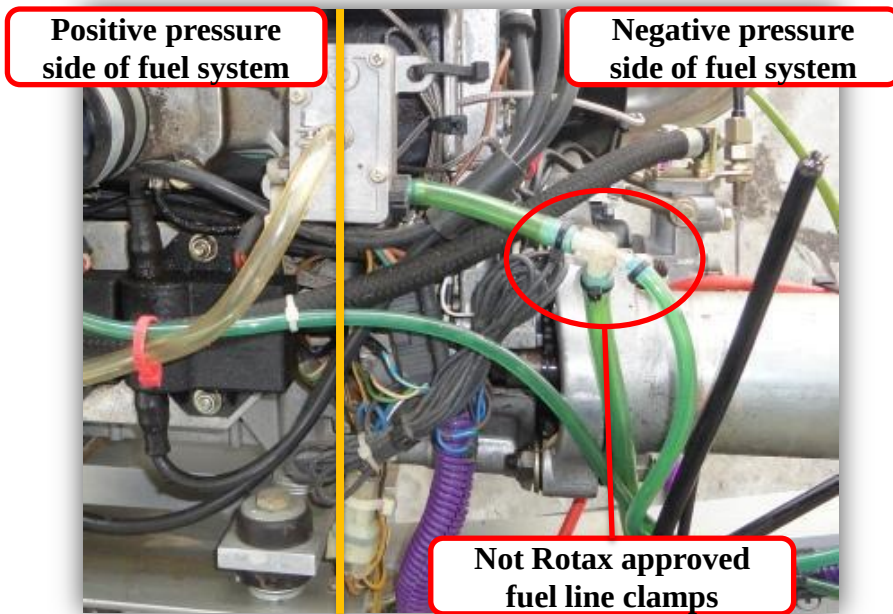
The fuel lines between the fuel tank and fuel pump (negative pressure side) were secured with non Rotax approved tie wraps. These tie wraps do not tighten uniformly and could cause air to leak into the fuel system especially if there are multiple connecting joints.

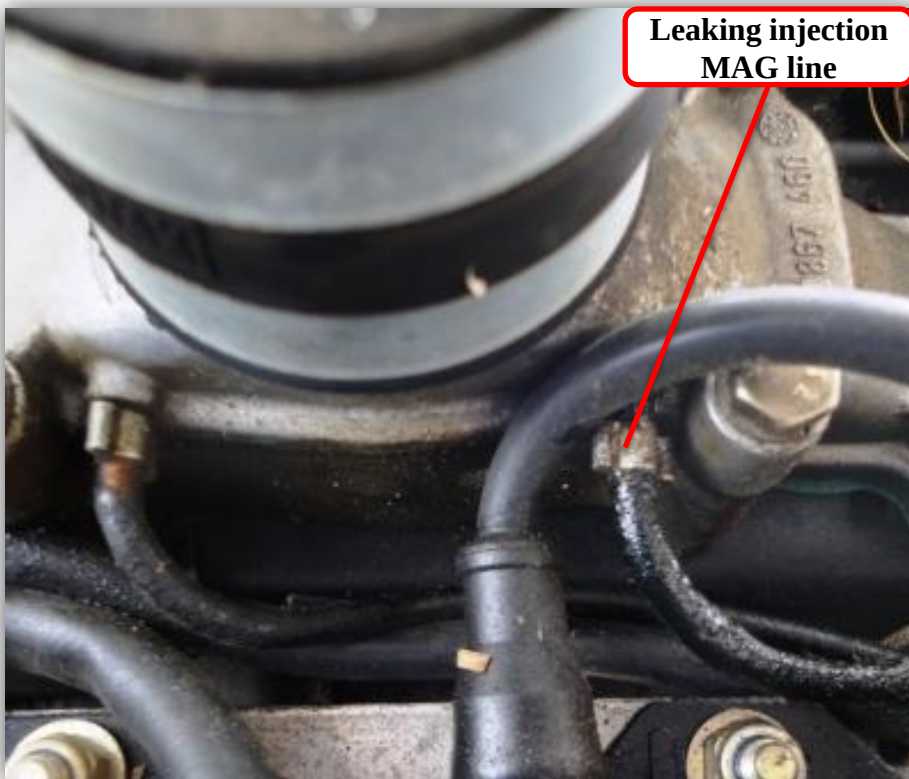
The MAG injection line appeared to be wet and seeping injection oil. A leaking injection line would affect the overall performance of the lubricating system which could lead to engine damage and a possible piston seizure.

In the Rotax operating manual in section **10.3.2) Daily Checks** it state “ Verify oil hoses for security, inspect for leaks and chafing (rotary valve gear lubrication system and oil injection system)”.

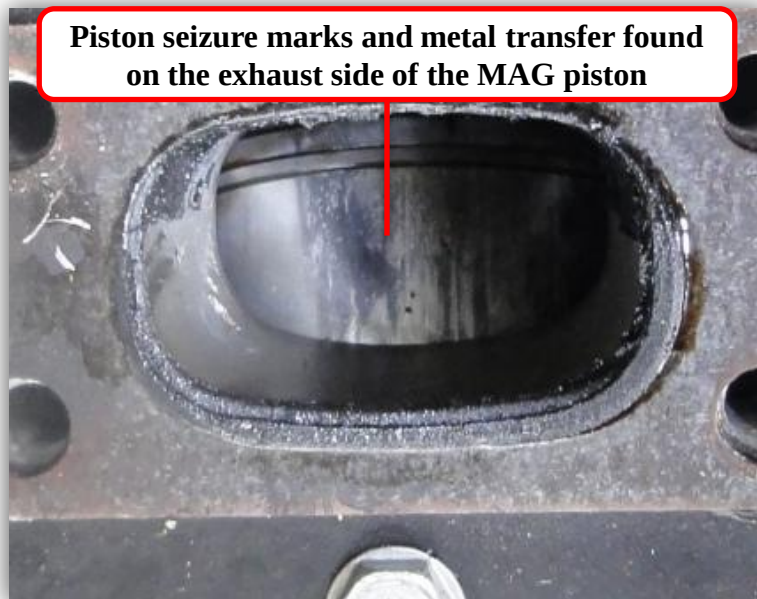
With the exhaust ports exposed the exhaust side of the Magneto piston could be examined. Metal transfer and seizure marks were seen on the exhaust side of the Magneto Piston.

It is determined that the cause of engine power loss was due to a magneto piston heat seizure on the exhaust side of the piston. The magneto piston also established a sympathetic seizure on the intake side of the piston.

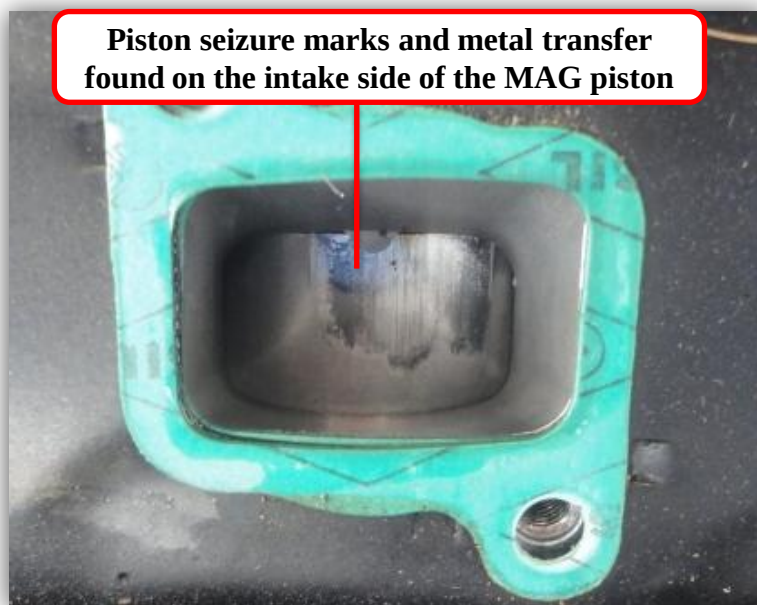
The intake manifold was removed to expose the intake side of the MAG piston. Metal transfer and seizure marks were seen on the intake side of t

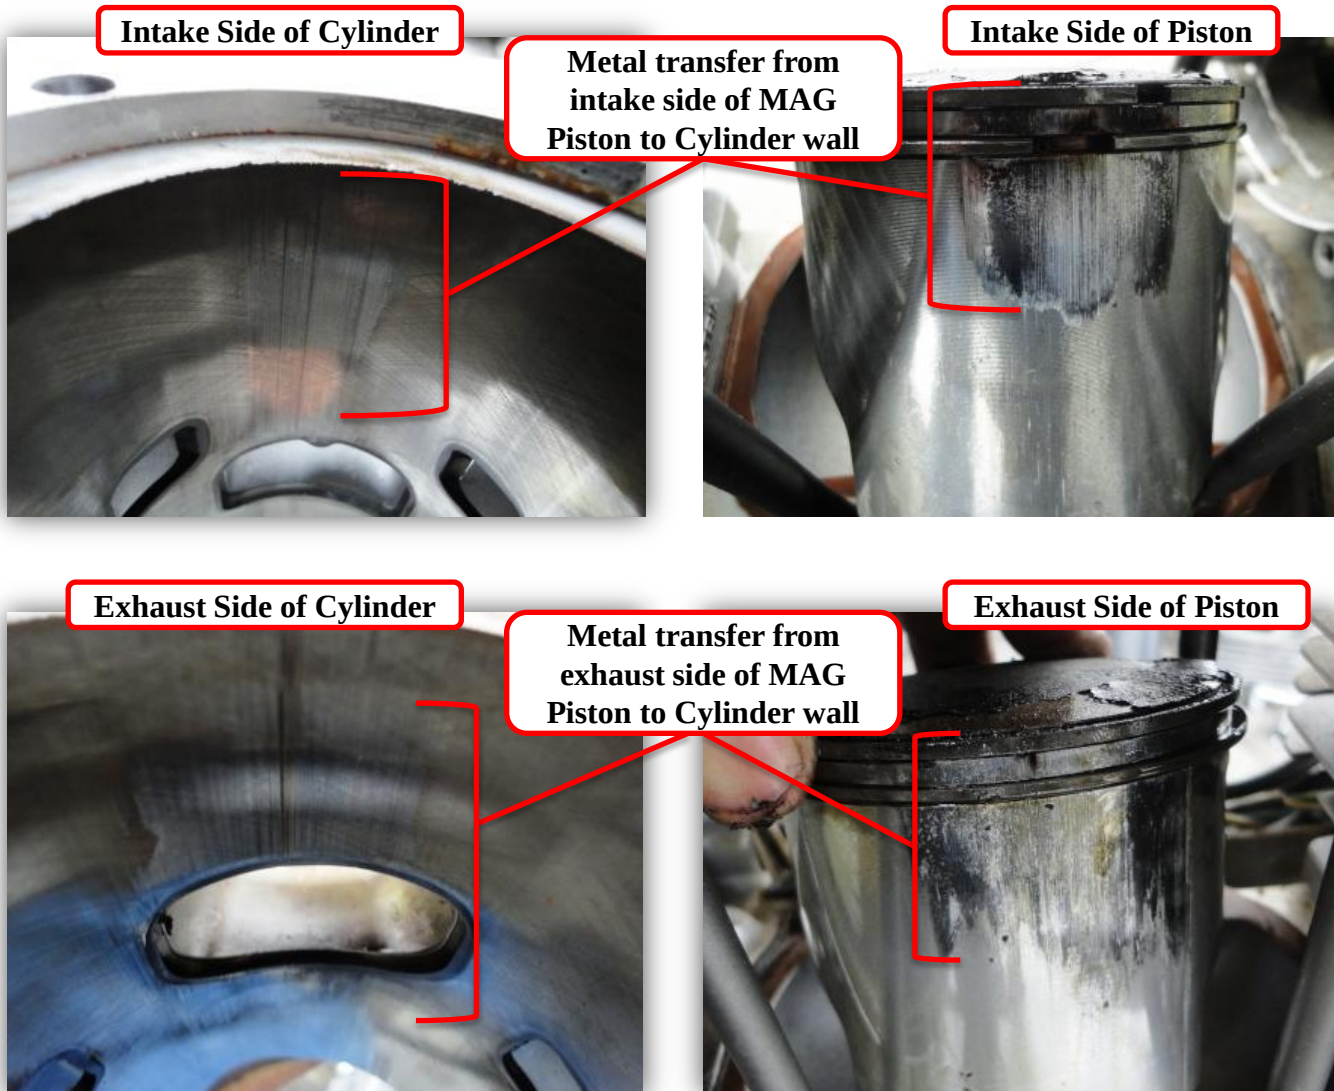
Metal transfer was seen on both the intake side and the exhaust side of the magneto piston and cylinder. The seizure marks on the magneto piston extended from the top of the piston, though the piston rings reaching approximately half way down the side of the piston.

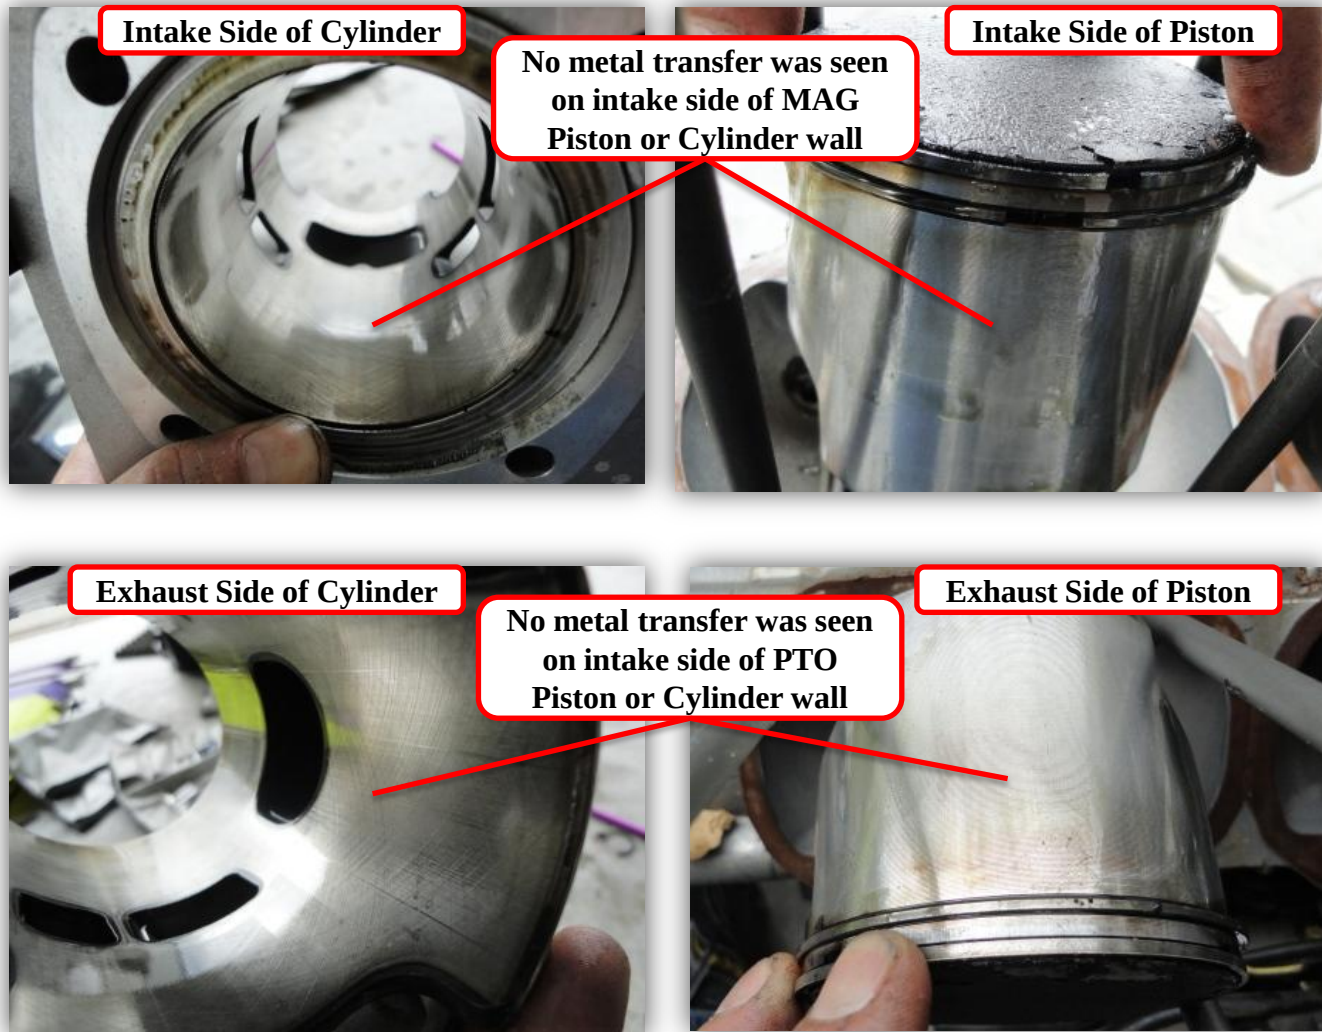
The PTO piston and cylinder appeared to be in good overall condition with no signs of seizure or metal transfer. No anomalies found with the PTO piston and cylinder
