# NATIONAL TRANSPORTATION SAFETY BOARD

## MATERIALS LABORATORY FACTUAL REPORT

Report No. 14-005

Place : Panama City Beach, Florida  
Date : March 18, 2013  
Vehicle : Piper PA-25-235, N86AB  
NTSB No. : ERA13LA174  
Investigator : Dennis Diaz, ASI-ERA

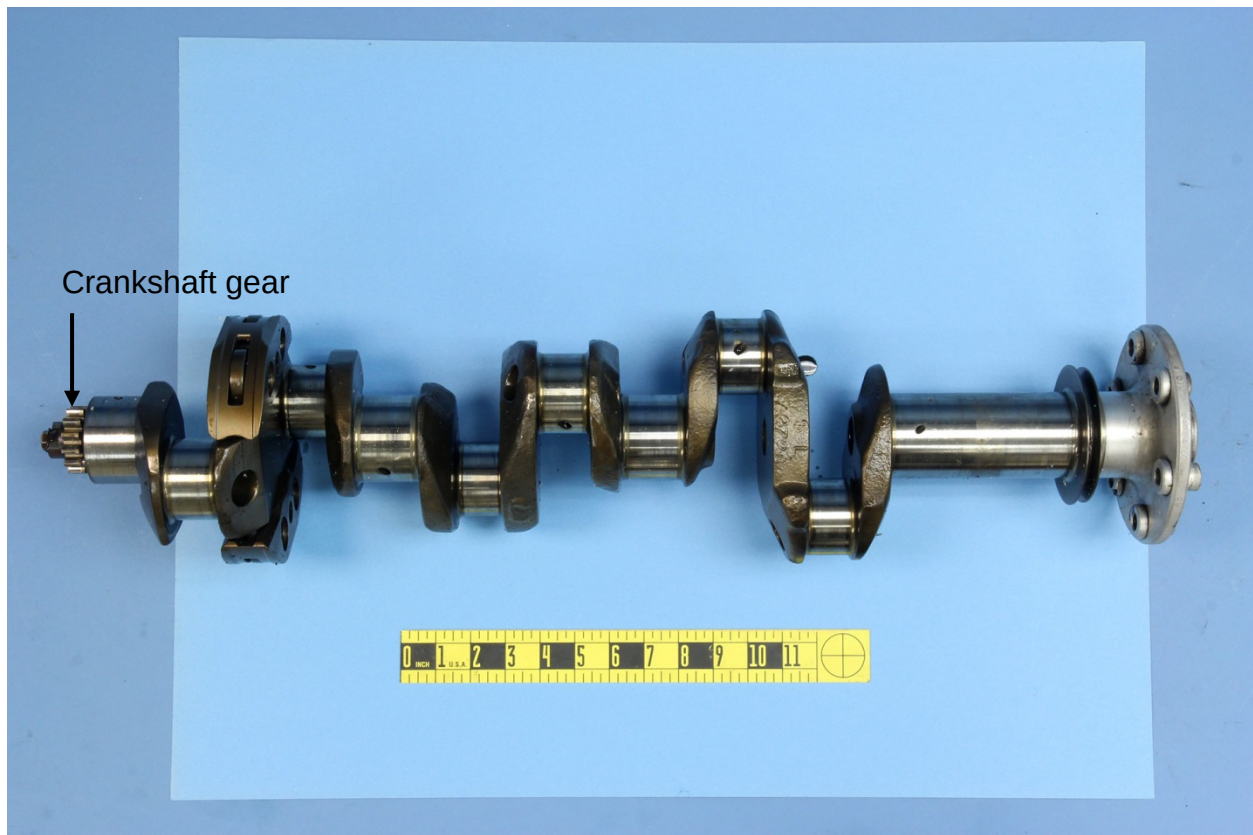
A crankshaft from a Lycoming engine (model and serial numbers given above) was submitted to the Materials Laboratory as shown in figure 1a. The connecting rods had been removed and the crankshaft gear was still attached. There were no signs of thermal or mechanical distress on any of the main bearing or connecting rod journals.

**Figure 1:** Crankshaft from the Lycoming engine as it was received by the lab.

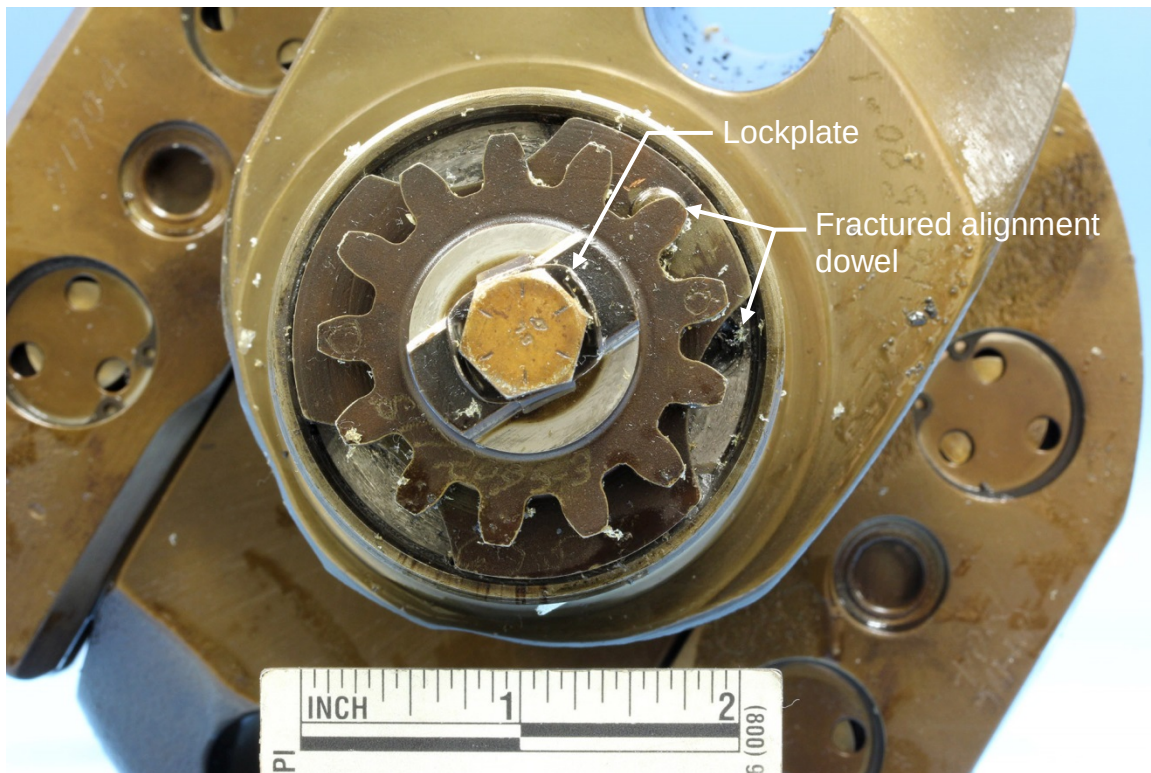
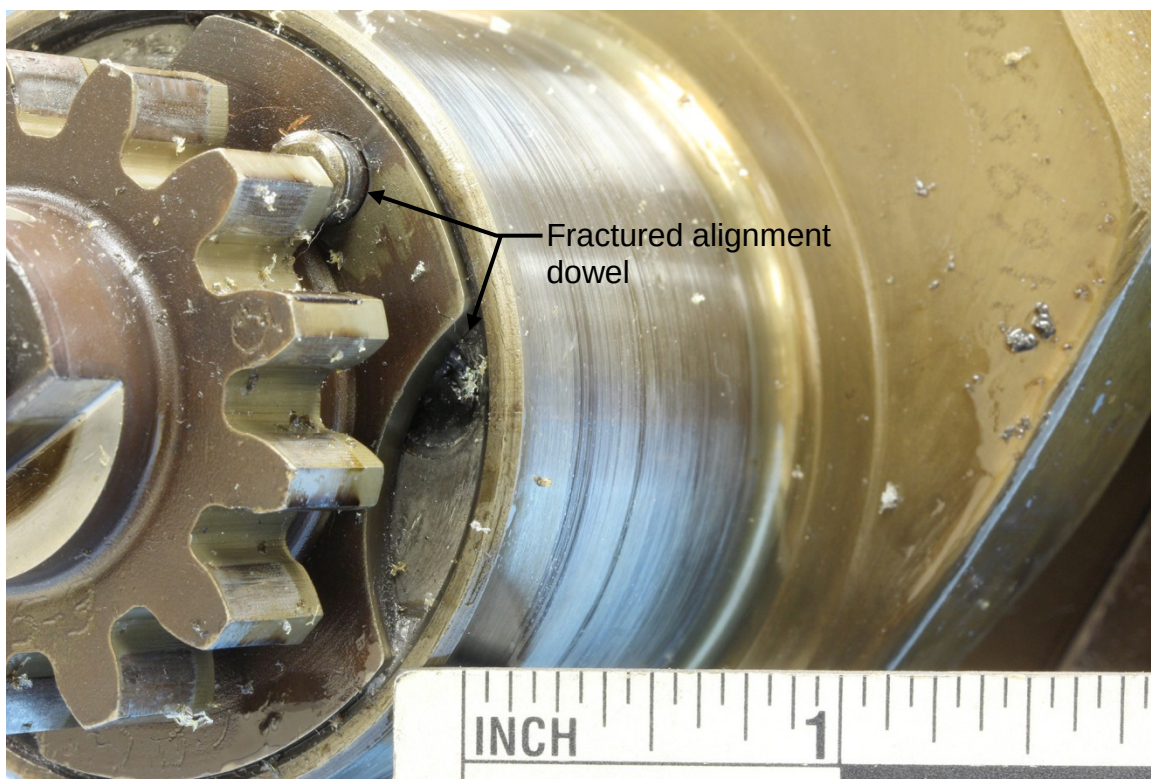
Two views of the crankshaft gear are shown in figures 2a and b. The crankshaft gear sits inside a counterbored pilot hole in the aft end of the crankshaft. The gear is pressed against the face of the recess by a bolt that engages a threaded hole in the end of the crankshaft. A lockplate is installed between the bolt and the gear with ears that fold down against the side of the gear and up against the head of the bolt. The gear is rotationally aligned to the crankshaft by an alignment dowel. The alignment dowel was fractured as shown in figures 2a and 2b. One end of the dowel was retained inside the alignment hole in the gear and the other end was press-fit and retained in the end of the crankshaft. Based on the rotational misalignment of the two dowel halves, the gear had rotated approximately 45° counterclockwise relative to the crankshaft. The lockplate had also rotated in the counterclockwise direction, but to a lesser degree.

**Figure 2:** a) axial view of the crankshaft showing the relative rotation of the gear and the lockplate relative to the crankshaft and b) off-axis view showing the two halves of the fractured alignment dowel.

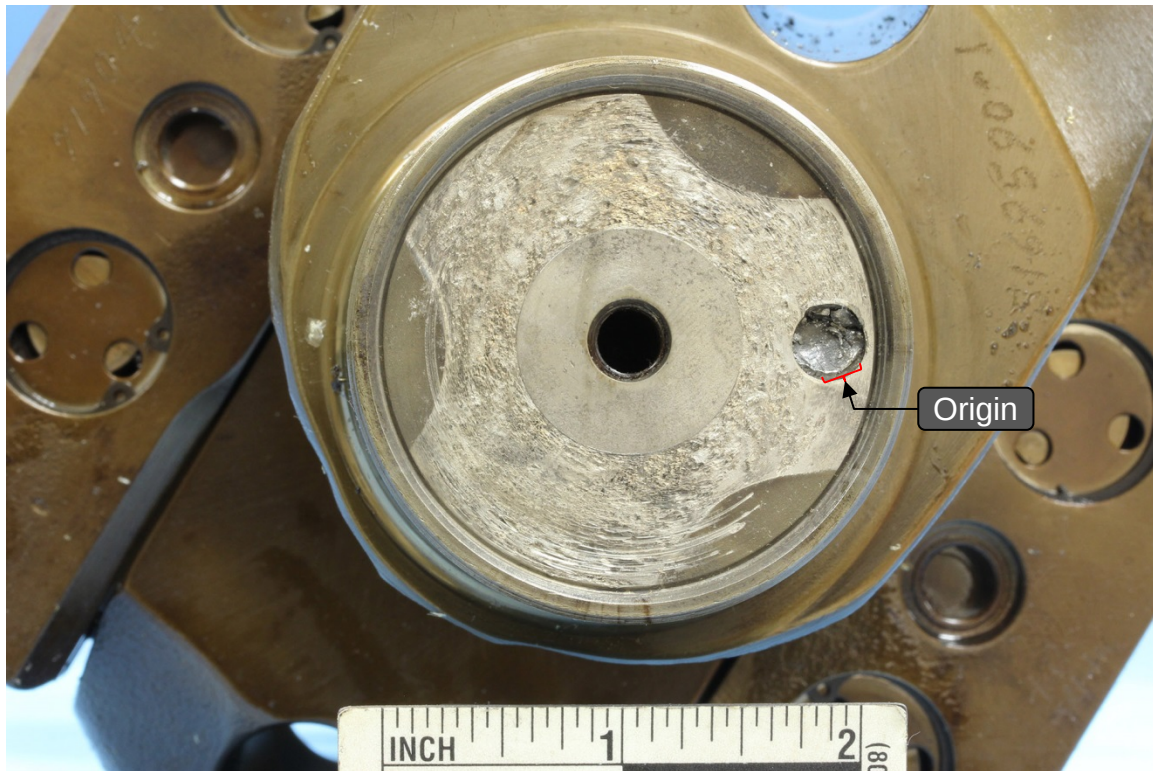
**Figure 3:** Image of the counterbored pilot hole after the crankshaft gear had been removed. In the area where the gear had been in contact with the face of the pilot hole, the surface exhibited scratch marks and adhered material.

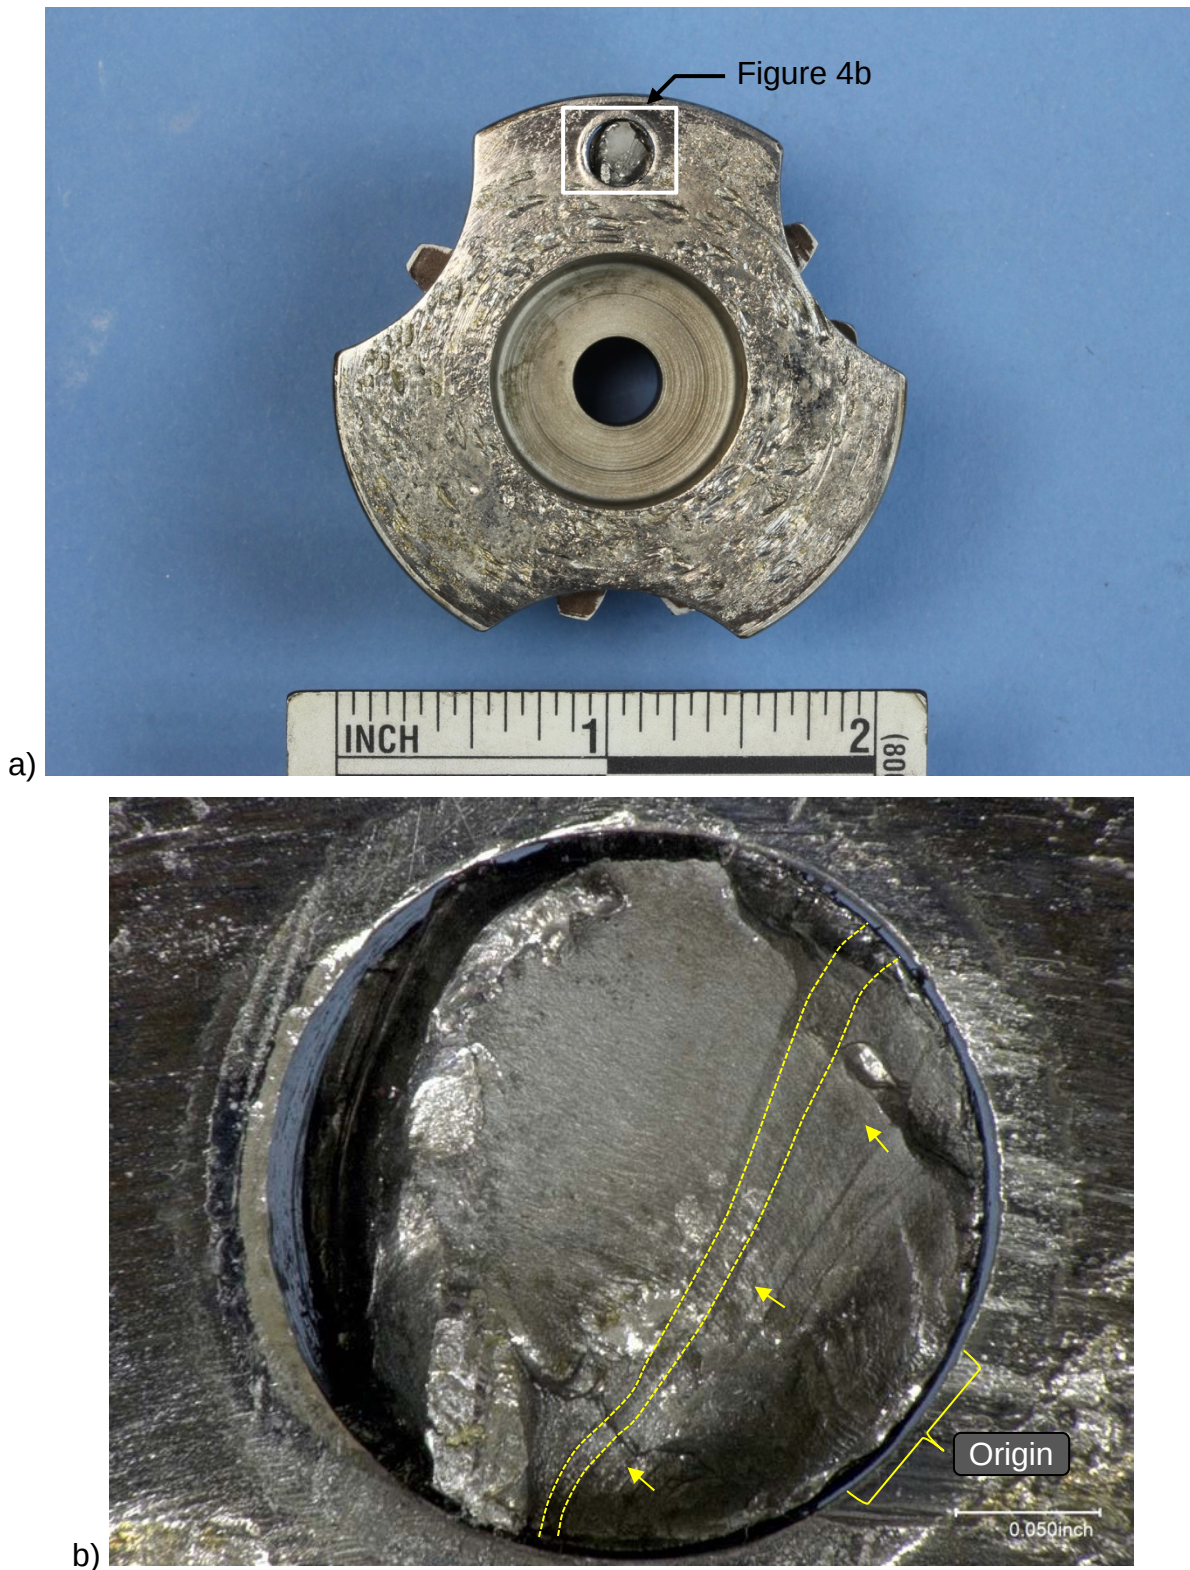
material consistent with an anti-seize compound. The bolt was turned into the threaded hole until it nearly bottomed out. The bolt could be turned with fingers up to the thread containing the compound at which point the compound provided some resistance to further insertion (approximately 3.5 in-lbs measured using a torque wrench). Over the area where the gear had been in contact with the face of the pilot hole recess the surface exhibited circumferential scratch marks and had transferred metal adhered to it, as shown in figure 3. The mating face of the gear, shown in figure 4a, exhibited corresponding scratches and gouges, consistent with galling.

The dowel fracture surface was examined on the piece of the dowel that was retained in the alignment hole. The fracture surface had a comparatively flat appearance and exhibited multiple crack arrest marks, several of which are indicated by yellow-dashed lines shown in figure 4b. The morphology of the fracture surface was consistent with a fatigue fracture. The curvature of the crack arrest marks was consistent with the fatigue fracture originating along the surface of the dowel in the area indicated in figures 4b. The fracture features were compared with the mating dowel piece retained in the crankshaft. The comparison indicated the fracture initiated along the clockwise face of the dowel (leading face in the direction of rotation), as indicated in figure 3 and that the dowel fragment retained in the gear alignment hole (shown in figure 4b) had rotated by approximated 180°.

**Figure 4:** a) Image of the face of the crankshaft gear that mates with the face of the counterbored pilot hole and b) image of the fractured alignment dowel. Crack arrest marks were observed and the fracture had a flat appearance, consistent with a fatigue fracture. The piece of the dowel rotated approximately 180° after it fractured.
