# NATIONAL TRANSPORTATION SAFETY BOARD

## MATERIALS LABORATORY FACTUAL REPORT

Report No. 15-033

Place : Hoosick Falls, NY  
Date : April 28, 2013  
Vehicle : Aeronca 11AC  
NTSB No. : ERA13LA221  
Investigator : Shawn Etcher

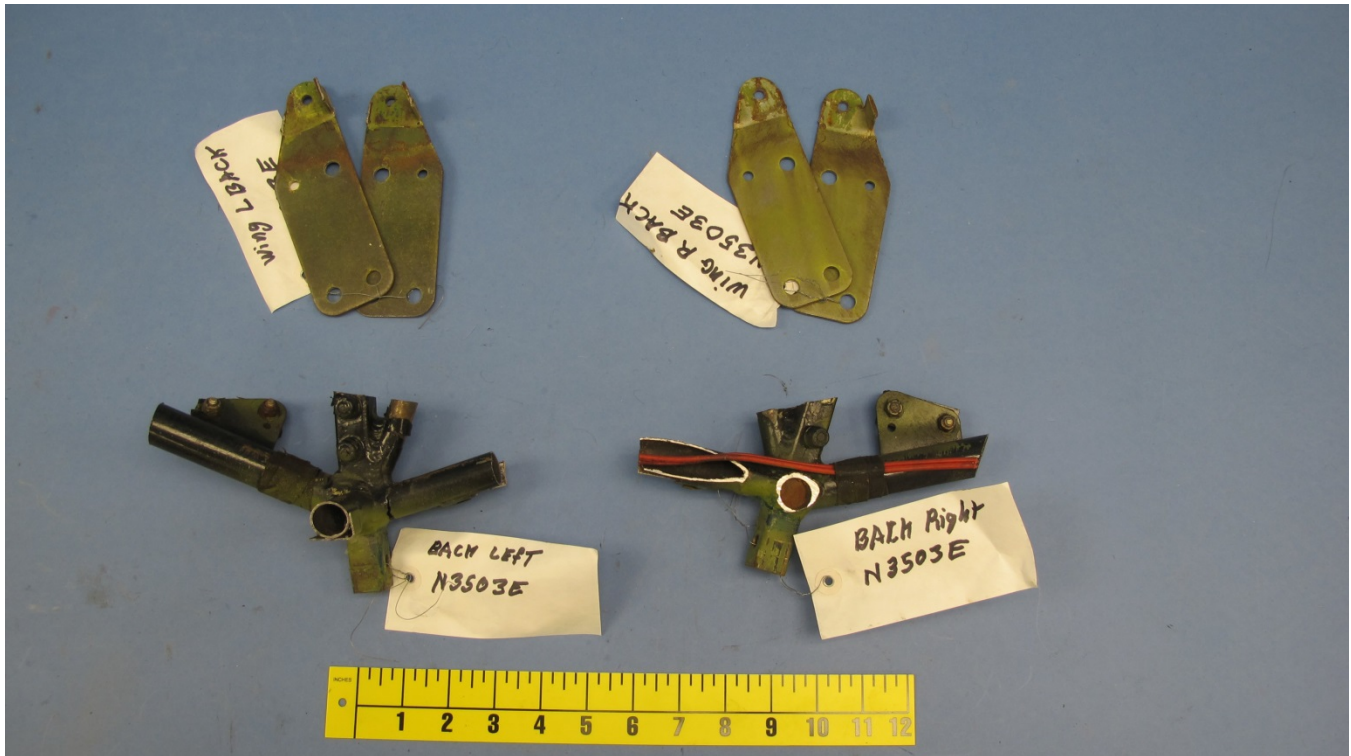
Both aft wing attach brackets for the left and right wings (figure 1)

Figure 1: Accident parts as received.

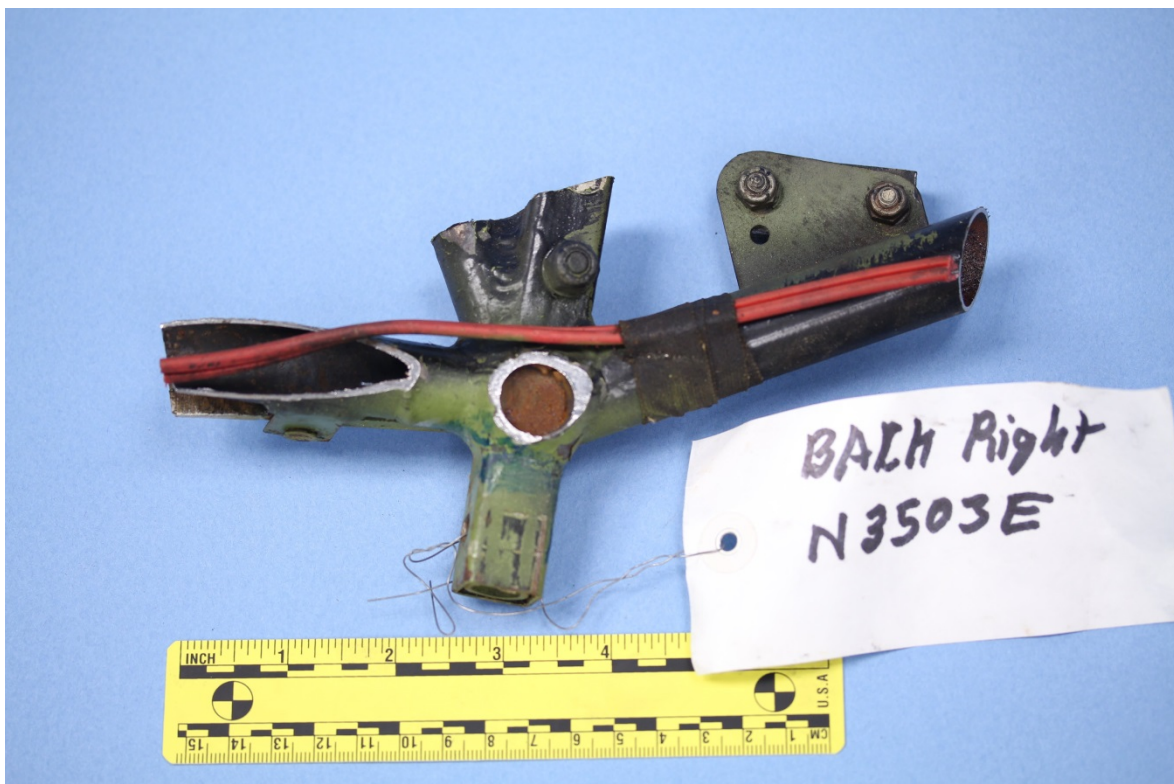
Figure 2: Aft right attachment bracket (exemplar)

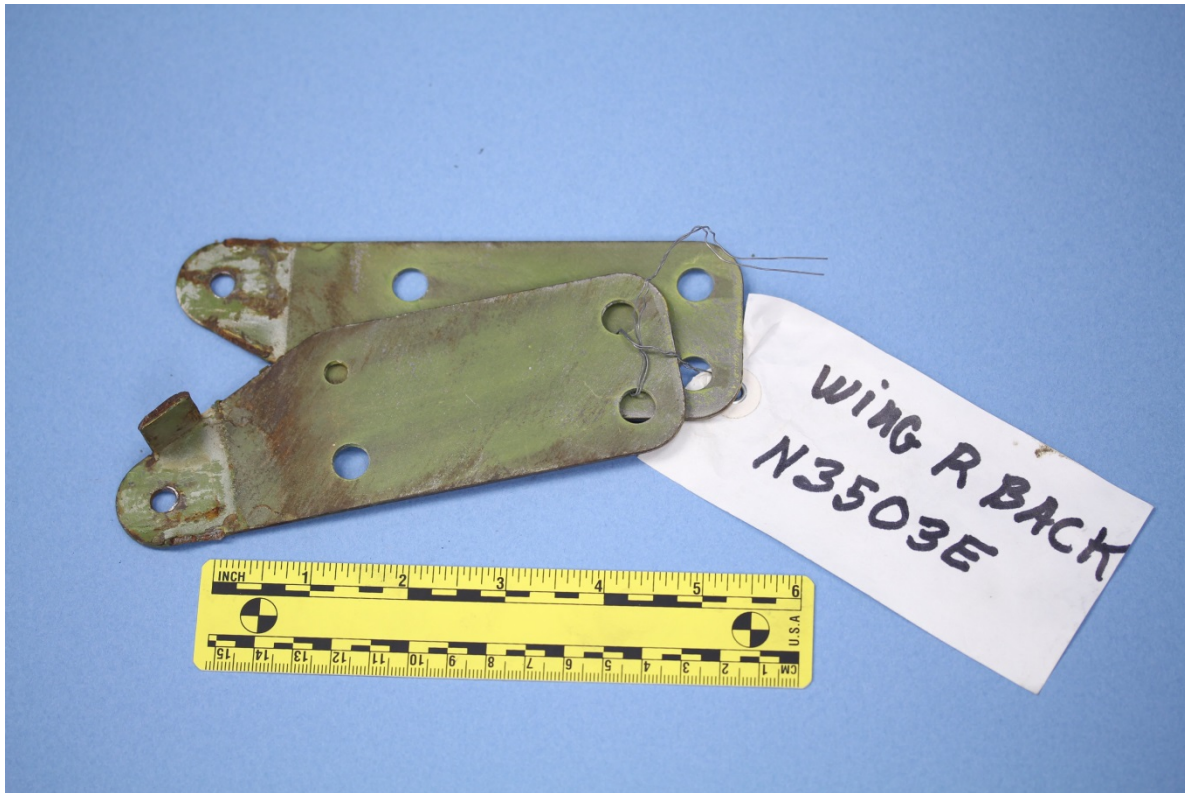
The aft wing attachment brackets were examined to determine the mode in which they failed. The aft right wing attachment bracket depicted in figure 2 was sent in as an exemplar and did not contain any fractures. The aft right wing attachment bracket depicted in figure 3 consisted of two plates which would have been parallel to each other and held in position by two short cross members welded in between them. One of the cross members separated from both plates and was not recovered. The other cross member remained attached to only one of the plates. Examination of the fracture surfaces revealed that the fractures were consistent with overstress. Additionally, The welds connecting the cross members to the plates appeared to lack full penetration into the base material.

Figure 3: Right wing aft attachment bracket

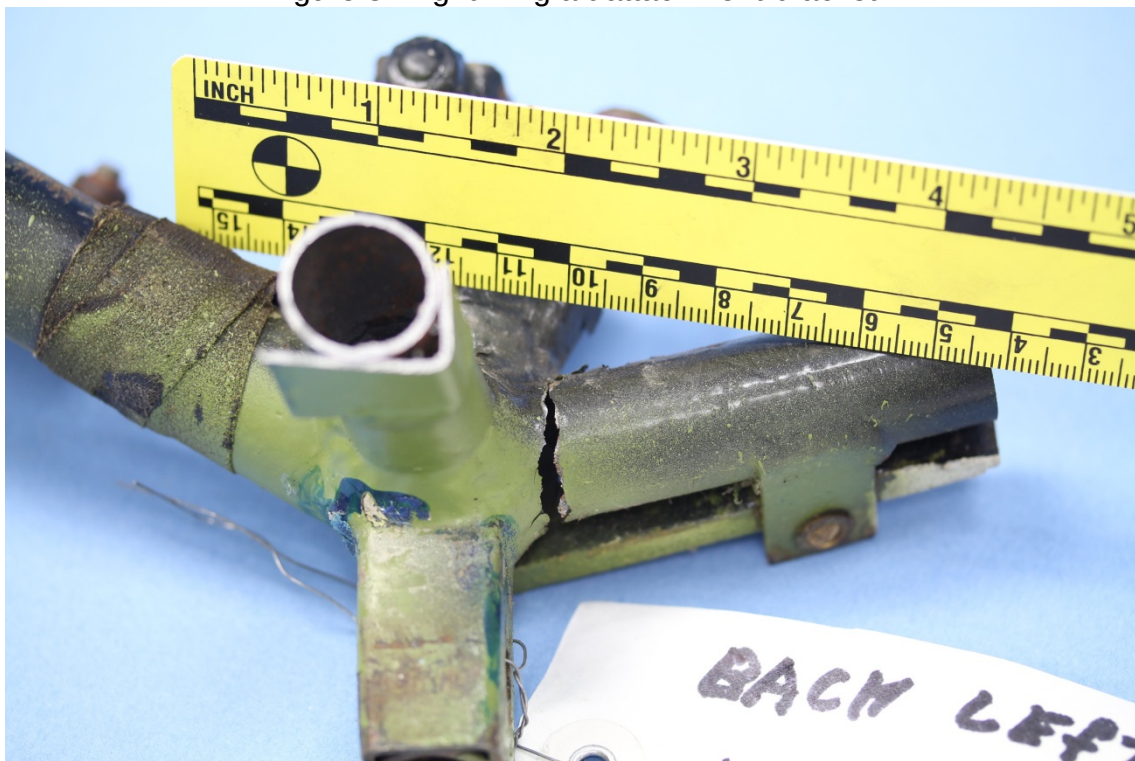
The aft left wing attachment brackets both exhibited fractures. The bracket shown in figure 4 consisted primarily of a welded cluster of tubing. One of the tubes was bent out of position and a corresponding fracture occurred at the location where it joined the other tubes in the cluster. This fracture is consistent with bending overstress. The second aft left wing attachment bracket was of the parallel plate type with two cross members in between (figure 5). The cross members had separated from the plates leaving one attached to each plate. The deformation to the plates and appearance of the fracture surfaces (figures 6 & 7) is consistent with bending overstress. Additionally, The welds connecting the cross members to the plates appeared to lack full penetration into the base material.

Figure 4: Left wing aft attachment bracket with fracture at the weld

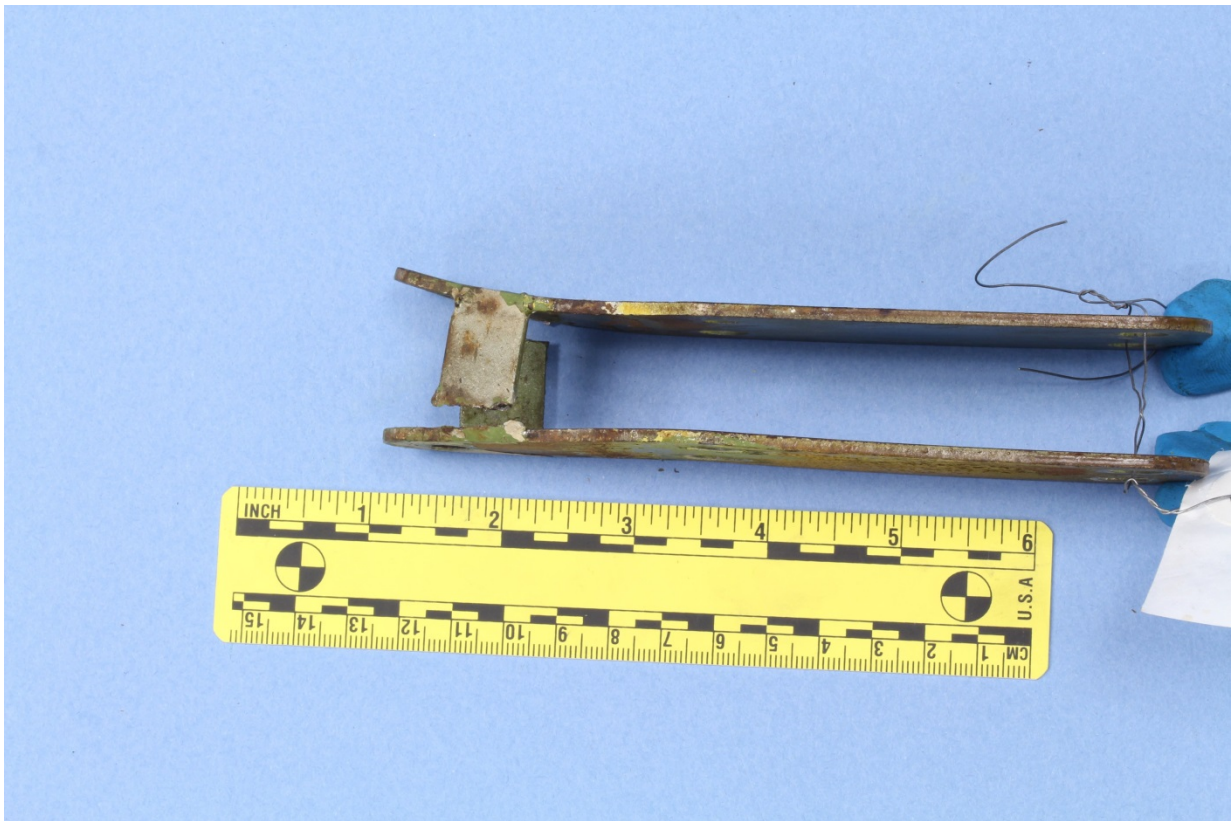
Figure 5: Left aft wing attachment bracket

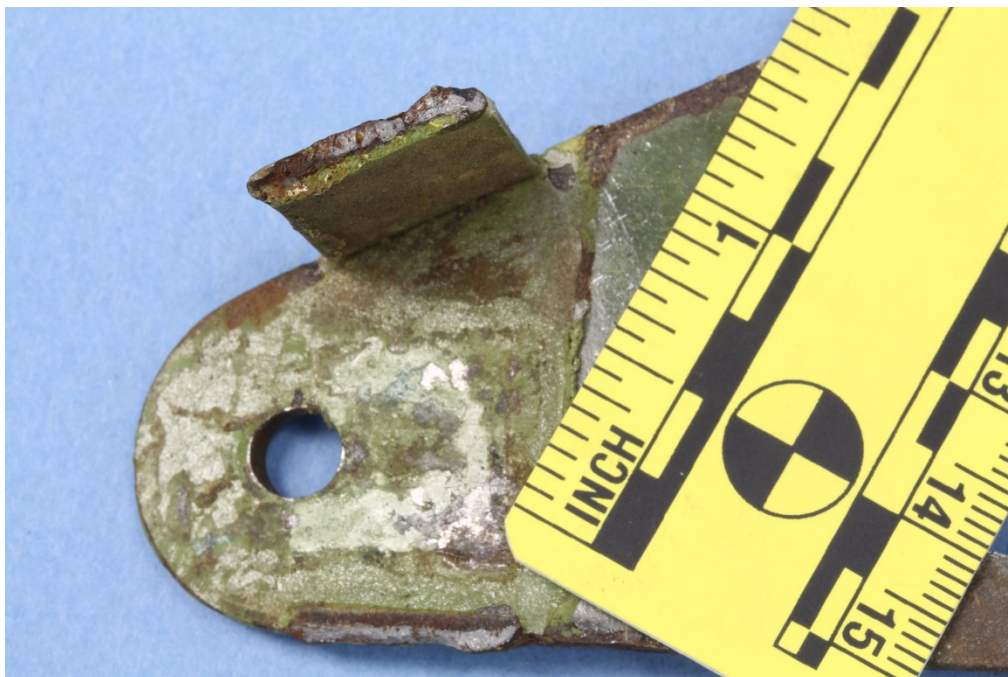
Figure 6: Plate from left aft wing attachment bracket

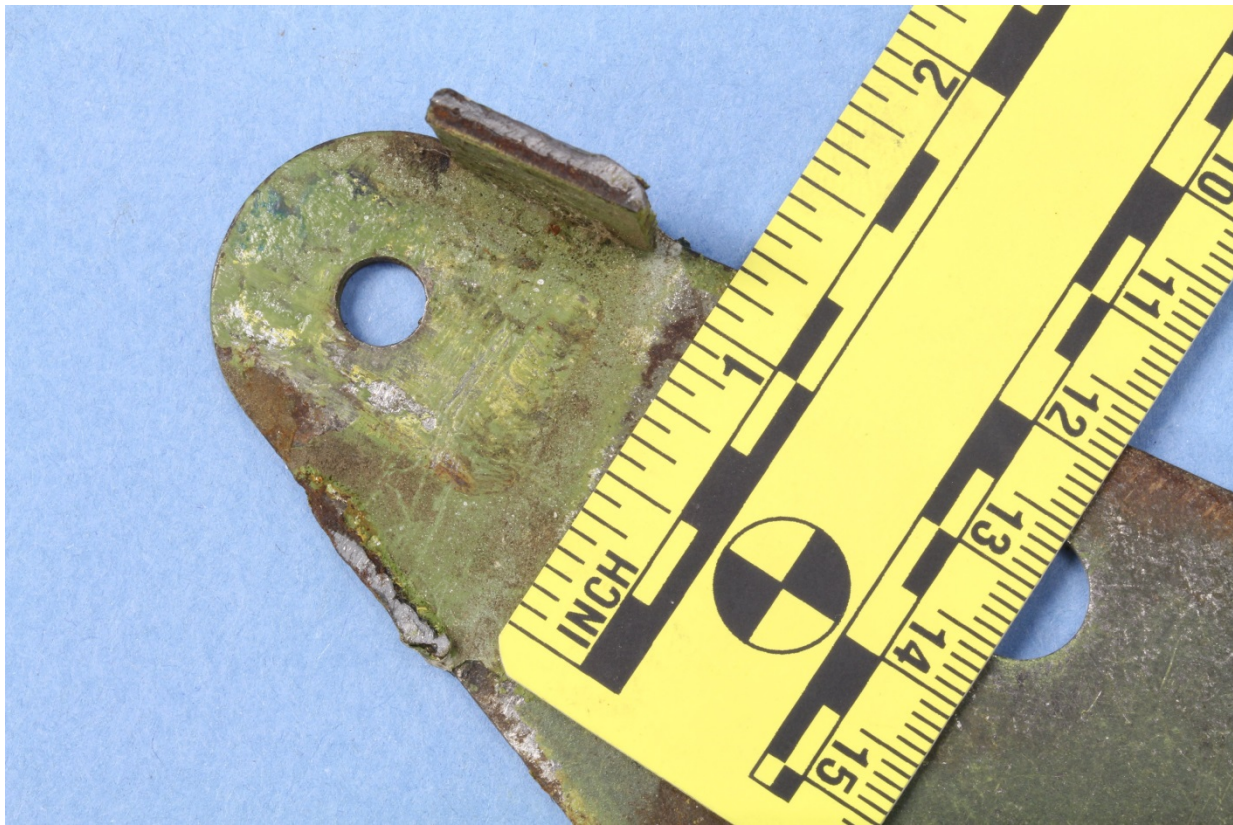
Figure 7: Plate from left aft wing attachment bracket
