**ERA13LA382**

**Revo, Incorporated Lake Model 250**

**N522WB**

**NTSB ENGINE EXAMINATION NOTES**

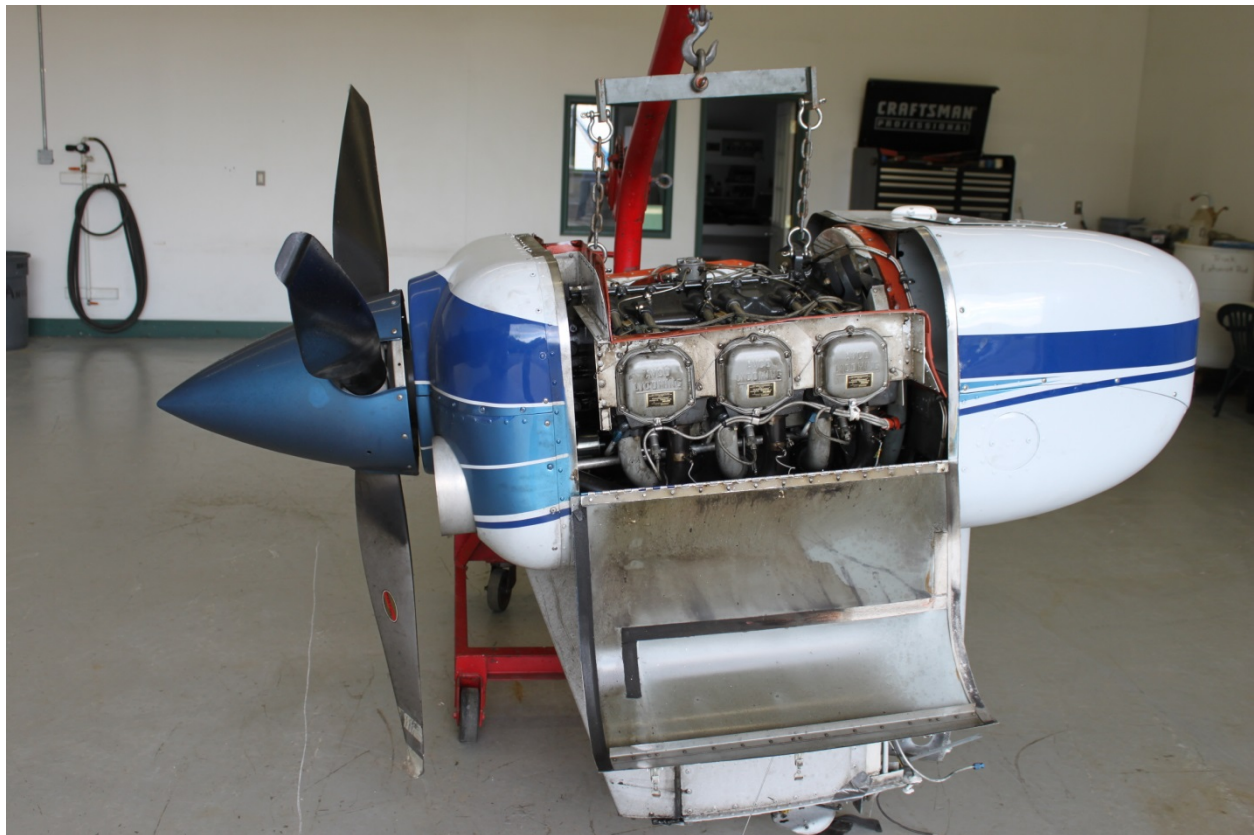
The engine was received attached to the vertical pylon. Examination of the engine revealed an engine crankcase breach in the vicinity of Cylinder No. 6. Further examination of the engine revealed that all three propeller blades exhibited curling at the tip. Oil was present on the engine as well as evidence of oil along the inside of the cowling. The engine cowling, propeller hub, and vertical pylon were removed for further examination of the engine.

Photo 1: Right Side of Engine as Received

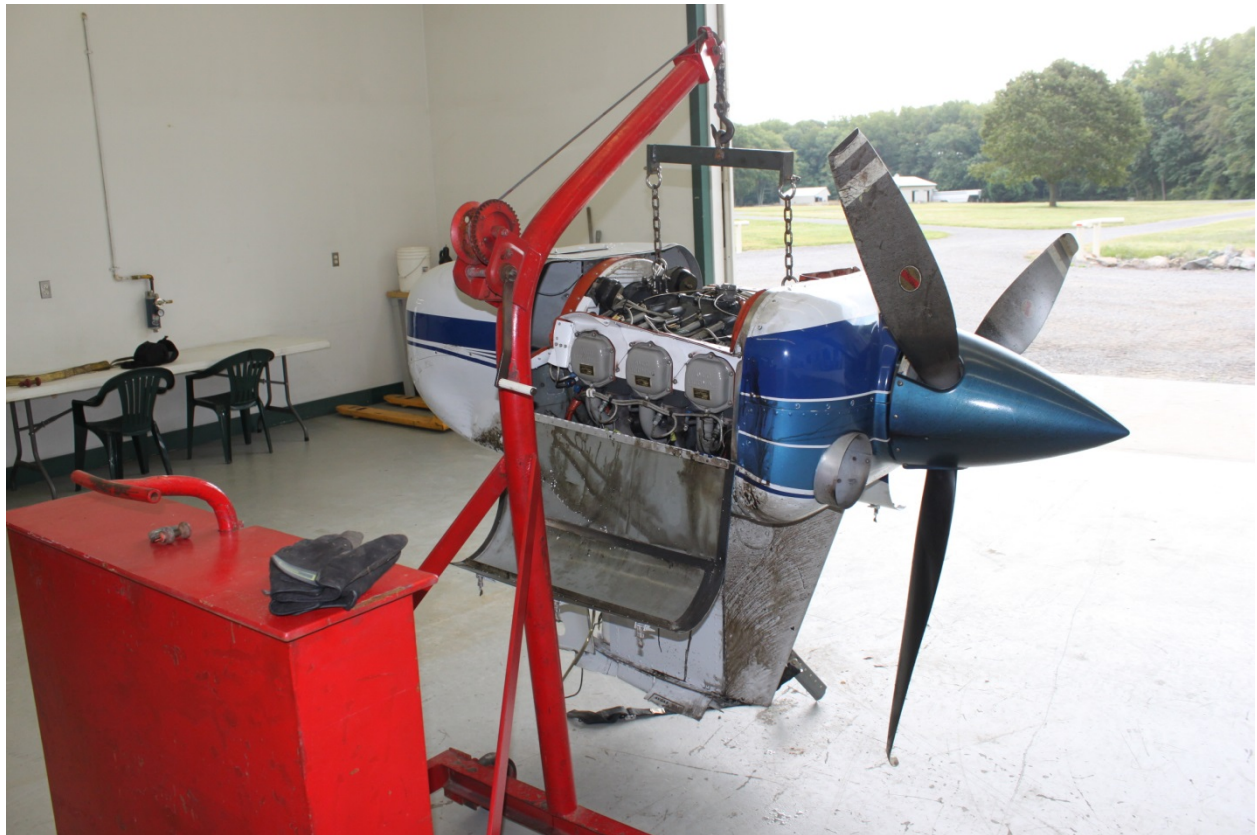
Photo 2: Left Side of Engine as Received

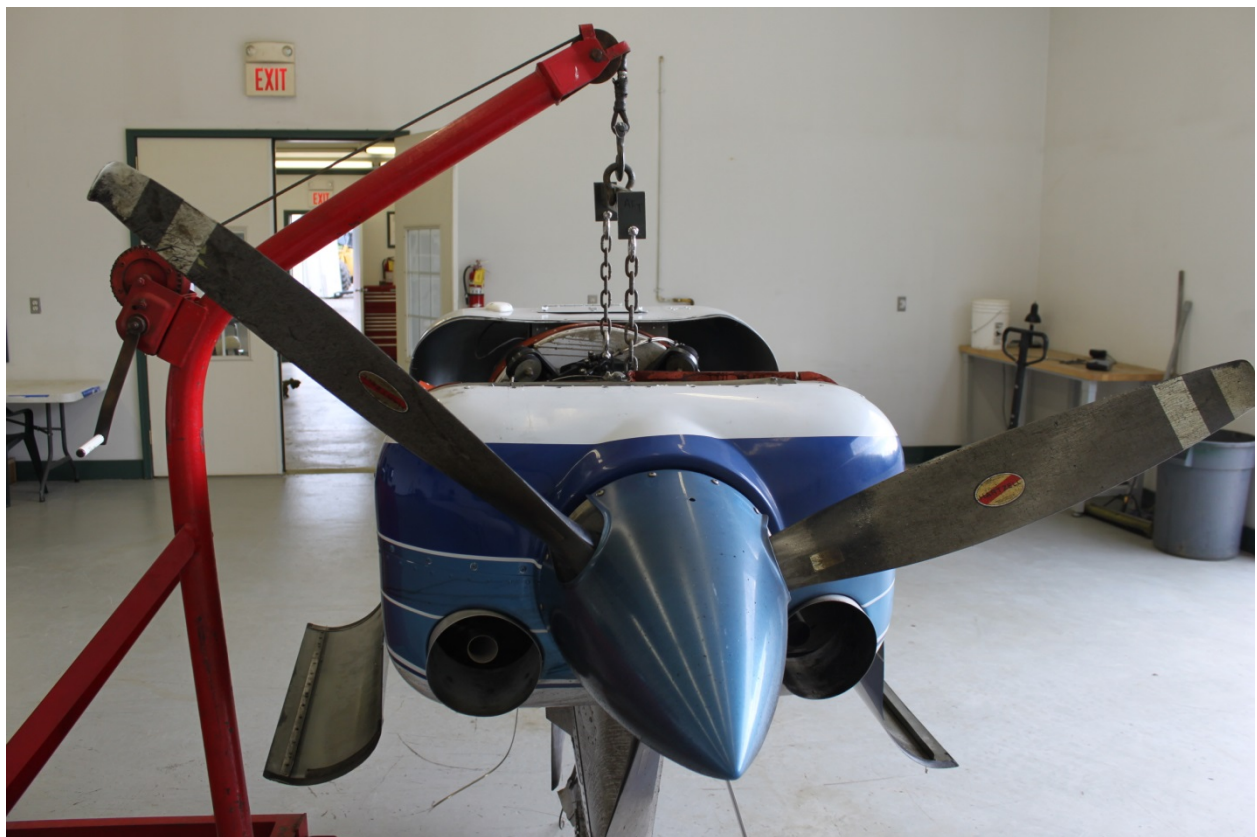
Photo 3: Rear of Engine with Propeller Hub

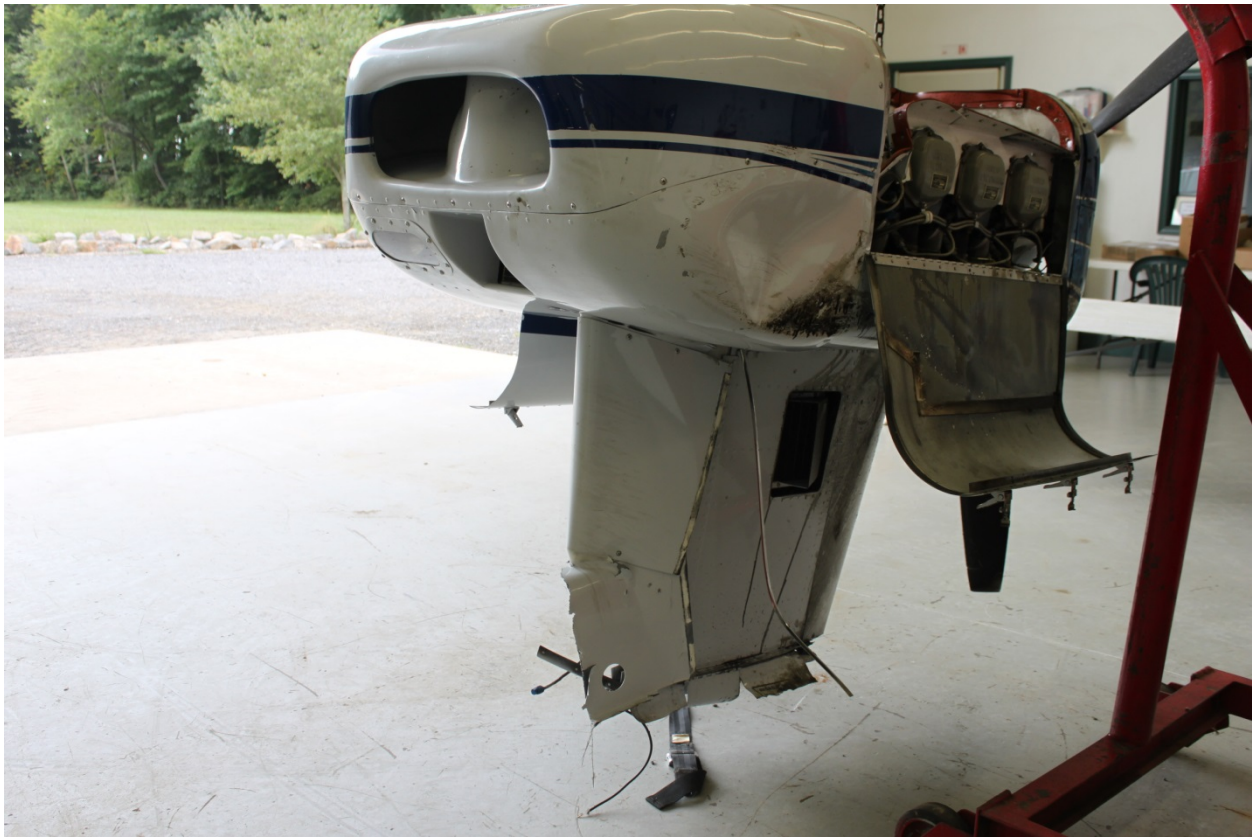
Photo 4: Front of Engine as Received

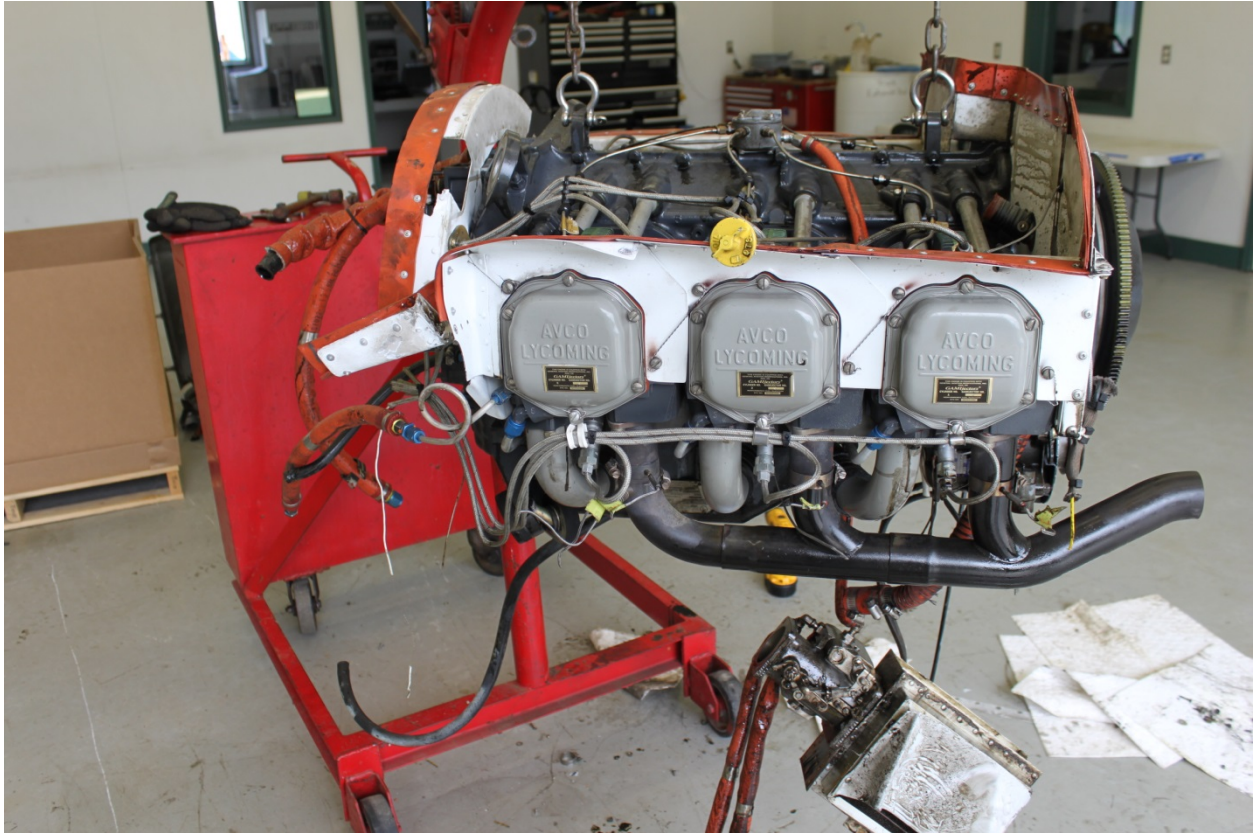
The engine was examined and the cylinder head covers were removed from all six (6) cylinders and all twelve (12) spark plugs were removed. Minimal damage was noted on the crank case excluding the breach. The oil filler cap was found secured and in place, it was removed and no oil was present on the stick. Prior to removal of the propeller hub the engine was attempted to be rotated by hand; however, resistance was noted and rotation was not achieved. All components on the rear accessory pad, which in this installation was the forward section of the engine as this engine had a rear mounted propeller assembly. The engine was mounted on a vertical engine tripod stand and Cylinder Nos 1, 2, 3, and 4 were removed; however, examination of Cylinder Nos. 5 and 6 revealed extensive damage to mounting surface of the associated cylinder and the engine case which precluded removal. The nuts associated with the through bolts and cylinder studs were painted in the same color as the engine case and no evidence was found indicating that any of the cylinders had been removed since assembly. Cylinder No. 6 connecting rod remained connected to the piston by the piston pin; however, the connecting rod was separated from the crankpin journal. The connecting rod cap was not attached to the connecting rod. The connecting rod was deformed at the yoke. The shank and threaded portion of one connecting rod bolt remained trapped in the deformed portion of the connecting rod, and the head portion of the bolt was separated. The head portion of the bolt was bent, fractured, and tapered. Approximately the last 3 to 4 threads of the bolt visually appeared undamaged, while numerous threads toward the shank portion of the bolt were damaged; the associated nut was not present on the bolt. The inside of the case in the vicinity of Cylinder Nos. 5 and 6 had extensive scoring and gouge marks indicative of rotation and failure of the connecting rod. All other cylinders appeared normal;

Photo 5: Cylinders No. 1, 3, and 5

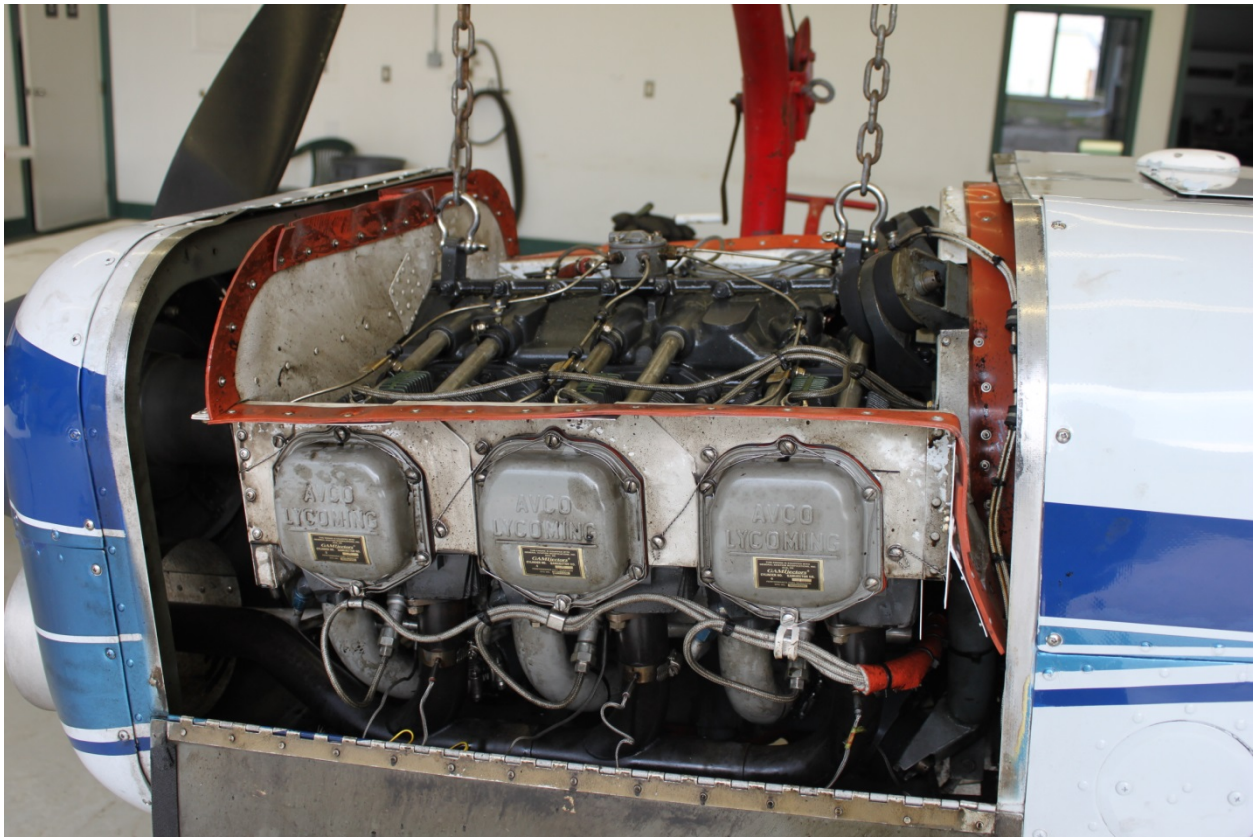
Photo 6: Cylinders No. 2, 4, and 6

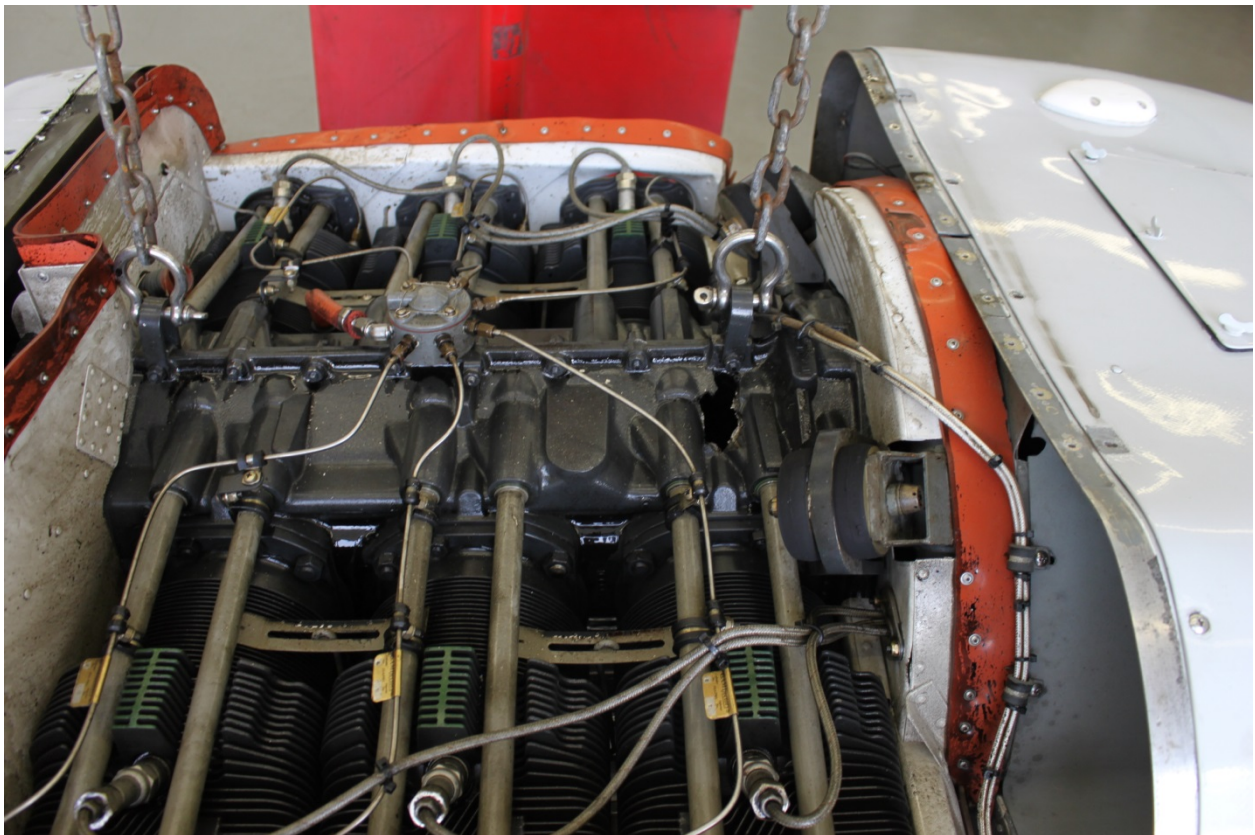
Photo 7: Top of Engine with Breach in Case in the Vicinity of Cylinder No. 6

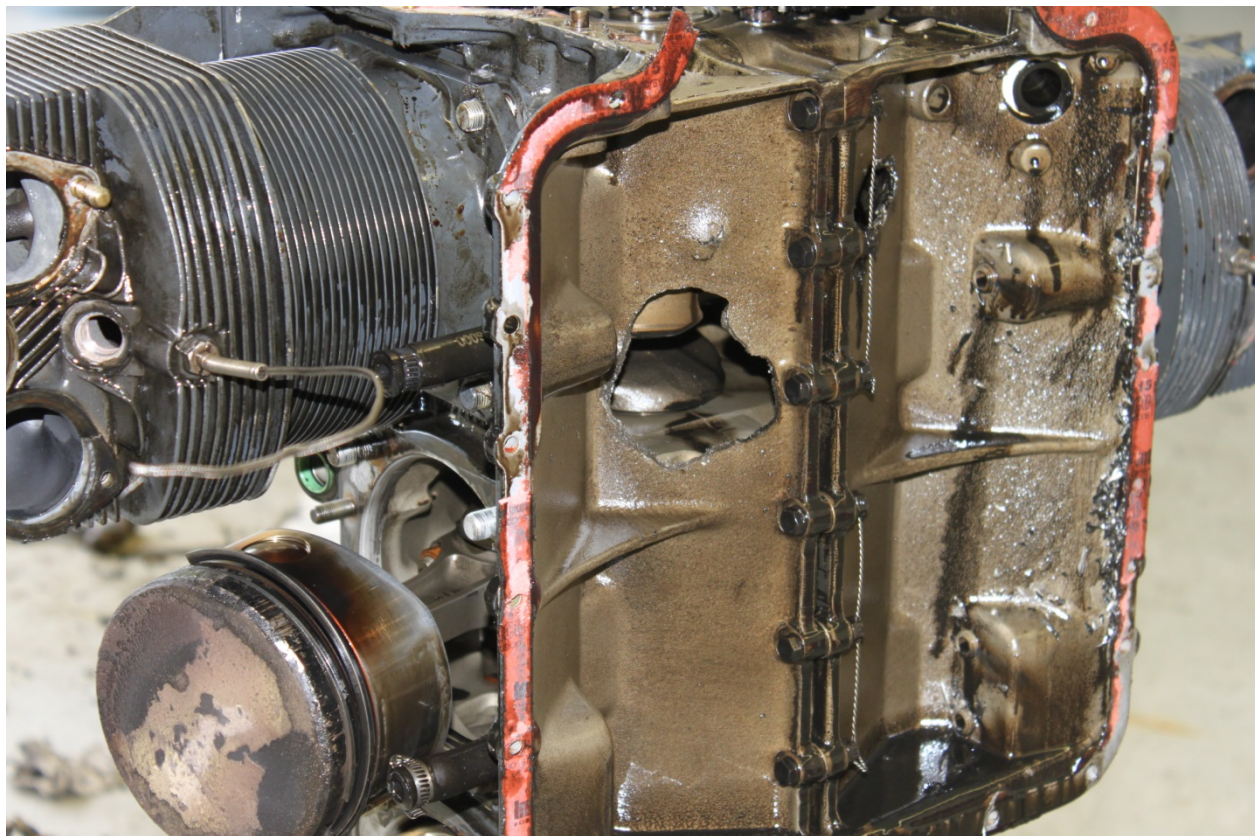
however, rotation was not able to be achieved due to internal damage noted through the breached hole in the engine case. The oil pan was removed and contained about 4 ounces of black oil and metal fragments. The fragments were recovered, examined, and appeared to consist of part of the engine case, part of the piston, main bearing, and the nut that was absent from the connecting rod attach bolt; however no other bolt was definitively identified. Cylinder No. 6 was cut between the cylinder barrel and cylinder head to facilitate the removal of the piston. Examination of the other cylinder connecting rods and main bearings were unremarkable and oil was present on all surfaces.

Photo 9: Two (2) Breaches in Bottom of Engine case as Viewed after Removal of Oil Pan

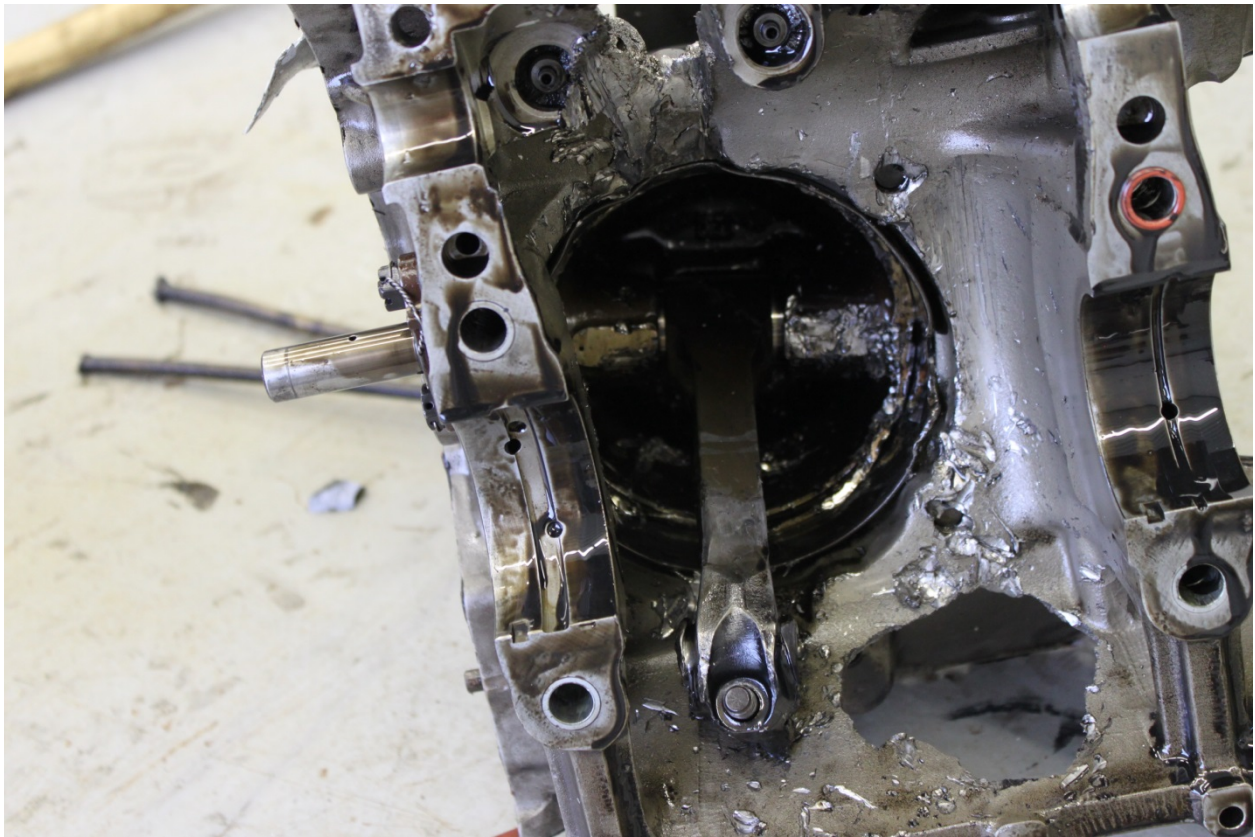
Photo 10: Cylinder No. 6 after Engine Case was Split

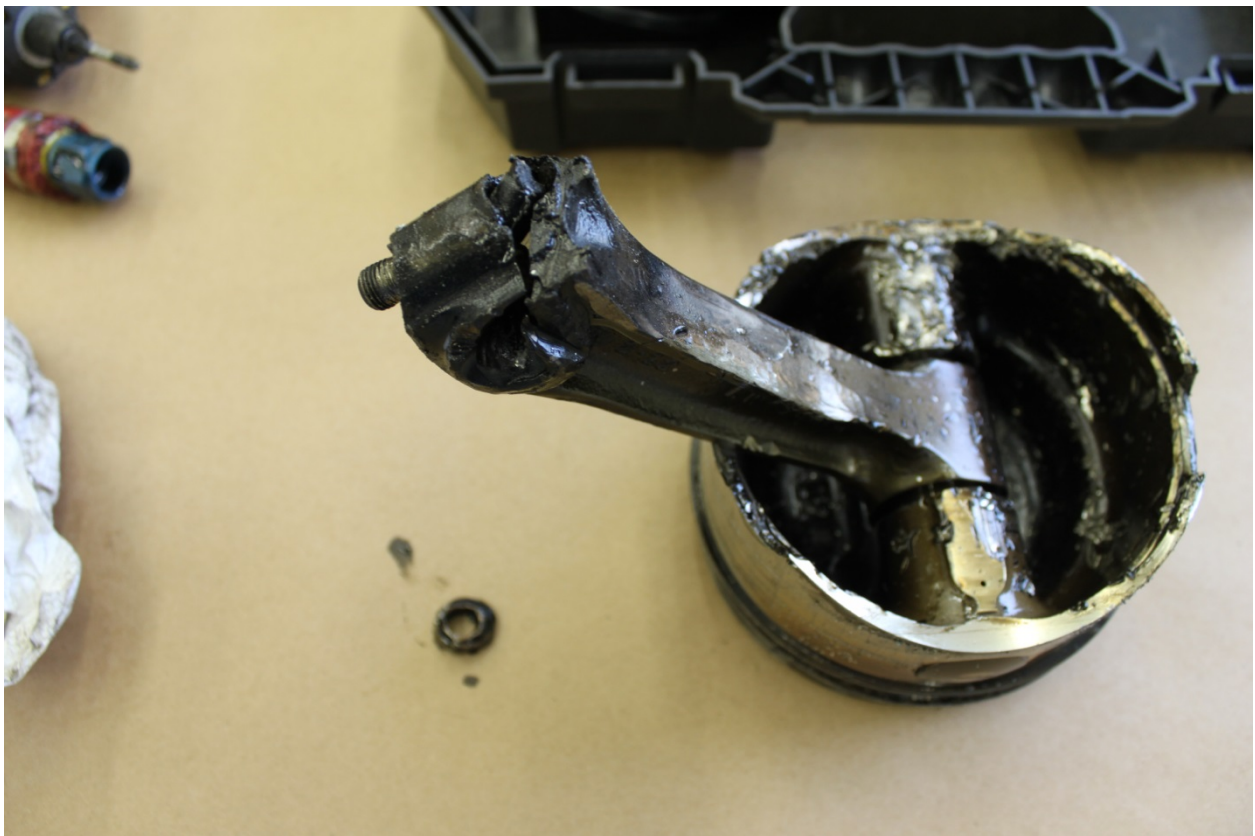
Photo 11: Cylinder No. 6 Arm with Bolt attached and Nut found in the Bottom of the Oil Pan

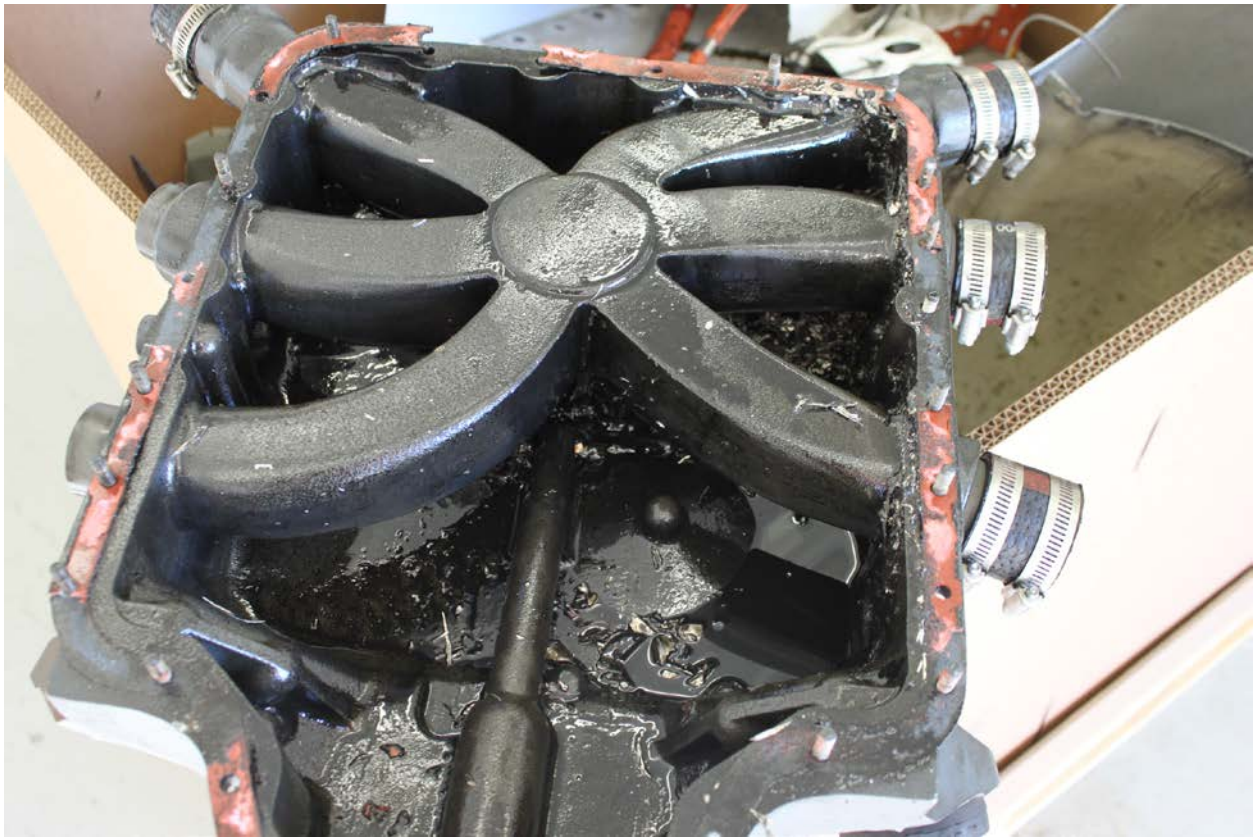
Photo 12: Oil Sump with Debris

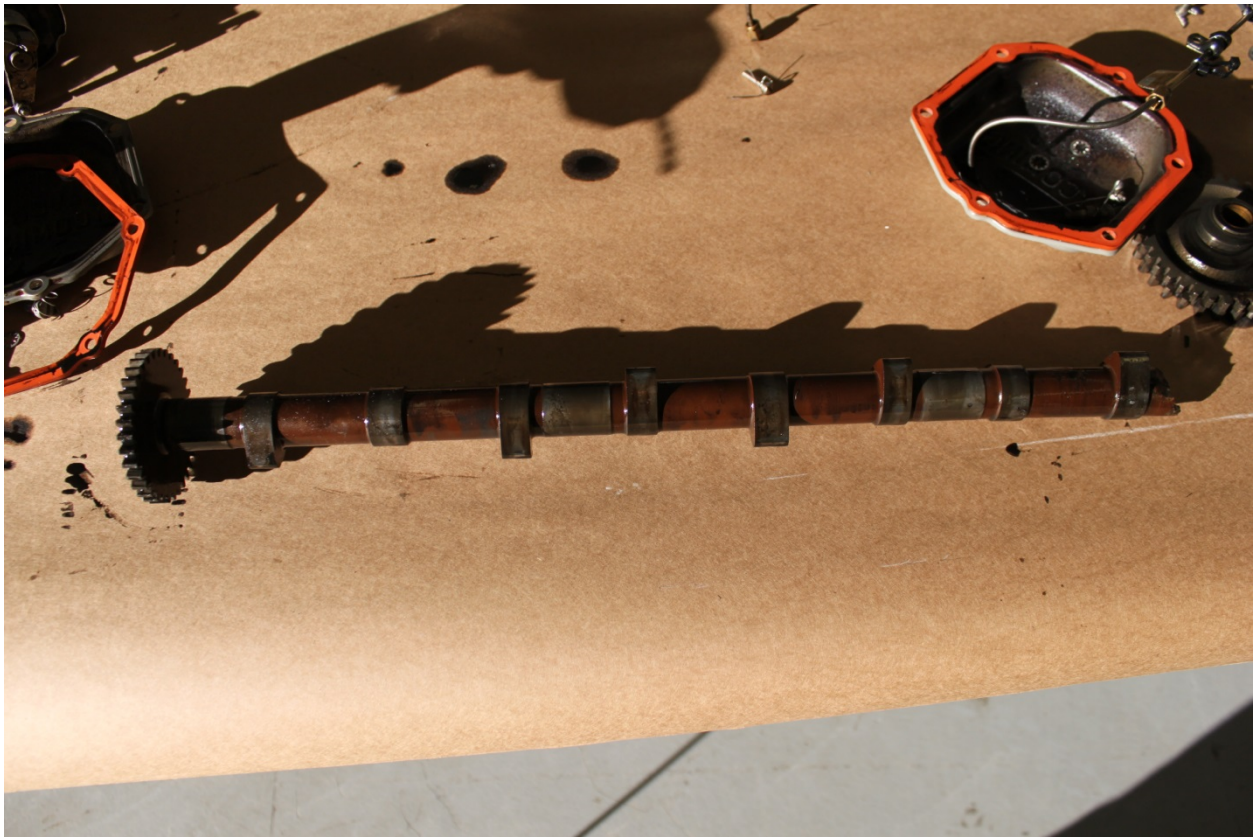
The camshaft was removed and exhibited torsional overload stress fracture near one of the camshaft lobes near the camshaft rear main journal, which would have been in the area of Cylinder No. 6.

Photo 13: Camshaft After Removal from Engine Case

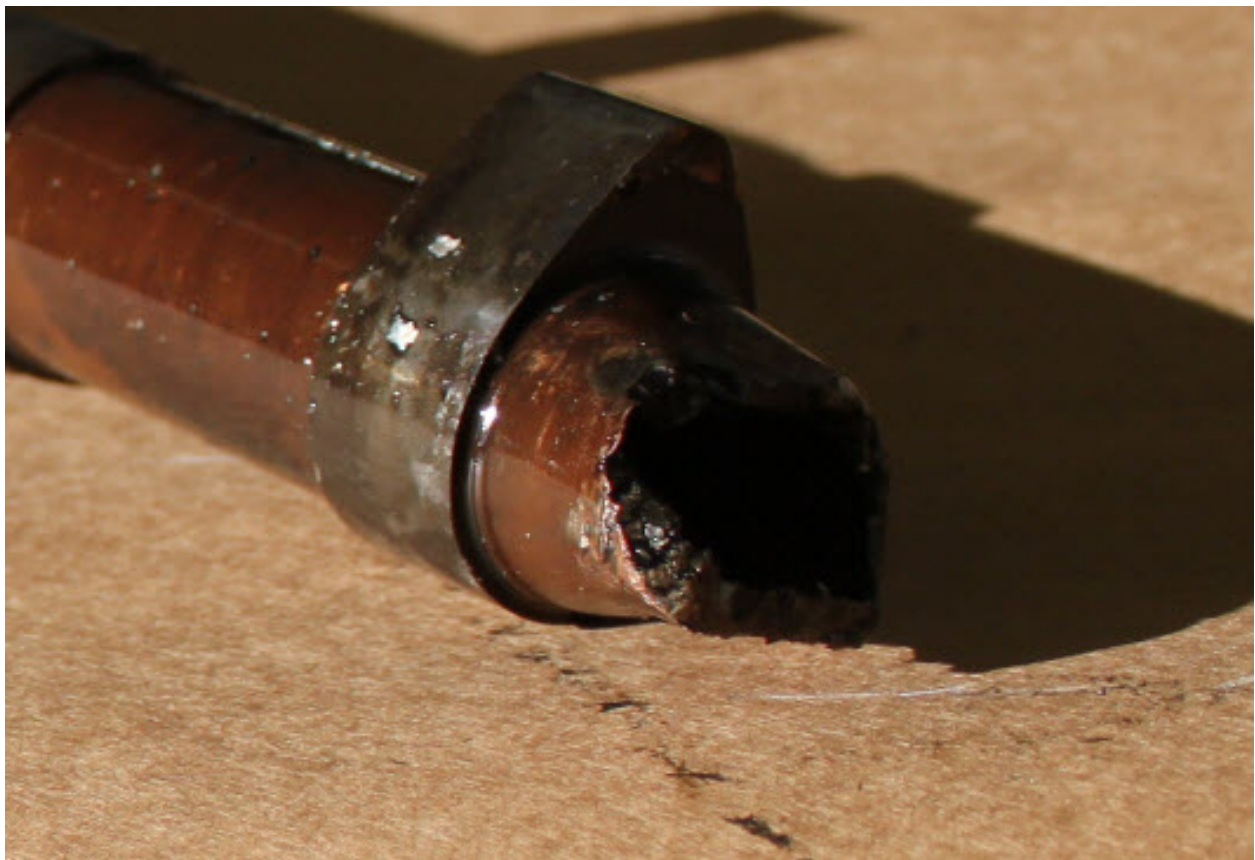
Photo 14: Fracture Surface of the Camshaft

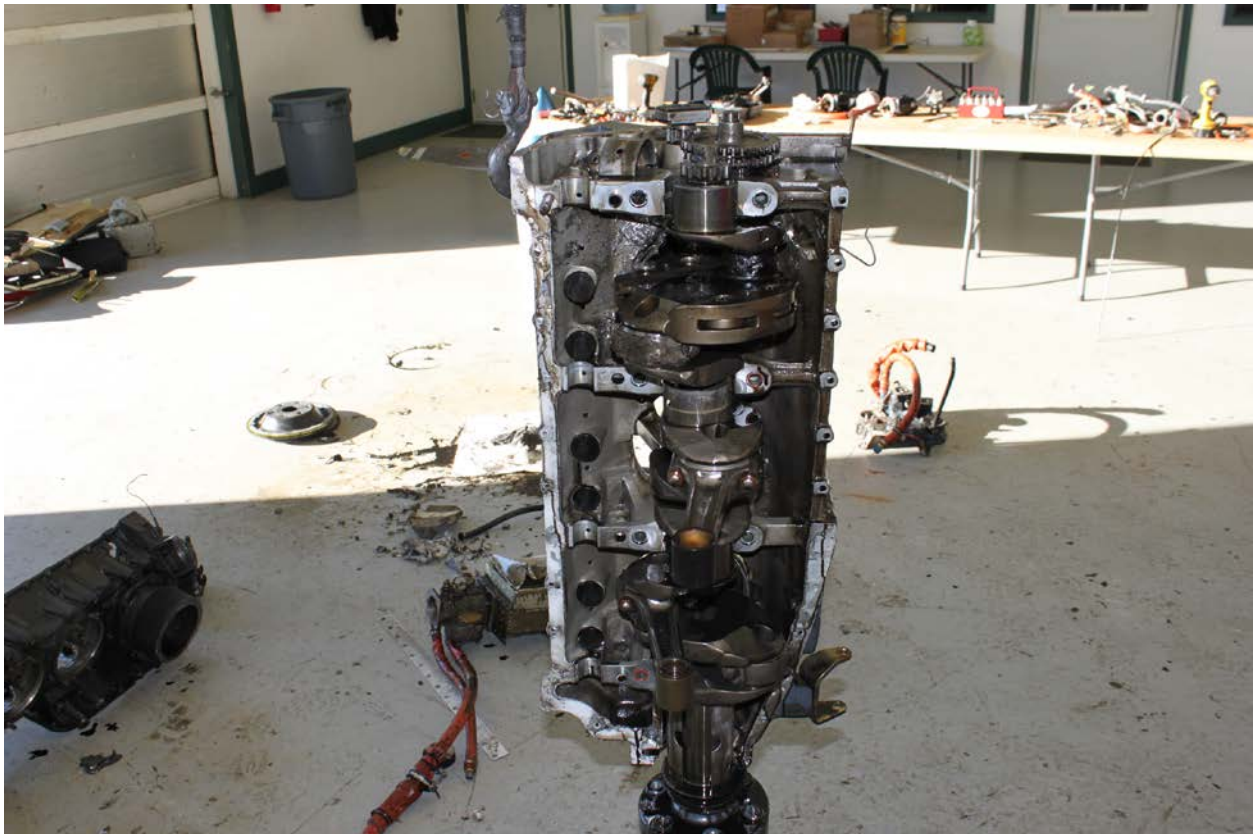
The crankshaft remained attached to Cylinder No. 5 after removal of the even numbered cylinders crankcase half as Cylinder No. 5 was damaged to the extent that removal of that cylinder would have required cutting of potential future examination needs. The crankshaft section associated with Cylinder Nos. 1, 2, 3, and 4 appeared unremarkable and intact; however, the section of the crankshaft associated with Cylinder Nos. 5 and 6 exhibited scoring and gouging along the circumference of the shaft. Visual continuity could be confirmed from the propeller flange, through the crankcase, to the accessory pad.

Photo 15: Crankshaft with the Odd numbered Cylinder Case Half Attached

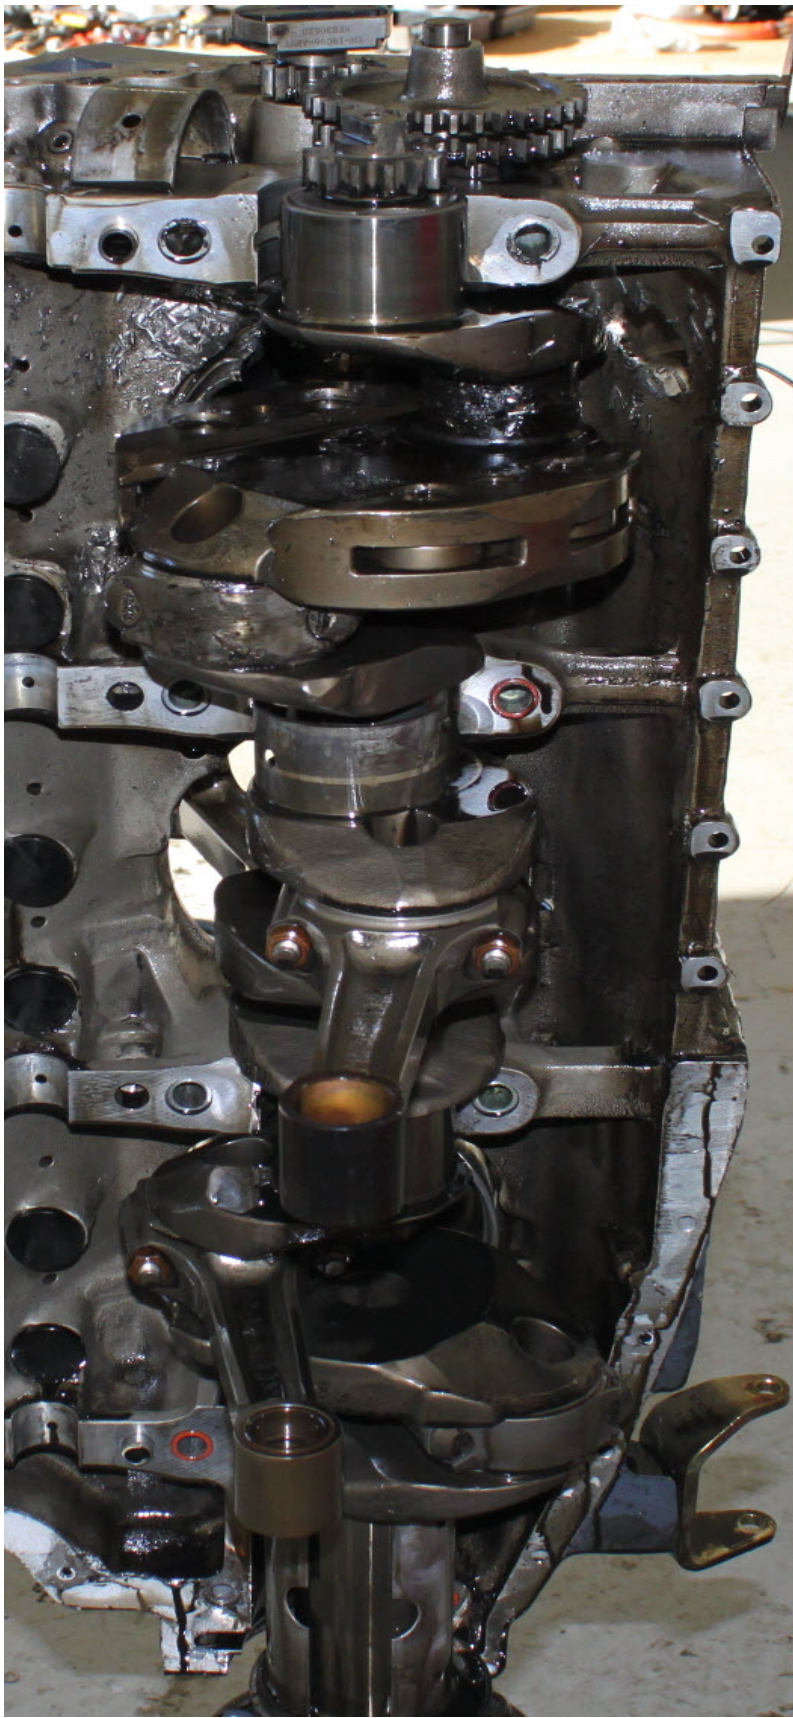
Photo 16: Expanded View of Picture Above

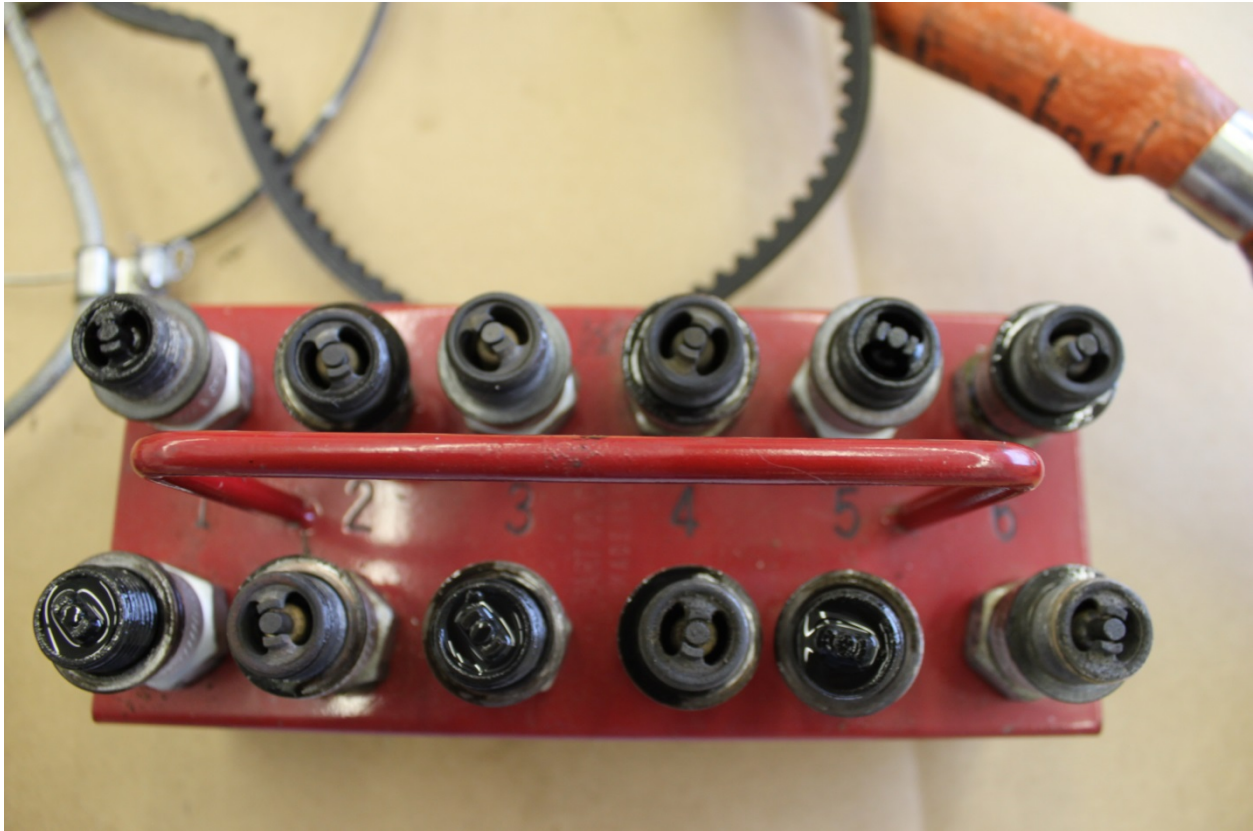
The spark plugs were removed and placed in a spark plug tray. The 6 top spark plugs and 6 bottom spark plugs were manufactured by Champion and were an REM40E. The plugs appeared to be oil coated and some especially those on the odd cylinder numbers side and installed on the bottom side of the cylinder, had oil present. According to the recovery personnel the engine was stored on its side pending the examination; however, it could not be definitively recalled as to which side of the engine was the lowest side. The even numbered cylinder's sparkplugs were dark in color and had normal wear when examined.

Photo 17: Champion Spark Plugs after Removal

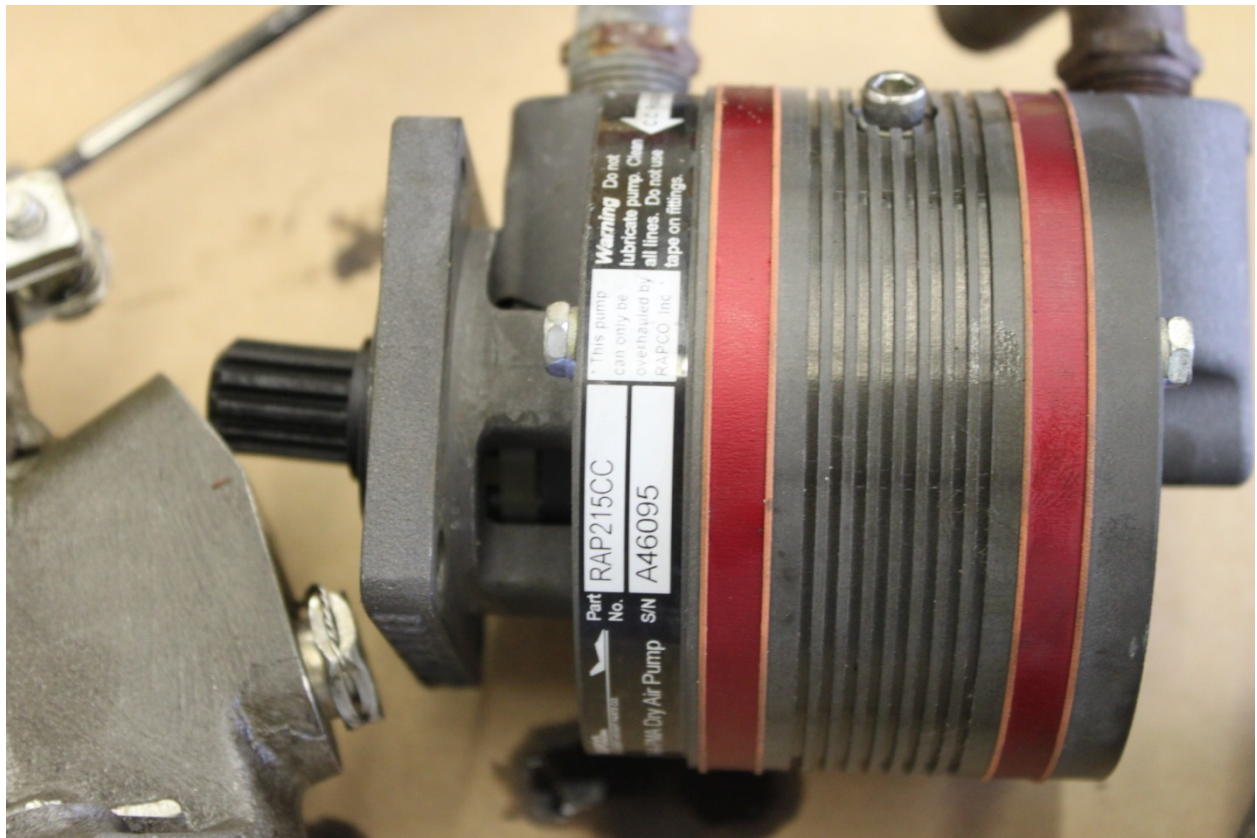
The vacuum pump was manufactured by RAPCO and had a part number of RAP215CCv , Serial Number A46095. The vacuum pump remained attached and when rotated smoothly by hand produced a suction. The vacuum pump was not disassembled and exhibited no damage.

Photo 18: Vacuum Pump after Removal

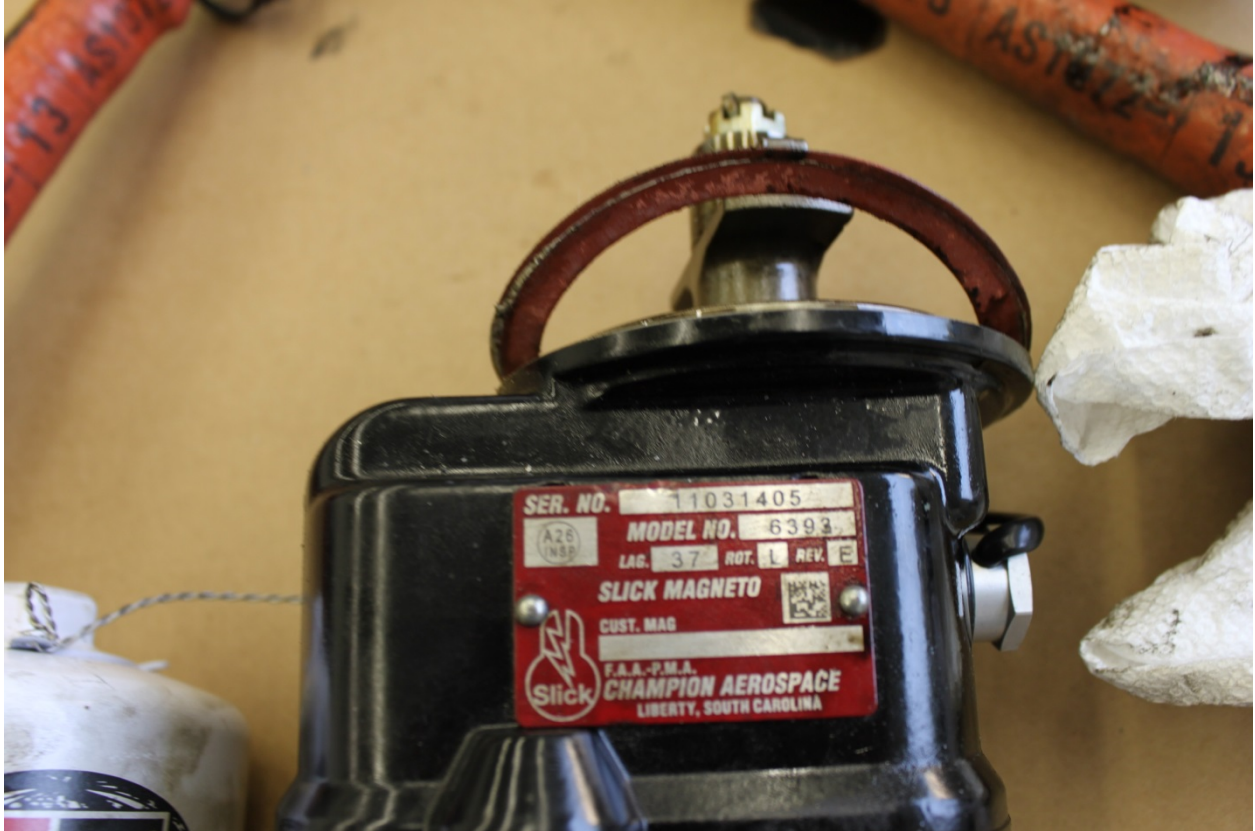
The magnetos had a remanufactured label affixed to them and were labeled LH and RH. The magneto labeled LH was a Slick Magneto; Model Number 6393, and a Serial Number 11031405. When the LH magneto's coupling was rotated by hand spark was generated from the associated towers and it rotated smoothly with no noticeable binding. The magneto labeled RH was a Slick Magneto; Model Number 6350, and a Serial Number 11090906. When the RH magneto's coupling was rotated by hand spark was produced on all towers with no noticeable binding.

Photo 19: Left Magneto after Removal

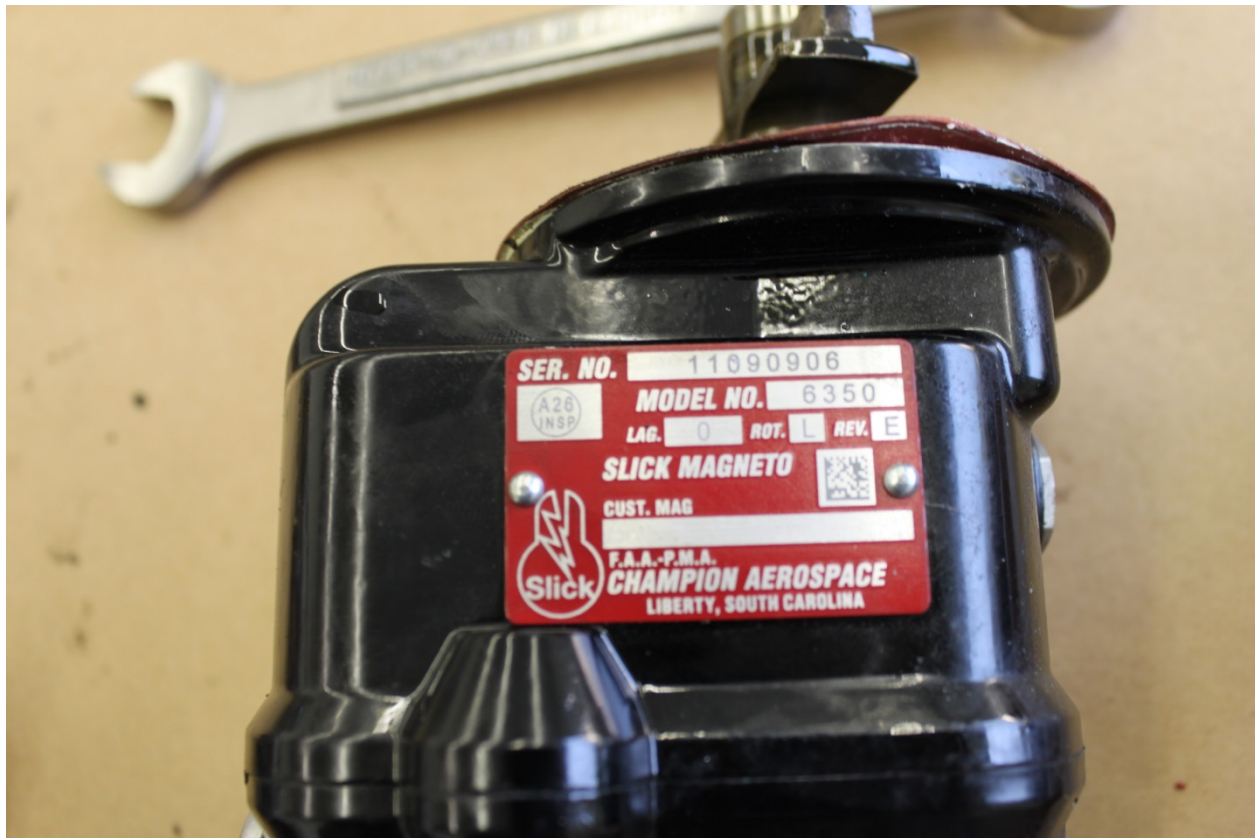
Photo 20: Right Magneto after Removal

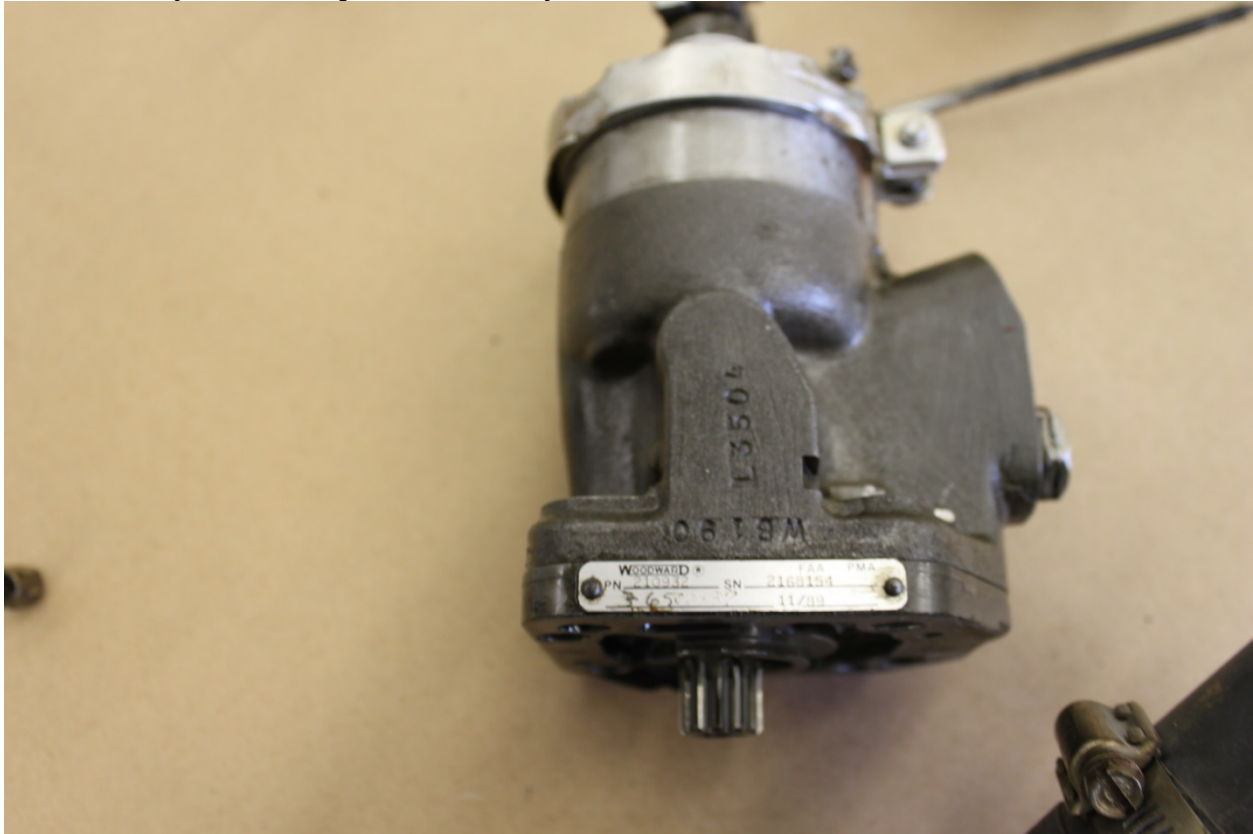
It was a Woodward Propeller Governor; Part number 210932 and a Serial No. 2168154. The unit was rotated by hand and operated smoothly.

Photo 21: Woodward Propeller Governor after Removal
