**ERA13LA382**

**Revo, Incorporated Lake Model 250**

**N522WB**

**NTSB ENGINE EXAMINATION NOTES**

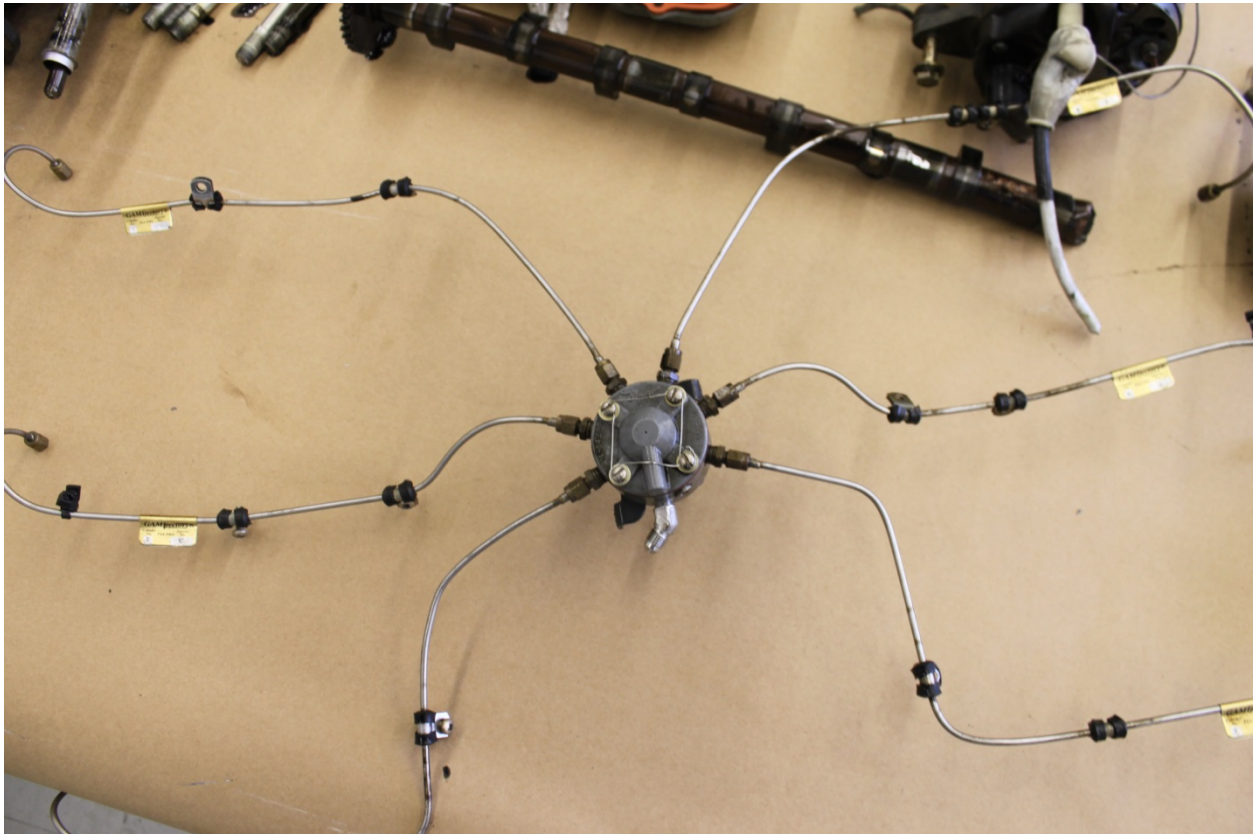
The fuel manifold was manufactured by Bendix, Part number 75283, Serial Number 25242232. The unit remained attached to the top of the engine case and all injectors remained attached their respective cylinders. No noticeable damage was noted to the fuel cylinder and when disassembled the gasket remained attached and also exhibited no damage. A liquid was observed similar in smell and color to 100LL aviation fuel, dripping from the injector labeled as cylinder 1.

Photo 22: Fuel Manifold after Removal

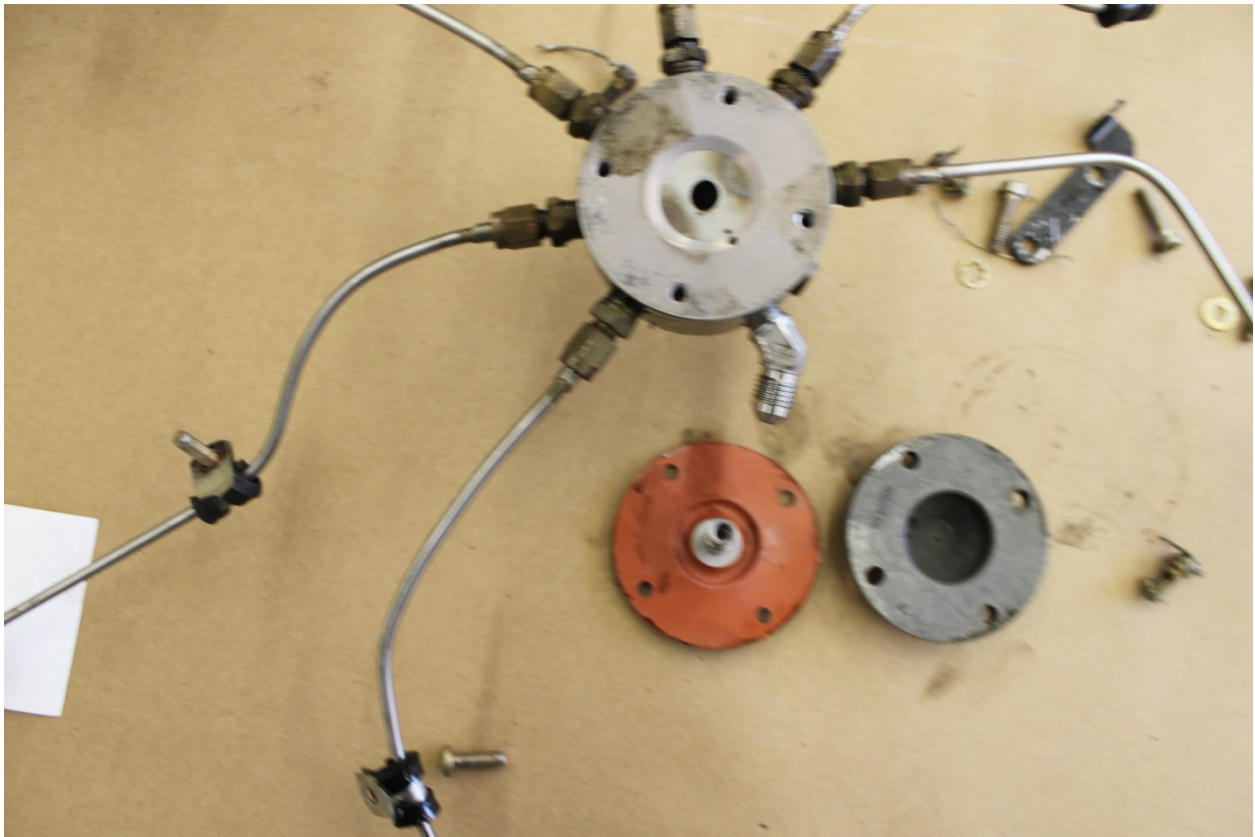
Photo 23: Fuel Manifold after Disassembly

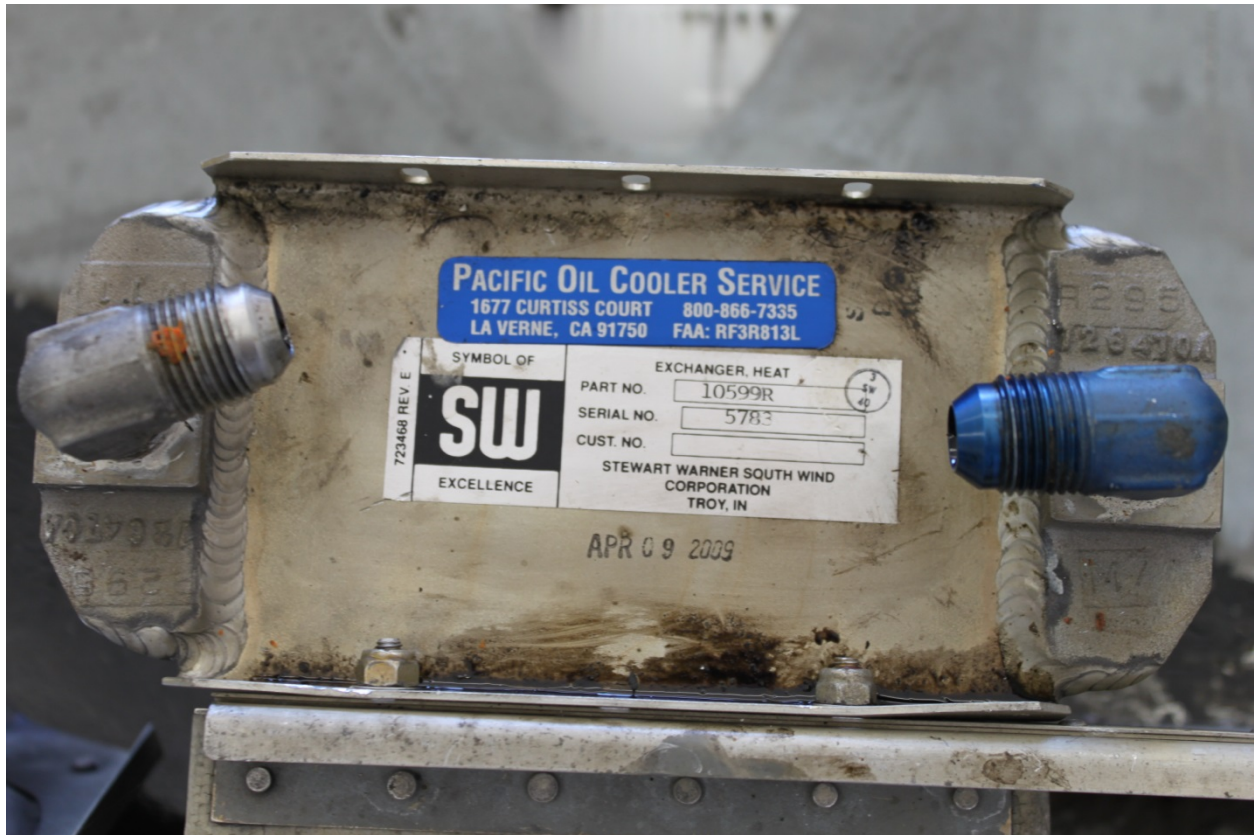
The engine oil cooler/heat exchanger was manufactured by Pacific Oil Cooler Service; Part No. 10599R; Serial No. 5783 with a date stamped on the case of "APR 09 2009." The oil cooler remained attached, was free of debris, and was noted as unremarkable. There was no evidence of oil leaking from the oil lines or the associated fittings.

Photo 24: Oil Cooler/Heat Exchanger

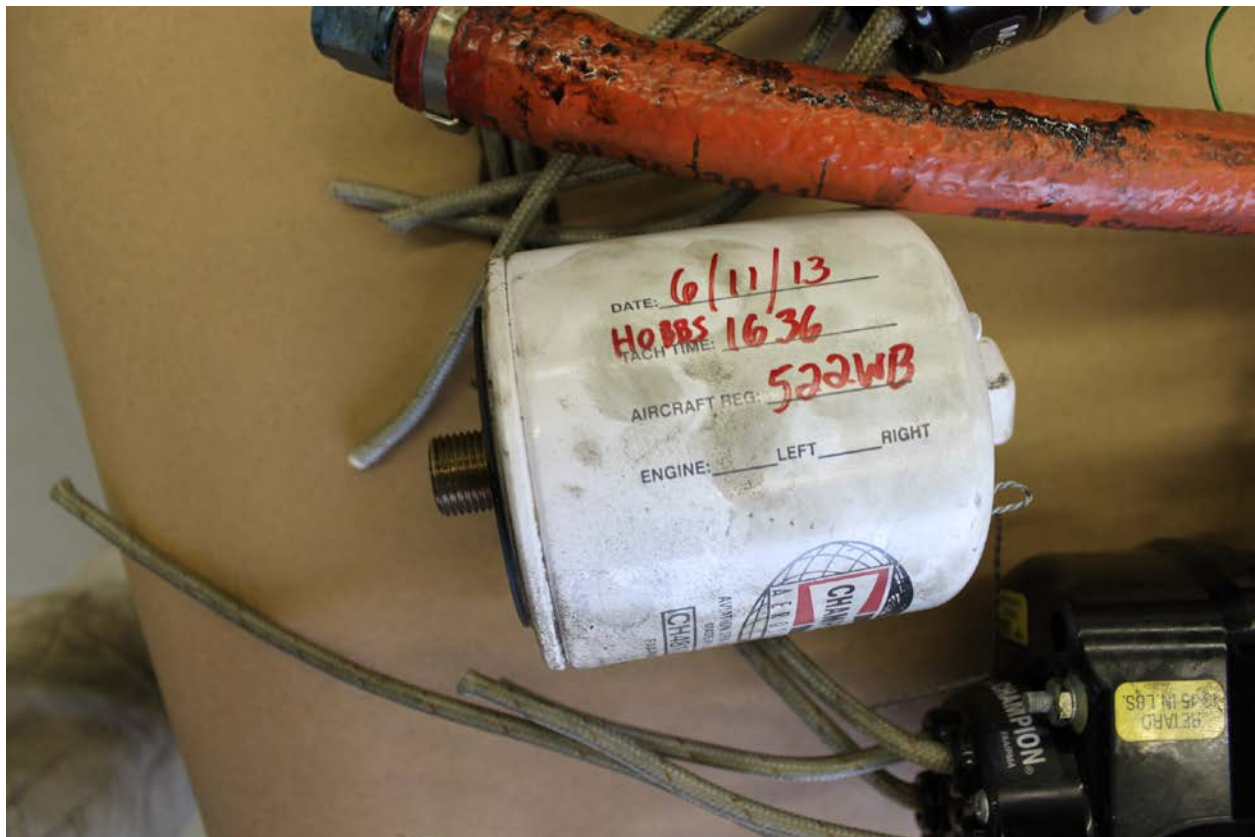
The oil filter remained attached to the accessory pad. The filter had a handwritten date of "6/11/13" written on it with a handwritten "Hobbs" time of "1636." The filter was removed; however, was not cut open as the examination was concerned of adding particulate matter to the filter paper with the improvised tools available. The suction screen was examined and appeared normal and no particulate matter was visible.

Photo 25: Oil Filter after Removal

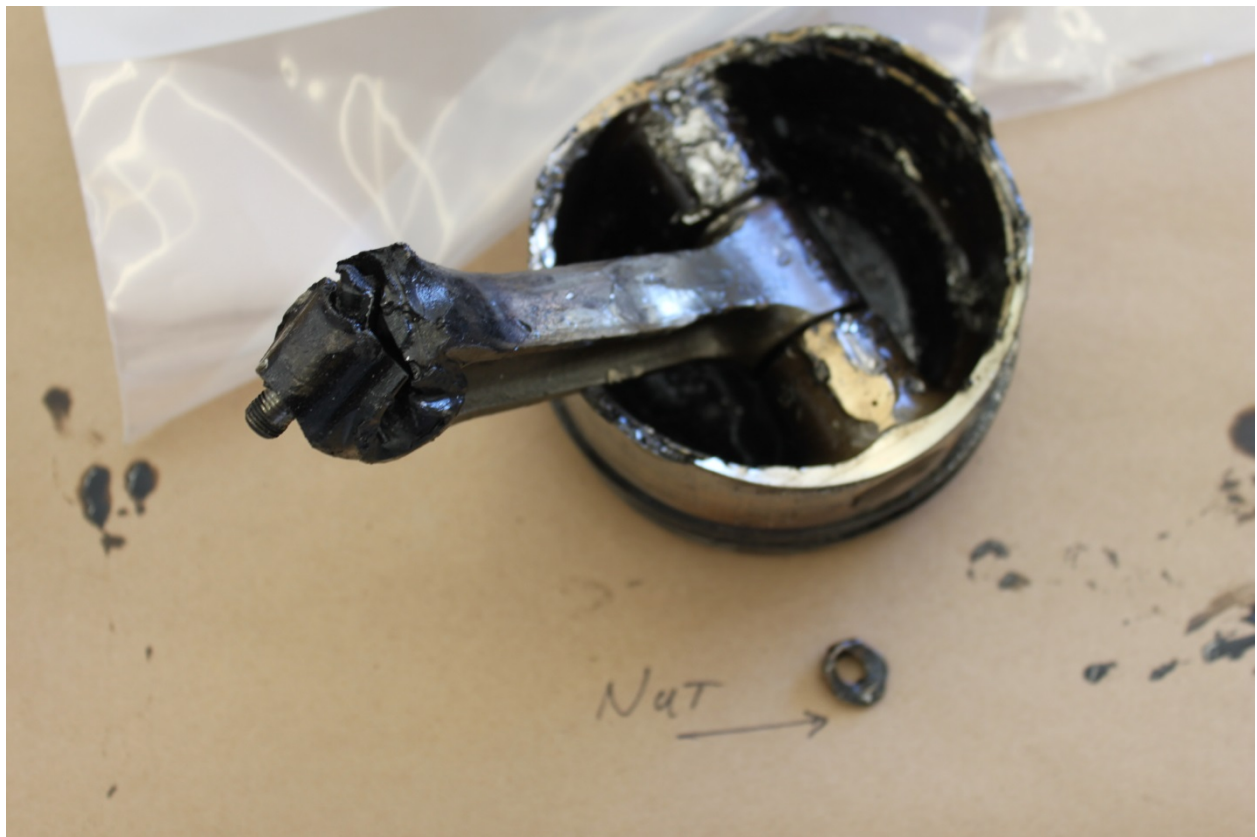
Cylinder No. 6 connecting rod, bolt, nut, and piston head have been retained by the NTSB (reference Evidence Control NO. ERA13LA382 – Exam – 001) and will be sent to the NTSB's material laboratory for further examination. The examination will attempt to determine failure mode of the assembly as well as examine the threads on both the bolt and nut to determine if the proper torque had been applied.

Photo 26: Retained Items (Reference Evidence Control No. ERA13LA382 - Exam - 001
