# NATIONAL TRANSPORTATION SAFETY BOARD

MATERIALS LABORATORY FACTUAL REPORT

Report No. 14-061

Place : Middle Grove, New York  
Date : August 27, 2013  
Vehicle : Lake Model 250, N522WB  
NTSB No. : ERA13LA382  
Investigator : Timothy W. Monville, AS-ERA

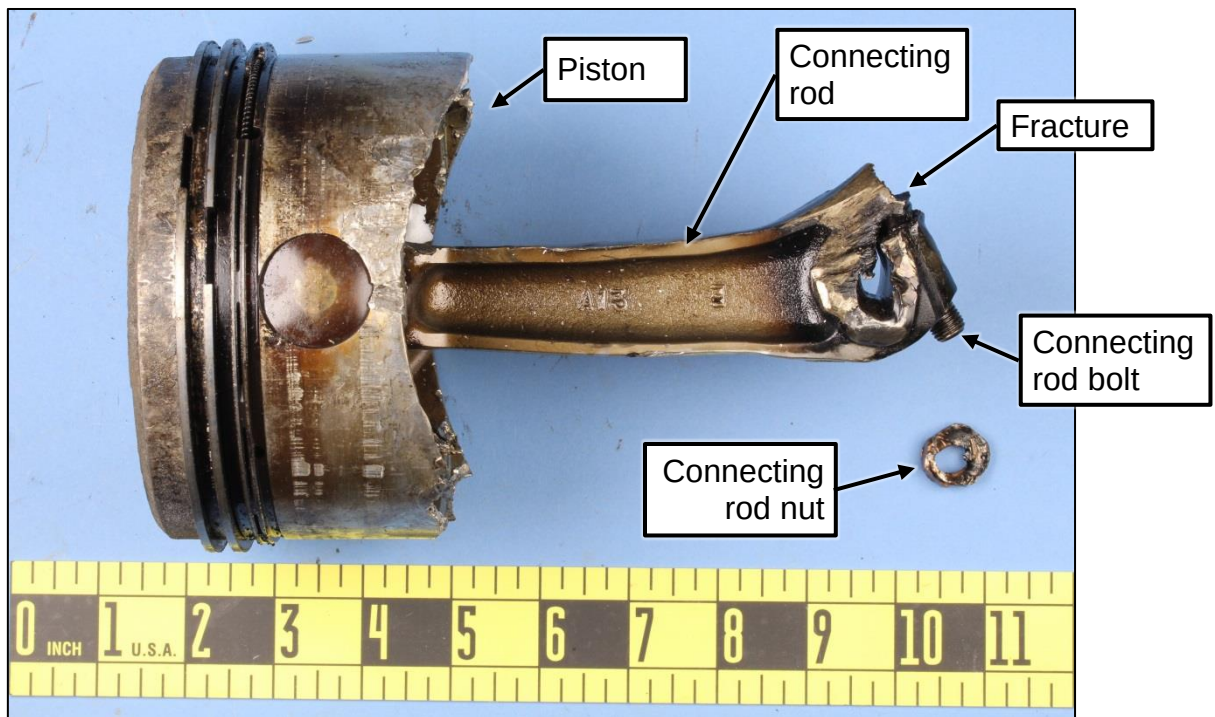
An overall view of the submitted components is shown in figure 1. The connecting rod was fractured through one side of the the strap at the crankshaft end of the connecting rod. The strap segment on the other side of connecting rod was deformed inward, and a fractured connecting rod bolt was trapped in the deformed strap segment. A deformed connecting rod nut was also received as shown in figure 1. The connecting rod cap, mating fractured strap segment, connecting rod bolt, connecting rod nut, and head end of the fractured connecting rod bolt were not included in the submitted components.

Figure 1. Overall view of the submitted components.

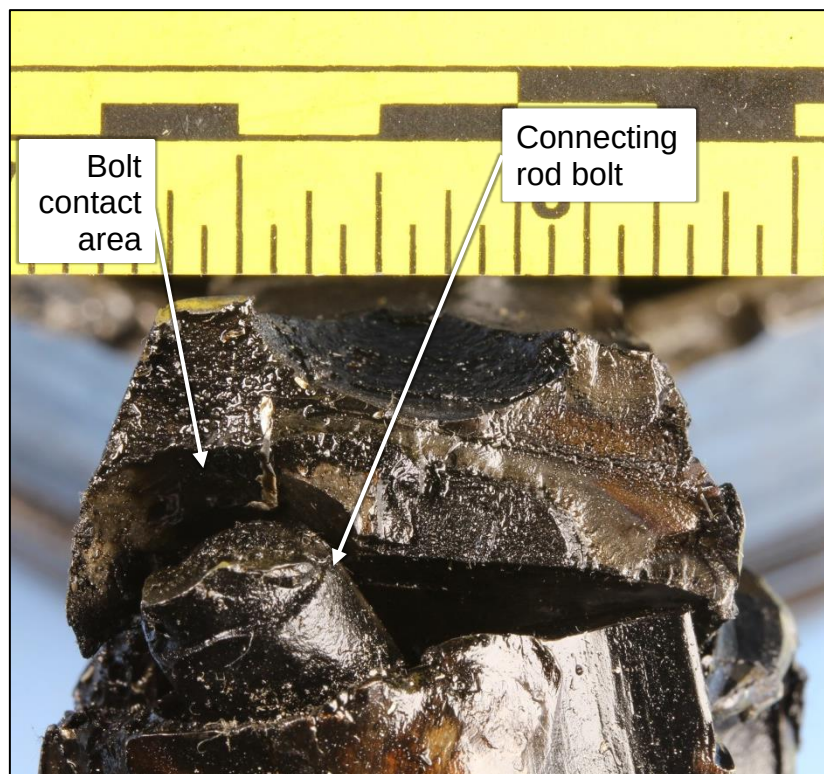
A view of the fractured end of the connecting rod as received is shown in figure 2. The deformed strap segment was deformed such the fractured end of the trapped connecting rod bolt contacted the fracture face of the fractured strap segment. The area of the fracture at the bolt contact area indicated in figure 2 was obliterated, and the surface was worn smooth.

Figure 2. View of the fractured end of the connecting rod bolt as received.

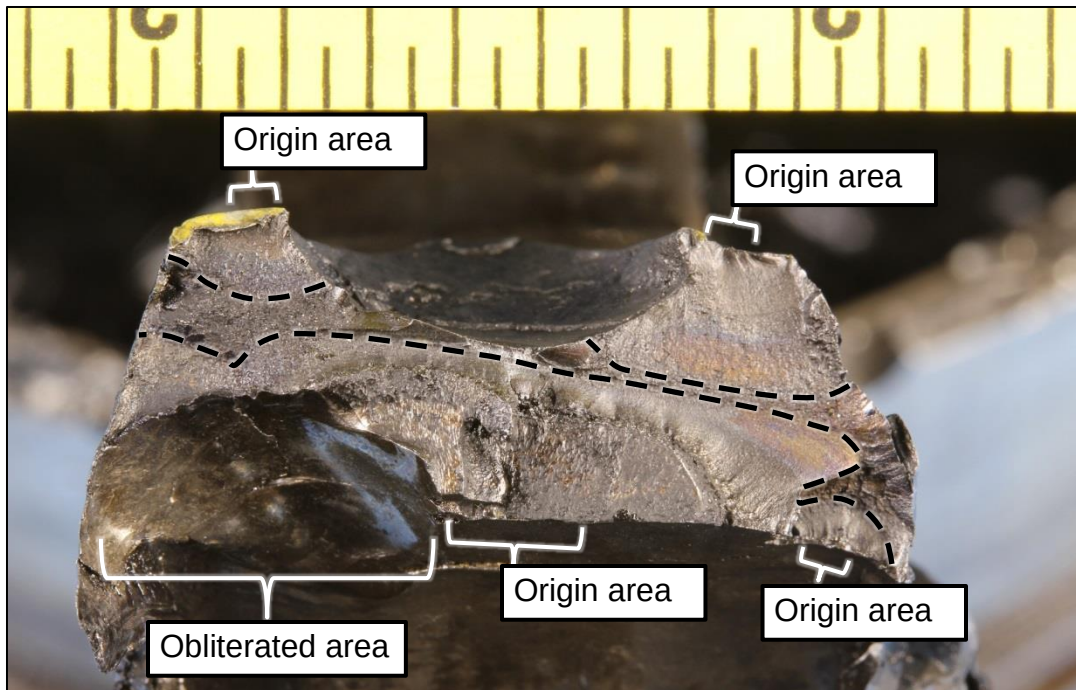
A close view of the cleaned fracture surface for the fractured strap on the connecting rod is shown in figure 3. Relatively smooth fracture features with curving crack arrest marks were observed on the fracture surface, features consistent with

fatigue fracture. Four brackets in figure 3 indicate fatigue origins located at both the outer and inner faces of the strap. One bracket in figure 3 indicates the area of the fracture that was obliterated by wear from contact with the fractured end of the connecting rod bolt trapped in the deformed strap segment. Dashed lines in figure 3 indicate the approximate boundaries of the fatigue crack features. The fatigue crack features extended across nearly the entire fracture surface.

Figure 3. View of the connecting rod fracture after cutting away the deformed strap segment and cleaning the fracture. Dashed lines indicate fatigue boundaries and brackets indicate fatigue origin areas and an area obliterated by wear.

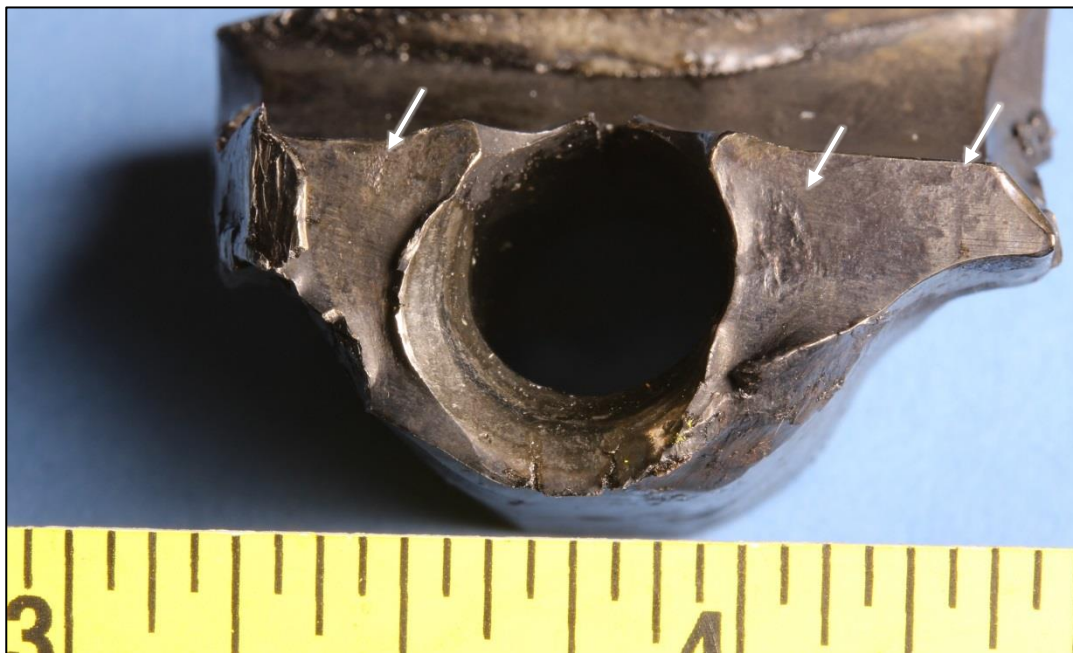
A view of the split line face on the deformed strap segment is shown in figure 4 after cutting the segment from the rest of the connecting rod and cleaning. Fretting damage, as indicated with arrows in figure 4, was observed on the face. The hole for the connecting rod bolt was enlarged, deformed around the edges, and worn smooth consistent with contact with the trapped connecting rod bolt.

Figure 4. View of the split-line face for the intact strap segment after cutting and cleaning. Arrows indicate areas of fretting damage on the surface.

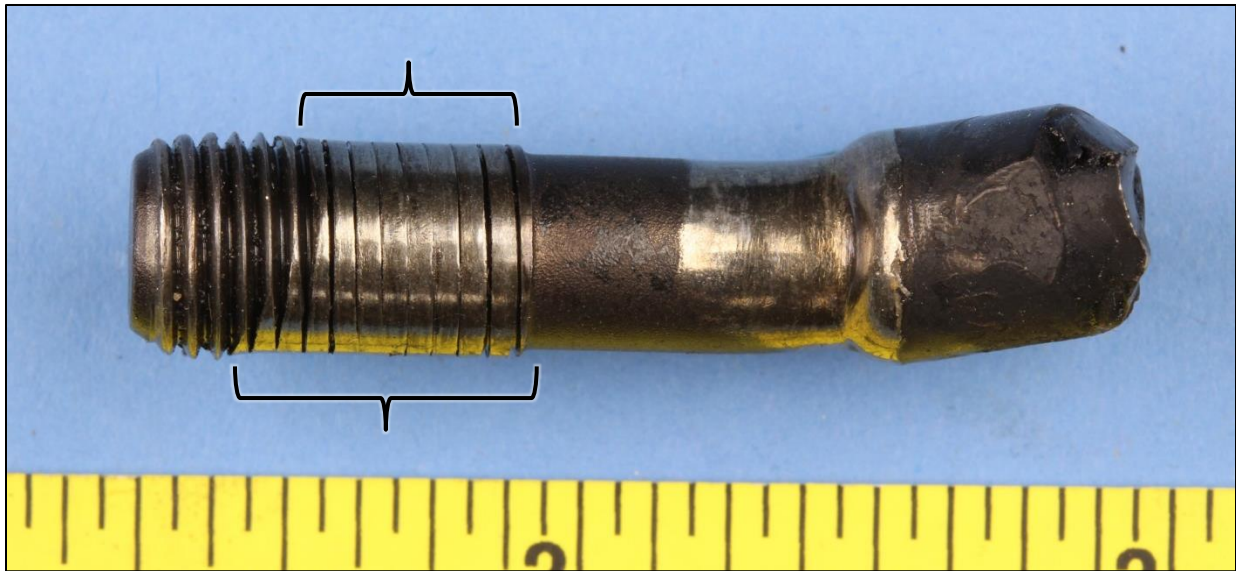
A view of the cleaned connecting rod bolt after removal from the strap is shown in figure 5. The bolt was fractured adjacent to the larger-diameter section of the grip. Fracture features were mostly on a slant plane and were relatively rough in the transverse portion of the fracture, features consistent with ductile overstress fracture. Brackets in figure 5 indicate areas of the threads adjacent to the grip where the thread peaks were worn. The areas of worn thread peaks corresponded to contact with the worn areas around the bolt hole in the deformed strap segment. Threads at the end of the bolt were intact and showed no evidence of impact or wear damage.

Figure 5. View of the connecting rod bolt piece after removal from the connecting rod and cleaning. Brackets indicate areas of worn thread peaks.

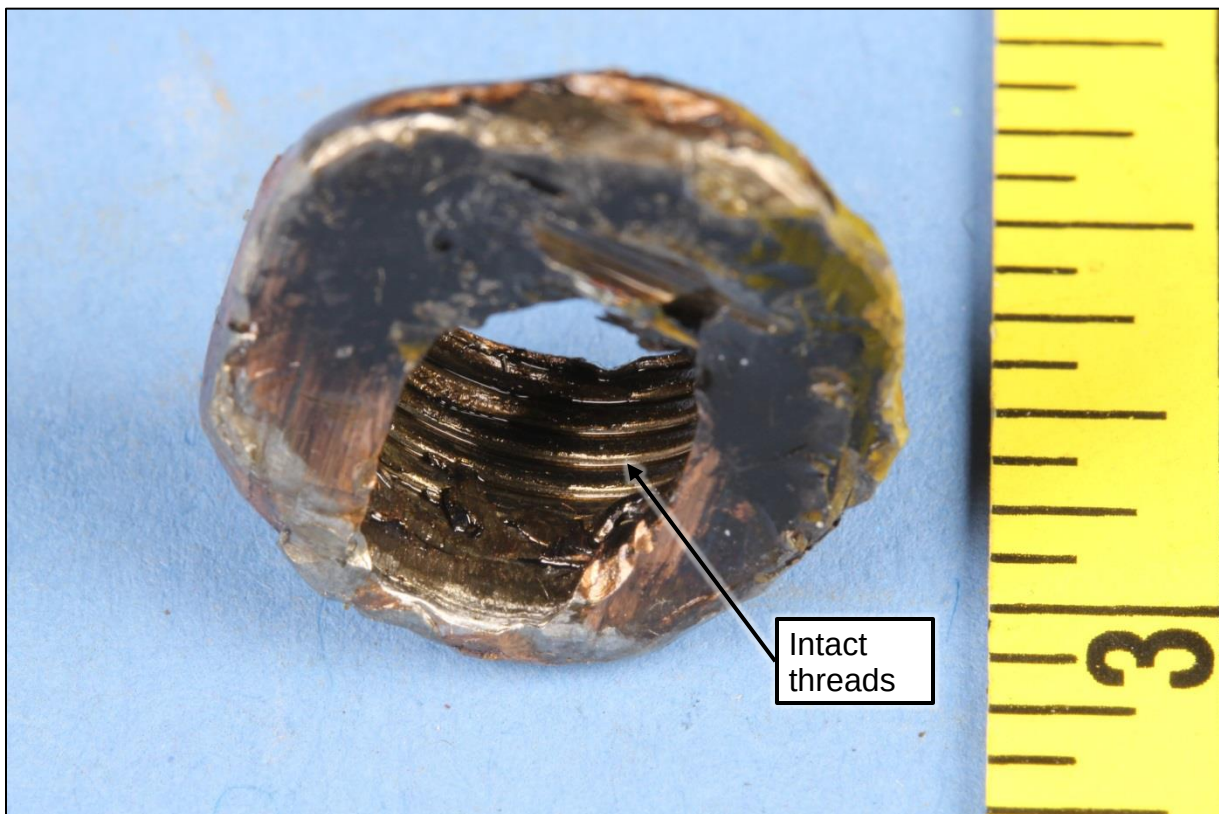
A close view of the connecting rod nut is shown in figure 6. The nut was impacted and deformed mainly on the clamping face and the opposite face of the nut. The nut remained intact around the circumference, and intact threads were observed on the interior of the nut as shown in figure 6.

Figure 6. Close view of the connecting rod nut showing intact internal threads.
