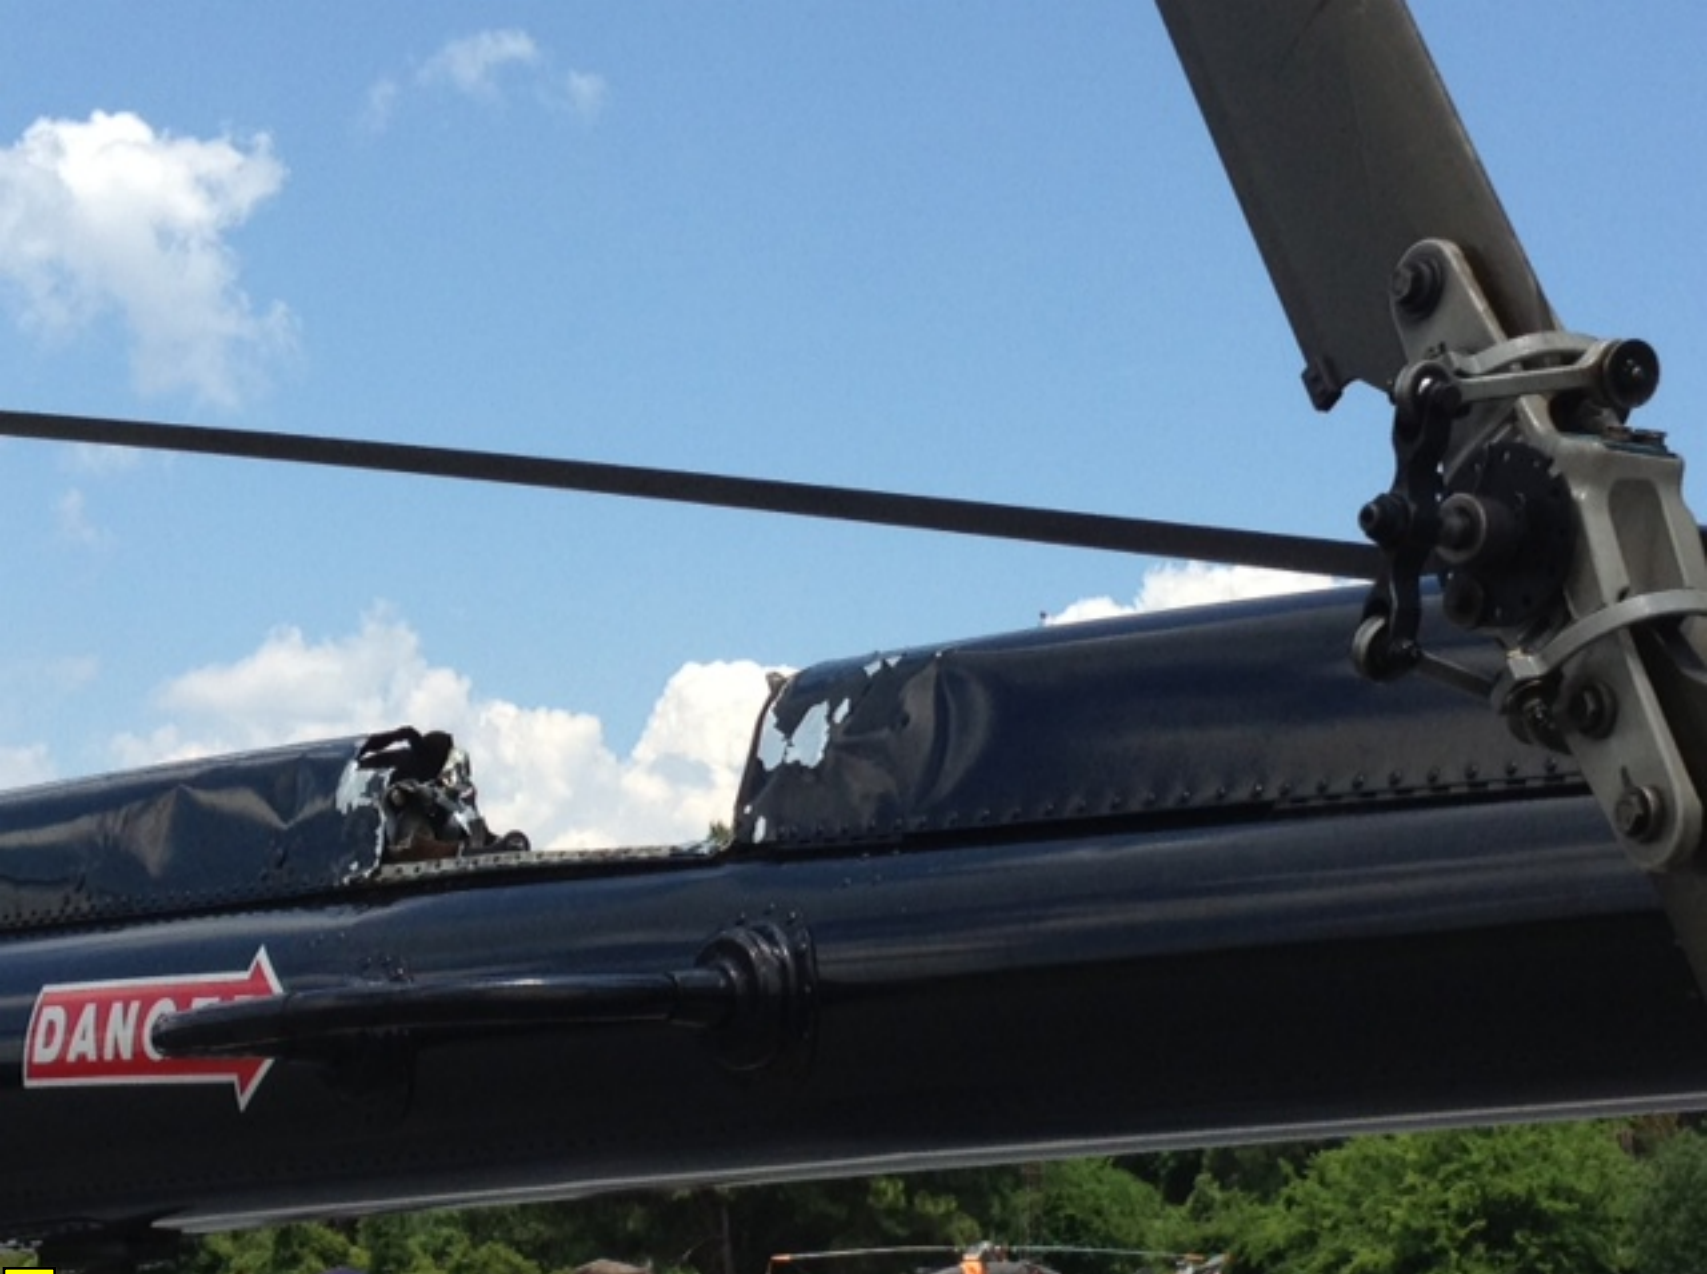
Photo 2 - View of Damage to Tail Rotor Driveshaft Cover and Severed Driveshaft
