Narrative of N2275G Accident on Sunday, July 27, 2014 at approximately 16:30 (EDT).

Location: GA18 – Big Creek Flying Ranch, Clayton, GA  
2800' x 50' grass strip

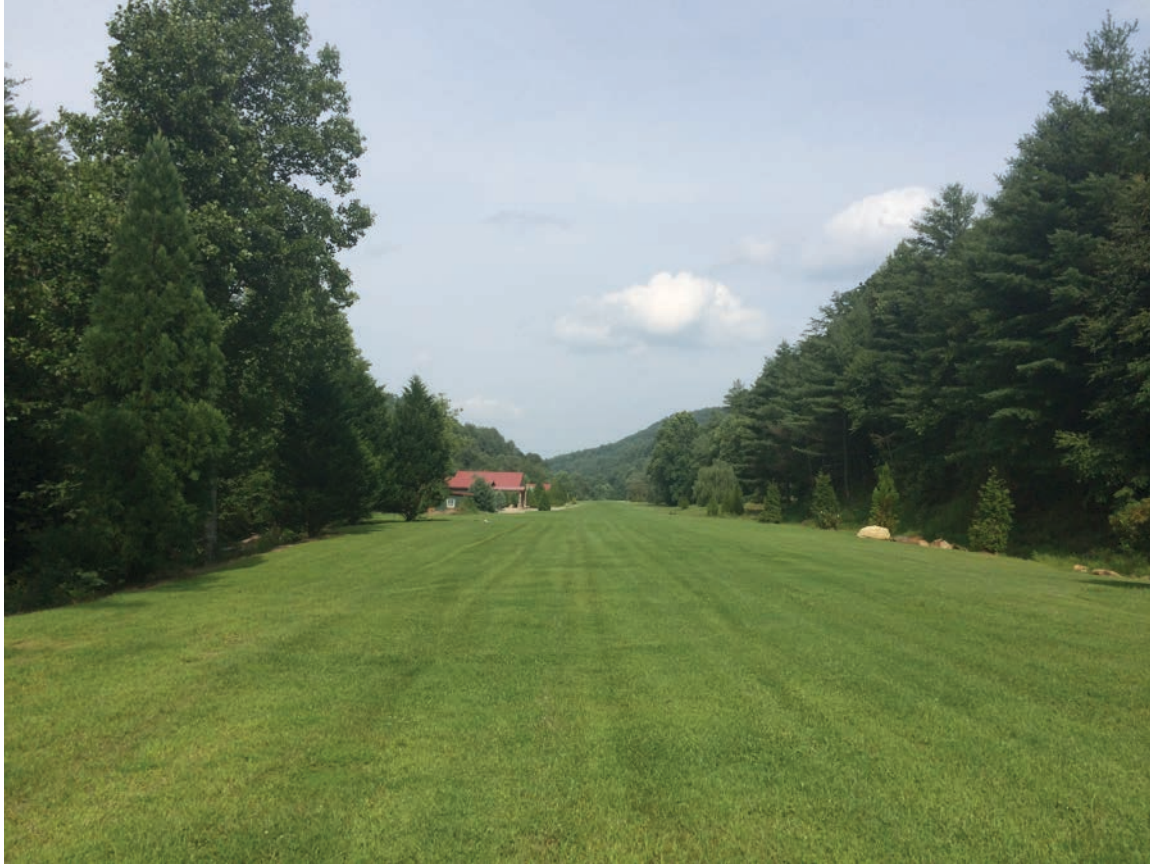
As can be readily noted from the aerial photos above, the runway is significantly narrower at the extreme west end, but I wanted to make sure I had the entire runway length available for takeoff due to the aforementioned conditions.

View from west end of field looking east (e.g. beginning of takeoff roll)

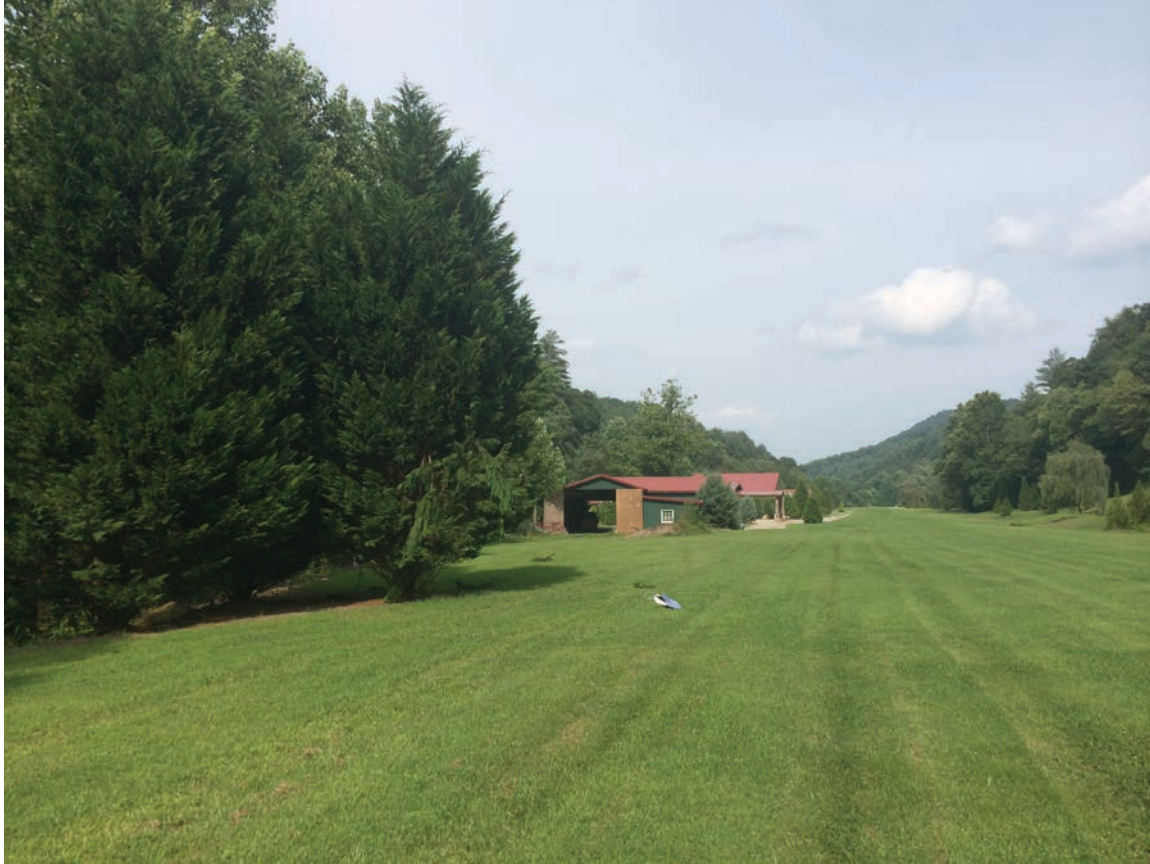
I began the takeoff roll with a standard soft field takeoff (yoke full aft and full power with the intention of raising the nose wheel and mains just above the grass surface until rotation speed reached). I was favoring the right rudder from the onset of the takeoff roll due to the upcoming “dogleg right” and prevailing wind conditions.

I was somewhere between one-third and one-half right rudder deflection when an unexpected significant gust of wind was encountered from the right quartering direction (approximately 4-5 o'clock). At that point, I immediately applied full right rudder to arrest any further drifting to the left. This was approximately 2 seconds prior to impact with the tree shown above.

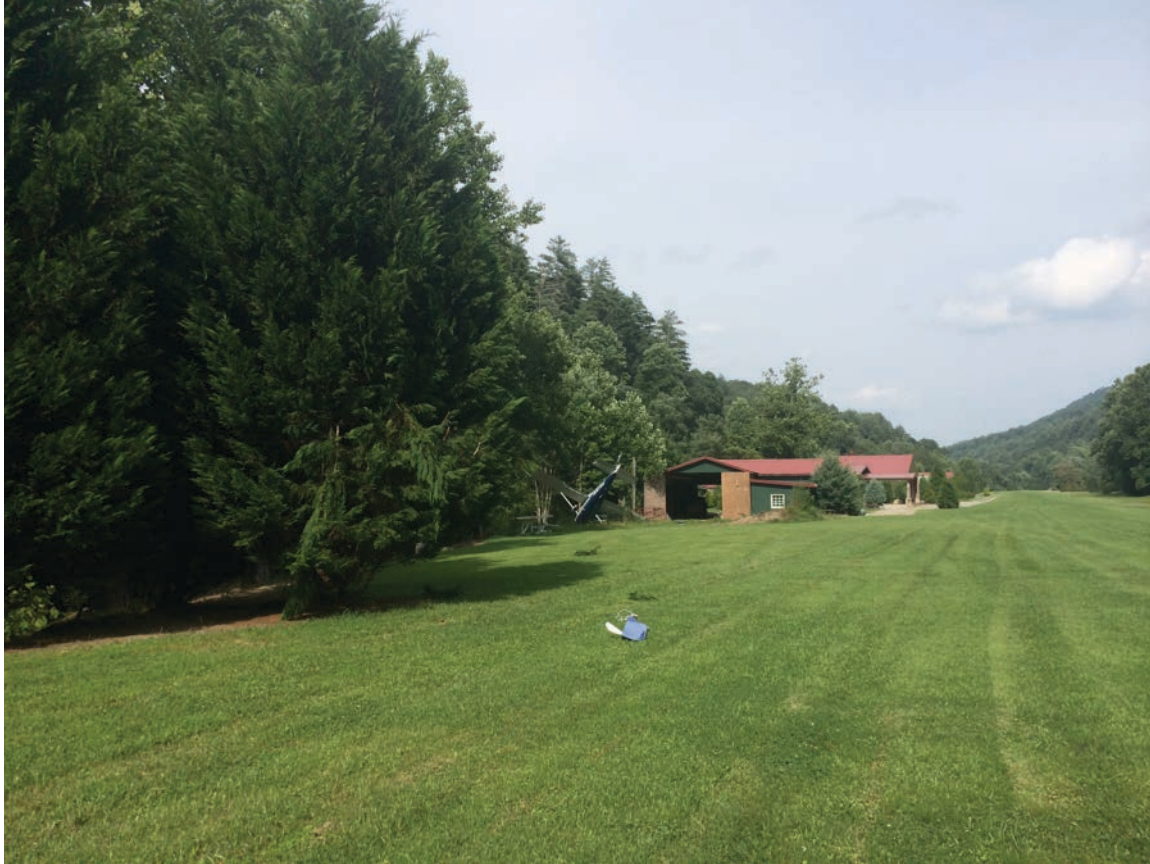
At that point, the left wingtip then clipped the sole tree shown above – causing a yaw to the left. I immediately returned the throttle to full idle, moved mixture to idle cutoff, and applied maximum braking. The two snapped branches shown are approximately 6” and 12” in from a point where the wing would have completely cleared.

The plane stopped quickly – aided by some pallets and other debris stacked in front of the shed. This debris caught the nose wheel and abruptly stopped the remaining forward motion of the aircraft, while causing the nose to “dig in.”

First, I would remove the lone tree that shouldn’t be there in the first place if it were up to me.

That said, instead of taking a pure soft field approach, I believe in this situation, keeping three wheels on the ground would have made more sense. I would have the benefit of nose wheel steering as well as differential braking to have positive, immediate directional control. The main factor here was limited control input – even with full deflection; due to the low airspeed and quartering wind gust from the rear. In this narrow area, if I had the wheels on the ground, I would have had exceptional forward visibility and direct, immediate directional control, while still building some forward airspeed until the point the runway opened up. At that point, I could have resumed a normal soft field takeoff when out of the confined area. That isn’t “textbook” – but in my opinion, that’s the only thing I could have done differently, in retrospect.

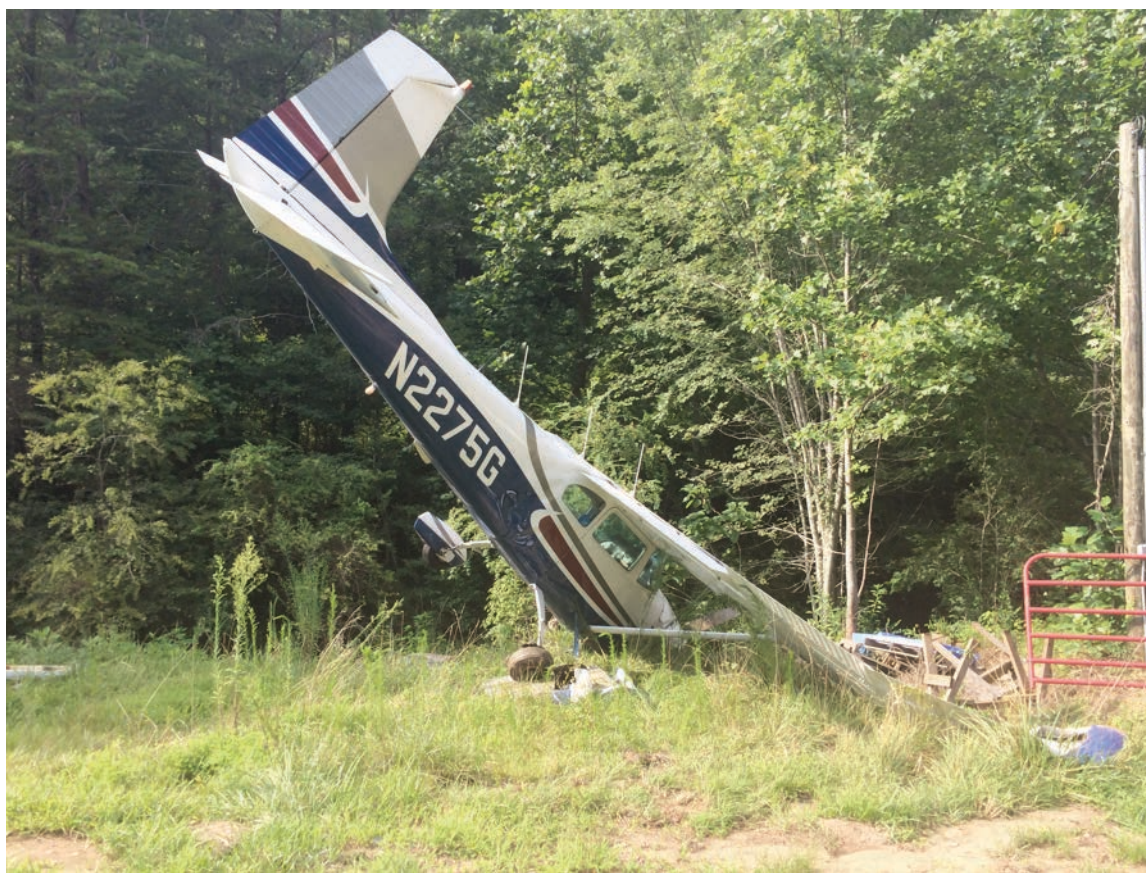
It was immediately apparent that myself and my passenger (my wife, a non-pilot) were unharmed and I focused my attention on securing the aircraft (verified fuel mixture was idle-cutoff, mags off, master off, fuel selector off). We then removed our seatbelts and exited the aircraft through the right passenger door.
