## **82-00067 Shear Coupling Force Failure Report**

**An analysis of shear mode characteristics of the 82-00067 shear coupling after a simulated in flight Vacuum Pump failure.**

**Prepared by: John L. Wicht  
Prepared for: Patrick White  
Date: August 28, 2008**

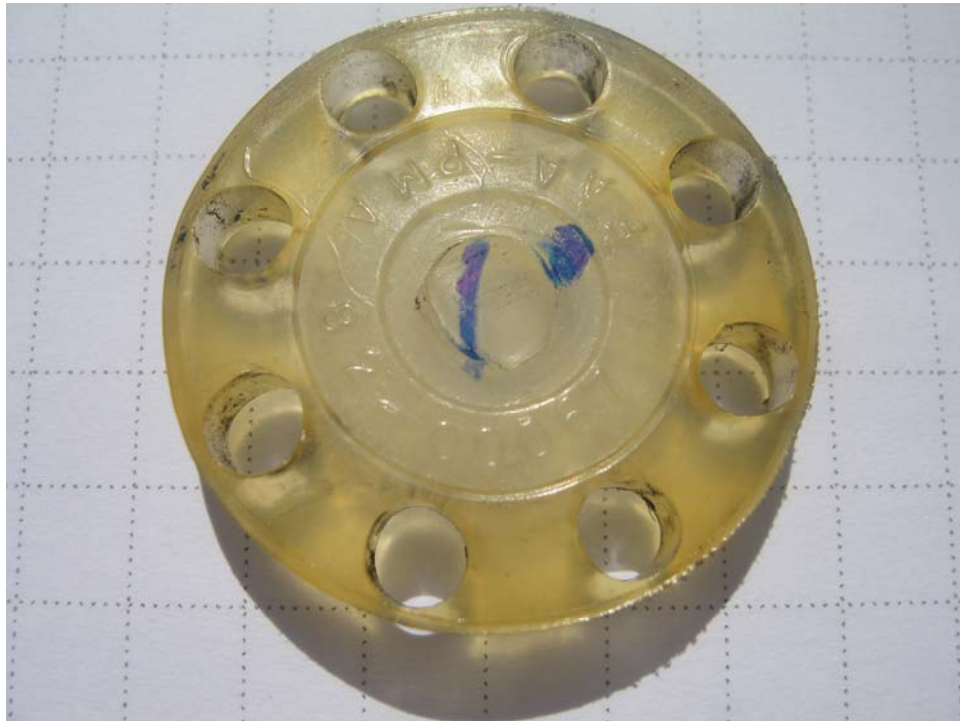
Sample 1 Outside External Face View

| <b>Sample</b> | <b>Post Failure Run Time</b> | <b>Failure /Post Failure Test Bench Motor RPM</b> |
|---|---|---|
| 1 | 10 seconds | 3600-3700 |

Summery: Each of the samples shows some melting of the base material after failure. As the run times after failure increase with each different sample the melting of the base material becomes more severe. This is due to the increased exposure to heat.

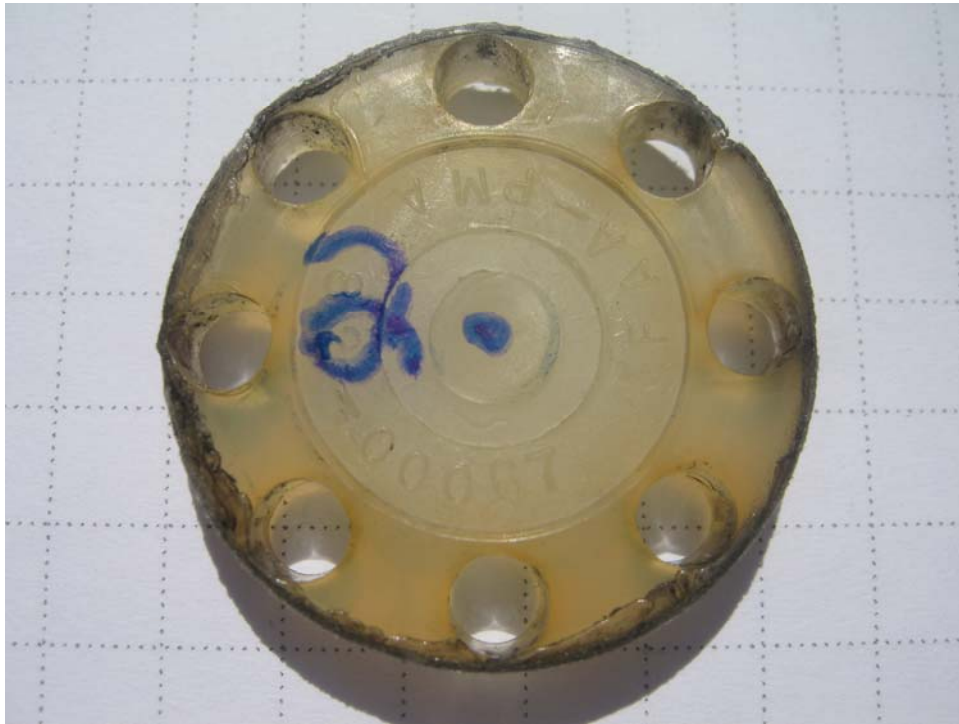
Sample 2 Outside External Face View

| <b>Sample</b> | <b>Post Failure Run Time</b> | <b>Failure /Post Failure Test Bench Motor RPM</b> |
|---|---|---|
| 2 | 30 seconds | 3600-3700 |

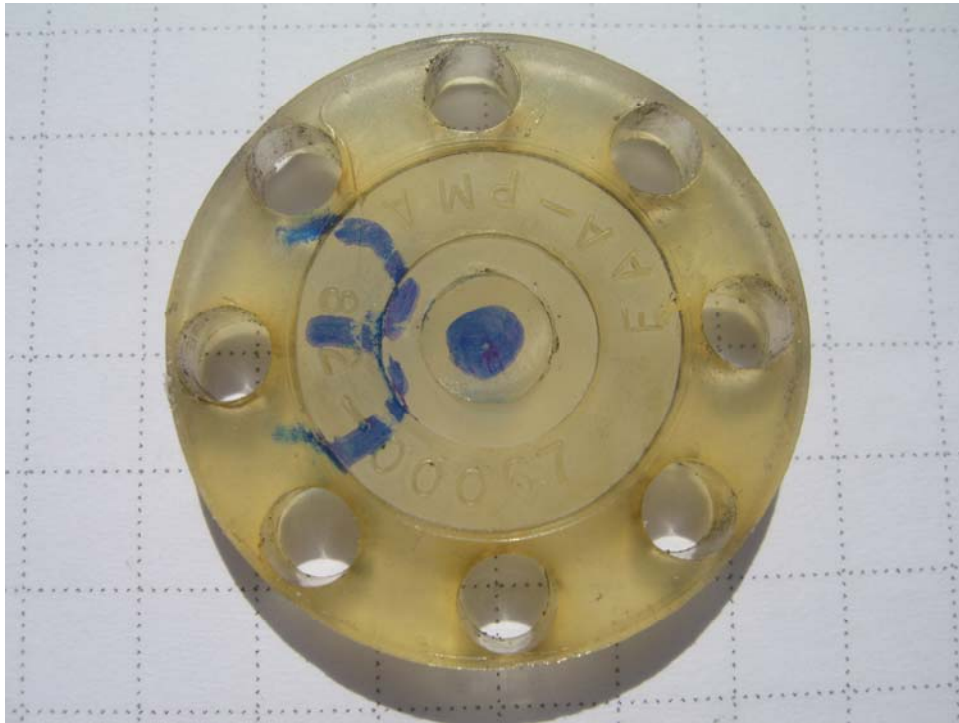
Sample 3 Outside External Face View

| <b>Sample</b> | <b>Post Failure Run Time</b> | <b>Failure /Post Failure Test Bench Motor RPM</b> |
|---|---|---|
| 3 | 1 minute | 3600-3700 |

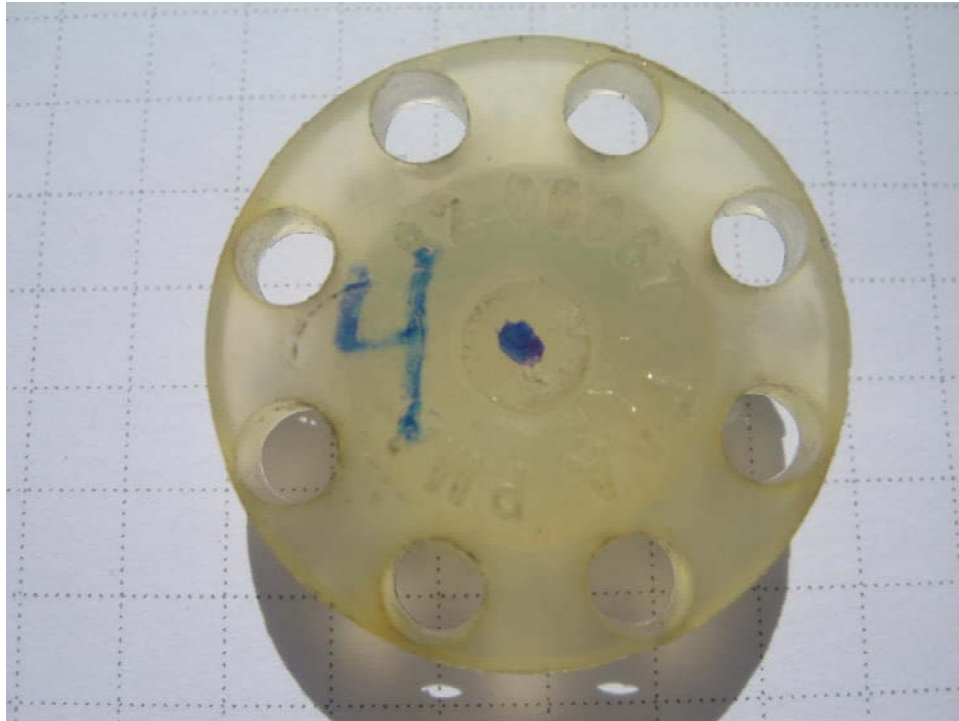
Sample 4 Outside External Face View

| <b>Sample</b> | <b>Post Failure Run Time</b> | <b>Failure /Post Failure Test Bench Motor RPM</b> |
|---|---|---|
| 4 | 5 minutes | 3600-3700 |
