# NATIONAL TRANSPORTATION SAFETY BOARD

## MATERIALS LABORATORY FACTUAL REPORT

Report No. 14-051

Place : Parma, New York  
Date : July 5, 2014  
Vehicle : Cessna 140, N76850, serial number 11284  
NTSB No. : ERA14FA327  
Investigator : Todd Gunther, ERA

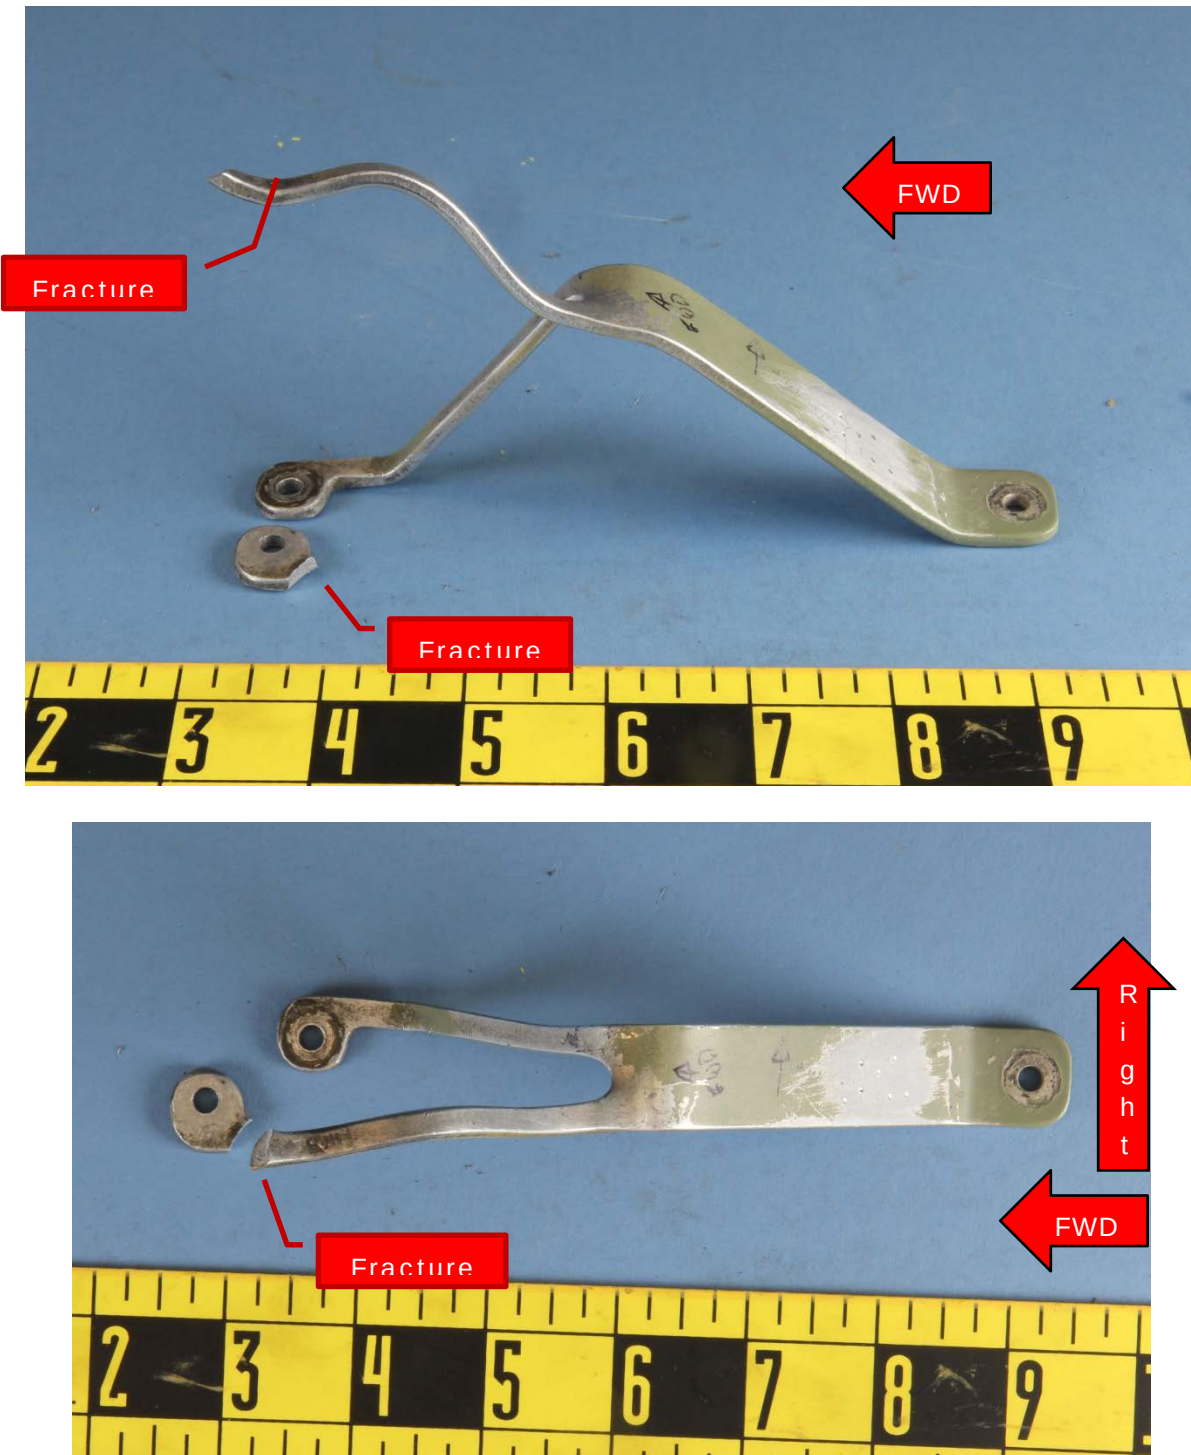
The as-received center safety belt bracket is displayed in figure 1. The bracket was used to attach the center portions of the left and right lap belts to the fuselage. It was reported to be an original part with Cessna part number 0425132. The Illustrated Parts Catalog depicts the bracket attached the floor of the cabin area between the seats in the orientation indicated.

As shown in greater detail by figure 2, the left side tang of the bracket was fractured adjacent to the forward foot for the left seat belt attachment. The fracture was oriented at about 45 degrees at the juncture between the tang and the foot. Magnified optical examinations revealed fracture features and deformation patterns indicative of a shearing overstress separation. No indications of preexisting cracking or corrosion were noted. As shown in the upper view of figure 1, the left side tang showed deformation patterns consistent with both pre and post fracture deflections.

Figure 1. Two views of the fractured seat belt bracket, left side at top, top view below. The extent and shape of both the pre and post fracture deformation is visible in the side view at top.

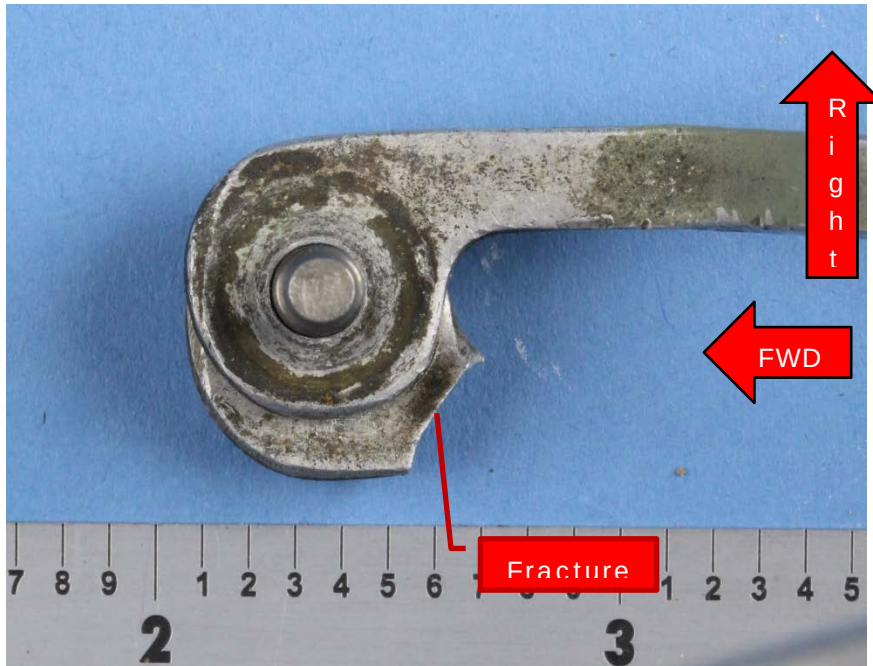
Figure 2. Two views of the fractured foot shown positioned relative to the intact right foot as installed. Exemplar bolt used.

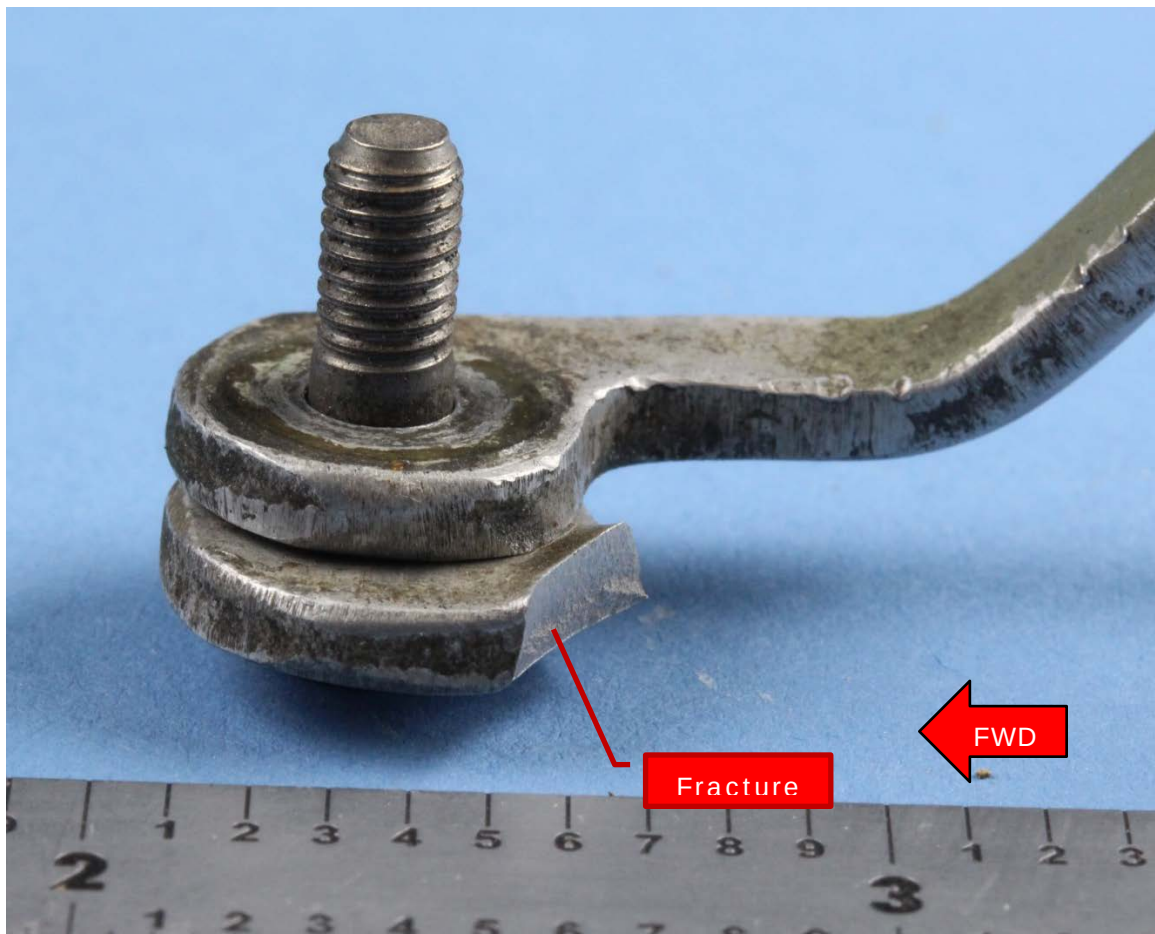
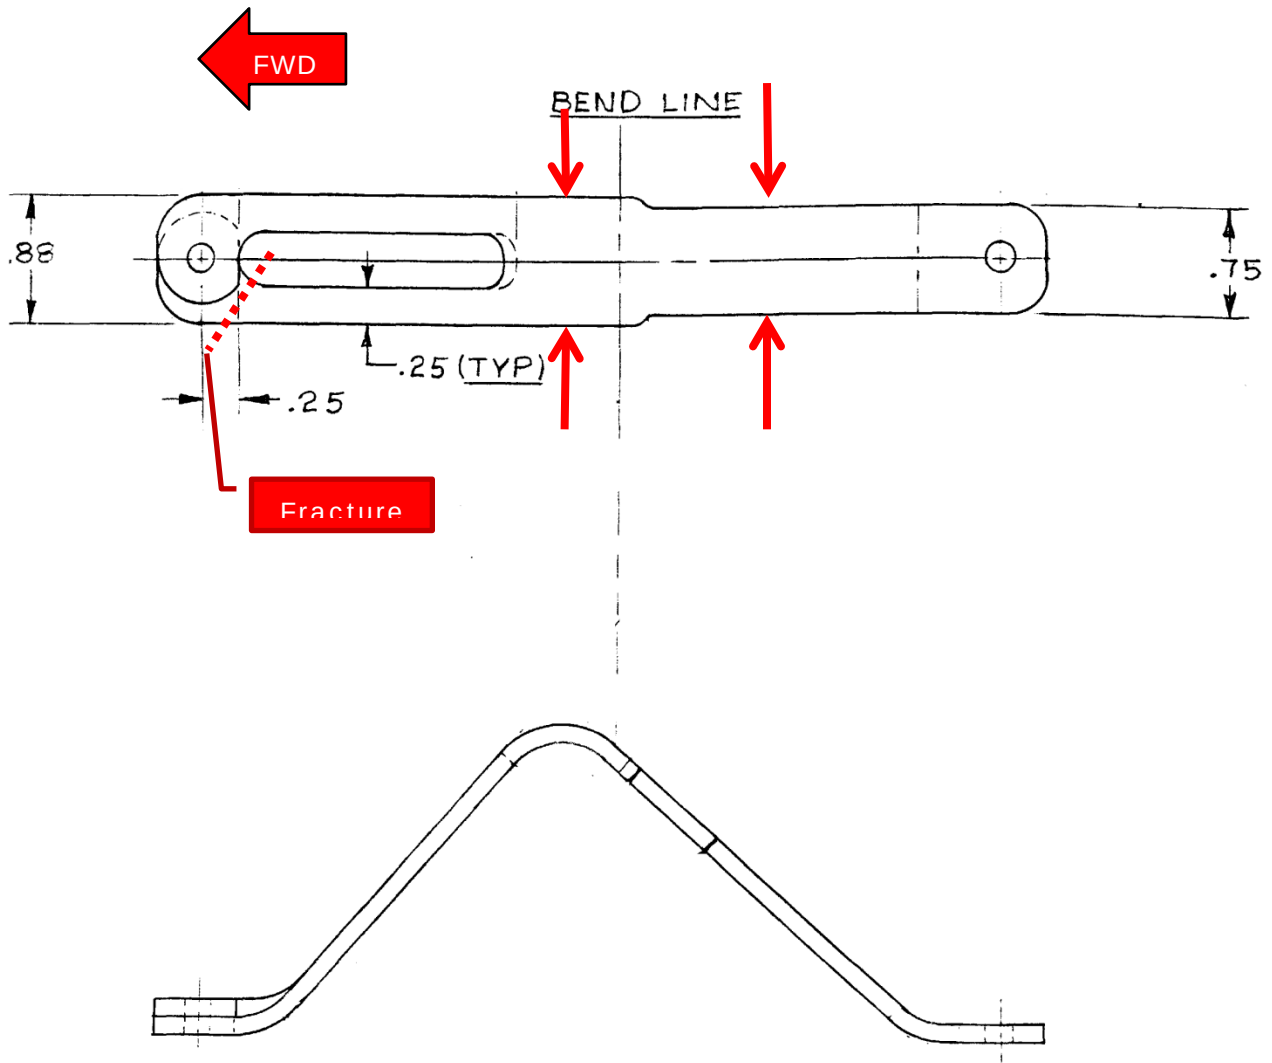
Engineering drawing, 0425132, Bracket-Seat Belt, became inactive for use in 1966. The latest drawing specified the bracket material as SAE 4130 alloy steel, normalized after forming. The drawing also depicted a shape with two different widths as shown in figure 3.

The drawing showed a forward 0.88 wide section with a 0.75 inch wide aft section. In comparison, the received bracket measured 0.75 inch wide along its entire length. The widths of the tangs on the fractured bracket also measured smaller than the drawing dimensions, 0.215 inch versus 0.25 inch on the drawing. Other dimensions including hole sizes, thickness, bend angles appeared to be consistent between the received bracket and the drawing.

Based on the 45 degree fracture across the tang, the received bracket has approximately 7% less cross sectional area than the latest version of the bracket.

Figure 3. Illustration of the bracket shape depicted in the latest Cessna drawing for the seat belt bracket. Note the two different widths as indicated by the opposed red arrows.
