# Continental Motors

## ENGINE FIELD INSPECTION REPORT

ENGINE MODEL: A-75-8F

AIRCRAFT MODEL: Piper J3C-65

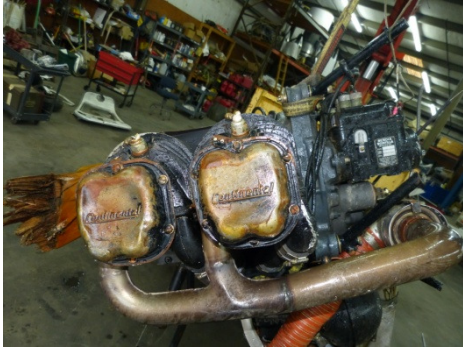
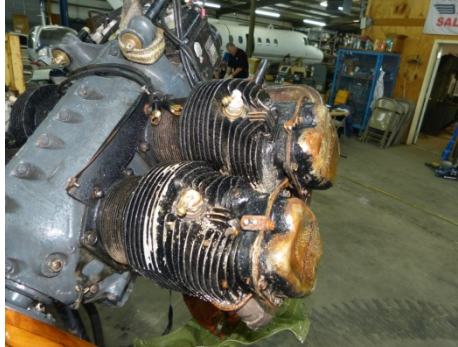
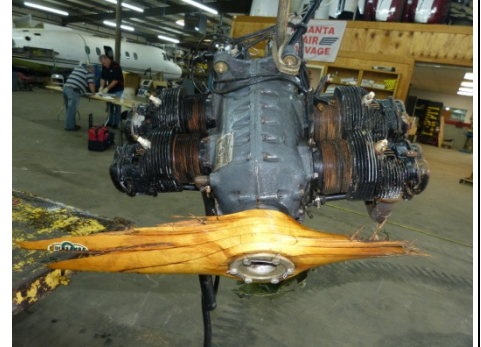
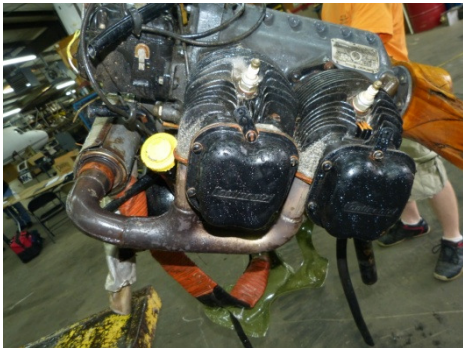
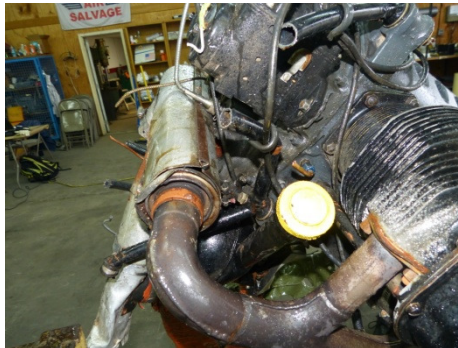
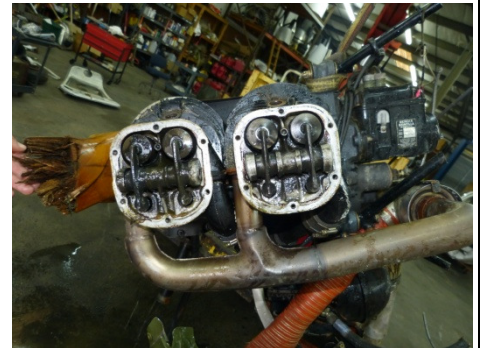
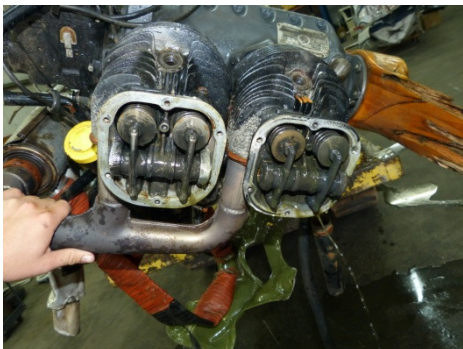
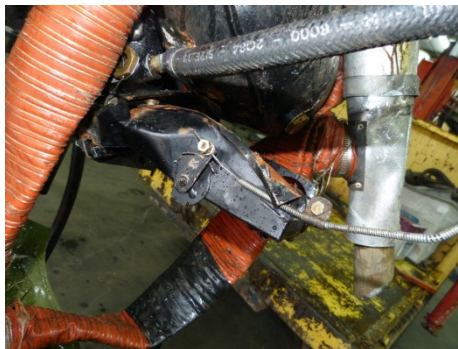
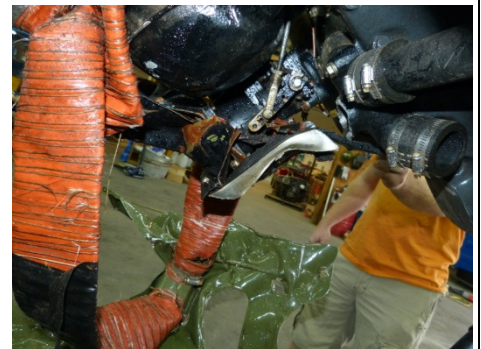
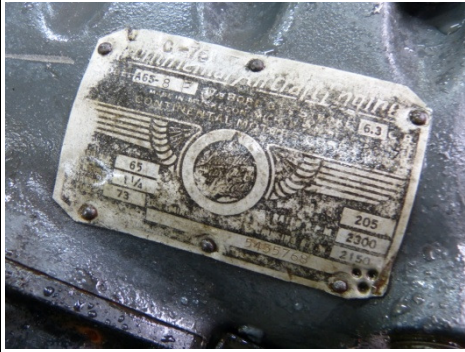
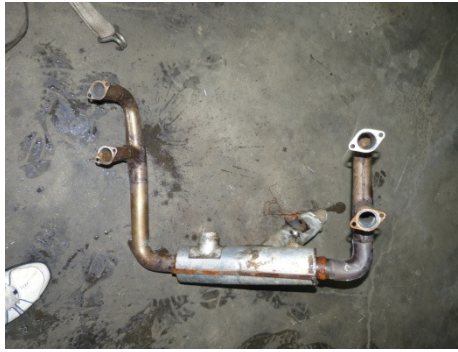
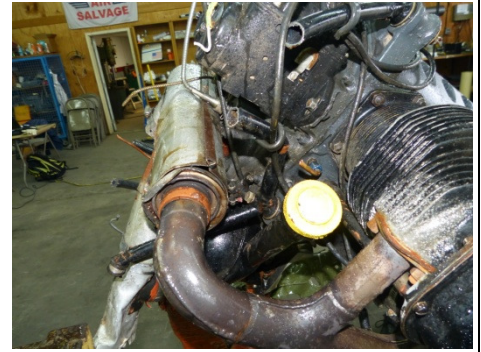
### EXTERNAL INSPECTION OF ENGINE:

The engine was intact with all accessories attached. The carburetor was partly separated and the oil sump had impact damage. The throttle and carburetor heat controls were hooked up. The ignition harness was separated from the spark plugs. All of the cylinders had chrome markings.

The top spark plugs and the rocker covers were removed. The crankshaft was rotated using the propeller. Continuity was confirmed to all of the cylinders and to the rear of the engine. Thumb compression was confirmed on all of the cylinders.

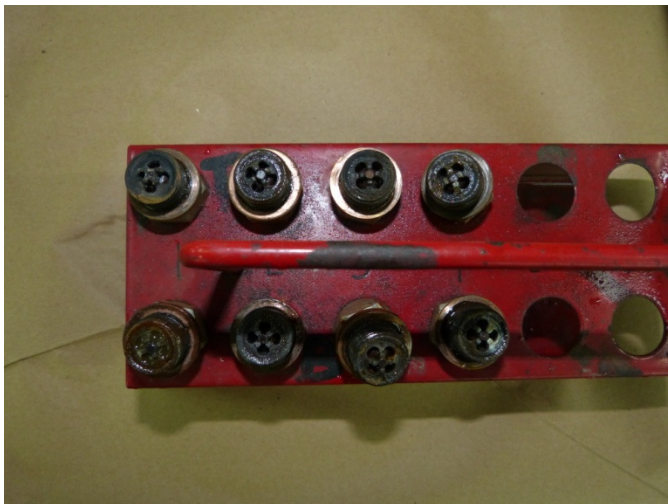
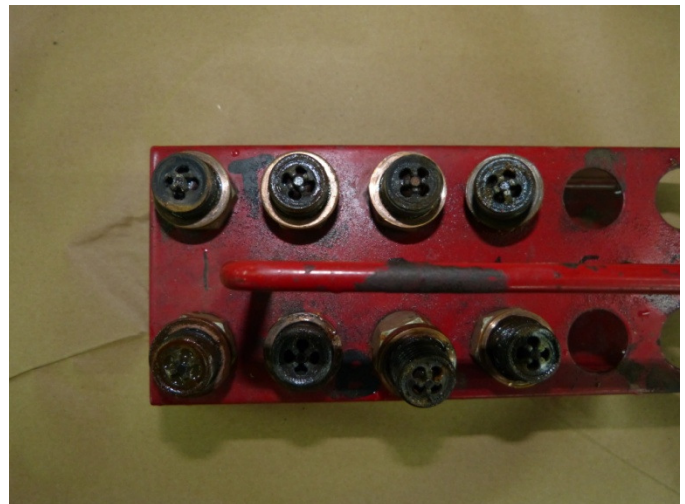
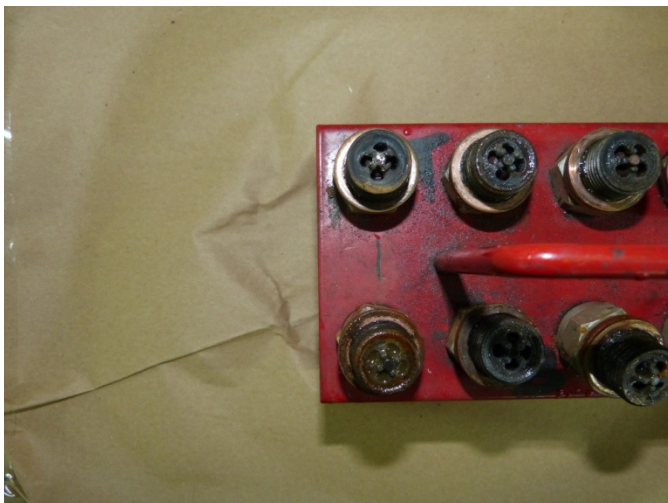
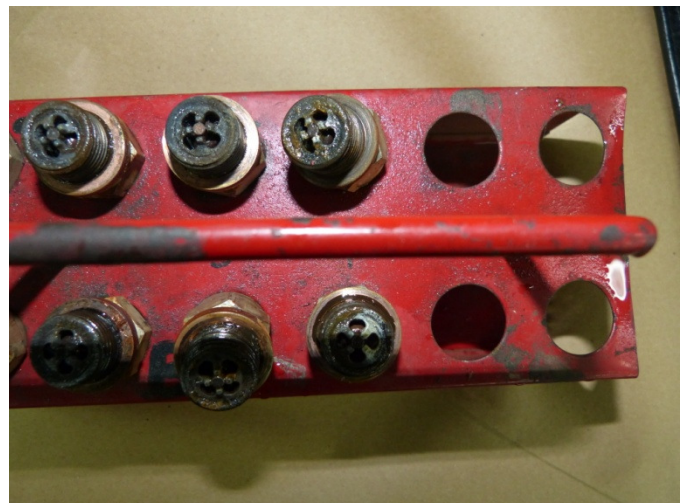
### Spark Plugs: AC, C-26, P10

All of the cylinder two and four spark plugs were broken in half. The spark plugs had normal wear when compared to the Champion Check-A-Plug comparison card. They had dark deposits in the electrode areas.

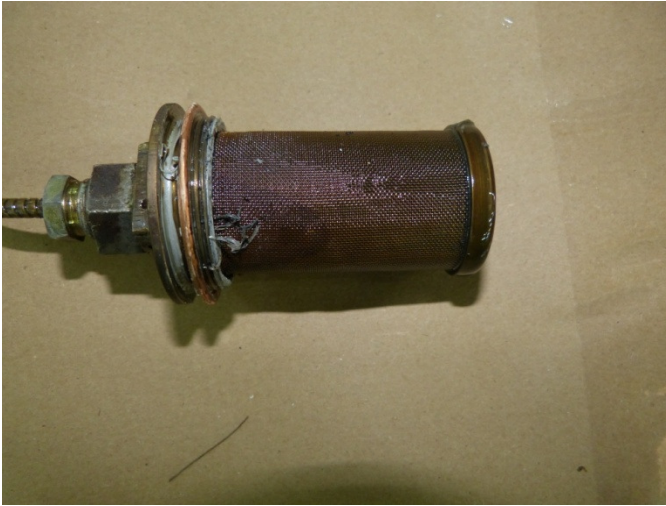
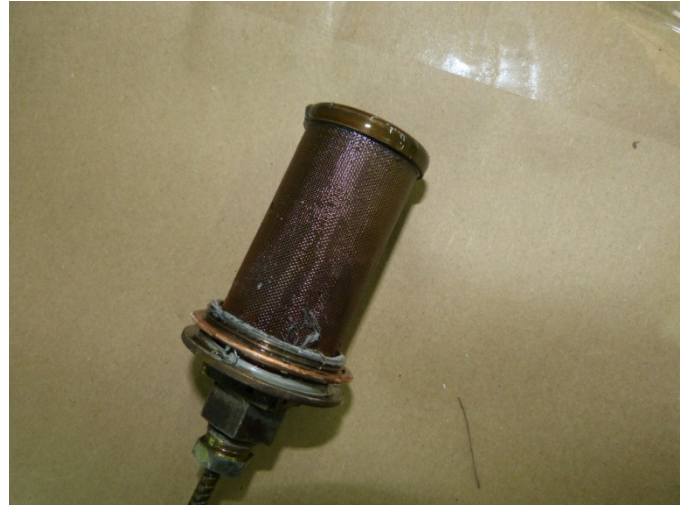
Oil Screen: The oil screen was removed and examined. It was clean, except for a few carbon deposits.

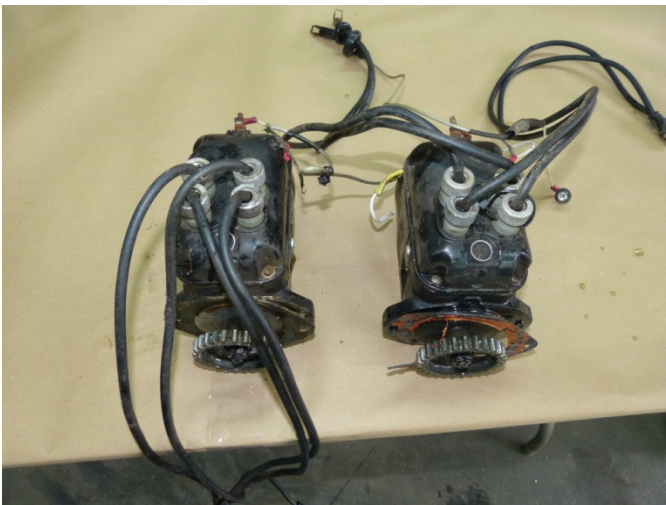
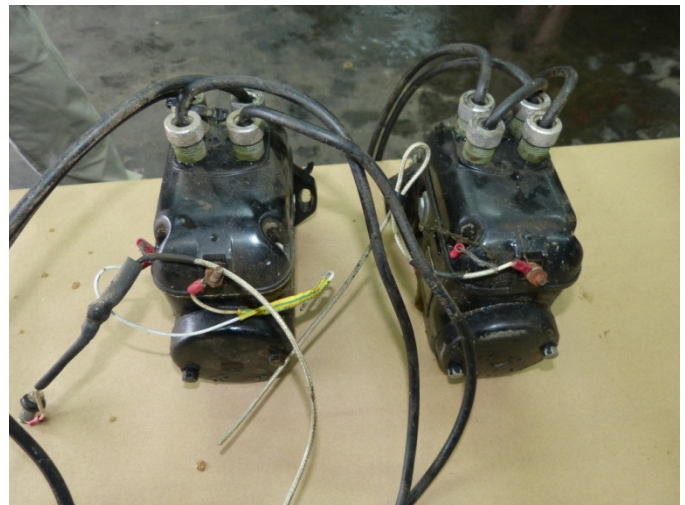
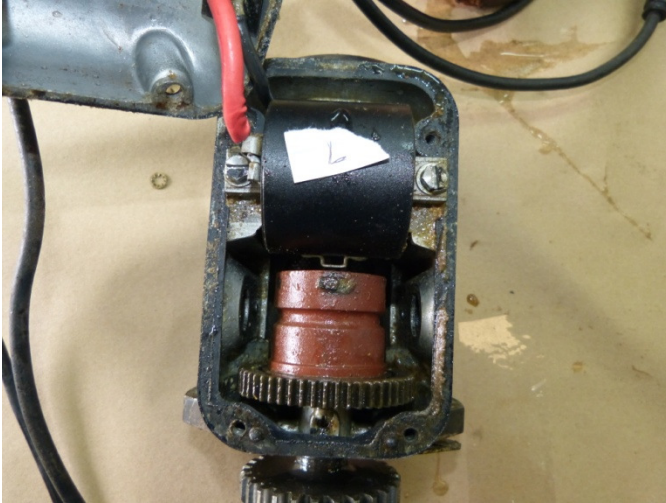
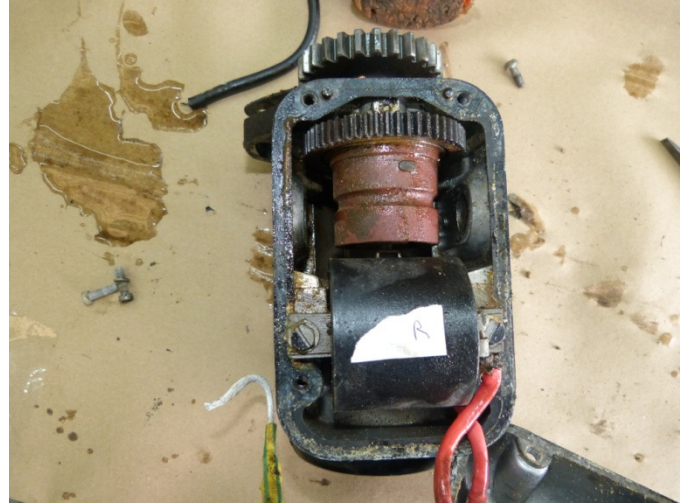
Magnetos: Left, Bendix, SF4R+8, PN-10-19293-1, SN-33114  
Right, Bendix, SF4R-8, PN-10-19293-1, SN-33767

The magnetos were in place on the engine. They were not impact damaged, but they had been under water for several days. The drive shafts were rotated with an electric drill, but no sparks were observed. The magnetos were disassembled and they were wet in the interiors. A hair dryer was used to dry out the interior of the magnetos, and they were then again rotated with an electric drill. Three out of four leads sparked on the left magneto, but no leads sparked on the right magneto.

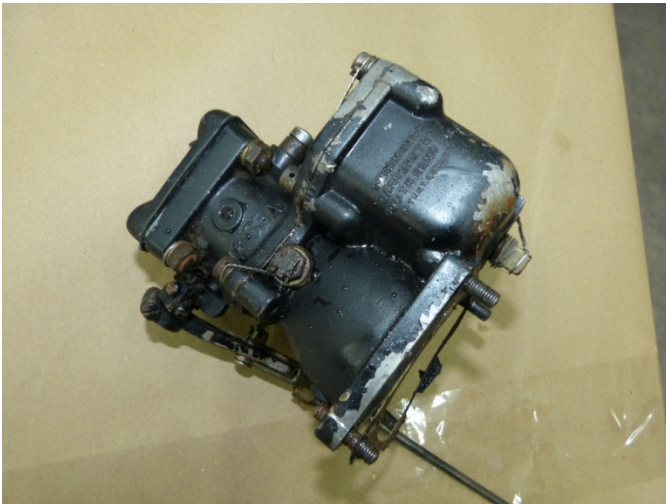
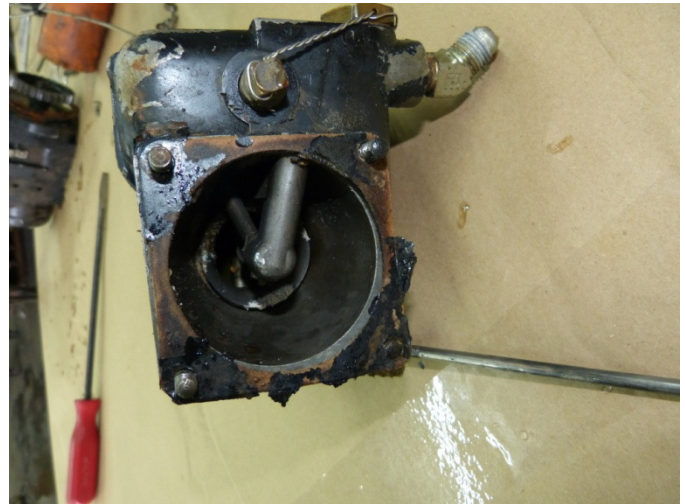
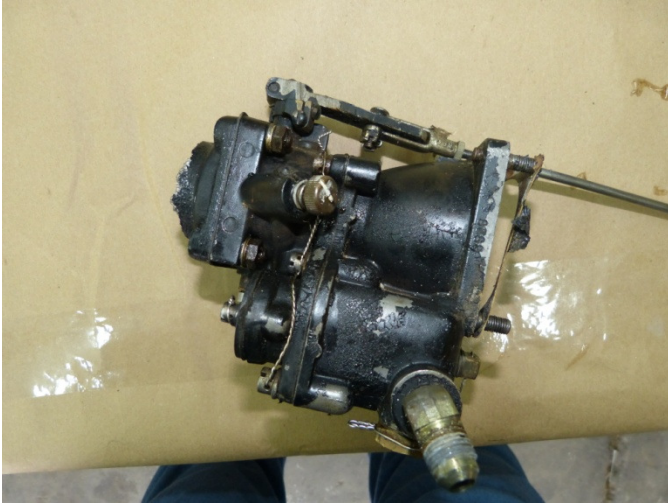
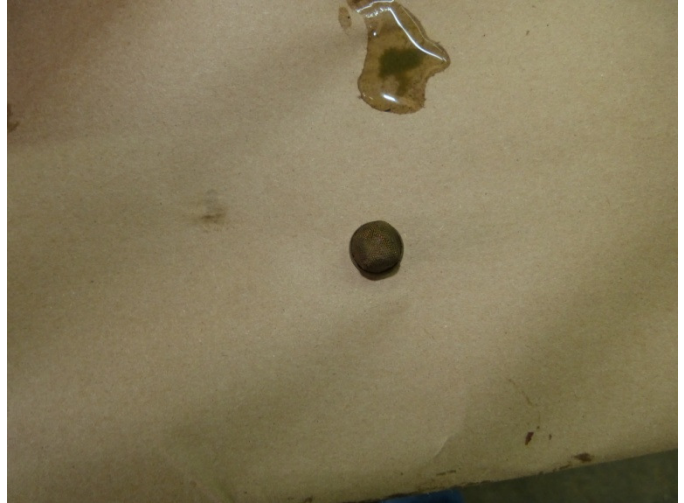
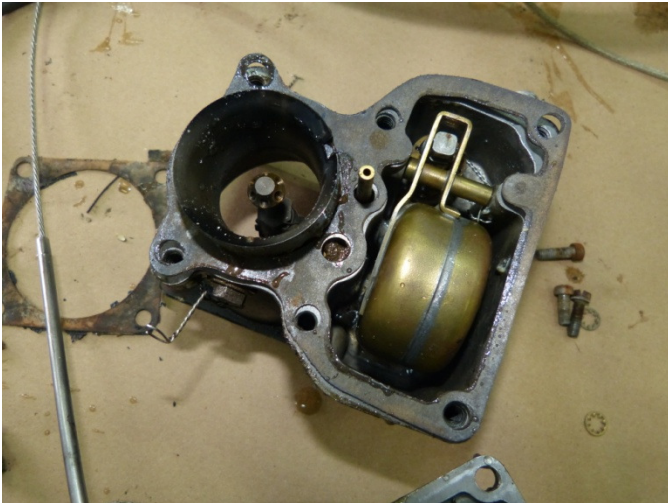
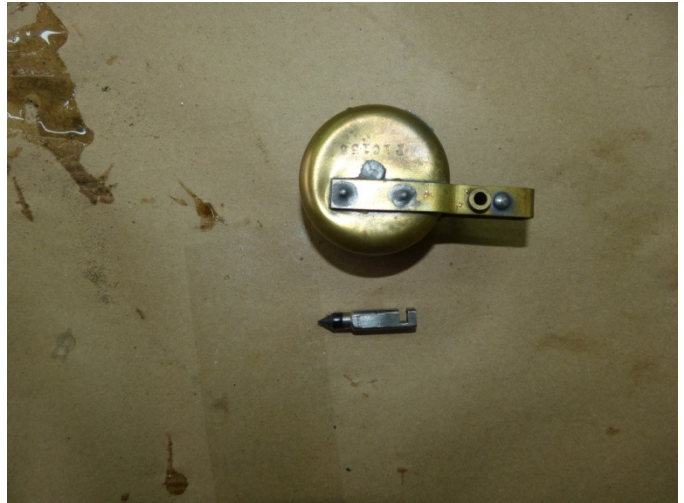
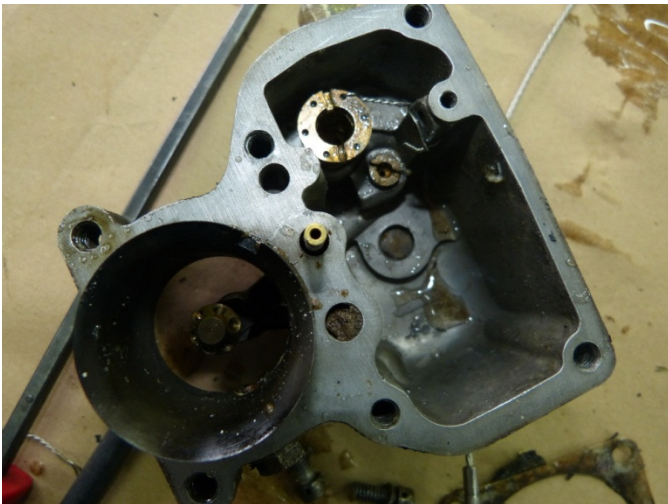
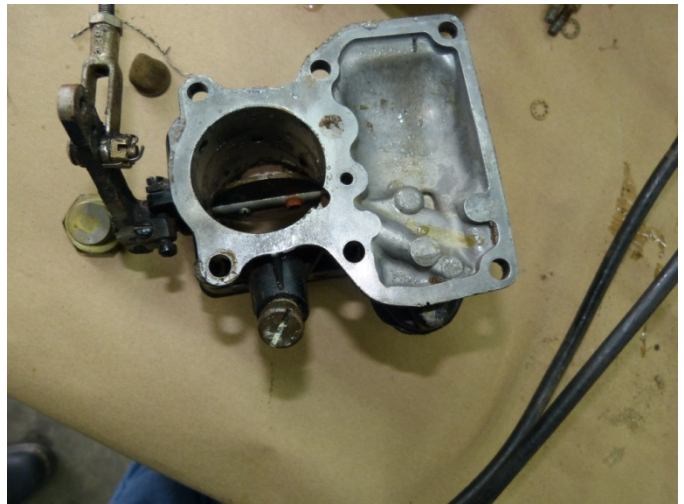
#### Carburetor: Stromberg, NA-S3A1

The carburetor was partly broken away from the bottom of the engine. It had no other damage, but the bowl was full of water. The fuel screen contained a small amount of debris. The unit was disassembled and the float and needle valve were in place and free to move. The needle valve seat was clean.

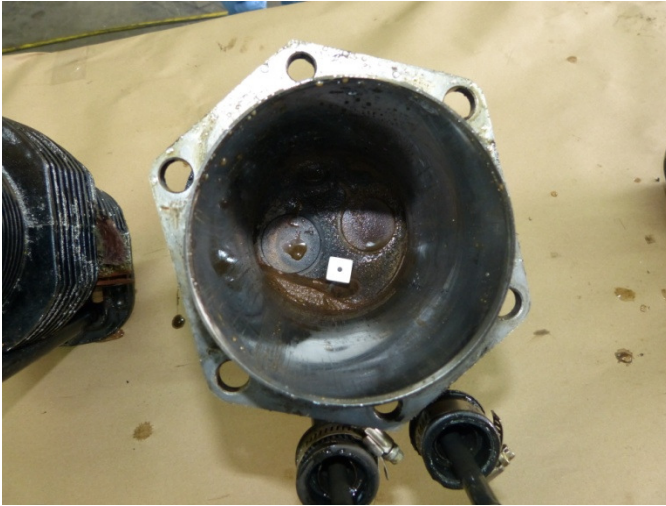
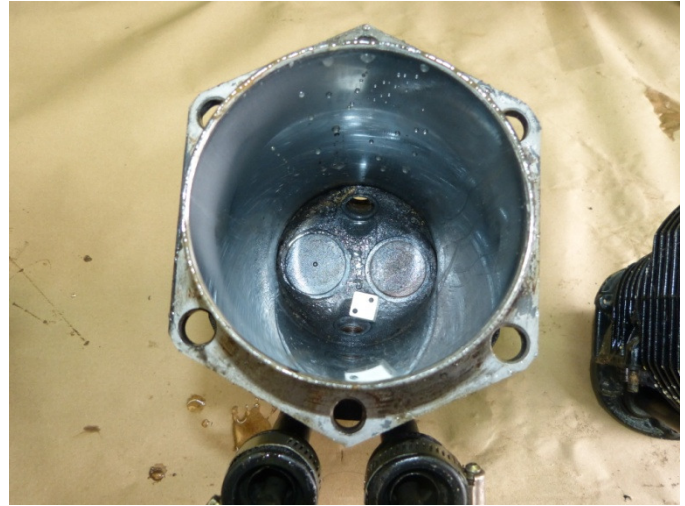
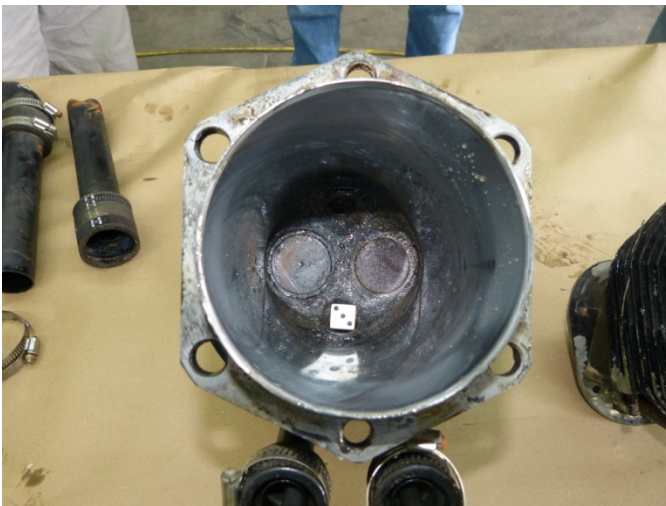
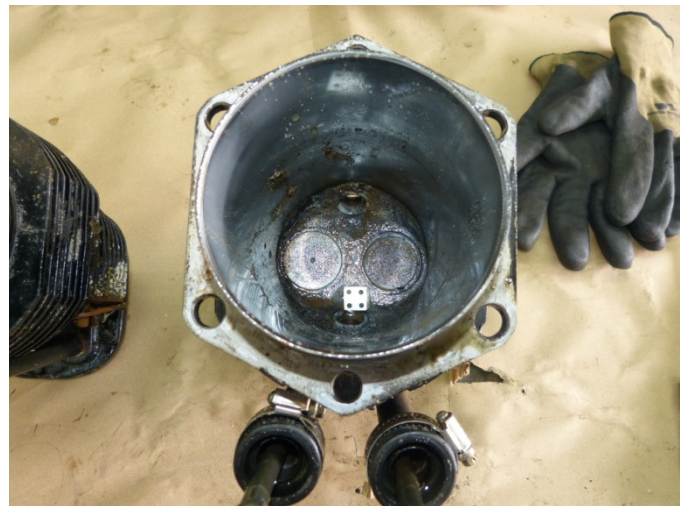
#### Cylinders: REG.T.MS.A.C.OFA

The cylinders were not damaged. They had combustion deposits in the domes, and all of the valves were in place. Light scoring was observed in the cylinder barrels.

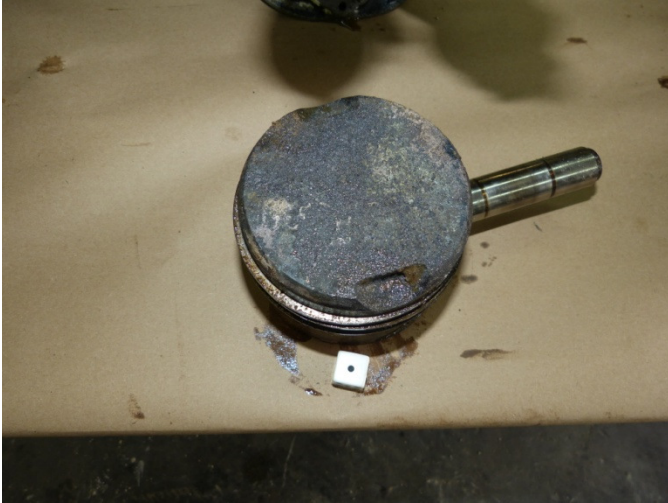
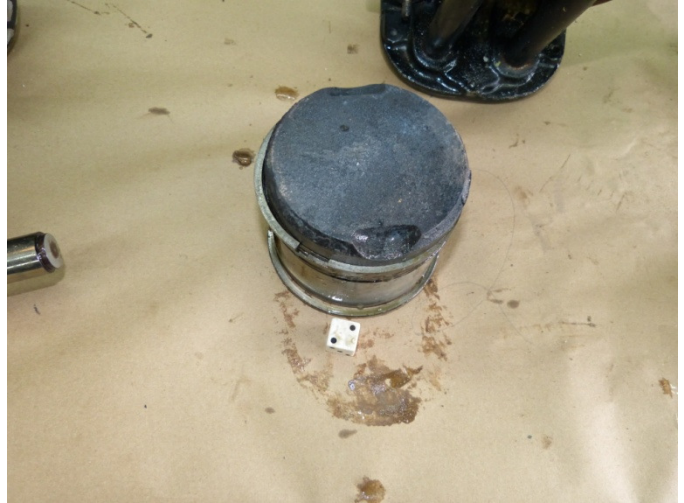
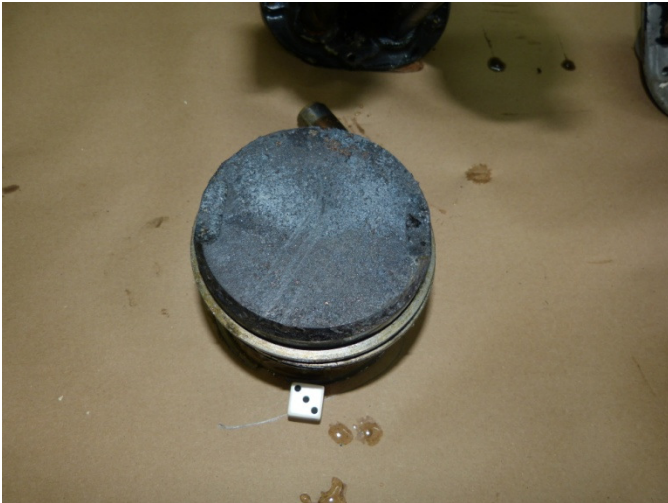
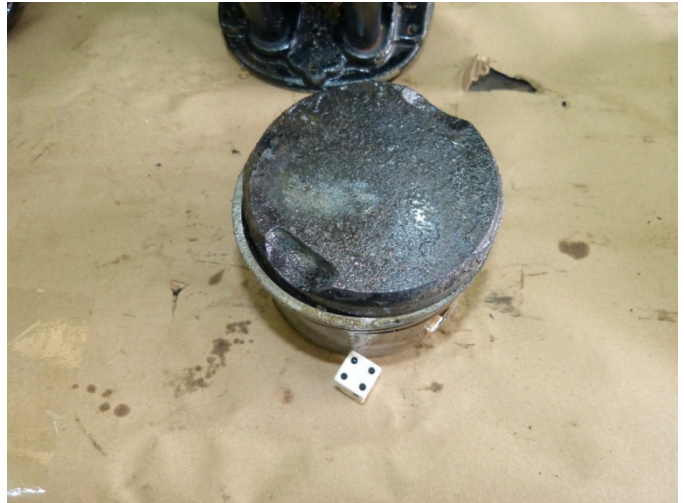
#### Pistons: 4701

The pistons were not damaged, and had normal combustion deposits. All of the rings were in place and were free to move.

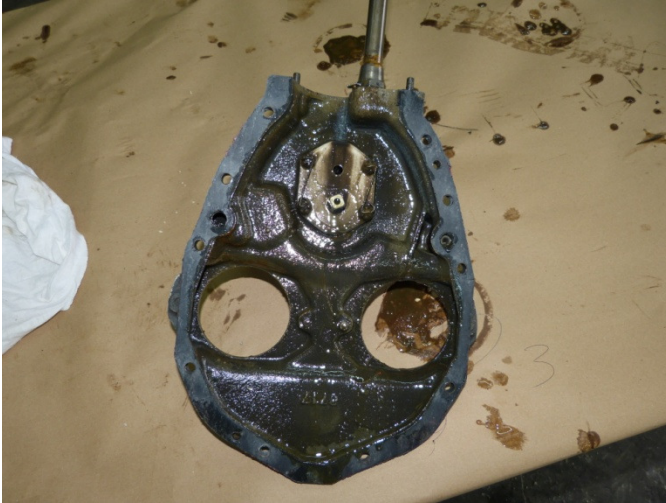
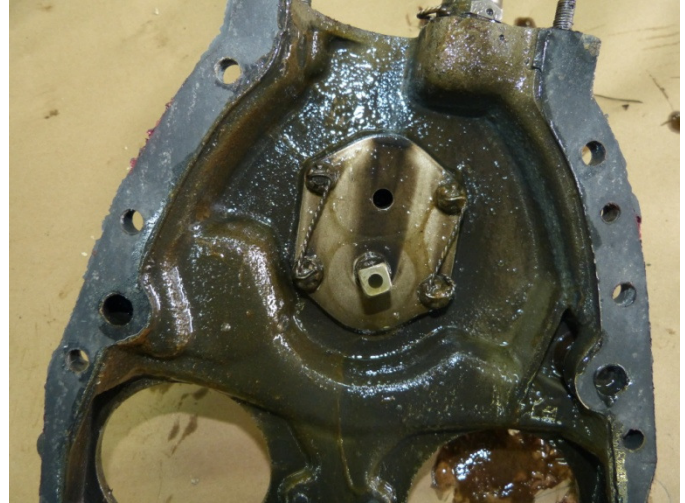
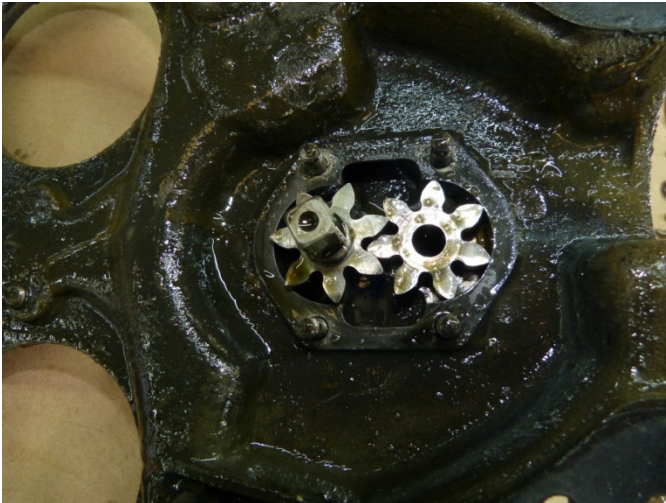
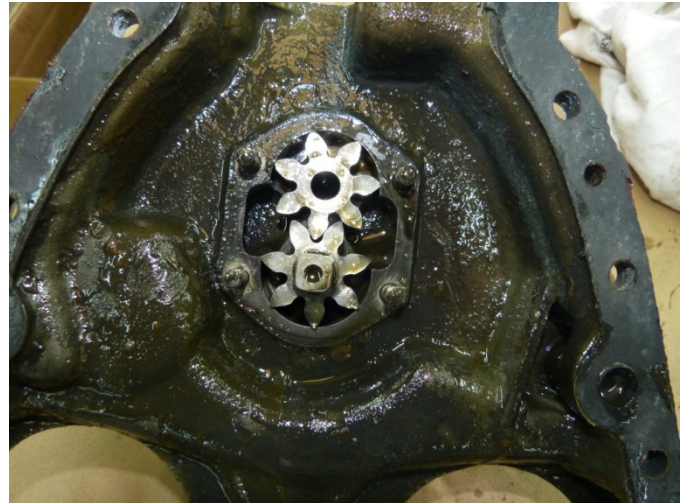
Accessory Case: The accessory case was in place and not damaged. They oil pump gears were free to rotate and were coated with oil.

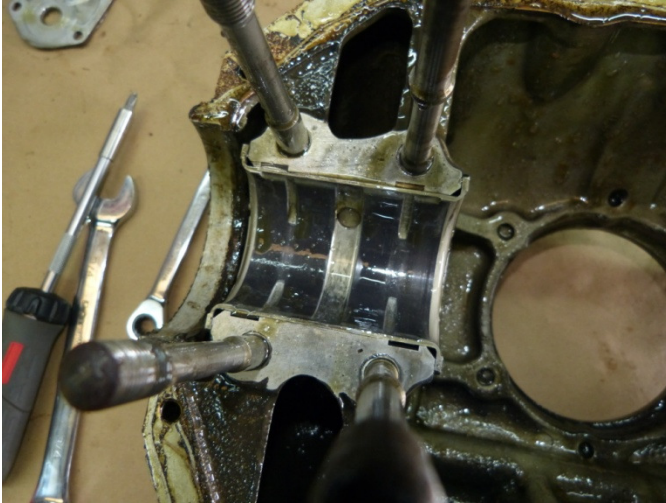
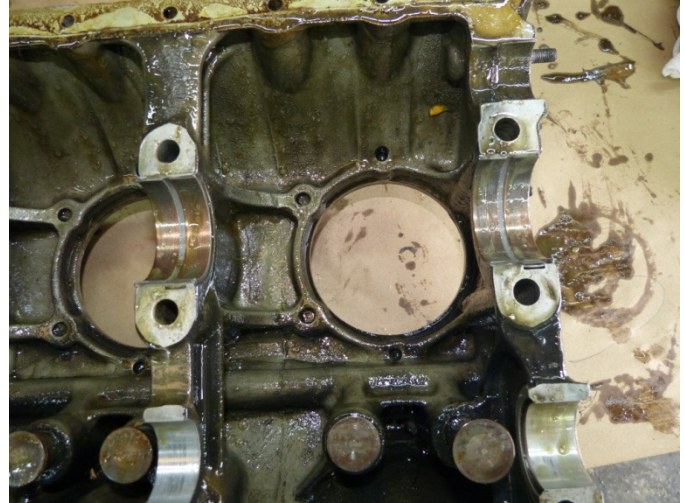
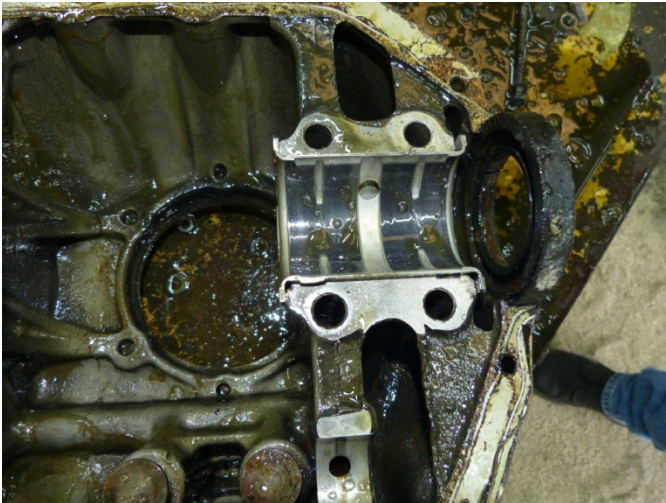
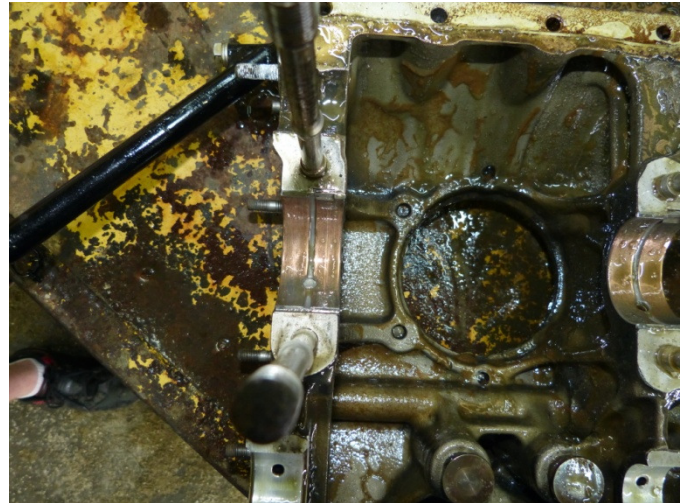
Main Bearings: Front-40237-010, Rear-633399M010  
The main bearings were in place and not damaged. They were coated with oil.

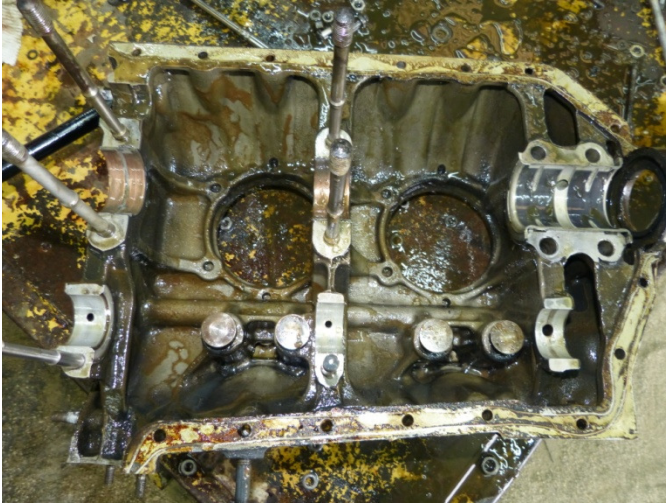
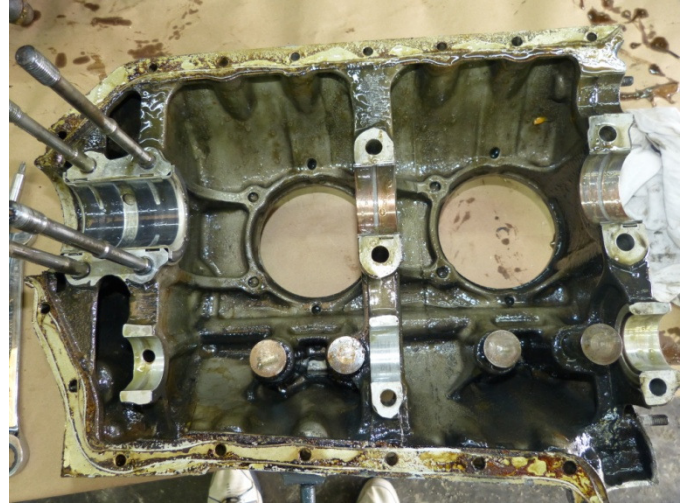
Crankcase Halves: There was no damage to either crankcase half. All of the valve lifters were in place and coated with oil.

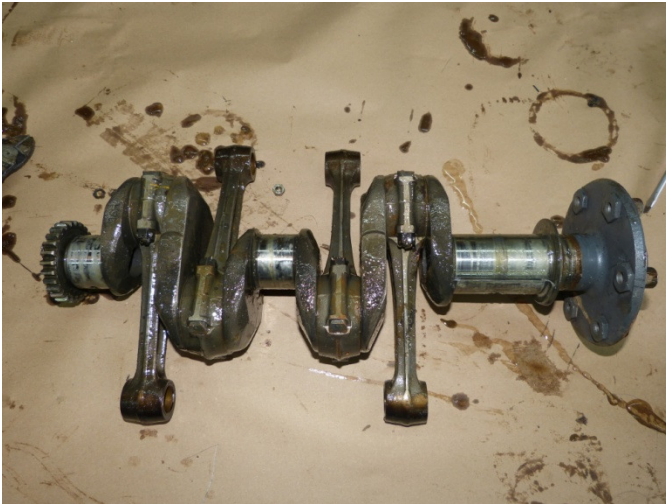
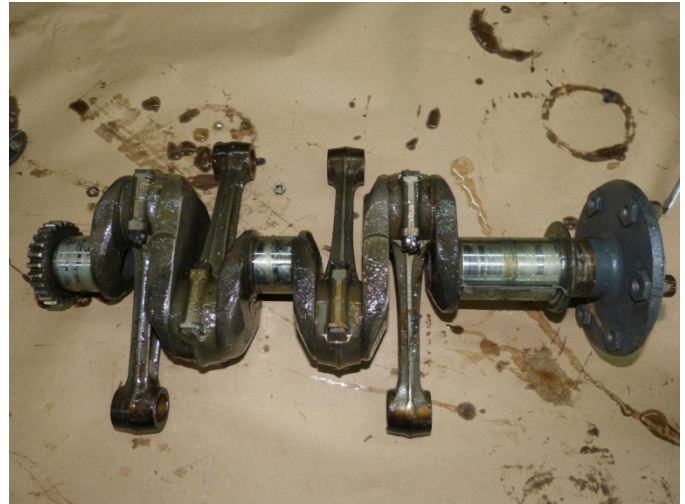
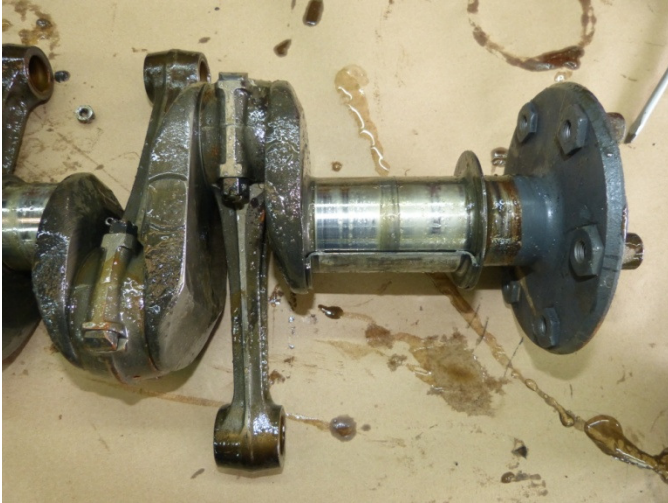
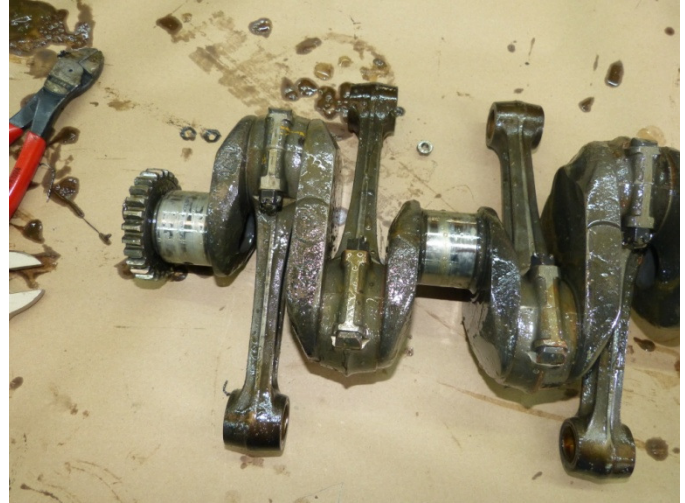
Crankshaft: A35908-2

The crankshaft was intact and not damaged. All of the connecting rods were attached and were free to rotate.

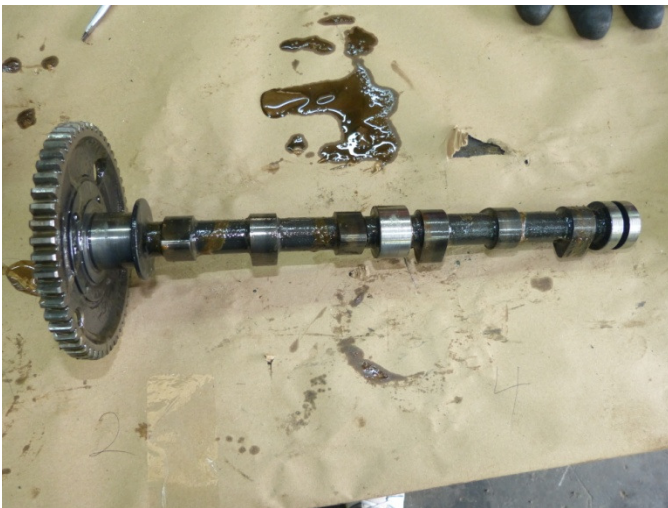
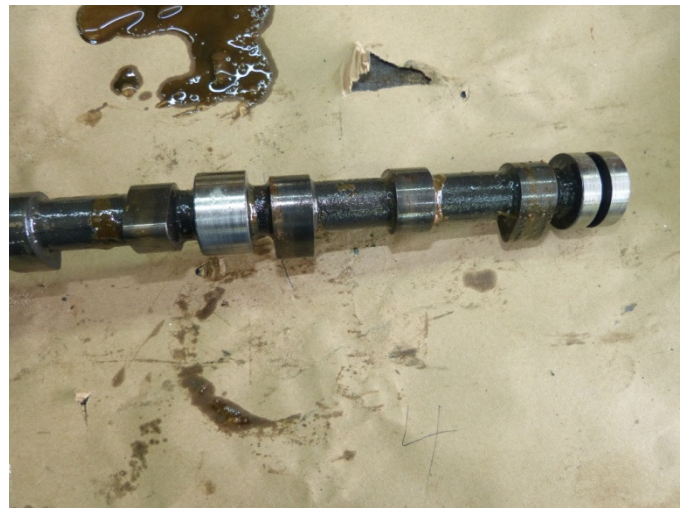
Camshaft: 4546

The camshaft was not damaged and was coated with oil.

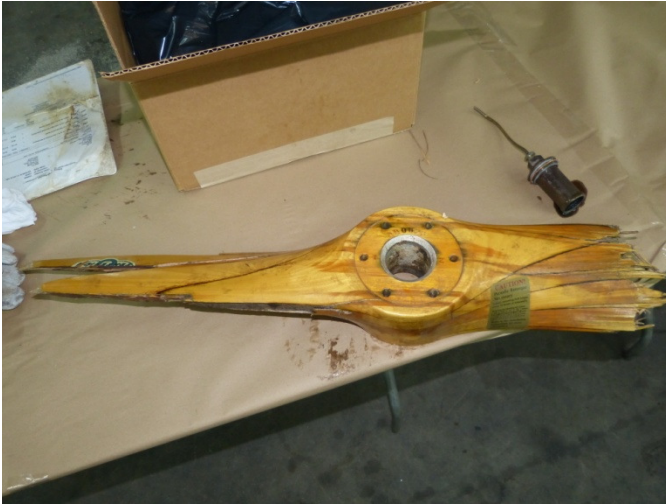
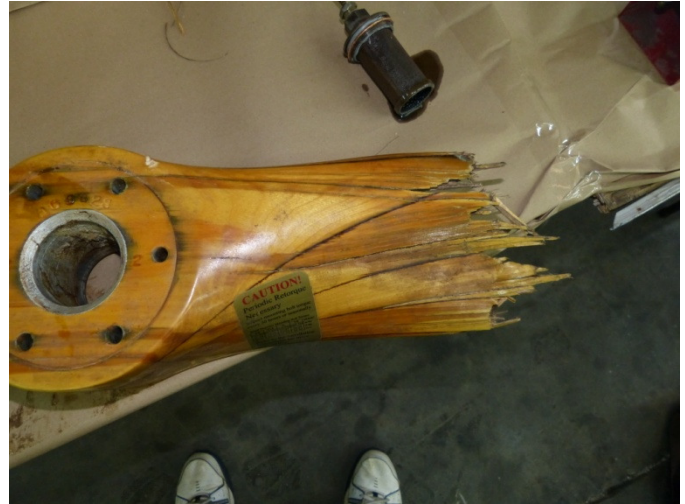
Sensenich, AGO628

Both wooden propeller blades were shattered, and the hub remained attached to the crankshaft.
