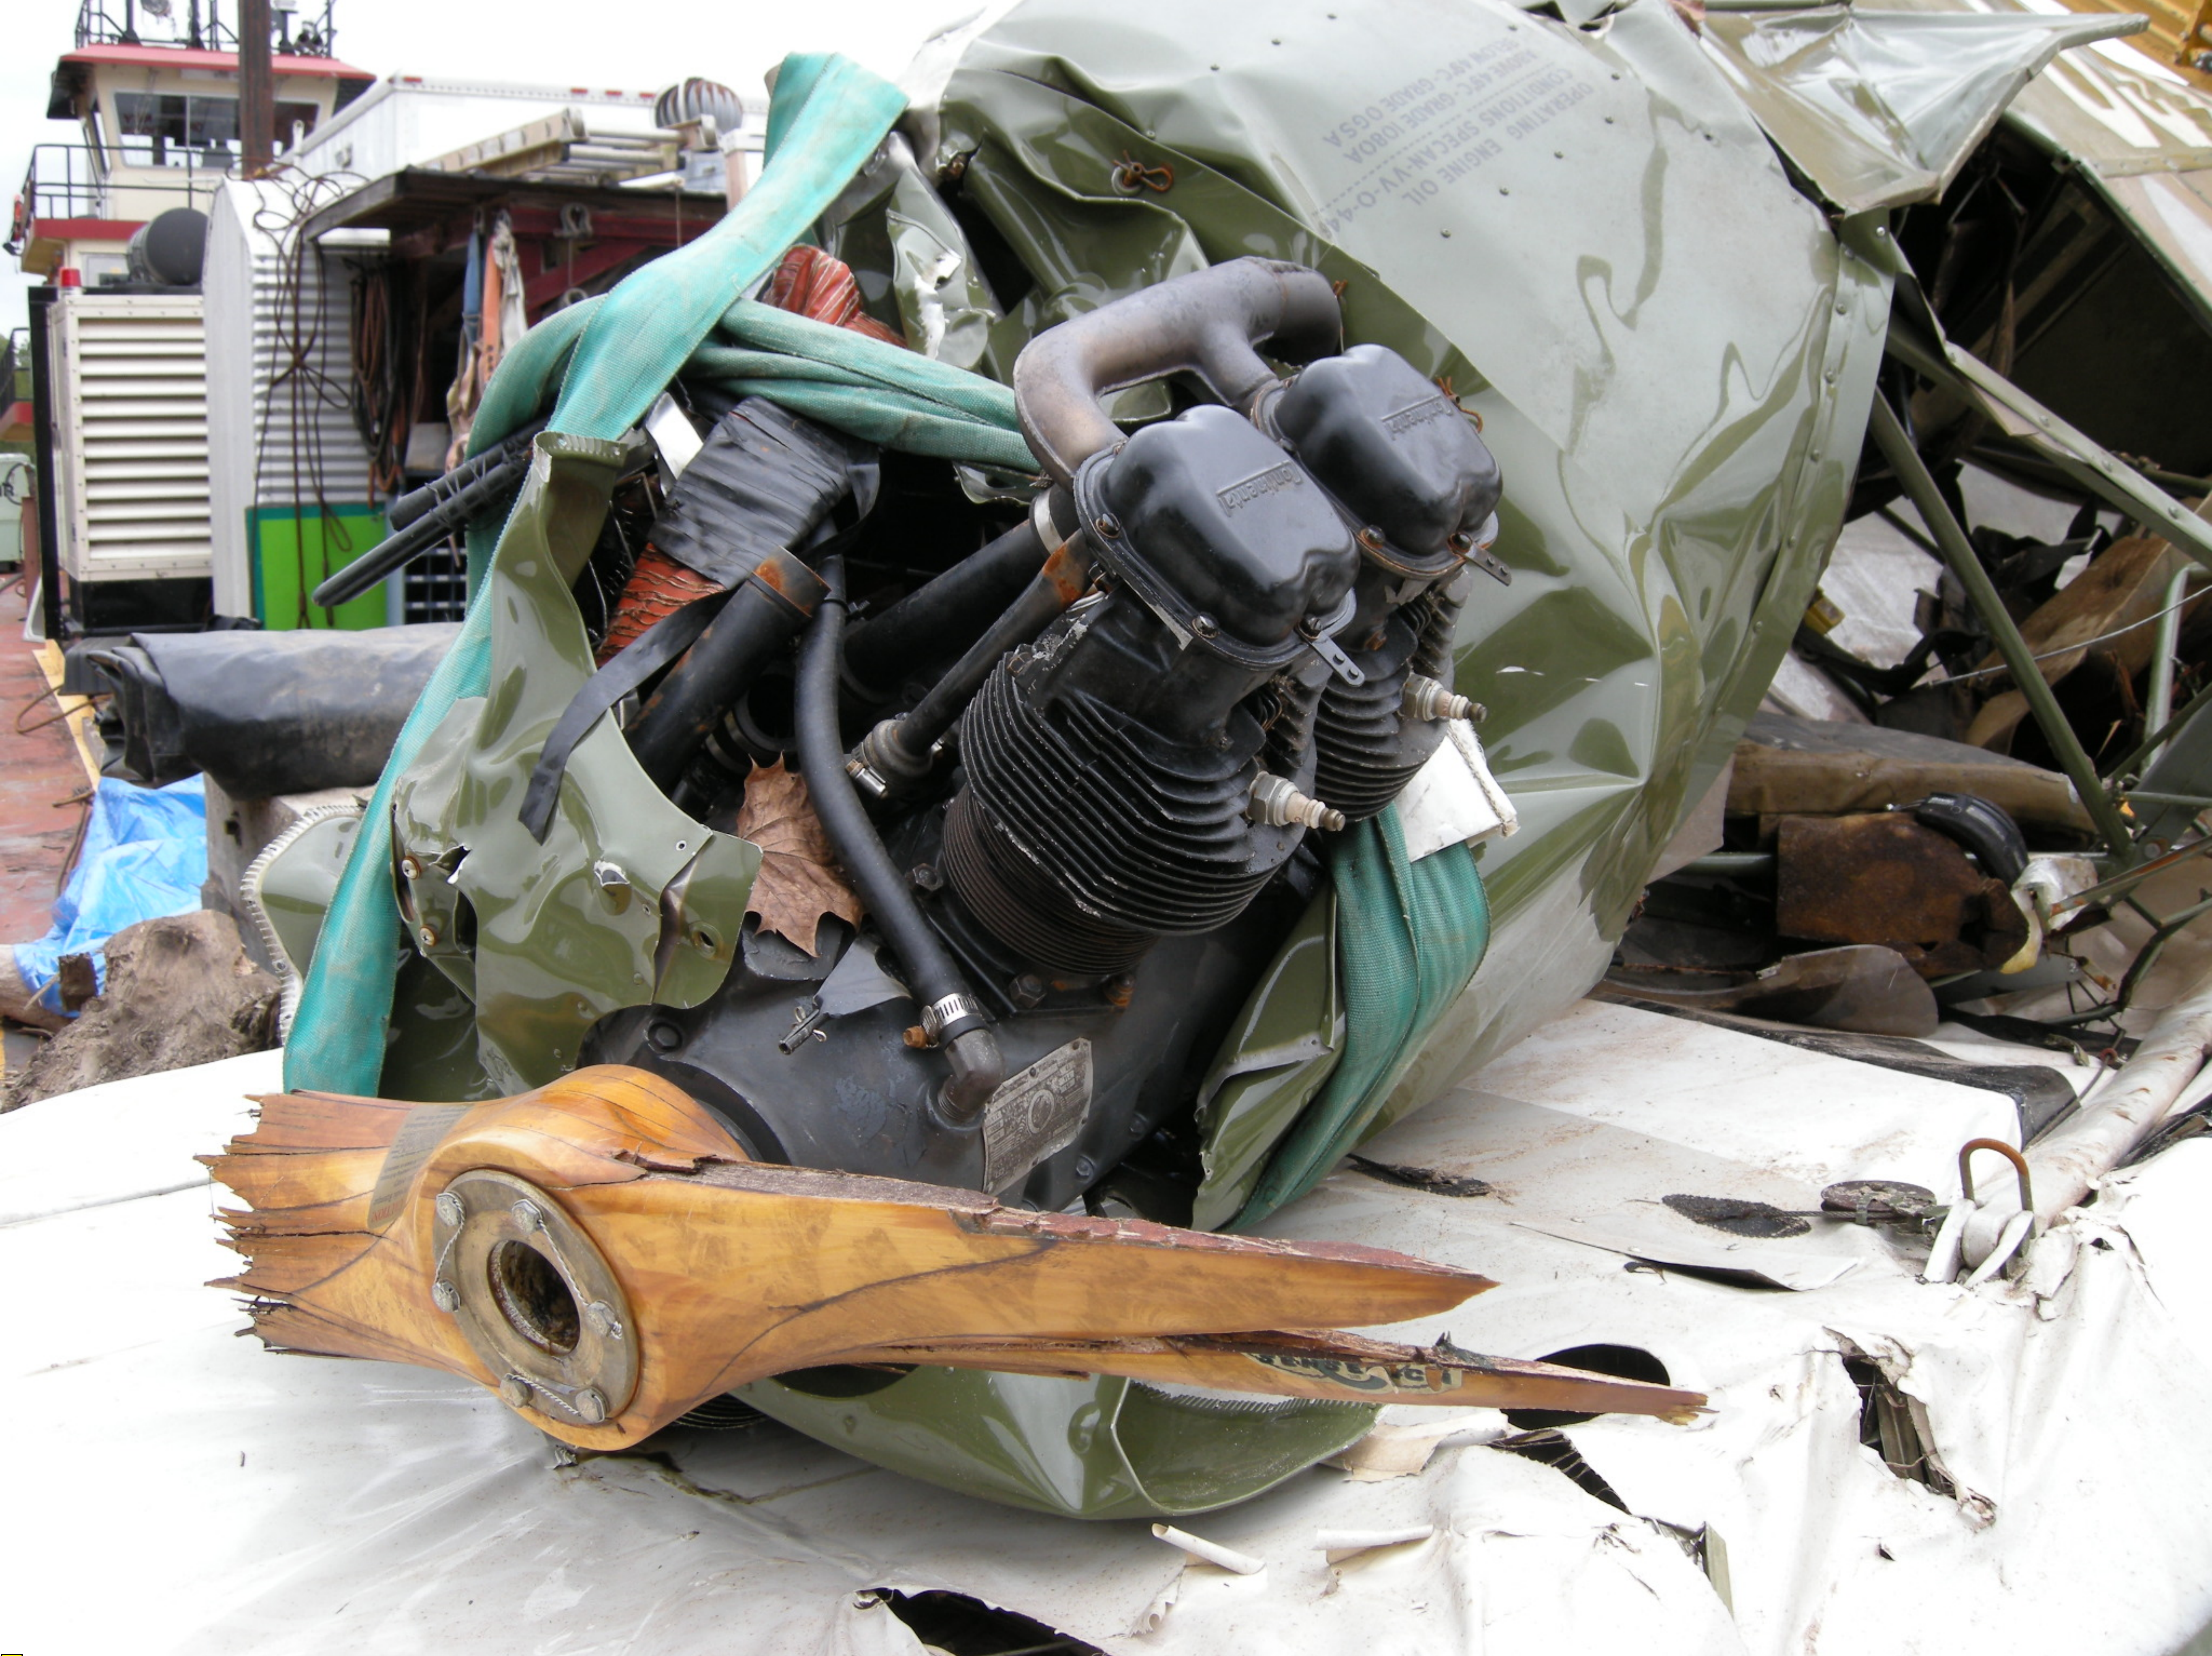
Photo 3 – Engine and Propeller, After Recovery
