## Inspectors Statement

On December 2, 2013 at approximately 1656 I received a call from the Regional Operation Center about an aircraft that went down near the Edgefield Airport (6J6). The aircraft is N355PT a Moffitt Oscar/ Kit Prostar PT2 experimental amateur built aircraft. The pilot is Larry Putt the registered owner of the aircraft. Mr. Putt was unhurt in the accident. I drove to the scene to inspect the aircraft and speak with the pilot/owner. Mr. Putt had already left the scene when I arrived, so I inspected the aircraft and took pictures. The aircraft hit a tree and power lines on its way to the ground. The aircraft was substantially damaged in the accident.

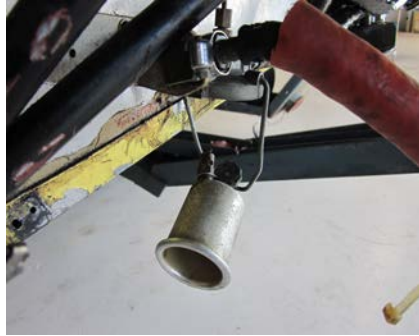
On December 6, 2013 I drove to Twin Lakes Airport and met Mr. Putt at his hangar. Mr. Putt had already removed the cowling from the engine. I noticed the fuel gascolator bowl was hanging from its safety wire. The owner said it was that way when he removed the cowling. He thought it had happened when the aircraft hit to ground. A visual inspection of the engine only found a hole in the #1 cylinder valve cover. This was caused by the cowling screws on impact with the ground. The magnetos and leads were all intact and appeared clean fairly new as if recent maintenance had been performed on them.

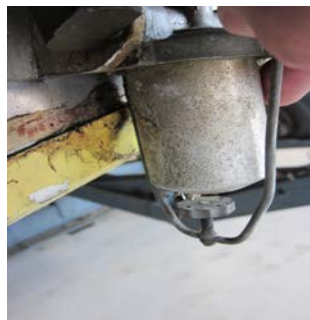
We inspected the air box for blockage and found none. Mr. Putt removed the air box and I inspected the carburetor venturi and no problems were noted. I had Mr. Putt remove the carburetor drain plug and we found no fuel in the carburetor. I had Mr. Putt turn the fuel selector to on and I took a sample of fuel from the open gascolator. Fuel ran freely from the gascolator. We then removed the fuel inlet line at the carburetor and blew air through it to the gascolator. It was clear with no blockage. I then went back to the gascolator and inspected it further. Between the thumb wheel and the gascolator bowl there is supposed to be an inverted bell that applies pressure to the bottom of the bowl. It is missing from the accident aircraft. There was no observable impact damage to the gascolator. Mr. Putt said the gascolator always seemed to be loose, but the thumb wheel would not turn any more to tighten it further.

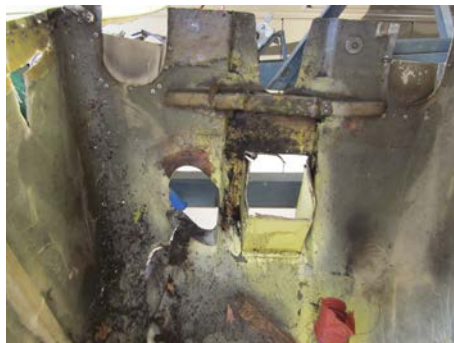
I inspected the bottom cowling and there was no observable impact damage on it that would have been consistent with the gascolator striking it. Oil and dirt residue were found throughout the cowling. In the area where the gascolator was mounted the oil and dirt residue was gone and the cowling appeared clean. The clean area is consistent with a leak that had occurred in flight and not post-accident. The aircraft was resting to the right and nose low and any fuel would have run forward and not aft as I found with the accident aircraft. The gascolator was mounted on the right side of the aircraft on the fire wall.

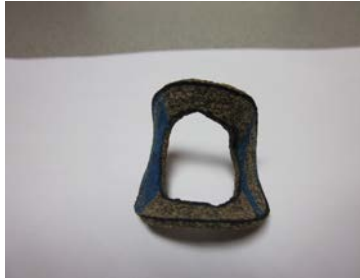
After reviewing the aircraft maintenance logbooks and Mr. Putt's flight times, I drove back to the accident site. I was able to find the gascolator gasket but not the missing bell from the gascolator. The gasket was a cork gasket that was handmade, as magic marker lines are still visible on the gasket.

On December 12, 2013 I spoke with Bob Martellotti from Piper Aircraft and he provided me with drawings and Service Letter 1141 dated 4/27/2011. This service letter calls out a new procedure for safety wiring the bail assembly on the Piper gascolator. What they have found is people are tightening the thumb wheel and causing the bail to expand out. When that happens the thumb wheel runs out of thread and does not tighten properly. The gasket that Piper calls out for this gascolator is made from rubber and not cork and it should have a thickness of 0.109 (7/64). The cork gasket found at the accident site was approximately 0.0625 (1/16) thick.

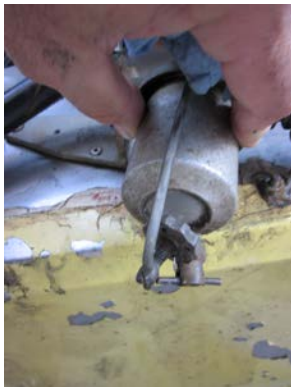
Mr. Putt said he believes the gascolator was salvaged from a Piper PA-28 aircraft at the time N355PT was built. The gascolator is consistent with the Piper part number 63839-03 gascolator. The Piper gasket for this gascolator is part number 462-049. The bail assembly Piper part number 494 644 includes the bail and thumb wheel assembly.
