# NATIONAL TRANSPORTATION SAFETY BOARD

## MATERIALS LABORATORY FACTUAL REPORT

Report No. 14-084

Place : Tampa, Florida  
Date : December 20, 2013  
Vehicle : Cessna 210N, N5307A  
NTSB No. : ERA14LA076  
Investigator : Dennis Diaz (AS-ERA)

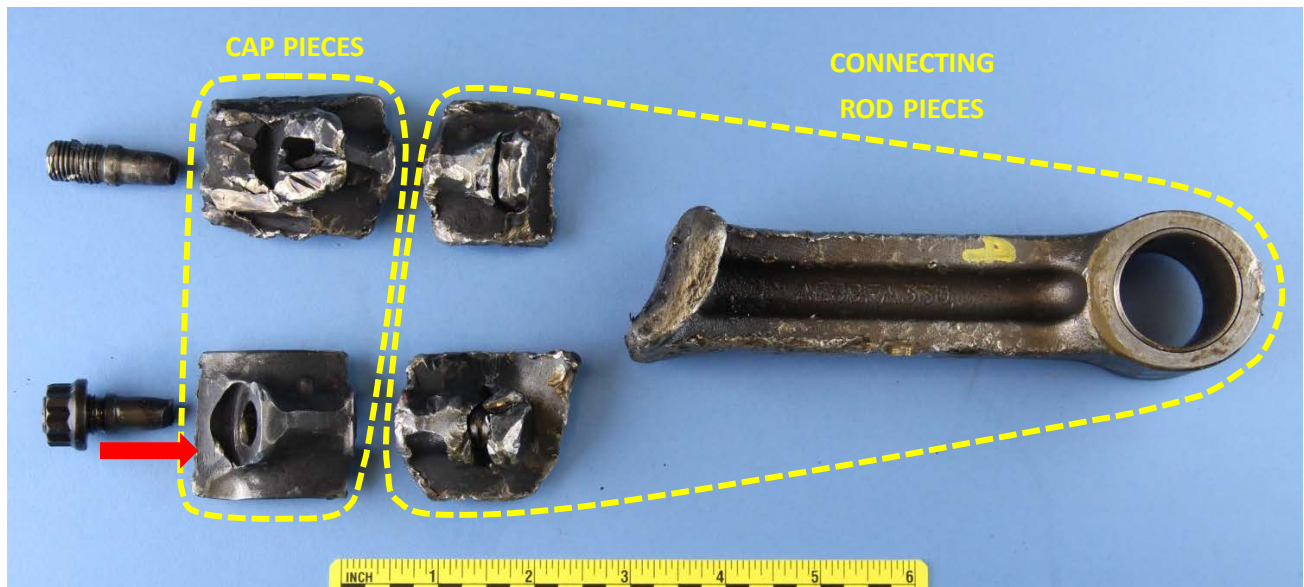
The submitted #4 connecting rod assembly pieces were from a Continental IO-520 engine. The assembly consisted of a connecting rod, a cap, and 2 bolts, all of which had fractured. Three (3) connecting rod pieces and 2 cap pieces were submitted, as shown in Figure 1. A section of the cap was missing. It was unknown if any portion of the connecting rod was also missing. Each of the bolts had fractured into 2 pieces, with the head ends wedged inside the mating connecting rod pieces and the threaded ends loose. A nut was still assembled onto the threaded end of one of the bolts.

Overall examination revealed that most of the pieces had post fracture damage that obscured the fracture surface features, with the exception of one cap piece (indicated by the red arrow in Figure 1) and the threaded ends of the bolts. The fracture surfaces of the cap and connecting rod pieces are shown in Figures 2 and 3.

**Figure 1:** Overall photo of the submitted connecting rod, connecting rod cap, and bolt pieces. The red arrow indicates the fracture surface on the cap piece that is shown in more detail in Figure 4.

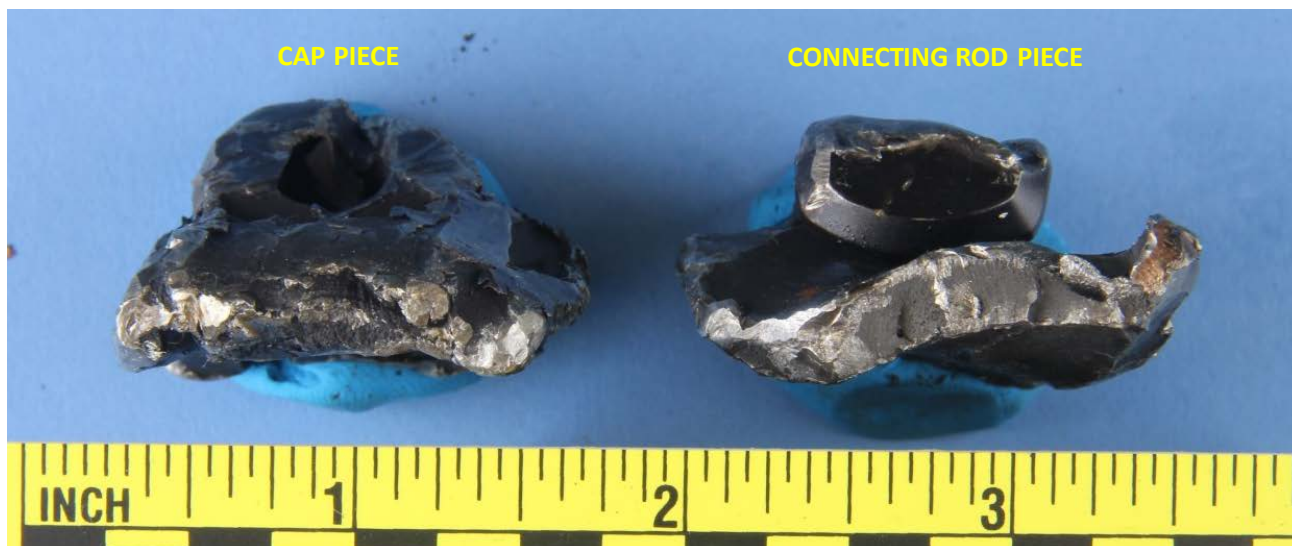
**Figure 2:** Close-up photos of the fracture surfaces on the connecting rod and cap pieces shown in the top of Figure 1.

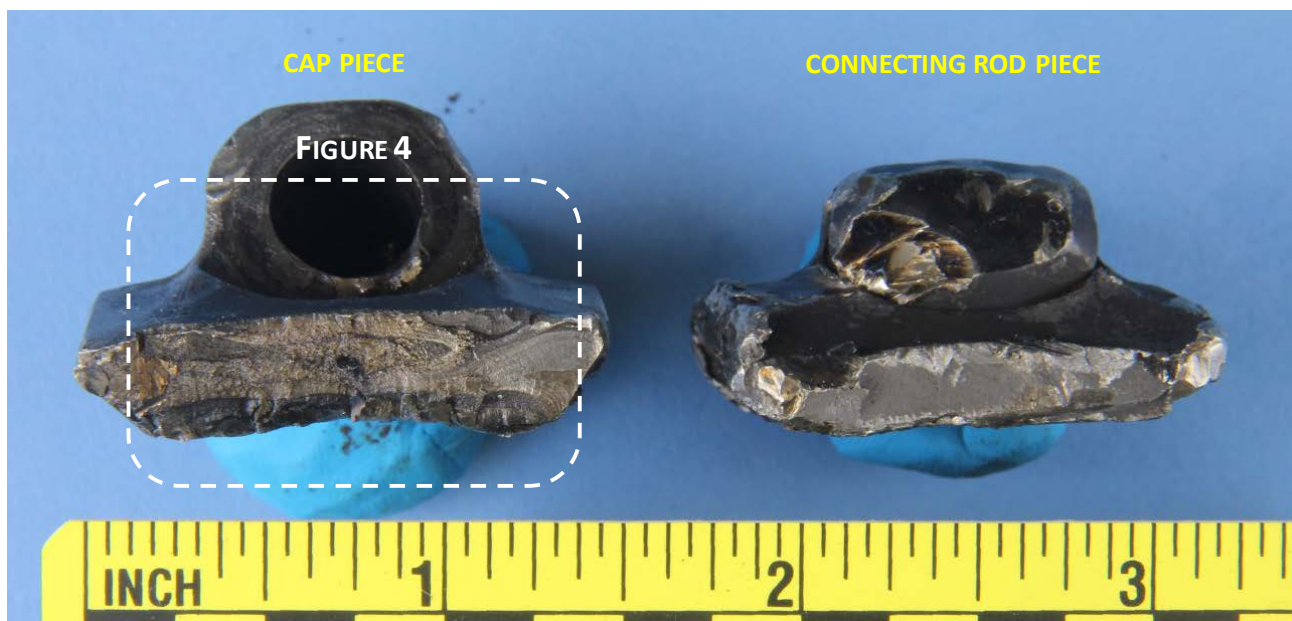
**Figure 3:** Close-up photos of the fracture surfaces on the connecting rod and cap pieces shown in the bottom of Figure 1. The fracture surface on the cap piece in the indicated area is shown in more detail in Figure 4.

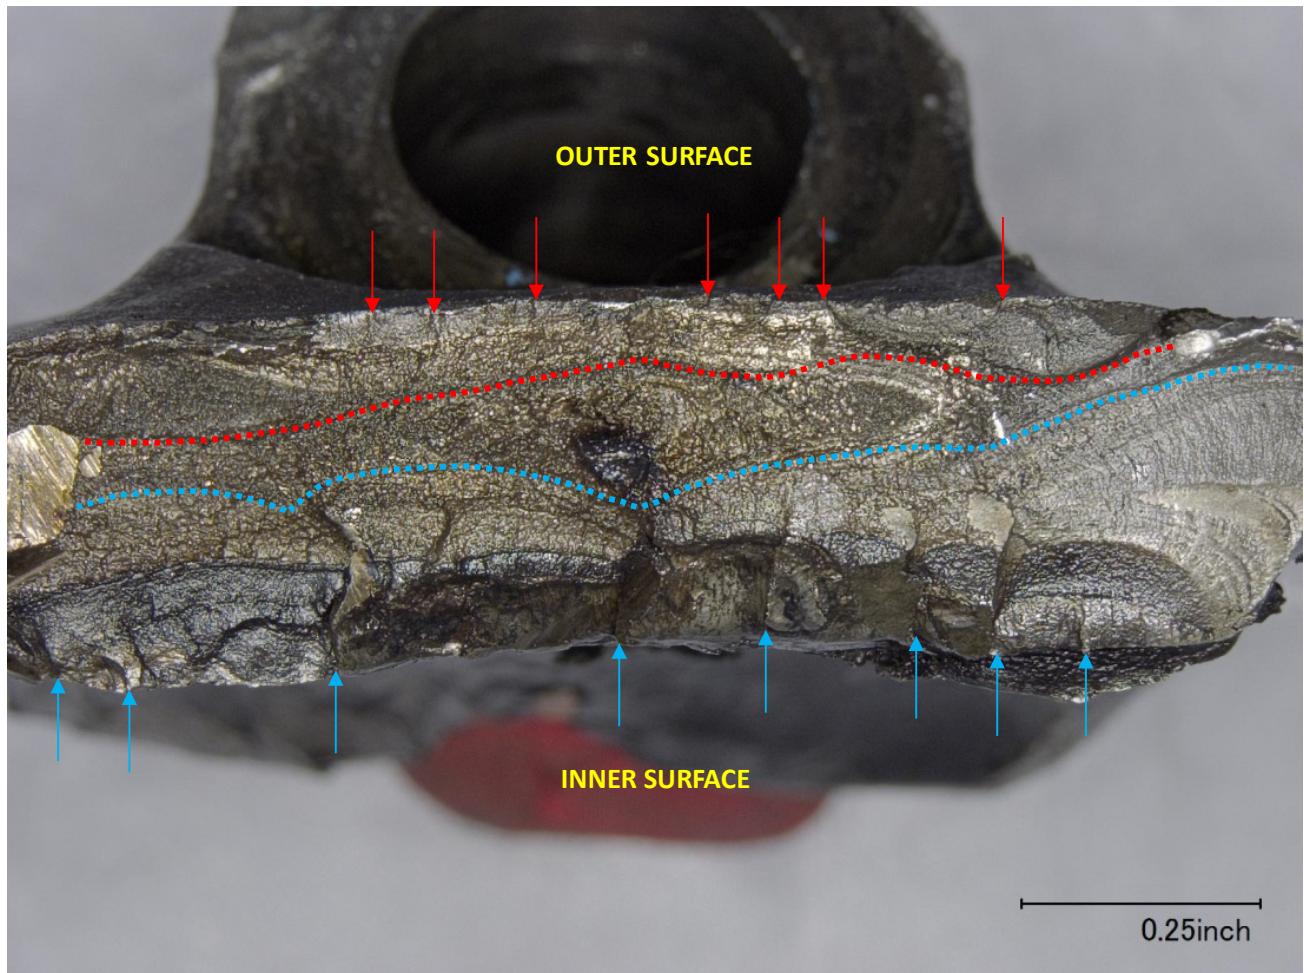
All of the fracture surfaces were examined in more detail using a 5X to 50X stereo-zoom microscope. The examination revealed that one of the cap pieces was relatively intact and did not display deformation around the edges like the other cap and connecting rod pieces. The fracture surface of this cap piece is shown in Figure 4. The fracture surface was relatively flat with multiple thumbnail-shaped patterns that are consistent with fatigue. The fatigue crack thumbnails emanated from the inner and outer surfaces of the cap. Numerous ratchet marks<sup>1</sup> were observed perpendicular to the inner and outer surfaces, as indicated by the blue and red arrows, respectively. The blue and red dashed lines indicate unified crack fronts typical of final fatigue crack arrest

positions that emanated from the inner and outer surfaces, respectively. The features are consistent with fatigue initiating from the inner and outer surfaces of the cap and propagating inward. The fracture surface was comprised of 57% fatigue cracking initiating from the inner surface, 21% fatigue cracking initiating from the outer surface, and the remainder consistent with overstress.

**Figure 4:** Close-up photo of the fracture surface on the cap piece that was shown in Figure 3. The fracture surface had multiple fatigue crack thumbnails emanating from the inner and outer surfaces. Ratchet marks perpendicular to the inner and outer surfaces are indicated by the blue and red arrows, respectively. Blue and red dashed lines indicate unified fatigue crack fronts that emanated from the inner and outer surfaces, respectively.

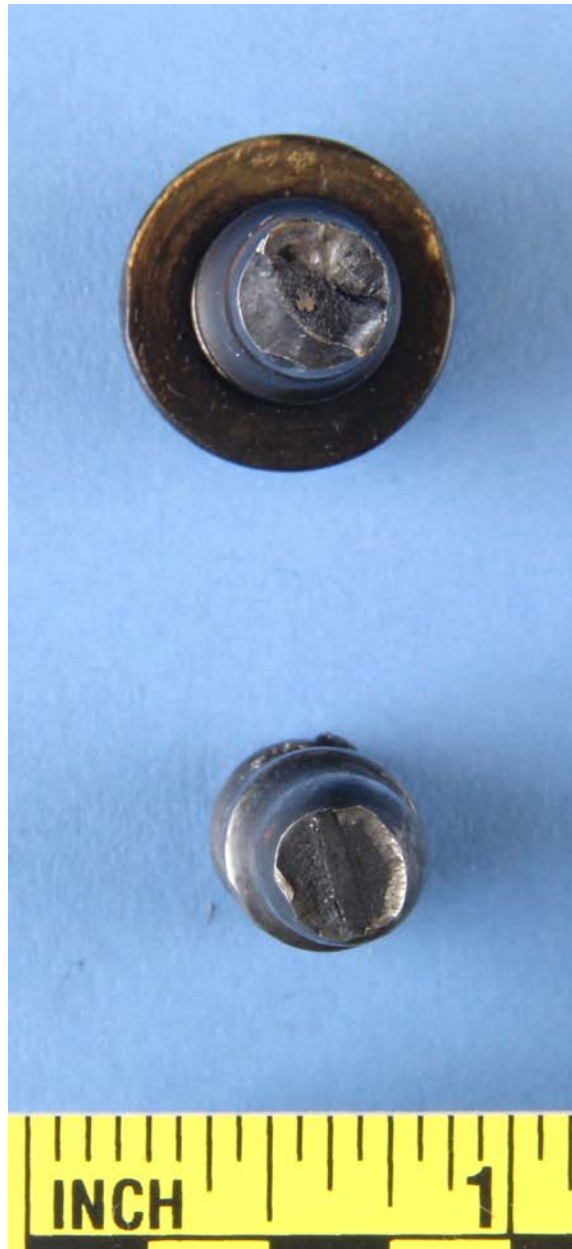
Stereomicroscopic examination of the threaded ends of the bolts revealed necking<sup>2</sup> of the shank of the bolts adjacent to the fracture surfaces. The features on the bolt fracture surfaces were rough and grainy, and were surrounded by shear lips. The necking, rough fracture surfaces, and shear lips were consistent with overstress failure.

**Figure 5:** Close-up photo of the fracture surfaces on the bolt pieces with the threaded ends.
