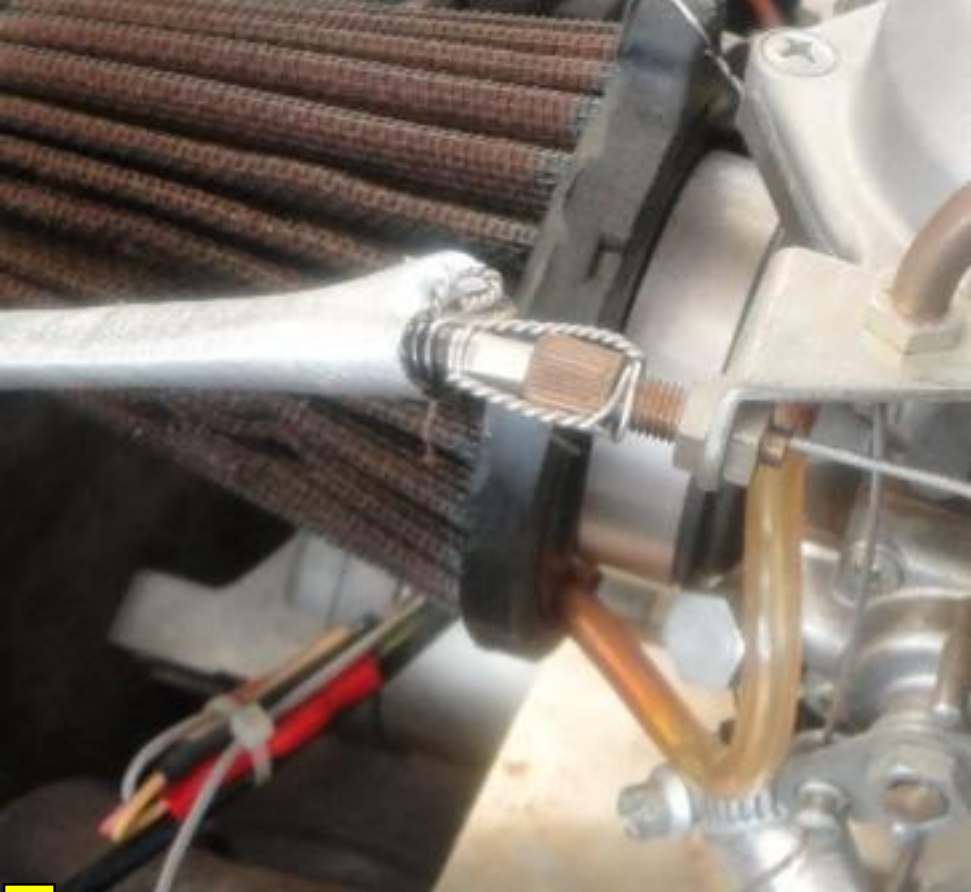
Photo 3 – Vent Line Routing as Found (Courtesy of Rotax)
