# NATIONAL TRANSPORTATION SAFETY BOARD

MATERIALS LABORATORY FACTUAL REPORT

Report No. 14-088

Place : St. Albans, Vermont  
Date : April 18, 2014  
Vehicle : Ultimate Aero 10-200, N827D  
NTSB No. : ERA14LA202  
Investigator : Todd Gunther, AS-ERA

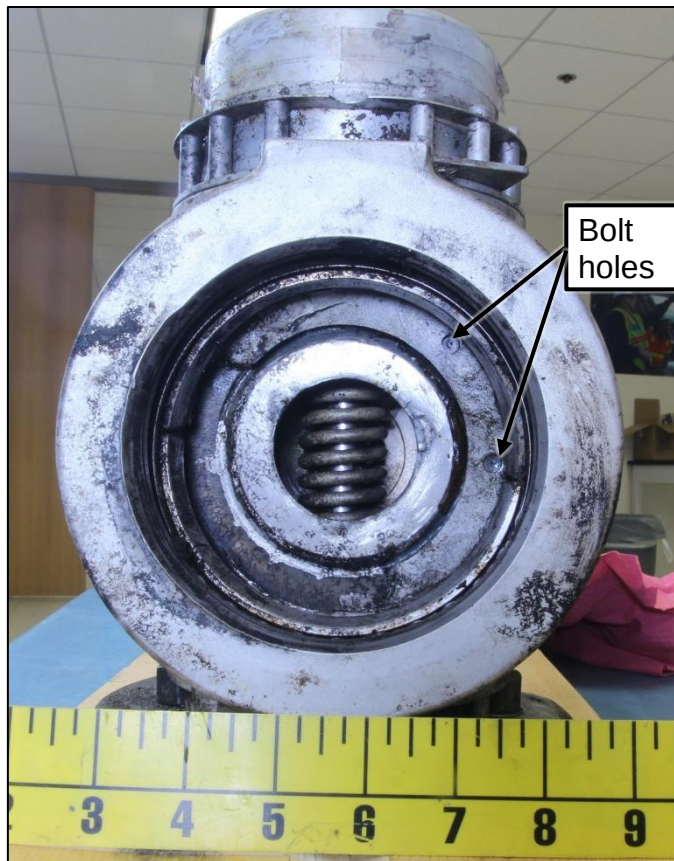
An overall view of the submitted components is shown in figure 1. The propeller was a Whirl Wind Aviation (WWA) model 200C propeller, serial number 200C-280 which was installed on a Lycoming IO-360 engine. Blade 1 was fractured in the root within the hub as shown in figure 2, and the portion outboard of the fracture was not recovered. Blade 2 was largely intact but showed damage consistent with exposure to a fire. A bag containing bearing balls and retainers that were recovered loose from inside the propeller hub and from the ground at the crash site and the governor were also received but were not examined in detail.

Figure 2. Blade 1 fracture surface as received. The location of threaded holes for bolts attaching the pitch change pin are indicated.

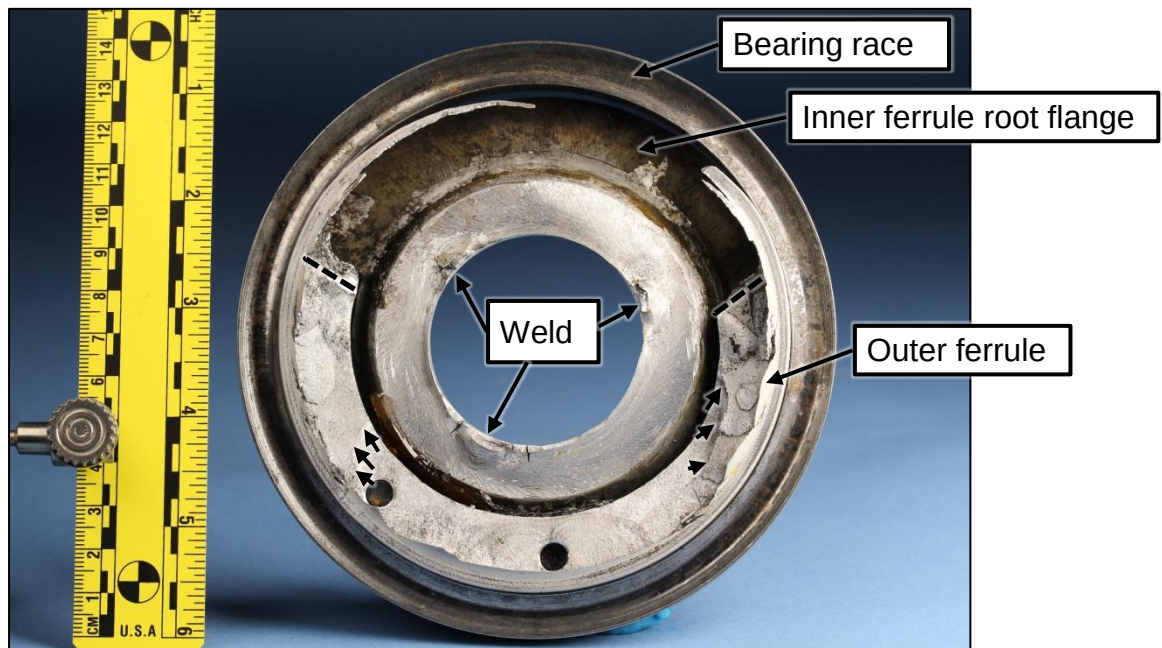
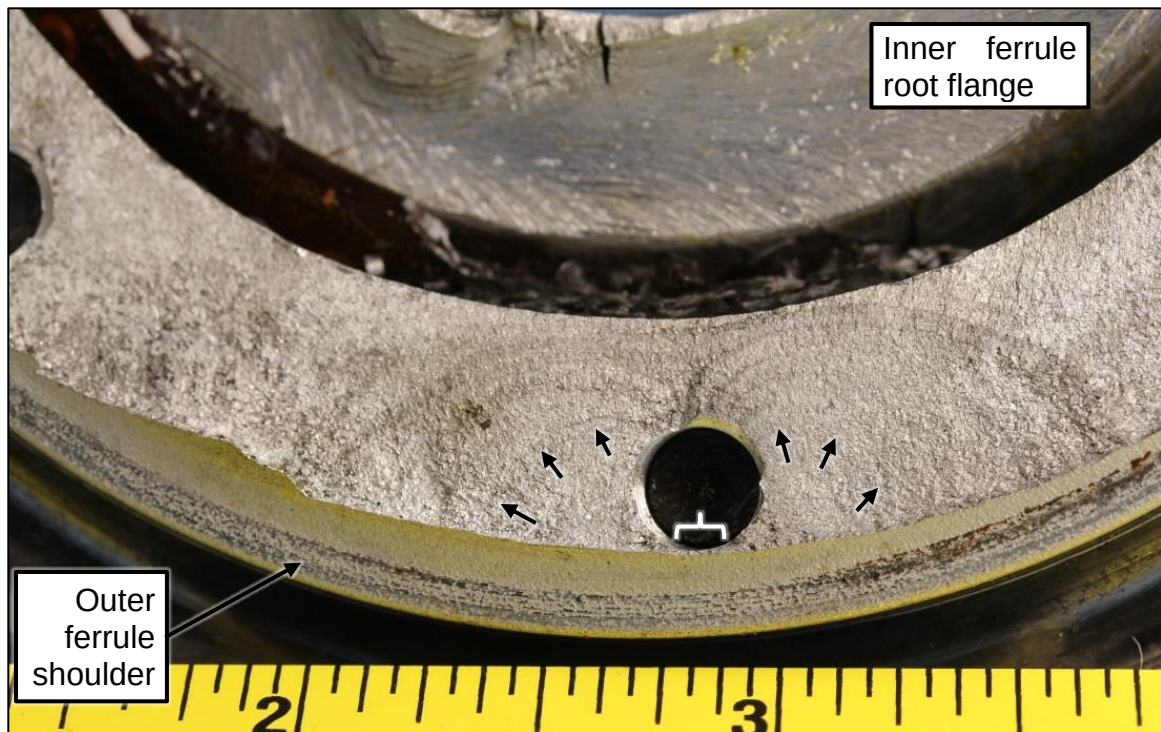
Views of the fracture surface after removal from the hub and cleaning with a degreaser are shown in figure 4. The outer ferrule was fractured around approximately 2/3 of the circumference with a fracture intersecting the outer surface in the fillet radius adjacent to the shoulder. The fracture surface had relatively flat features with curving crack arrest lines, features consistent with fatigue. The fatigue features emanated from an origin area at a bolt hole for one of the two bolts attaching the pitch change pin as indicated with a bracket in the lower image in figure 4. The primary crack propagated around approximately 1/3 of the circumference to the locations indicated with unlabeled arrows in the upper image in figure 4. Fatigue features from secondary fatigue cracks were observed propagating up to the dashed lines shown in the upper image in figure 4. At the location of the dashed lines, shear fractures were present where the outer ferrule fractured to the root face, and the remainder of the outer ferrule separated where it was bonded to the inner ferrule root flange.

The inner ferrule from blade 1 consisted of a root flange that was welded at three locations to a center tube. The inner ferrule was fractured at the 3 weld locations as indicated in figure 4. Fracture features at the weld locations had rough features and deformation adjacent to the fracture consistent with overstress fracture.

Figure 4. Blade 1 fracture surface (upper image) with a closer view of the fatigue origin area (lower image) after removal from the hub and cleaning with a degreasing solution. In the upper image, unlabeled arrows indicate the extent of crack propagation from the primary origin area as indicated with a bracket in the lower image. Dashed lines indicate the extent of cracking from secondary fatigue cracks. Unlabeled arrows in the lower image indicate the crack propagation direction in the vicinity of the bolt hole.

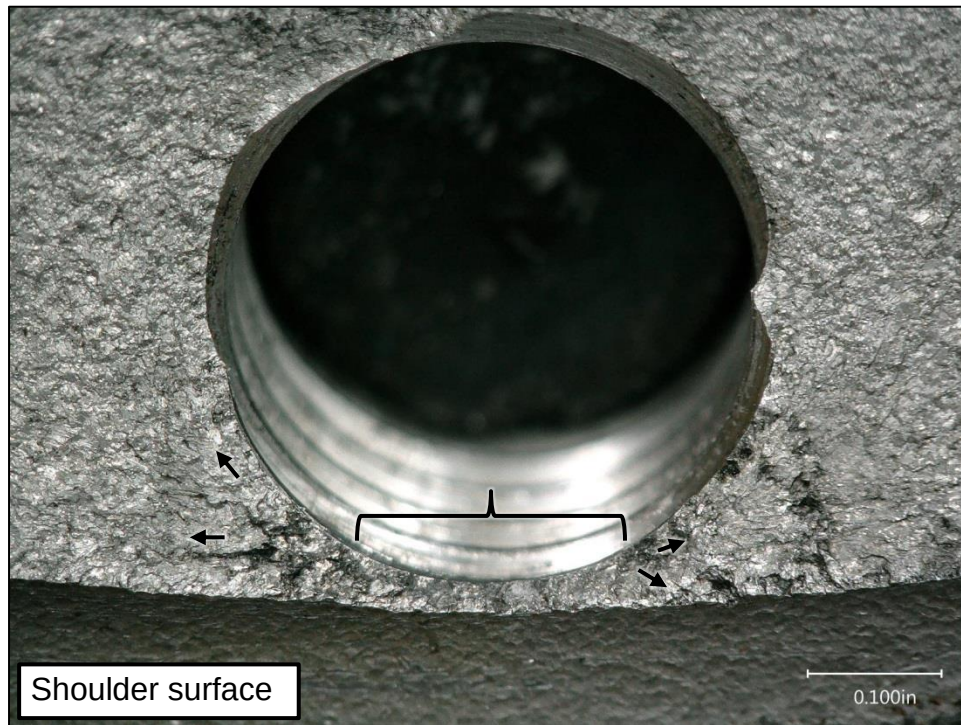
A closer view of the fatigue origin area is shown in figure 5. The origin was located at the edge of the hole as indicated with a bracket in figure 5, and propagated toward the fillet surface adjacent to the shoulder. Arrows in figures 4 and 5 indicate where the crack then radiated in either direction along the surface and circumferentially around the hole. The shoulder and fillet surface adjacent to the fracture had a rough crater-like appearance consistent with a peening operation.

Figure 5. Closer view of the origin area as indicated with a bracket. Arrows indicate crack propagation directions emanating from the origin area.

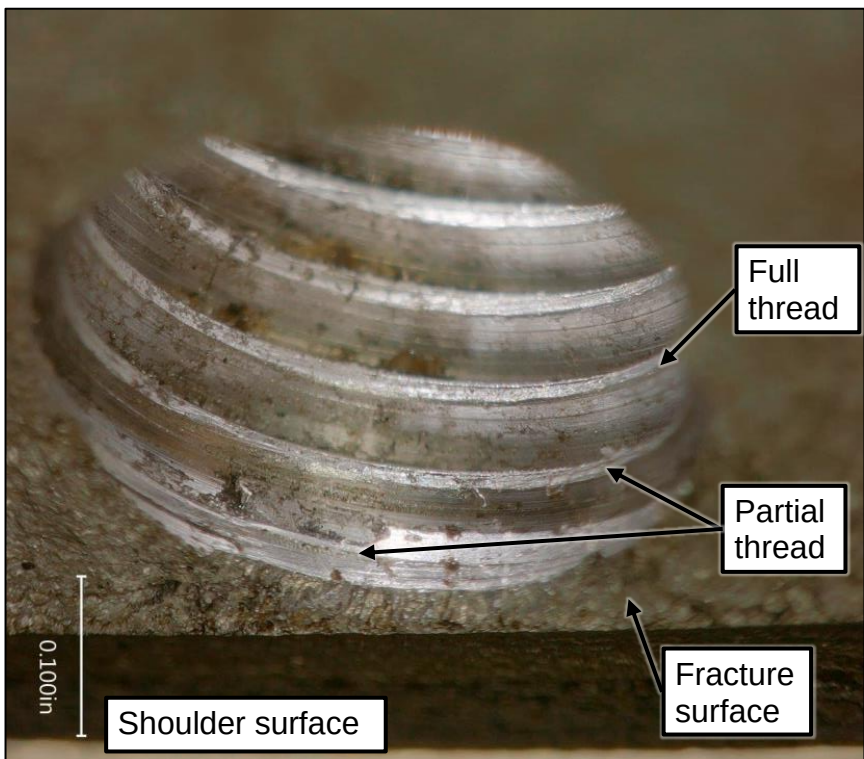
Approximately 4 threads were observed between the threaded end of the bolt attaching the pitch change pin to the blade root and the fracture surface at the origin. The bolts attaching the pitch change pin were removed and the pitch change pin was separated from the inner ferrule end flange to facilitate photographing the threads by transmitting light through the hole (see figure 6) and for measurement of the thread depth. Partially cut threads consistent with a location at or near the end of the tapped threads were observed in the bolt hole adjacent to the fracture surface as indicated in figure 6.

origin, the hole was 0.806 inch deep, and the other hole was 0.796 inch deep. According to a representative from the propeller manufacturer, production procedure notes for the blade specified a hole depth up to 0.750 inch. A vernier caliper was also used to measure the distance between the shoulder and the root end face of the blade. The shoulder was located 0.782 inch from the root face of the inner ferrule root flange in the area where the pitch change pin had been attached.

Figure 6. Bolt hole threads adjacent to the fracture surface after the bolt was removed from the hole. Partial threads consistent with the end of the tapping operation are indicated.

As of May, 2014, the pitch change pin attachment holes in newly-manufactured blades have a specified depth of 0.670 inch  $\pm$  0.010 inch as measured from the surface of the inner ferrule root flange, and manufacturing and quality controls were instituted to prevent variations in the hole depths from specified levels. Additionally, the holes in blades manufactured since May, 2014, are shaped with a flat bottom through a reaming operation, and the threads are formed with a roll-thread tap.

On January 30, 2015, Whirl Wind Aviation issued Mandatory Service Letter SL-200/400C-070214, which included a requirement to measure the depth of the bolt holes for attaching the pitch change pin on model 200C (serial numbers 200C-385 and lower) and model 400C (serial numbers 400C-226 and lower) propellers. The stated reason for the service letter was that pitch change pin attachment bolt holes could vary in depth, which in some cases could compromise the integrity of the blade outer ferrule and lead to fatigue failure of the ferrule and loss of blade retention. Upon inspection, blades found with bolt holes greater than 0.760 inch in depth as measured from the root face of the internal ferrule root flange are to be removed from service.

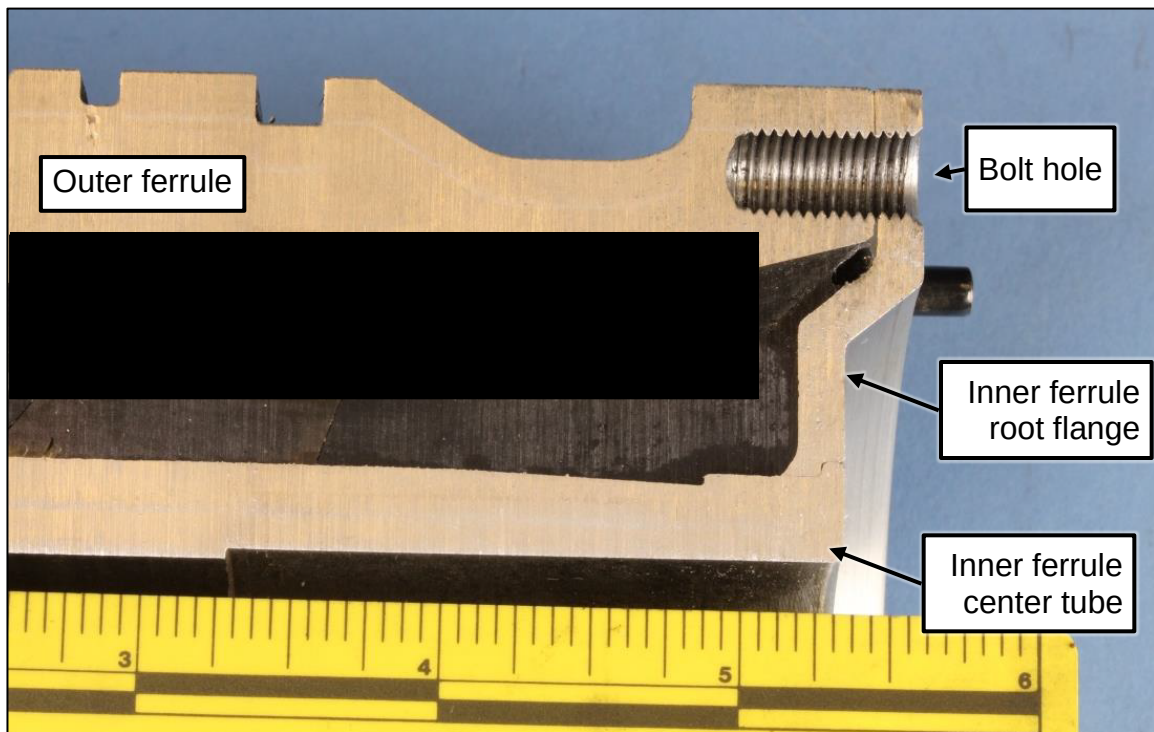
The root end of blade 2 was then cut axially using a bandsaw approximately through the center of the blade and the center of one of the pitch change pin attachment holes. The resulting cross-section is shown in figure 8, and a closer view of the pitch change pin attachment bolt hole is shown in figure 9. The depth the the threaded portion of the bolt hole was measured on the cross-section, and the threaded portion of the hole extended up to 0.65 inch from the root face of the inner ferrule root flange.

Figure 9. Closer view of the blade 2 cross-section showing the pitch change pin attachment bolt hole in the inner and outer ferrules. A portion of the image is redacted.

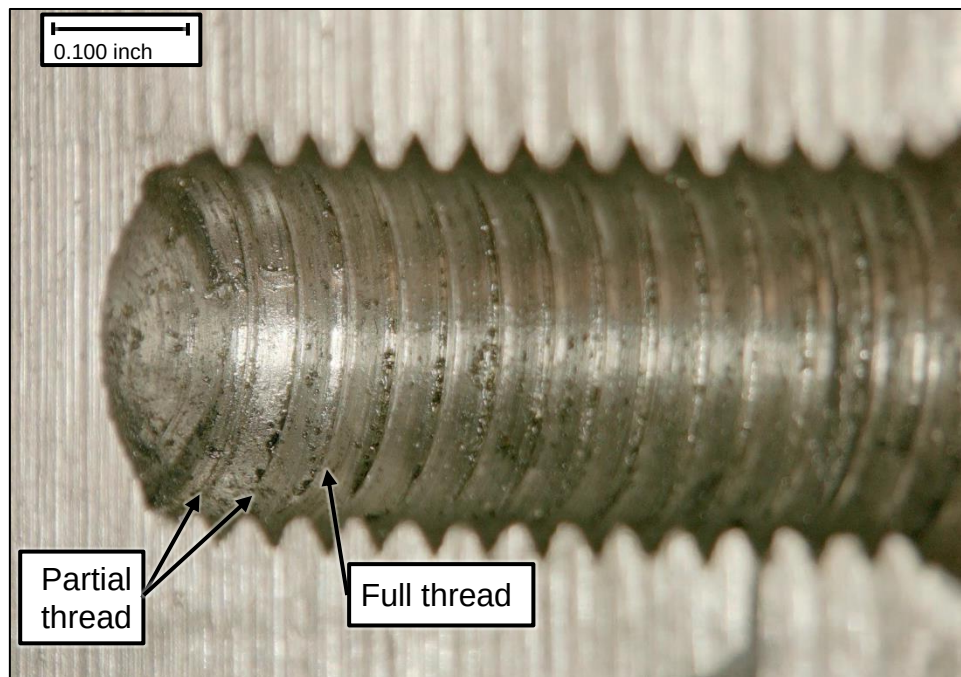
A closer view of the threads at the end of the pitch change pin attachment hole is shown in figure 10. Two partially-cut threads were present at the end of the threads as indicated in figure 10.

Figure 10. Threaded end of the the pitch change pin attachment bolt hole in the outer ferrule showing partially cut threads at the tip end of the hole.
