## MANDATORY SERVICE LETTER

SL-200C/400C-0002

**TO:** ALL OWNERS / OPERATORS OF AFFECTED PROPELLERS  
**SUBJECT:** MANDATORY BLADE FERRULE ROOT MODIFICATION  
**DATE:** FEBRUARY 4, 2003

**MODELS AFFECTED:** All Whirl Wind 200C Series and 400C Series aerobatic propellers manufactured prior to the date of this letter.

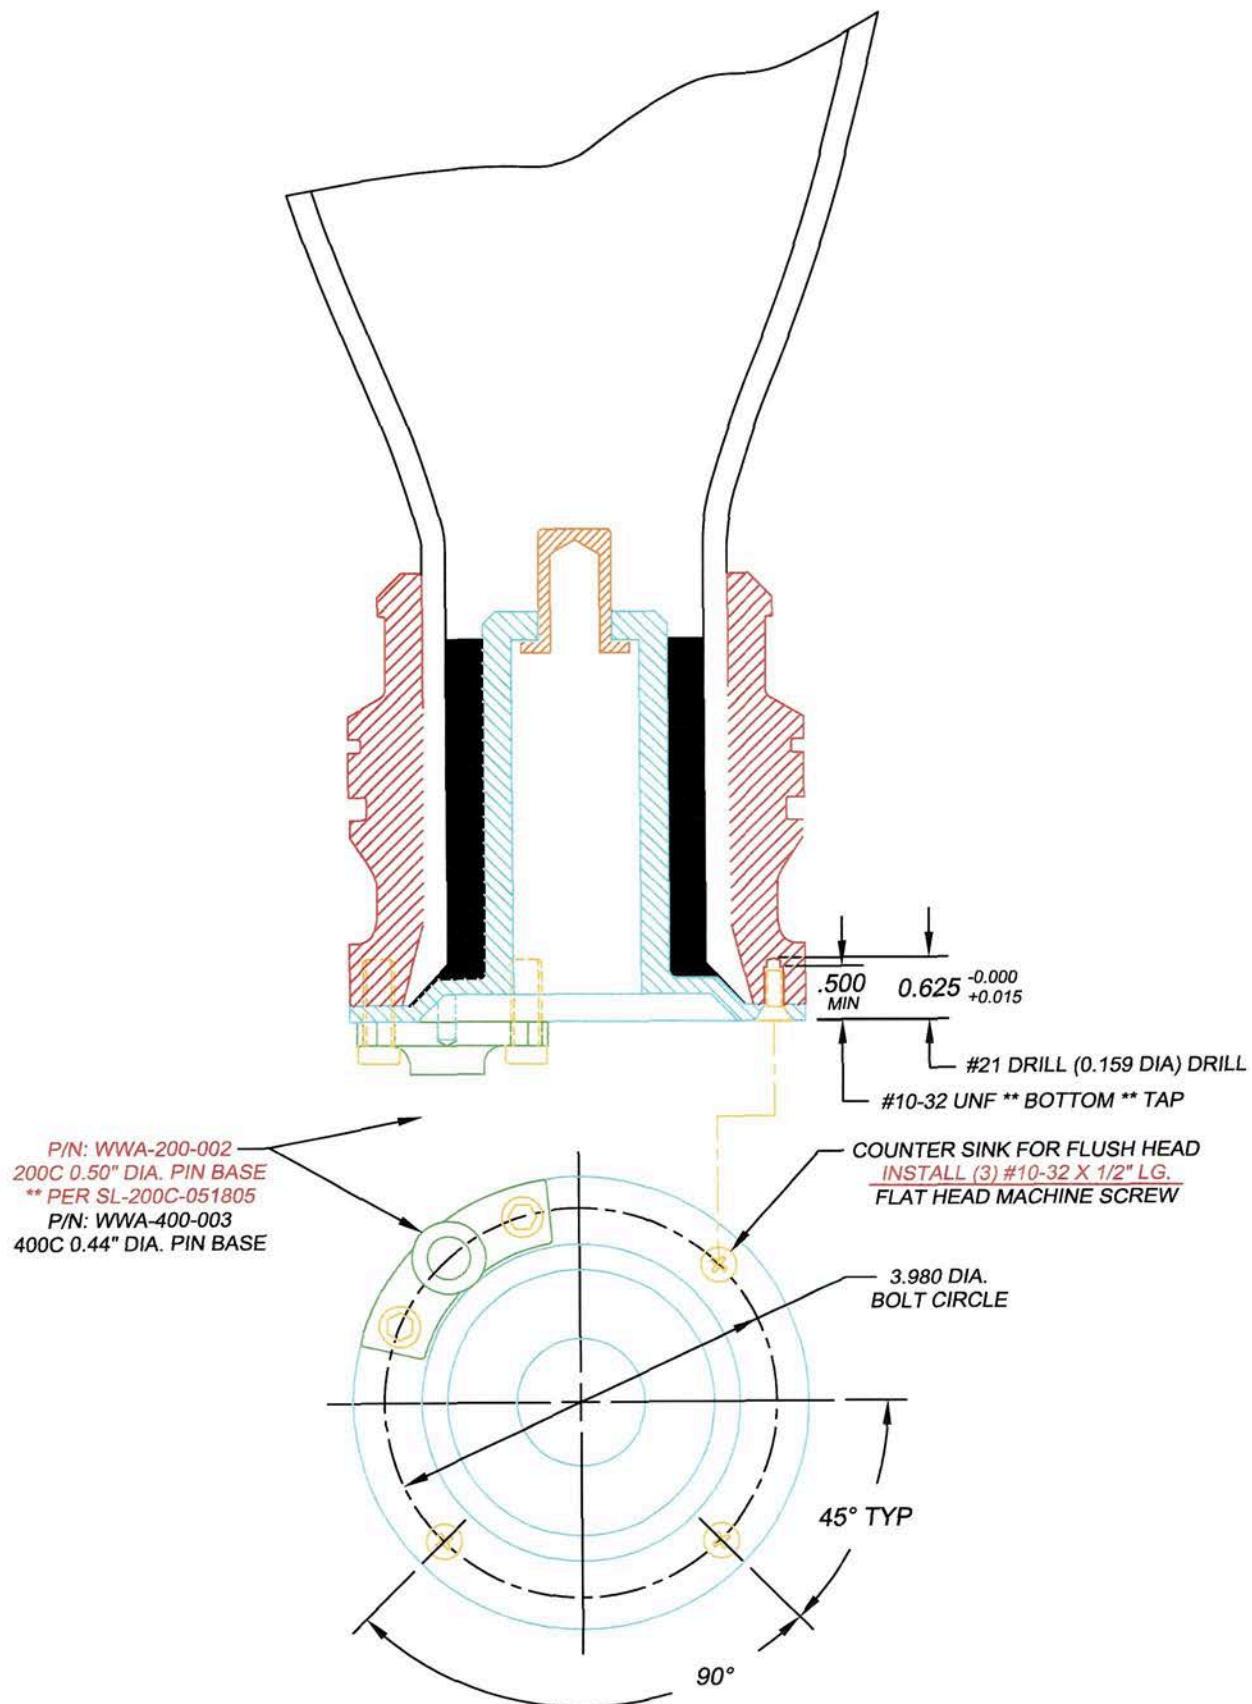
## 200C / 400C SERIES PROPELLER SL-200C-400C-0002 FASTENER INSTRUCTIONS

**REASON:** Blade root inner ferrule may slip resulting in loss of pitch control in affected propeller models.

1. A blade ferrule root modification must be performed for all affected propeller models. This modification will require the affected propeller models to be disassembled for the removal of the blades. The blade modification requires three #10 fasteners to be installed at the ferrule root of each blade. After the blade modification is complete, the propeller can then be reassembled and returned to regular service.
2. This modification can be performed by the Whirl Wind Propellers factory. Alternatively, a modification kit will be provided to a qualified propeller service center to perform this modification per Whirl Wind drawing upon approval by Whirl Wind.
