**Service Letter No: SL-200C/400C-013015**

**SUBJECT:** Actuating pin base to outer ferrule attachment bolt hole depth.

**MODELS AFFECTED:** Model 200C; all propellers with blade serial numbers 200C-385 and lower  
Model 400C; all propellers with blade serial numbers 400C-226 and lower

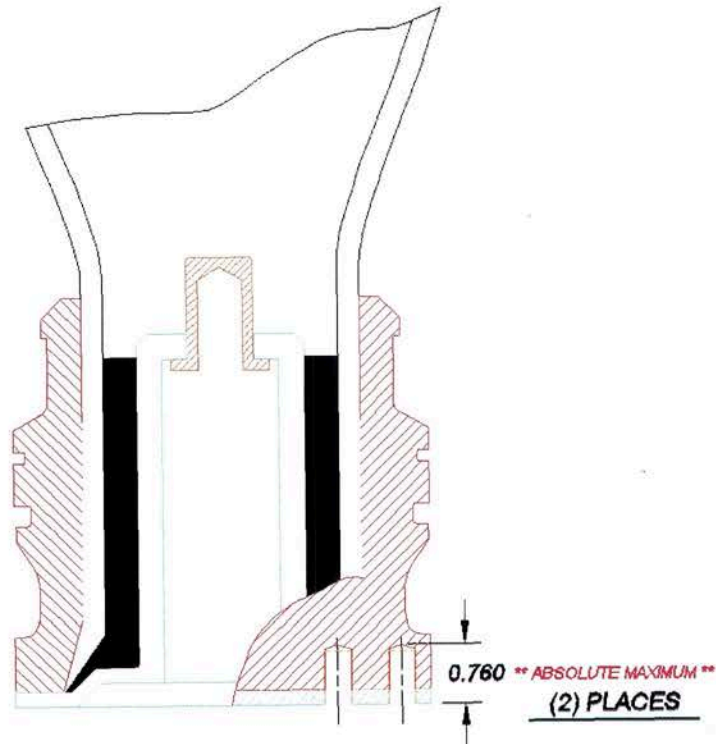
Figure 1

**REASON:** The actuating pin base mounting holes could vary in depth. In some cases inconsistent hole depths could compromise the integrity of the blade outer ferrule which can lead to premature material fatigue and possible failure of the ferrule, which can in turn lead to the loss of blade retention.

Through testing and / or removal of the 5/16-24 actuating pin base mounting screws the drill depth of the screw holes must be found **not to exceed 0.760"** deep from the surface of the inner ferrule to the drill point (see figure 1 below). Blades with holes exceeding this maximum allowable depth must be taken out of service immediately.

Blade ferrules that have actuating pin base holes with maximum depths of 0.760" and less and are NDT tested and verified to be structurally sound (no evidence of cracks) may be returned to service, continuing to follow the propeller 250 hour or annual tear down inspection service interval, whichever comes first.
