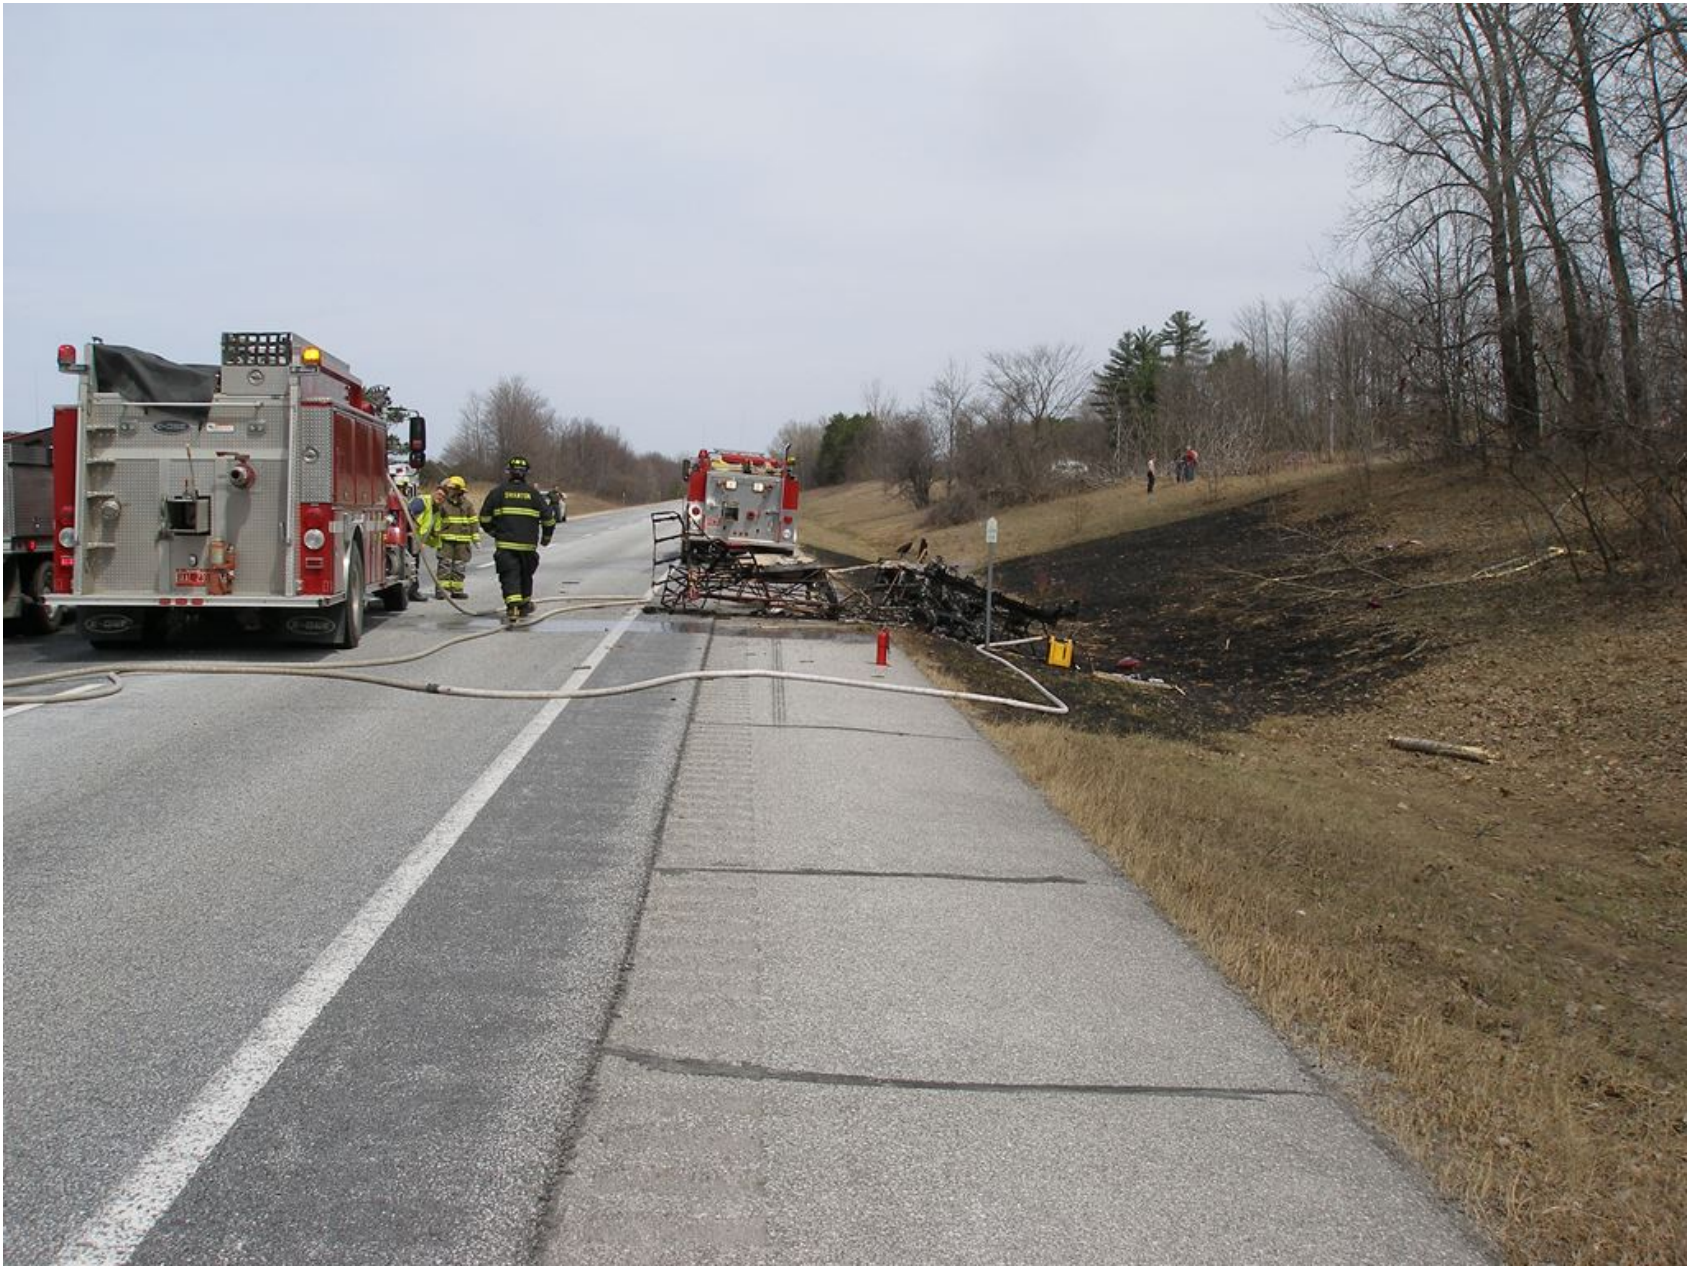
**Photo 1 – Accident Site – Courtesy of VSP**

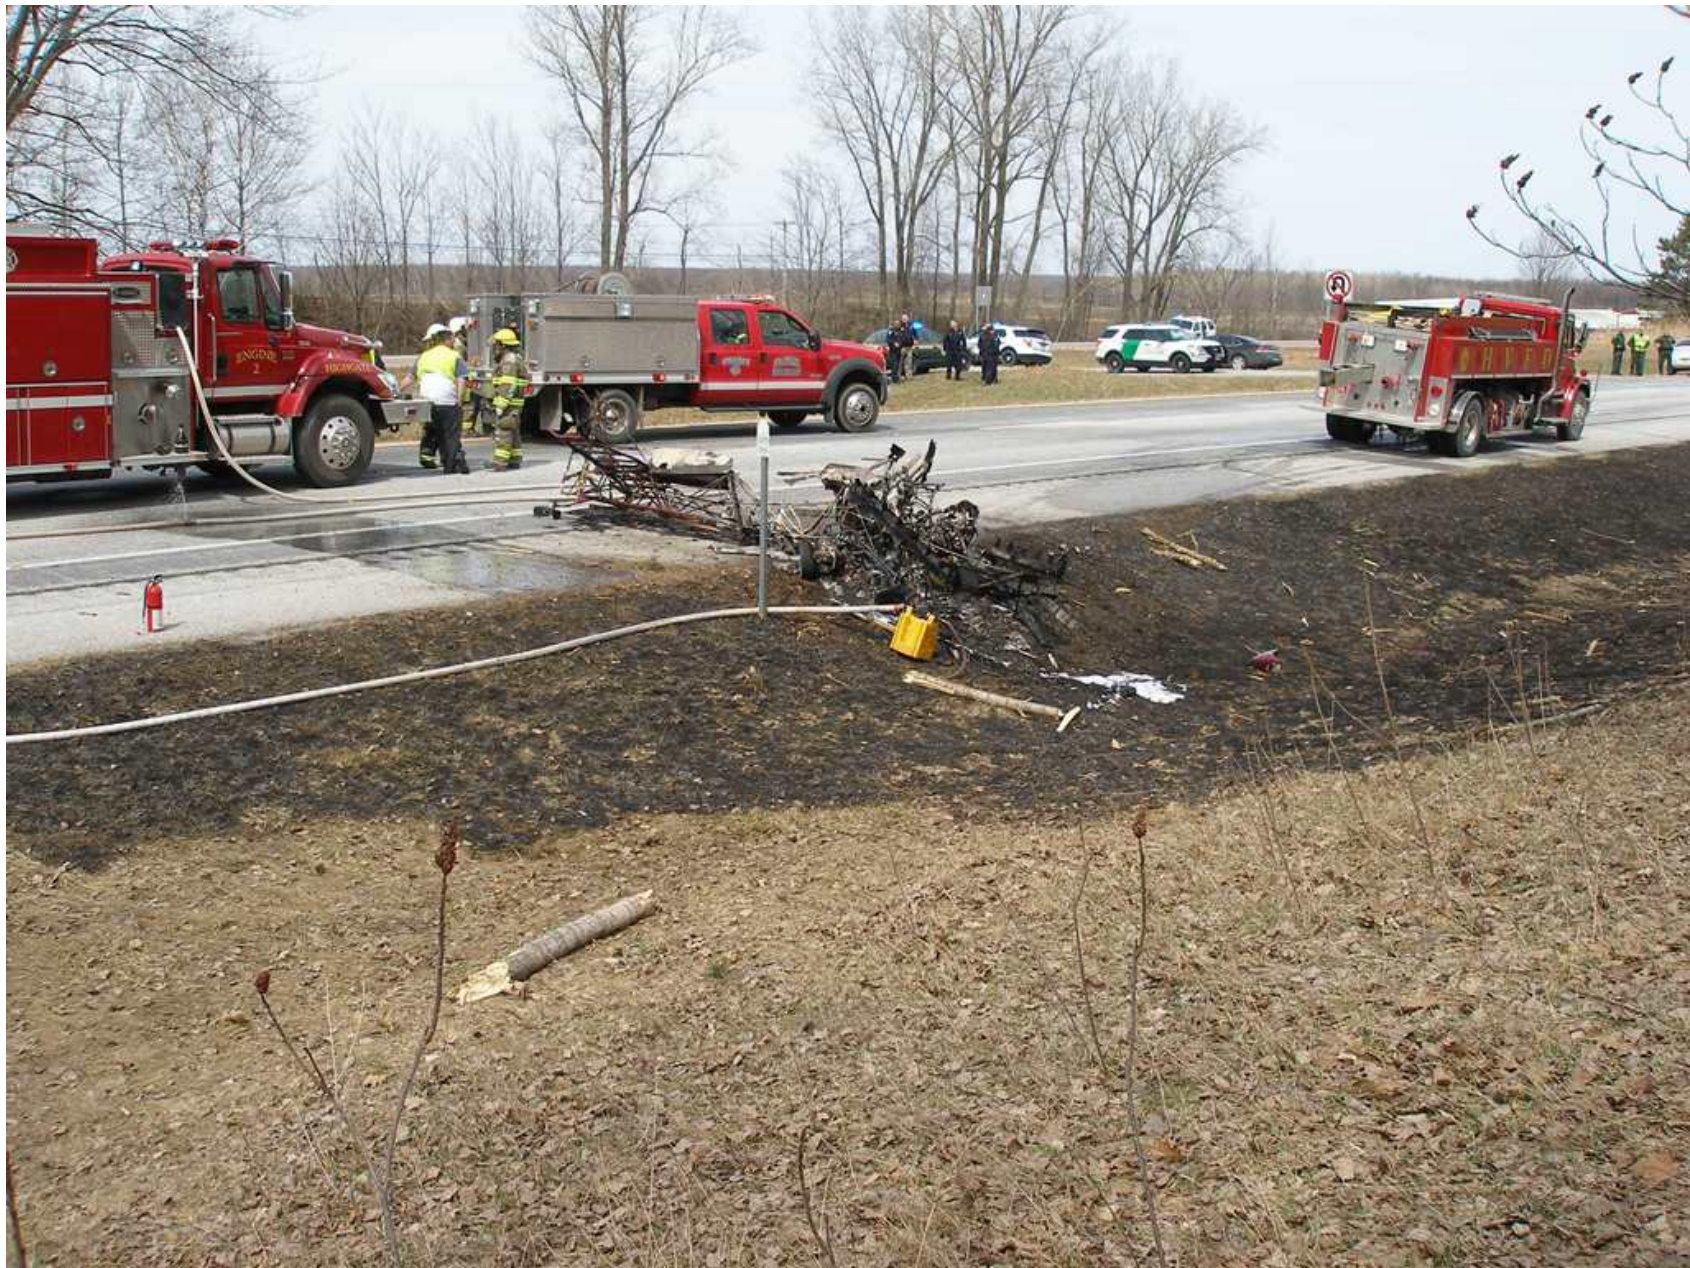
**Photo 2 – Main Wreckage – Courtesy of VSP**

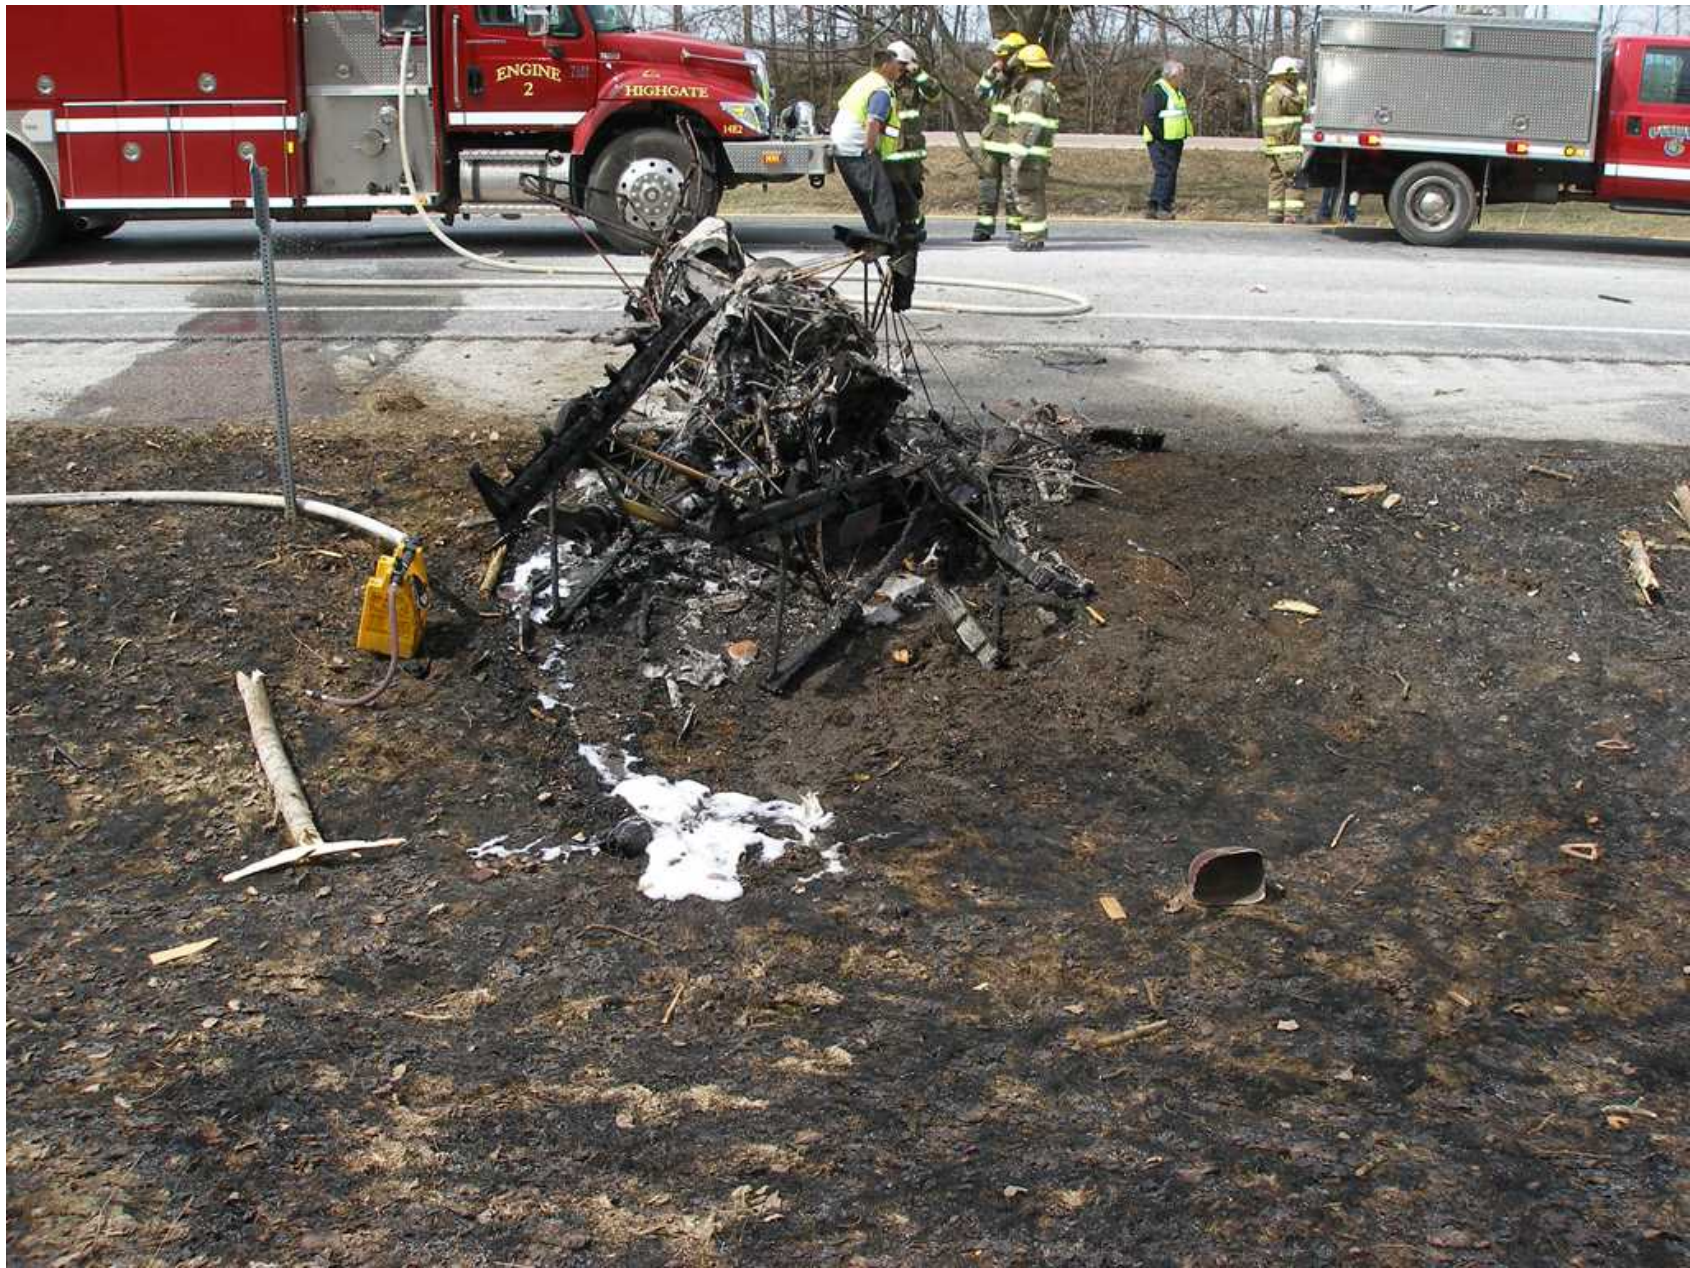
**Photo 3 – Close Up of Main Wreckage – Courtesy of VSP**

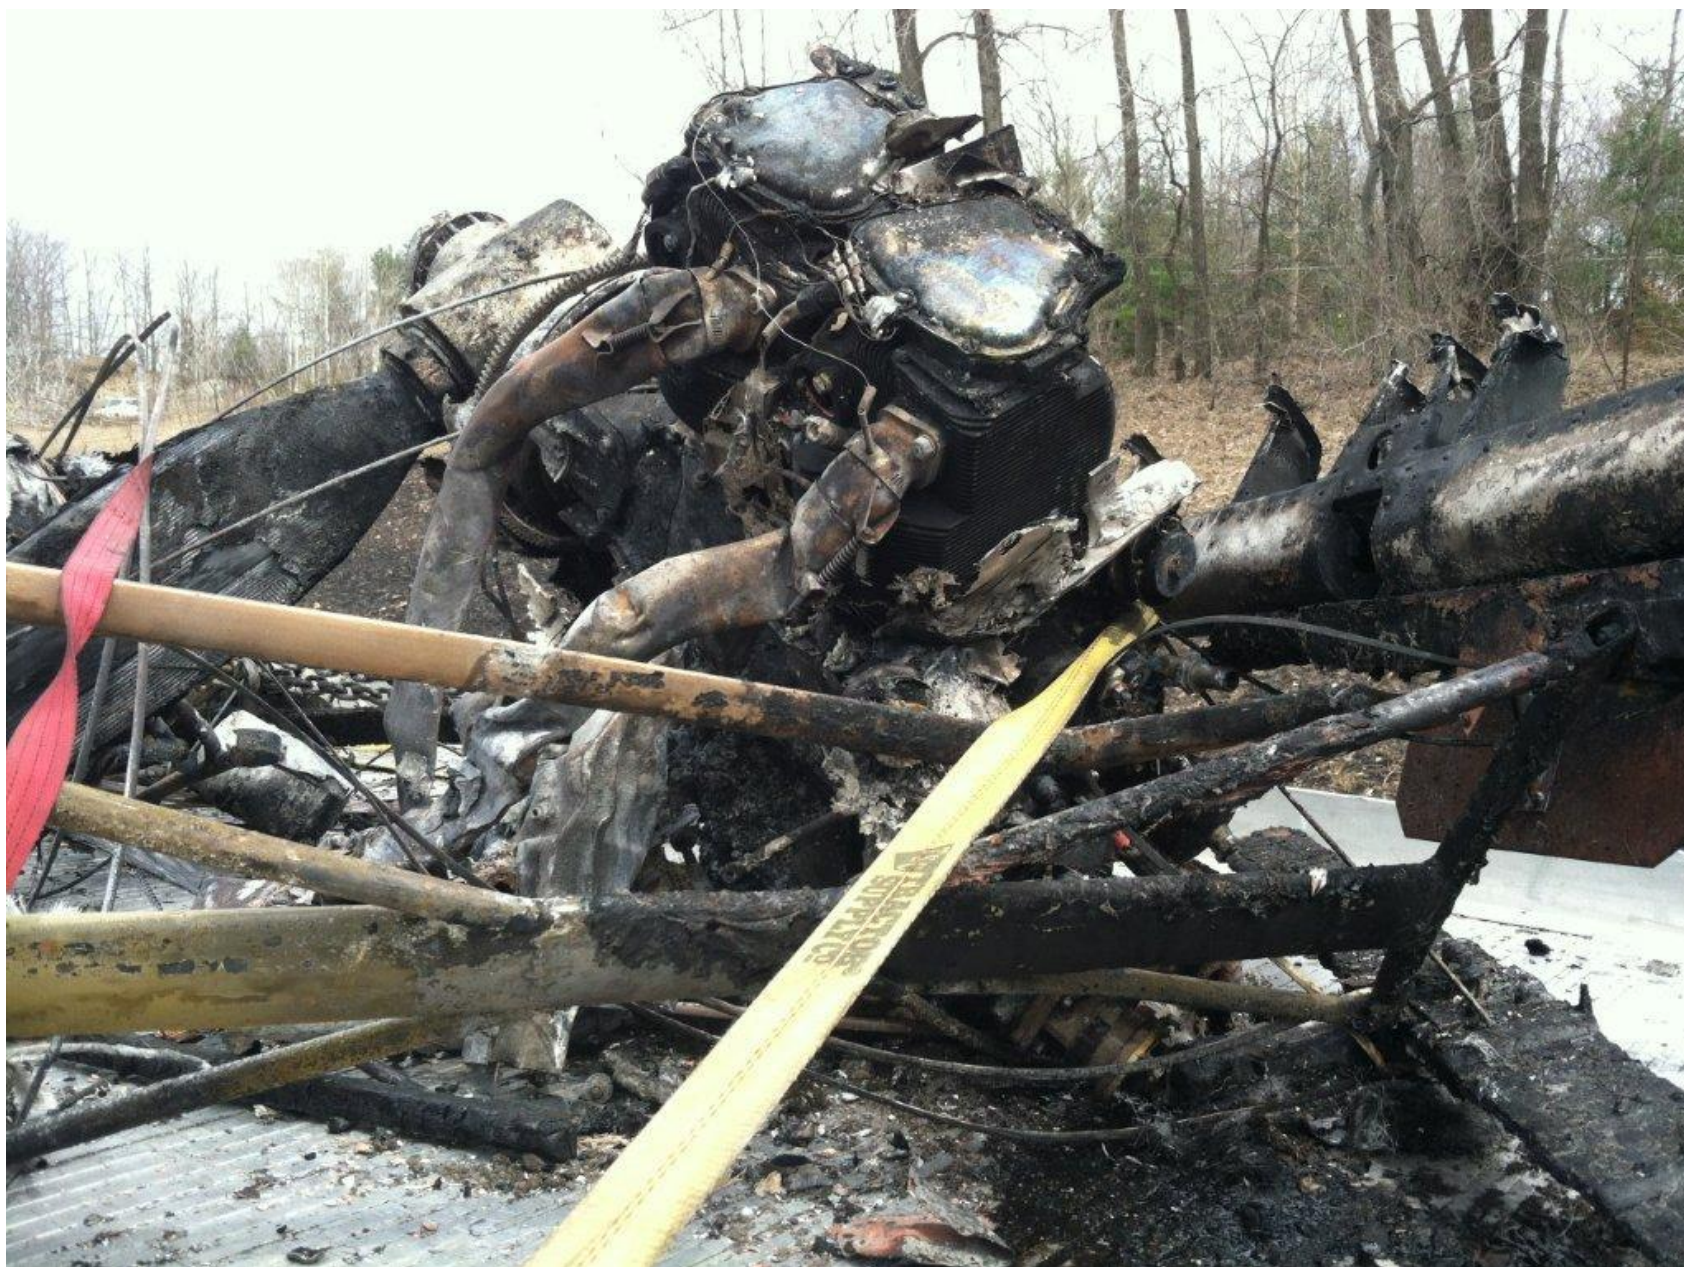
**Photo 4 – Engine and Propeller Hub – Courtesy of FAA**

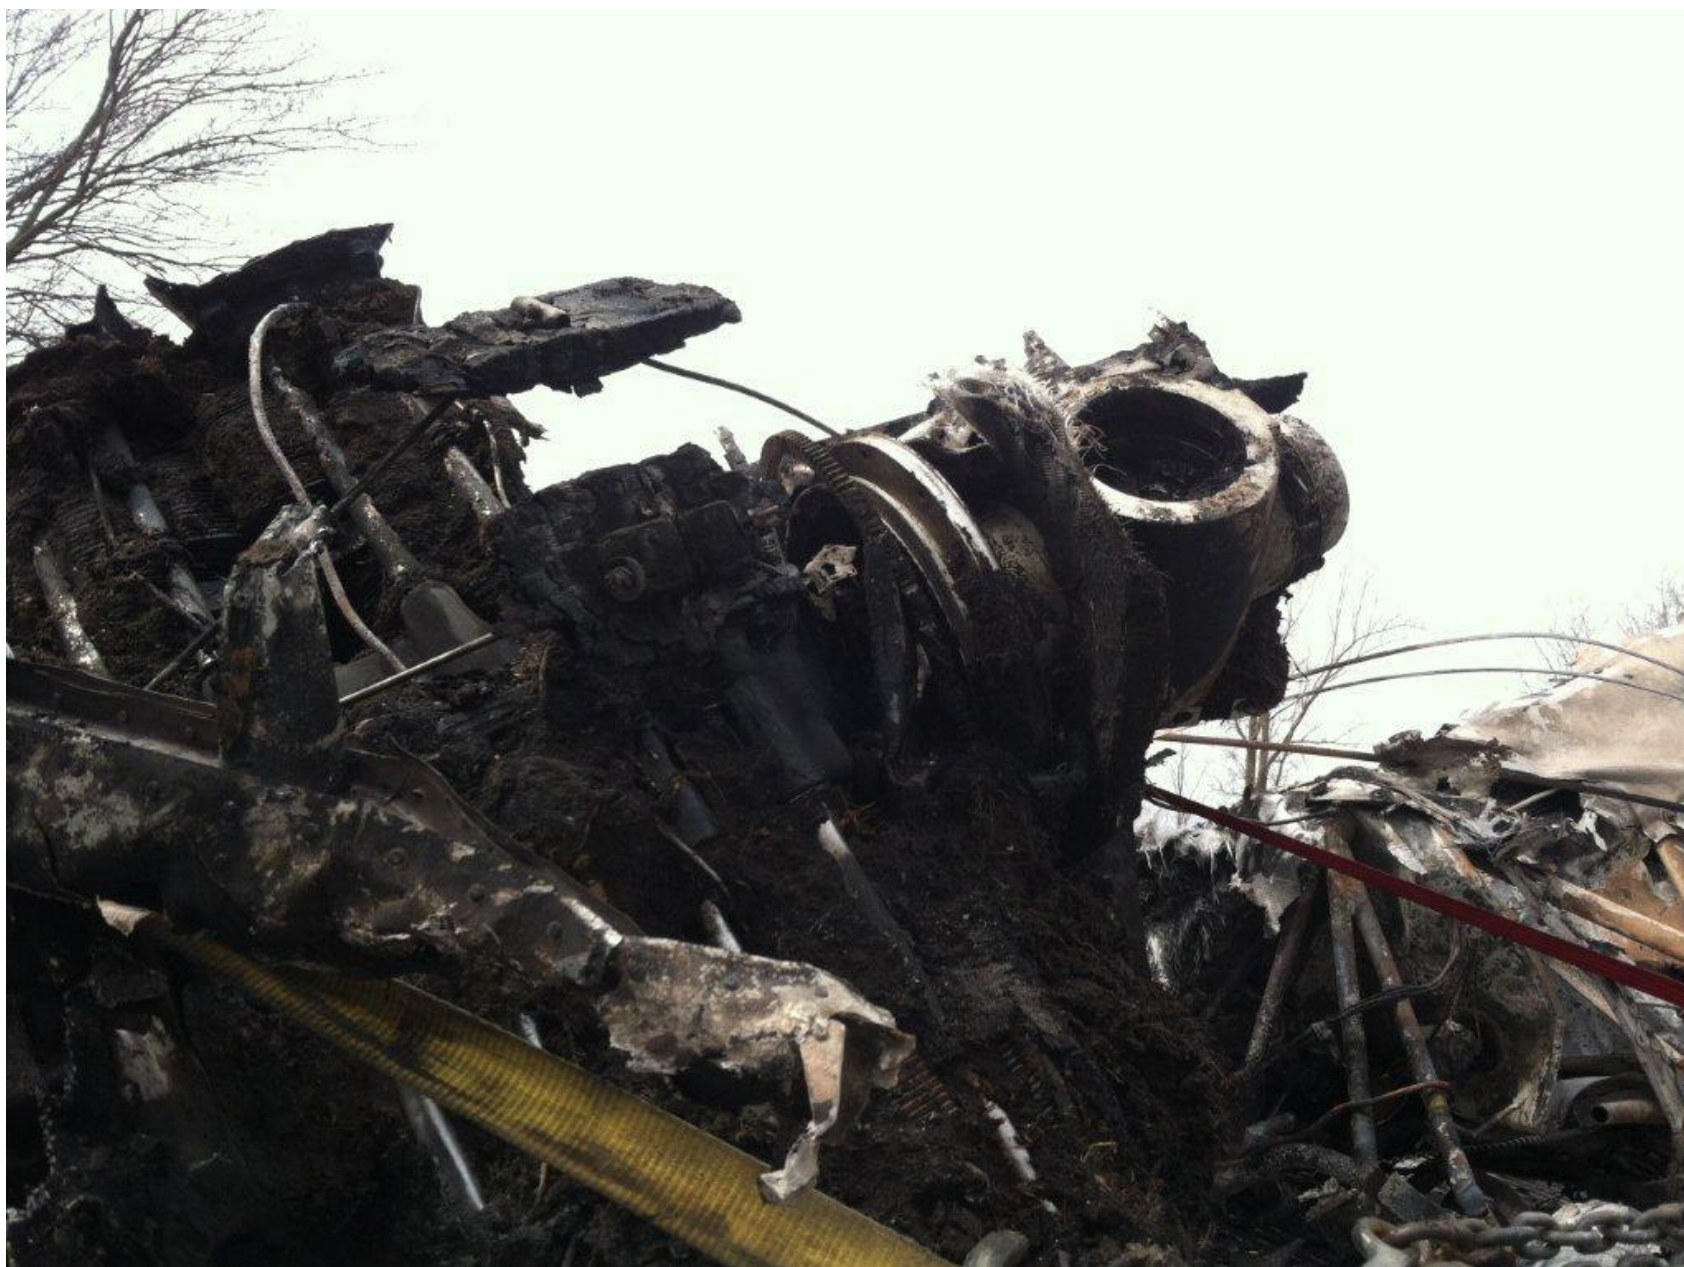
**Photo 5 – Propeller Hub with Blade Missing – Courtesy of FAA**

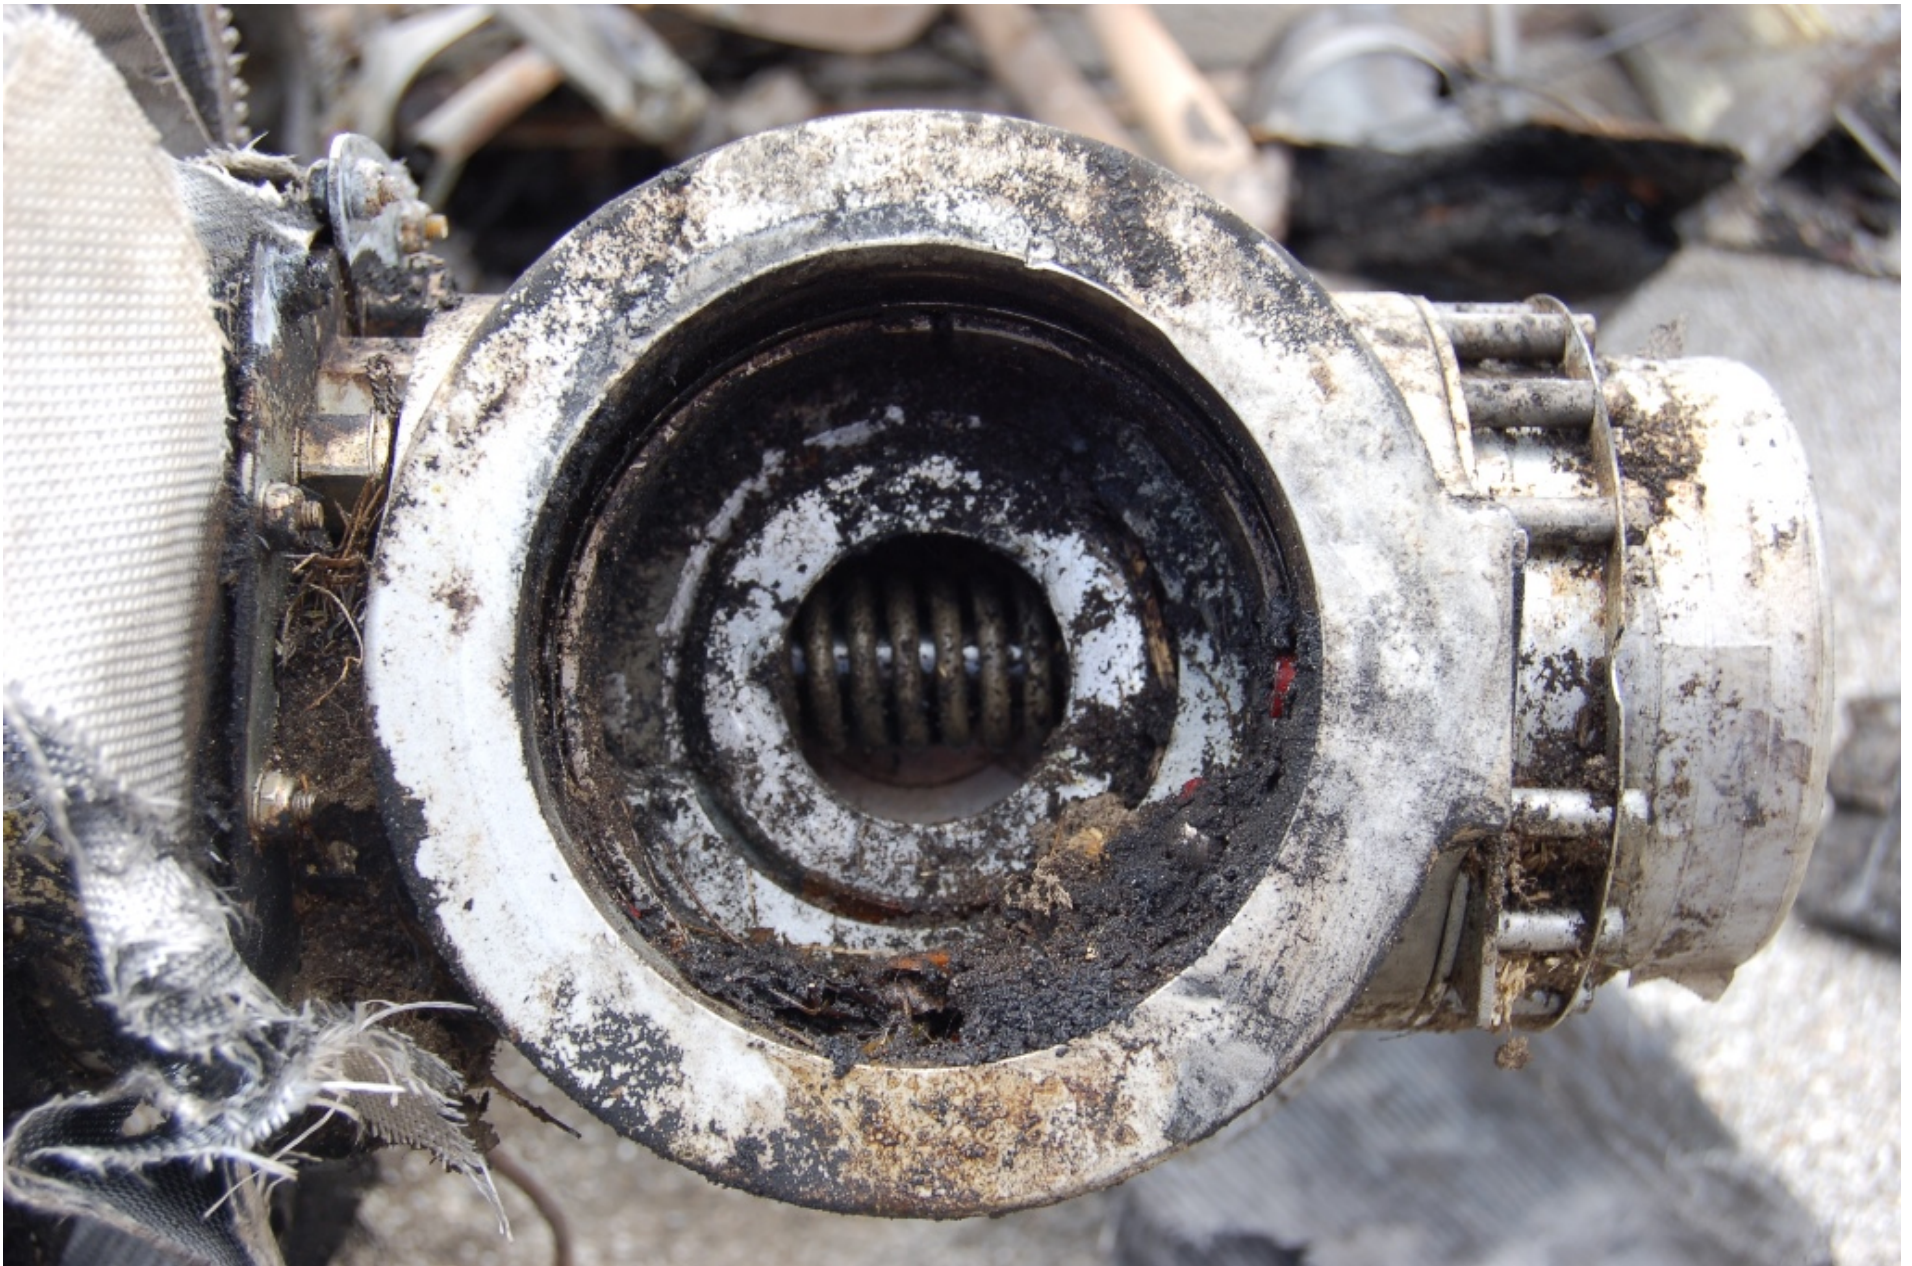
**Photo 6 – Close Up of Propeller Hub Showing Fractured Blade Root – Courtesy of FAA**
