# NATIONAL TRANSPORTATION SAFETY BOARD

## MATERIALS LABORATORY FACTUAL REPORT

Report No. 15-040

Place : Beverly, MA  
Date : May 21, 2014  
Vehicle : Bell 206L-4, N55SL  
NTSB No. : ERA14LA248  
Investigator : Ralph Hicks, AS-ERA

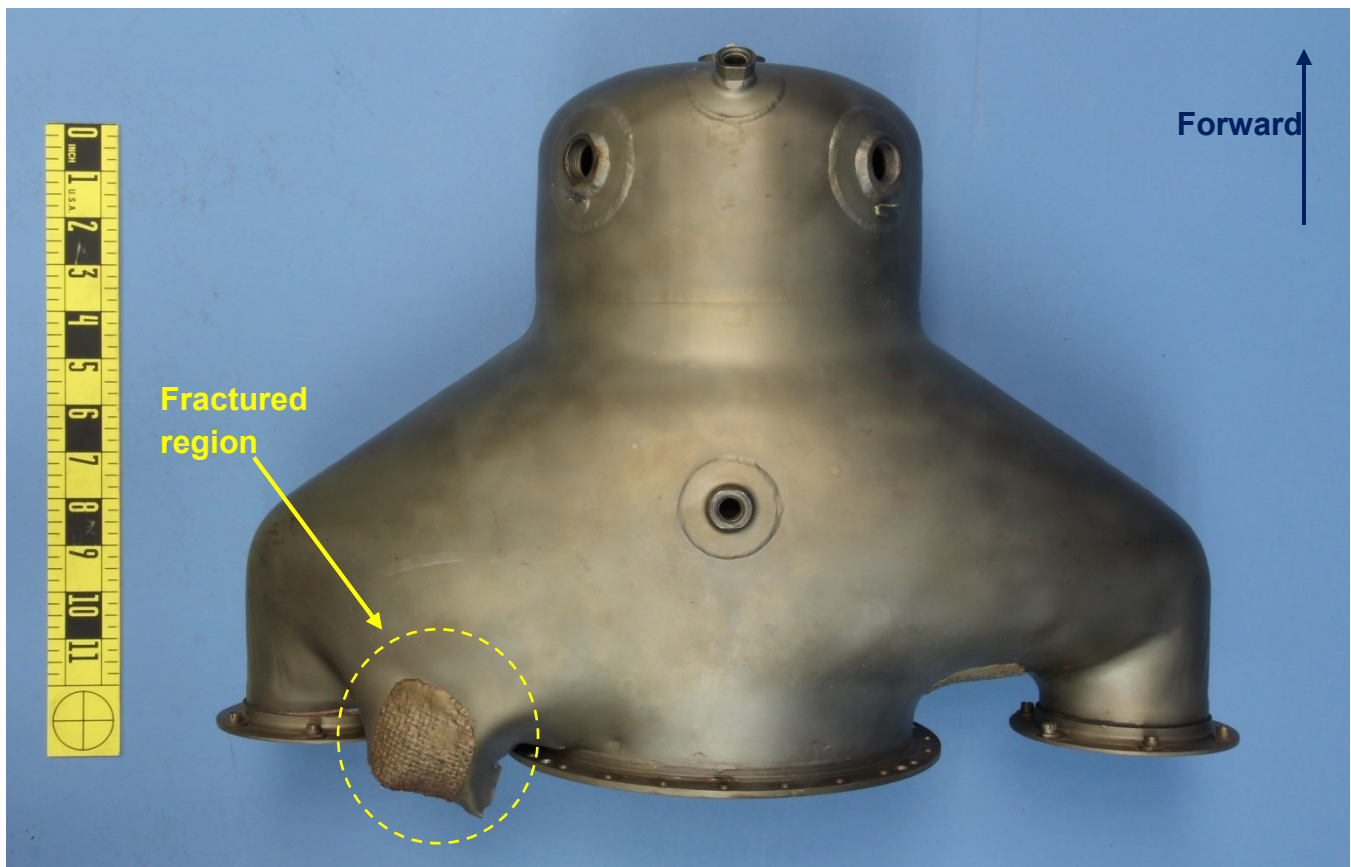
The combustion case is shown in Figure 1 and Figure 2, as received. The case contained a rupture aft of the left elbow shown in the figures. The rupture was manifested as case material protruding outward, with the mating fracture surfaces located along a horizontal butt weld line of the case (Figure 3). This fractured weld line was located where a wire mesh reinforcement patch was brazed to the case.

Figure 1 – The combustion case, as received. The breach was located on the lower left side.

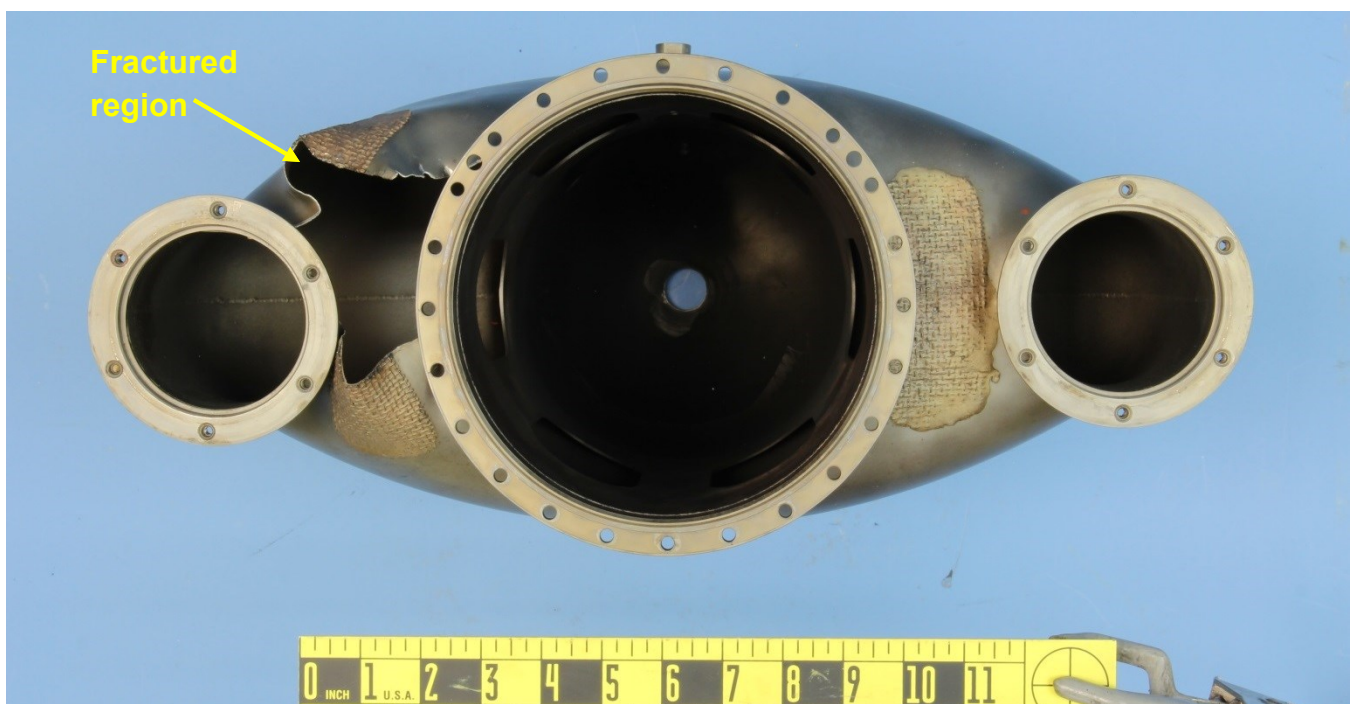
Figure 2 – The combustion case, as received, viewed from the aft side. The breach was located on the left side, where a braze reinforcement was placed. The right side braze reinforcement was intact.

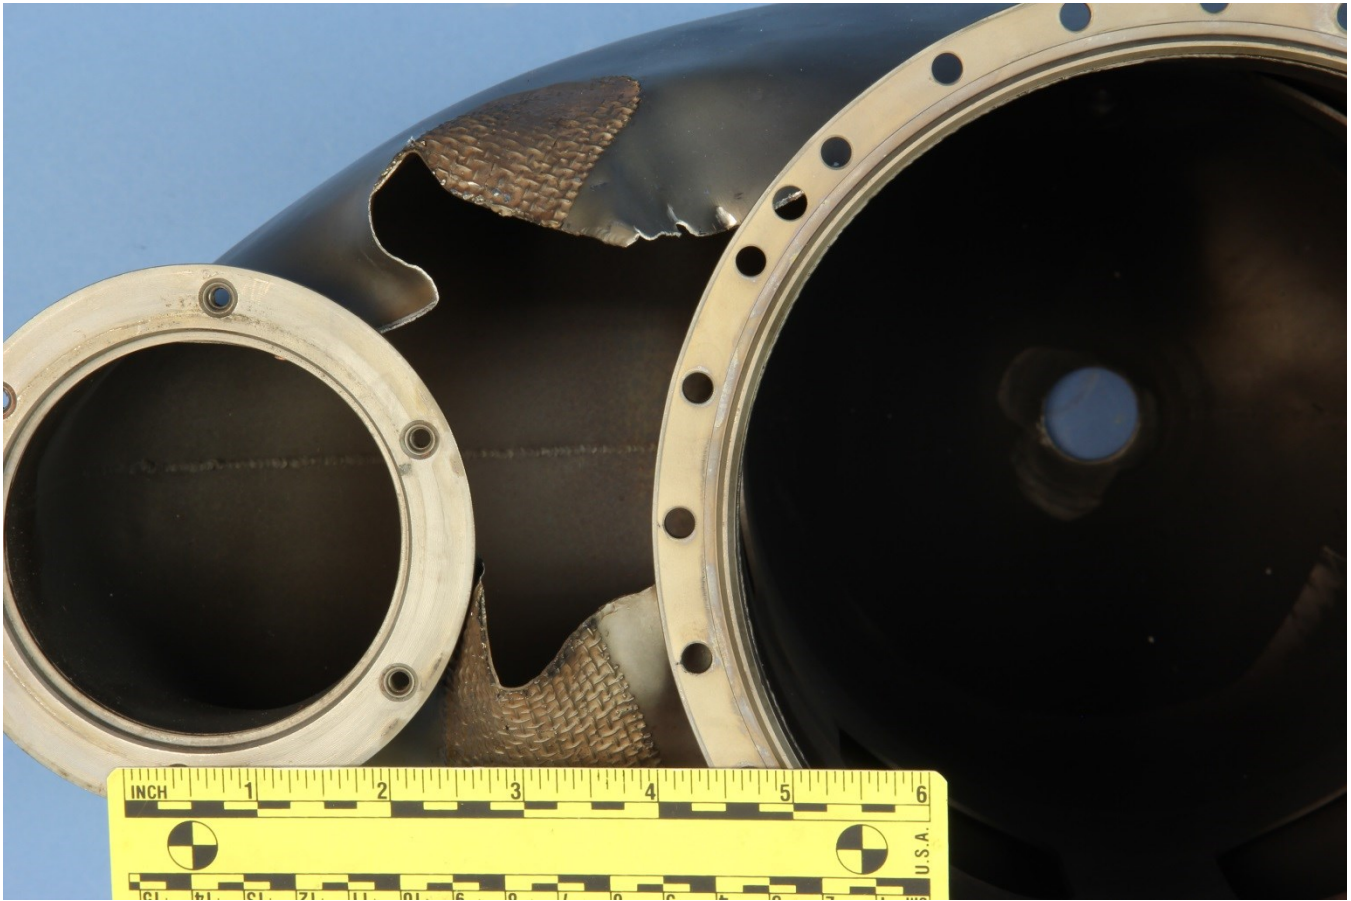
Figure 3 – A closer view of the fracture from Figure 2, showing tearing along the weld line through the braze patch, and secondary tearing from where the tear propagated along the joint with the connecting flanges.

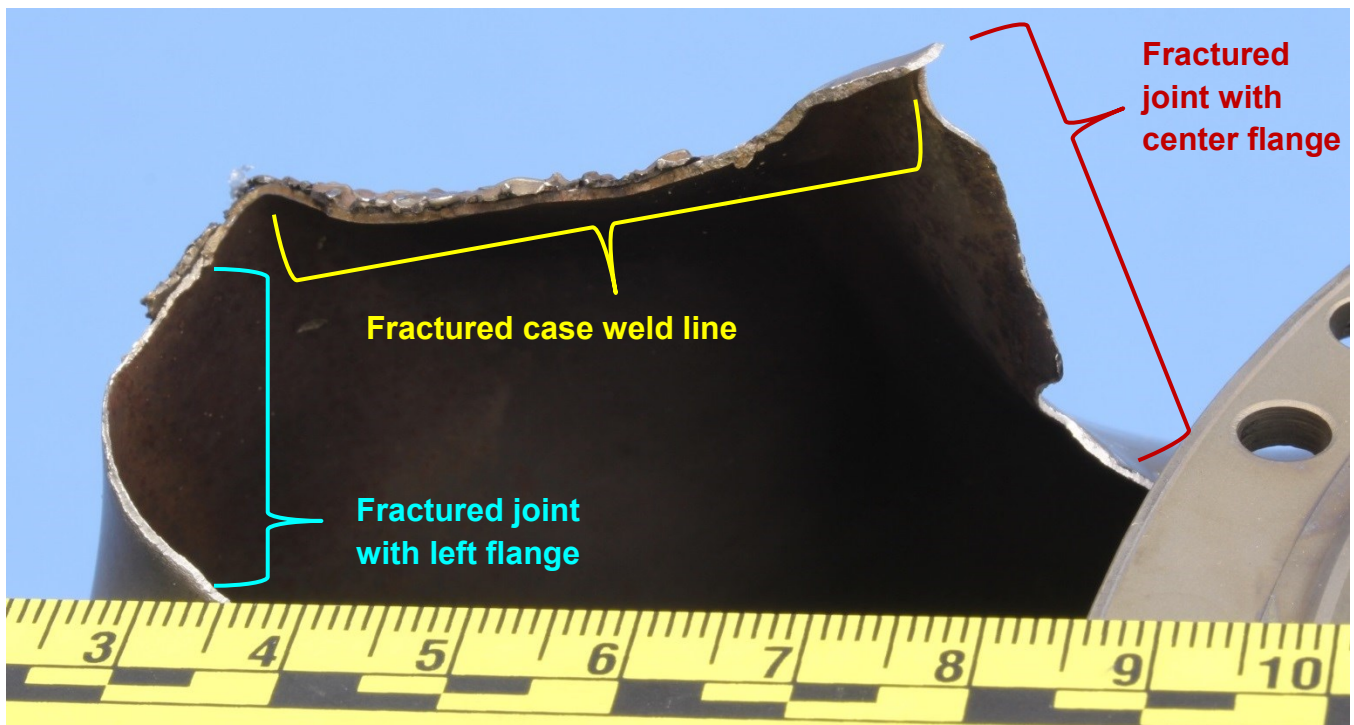
Figure 4 shows one of the mating halves of the fracture surface along the horizontal butt weld of the case. The fracture extended into the braze joint around the left connecting flange and the butt weld of the center connecting flange. Much of the fracture along the flange joints outside the case butt weld exhibited a 45° slant consistent with overstress fracture. The fracture surface along the case weld exhibited a relatively flat orientation.

Figure 4 – One of the mating halves of the tear fracture, tilted to face the reader.

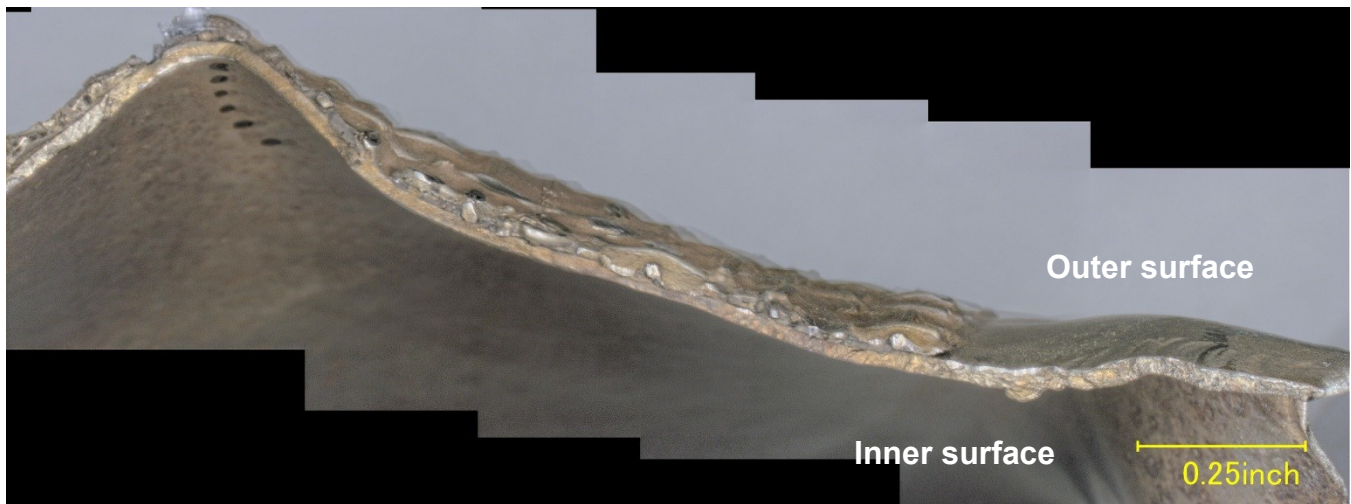
As shown in Figure 5 and Figure 6, the weld fracture surface exhibited crack arrest marks and ratchet marks consistent with progressive fracture. In the progressive regions, the fracture surface appeared dark with visible crack arrest marks, which were more visibly evident towards the periphery. The portions of the fracture surface outside the butt weld exhibited a brighter luster, but still exhibited crack arrest features (see Figure 7). Using a measurement standard for comparison, the thickness of the case was measured along the progressive regions of the fracture surface. As exemplified in Figure 8, the thickness of the case averaged 0.027 inches.

Figure 5 – Montage of the progressive portions of the weld tear fracture surface.

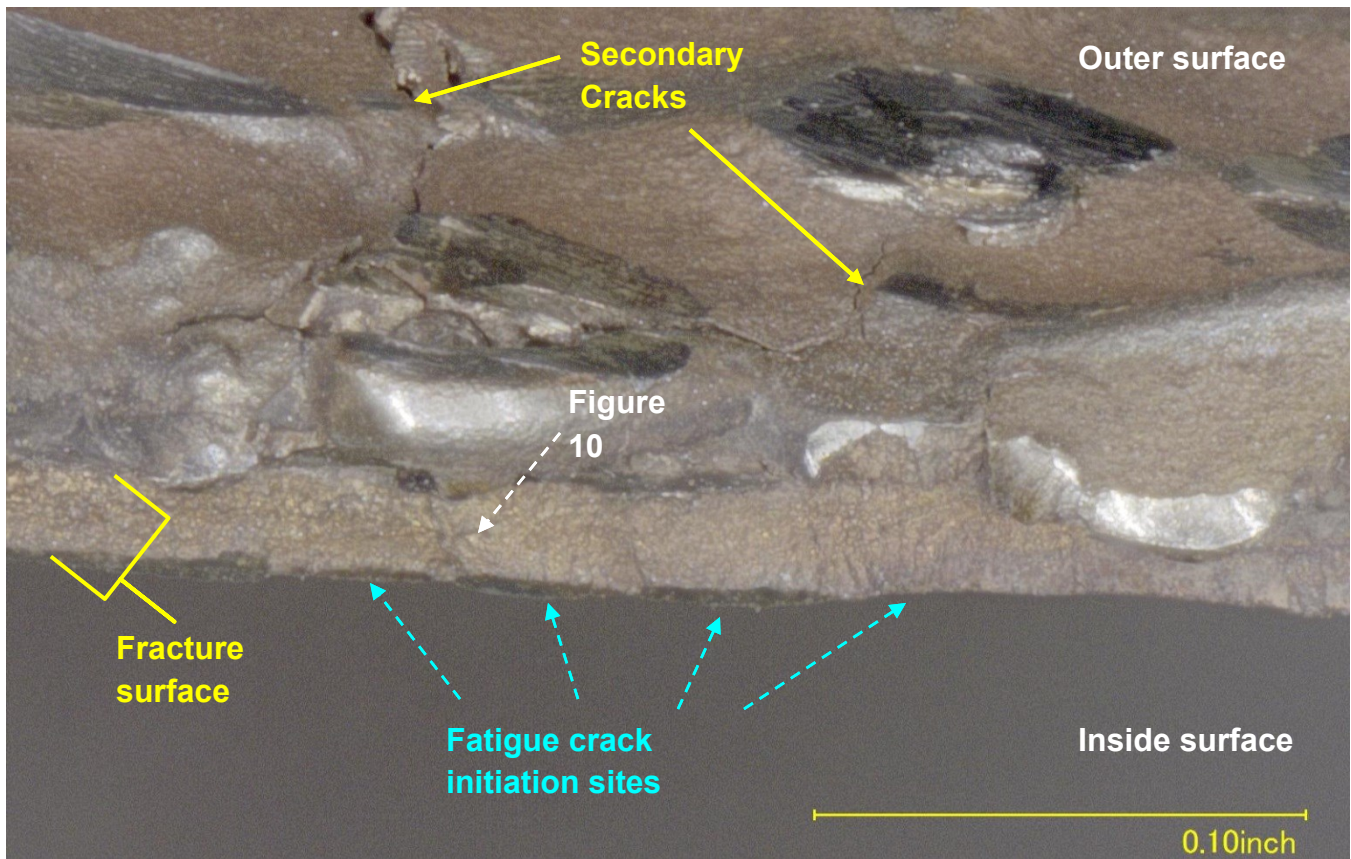
Figure 6 – View of the weld line fracture surface, at progressive crack initiation points (arrows). The braze reinforcement also contained an outer surface crack perpendicular to the fracture surface.

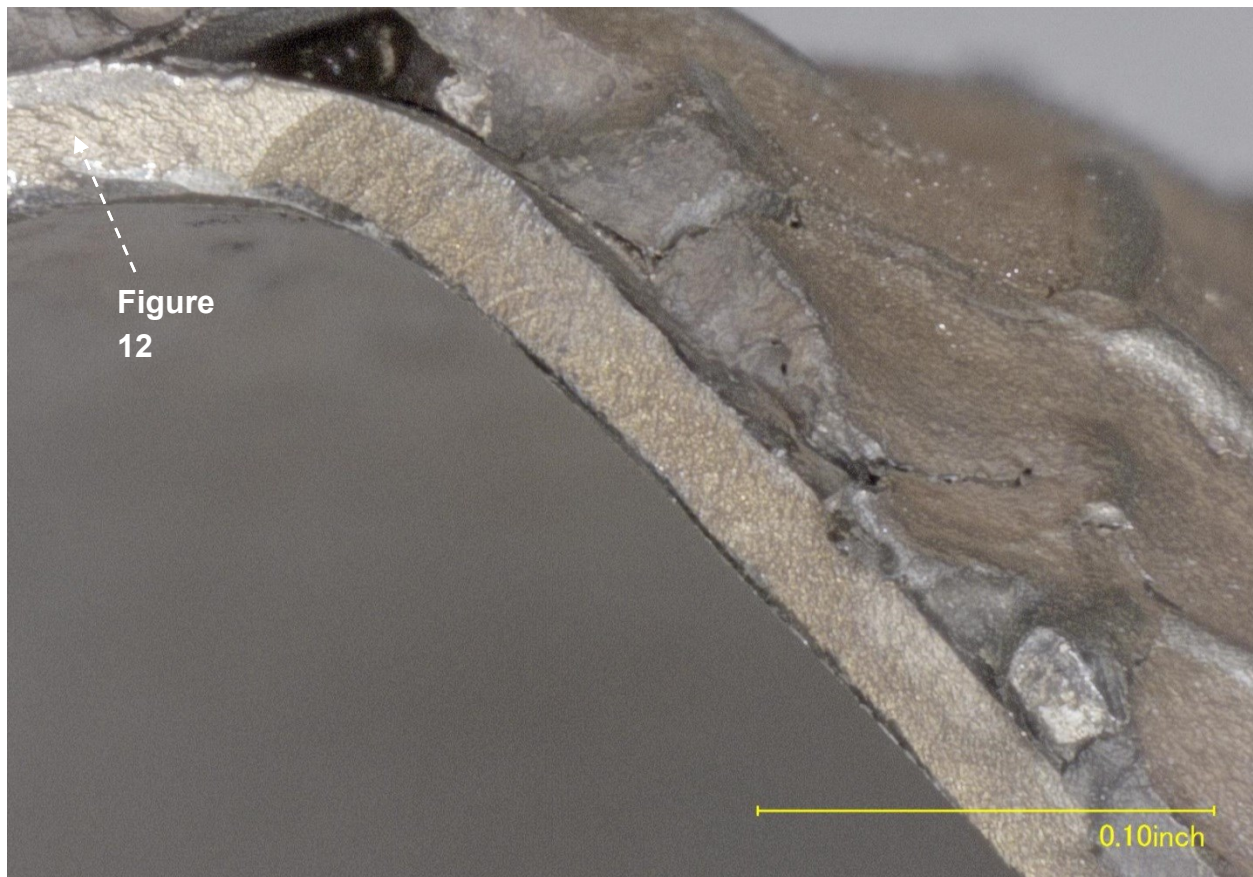
Figure 7 – Closer view of the fracture surface, as the progressive fracture transitioned from the case weld line to the braze joint with the left side connecting flange. The numbers refer to later figure locations.

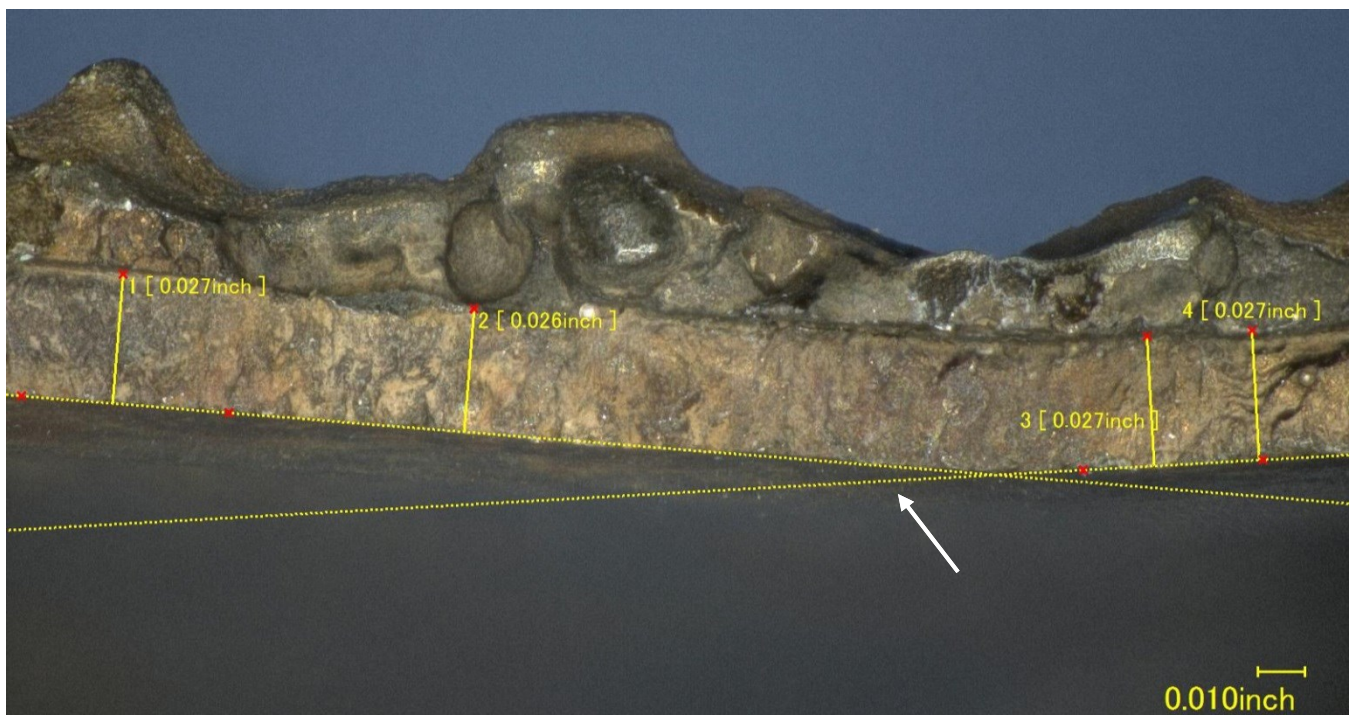
Figure 8 – One of the fatigue crack initiation points (white arrow) on the combustion case weld line, with case thickness measurements taken at four locations.

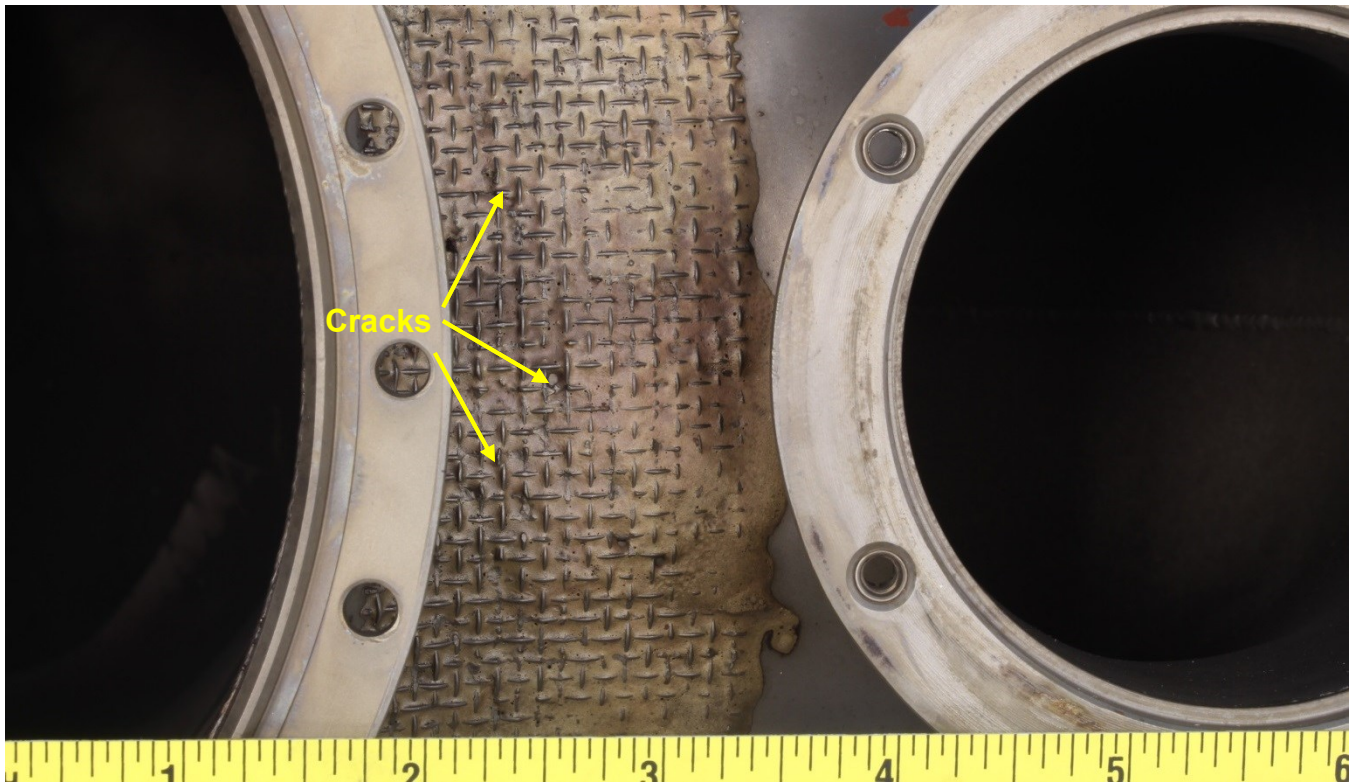
Examination of the opposite braze patch (right side Figure 2) revealed small cracks present on the outside surface (see Figure 9). These were consistent with smaller versions of outer surface defects observed on the braze patch from the fractured braze patch (compare with Figure 6).

Figure 9 – Closer view of the right side braze reinforcement patch, showing small surface cracks visible from the braze side.

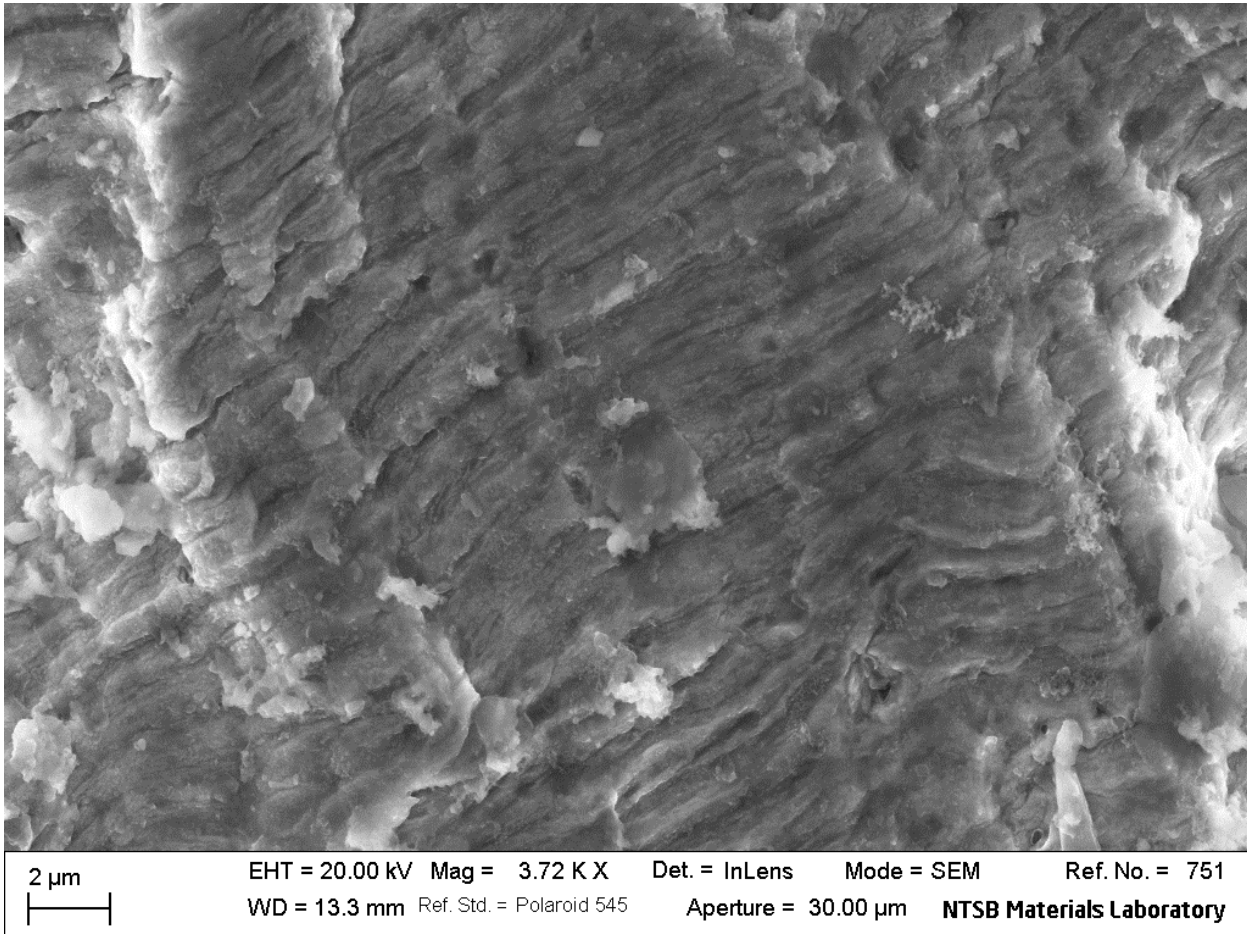
One half of the fracture surface was sectioned away from the rest of the combustion case and was examined using a scanning electron microscope (SEM). As displayed in Figure 10, examination of the progressive portions of the fracture surface exhibited fatigue striations, consistent with fatigue fracture. The fatigue cracking originated along the weld line approximately halfway between the connecting flange joints. The fatigue regions consisted of relatively large striations with smaller striations overlapping—these fatigue features were consistent with spectrum loading.

Figure 10 – Secondary electron (SE) micrograph of fatigue striations on the progressive portion of the fracture surface shown in Figure 6.

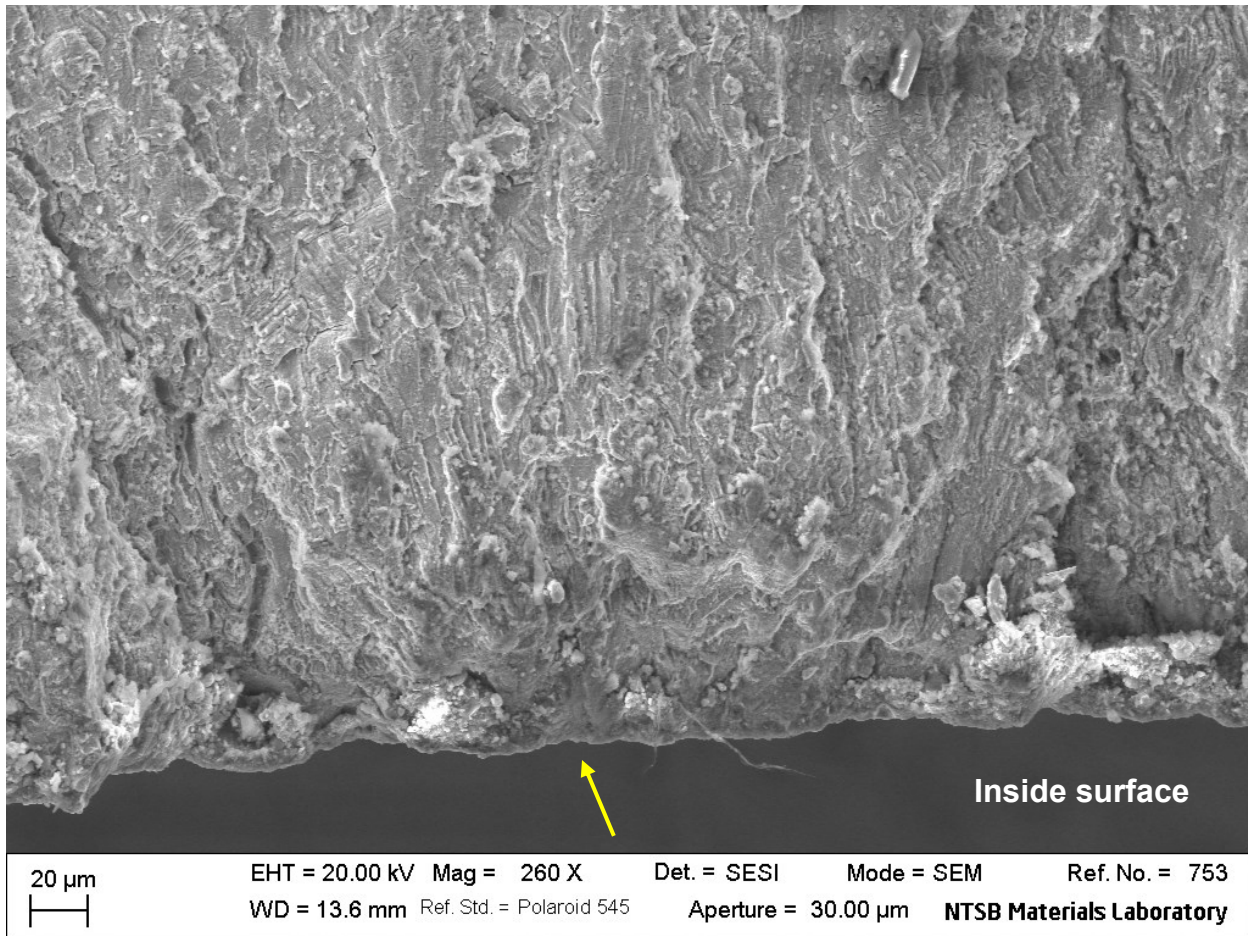
Examination of this initiation area revealed the fatigue cracks started on the inside face of the case weld at multiple crack initiation sites (such as illustrated in Figure 11). No material defects, such as pores or inclusions were found at these initiation sites. At the end of the fatigue crack in the weld, features that appeared to represent transition to other failure modes (such as Figure 7) were also found to contain fatigue striations microscopically, as shown in Figure 12. Fatigue striations were present outside the main weld line. Outside the fatigue regions, dimple rupture, which was indicative of overstress failure, was observed (see Figure 13).

Figure 11 – SE micrograph of one of the fatigue crack initiation sites (yellow arrow) on the case weld fracture, location depicted in Figure 6.

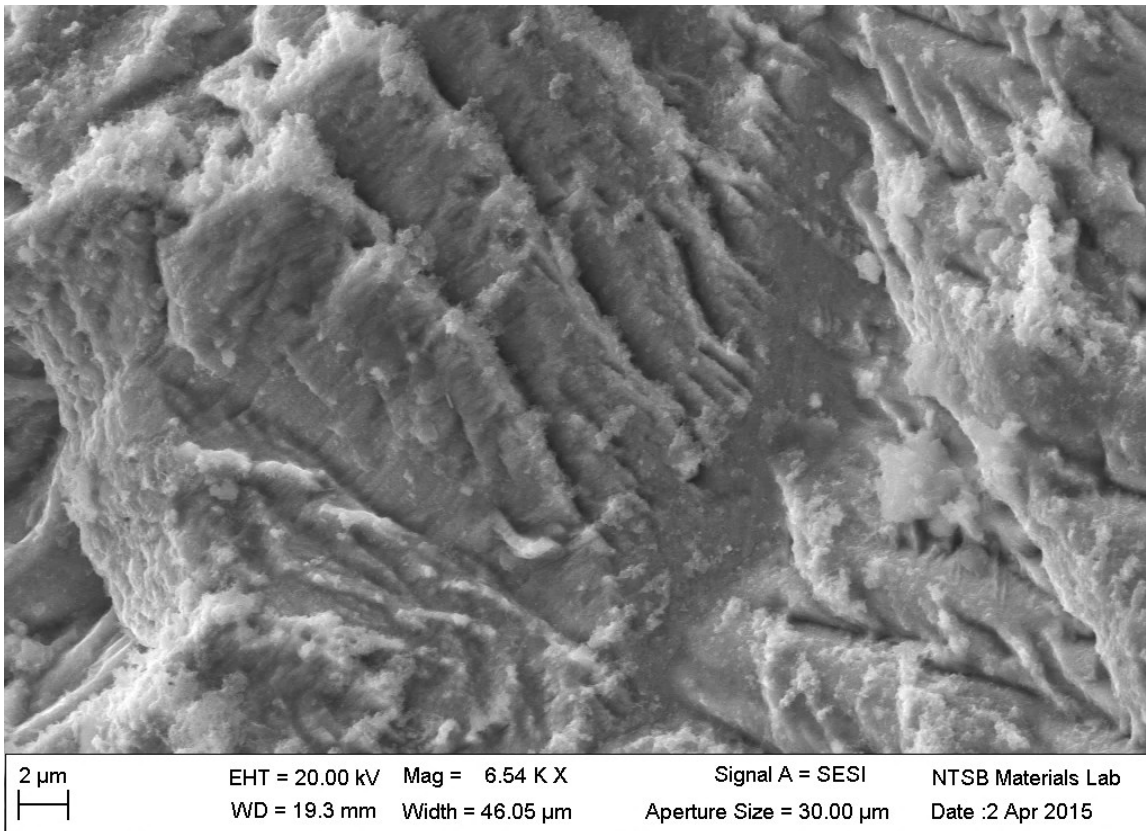
Figure 12 – SE micrograph of fatigue striations on the portion of the fracture surface located at a joint between the case and the left connecting flange, location depicted in Figure 7.

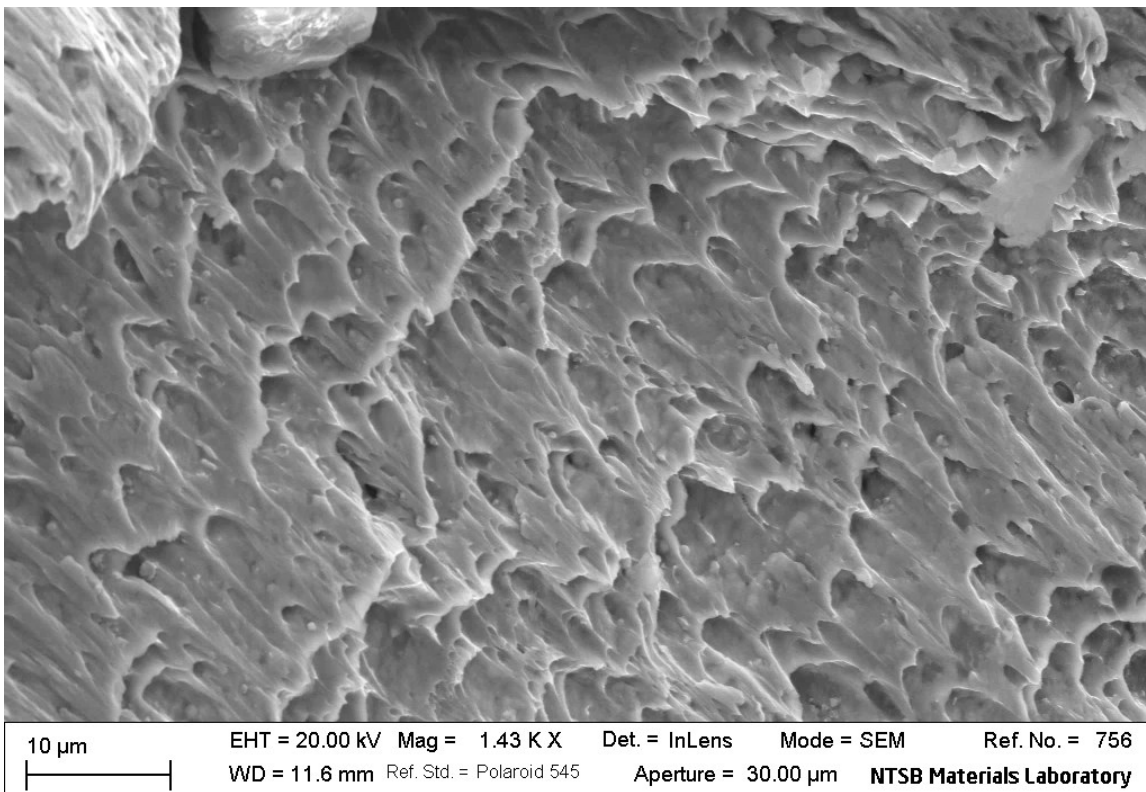
Figure 13 – SE micrograph of dimple rupture in the overstress regions outside of the fatigue regions on the case fracture surface (outside of Figure 7, left side).

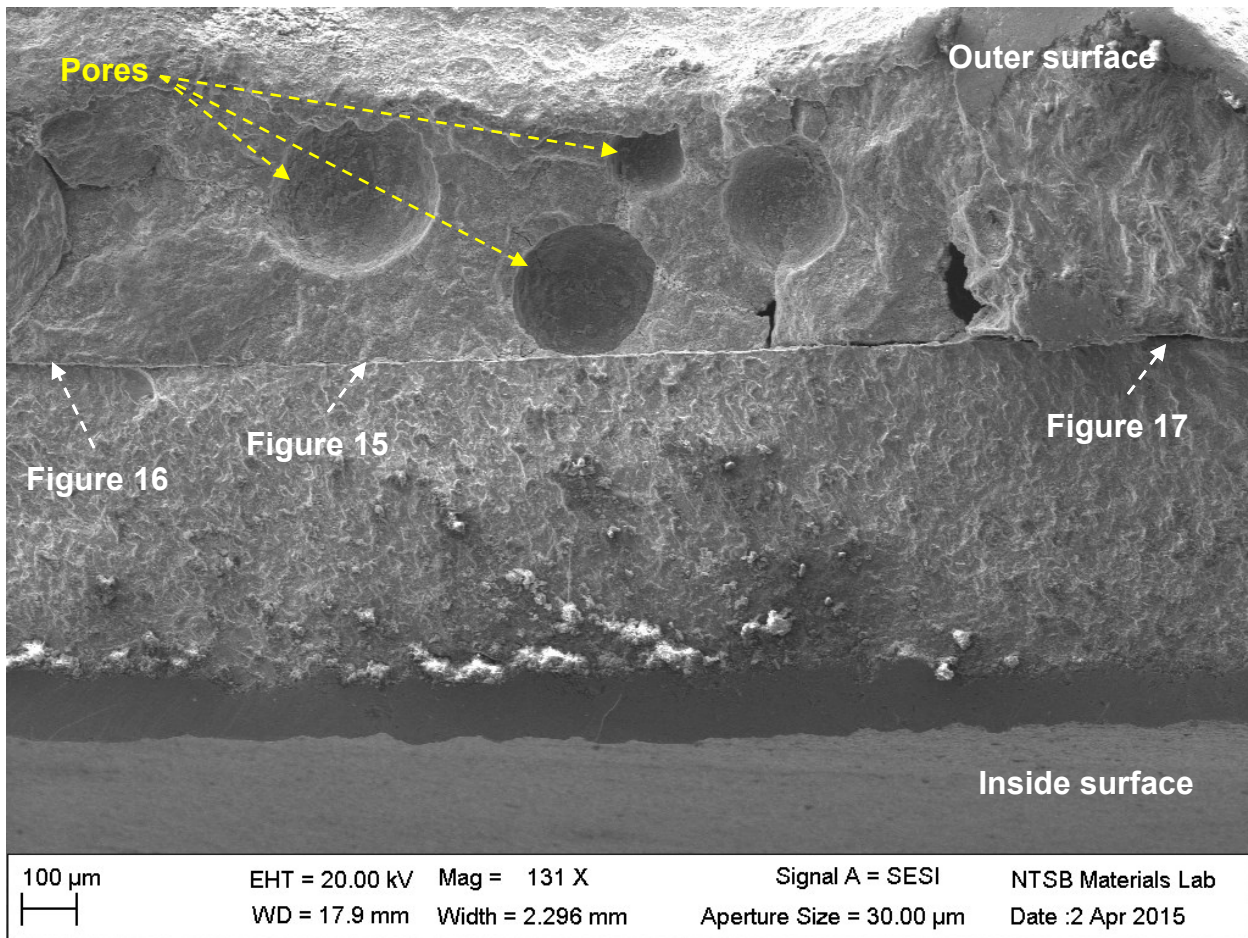
Examination of the exterior fractured braze patch revealed a region with pores, approximately 0.005 to 0.010 inches in diameter (see Figure 14). In areas where the braze material was well adhered to the case material, the fatigue cracking had

Figure 14 – SE micrograph of the weld line fracture surface, also showing the fractured outer braze layer that contained pores.

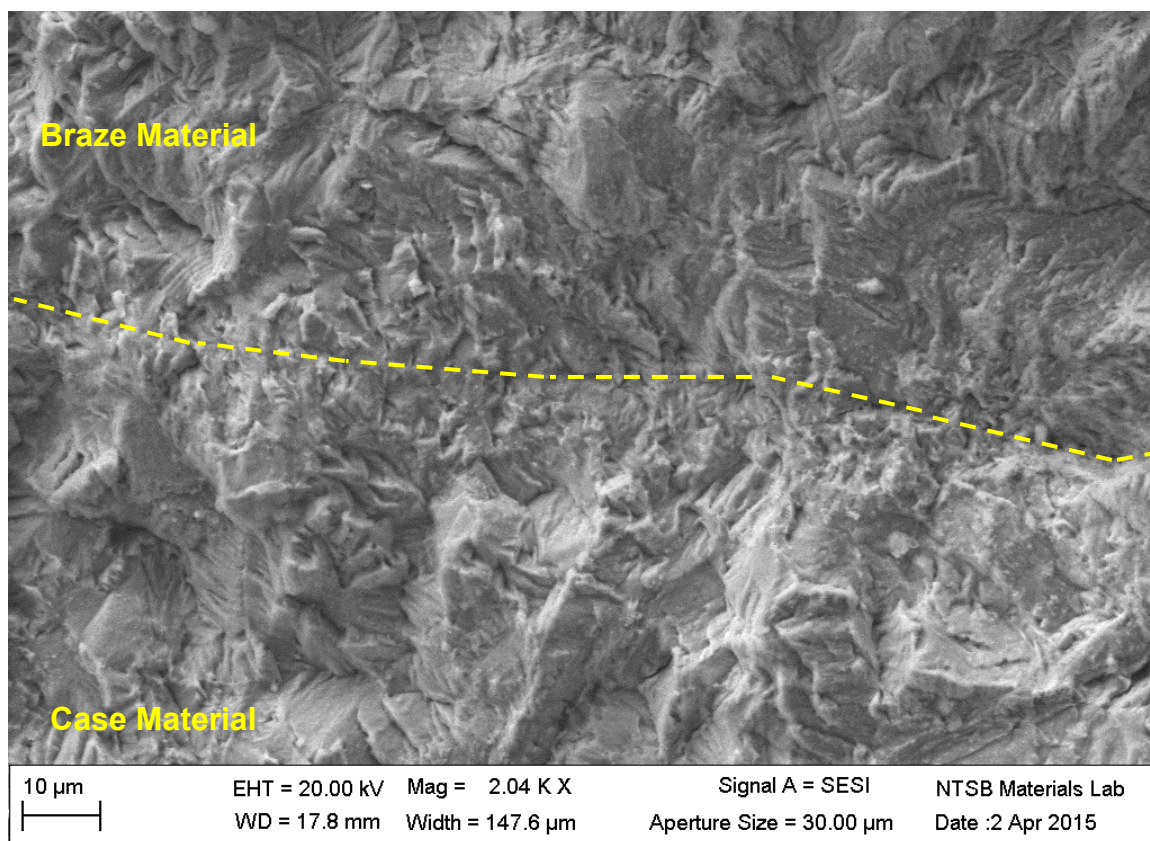
propagated through the interface into the braze material (Figure 15). In regions where there was a gap between the braze and the case, the braze material was more oxidized and the fracture features could not be discerned (Figure 16). The fracture surface of the braze filler in these regions contained smaller microcracks perpendicular to the fracture surface. Near the pores in the braze filler, these microcracks could be observed emanating from the pores (Figure 17). In addition, cracks were present on the exterior surface of the braze patch. However, neither the appearance of external surface cracks nor the interior microcracks were consistent with initiation of the fatigue crack on the interior of the case.

Figure 15 – SE micrograph of fatigue striations across a well-adhered interface between the case and braze material, location depicted in Figure 14.

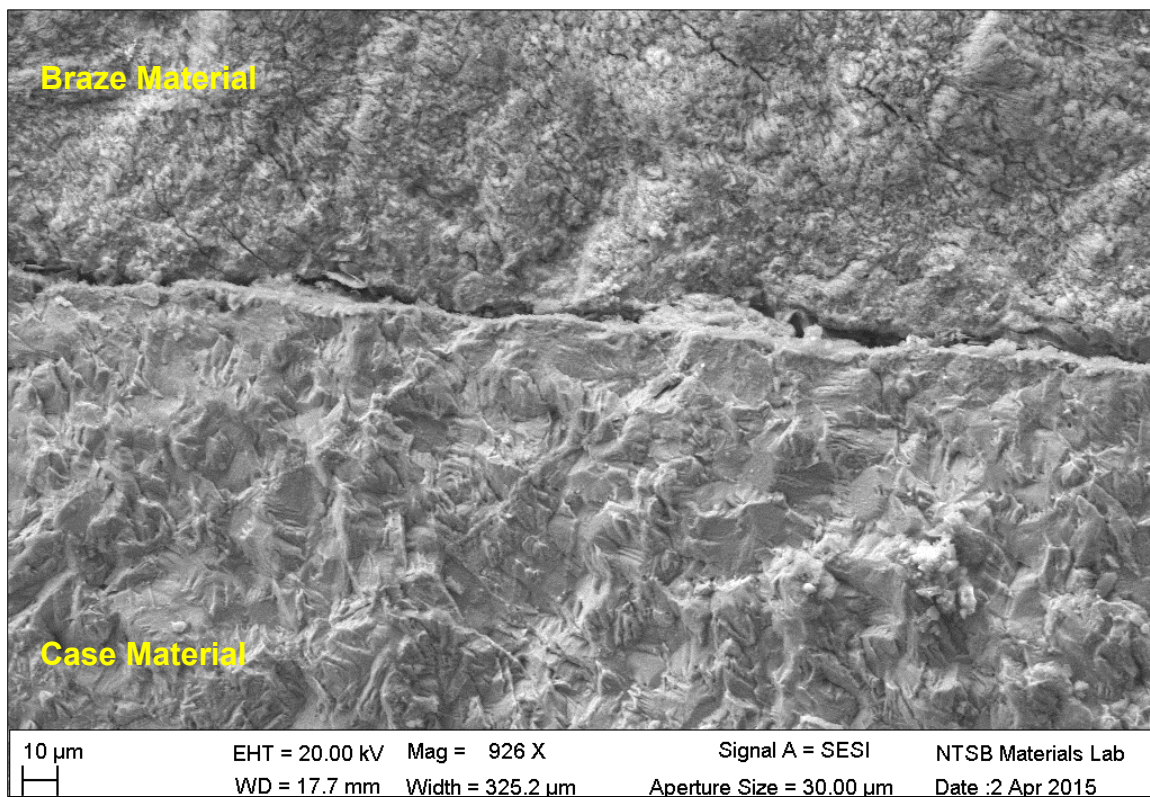
Figure 16 – SE micrograph of fatigue striations across a gapped interface between the case and braze material, location depicted in Figure 14.

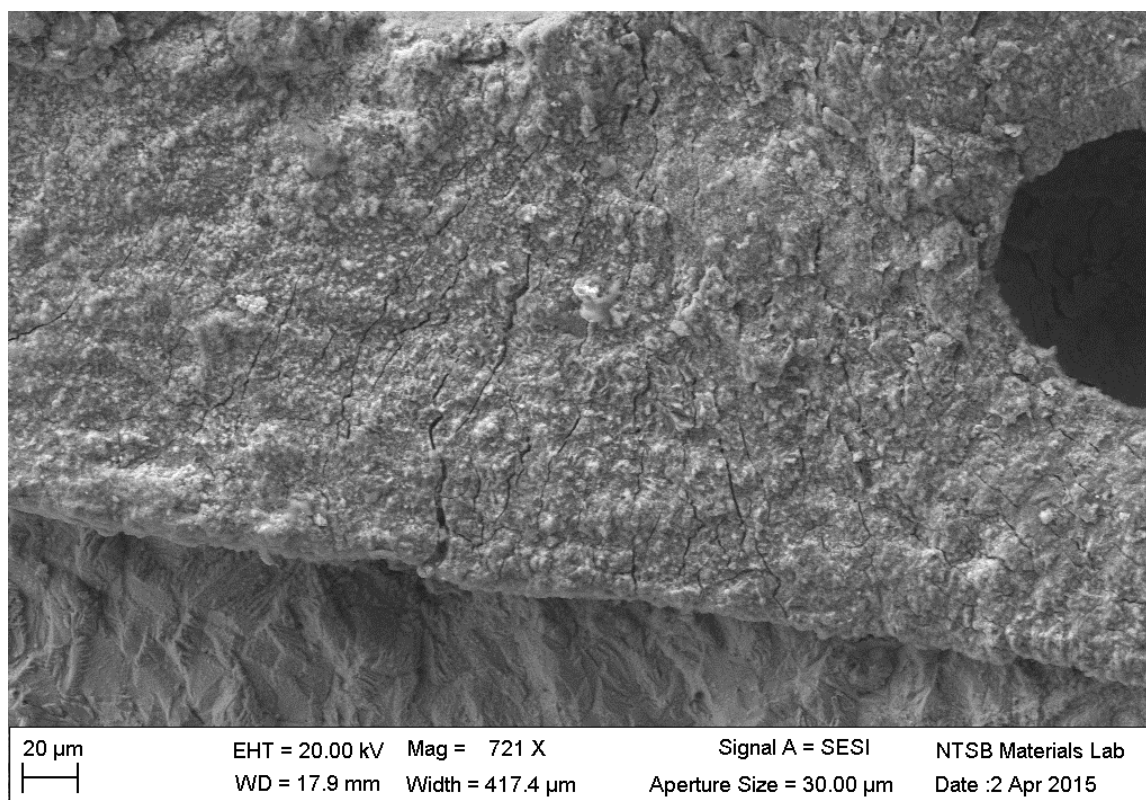
Figure 17 – SE micrograph of the braze fracture surface, showing small perpendicular cracks in the braze, location depicted in Figure 14.

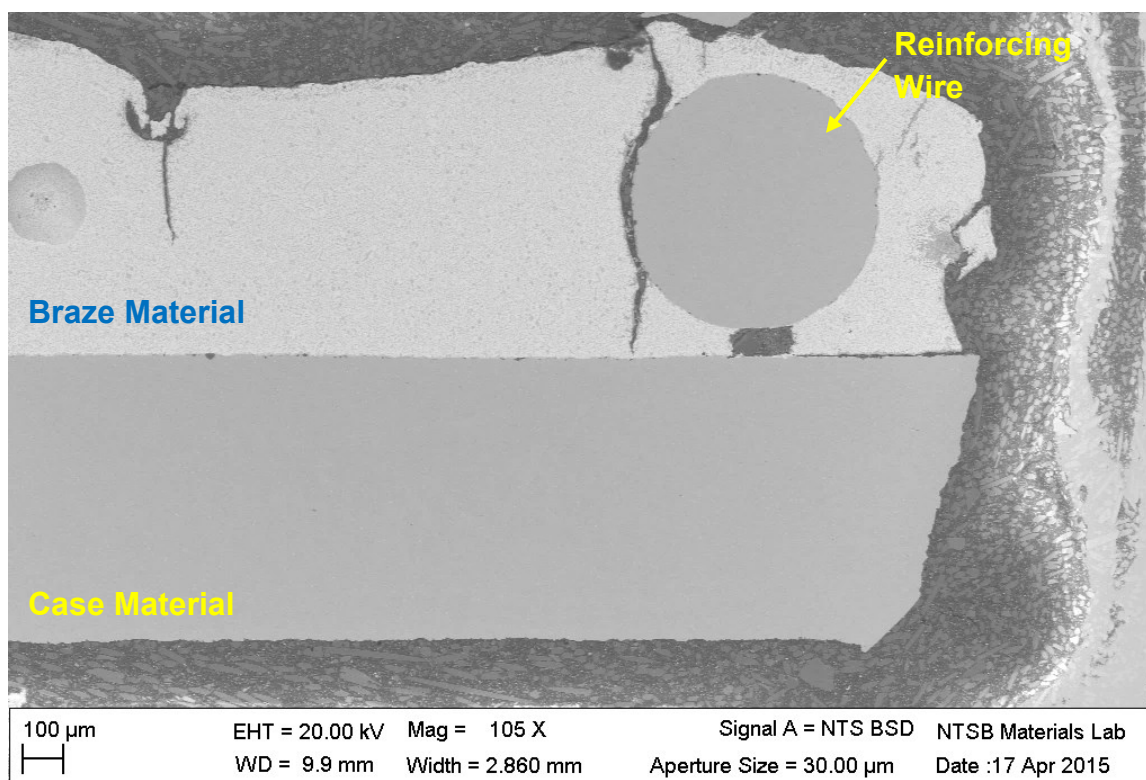
A portion of the case fracture surface was cross-sectioned, mounted, and polished for metallographic examination. Figure 18 shows a portion of the cross section. In backscattered mode, the braze material appeared lighter relative to the case material and wire mesh in the braze.<sup>2</sup> Like the fracture surface, the cross section of the braze filler contained multiple pores. These appeared light consistent with the braze material, whereas the wire mesh contrasted darker. Cracks were visible initiating from these pores. Gaps were found between the braze material and the case adjacent the fatigue fracture surface (see Figure 19). The mating surfaces of these gap exhibited backscattered electron contrast and chemical compositions consistent with oxidation. Gaps were also found adjacent to the wire mesh. Additional cracks were found perpendicular to the case and braze patch. Even in well adherent areas, cracks were found propagating into the case material, as shown in Figure 20. The interior surface of the case was not uniformly smooth, containing small crevices and gaps, as illustrated in Figure 21.

Figure 18 – Backscattered electron (BE) micrograph of a polished cross section of the braze reinforcement of the case, away from the fracture surface. Pores were visible in the braze, with cracks emanating from the pores and stainless steel wire reinforcement.

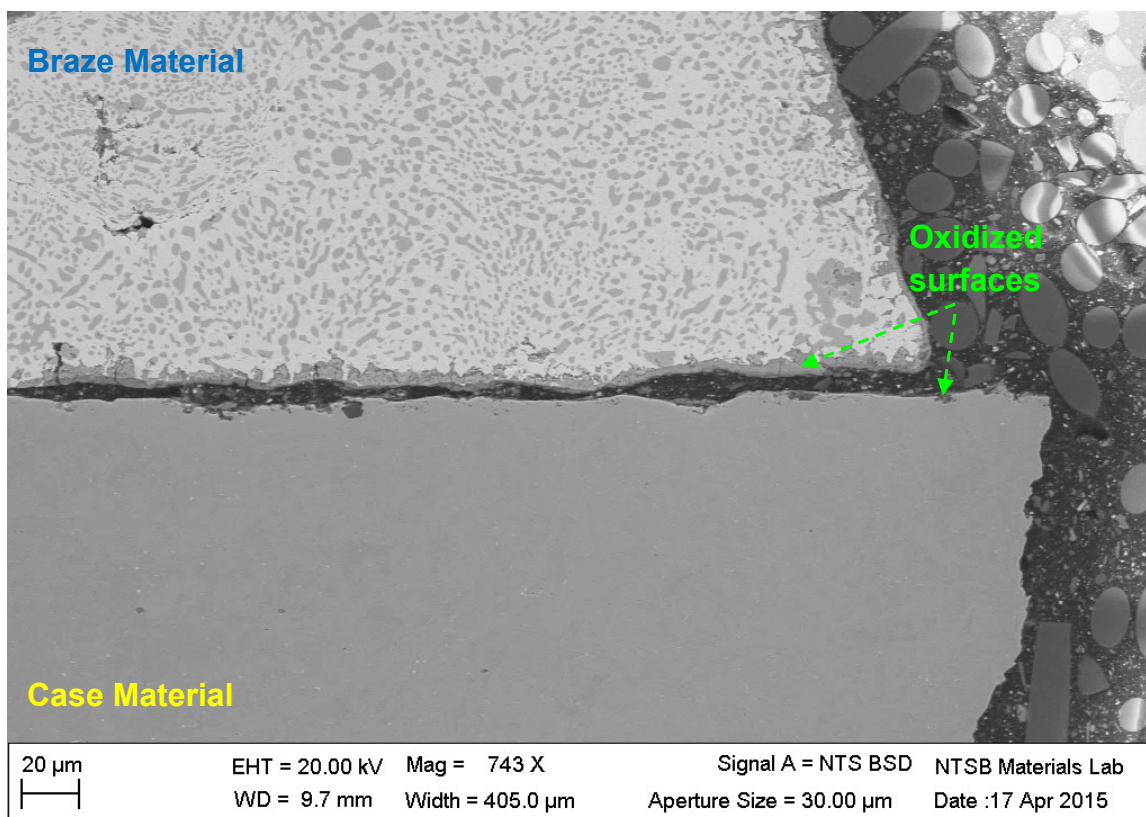
Figure 19 – BE micrograph showing an oxidized gap between the braze and the case materials.

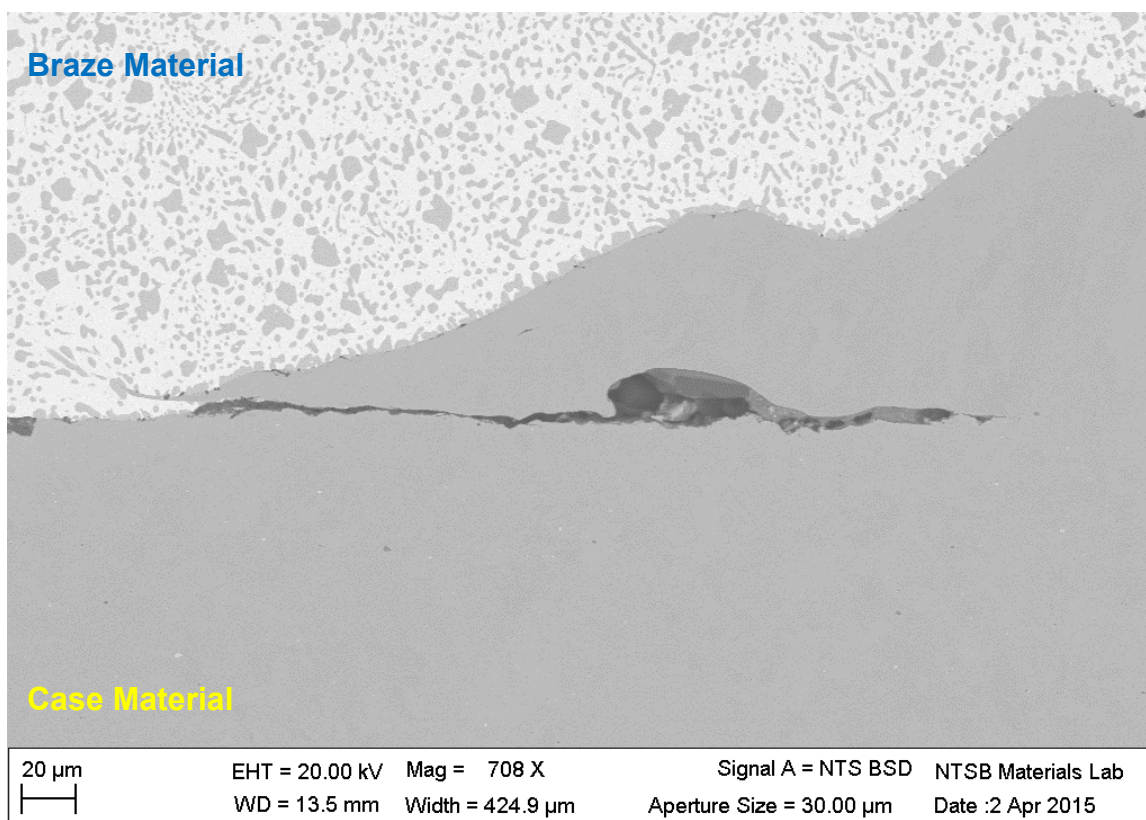
Figure 20 – BE micrograph of a crack in the case material emanating from the interface between the braze and the case.
