# **National Transportation Safety Board**

## **GEAR BOX/PROPELLER EXAM FACTUAL REPORT**

**ERA14LA272**

Vehicle: RV-6, S/N 23075, N6RP, Experimental Amateur Built

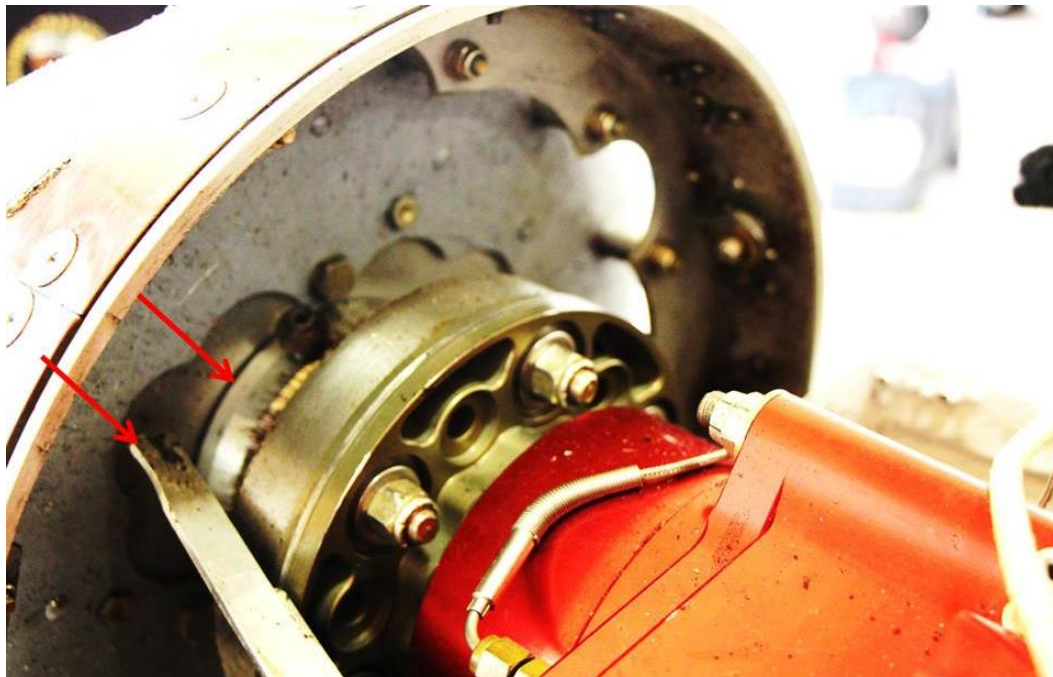
**Photo 1 – The left arrow points to the hydraulic hose support bracket. The right arrow points to the slave piston. The slave piston is supposed to be attached to the support arm and remain stationary relative to the engine. The slave piston expands fore and aft moving the blade pin spool (not pictured). The slave servo had been stabilized by securing a bracket to the hydraulic fitting threaded into the slave servo. The bracket consisted of two pieces of angle aluminum attached so that the longer piece was cantilevered from the front of the PSRU. Four wraps of safety wire were wound around the inflow tube and through a hole in the bracket.**

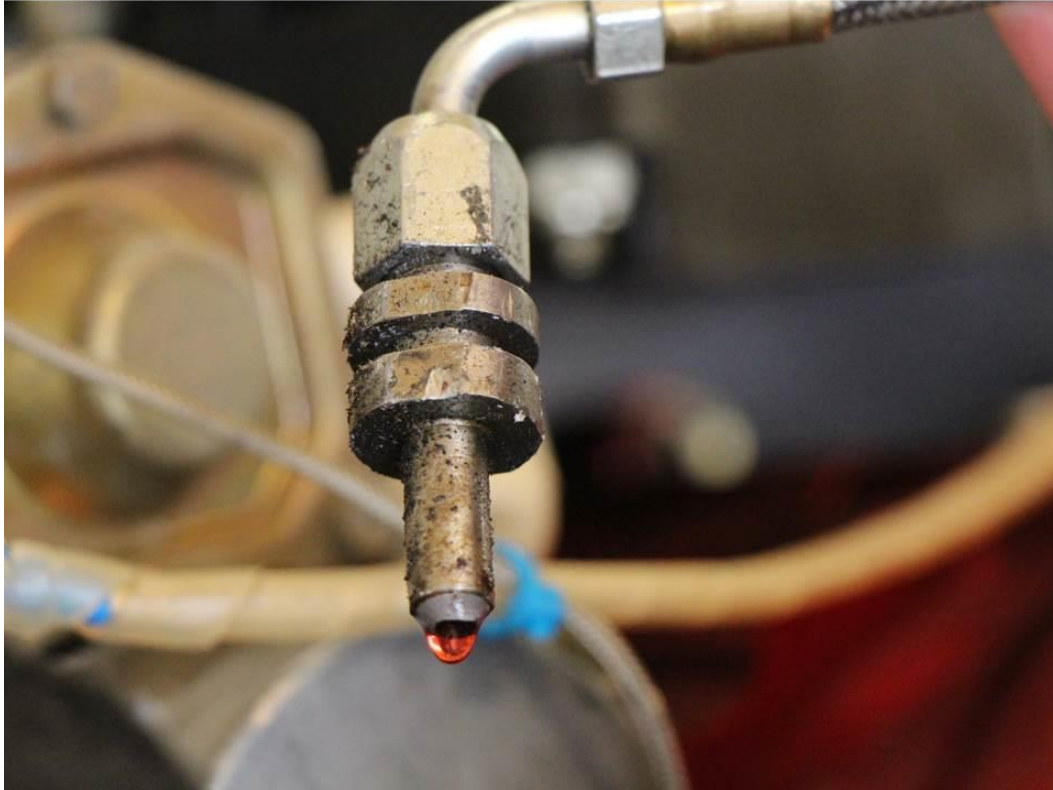
**Photo 2 -The propeller hydraulic line fitting is designed to fracture if the slave piston starts rotating with the propeller. The fitting at the end of the inflow tube was broken, which allowed the hydraulic fluid to escape and also allowed the slave servo to rotate with the propeller rather than remaining stationary with the engine. In addition, the blades could rotate to a lesser pitch angle.**

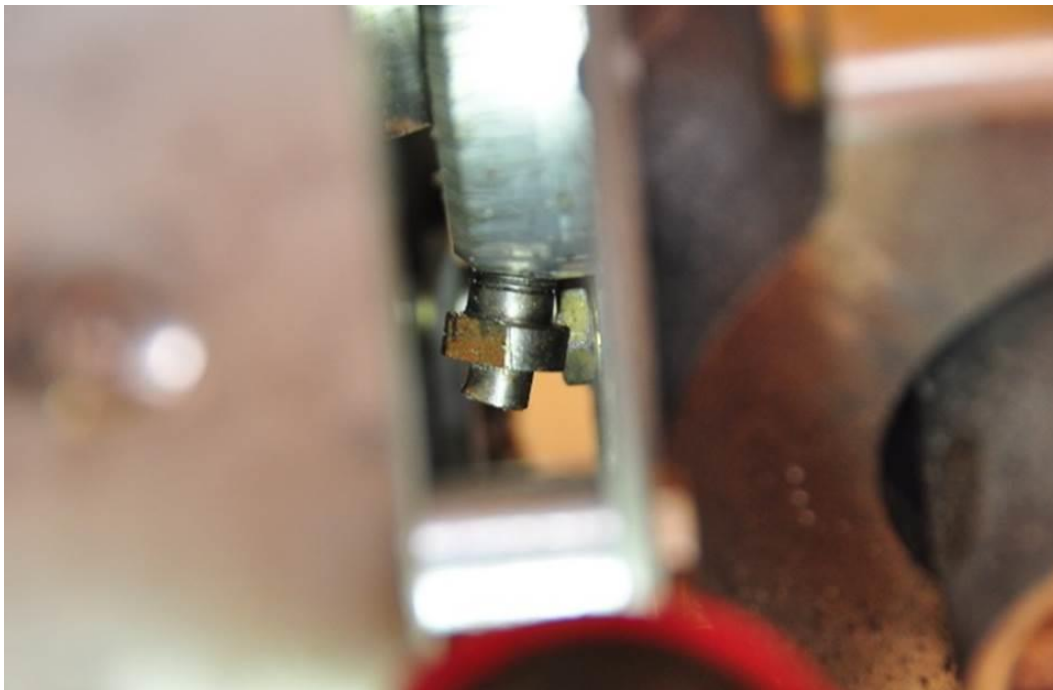
**Photo 3 – The fractured hydraulic line fitting at the slave servo.**

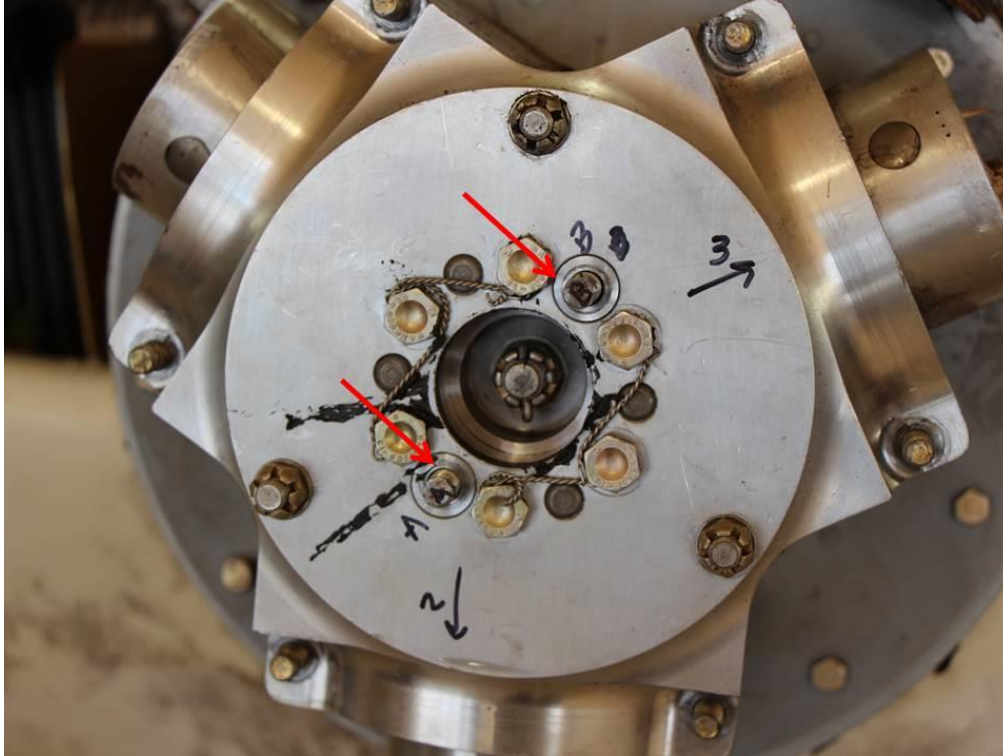
push the spool aft to achieve lower blade angles. In this installation, the builder set blade angles to achieve a static rpm of 2520 rpm. Two stop nuts attached to the slave piston provide a mechanical low pitch stop in the event of loss of hydraulic fluid or other failure of the pitch control system. According to the builder/pilot, the stop nuts that provide the mechanical limit to the low pitch angle were tightened so that the washers were slightly loose when the propeller blades were at the low pitch stop position. At the initial examination, the stop nuts were missing. Further examination of the bolts did not disclose any evidence of damage or remnants that could be attributed to the stop nut being present. The propeller designer provided in-service information where he lost hydraulic pressure and the propeller pitch returned to the low pitch stop set by the stop nuts.

**Photo 4 - The fine pitch adjusting nuts (A) and (B) were not present. With the loss of hydraulic fluid and the absence of the nuts, the blade pitch angles would rotate to a blade angle less than the optimum fine pitch blade angle.**

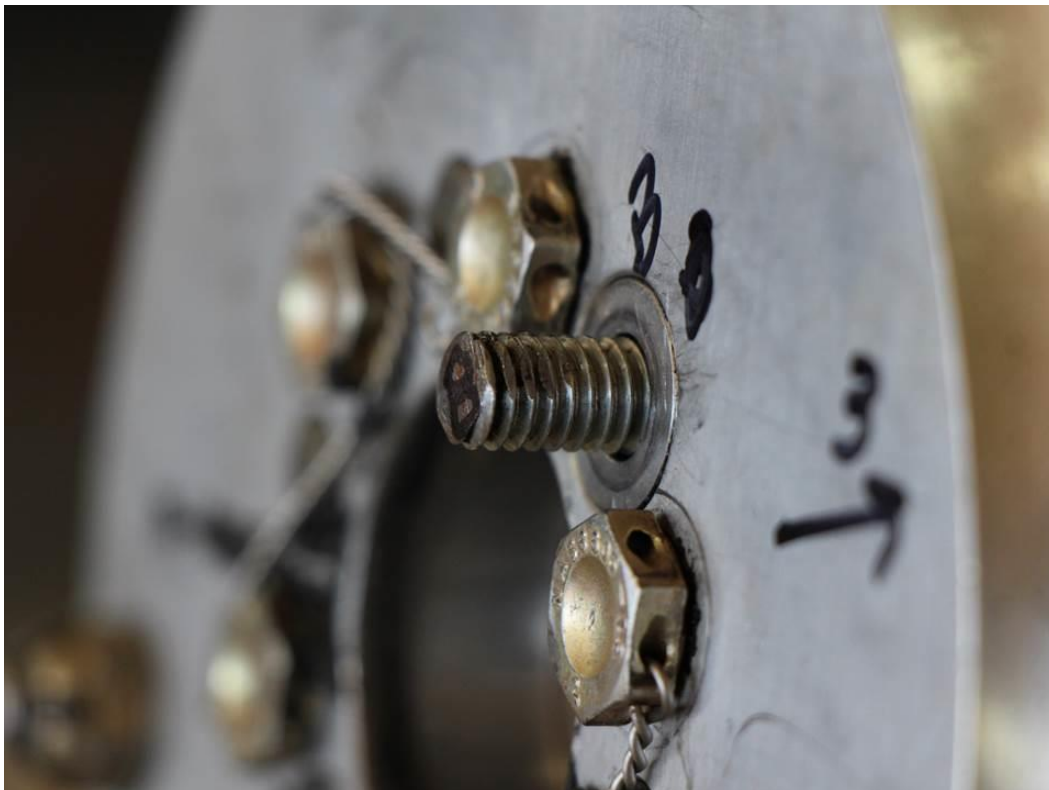
**Photo 5 - Damage to the fine pitch adjusting bolt (B).**

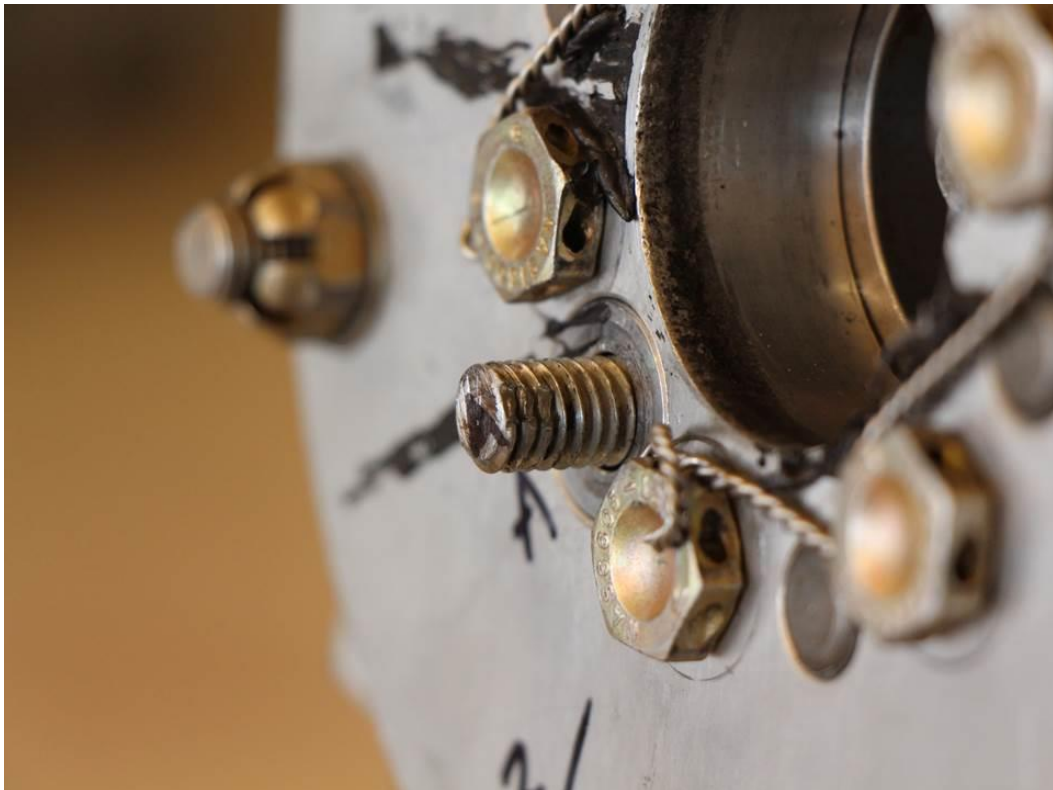
**Photo 7 - Damage to the fine pitch adjusting bolt (A).**

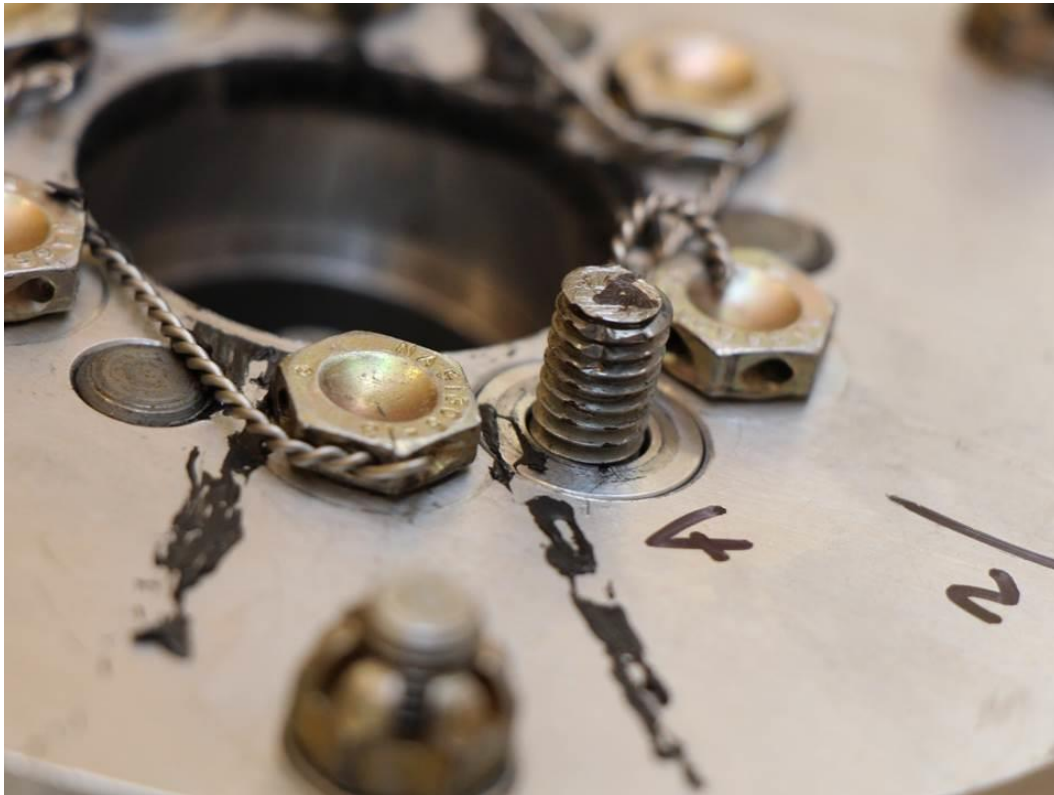
**Photo 8 - Damage to the fin pitch adjusting bolt (A).**

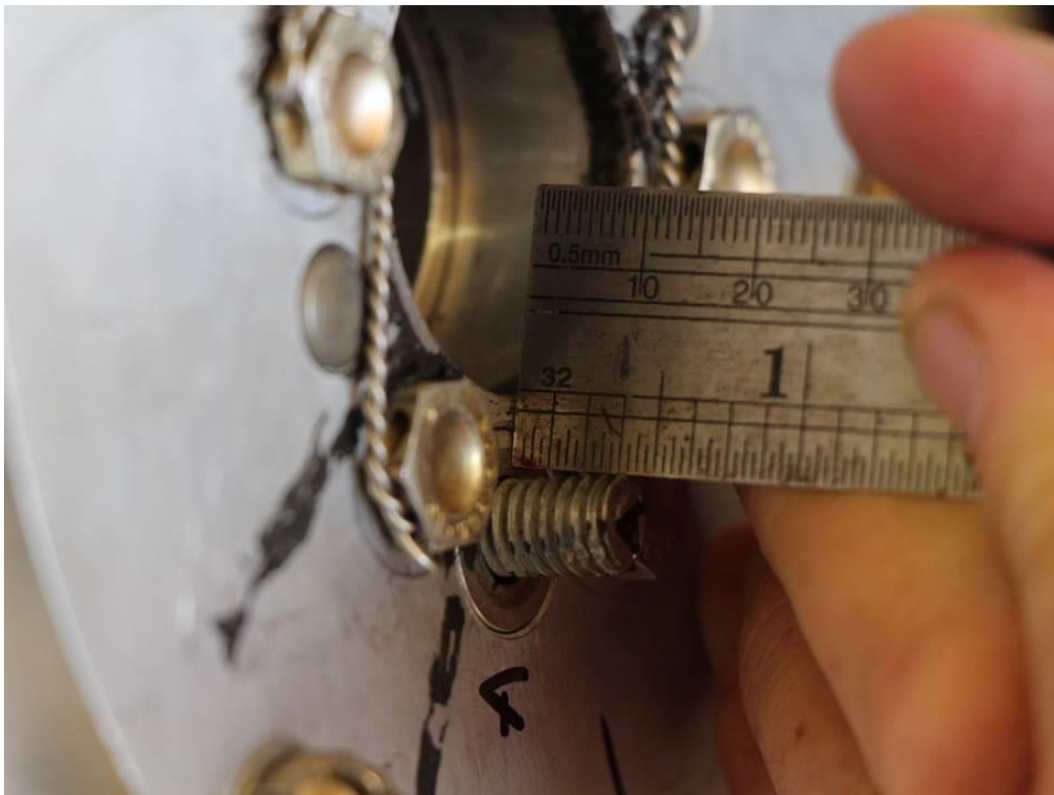
**Photo 9 - Measurement was 0.41 inches at bolt (A).**

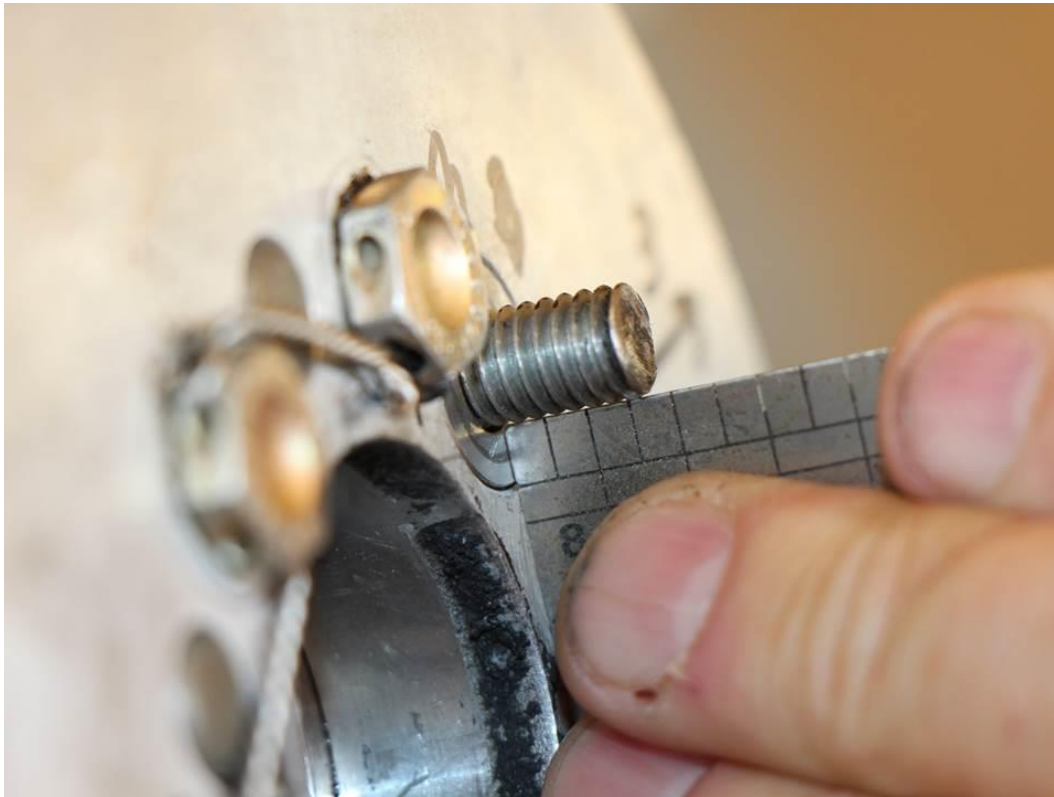
**Photo 10 - Measurement was 0.46 inches at bolt (B).**

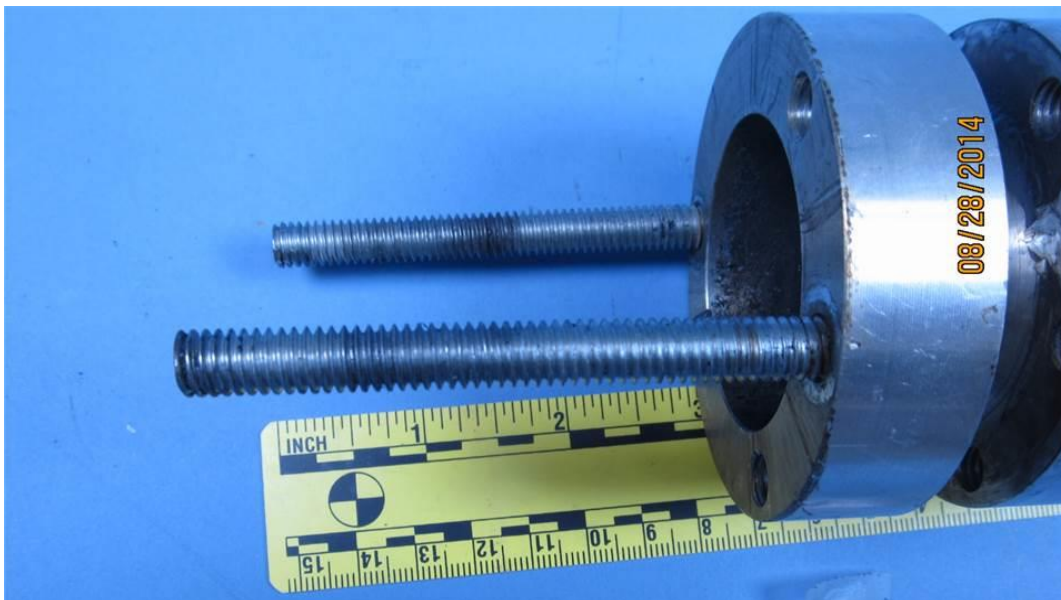
**Photo 11 – Fine pitch adjusting bolts. Examination of the bolts did not disclose any evidence of damage or remnants that could be attributed to the elastic stop nut being present.**

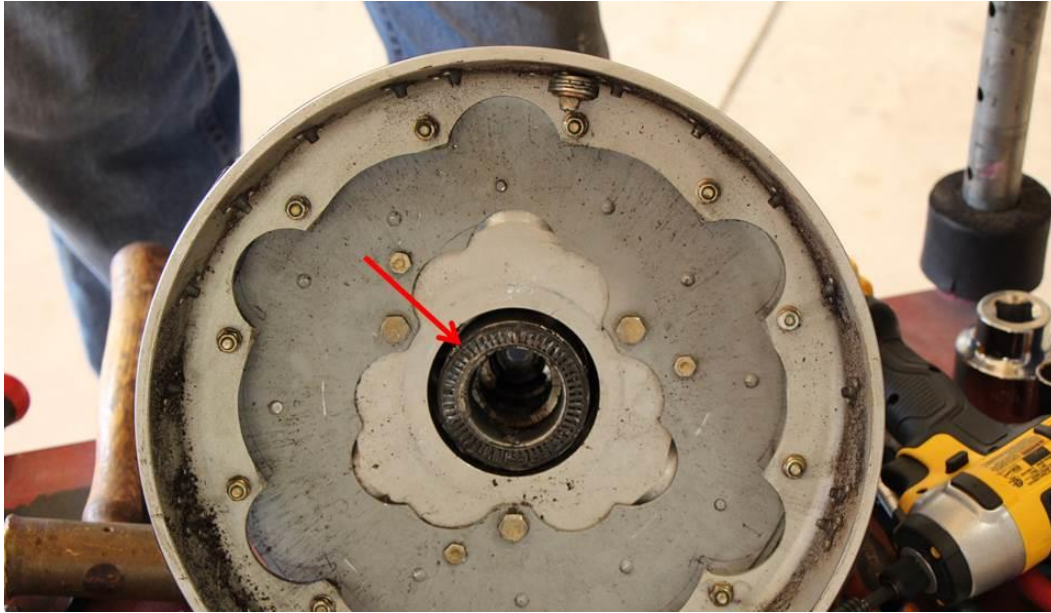
**Photo 12 - Damage to the forward needle thrust bearing stuck to the blade pin spool. The needle thrust bearing rides between the blade pin spool and the slave piston collar.**

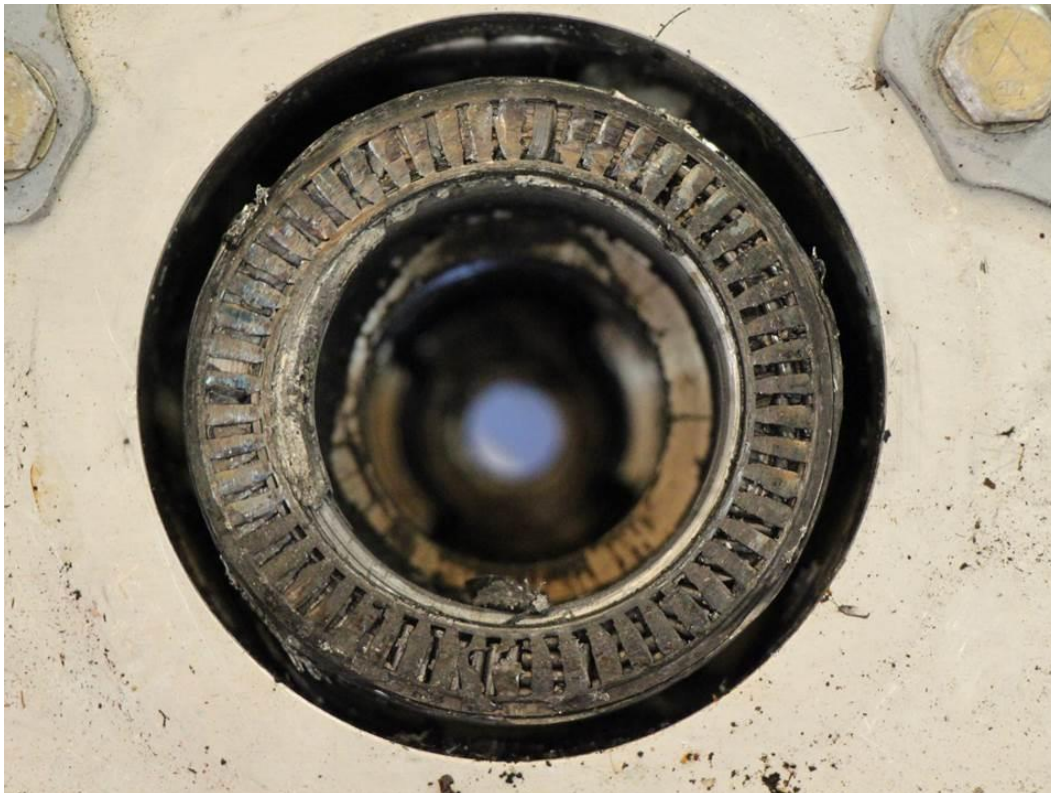
**Photo 13 - Damage to the needle thrust bearing. Grease was not present. Many needle rollers were either mispositioned or loose. The examination disclosed that the needle rollers and the bearing race were damaged. All of the needle rollers had separated and were loose or displaced within the bearing. Severe heat damage was present in all parts near the needle thrust bearing.**

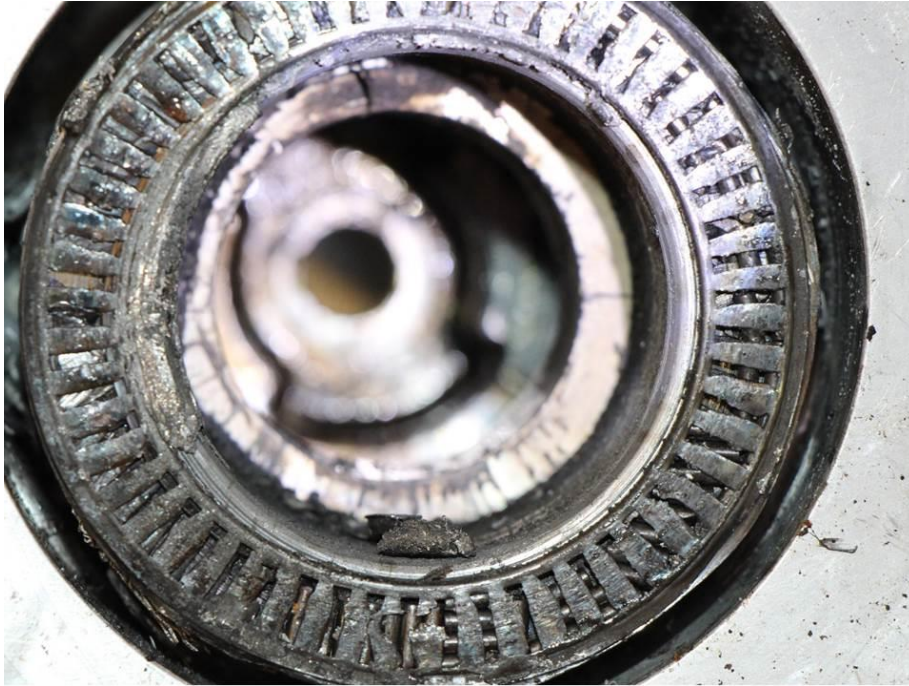
**Photo 14 - Damage to the needle thrust bearing.**

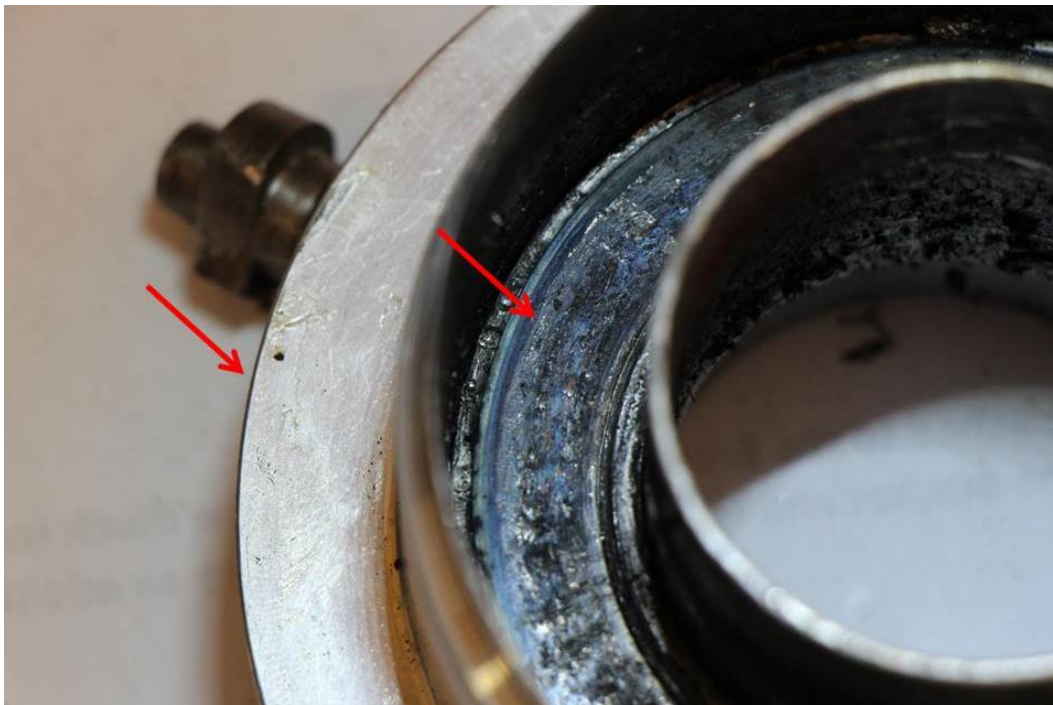
**Photo 15 – The right arrow points to mechanical and heat damage at the slave piston collar bearing race that supports the needle thrust bearing. Grease was not present. The collar is still stuck to the slave piston cup (left arrow). The collar should be free to move fore and aft inside the slave piston and should not rotate relative to the slave piston. The blade pin spool rotates inside the slave piston collar.**

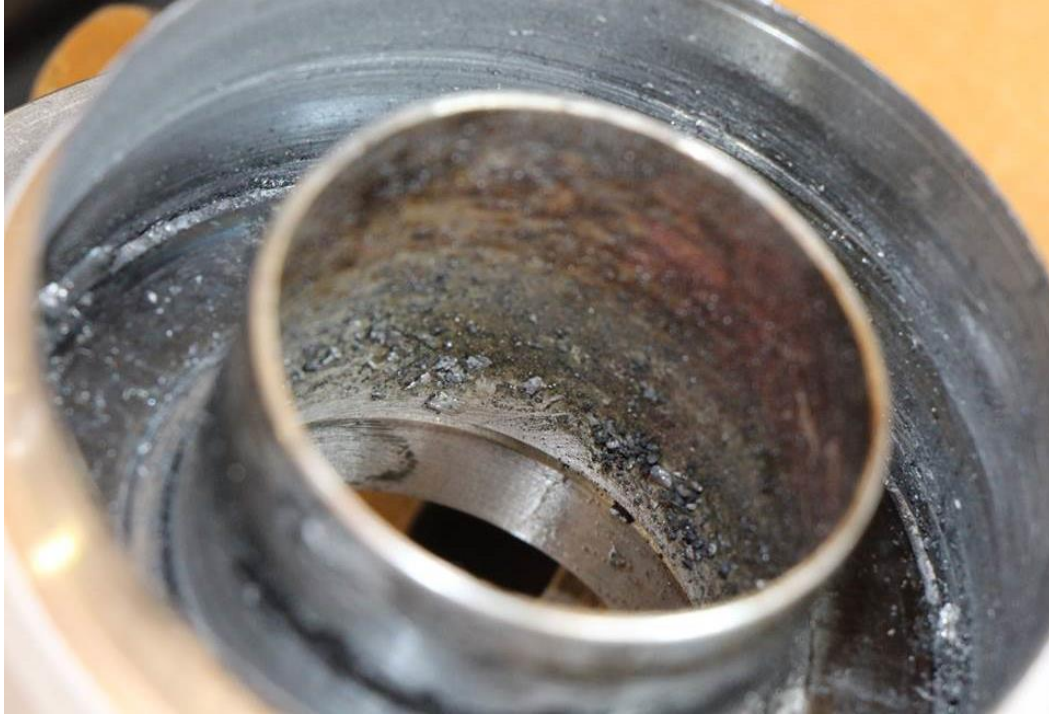
**Photo 16 - Galling damage to the three visible walls of the slave piston collar. The galling at the inner core is adjacent to the propeller drive shaft. The galling in the race area is adjacent to the blade pin spool and needle thrust bearing.**

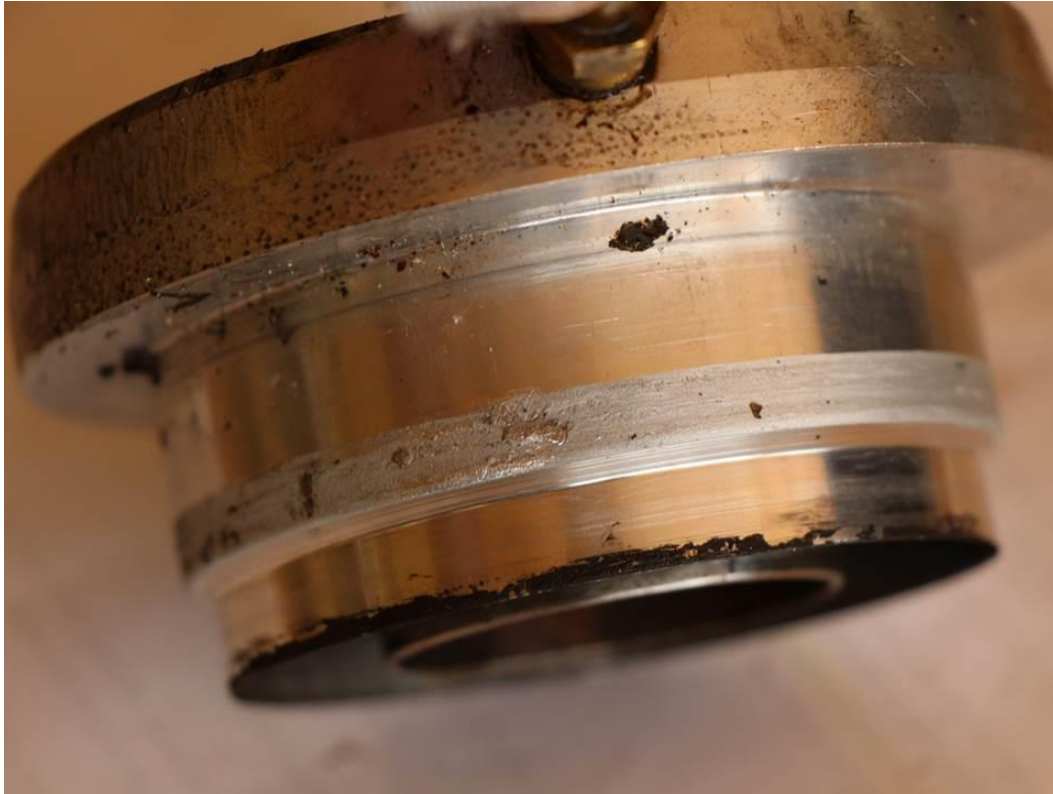
**Photo 18 - Galling and heat damage on the slave piston cup.**

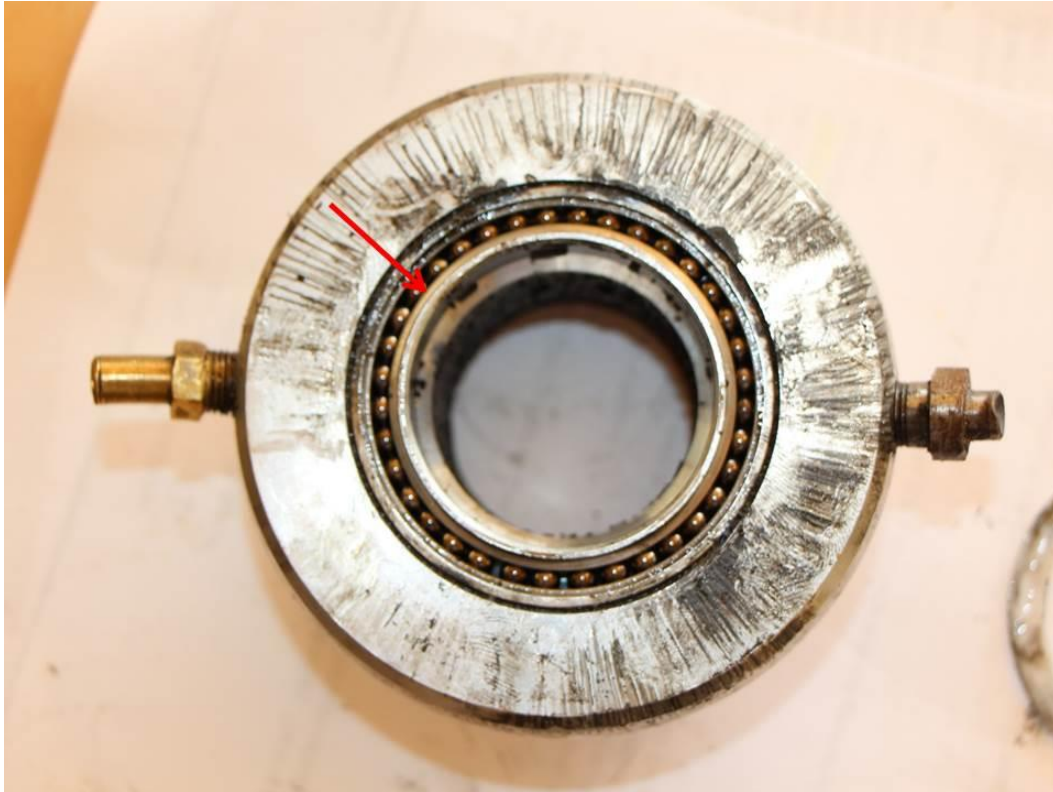
**Photo 20 - Each ball had multiple scoring marks. Grease was not present.**

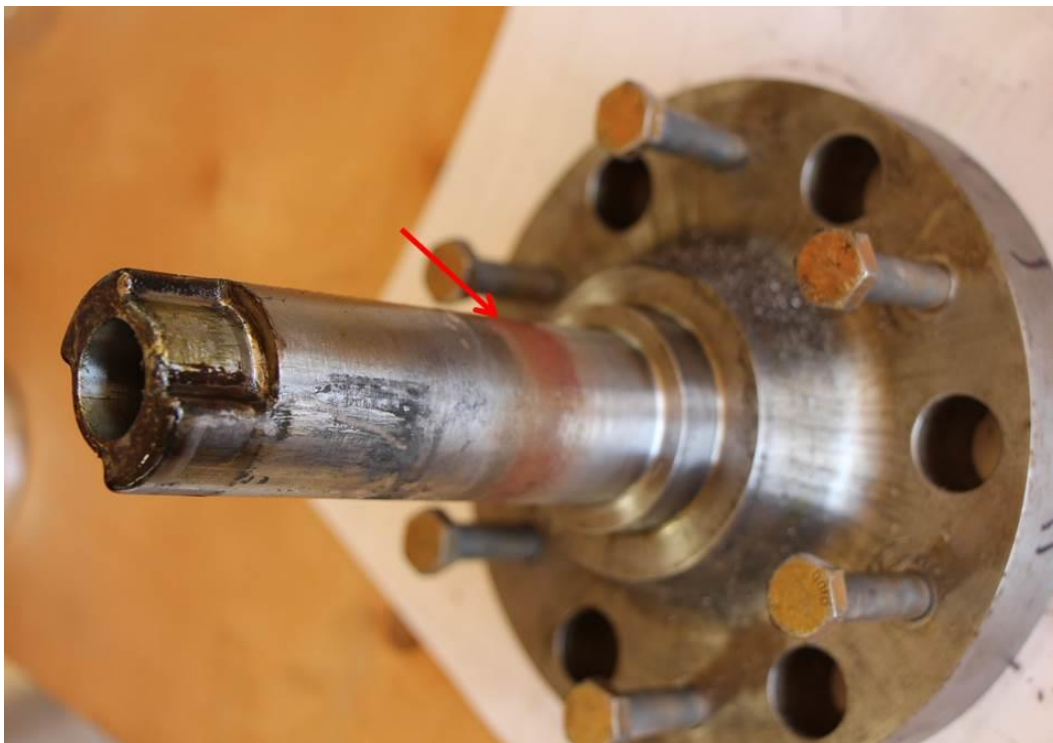
**Photo 21 - The rust colored damage on the propeller drive shaft aligns with the galling damage to the inner side of the slave piston collar.**

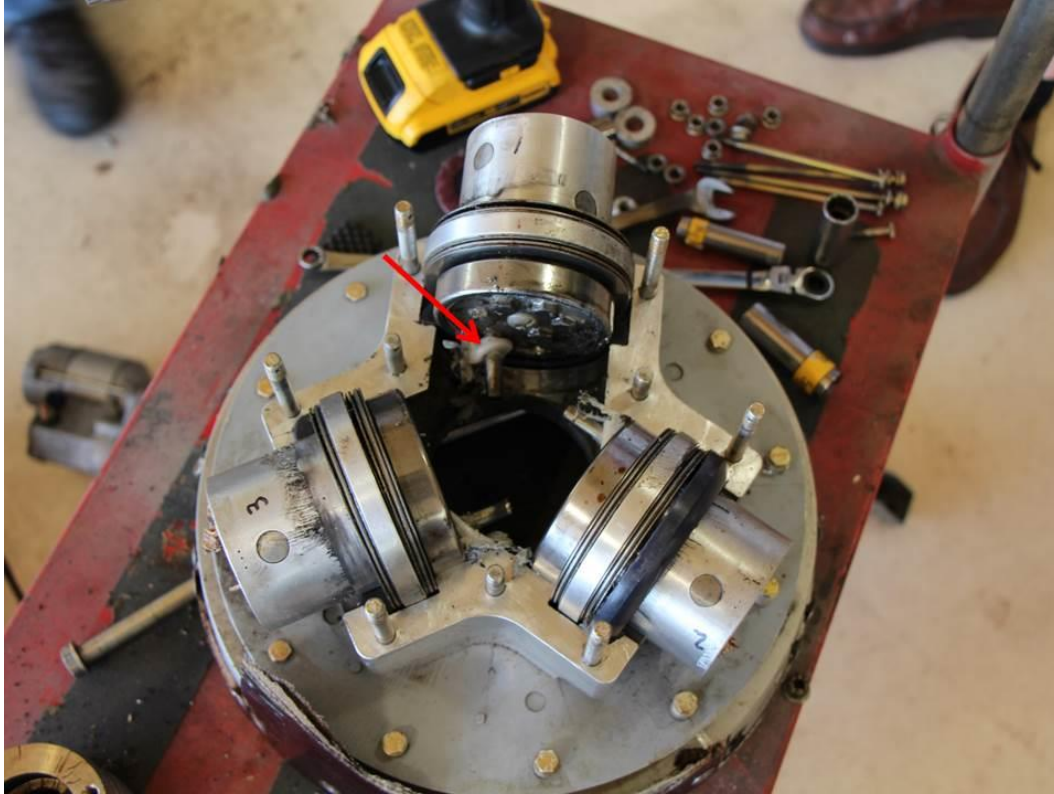
The slot in the blade pin spool was about 0.52 inches wide. The pin was 5/16 inch in diameter suggesting that the gap could be filled with a 0.104 inch thick Delrin sleeve. The center of the pin was about 1.0 inch from the center of the blade root. The Delrin was melted in this area of contact allowing the blade pin to move 0.104 inch. If the blade pin moved 0.104 inch at a radius of 1.0 inch, the blade pitch angle would change about 5.9 degrees toward a finer or lower blade pitch angle.

**Photo 22 - The arrow points to one of the melted Delrin bushings. The Delrin bushings fit over the blade's pitch change pin. The pin and bushing fit in a groove in the blade pin spool (removed).**

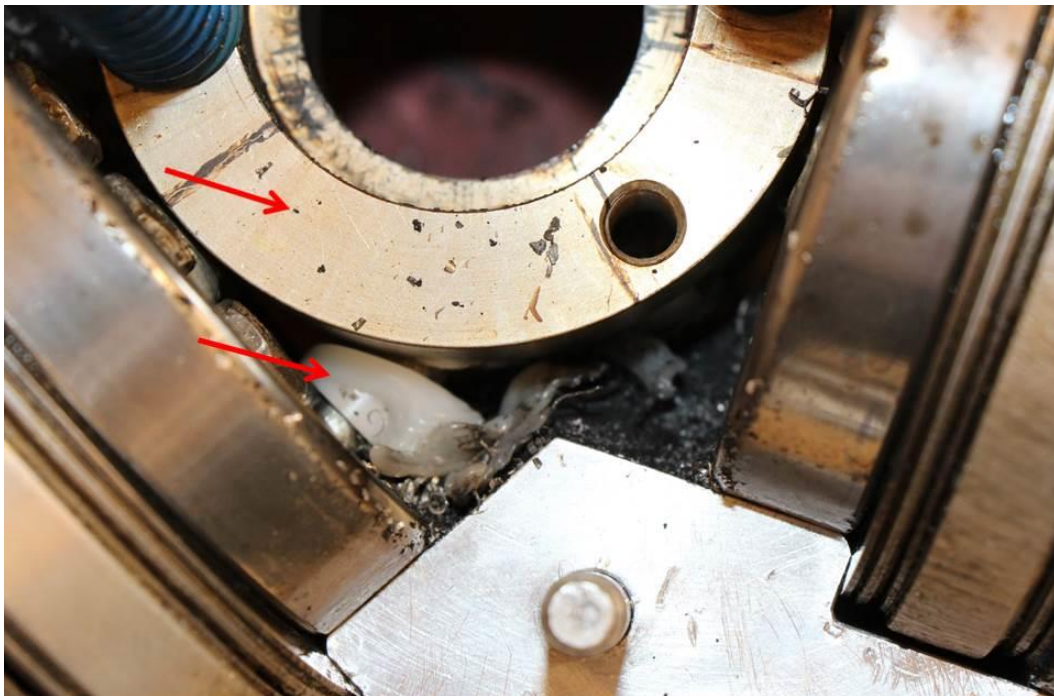
**Photo 23 - Melted Delrin bushing with the pitch change pin (lower arrow) positioned in the blade pin spool (upper arrow).**

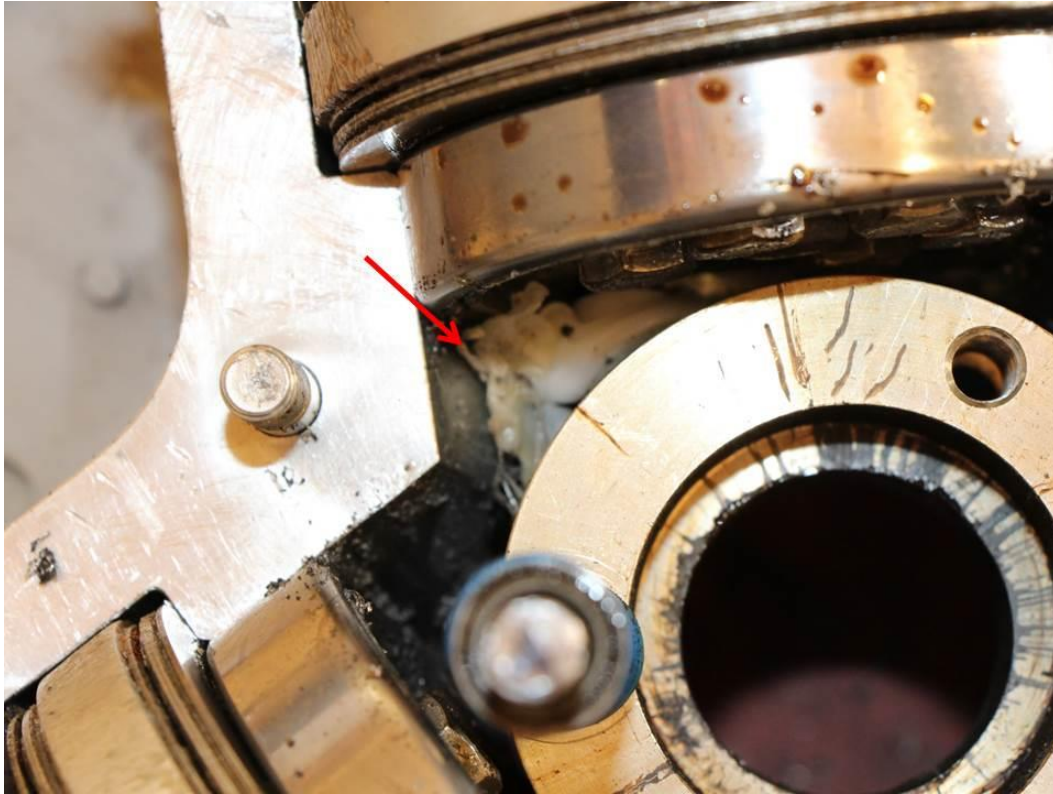
**Photo 24 – Melted Delrin bushing with the pitch change pin positioned in the blade pin spool.**

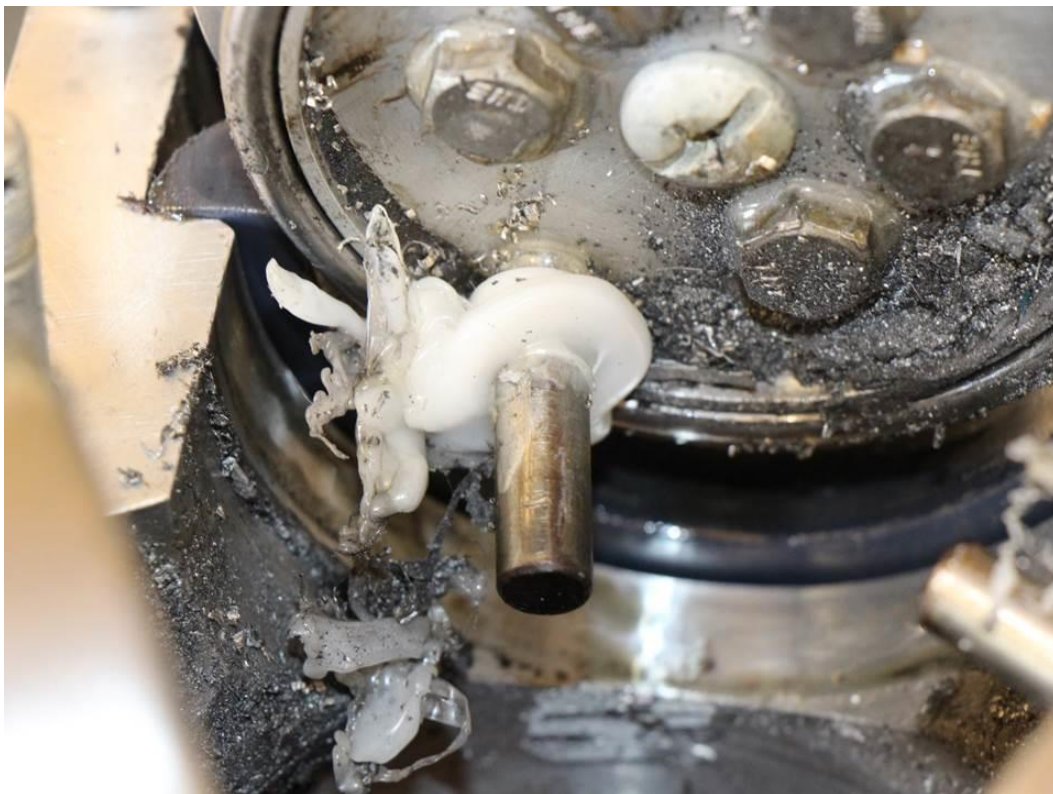
**Photo 25- Melted Delrin bushing and bent pitch change pin.**

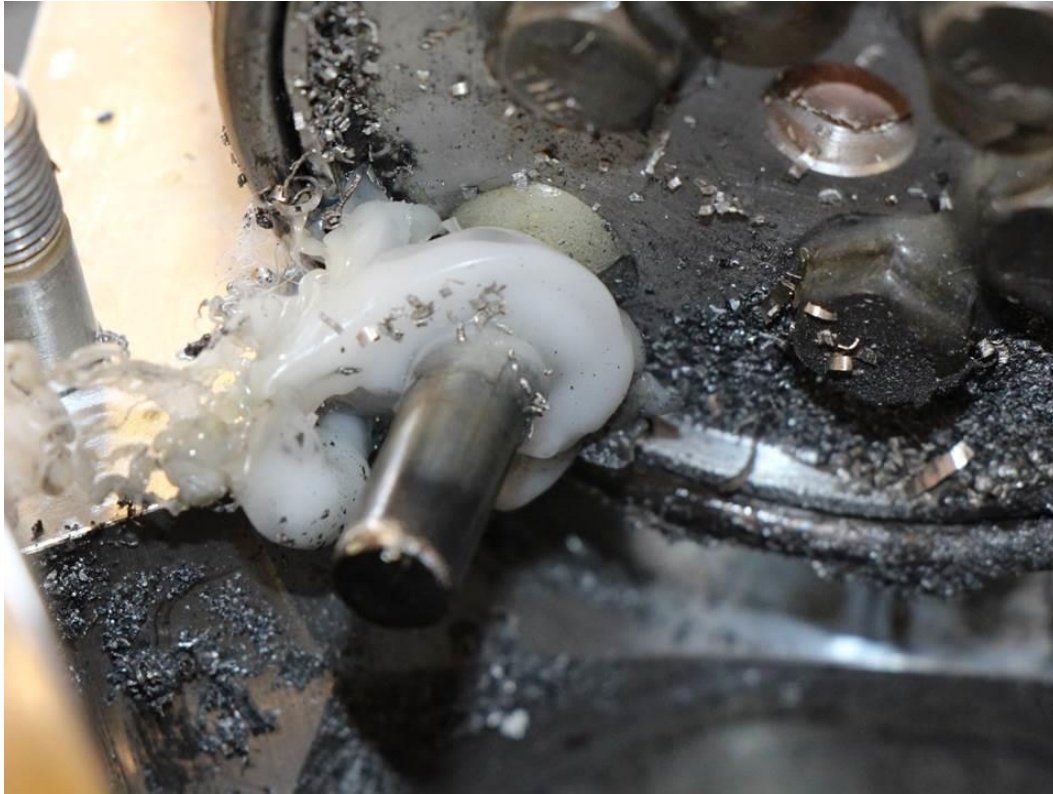
**Photo 26 - Melted Delrin bushing and pitch change pin.**

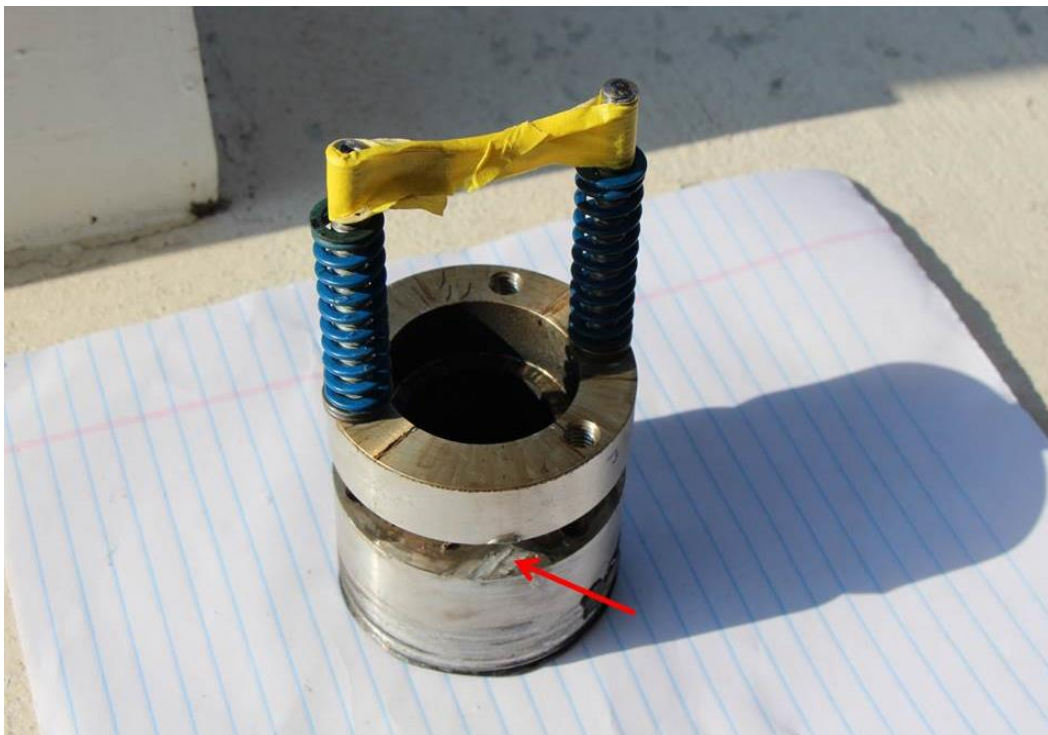
**Photo 27 - Blade pin spool with damage on aft side of slot; damage is from pitch change pin at the butt end of the blade. When the pin moves from centered in the slot to the aft side, the blade pitch angle would change about 6 degrees to a lower pitch angle.**

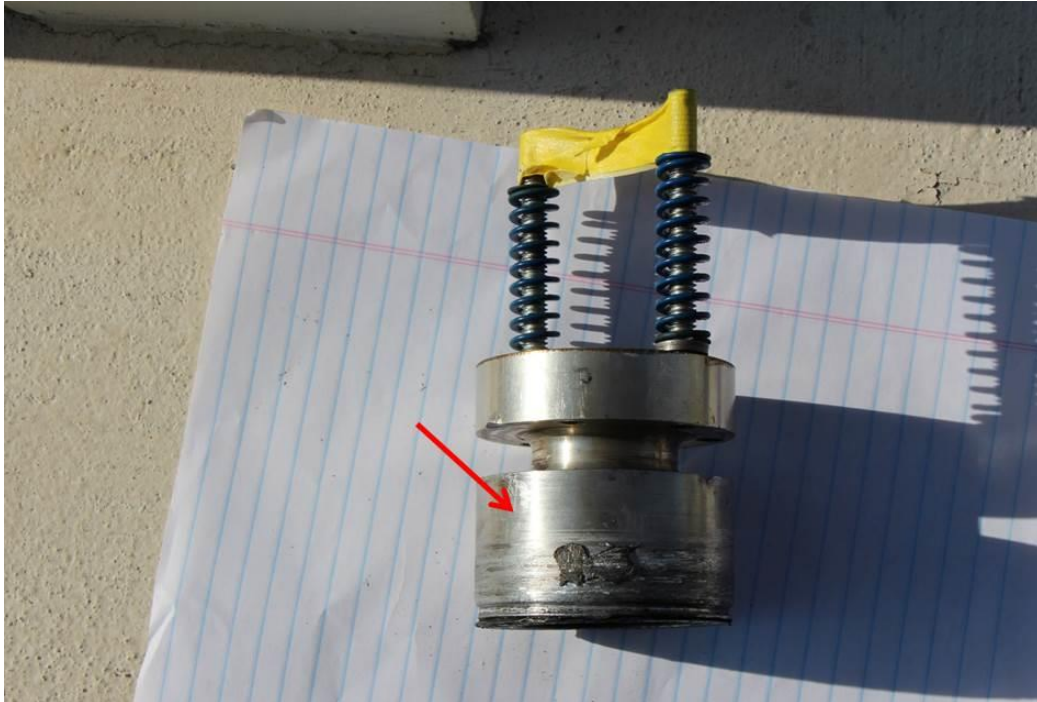
**Photo 28 - The arrow points too galling damage to the side of the blade pin spool. The damage is consistent with damage to the inside of the slave piston collar. The blade pin spool should rotate while the slave piston collar remains stationary.**

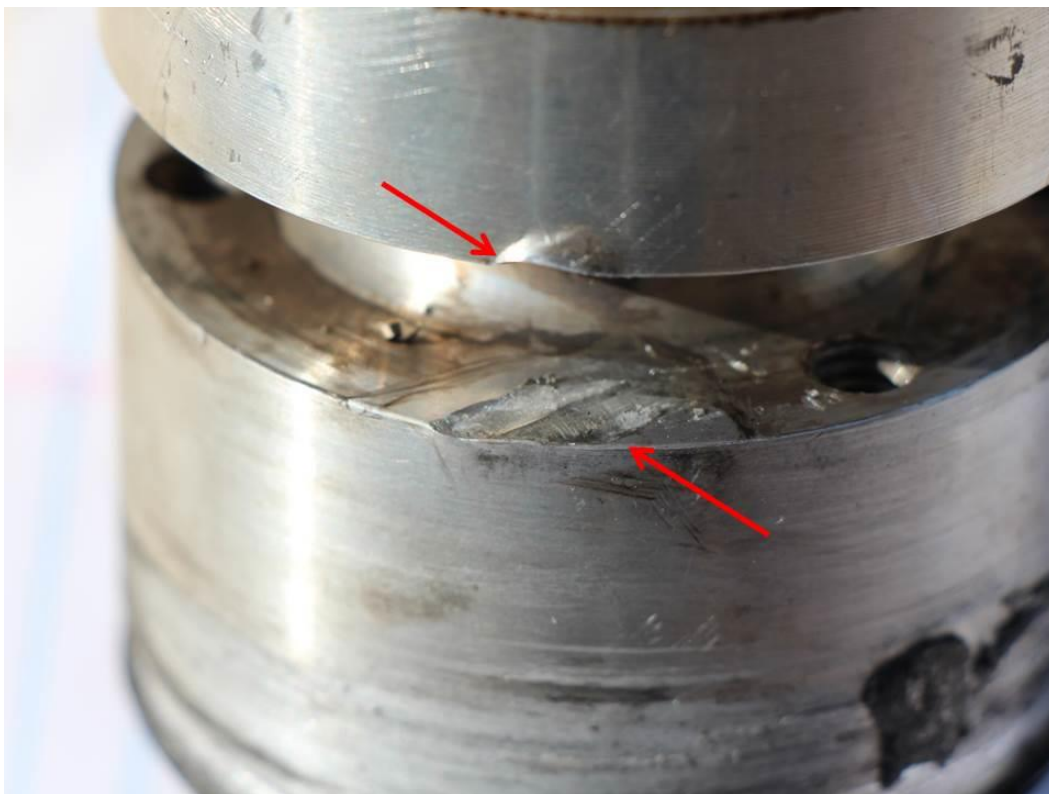
**Photo 29 – Damage to the blade pin spool from the blade pitch change pins after the Delrin sleeve has melted.**

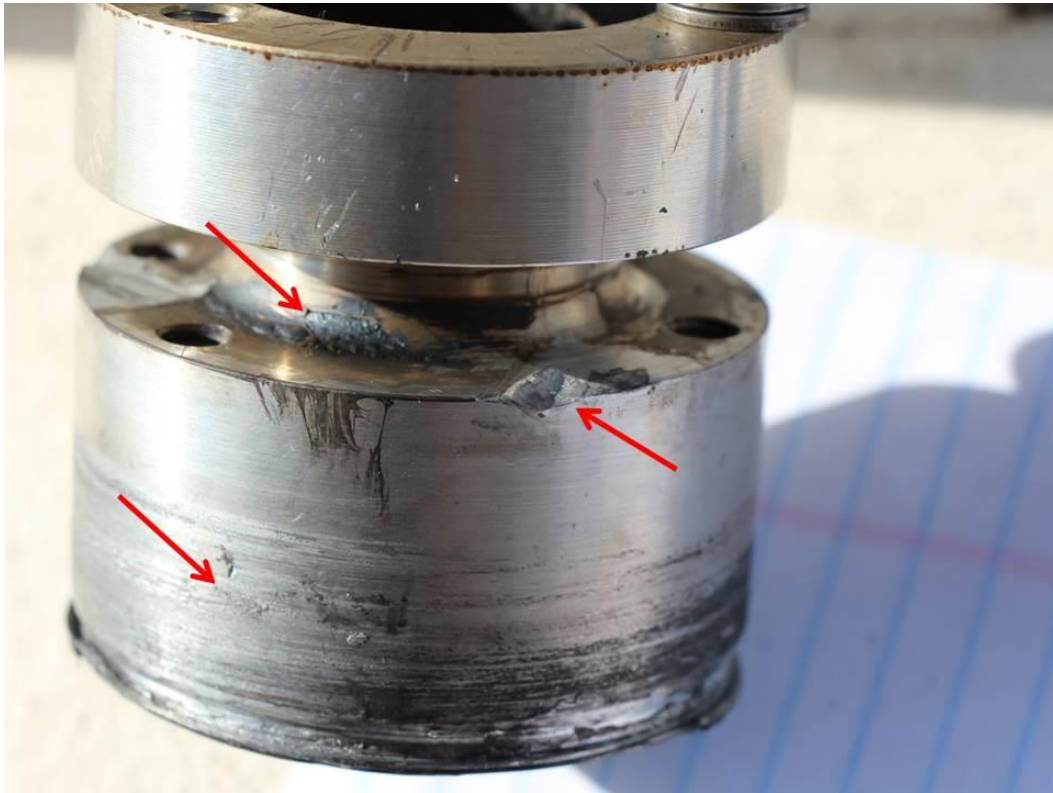
**Photo 30 - Galling damage and impact damage from the pitch change pins.**
