June 20, 2014

# Sentimental Journey Fly-In

### Accident Report

Prepared by: Ben R. Coleman

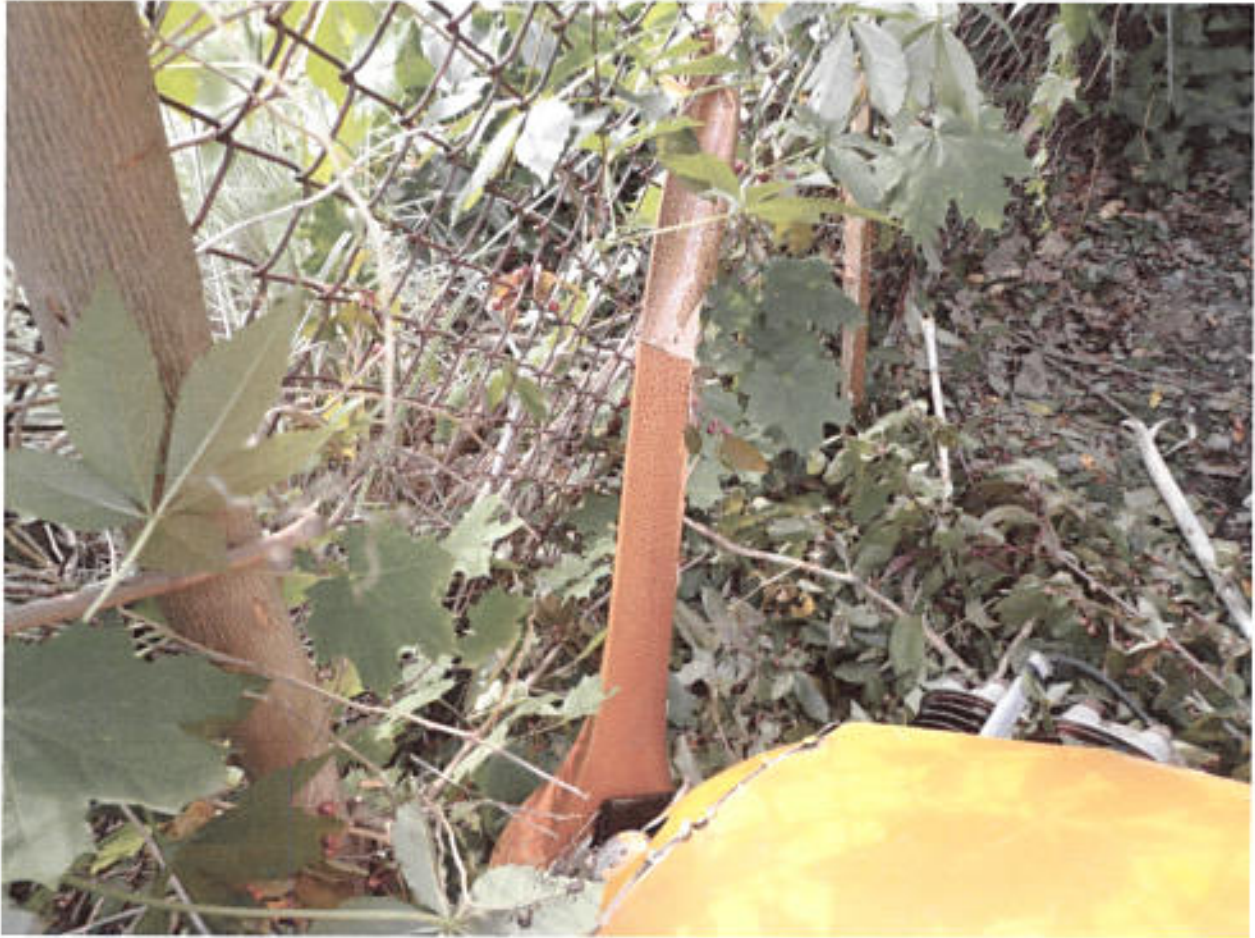
The propeller blade was splintered and tangled into the fence. Photo taken. The nose section of the aircraft appeared to have little to no damage. There was a slight drip of fluid that had the aroma of 100LL Avgas. The drip was measured at one drip per 8 seconds. A fuel spill mat was placed under the drip. The responding firemen stated that the pilot had turned the fuel control valve "Off". A series of photos were taken at cardinal points and all aspects of the aircraft were located at the crash site.

5. Propeller blade trapped in chain link fence

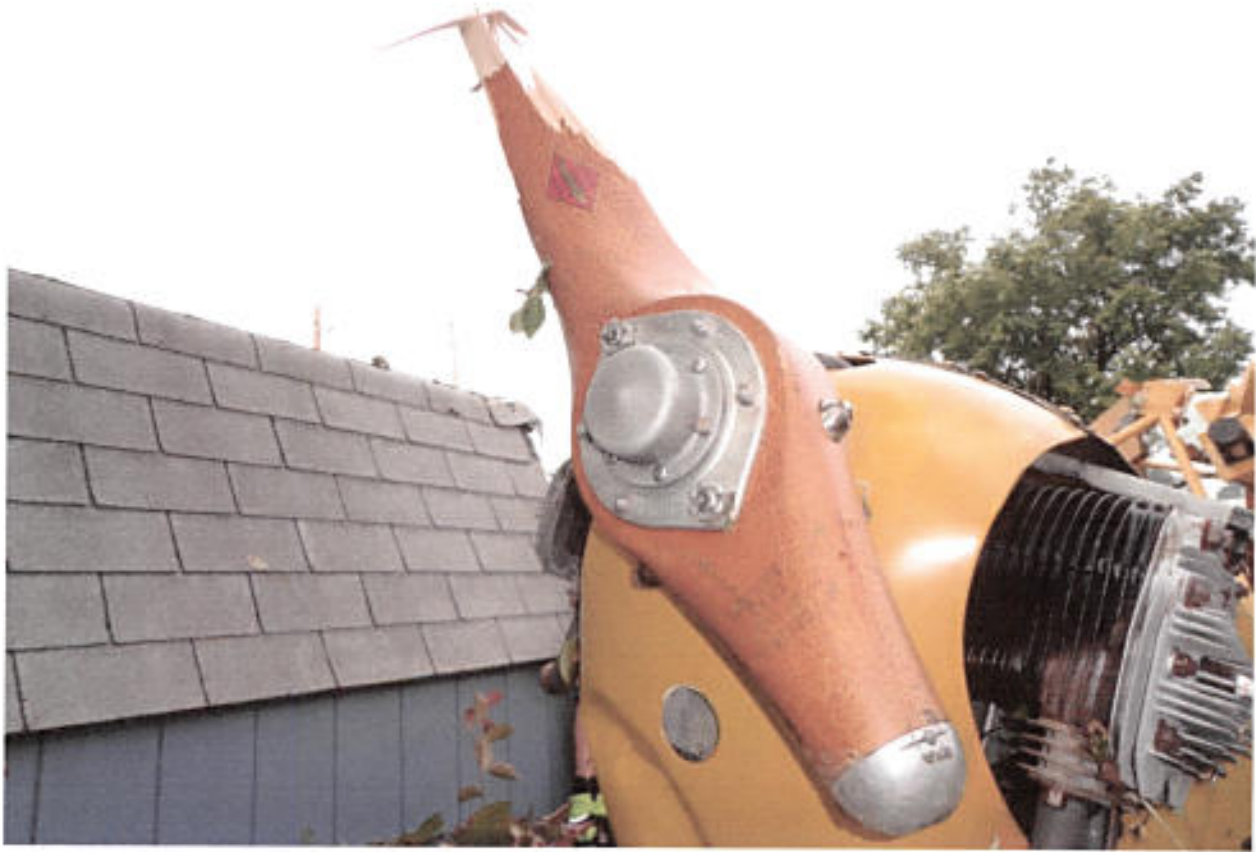
12. Damaged single blade propeller. Hub mechanism is not damaged.

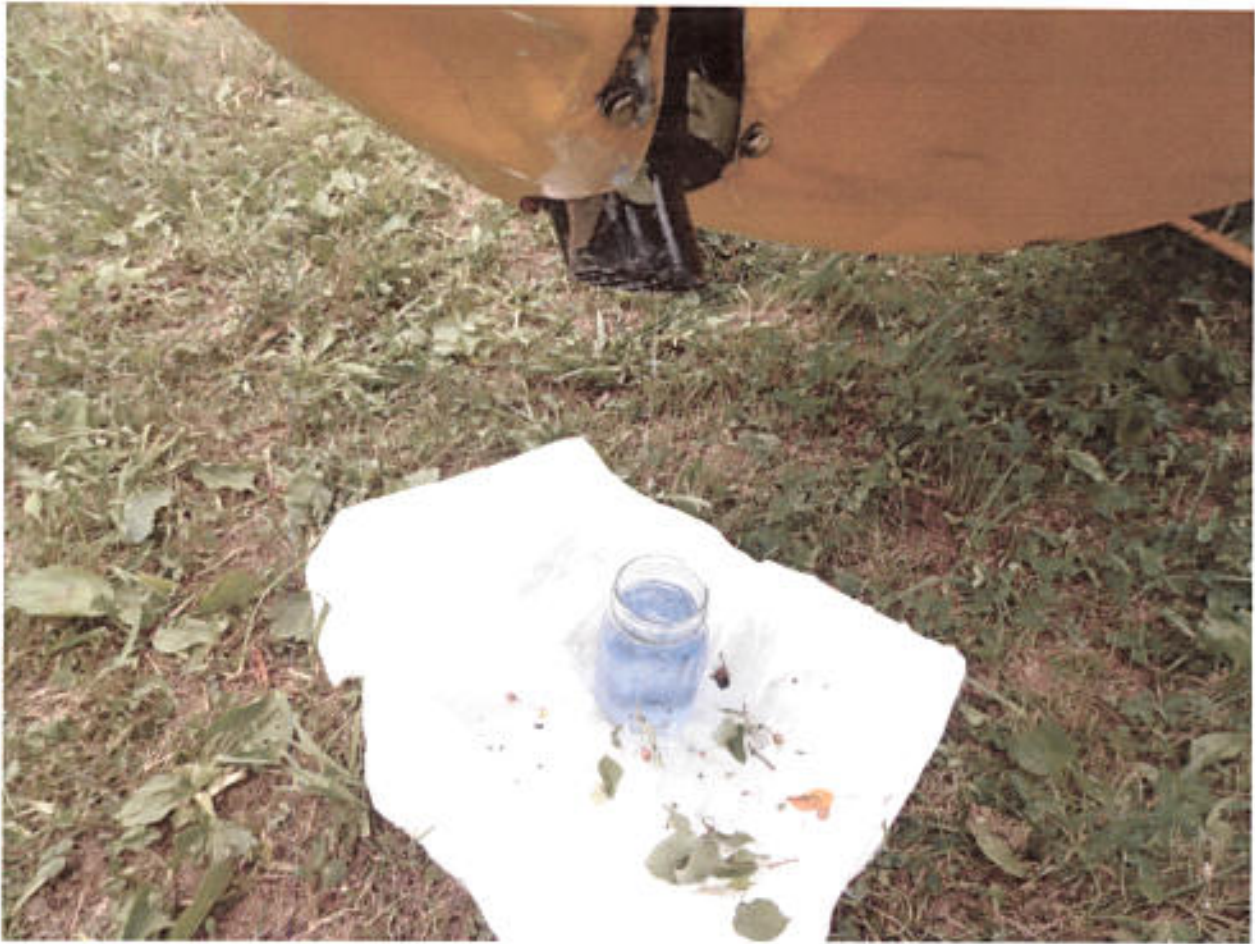
The aircraft was carefully pulled down from the tree and off the wooden shed. The fuel drip continued and was traced to the carburetor. A mason jar was used to contain the fuel that appeared clear and light blue in color. I gained access to the fuel shut off and found it had not been fully closed. I turned the control until the valve was seated and fuel leak stopped.

13. Fuel captured prior to closing the fuel shut off valve
