TruTrak Flight Systems, Inc.

### **Inspection Report Summary**

In support of the NTSB ID: ERA14LA329 investigation and FAA Accident number # AEA2314004;

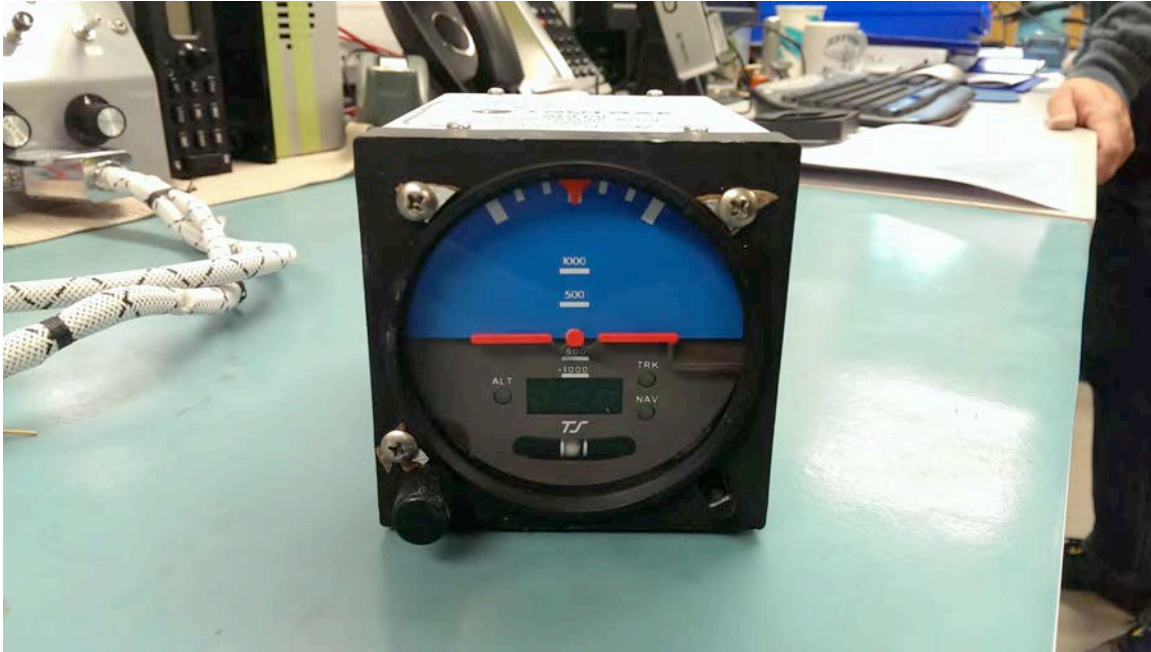
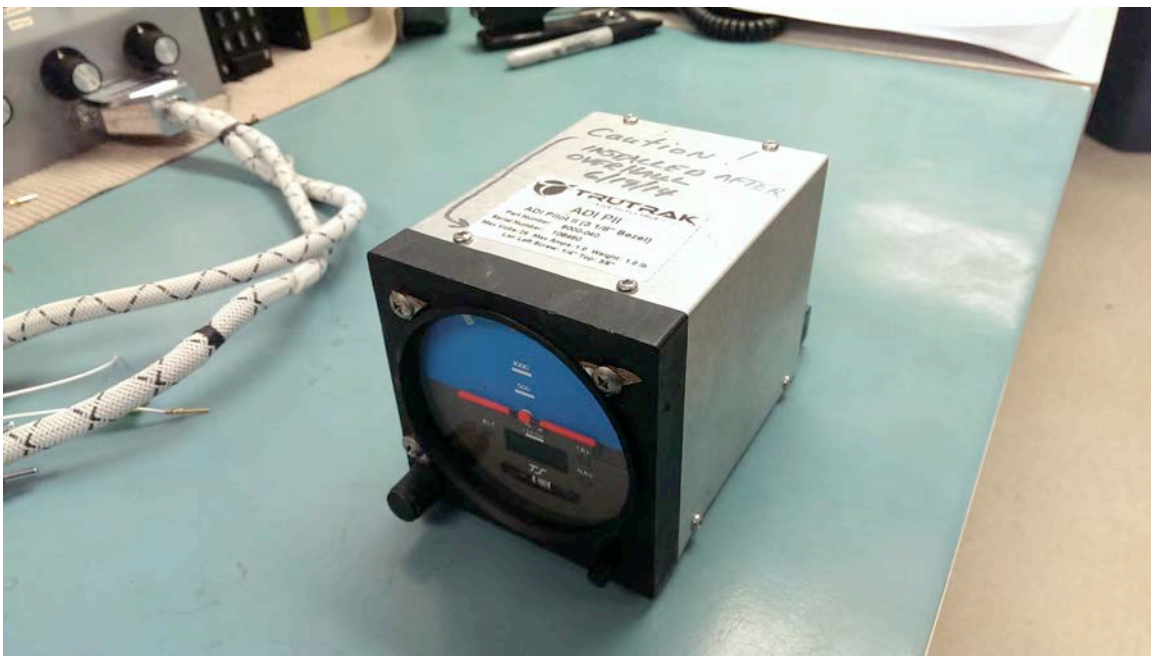
The inspection of the autopilot controller showed minor cosmetic damage to the instrument case, and was missing one control knob. The unit also appeared to have been torn out of the aircraft panel, as there were pieces of panel still under the mounting screws. No other visible damage was noted, and the flight instrument portion of the display was centered and undamaged. The operational aspects of the autopilot controller showed no damage and proper operation. Unit was found to be fully functional.

The photos below show the autopilot controller at time of inspection. These photos were taken prior to opening or powering the unit. Prior to applying power to the system, the flight instrument portion of the display was centered and correct. The minimal cosmetic damage to the autopilot controller did not cause any performance issues.

Because of the way the flight instrument is designed, the display will “zero” in a non-rotating, non-climbing, non-moving environment. Because of this, the autopilot controller must have either been unpowered during the accident, or the autopilot remained powered and functional after the accident. The display would have required less than 30 seconds of power for the display to re-zero.

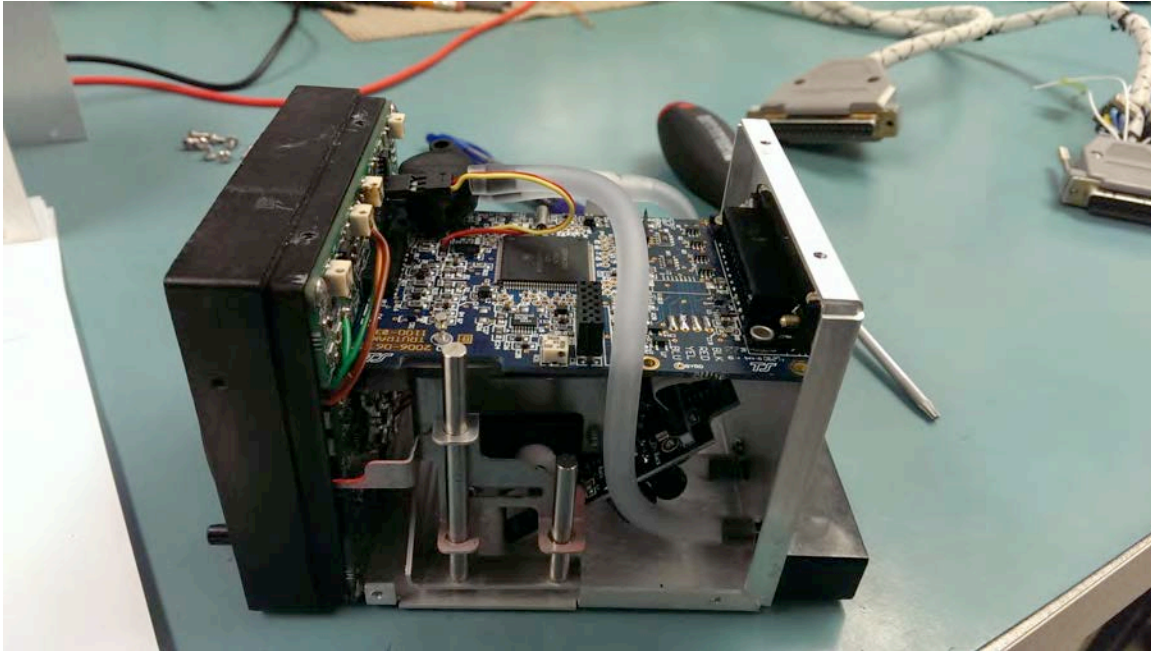
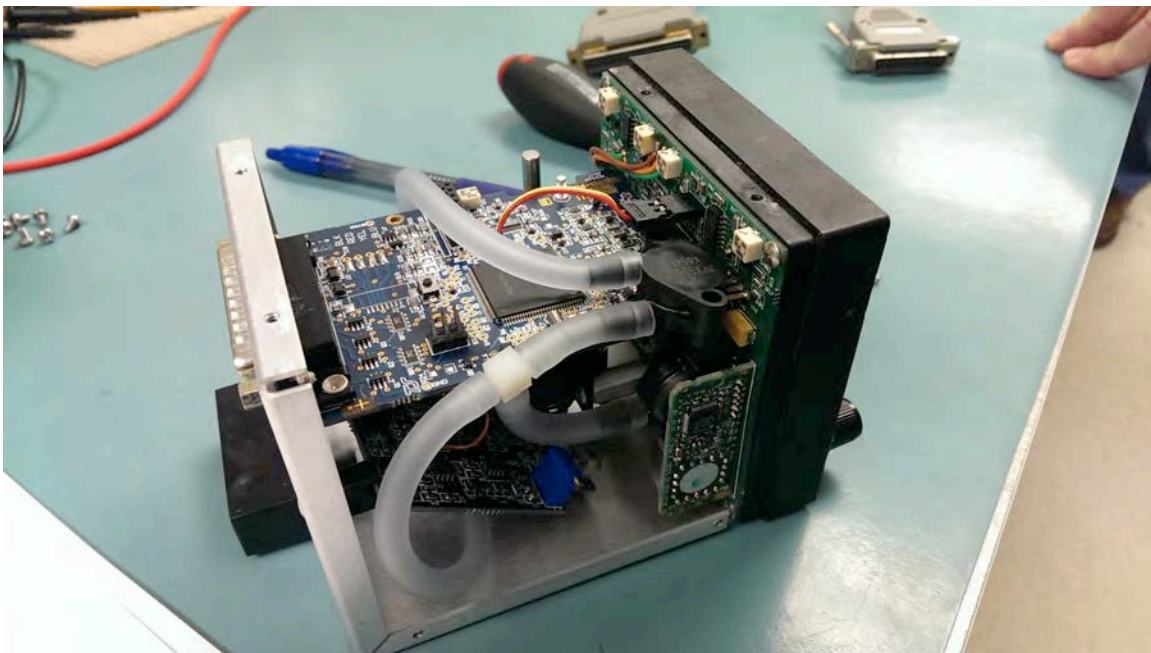
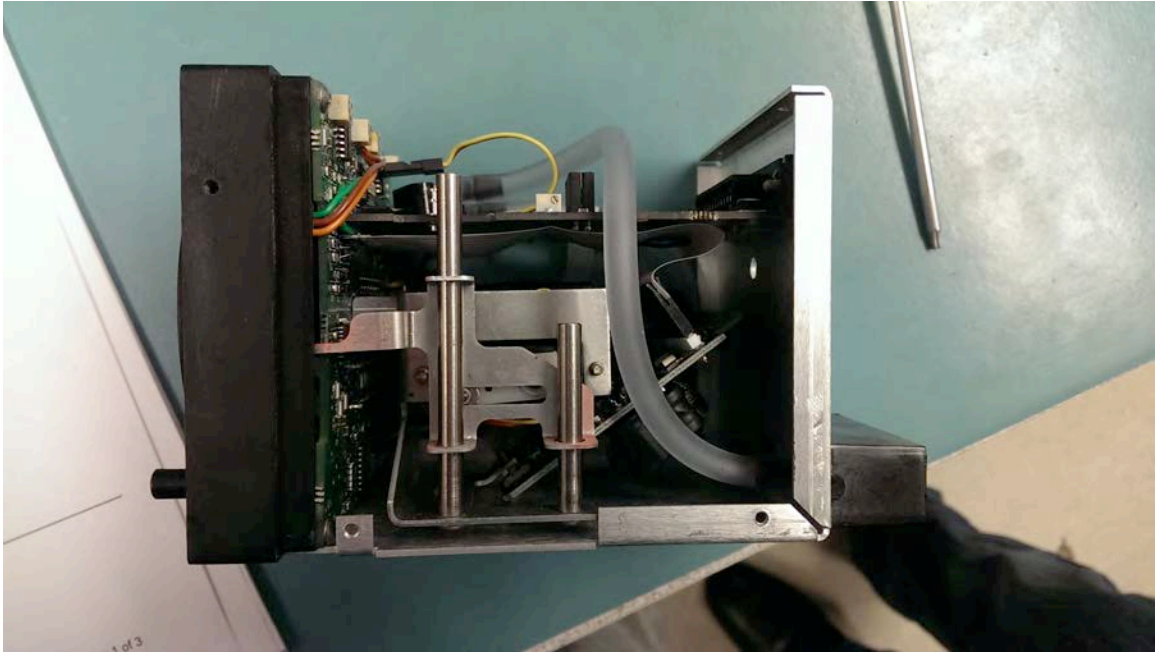
The autopilot controller was tested to the standards of a new autopilot. No issues were found.

The following pictures were taken after the autopilot top case was removed.

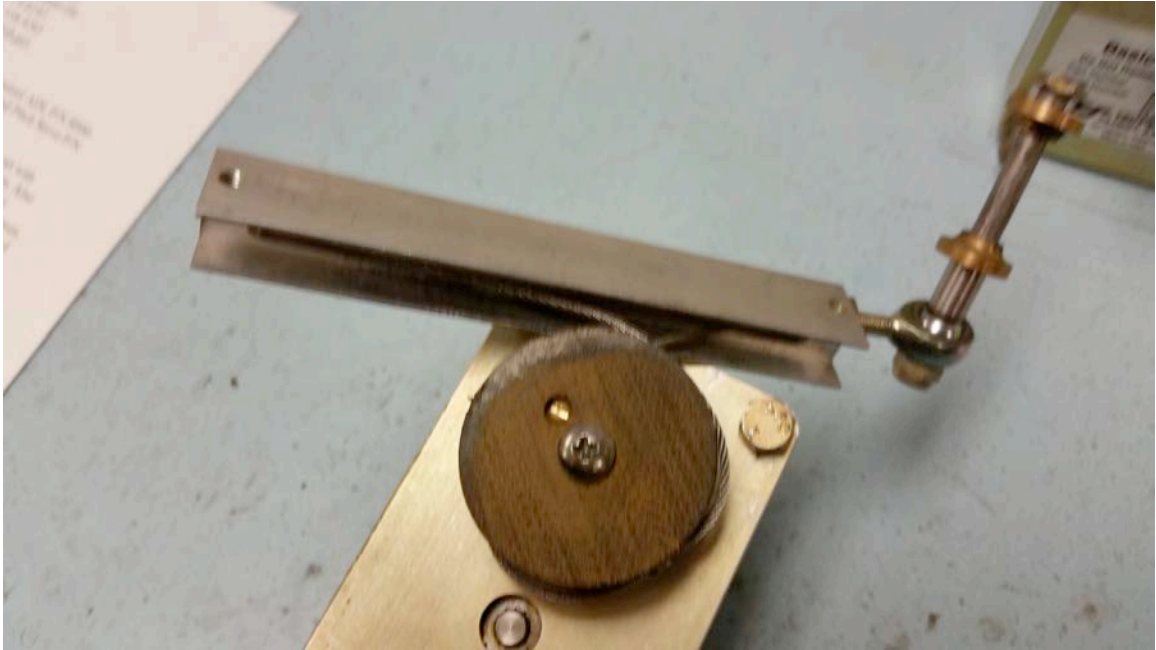
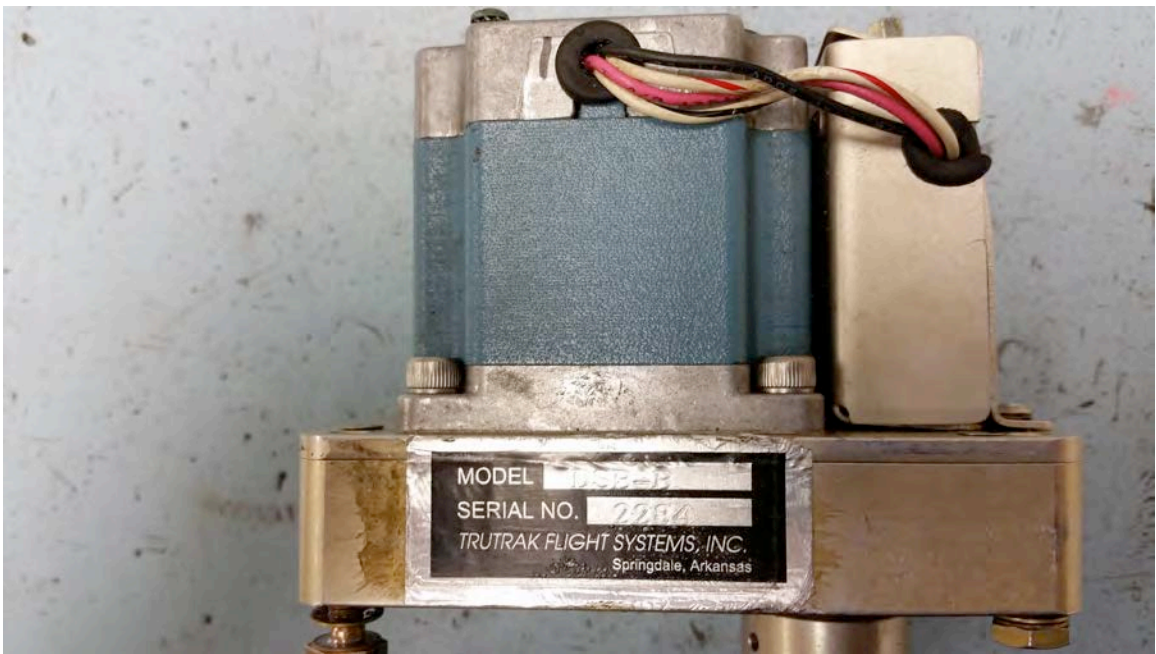
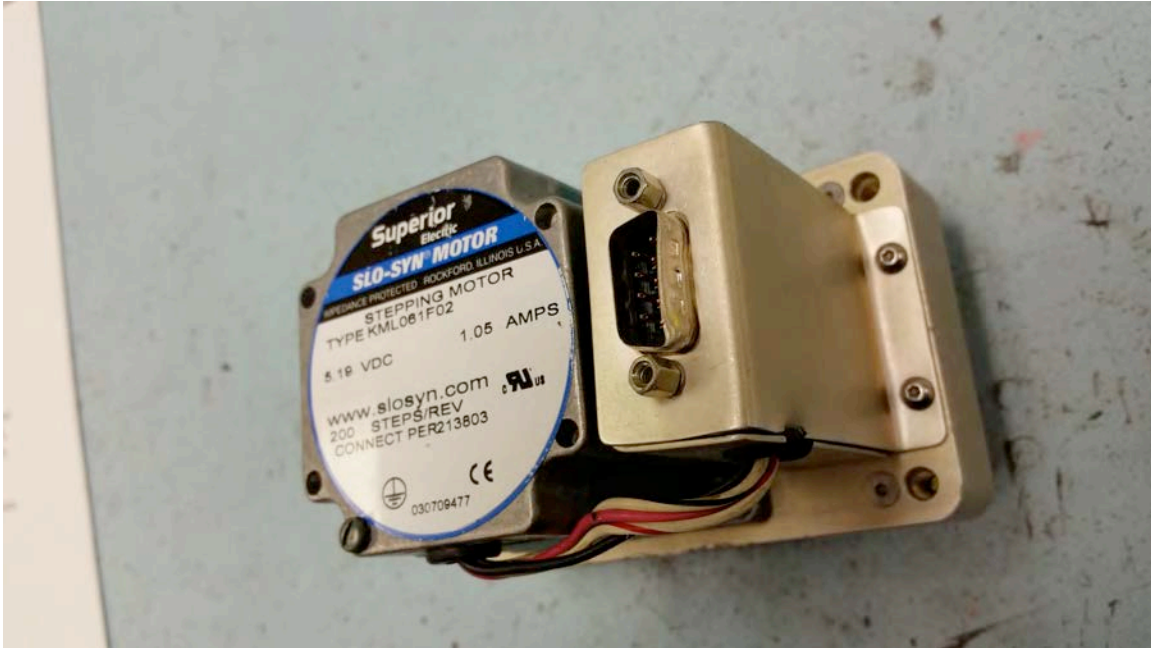
The following pictures show the servo with torque enhancer attached and prior to any attempt to connect the servo the test equipment. The torque enhancer was damaged and not operational upon receipt of the servo.

The photos above shows some of the damage to the roll servo. The nine-pin D-SUB connector has been deformed to the point of contacting the top row of electrical contacts. Also, there is some damage to the electronics enclosure.

Upon further inspection once the top of the electronics enclosure was removed, the nine-pin D-SUB connector was cracked and partially broken. It did however remain operational.

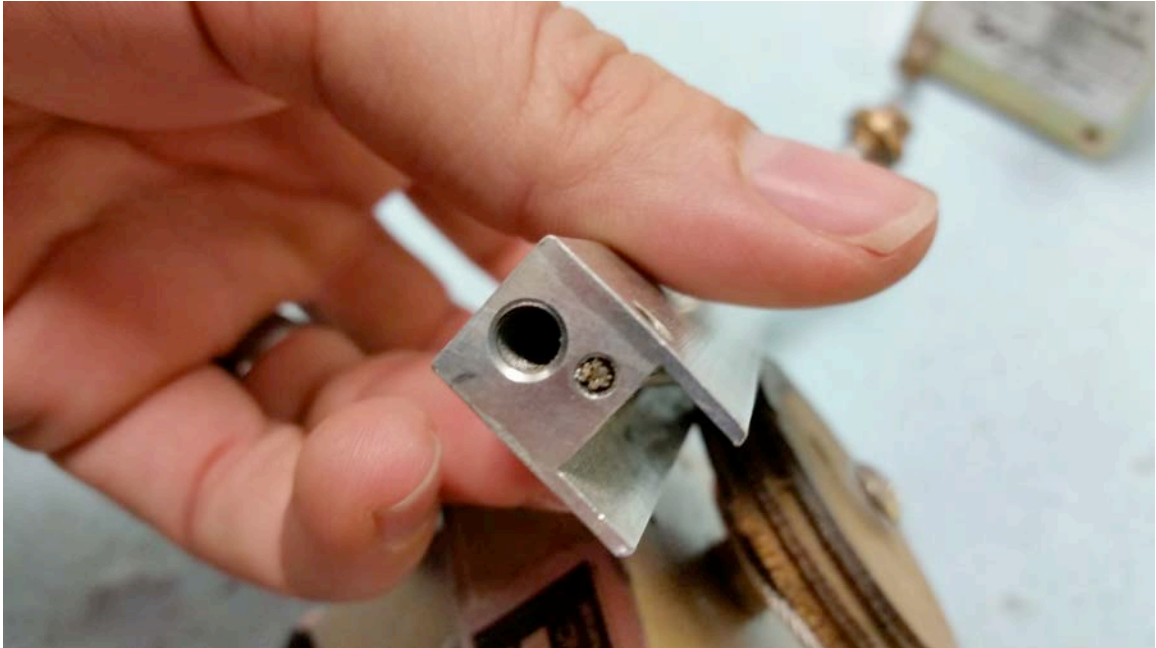
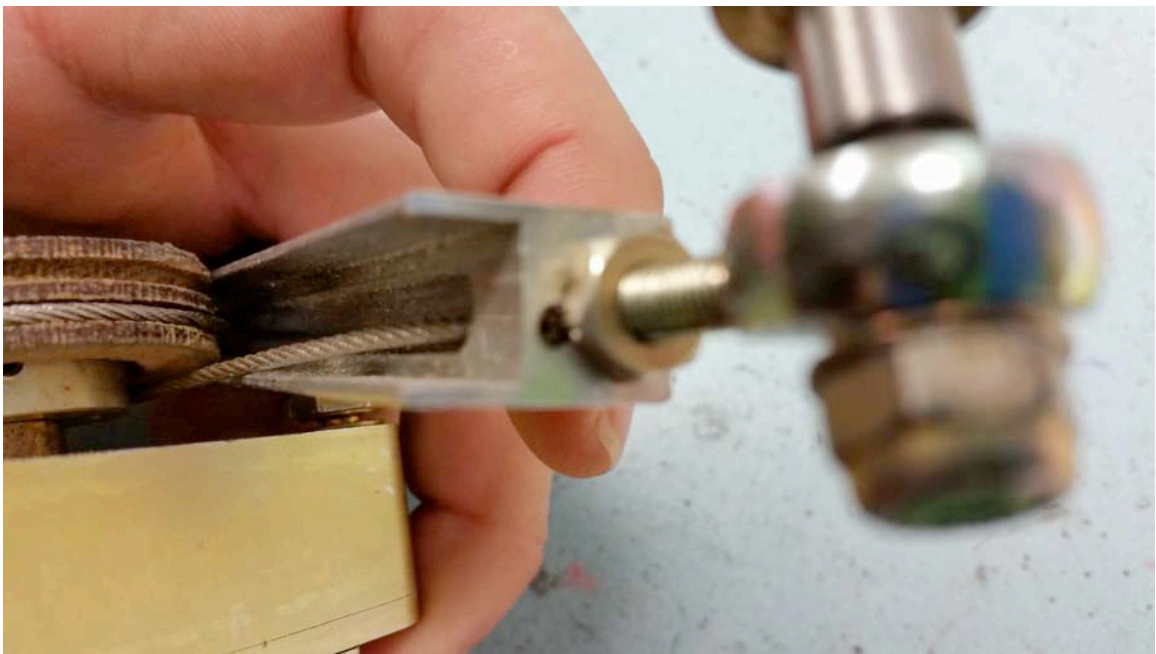
The torque enhancer wheel has been forced out of the trough. The cable holding the wheel to the output arm remains tight and the setscrews properly installed. The following photos show each end of the cable flush with the end of the trough.

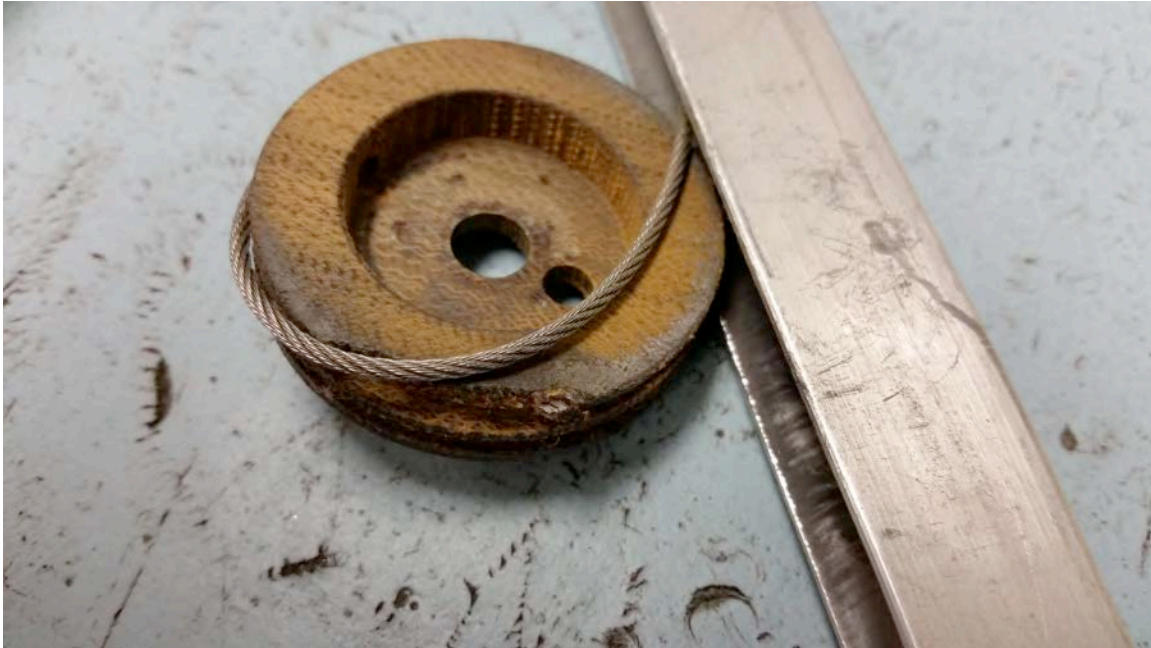
Shown in the photo below is the damage to the capstan wheel

The damage to the mechanism is consistent with extreme loads being placed upon the mechanism in a direction not consistent with normal flight loads.

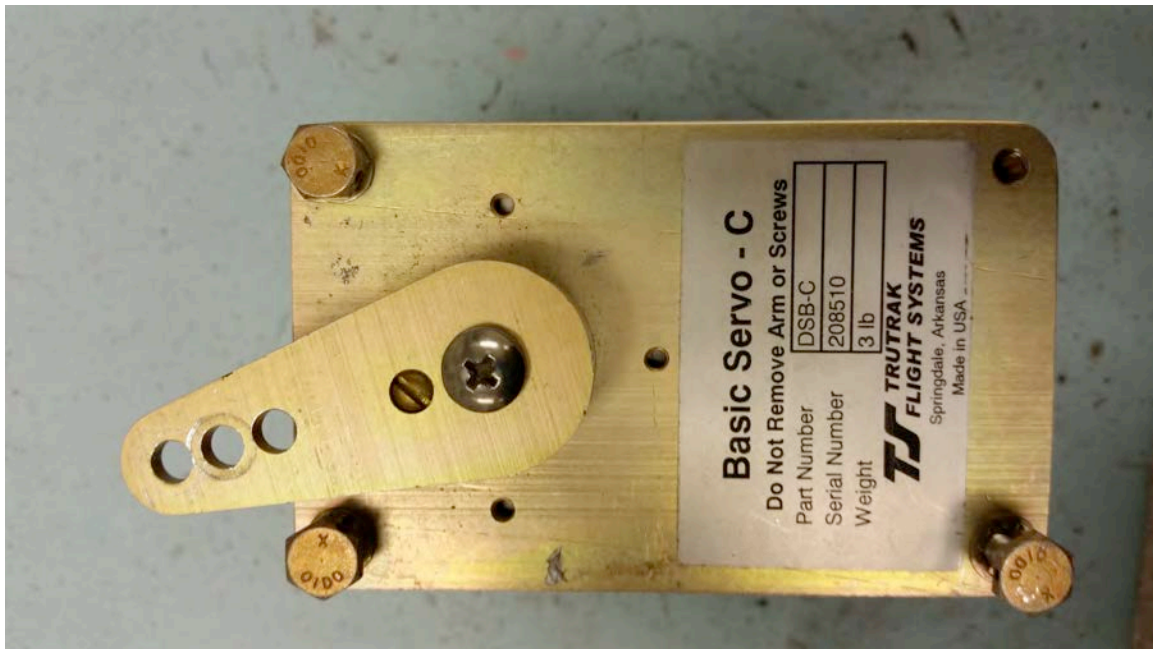
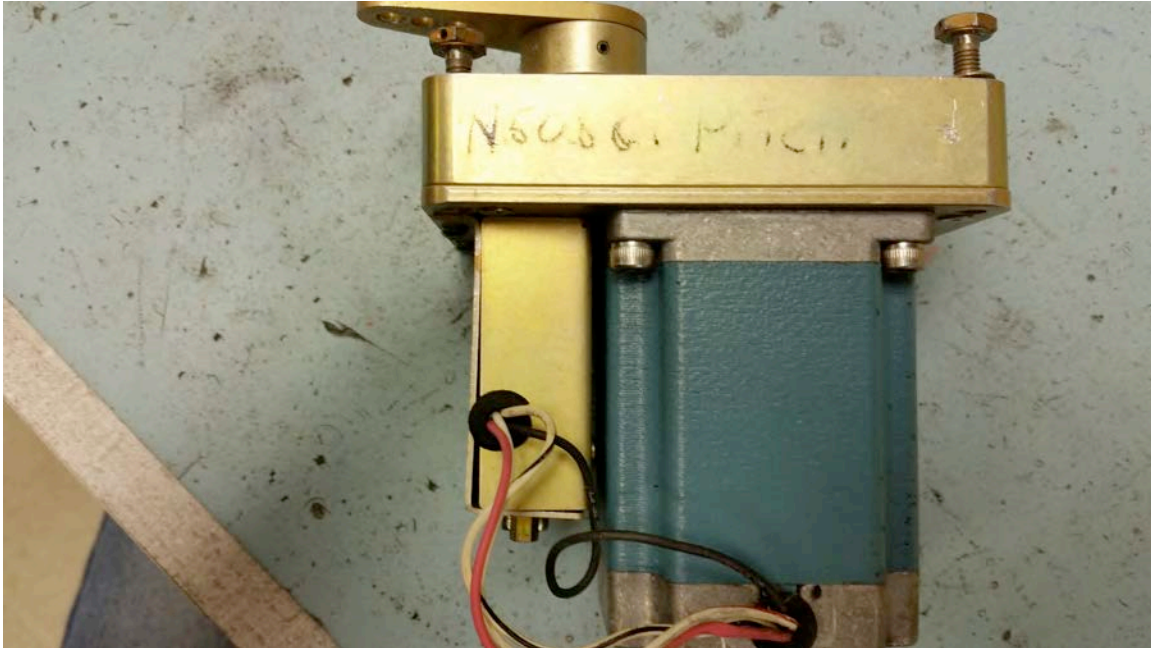
There was no apparent damage to the pitch servo. The photos below show the pitch servo prior to any attempt to connect the servo the test equipment.

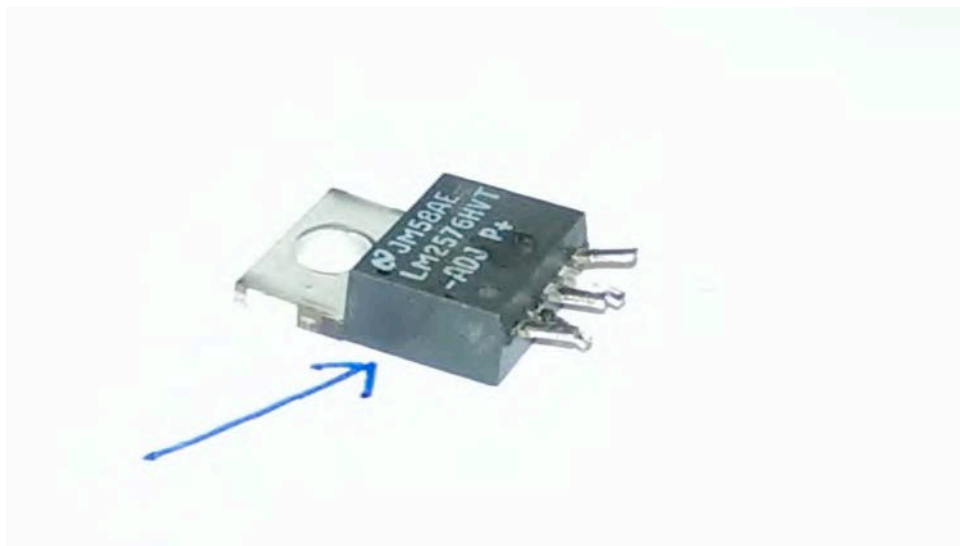
The electronics cover was removed and a failed voltage regulator was found on the drive electronics. It cannot easily be determined whether the voltage regulator failed due to shock from the accident or due to some other cause such as over voltage. There was a crack in the regulator that ran along the edge of the heatsink. The faulty regulator is shown in the photo below.

The blue arrow points to the cracked area of the voltage regulator.

The failure of the voltage regulator rendered the servo inoperative, but due to servo design, could not cause any increased torque or servo runaway.

Upon replacement of the failed voltage regulator, the servo was properly operational and met the performance specs.

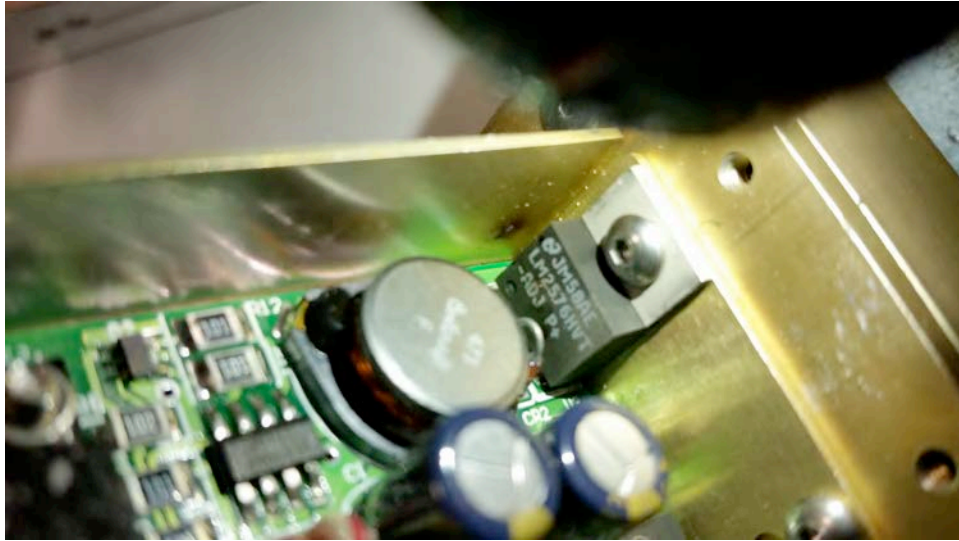
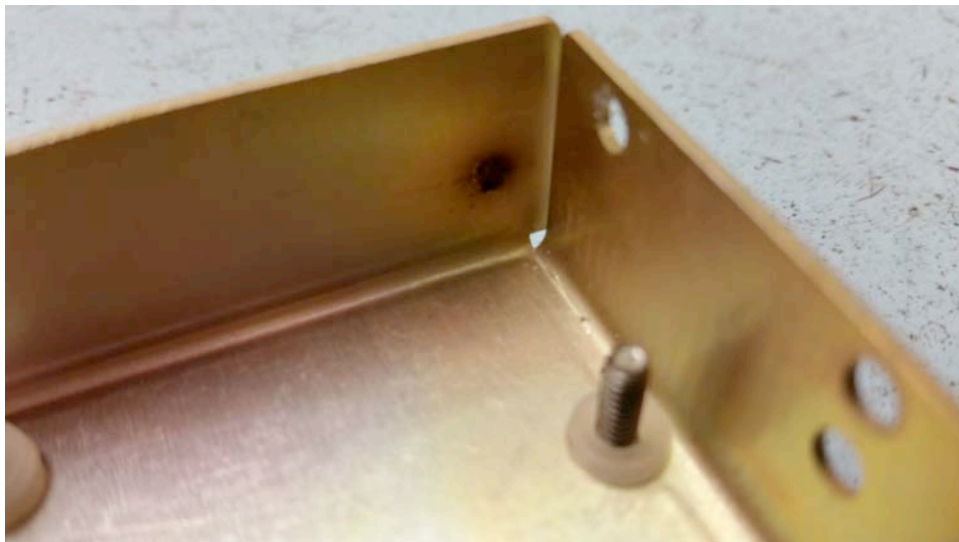
Shown below is the voltage regulator and the dark spot in the case is the result of the failure of the voltage regulator.

Shown above is a photo of the inside of the electronics enclosure once the electronics had been removed. The dark circle was next to the failed voltage regulator.
