## **INVESTIGATION REPORT**

| <b>Aircraft Make:</b> | FLIGHT DESIGN GMBH | <b>Aircraft registration:</b> | N508CT |
| <b>Aircraft Model:</b> | CT-SW 2006 | <b>Aircraft S/N</b> | Unknown |

| <b>RFS File number:</b> | 2015-028 | | |

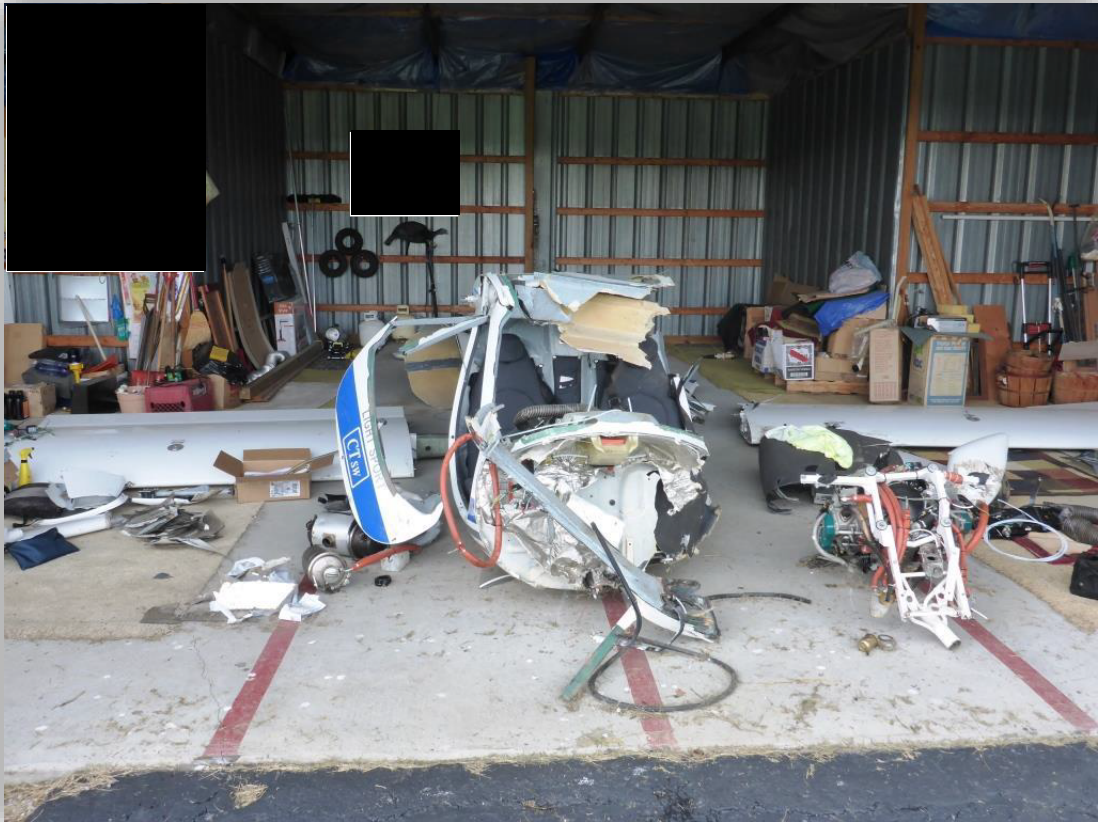
The aircraft sustained severe frontal impact damage. The Rotax 912 ULS, S/N 5647162 was still attached to the engine mount but not attached to the airframe.

All three propeller blades were unevenly broken off at the hub. Both carburetors were displaced from there respective intake manifolds and the exhaust muffler was found displaced from the engine. The engine's oil tank was separated from aircraft and found next to wreckage on hanger floor.

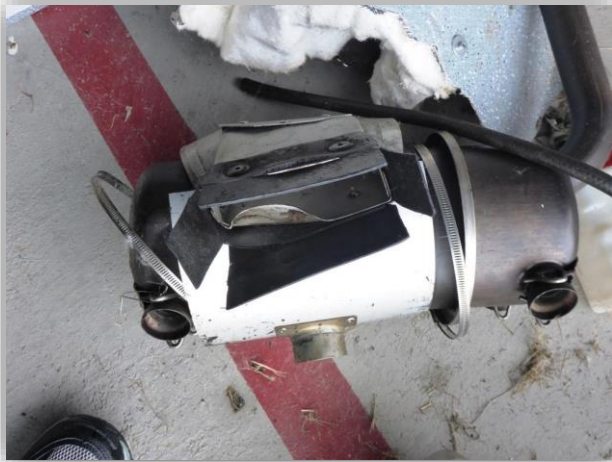
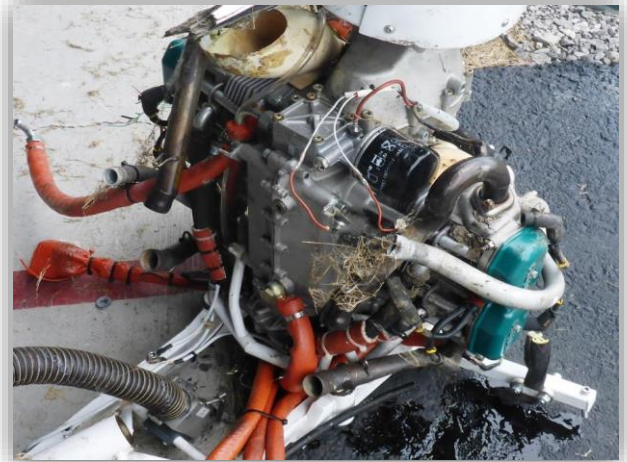
The exhaust system was examined for condition, modifications and conformity. The exhaust muffler was found displaced from the exhaust pipes and was found next to the aircraft wreckage. The exhaust muffler was also equipped with a non-Rotax heat shroud for what appeared to be cabin heat. The 4 exhaust pipes were still attached to there respective cylinders and were undamaged. No anomalies were found with the exhaust system.

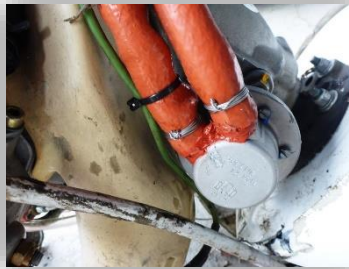
- P/N 893 110
- S/N 12.1814

**Fuel Pump:** No anomalies were found with the diaphragm fuel pump.

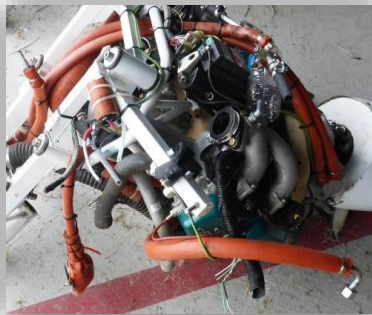
**Rubber Fuel Lines:** No anomalies were found with the fuel lines.

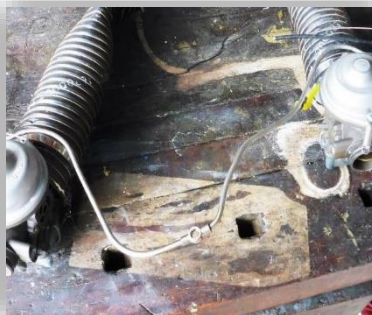
**Stainless steel fuel line:** The stainless steel fuel line was found removed from the distribution block but still attached to both carburetors. No anomalies were found with the stainless steel fuel line.

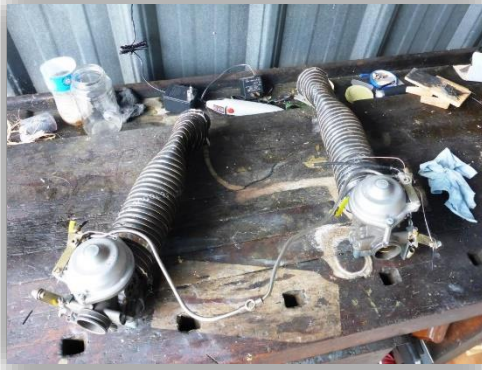
**Carburetors:** The carburetors were found displaced from there intake manifolds but still attached to the stainless steel fuel line. Both carburetors were examined for condition, modification and conformity.

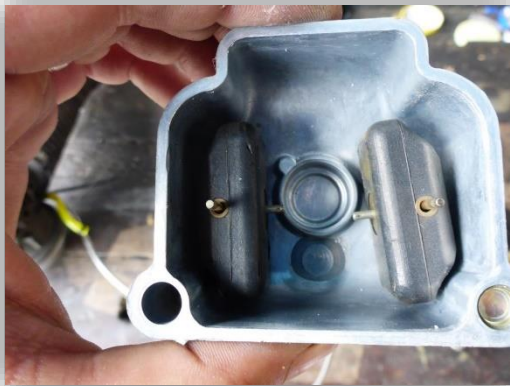
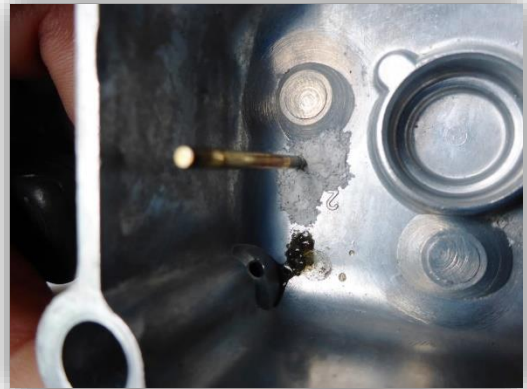
**1/3 Carburetor:** The 1/3 Carburetor float bowl was removed and examined for fuel contamination. Contamination was found within the 1/3 float bowl underneath the float. No fuel was contained inside.

Other than slight contamination found in carburetor float bowls and improper spark plug gap on several spark plugs, No mechanical anomalies were found during the initial inspection of the engine that was conducted at the pilot/owners hanger on July 1 2015, under the supervision of FAA Airworthiness Inspector, Randall Steele out of the Rochester NY FAA office.

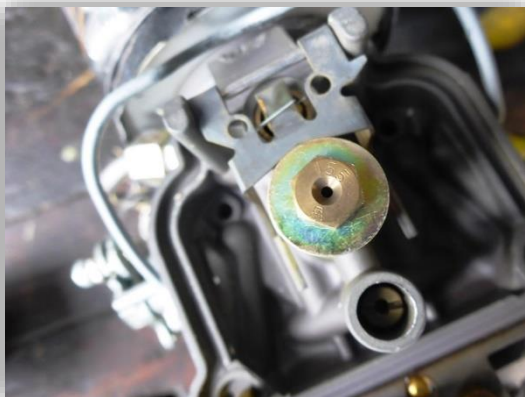
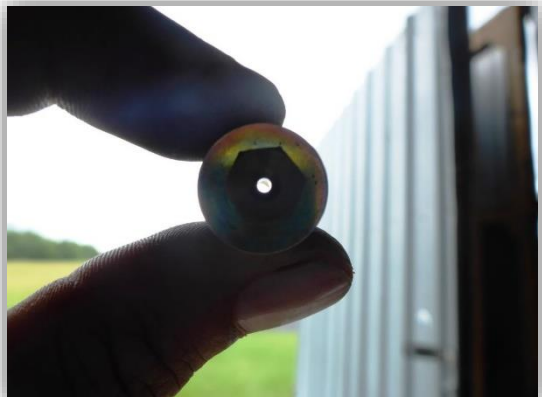
The main jet was removed and examined for any obstructions and proper size. No obstructions were seen and it was the stock 155 size main jet.

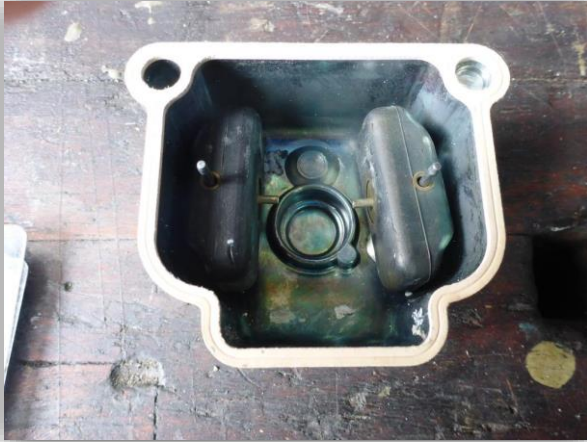
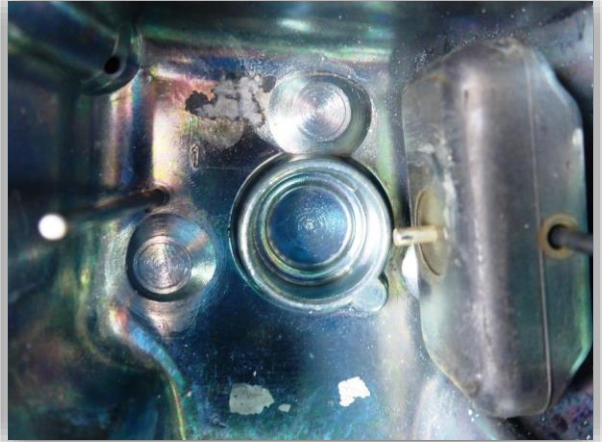
**2/4 Carburetor:** The 2/4 Carburetor float bowl was removed and examined for fuel contamination. Contamination was found within the 2/4 float bowl underneath the float. No fuel was contained inside.

Other than the contamination found within both the 1/3 and 2/4 Carburetor float bowls, no other anomalies were found.

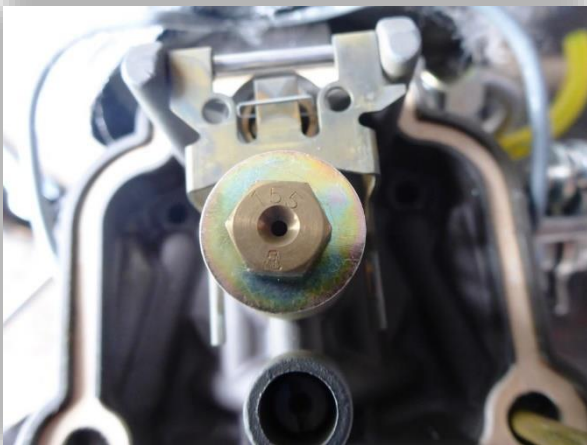
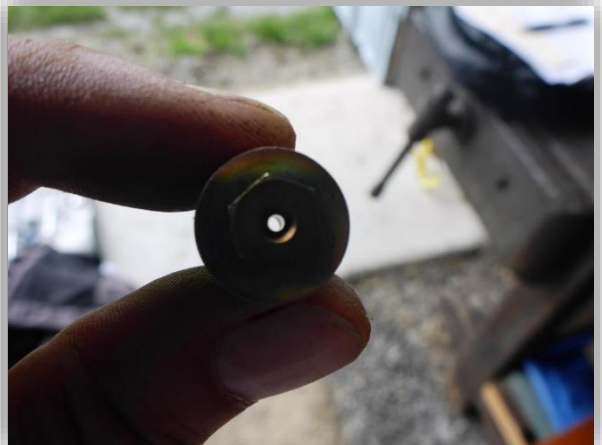
The main jet was removed and examined for any obstructions and proper size. No obstructions were seen and it was the stock 155 size main jet.

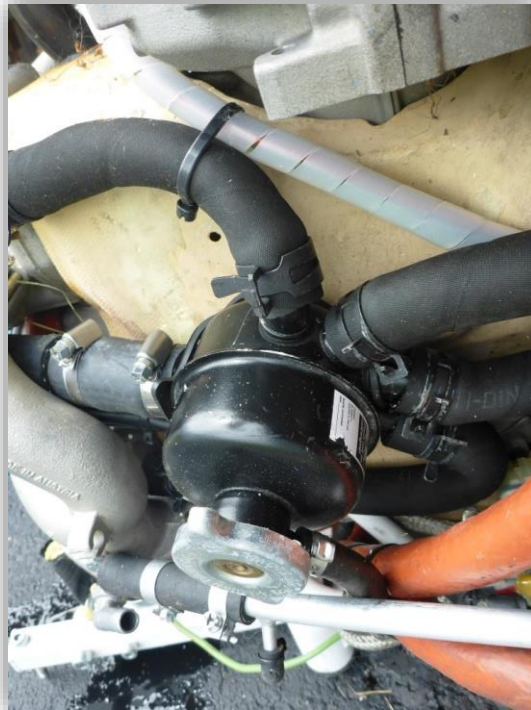
**Expansion tank:** The expansion tank cap was removed to examine the contents within. No coolant remained within the expansion tank due to a breach in the system from impact. No anomalies were found with the coolant expansion tank.

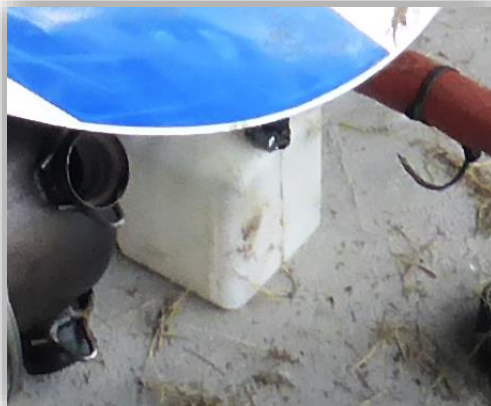
**Overflow bottle:** The coolant overflow bottle was displaced from its original location on the fire wall and was sitting next the aircraft wreckage on the hanger floor. No coolant was seen inside the tank due the system being breached. No anomalies were found with the overflow tank.

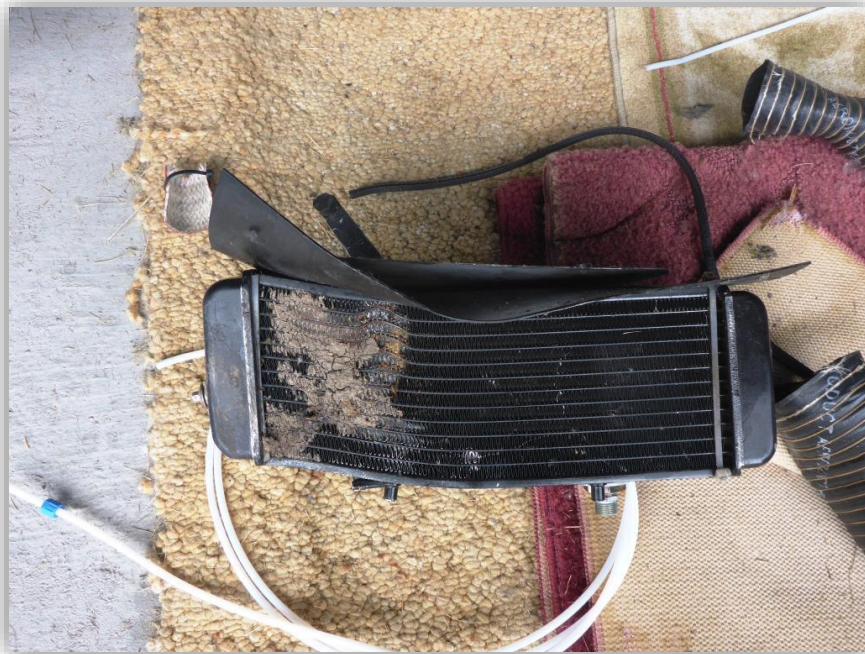
**Radiator:** The radiator was substantially damaged from impact and was found sitting next to aircraft on hanger floor. There was no coolant contained within the coolant radiator due to the system being breached. No anomalies were found with the coolant radiator.

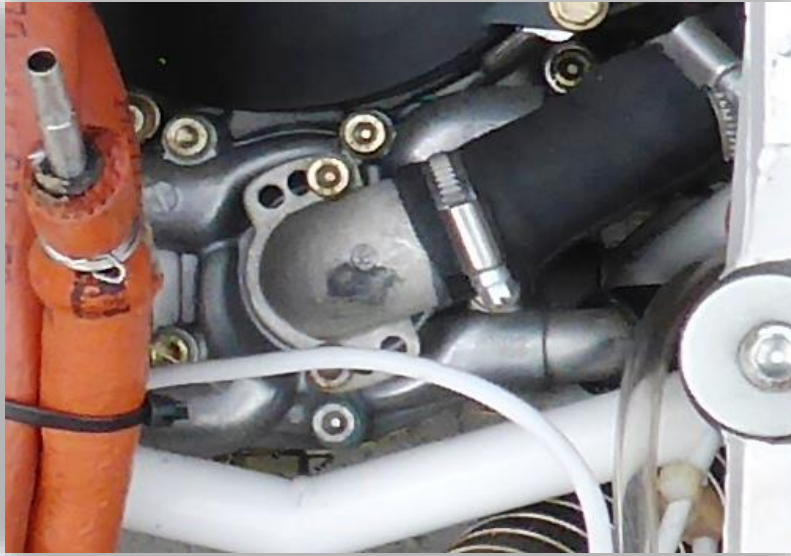
**Water Pump:** The Coolant Water Pump was examined for condition and modifications. No anomalies were seen with the Coolant Water Pump. In order to perform a function check, an engine run would be required.

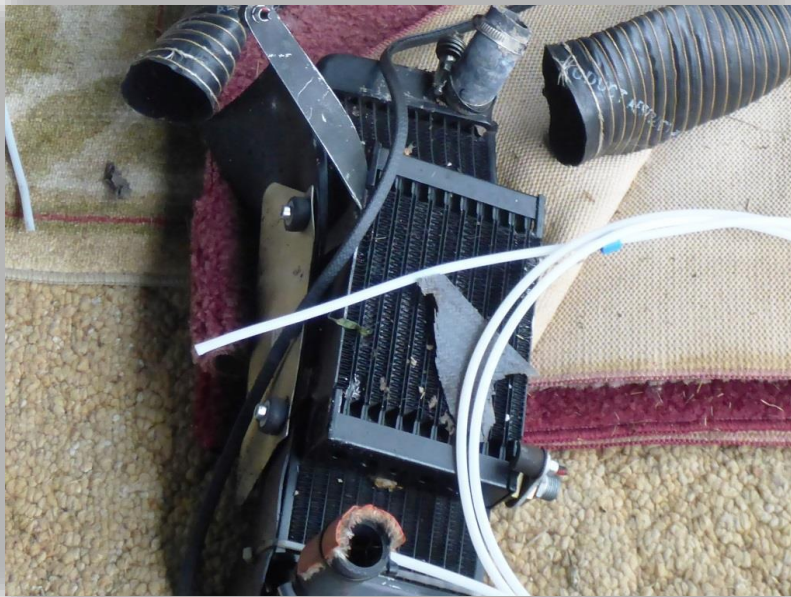
**Coolant Lines:** The coolant lines were examined for condition. All coolant lines were in good condition with the exception of the lines that connected to the Coolant radiator. The Coolant Radiator lines were breached due to impact damage. No other anomalies were seen with the coolant lines.

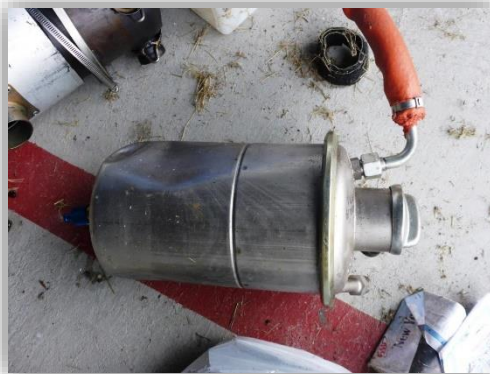
**Oil Tank:** The oil tank was found separated from the engine and firewall. It was sitting next to the aircraft wreckage on the hanger floor. The oil tank was examined and found to be damaged from impact but still contained remnants of oil within. The oil tank still had one of the two oil lines attached. The system however was breached due to impact. No other anomalies were found with the oil tank.

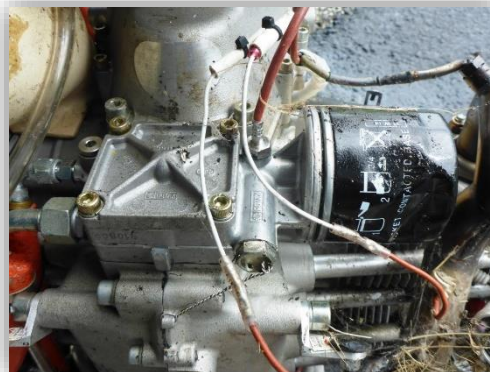
**Oil Pump:** The Trochoid style oil pump was examined for condition and modifications. No anomalies were found with the oil pump. During rotation of the engine, oil was seen squirting out of one of the breached oil lines. This was an indication that the oil pump was operational. In order to perform a complete function check, an engine run would be required

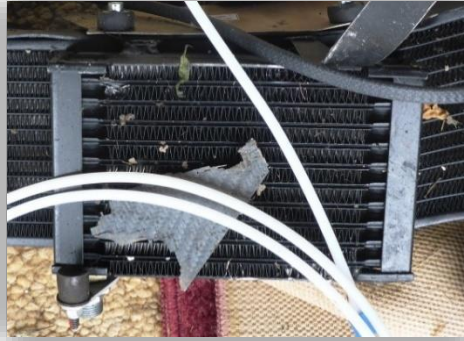
**Oil Cooler:** The oil cooler was examined for condition, conformity and installation. The oil cooler was in good physical condition and mounted correctly. The oil lines were previously disconnected from the oil cooler causing a breach in the oil system. No further anomalies were found with the oil cooler.

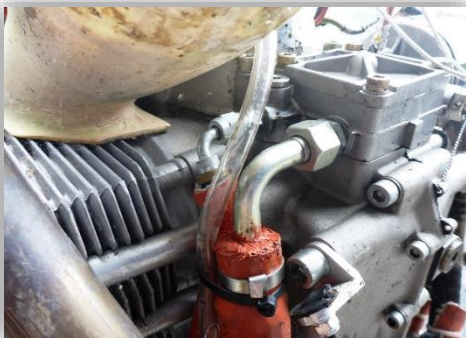
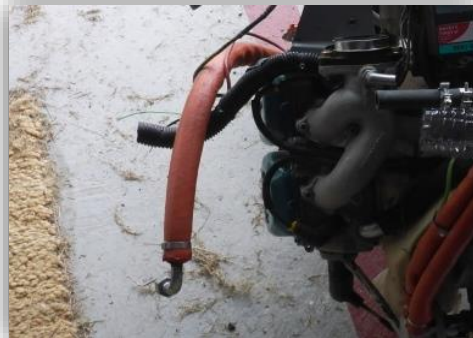
**Oil lines:** The oil lines were examined for condition and proper type. The oil lines were the proper type but were found disconnected at several locations (prior to this investigation). Some of the oil lines were damaged from impact. No further anomalies were found with the oil lines.

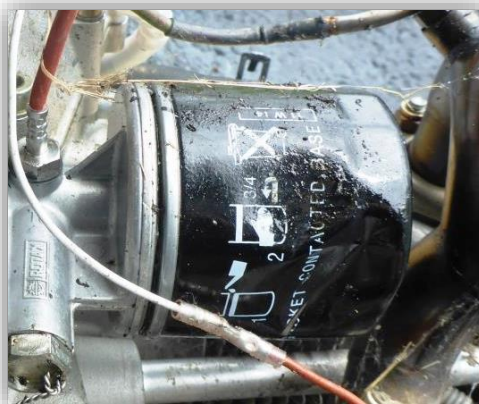
**Oil Filter:** The oil filter was examined for condition and proper type. The oil filter showed slight impact damage but was the proper ROTAX type filter. No other anomalies were found with the oil filter.
