# **National Transportation Safety Board**

## **Performance Study**

### **Specialist Report**

| NTSB Number: | ERA14LA329 |

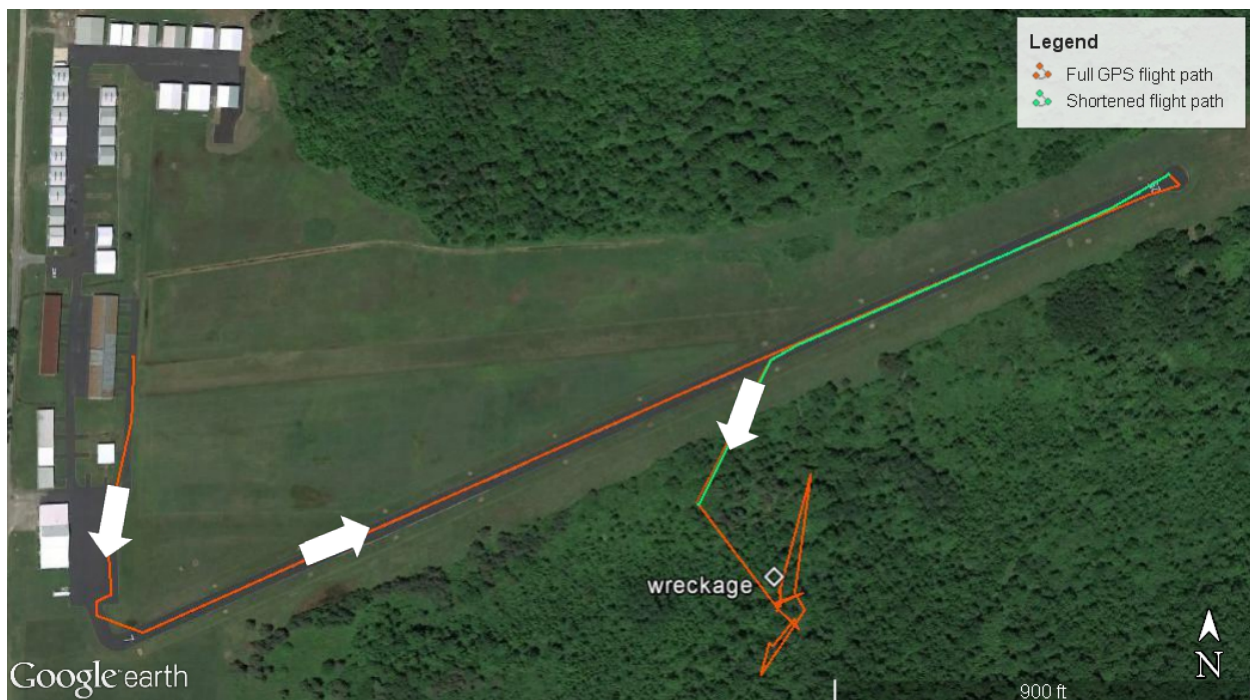
The aircraft taxied from the hanger area of Royalton airport along the runway to the threshold of runway 25. In Figure 1 the aircraft's track as recorded by the GPS unit is shown in orange. The GPS recording at the end of the flight show a number of unreliable recordings and were discarded. The green path shows the aircraft's take-off roll and three in-air data points that are consistent with witness testimony and the location of the wreckage.

**Figure 1.** Aircraft GPS path in orange and shortened path in green. White arrows show aircraft direction. Wreckage location is shown by a white diamond.

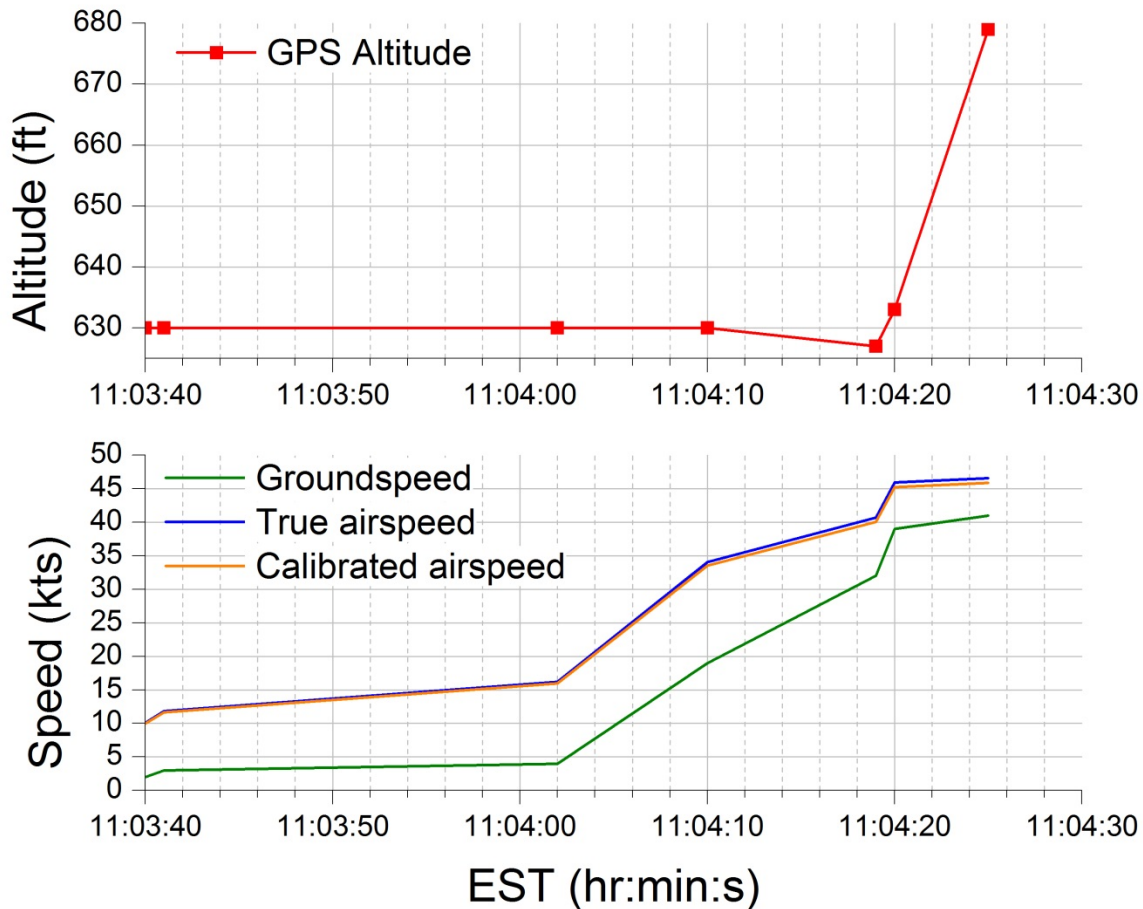
The GPS location data and the weather information were used to calculate the aircraft's groundspeed, true airspeed (TAS), and calibrated airspeed (CAS), shown below in Figure 2. The elevation of the Royalton airport is reported as 628 ft, but the runway elevation is unreported. The aircraft's TAS for the last two GPS points was approximately 46 kts (CAS was 0.7 kts lower than true airspeed). Figure 3 shows the aircraft's flight path and wreckage location with TAS noted for each GPS point.

**Figure 2.** Aircraft recorded altitude and calculated groundspeed, true airspeed, and calibrated airspeed versus time.

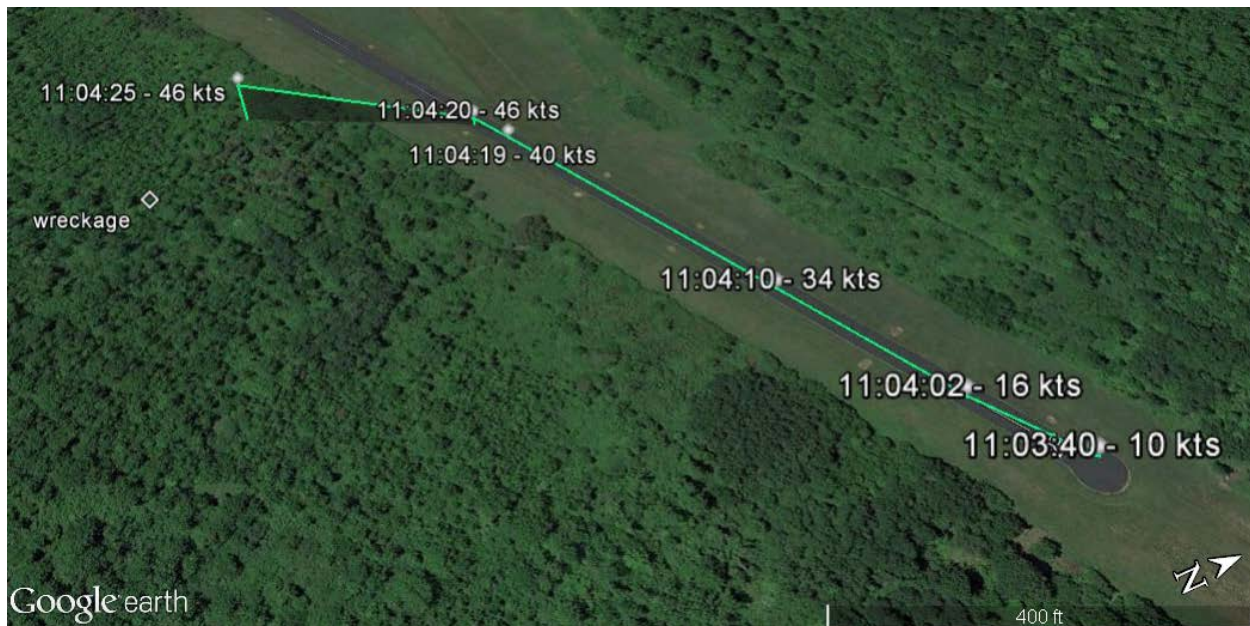
**Figure 3.** Aircraft take-off roll, flight, and wreckage location. Times and calculated true airspeeds are shown for each GPS point.

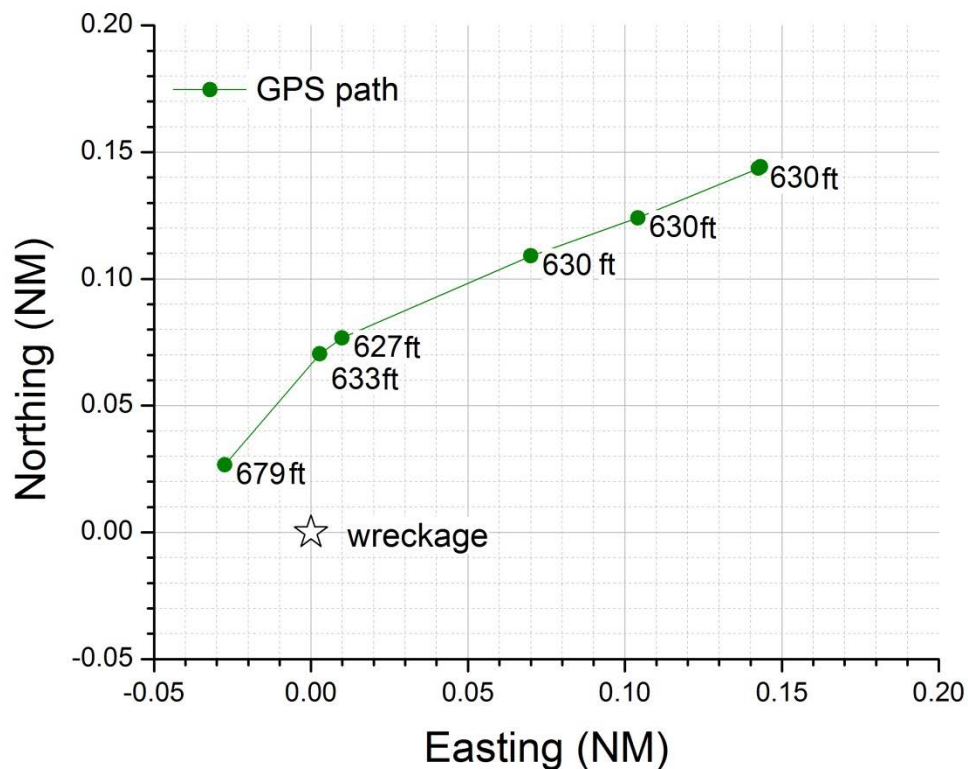
The aircraft began heading left as soon as its altitude indicated that it lifted off. Figure 4 shows the aircraft's take-off roll, flight, and altitude.

**Figure 4.** Aircraft take-off roll, flight, and wreckage location. Aircraft altitude is shown for each GPS point.

The aircraft wreckage was located along an easterly track, 230 ft from the final GPS location (see Figure 4 and Figure 5). Assuming a single banked turn between the final GPS point and the wreckage location, the aircraft's bank angle would have had to increase beyond the 27° calculated earlier and the aircraft's stall speed would have continued to increase.

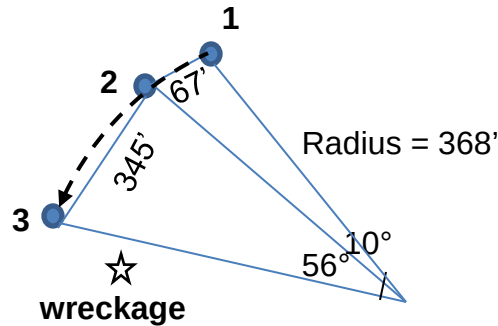
Assuming that the aircraft's flight path between the last three GPS points was part of a smooth, coordinated turn, the radius of that turn was 368 ft (see Figure 5).

**Figure 5.** Radius of smooth coordinated turn (black dotted line) between final three GPS locations (blue circles labeled '1', '2', and '3'). Approximate wreckage location is also shown.

The aircraft would have traveled about 424 ft along the dotted black line in Figure 5 over six seconds for a ground speed of 41 kts which with the winds was about 46 kts TAS (~ 45 kts CAS). In the equation below,  $\theta$  is the bank angle necessary to complete a turn of radius  $R$  and airspeed  $V$  ( $g$  is the gravitational constant,  $9.81 \text{ m/s}^2$ ), assuming there are no winds.

Applying a speed of 46 kts and a radius of 368 ft, the necessary bank was calculated to be about  $27^\circ$  for the lift to balance the centripetal force of the turn and keep the aircraft aloft. However, this is a kinematic equation and does not guarantee that a particular aircraft would be able to generate the necessary lift at that speed.
