# Continental Motors

## ENGINE FIELD INSPECTION REPORT

ENGINE MODEL: O-300-A

AIRCRAFT MODEL: Temco GC-1B Swift

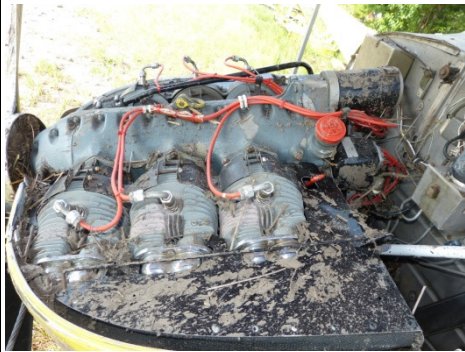
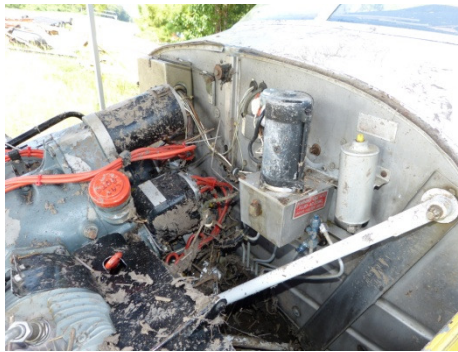
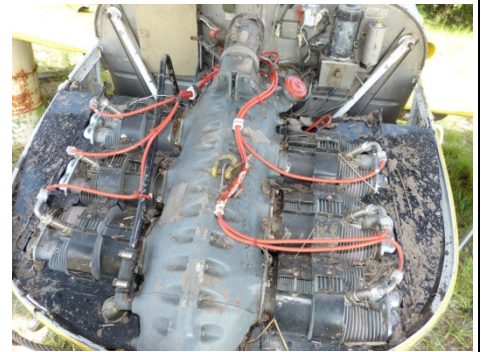
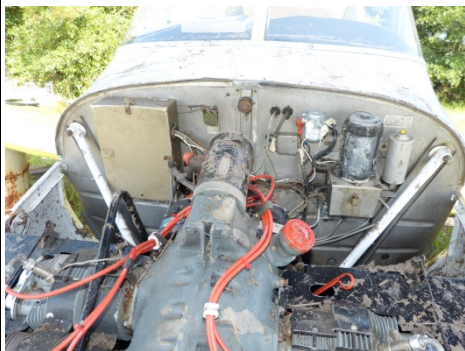
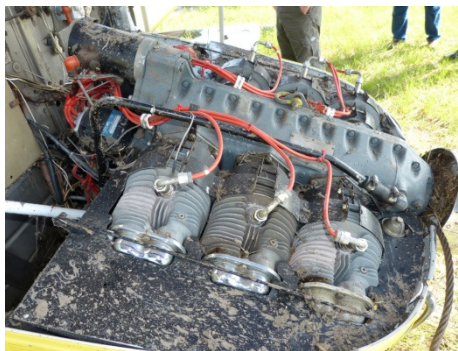
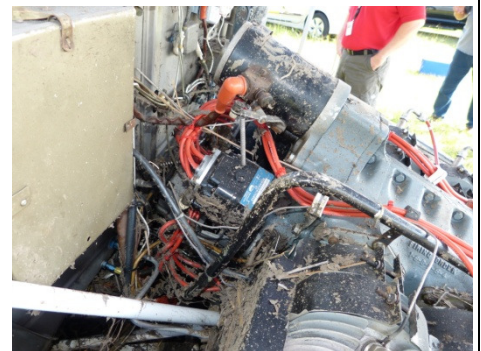
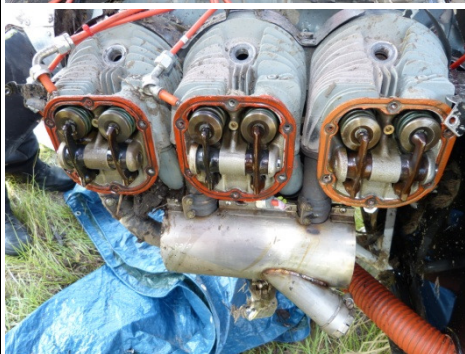
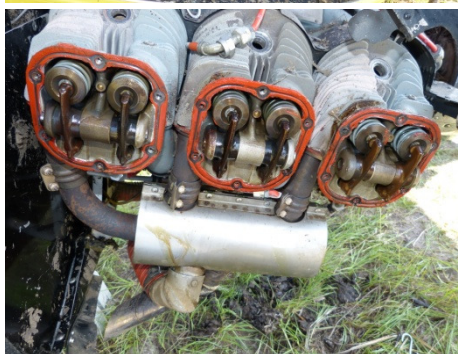
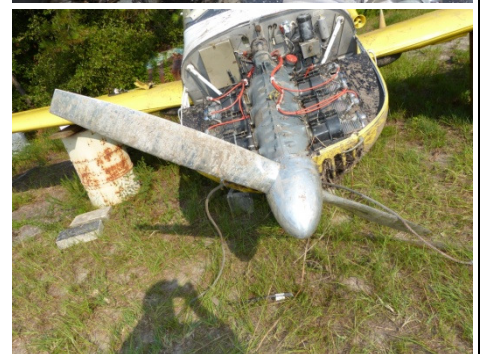
### EXTERNAL INSPECTION OF ENGINE:

The engine was in place on the airframe and not damaged, except that both exhaust pipes were crushed.

The top spark plugs and rocker box covers were removed, and the crankshaft was rotated using the propeller. Good thumb compression was obtained on all cylinders. Continuity was confirmed to all cylinders and to the rear of the engine. The cylinders were examined using a lighted borescope and all of the pistons and the cylinders had normal combustion deposits. All of the valves were in place and not damaged.

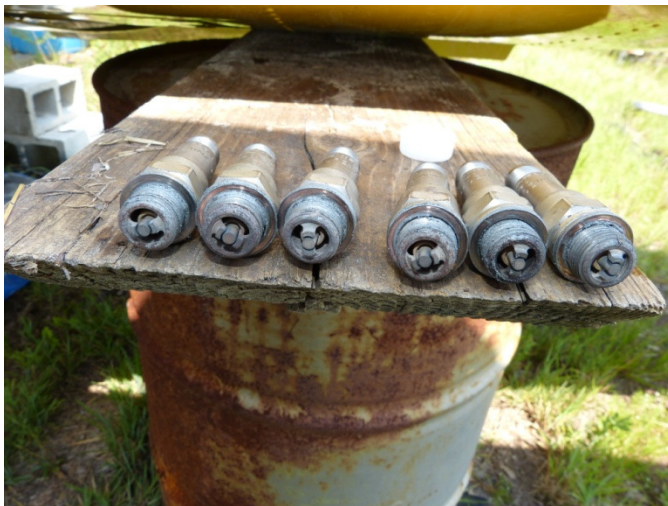
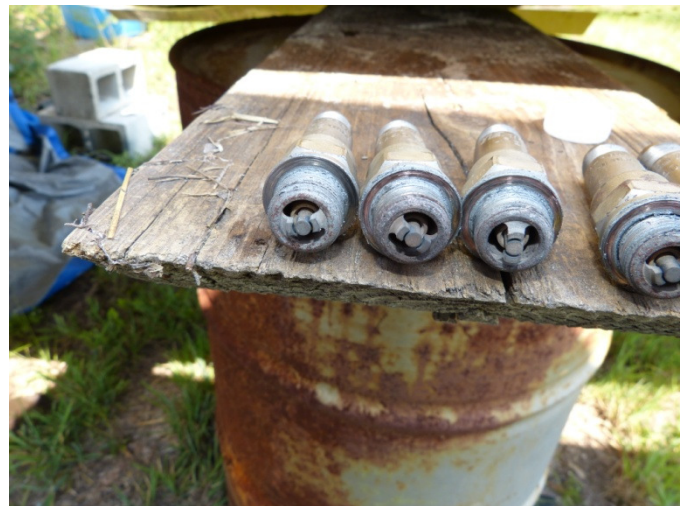
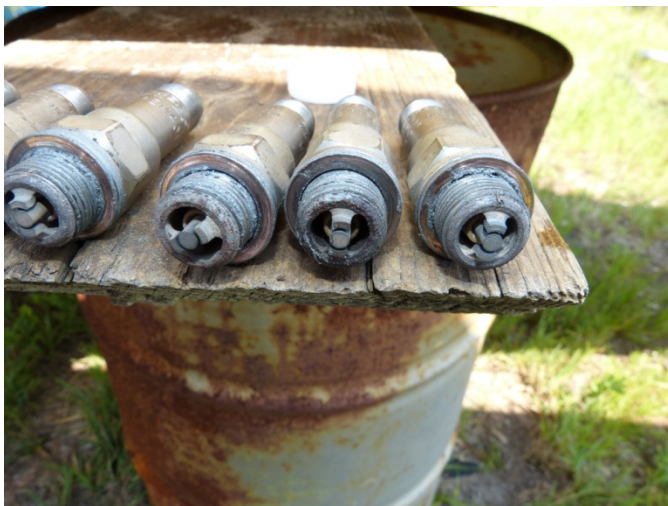
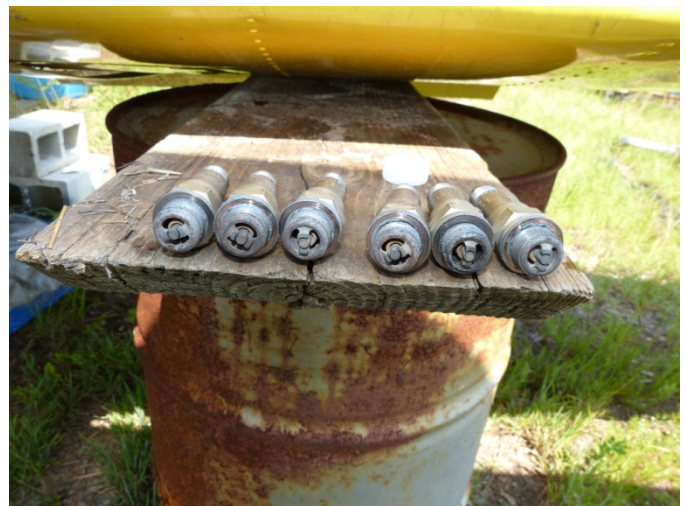
### Spark Plugs: Tempest UREM-40E

The top spark plugs were removed and examined. They had normal wear when compared to the Champion Check A Plug Comparison card, and light gray deposits in the electrode areas.

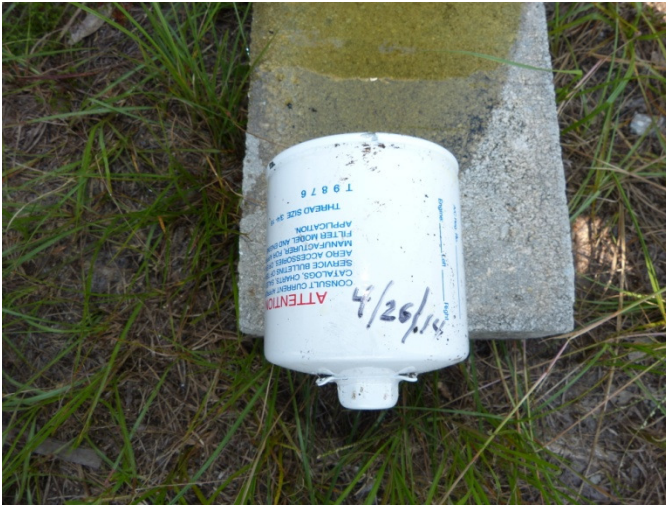
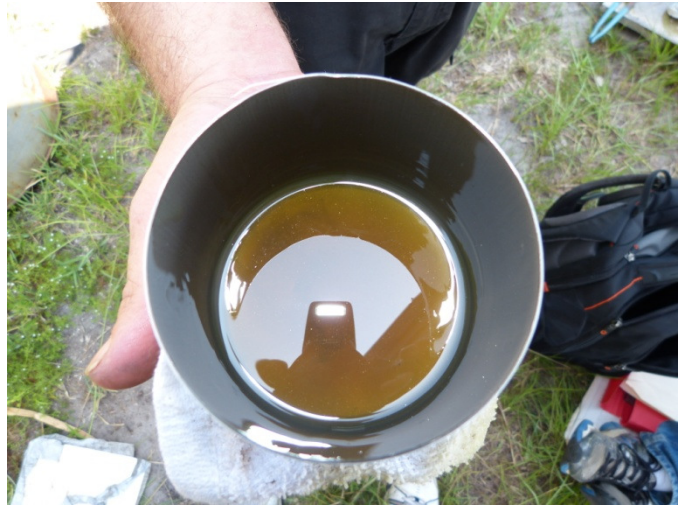
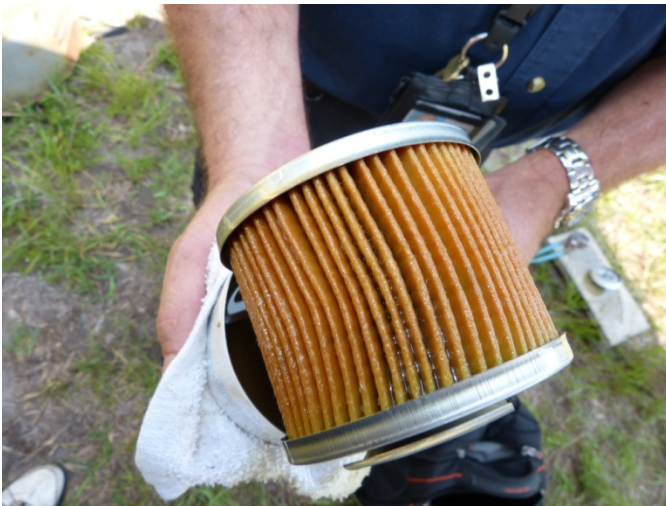
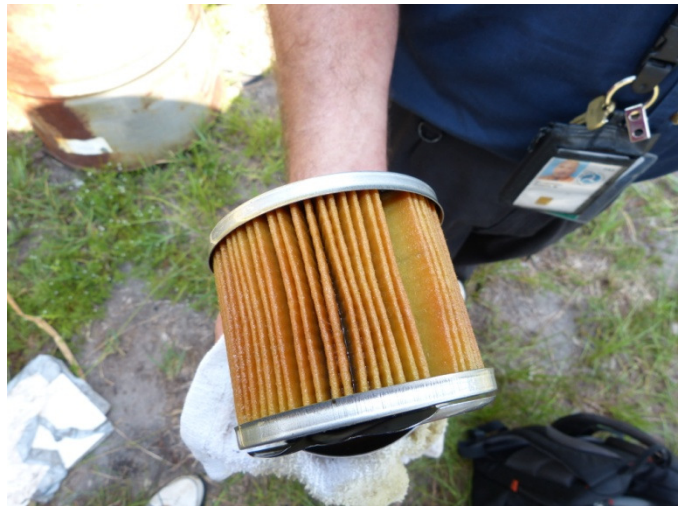
#### Oil Filter: Tempest AA48110-2

The oil filter was in place and not damaged. It was cut open and the filter contained clear lubricating oil. The element was clean and clear with no metal deposits. The number 4/26/14 was observed on the side of the filter case.

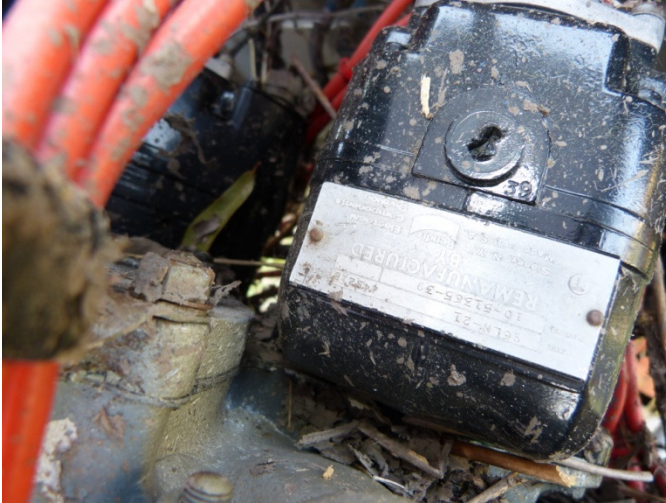
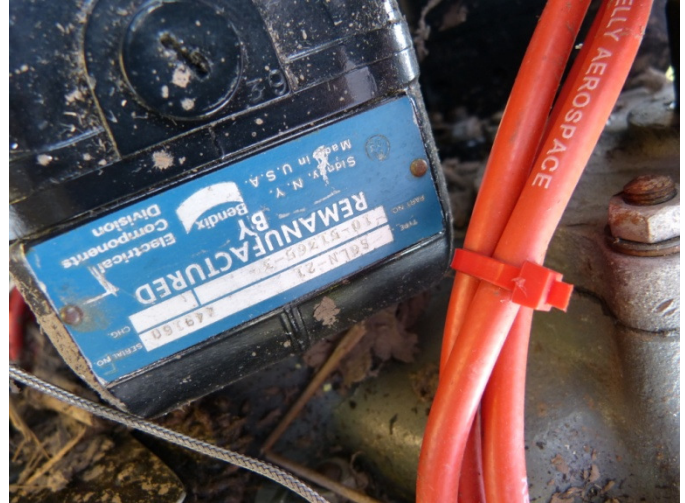
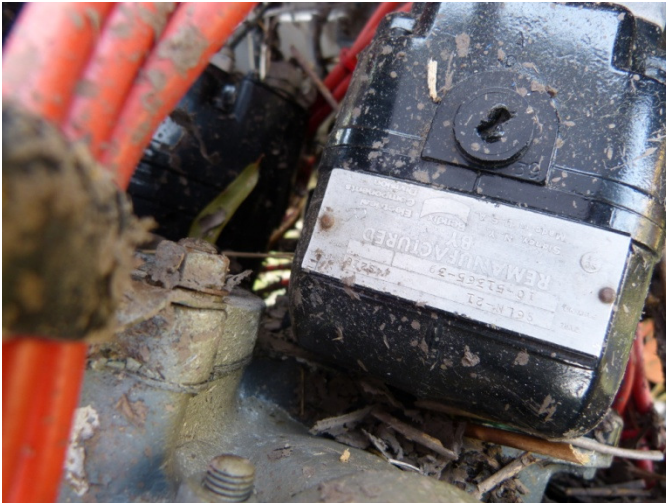
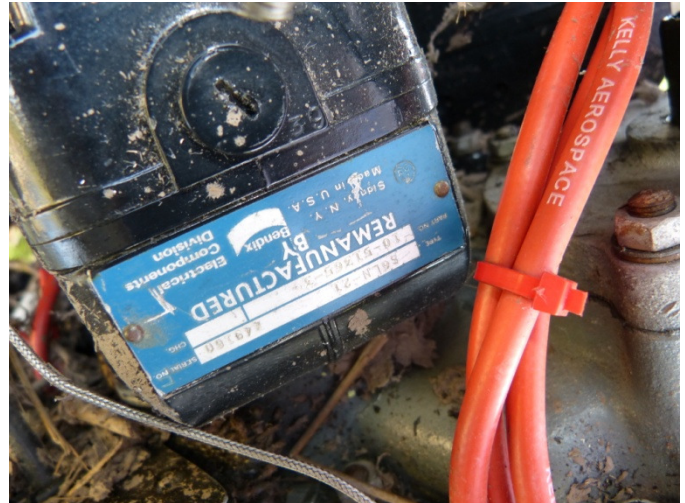
Magnetos: Left, Bendix, S6LN-21, PN-10-51365-39, SN-449218

The magnetos were both in place on the engine and were not damaged. The magneto switch was turned on in the cockpit, and the crankshaft was rotated. All of the ignition leads for both magnetos sparked at all terminals when the crankshaft was rotated. Both magneto impulse couplings snapped at top dead center on the number one cylinder.

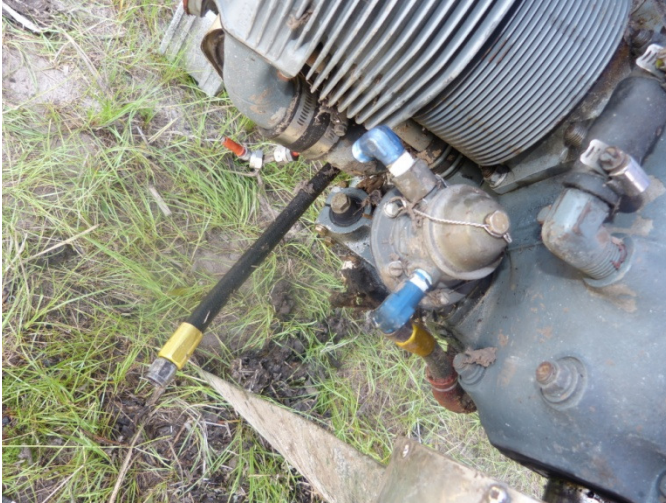
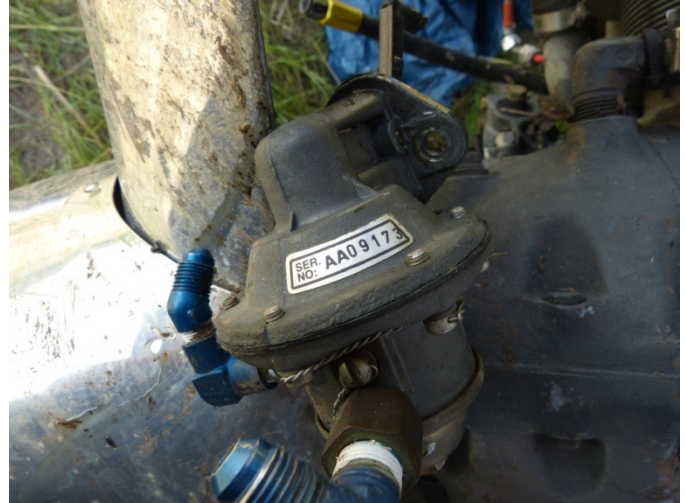
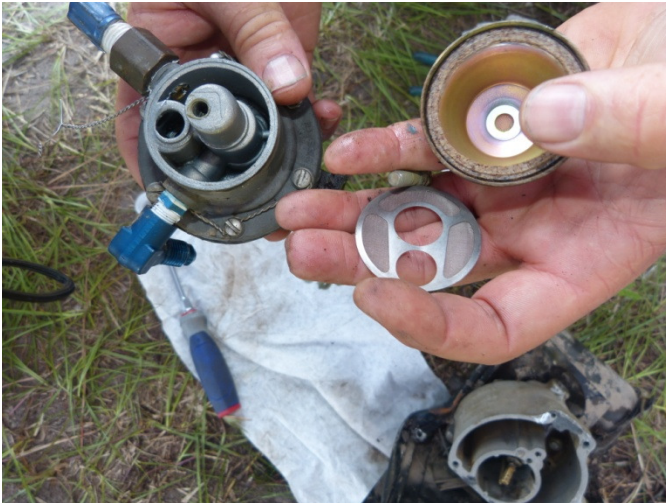
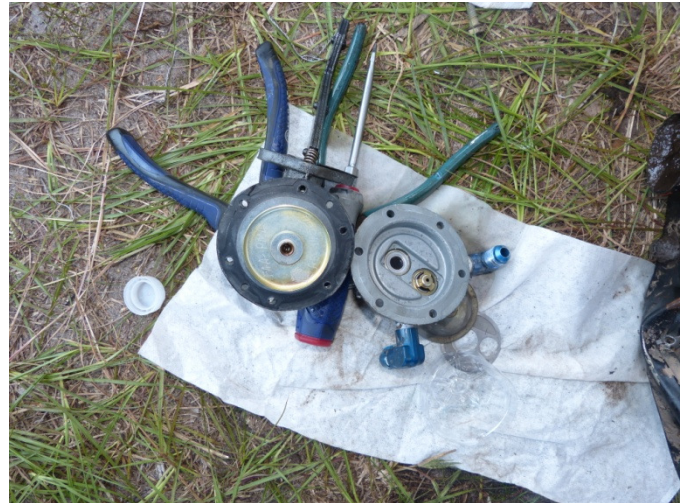
#### Fuel Pump: AC SN-AA09173

The fuel pump was in place and not damaged. The inlet line was removed and it contained a large amount of fuel. The propeller was rotated and fuel was pumped from the outlet line. The unit was disassembled and the fuel screen was clean and clear. The interior of the fuel pump was intact and not damaged.

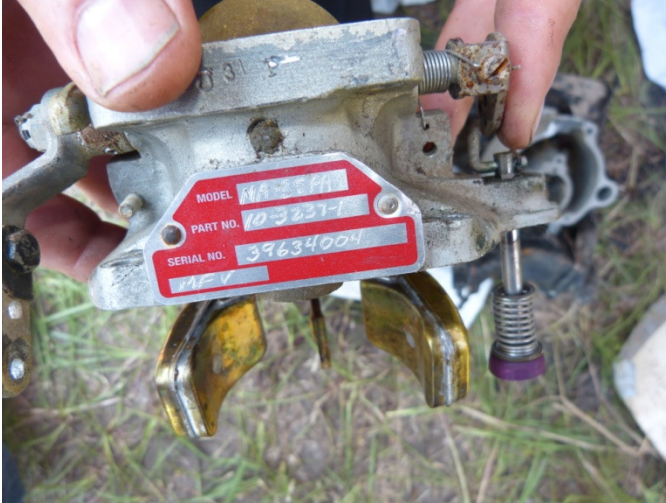
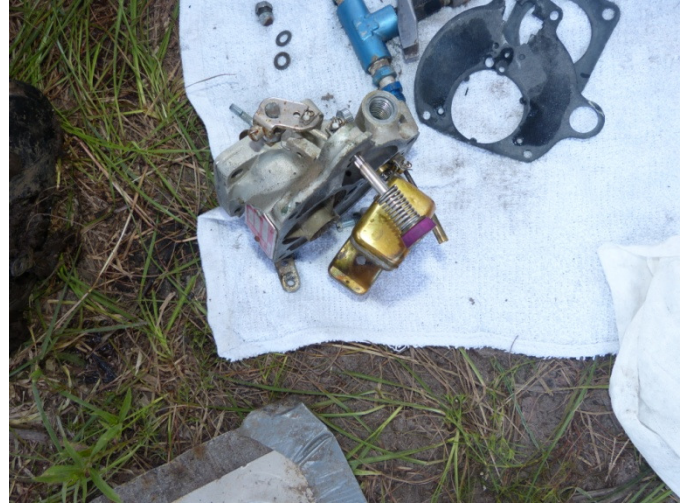
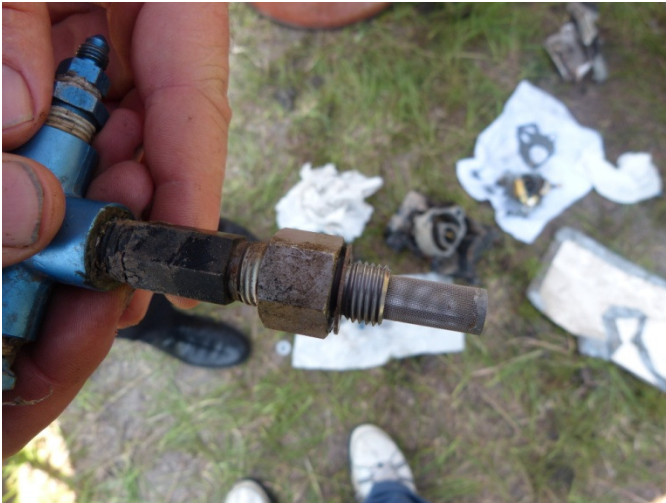
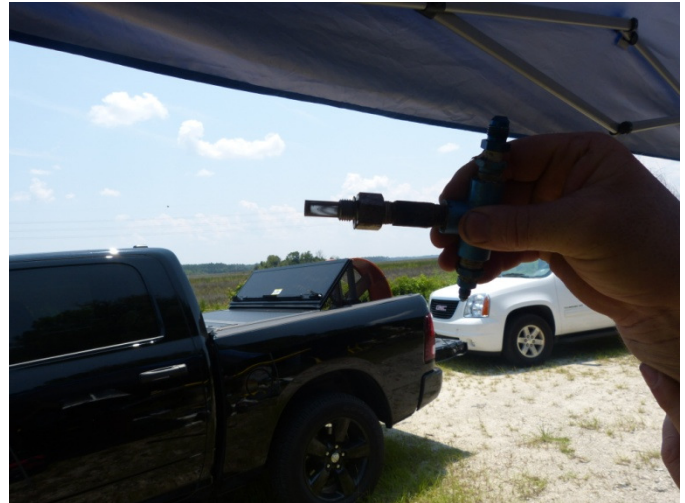
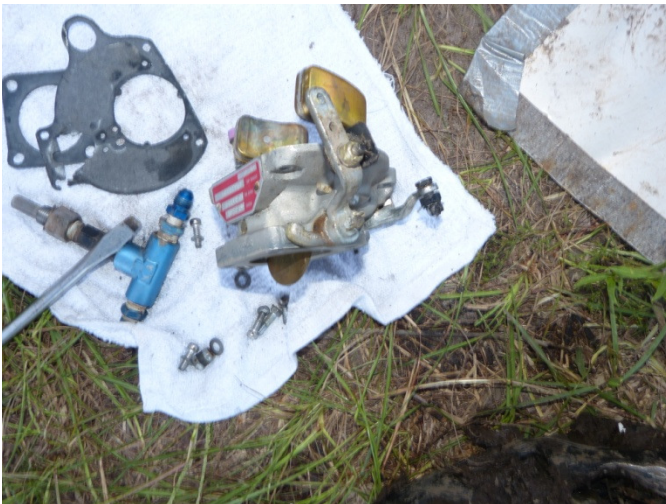
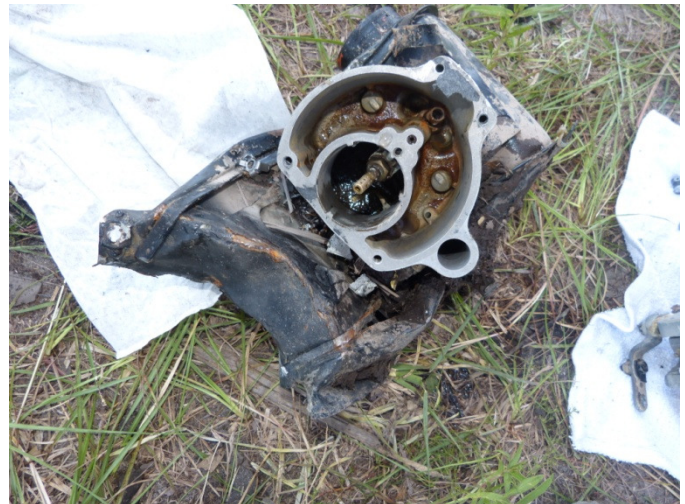
Carburetor: Marvel Schebler, MA-3SPA, PN-10-3237-1, SN-39634004

The carburetor bowl was found to be contaminated with dirty water and the bowl was rusted and corroded.

The carburetor was in place on the bottom of the engine. The throttle and mixture control were hooked up and were free to move. The fuel screen was clean and clear. The unit was disassembled and the bowl contained dirty water. The bottom of the bowl contained rust and corrosion. The float and needle valve were hooked up and were free to move. The accelerator pump was not damaged.

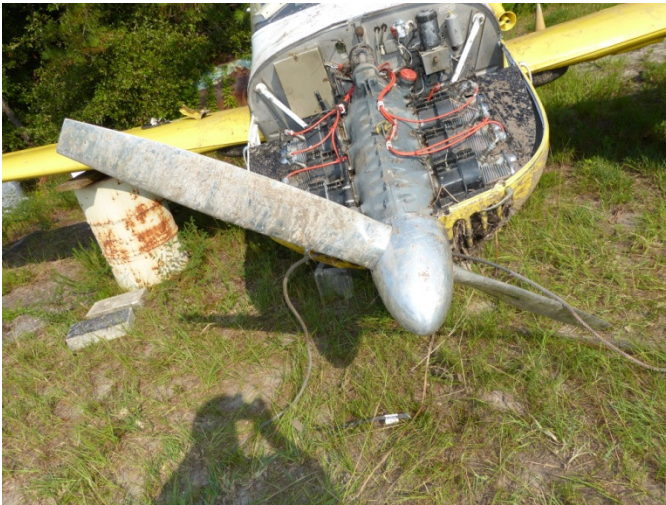
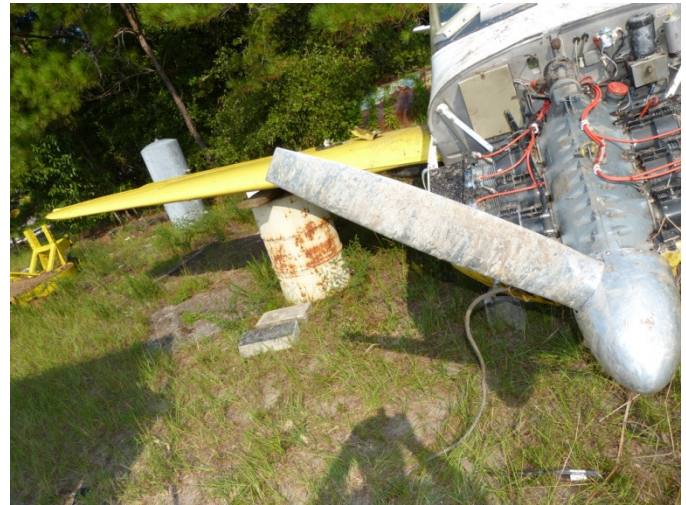
Propeller: McCauley, 1A170, DM7359, SN-P106

The propeller was in place on the crankshaft attachment flange. The spinner was not damaged. No damage was observed on either of the propeller blades.
