## Accident / Incident Summary Report

**Report No.: 14-081**

**Croom Aviation  
Gulfstream-Schweizer G-164B Reg. N425LS  
Bonifay, Florida  
25 July 2014  
PT6A-27 Engine  
S/N 40160**

**Date of Issue:** 5 October 2015

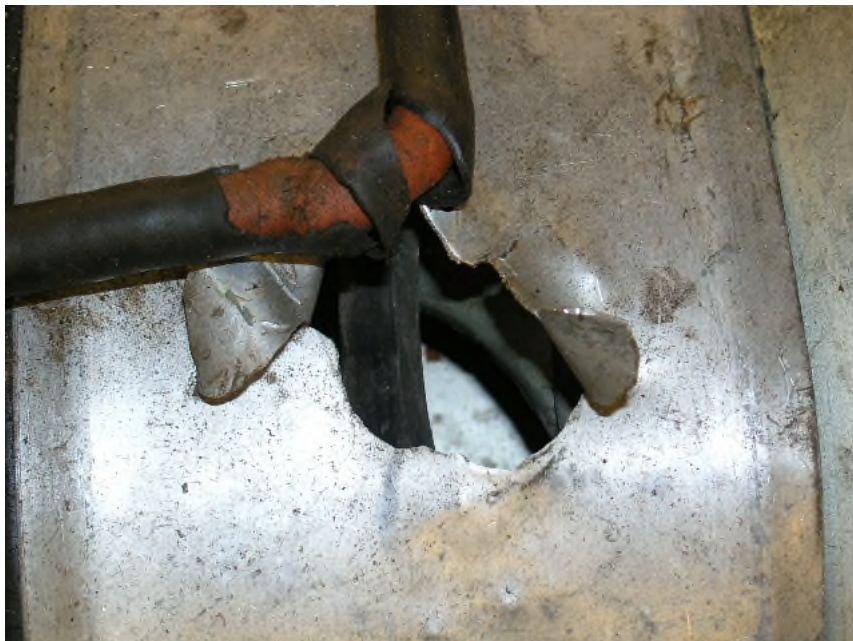
Photo No. 10

Gas generator case compressor housing and shroud, approximate 2:00 position.

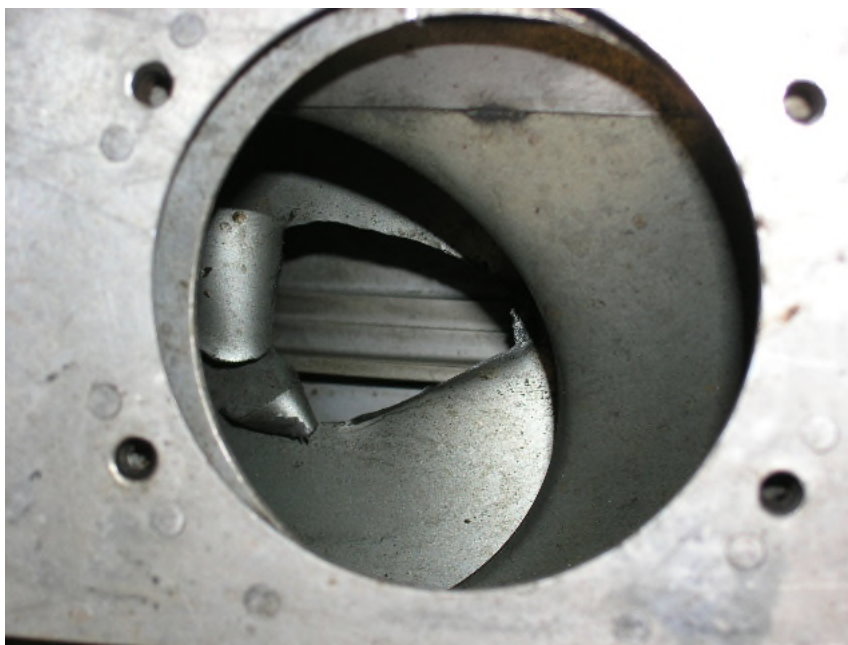
Photo No. 11

Gas generator case compressor housing and shroud, 9:00 position.

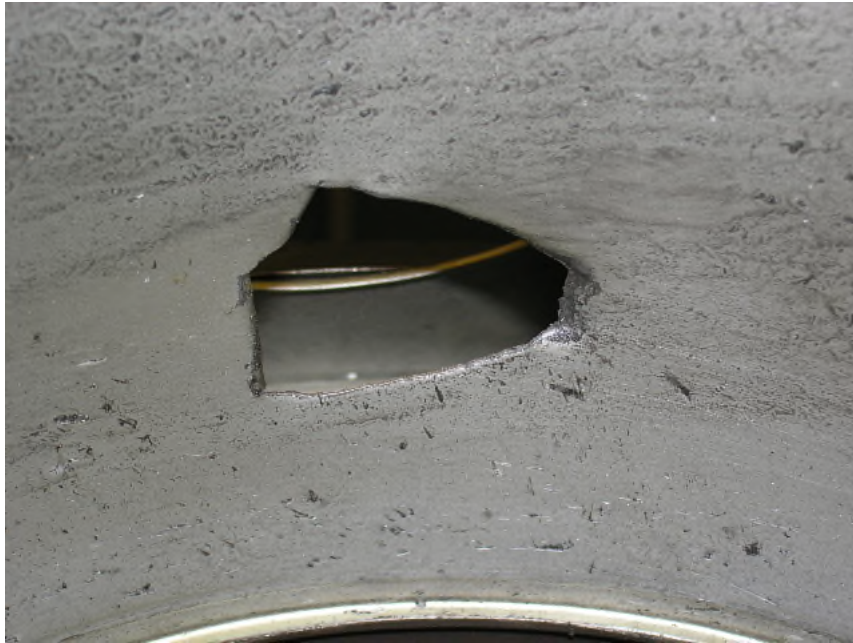
Photo No. 15

Gas generator case compressor housing interior, approximate 2:00 position.

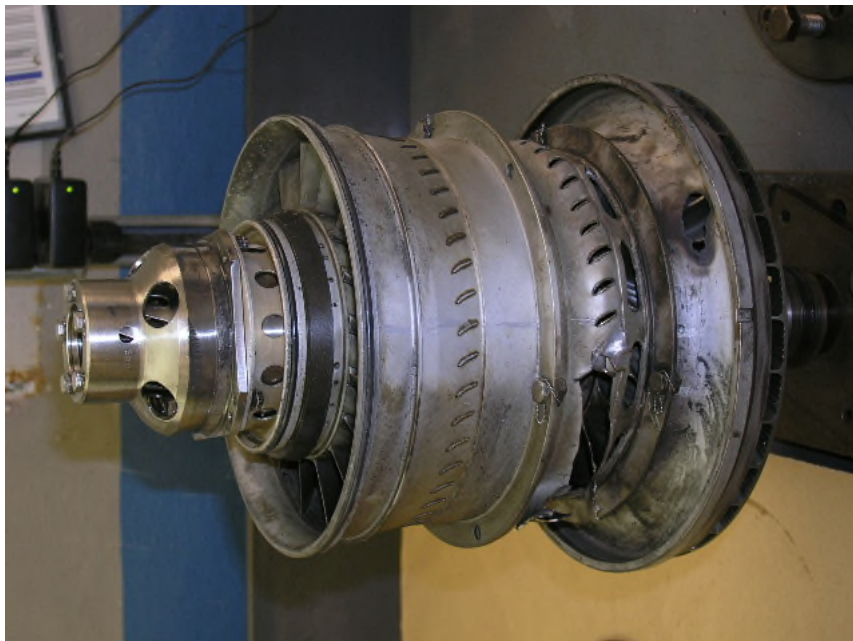
Photo No. 18

Compressor assembly as removed, centered at 12:00 position.

**Compressor 1<sup>st</sup>, 2<sup>nd</sup>, and 3<sup>rd</sup> Stage Stators and Shrouds:** The 3<sup>rd</sup> stage stator housing displayed an approximate 3-½ inch x ¾ inch outward rupture centred at the approximate 2:00 position and an approximate 1 inch x 1 inch outward rupture at the approximate 7:00 position. The 1<sup>st</sup> and 2<sup>nd</sup> stage stators and shrouds displayed heavy rubbing and deformation due to radial contact with the compressor rotor. The 3<sup>rd</sup> stage stator vanes were completely obliterated and the shroud rubbed completely though due to radial contact with compressor rotor. Only 7 identifiable fragments of the 3<sup>rd</sup> stage stator vane were recovered. Please refer to photos No. 18 and 19, and 30 through 38.

**Centrifugal Impeller Shroud:** The shroud face showed severe rubbing, with heavy frictional heat discoloration and material smearing, due to radial contact with the impeller. The shroud face was rubbed completely through at the approximate 7:00 and 11:00 positions. Please refer to photos No. 18 and 19, 31, 48, and 49.

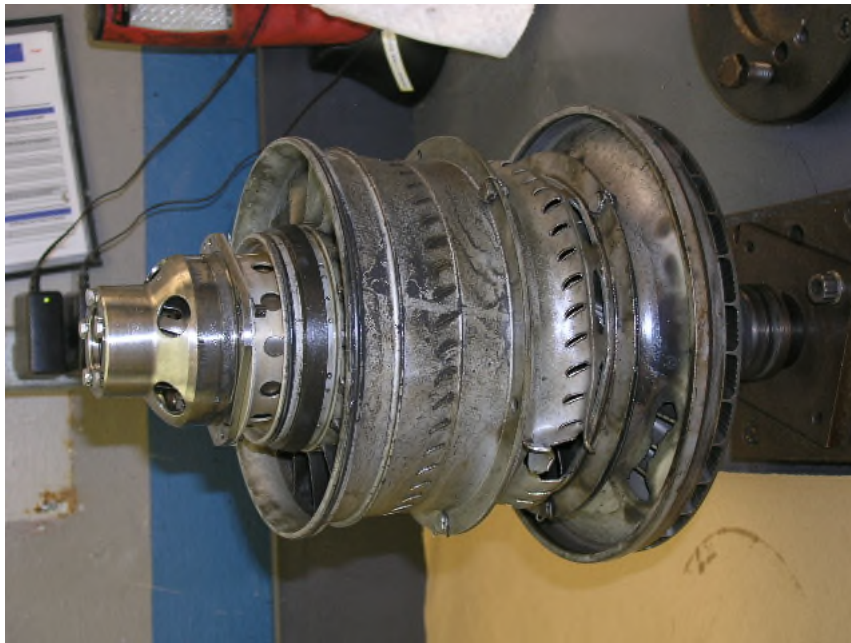
Photo No. 19

Compressor assembly as removed, centered at 6:00 position.

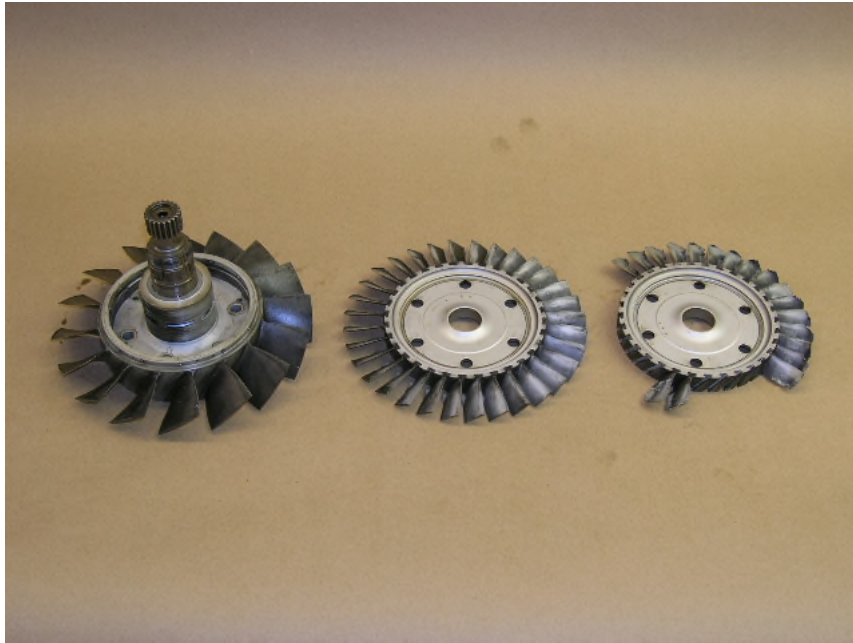
**Compressor 1<sup>st</sup>, 2<sup>nd</sup>, and 3<sup>rd</sup> Stage Discs and Blades:** The 1<sup>st</sup> stage blades were intact, with circumferential rubbing at the blade tips due to contact with the shroud. The 2<sup>nd</sup> stage blades were intact, with circumferential rubbing at the blade tips and trailing edge roots, due to contact with the shroud and 2<sup>nd</sup> stage stator. The third stage blades displayed heavy rubbing and tearing due to contact with the shroud and adjacent stator. 9 blades and root sections were displaced axially from the disc and liberated due to the partial obliteration of the adjacent spacer. Two blades were not recovered. Please refer to photos Nos. 20 through 29.

Photo No. 20  
Compressor 1<sup>st</sup>, 2<sup>nd</sup>, and 3<sup>rd</sup> stage discs and blades.

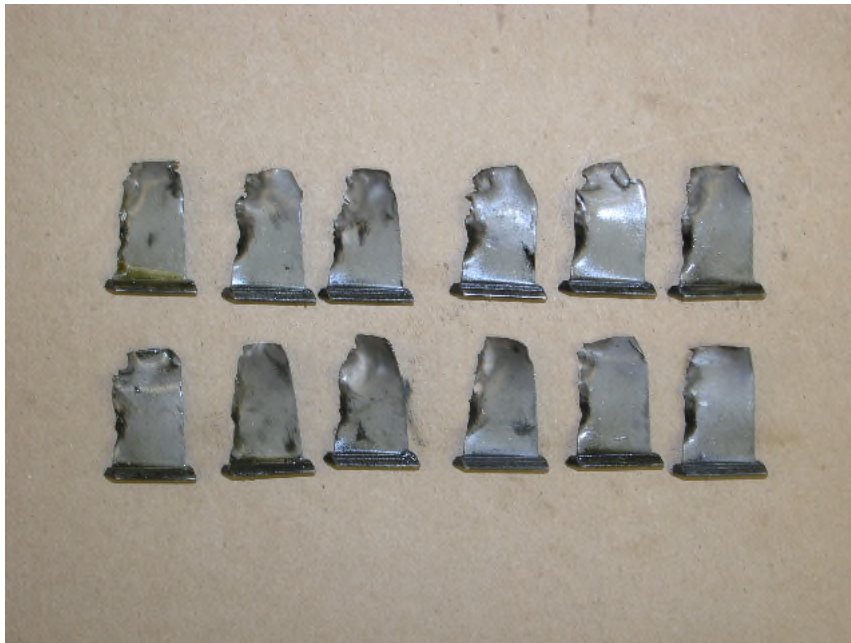
Photo No. 28  
Recovered 3<sup>rd</sup> stage blade airfoils.

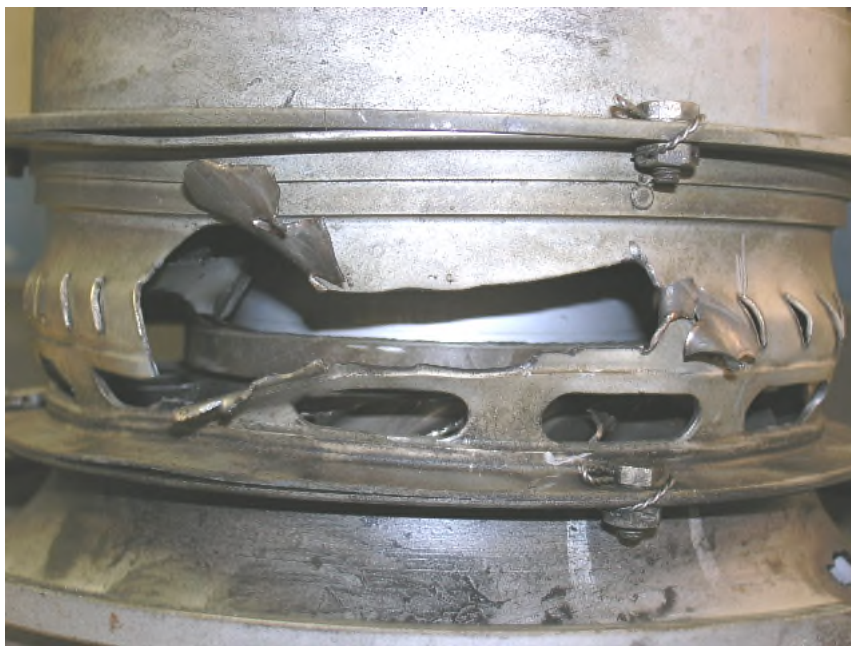
Photo No. 30

Compressor 3<sup>rd</sup> stage stator housing, centered at the approximate 2:00 position. ¾ inch x 3 ½ inch

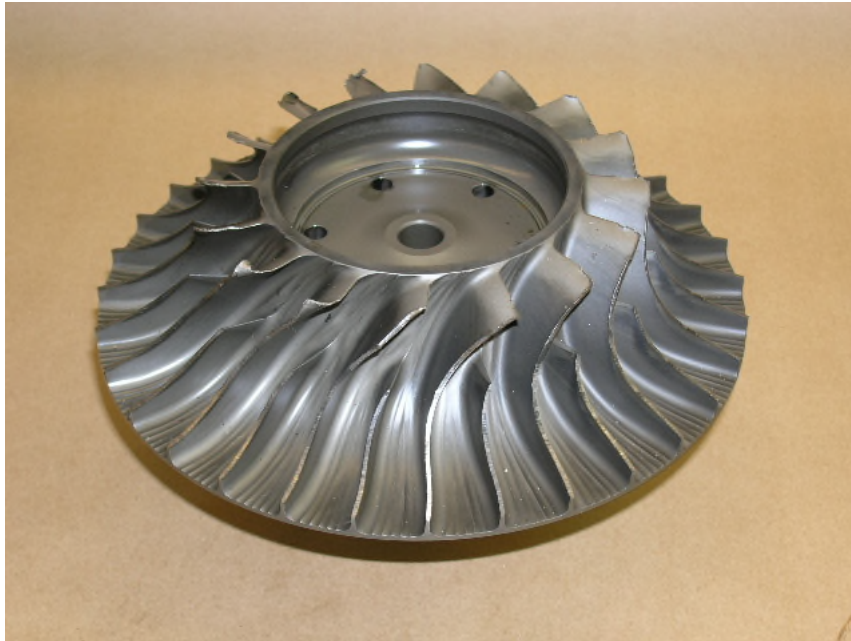
**Centrifugal Impeller:** The impeller vanes displayed heavy circumferential rubbing due to radial contact with impeller housing. The impeller inlet leading edges were gouged, torn, and deformed due to ingested compressor debris. Please refer to photos No. 46 and 47.

Photo No. 46  
Centrifugal impeller.

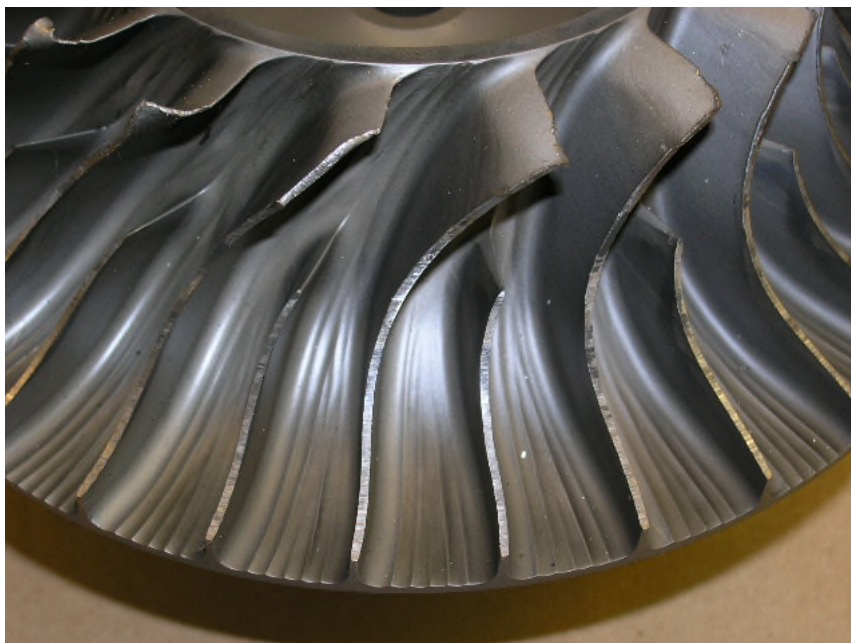
Photo No. 47  
Centrifugal impeller, detail.

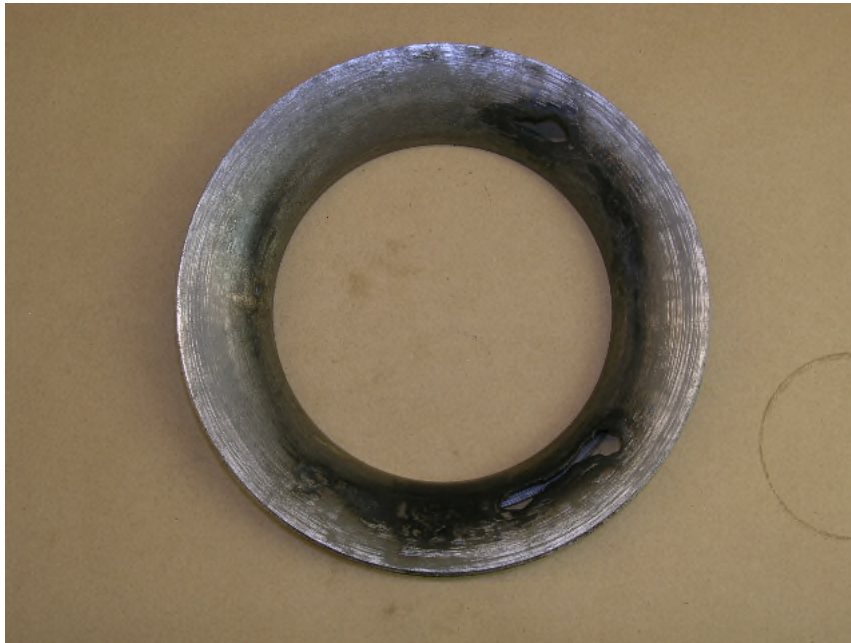
Photo No. 48  
Centrifugal impeller shroud.

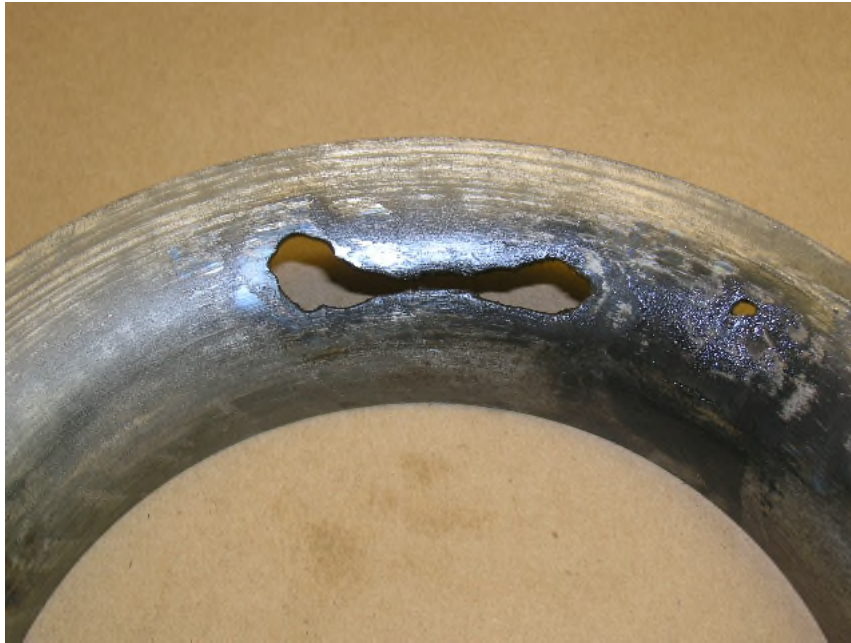
Photo No. 49

Centrifugal impeller shroud, centered at the approximate 7:00 position.

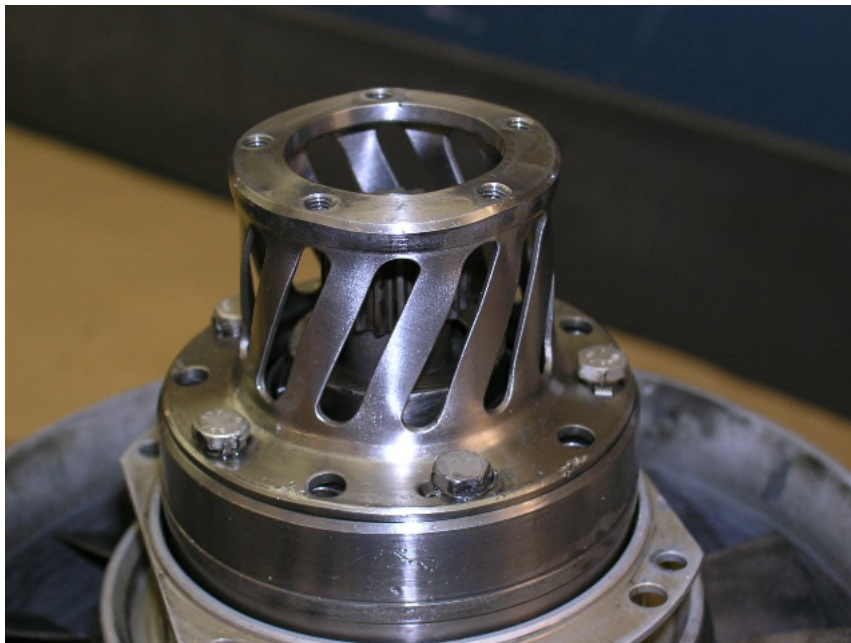
Photo No. 50

**No. 1 Bearing and Air Seals:** The No. 1 bearing displayed no indications of operational distress. The compressor bearing adapter housing forward face was displaced in clockwise torsion approximately 20 degrees in relation to the aft flange. Please refer to photos No. 50 through 52.

Compressor bearing adapter.

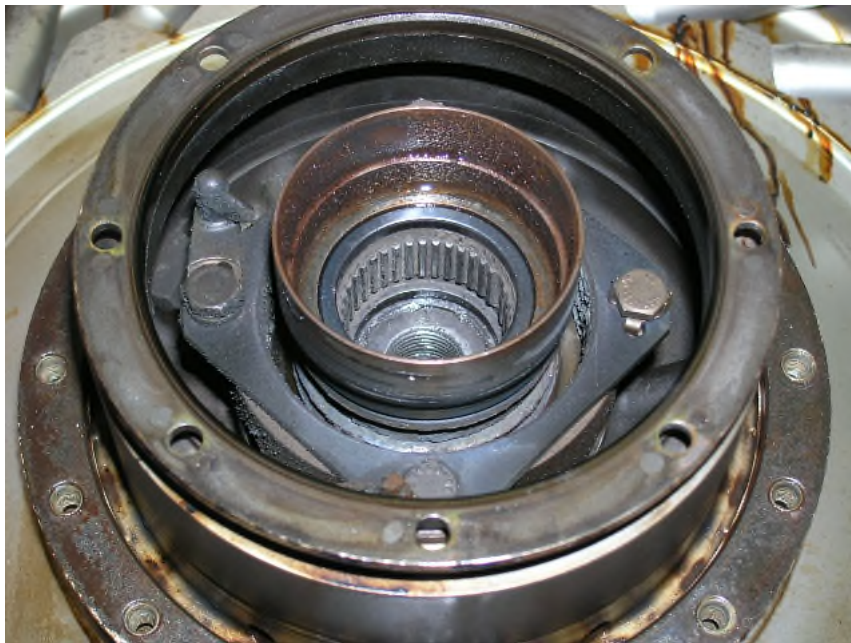
Photo No. 53

**No. 2 Bearing and Air Seals:** P/N 3006146, 3011426, S/N C757. The bearing rolling elements and cage were disintegrated. The compressor stub shaft could be moved radially by hand. The bearing air seal rotors displayed heavy circumferential scoring and machining due to radial contact with the air seal stator knife edges. 12 of the 16 rolling elements were recovered and displayed severe heat oxidation and mechanical damage. The cage was fractured into 5 sections and displayed severe heat oxidation, mechanical damage, and deformation. The bearing inner and outer races were coated with heat fused melted material. P&WC Materials Engineering analysis determined the material fused to the bearing races to show a significant amount of rolling element material under Scanning Electron Microscope - Energy Dispersive X-ray Spectroscopy (SEM-EDS) analysis. Trace amounts of Cadmium was observed on the inner race. The origin of this element could not be identified. Micro structural analysis and SEM-EDS chemical analysis of the bearing races and cage showed the material to be consistent with drawing requirements. The hardness of the inner race and the cage was consistent with drawing requirements. The hardness of the outer race appeared to be compromised by heat exposure. The material and hardness of the rolling elements could not be determined to meet drawing requirements due to their severe heat exposure. The primary mode of the bearing distress could not be determined due to the extent of mechanical and heat damage to all of the components.

No. 2 bearing and air seals, in-situ.

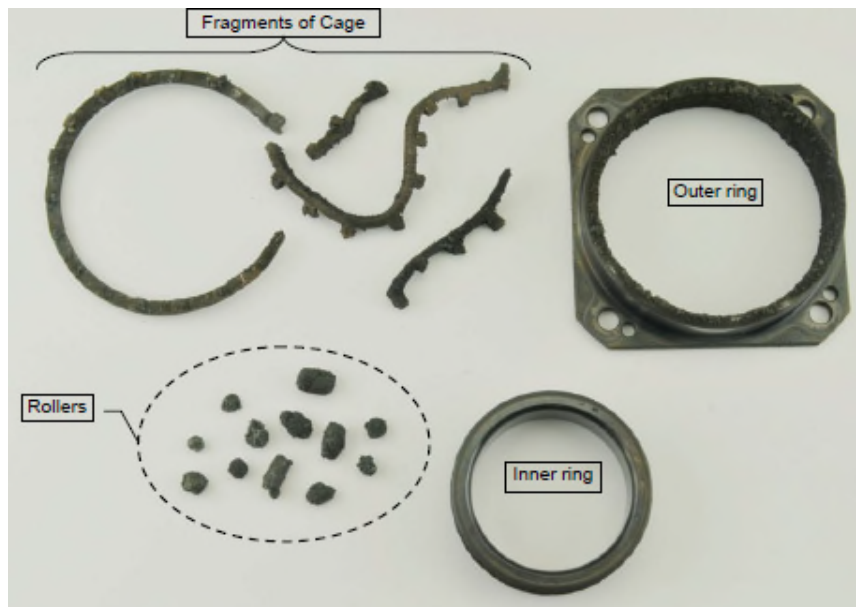
Photo No. 56

The engine gas generator rotor roller bearing (No. 2 bearing) was disintegrated. 12 of the 16 rolling elements were recovered and displayed severe heat oxidation and mechanical damage. The cage was fractured into 5 sections and displayed severe heat oxidation, mechanical damage, and deformation. The bearing inner and outer races were coated with heat fused melted material. Scanning Electron Microscope - Energy Dispersive X-ray Spectroscopy (SEM-EDS) analysis determined the material fused to the bearing races to show a significant amount of rolling element material. Trace amounts of Cadmium were observed on the inner race. The origin of this element could not be identified. Micro structural analysis and SEM-EDS chemical analysis of the bearing races and cage showed the material to be consistent with drawing requirements. The hardness of the inner race and the cage was consistent with drawing requirements. The hardness of the outer race was compromised, likely by heat exposure. The rolling elements material and hardness could not be assessed for conformance to drawing requirements due to their severe heat exposure.

General view of No. 2 roller bearing components. The components were significantly oxidized and exhibited substantial amounts of deposited material. The cage had fractured into several pieces which were deformed and contained deposits of coked oil and molten material. Twelve out of the sixteen rollers were recovered.

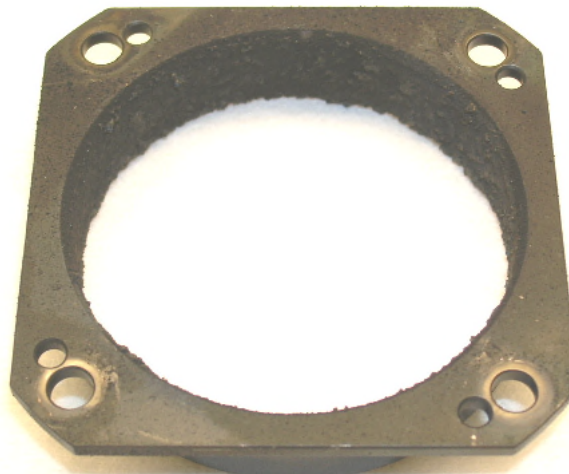
Photo No. 57

No. 2 bearing outer race.

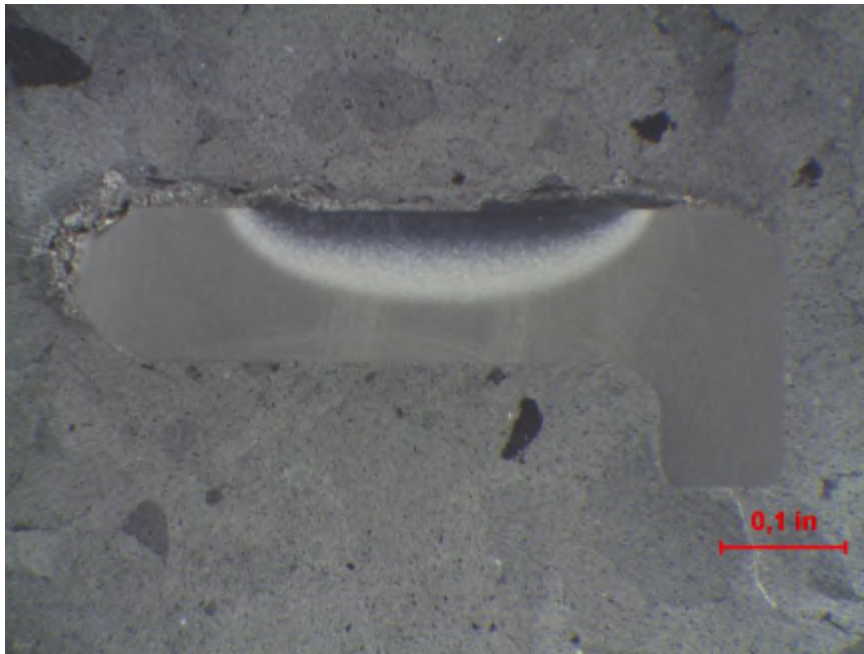
Photo No. 58

View of cross-section through the outer race, showing a significant heat affected region associated with a worn band at the inner surface of the race matching the area of contact with the rollers.

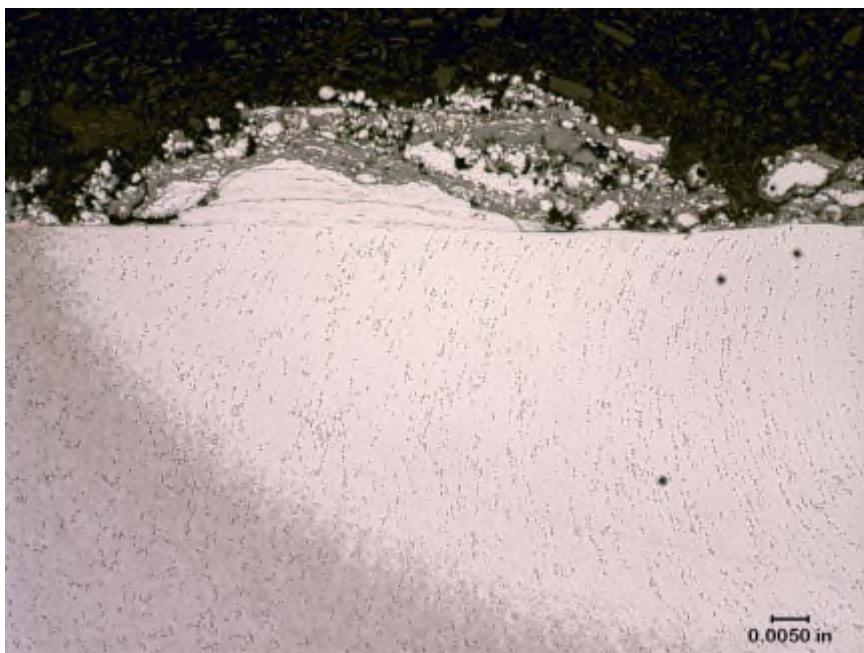
Photo No. 59

Heat fused material on the outer race. SEM-EDS analysis of this material showed material elements characteristic of rolling element and cage material, with phosphorous characteristic of coked engine oil.

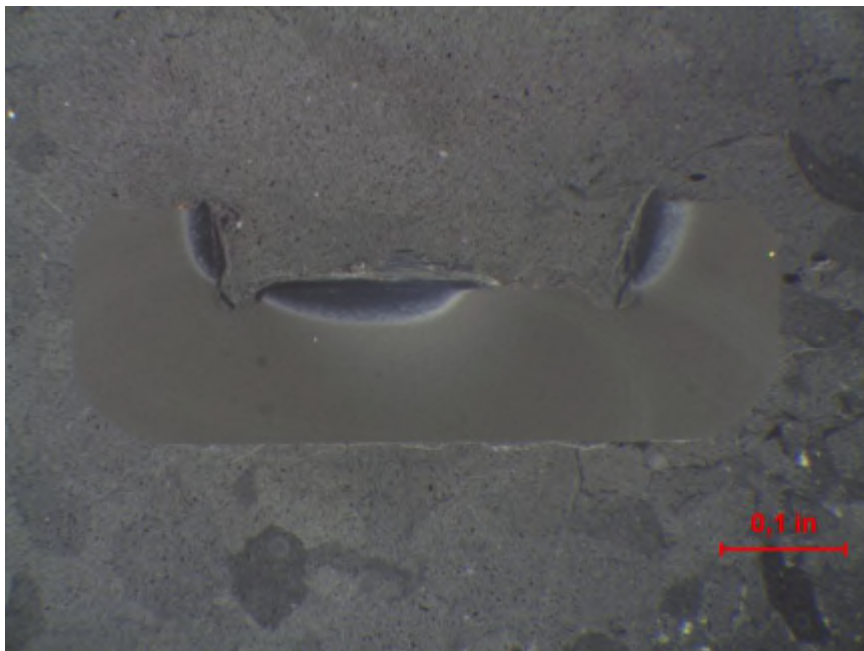
Photo No. 61

View of cross-section through the inner race, showing a significant heat affected region associated with a worn band at the inner surface of the race matching the area of contact with the rollers.

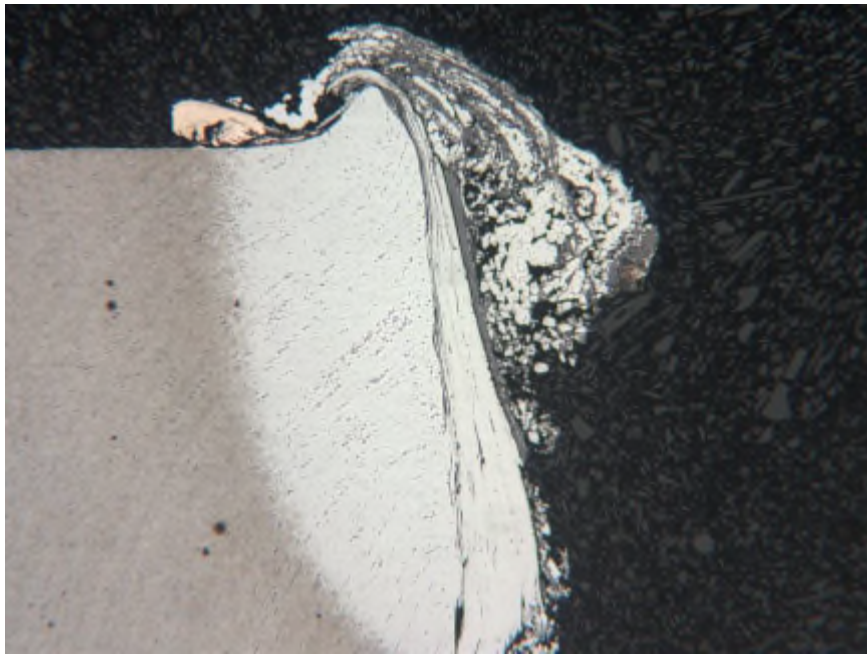
Photo No. 62

Heat fused material on the inner race. SEM-EDS analysis of this material showed material elements characteristic of rolling element and cage material, with Phosphorous characteristic of coked engine oil. Traces of cadmium were identified.

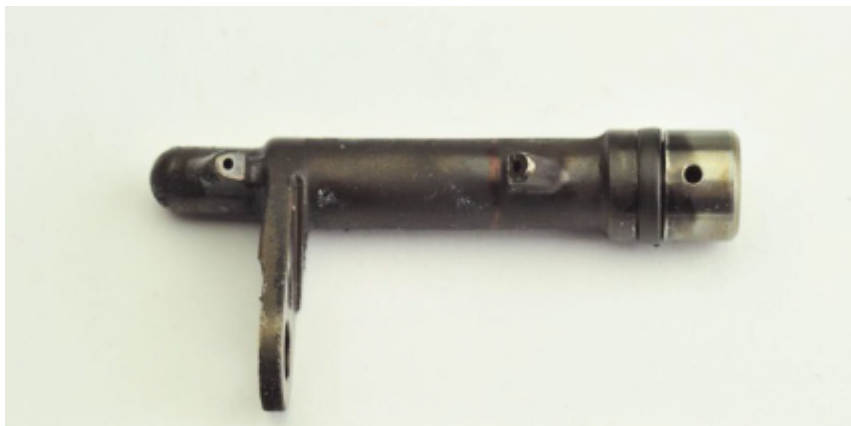
The bearing oil nozzle was flow checked, and the outer nozzle jet was found to be obstructed. SEM-EDS analysis determined the material blocking the jet to correspond to material used in the composition of the bearing races and rollers.

Photo No. 67  
No. 2 bearing oil nozzle.

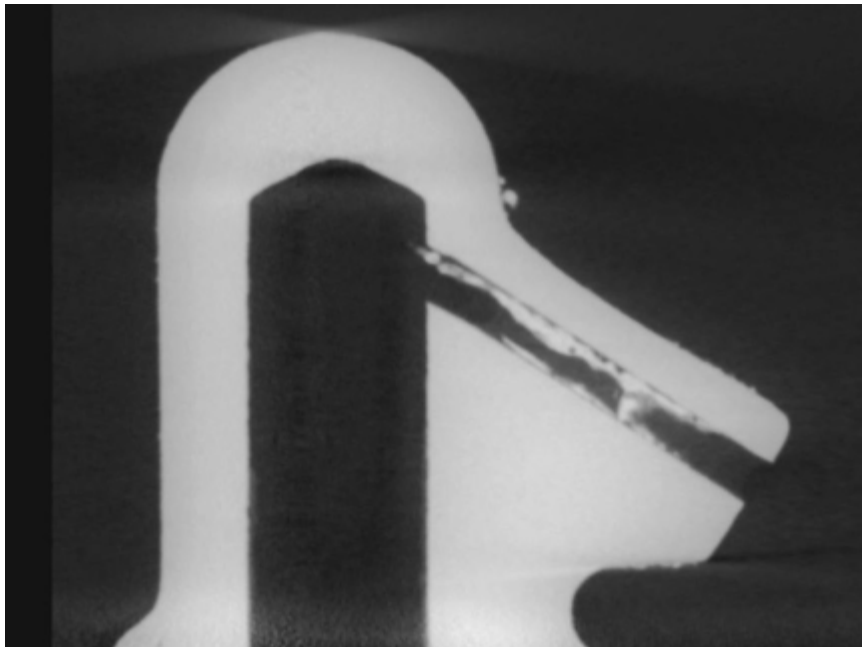
Photo No. 68

The bearing oil nozzle outer jet was found to be obstructed. SEM-EDS analysis determined the material blocking the jet to correspond to material used in the composition of the bearing races and rollers.

X-ray photograph of the No. 2 bearing oil nozzle showing material build up within the top nozzle jet.

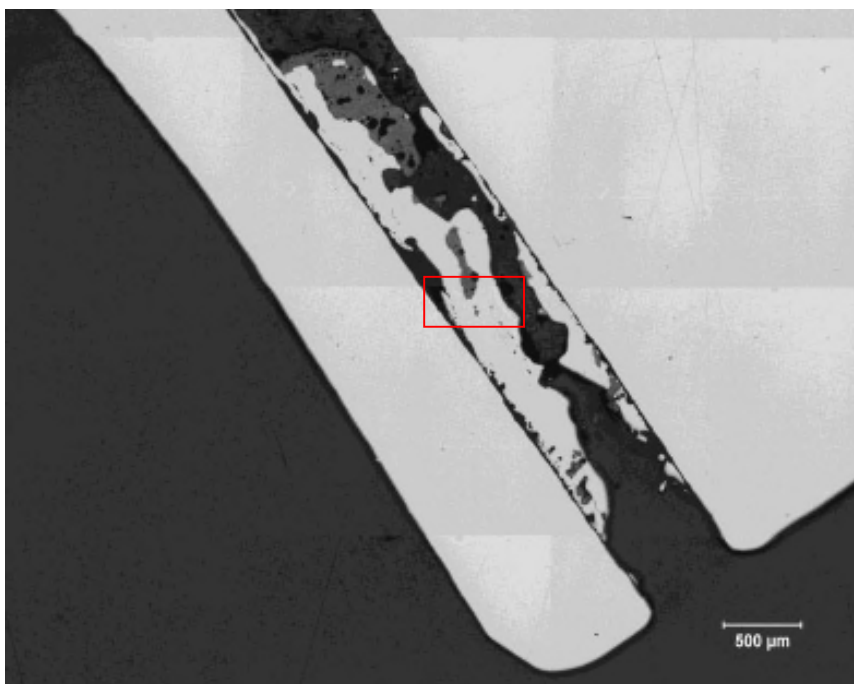
Photo No. 69

Metallographic cross-section through the top nozzle showing the material build-up. SEM-EDS analysis taken in the area marked in red box showed material elements characteristic of bearing race rolling element material.

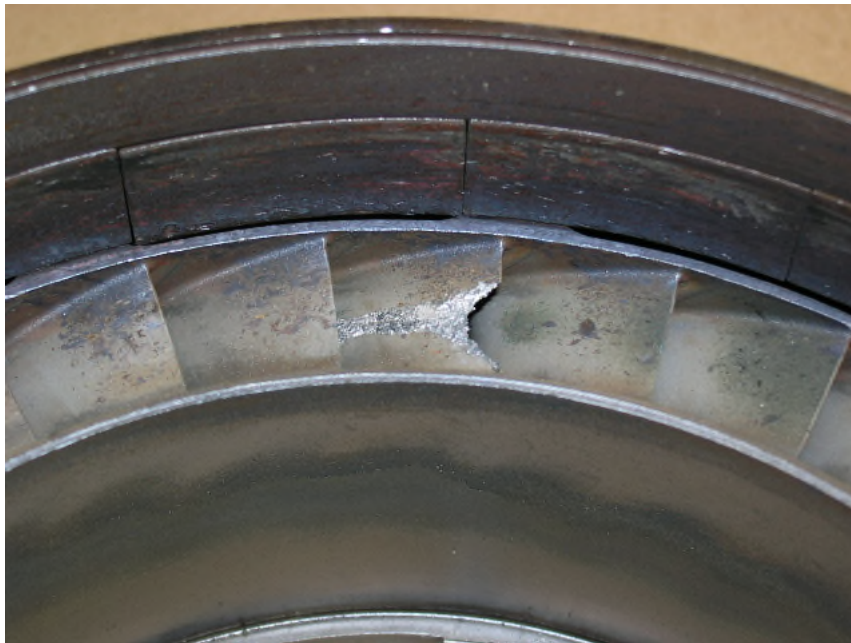
Photo No. 73

**Compressor Turbine Guide Vane Ring:** The vane airfoil leading edges were intact. One vane airfoil at the approximate 8:00 position trailing was eroded, and the vane airfoil showed a bright silver metal deposit characteristic of melted compressor blade or vane material. Please refer to photos No. 71 through 73.

Compressor turbine guide vane ring downstream side and shroud, centered at the approximate 8:00 position.

**Compressor Turbine Shroud:** Displayed circumferential rubbing, with frictional heat discoloration and material transfer, due to contact with the compressor turbine blades. Please refer to photo No. 73.

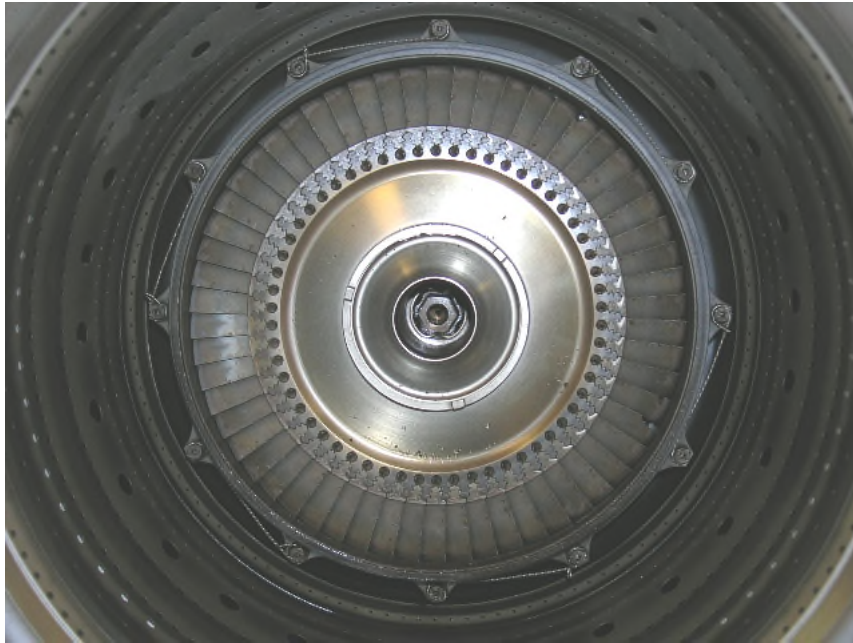
**Compressor Turbine:** The blade airfoils were lightly battered and gouged due to contact with upstream debris. The blade tips displayed circumferential rubbing due to contact with the shroud. Fine silver metal material was heat fused to the airfoil surfaces. The disc downstream side displayed circumferential rubbing due to contact with the power turbine guide vane ring. Please refer to photos No. 74 through 78.

Photo No. 74  
Compressor turbine, in-situ.
