# Continental Motors

## ENGINE FIELD INSPECTION REPORT **FINAL**

| ENGINE MODEL | IO-520-FcD |
| FILE NUMBER | 14-176 |

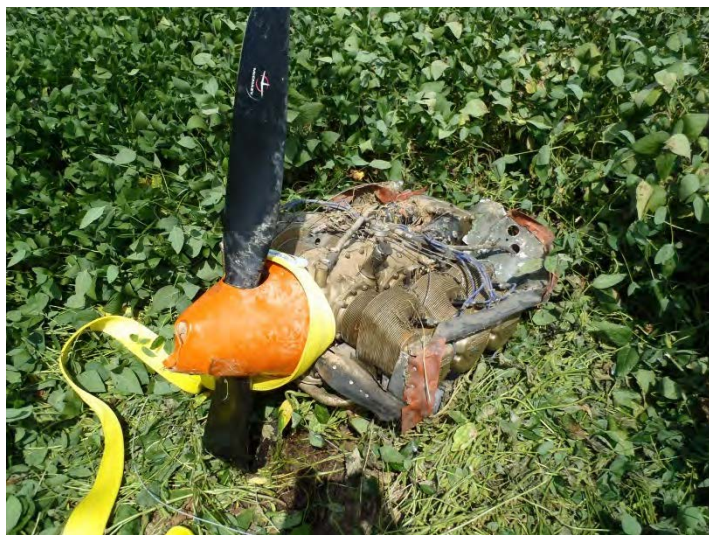
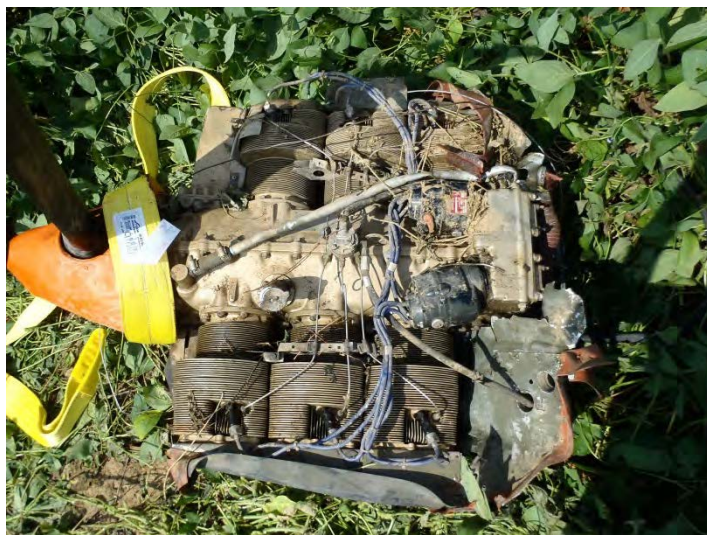
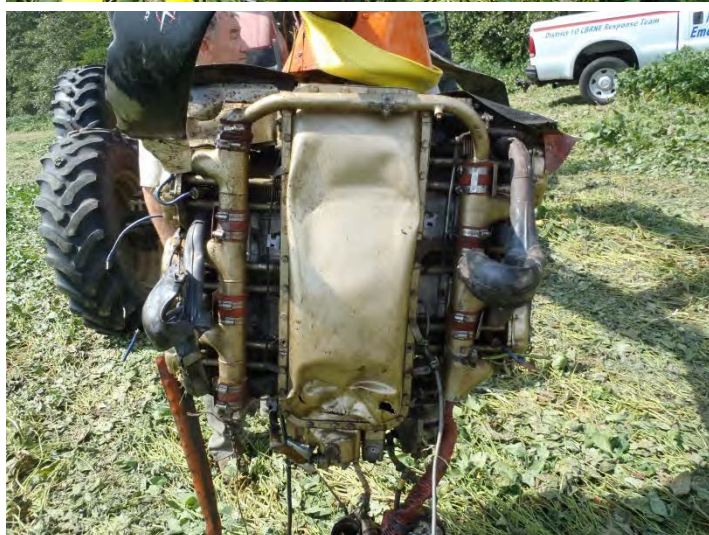
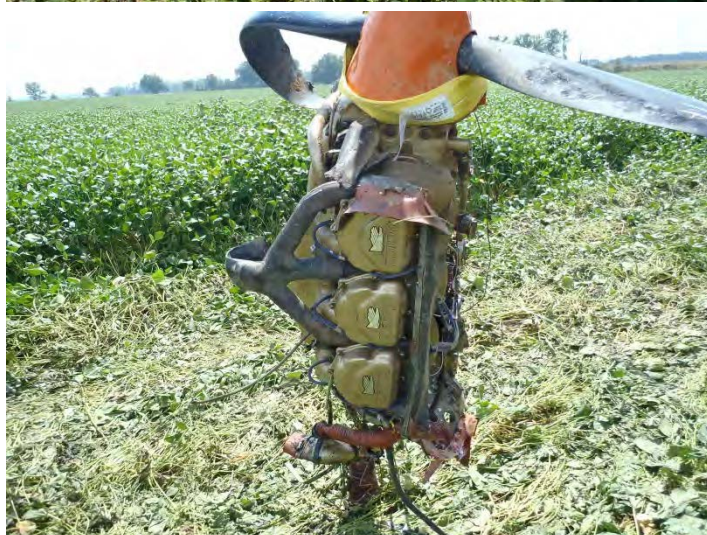
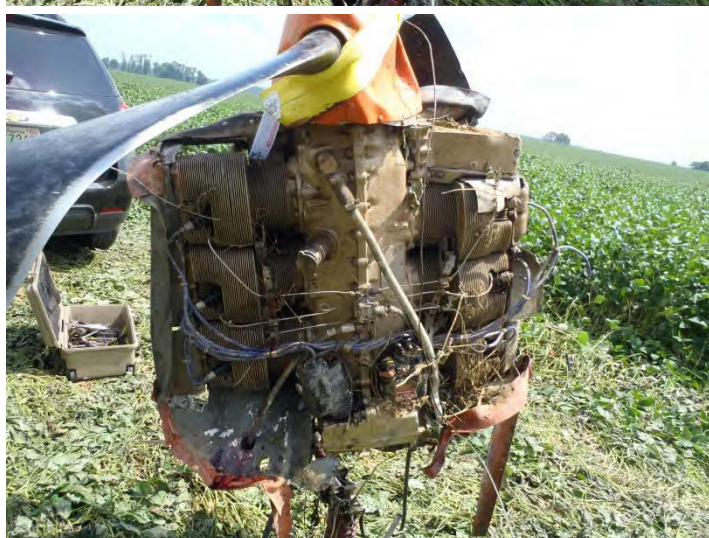
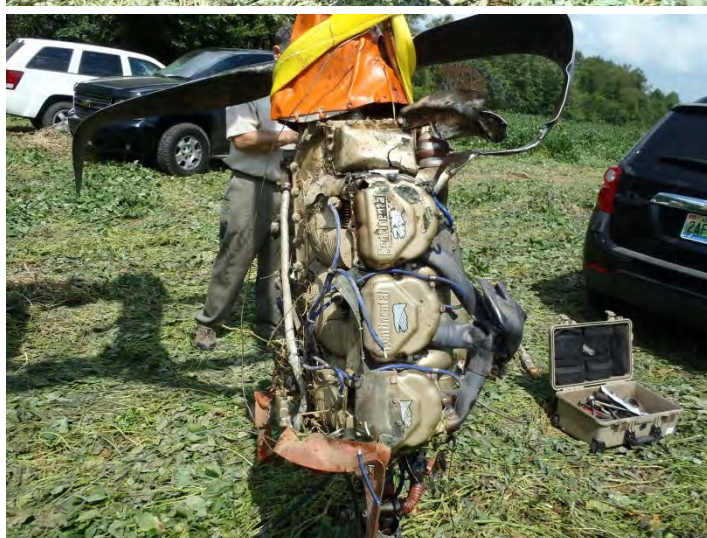
The engine had broken free from the airframe and came to rest approximately 160 feet away from the main wreckage. The engine sustained damage consistent with impact damage concentrated to the front and bottom of the engine. All six cylinders remained attached to the engine and all of the cylinders displayed varying amounts of impact damage. The two blade, variable pitch propeller remained attached to the propeller flange and the propeller flange remained attached to the crankshaft. One of the propeller blades displayed twisting deformation, polishing of the leading edge and propeller tip. The other propeller blade displayed a significant amount of bending deformation towards the rear, twisting, and gouges in the trailing edge of the propeller blade. It was also noted that several branches were found among the trees near the primary wreckage site that were cut at a smooth 45 degree angle.

The left magneto remained partially attached to its respective installation point and displayed damage consistent with impact damage. The right magneto remained attached to its respective installation point and sustained damage consistent with impact damage. The ignition harness displayed impact damage signatures; a couple of the ignition leads were torn or severed. All of the spark plugs remained installed in their respective cylinders and displayed minor impact damage signatures.

The fuel pump remained attached to its respective installation point and displayed damage consistent with impact damage. The throttle body and fuel metering assembly remained partially attached to the engine through fuel lines and displayed damage consistent with impact damage. The fuel manifold valve remained attached to its respective installation point and displayed impact damage signatures to the vent line fitting. All six fuel injectors remained installed in their respective cylinders and there were no defects noted with the injectors.

The intake system sustained damage consistent with impact damage; a few pieces of intake tubing were located along the wreckage path. There were no anomalies noted with the intake system. The exhaust risers remained attached to their respective cylinders and sustained damage consistent with impact damage; the exhaust system was crushed and bent in several locations. There were no anomalies noted with the exhaust system.

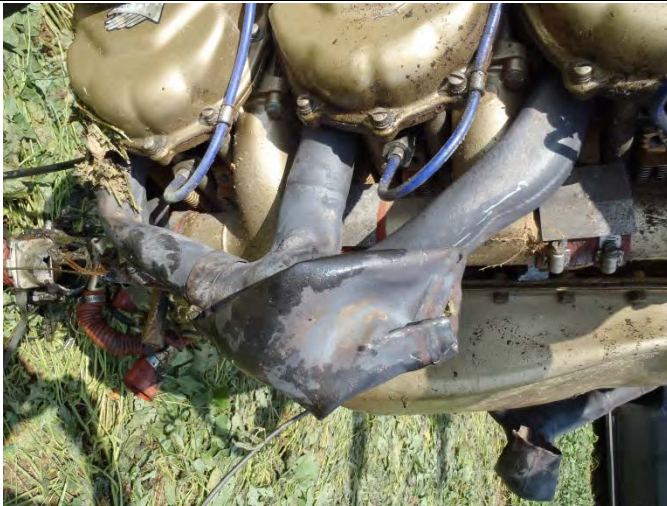
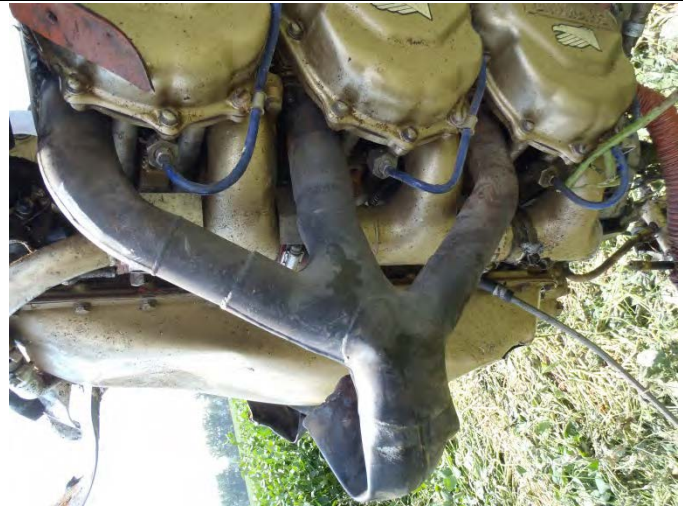
#### EXHAUST SYSTEM

All of the exhaust risers remained attached to their respective cylinders. The exhaust system sustained damage consistent with impact damage; a portion of the exhaust system broke free from the rest of the exhaust and the exhaust risers displayed crushing and bending deformation. There were no anomalies noted with the exhaust.

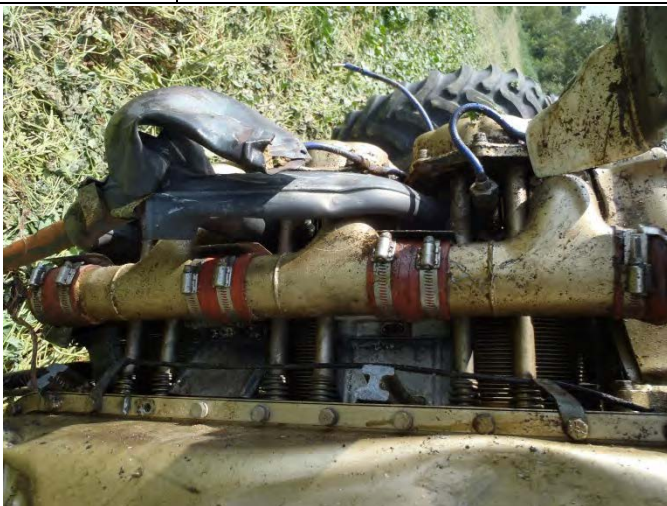
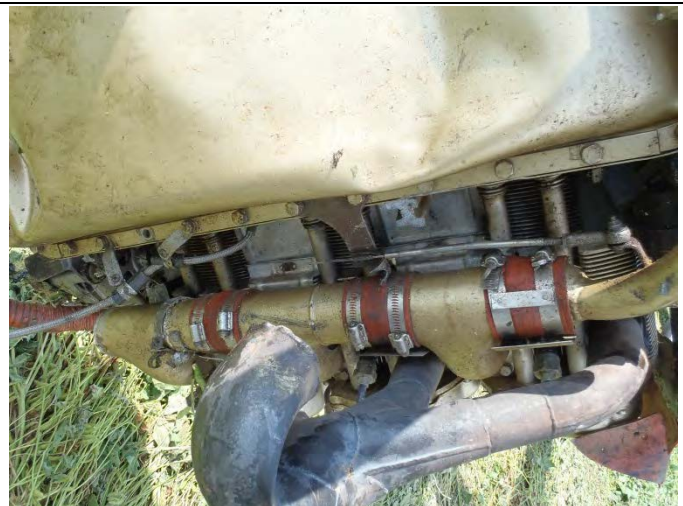
#### INDUCTION SYSTEM

The intake system sustained damage consistent with impact damage; portions of the intake tubing going to the throttle body had broken free and were located along the wreckage path. All of the intake risers remained attached to their respective cylinders. There were no anomalies noted with the intake system.

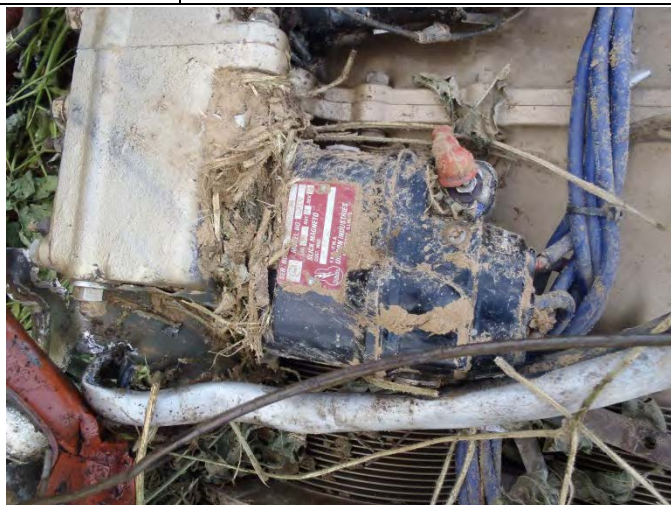
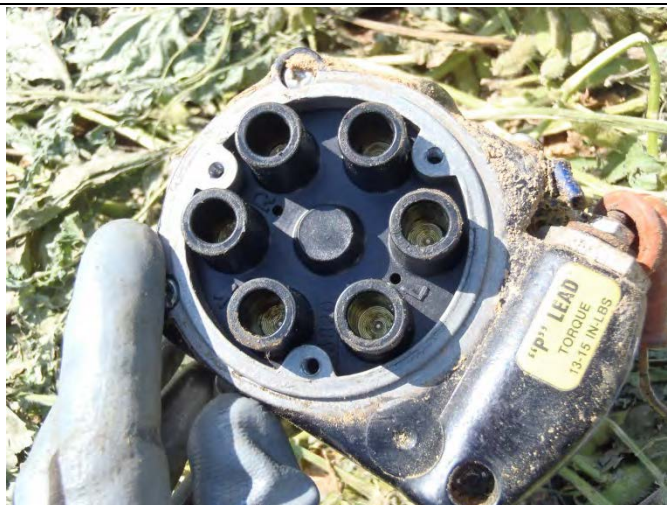
### RIGHT MAGNETO

The magneto remained attached to its respective installation point and sustained damage consistent with impact damage. The magneto was removed from the engine and the magneto drive was spun by hand; it was noted that the magneto was capable of creating a spark on each of the six posts when the impulse coupling was engaged.

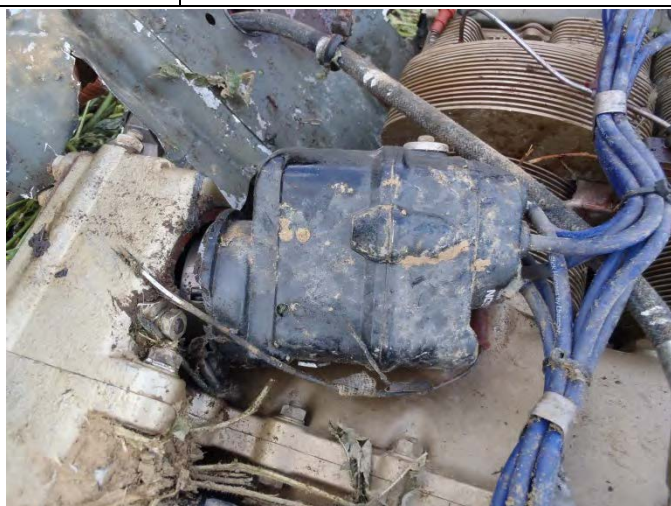
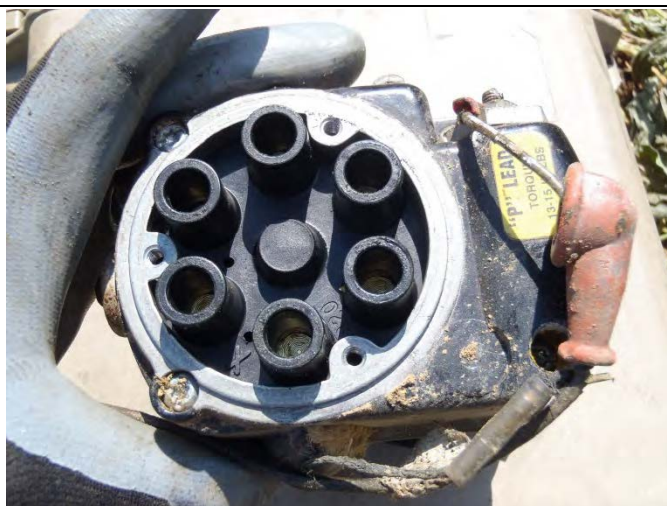
### LEFT MAGNETO

The magneto remained partially attached to its respective installation point and sustained damage consistent with impact damage. The magneto was removed from the engine and the magneto drive was spun by hand; it was noted that the magneto was capable of creating a spark on each of the six posts when the impulse coupling was engaged.

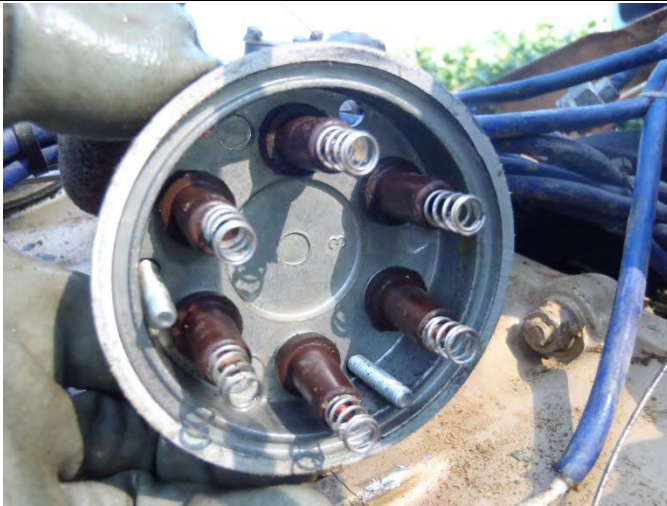
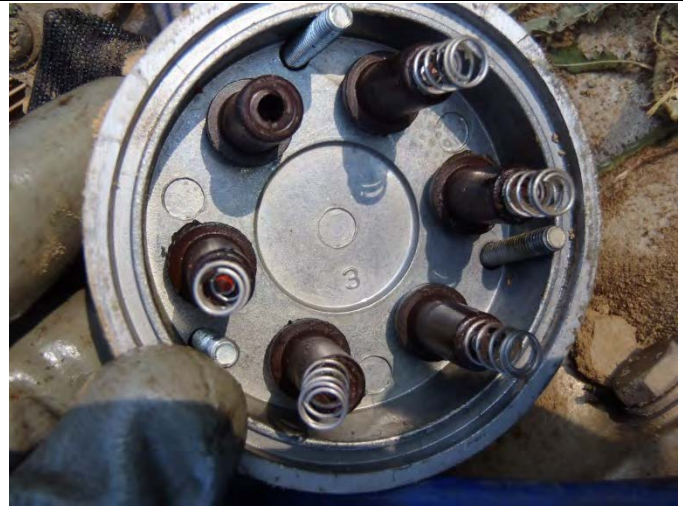
| Condition: | The ignition harness sustained damage consistent with impact damage; several of the ignition leads were torn and severed. It was noted one of the metal spring contacts for the right distributor cap fell out when it was removed from the magneto. There were no further anomalies noted with the ignition harness. | | |

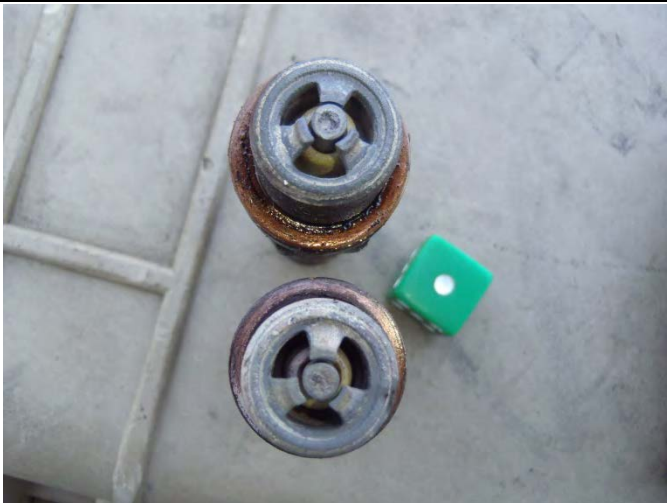
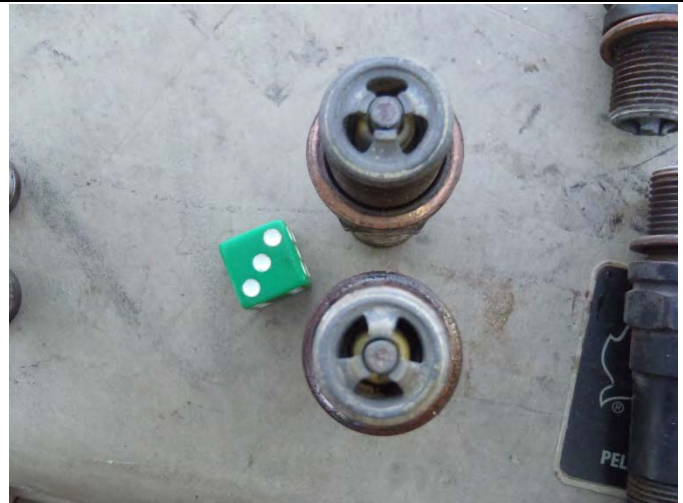
| Condition: | All of the spark plugs remained installed in their respective cylinders. All of the spark plugs were removed and visually inspected. All of the spark plugs displayed normal operating signatures. | |

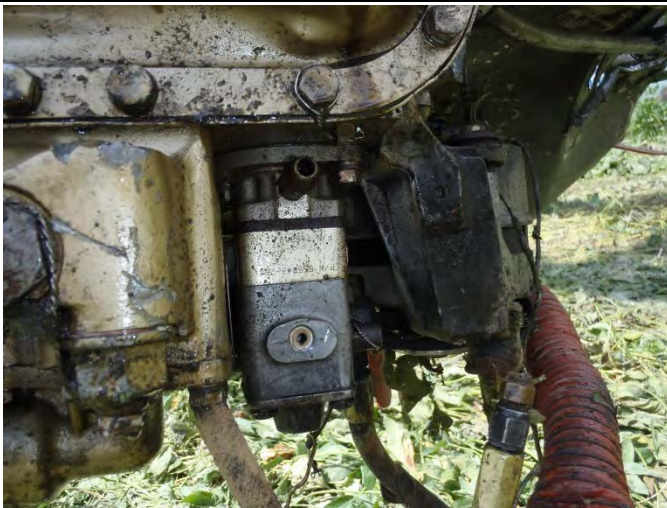
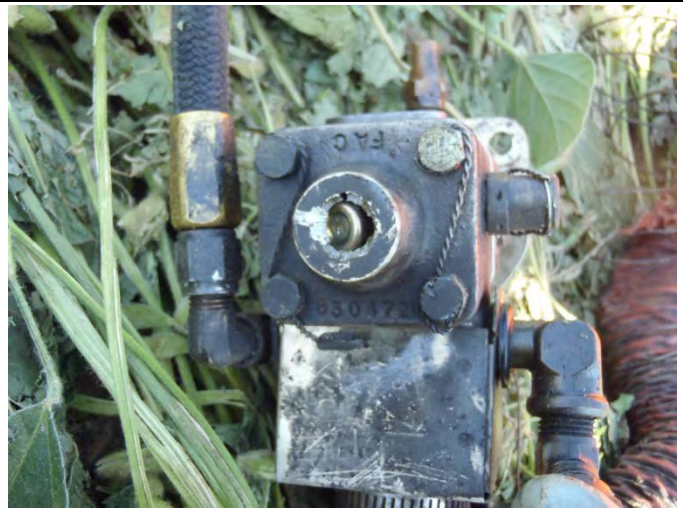
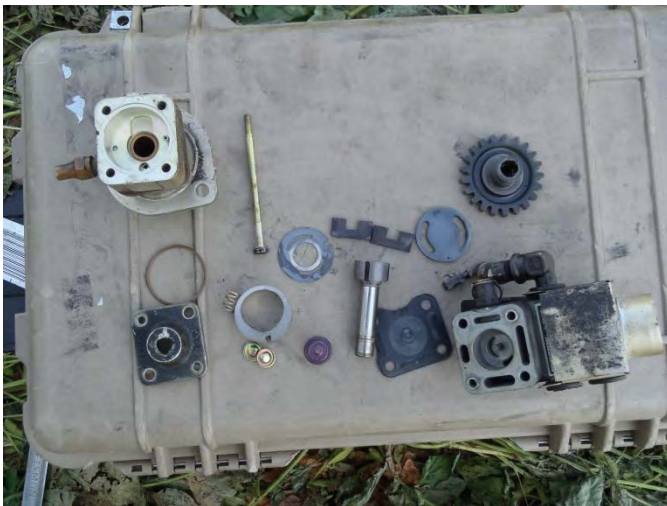
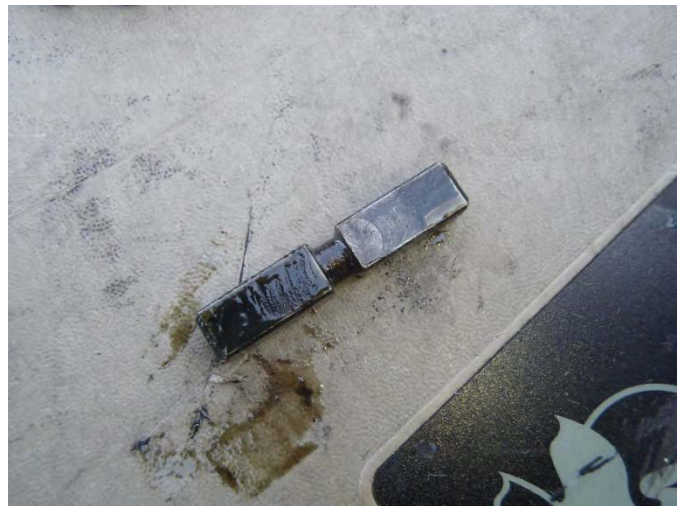
### FUEL PUMP

The fuel pump remained installed in its respective installation point and had sustained damage consistent with impact damage. The fuel pump was removed from the engine and it was noted that the fuel pump drive coupling was intact. The fuel pump drive was rotated by hand and it was noted the fuel pump drive rotated normally. The fuel pump was disassembled and the internal components were visually inspected; the internal components displayed normal operating signatures. There were no anomalies noted with the fuel pump.

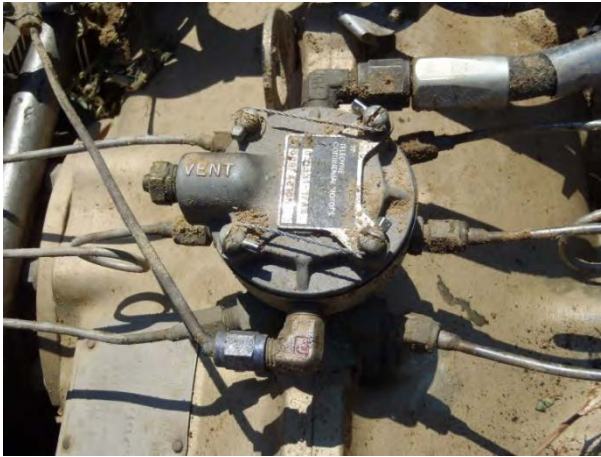
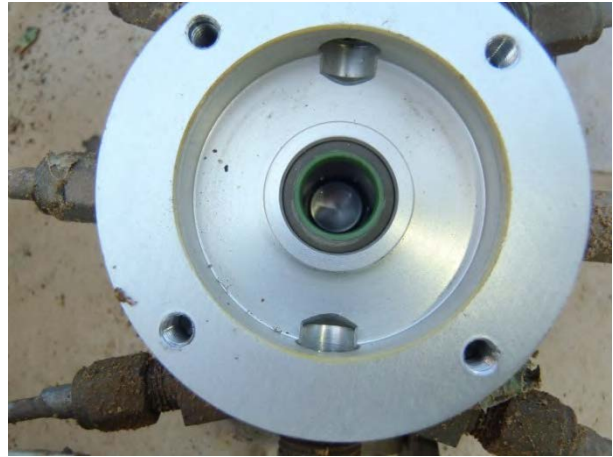
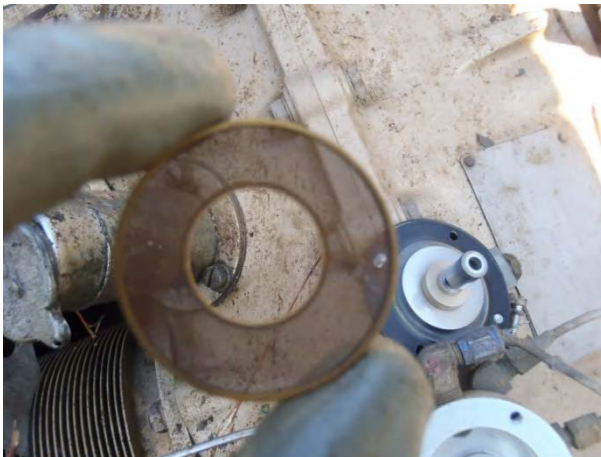
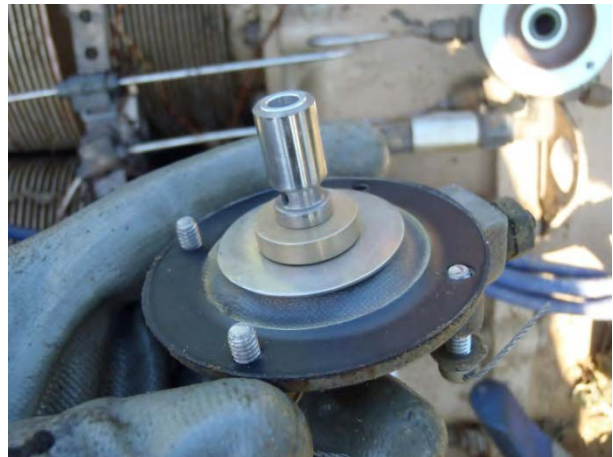
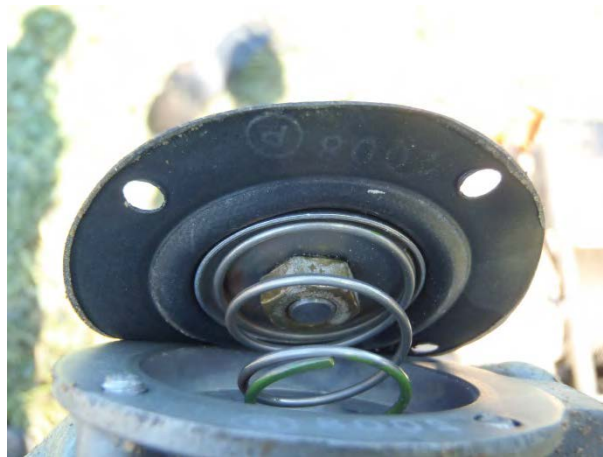
## FUEL MANIFOLD VALVE

The fuel manifold valve remained attached to its respective installation point and displayed impact damage to the manifold vent fitting. The fuel manifold valve was disassembled and the internal components were visually inspected. The internal components displayed normal operating signatures; there were no anomalies noted with the manifold valve.

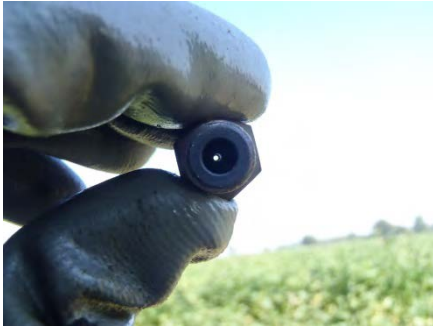
| Position | #1 | #3 | #5 | #2 | #4 | #6 |
|---|---|---|---|---|---|---|
| Condition: | All of the fuel injectors remained installed in their respective cylinders and were undamaged. The fuel injectors were removed and visually inspected. All of the injectors were clear of blockages. It was noted that several of the injectors were installed in the incorrect cylinders according to the fuel injector part numbers. | | | | | |

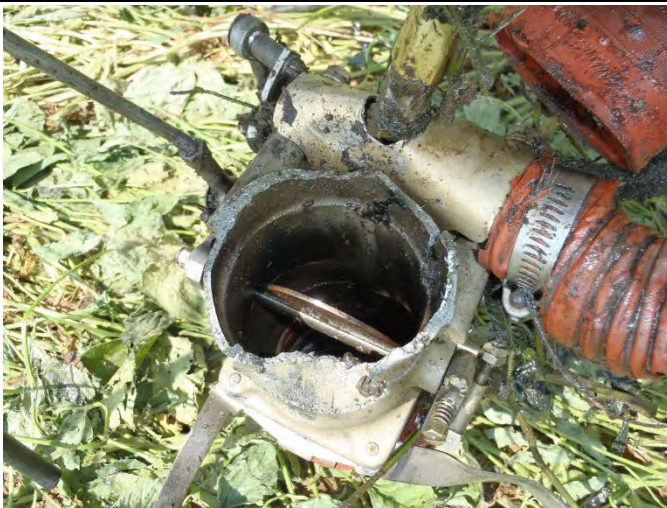
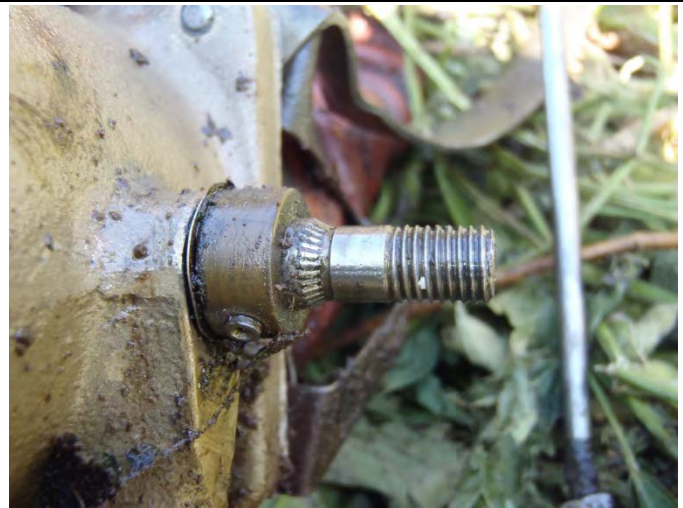
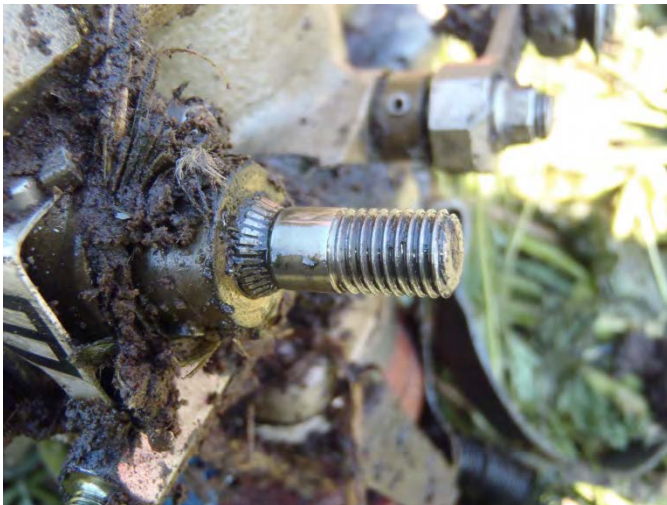
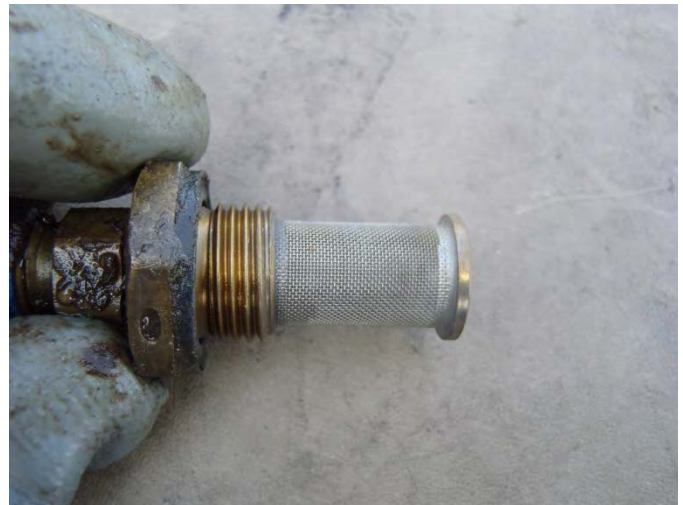
## THROTTLE BODY METERING UNIT

The throttle and fuel metering assembly remained attached to the engine only through fuel lines and had sustained damage consistent with impact damage. The fuel return AN elbow had broken free from the fuel metering unit and the throttle body had several pieces that had broken free. It was noted that both the mixture and the throttle control arms were free moving around their respective control shafts. The control arms were removed and the splines for both controls displayed smearing consistent with the splines being overloaded. The fuel inlet screen was removed and it was noted there were no contaminants within the fuel screen. There were no anomalies noted with the assembly.

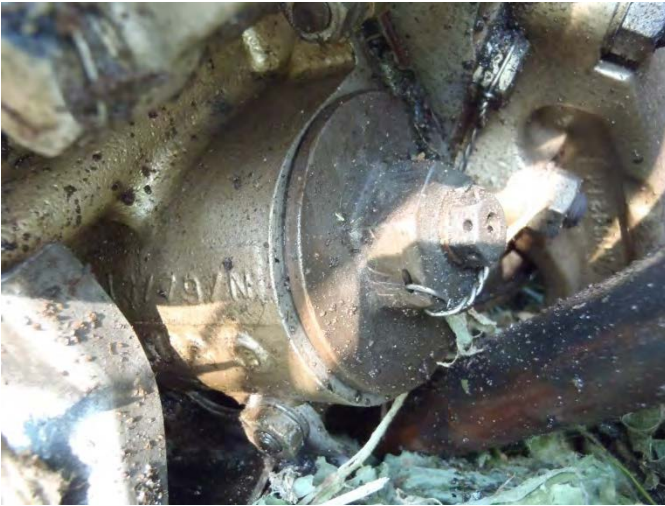
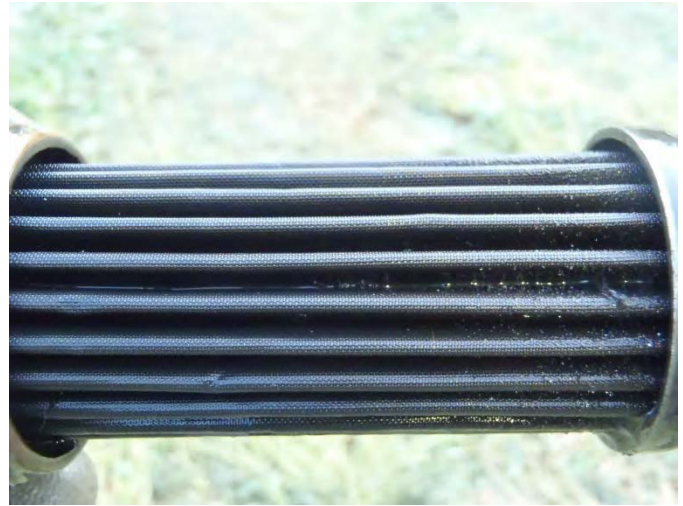
#### OIL SCREEN

The oil screen was removed from its respective installation point. The screen pleats were visually inspected; it was noted there was a minor amount of carbon within the screen pleats. There were no anomalies noted.

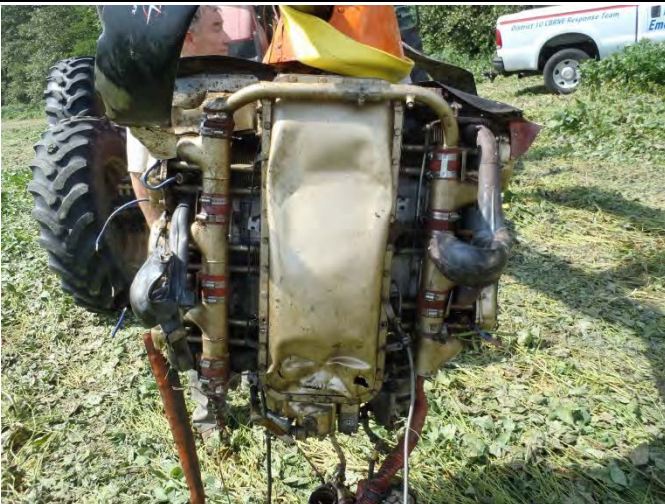
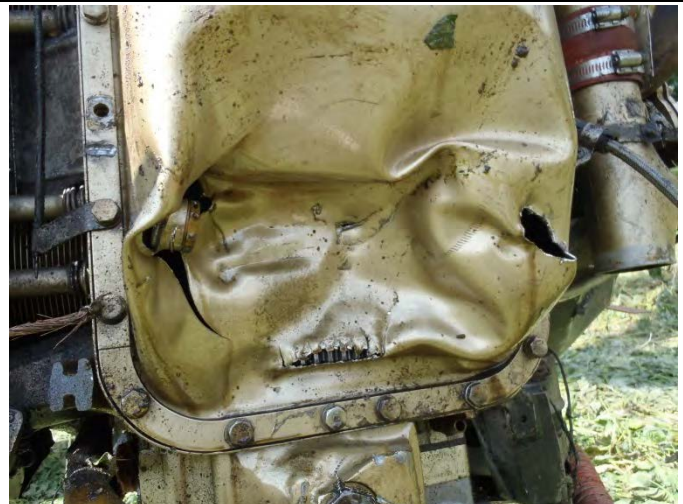
#### OIL SUMP

The oil sump sustained a significant amount of damage consistent with impact damage. The oil sump was crushed and was breached; there were no anomalies noted with the oil sump.

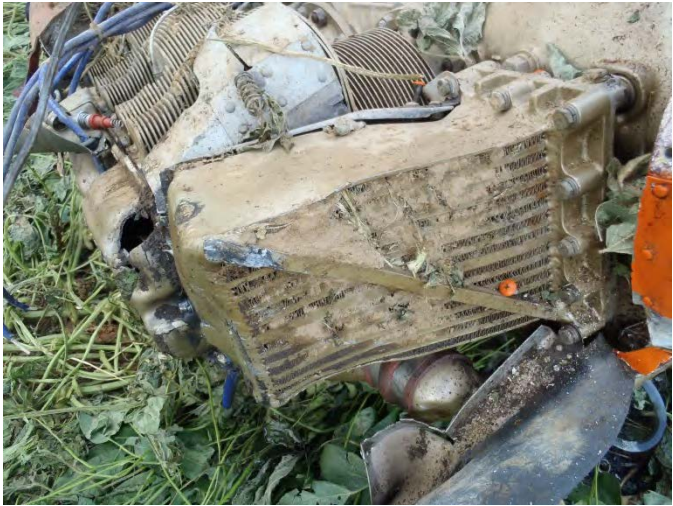
| Condition: | The oil cooler remained attached to the engine and sustained a significant amount of damage consistent with impact damage. There were no anomalies noted with the oil cooler | | |

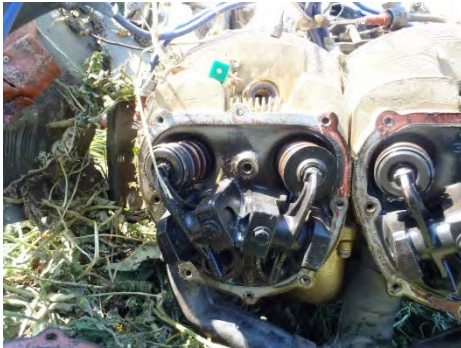
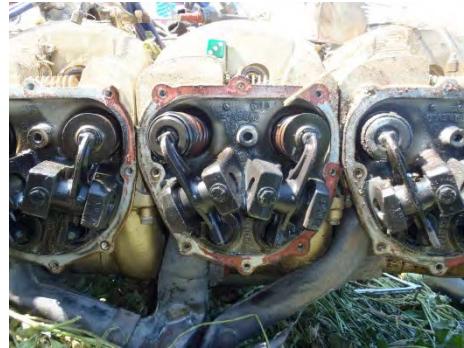
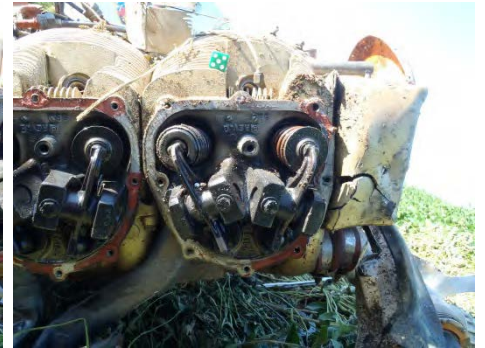
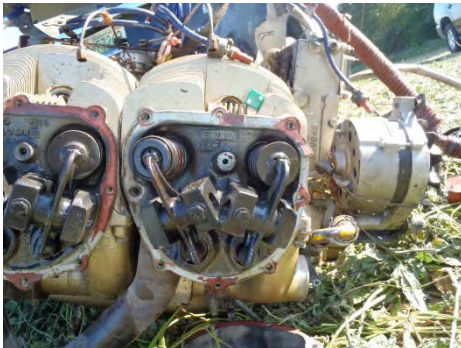
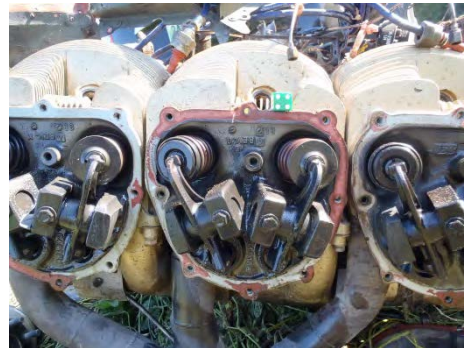
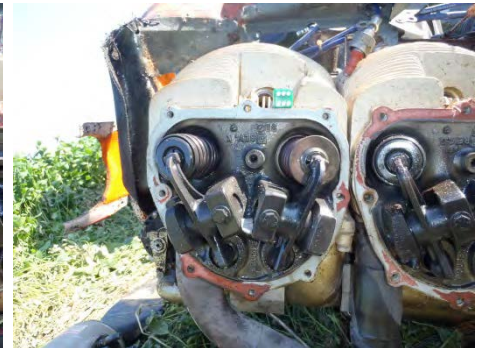
## CYLINDERS

Condition: All of the cylinders remained attached to their respective installation points and displayed varying degrees of impact damage signatures. The cylinders were inspected using a borescope; the cylinder bores, piston heads, and valve heads displayed normal operating signatures. The crankshaft was rotated and it was noted that all six cylinders displayed thumb compression and suction. There were no anomalies noted with the cylinders.

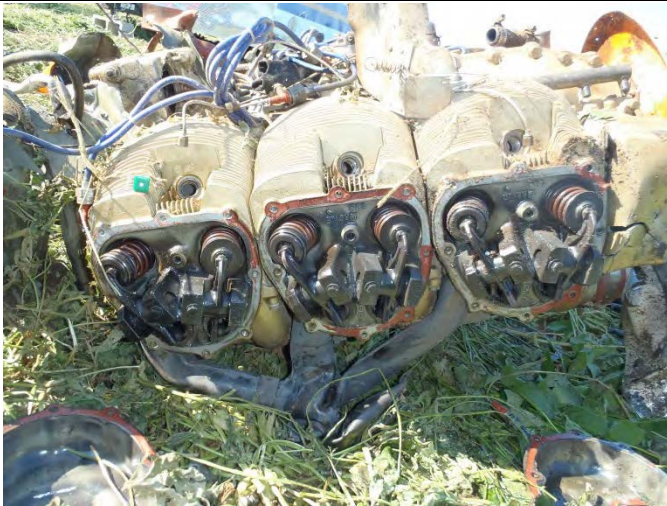
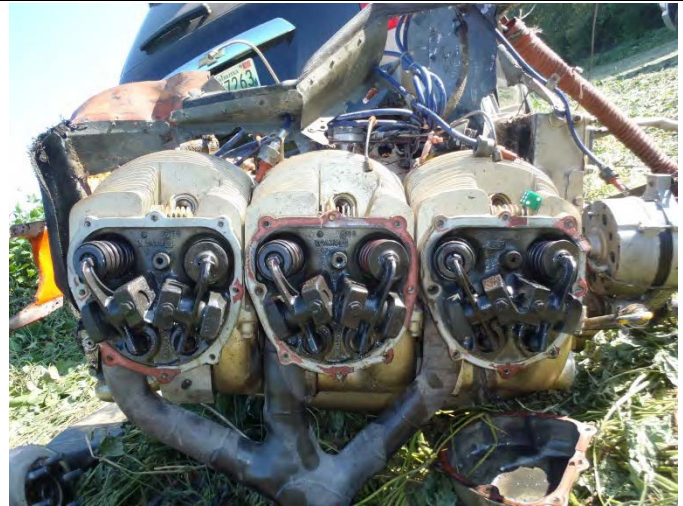
## ROCKER ARMS AND SHAFTS

All of the rocker arms were visually inspected; the rocker arms displayed normal operating signatures. All of the rocker arms operated normally during crankshaft rotation; there were no anomalies noted with any of the rocker arms.

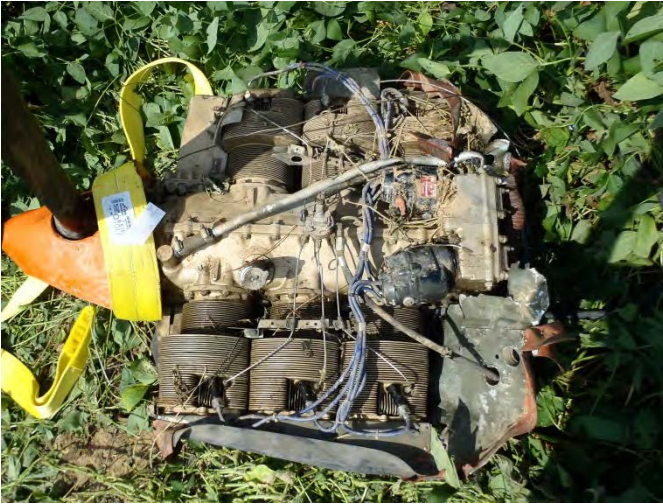
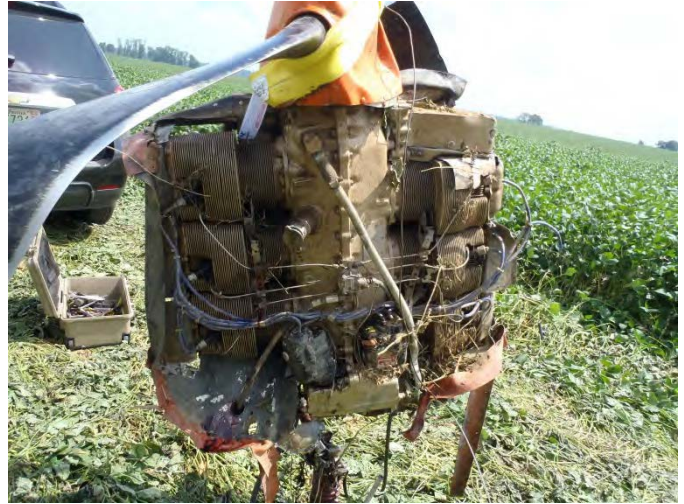
| Condition: | The crankcase remained intact and sustained only minor impact damage. There were no anomalies noted with the crankcase. | | | |

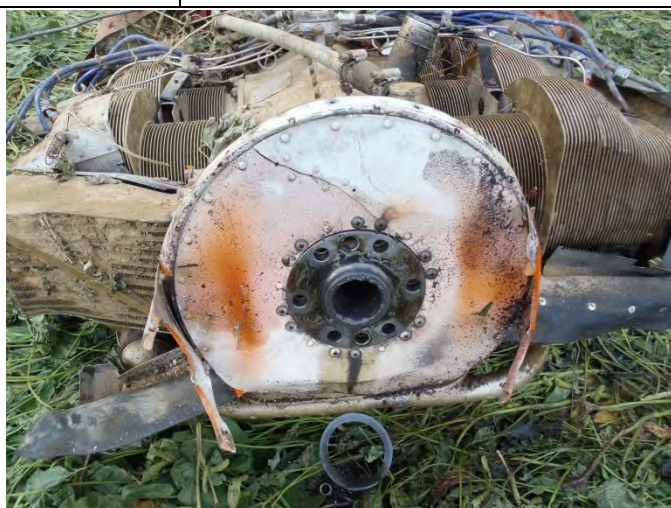
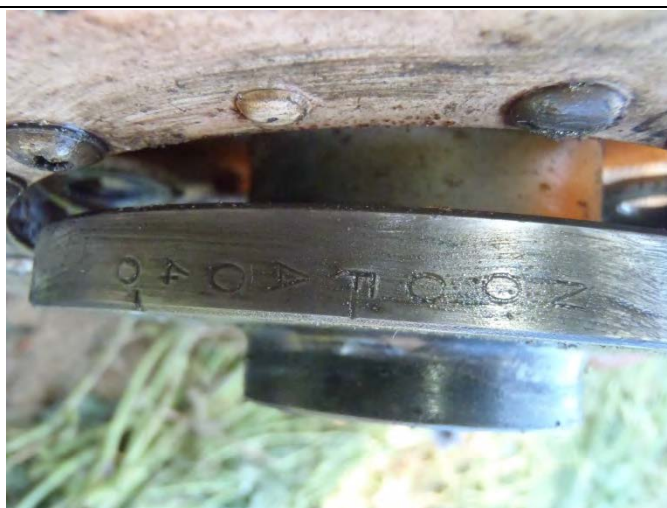
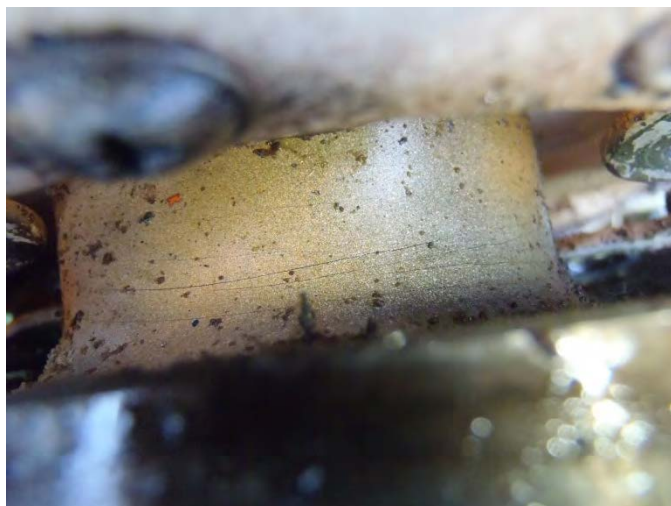
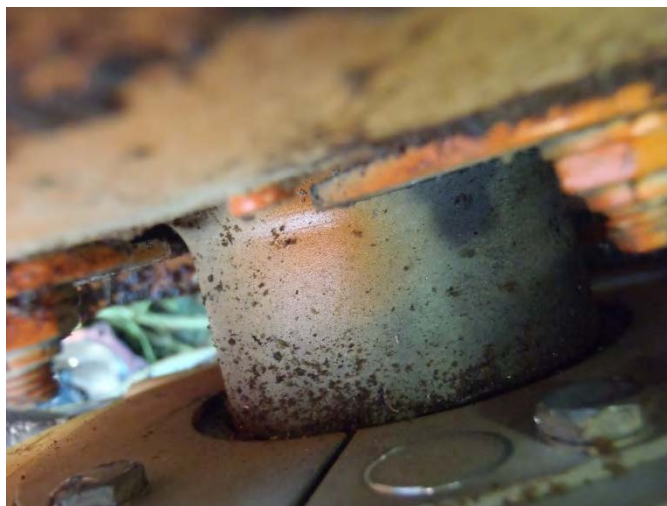
### CRANKSHAFT

The crankshaft remained intact and displayed impact damage signatures; there were several cracks noted aft of the propeller flange. The propeller was removed from the crankshaft and the crankshaft was rotated by hand; continuity was established between the crankshaft, camshaft, connecting rods, and associated components. There were no anomalies noted with the crankshaft.

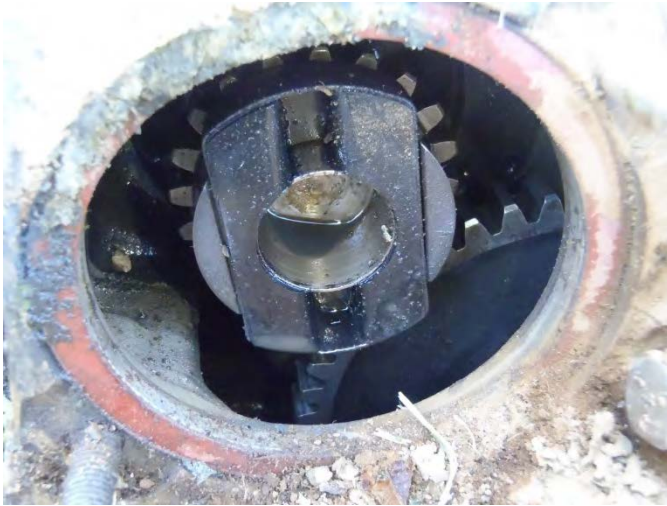
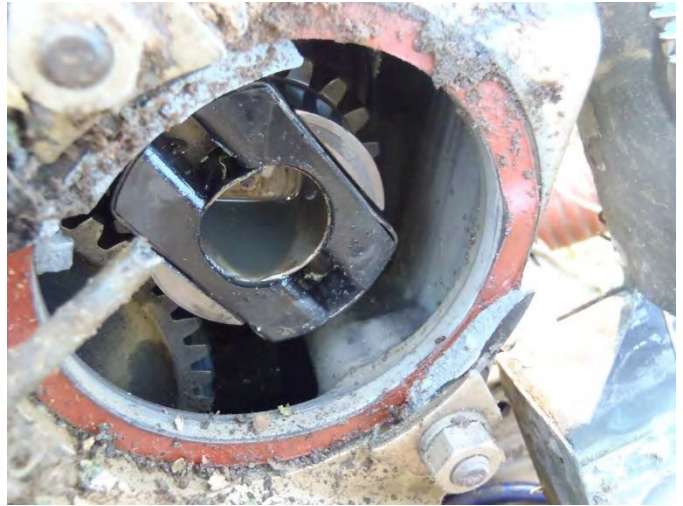
Operation of the camshaft was verified by rotating the crankshaft and observing rocker arm movement. The camshaft operated normally.

All of the visible accessory gears operated normally. There were no anomalies noted.

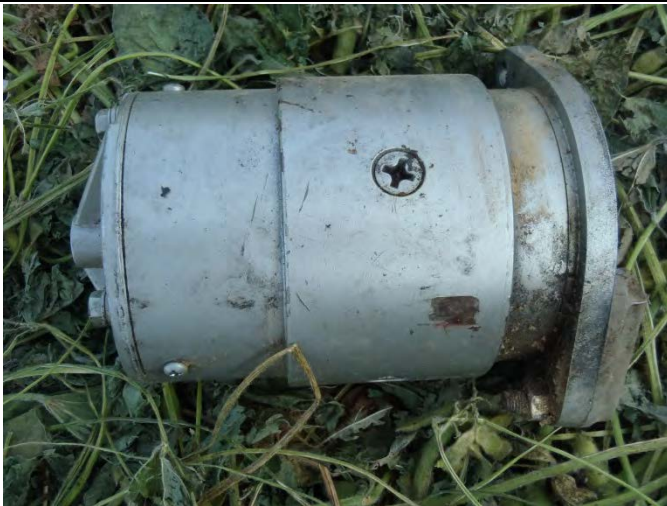
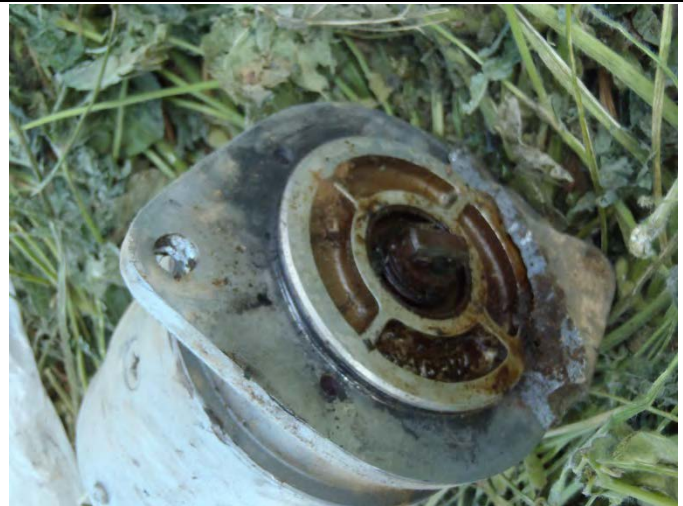
### STARTER

The starter had broken free from the starter adapter and displayed impact damage signatures. There were no anomalies noted with the starter.

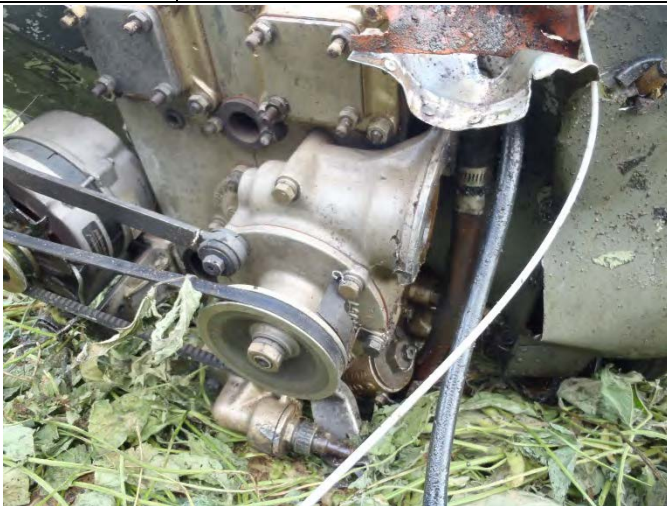
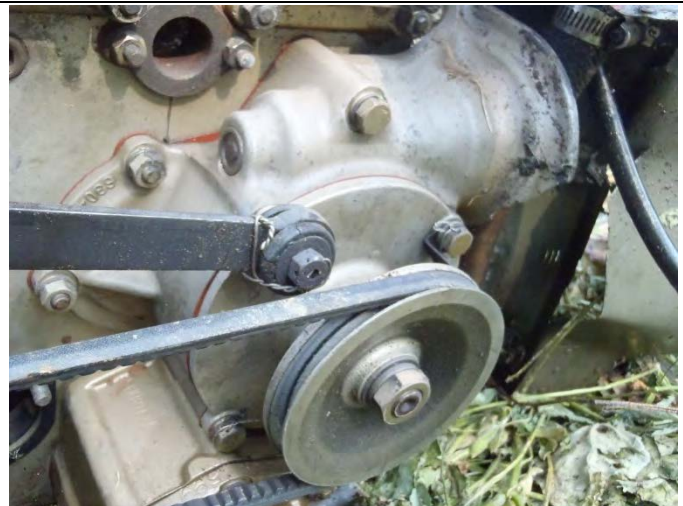
### STARTER ADAPTER

The starter adapter sustained damage consistent with impact damage. There were no anomalies noted with the starter adapter.

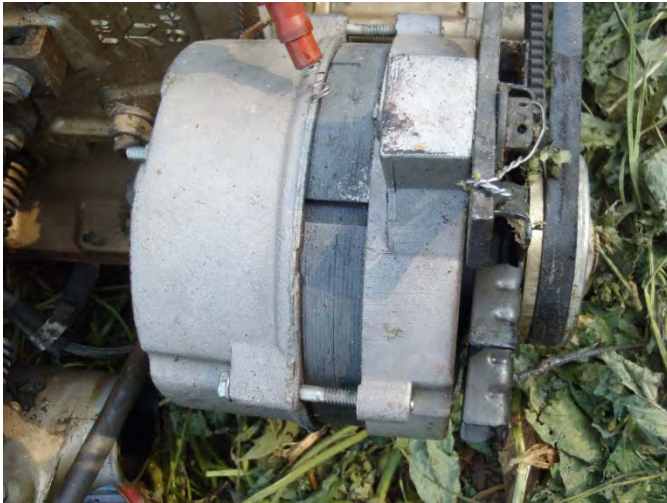
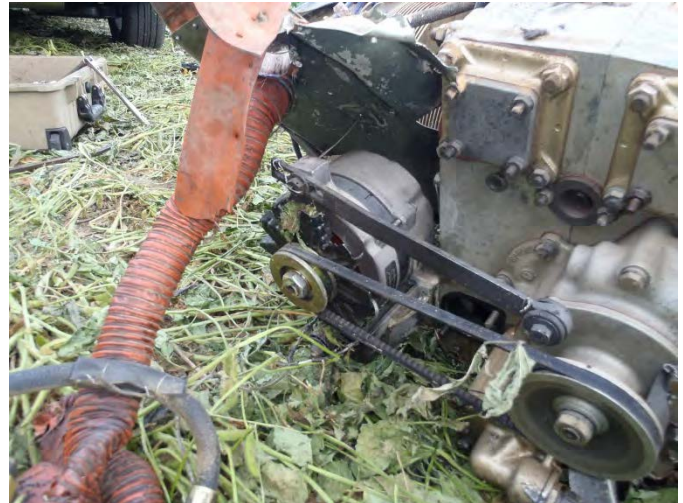
## ALTERNATOR

The alternator remained attached to its respective installation point and the alternator drive belt remained intact. The alternator was capable of rotating freely by hand. There were no anomalies noted with the alternator.

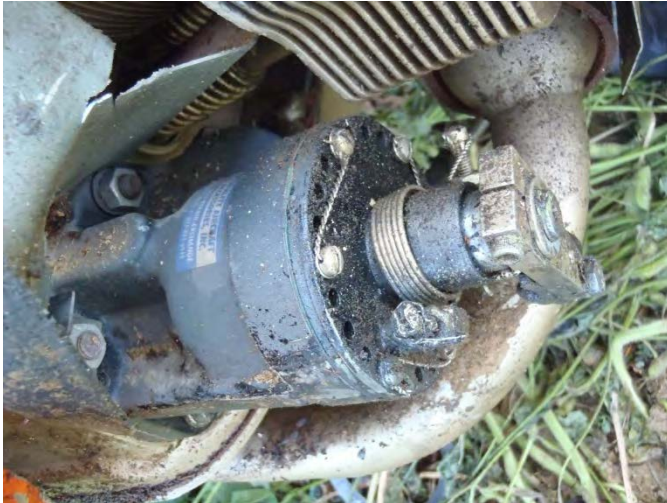
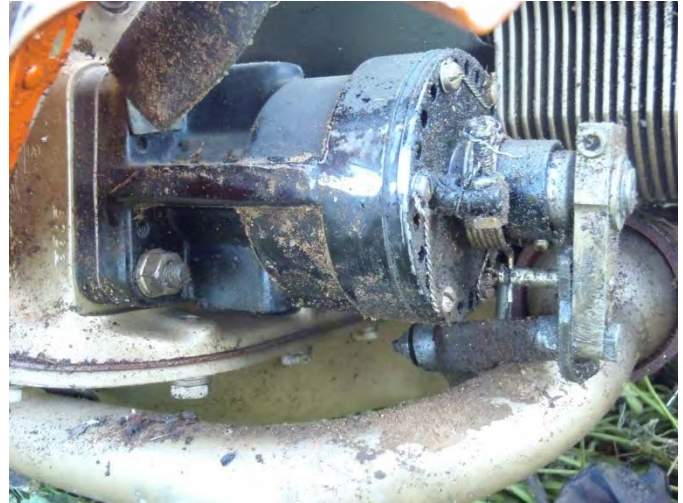
The propeller governor remained attached to its respective installation point and displayed minor impact damage signatures. There were no anomalies noted with the propeller governor.
