# Continental Motors

## ENGINE FIELD INSPECTION REPORT **FINAL**

| ENGINE MODEL | IO-520-FcD |
| FILE NUMBER | 14-176 |

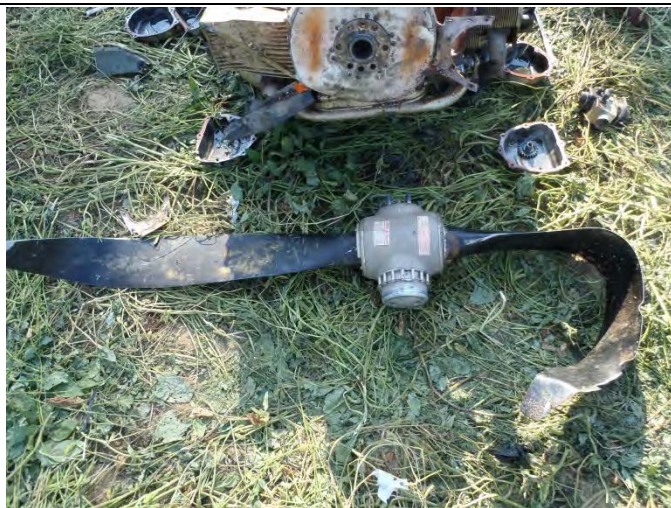
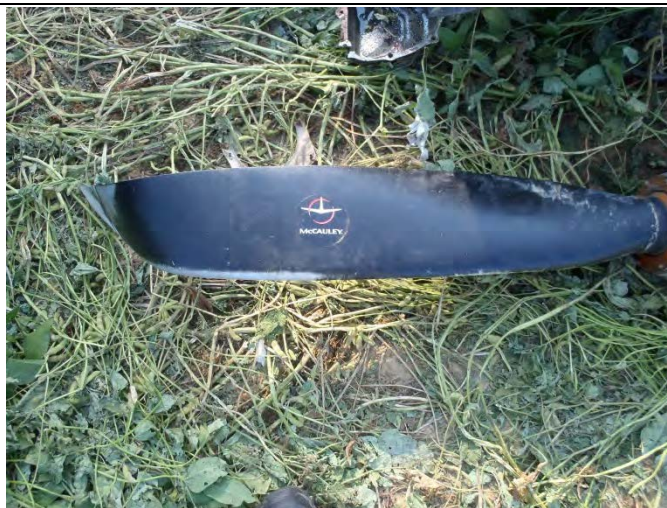
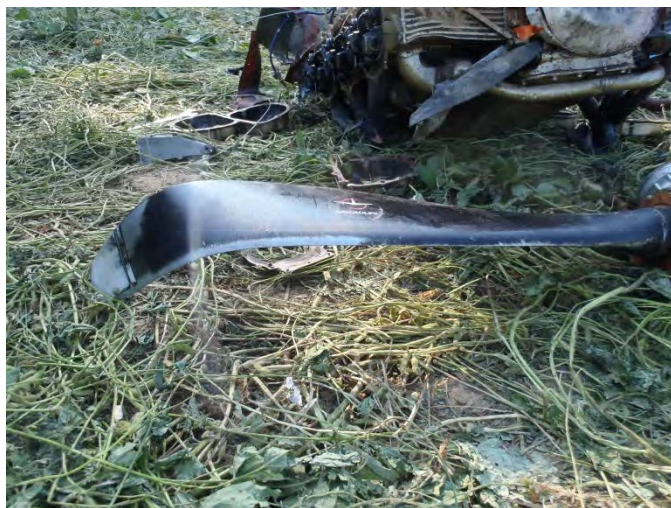
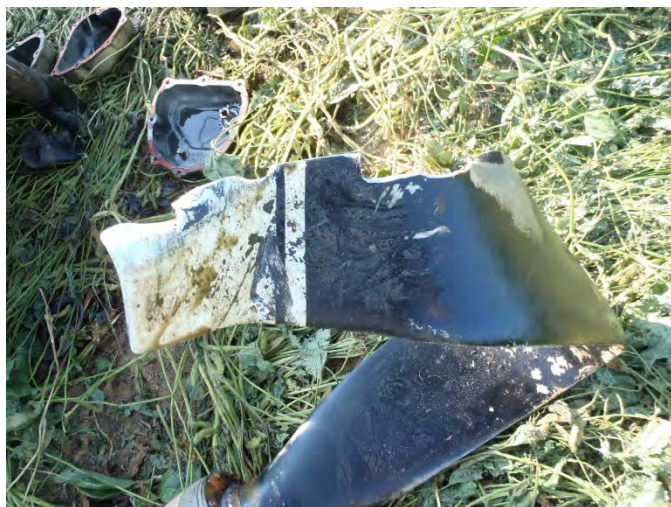
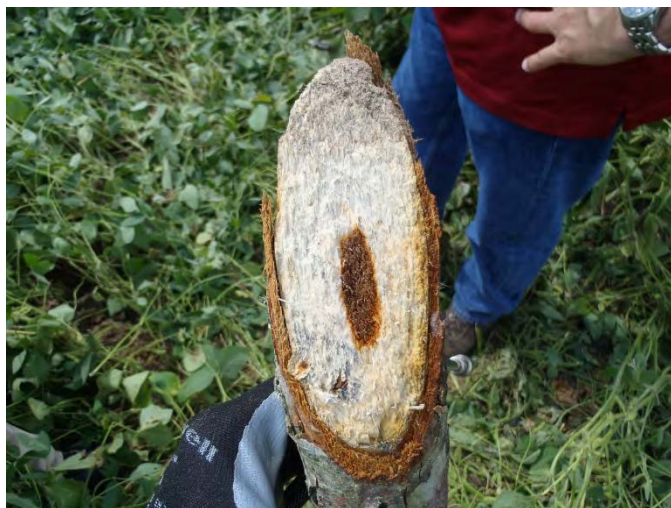
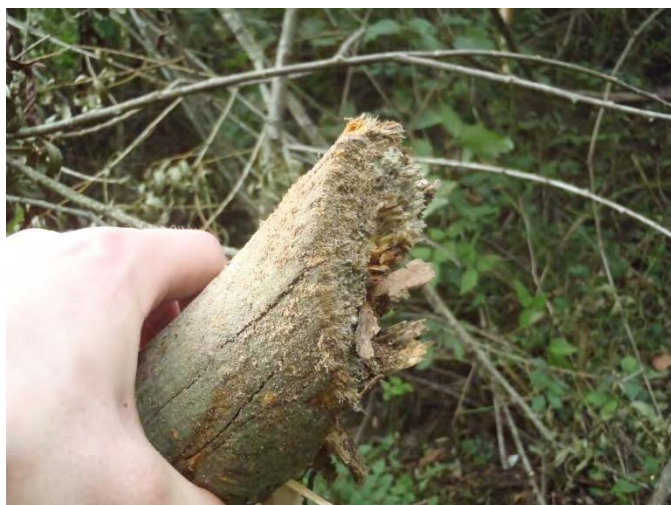
**PROPELLER**

The two blade, variable pitch propeller remained attached to the propeller flange and the propeller flange remained attached to the crankshaft. One of the propeller blades displayed twisting deformation, polishing of the leading edge and propeller tip. The other propeller blade displayed a significant amount of bending deformation towards the rear, twisting, and gouges in the trailing edge of the propeller blade. It was also noted that several branches were cut at a smooth 45 degree angle and were found among the trees near the primary wreckage site.
