# **NATIONAL TRANSPORTATION SAFETY BOARD**

## **SYSTEMS GROUP CHAIRMAN'S FACTUAL REPORT**

A. **ACCIDENT:** ERA14LA424

**AIRCRAFT:** Socata TBM700, N900KN

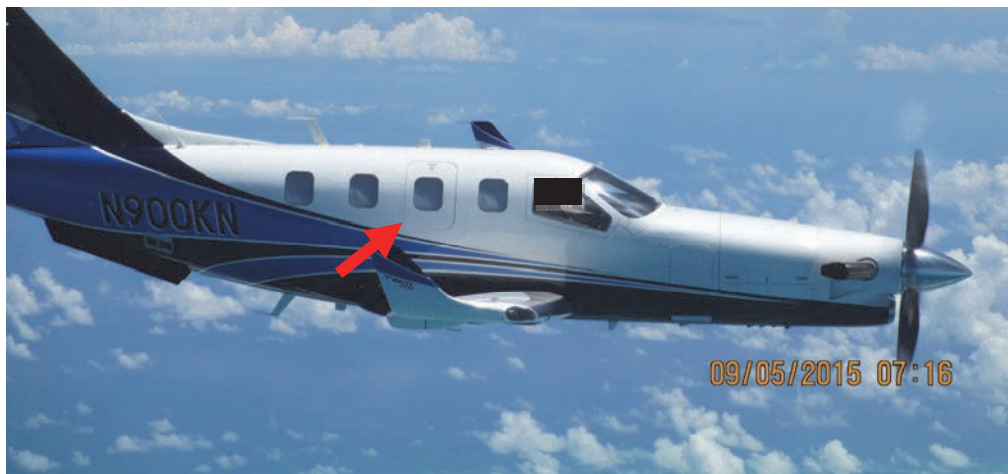
Air Force jets followed the airplane from South Carolina to Andros Island, Bahamas. Photographic evidence from the Air Force showed that the emergency exit of the TBM900 was in a position consistent with a depressurized cabin and showed the unconscious pilot without an oxygen mask. (See Figure 7A and 7B)

Figure 7A. This Air Force photograph shows the airplane when at about 28,000 feet. The red arrow shows the frame of the emergency exit enlarged in Figure 1B. The passenger and rear cabin oxygen masks were not visible. The image of the pilot has been redacted by the black rectangle.

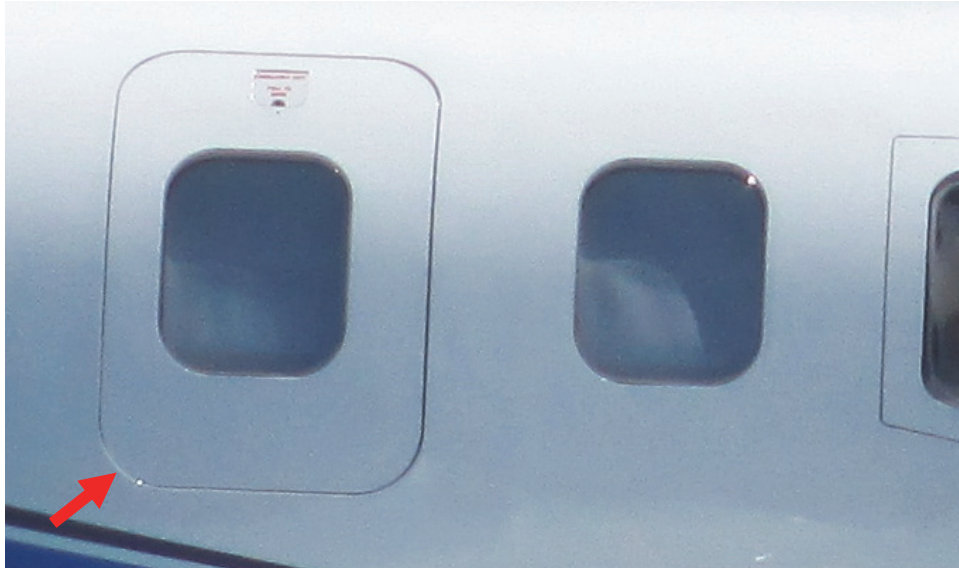
Figure 7B. The red arrow in this enlarged and cropped photo shows sunlight reflecting off of the emergency escape hatch frame. The hatch is designed to slightly protrude when the cabin is pressurized and the sunlight reflection would not be possible in that position.

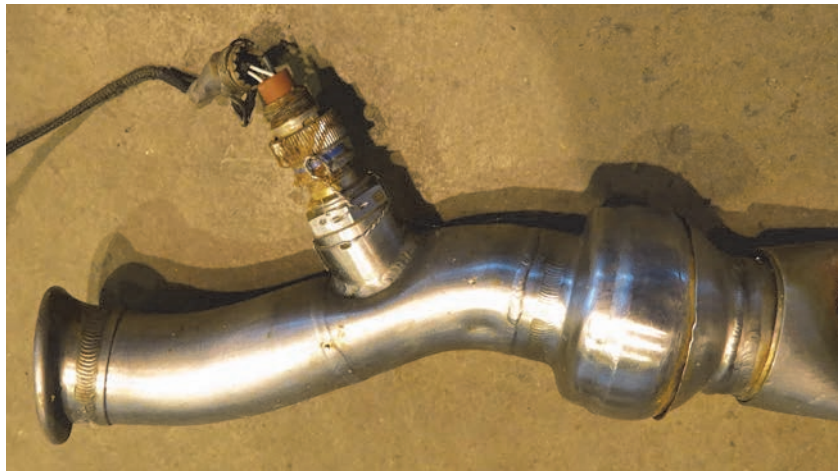
Figure 9. OTSW switch prior to removal from wreckage on June 4, 2015.

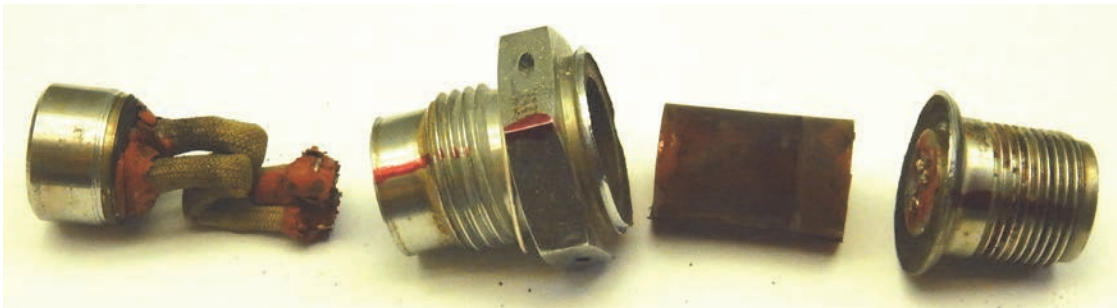
The N900KN OTSW was found to be comprised of two chambers, one of which held wiring and the other contained the switch contacts. The wires within the switch were found to be electrically insulated by two layers of woven glass fibers and the connector pins are held in place by a rubber-like material. Red material resembling room temperature vulcanizing (RTV) rubber coated each end of the internal exposed wiring. (See Figure 13)

Figure 13. This photo of the disassembled N900KN OTSW shows the capsule containing the thermal switch at the left, the mounting body to the left of center, an insulating Kapton liner to the right of center, and the electrical connector (shown at top in previous photo) on the right. The wires had to be cut during the examination at the base of the electrical connector and a small split in the Kapton was created.

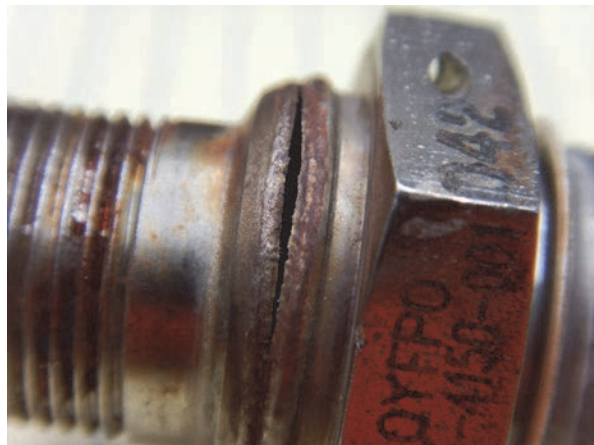
The switch was mounted on a rack and placed into a wind tunnel heated to 636F, next to the exemplar switch. The exemplar electrically opened after 2:47.<sup>19</sup> At 3:25 the N900KN part burst with a loud bang and sufficient force to bend the test fixture. Examination revealed that a welded joint near the wrenching flat had burst and the switch body had bent at the split. (See Figure 14)

Figure 14. N900KN OTSW after the welded area burst when heated.

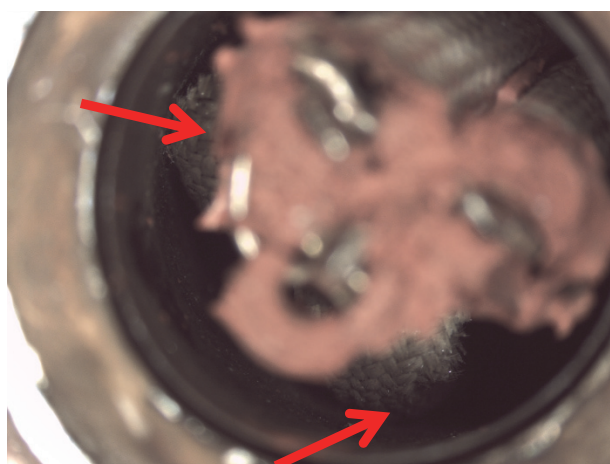
Figure 16. Wires in switch body resting against Kapton liner of tube wall. (See arrows)

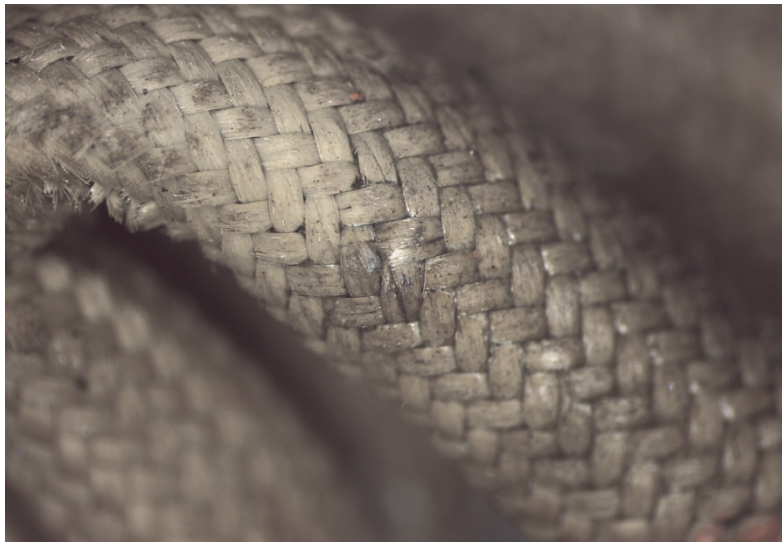
The outer layer of some fibers had minor areas where they had worn though, flattened, or become dark in locations where the switch rested against the Kapton. (See Figure 18) The interior layer of wire insulation remained intact, as had the Kapton where the wire had been in contact, and no short circuits of the wires or connectors to the switch housing were seen.

Figure 18. Worn area of wire insulation. (typical)

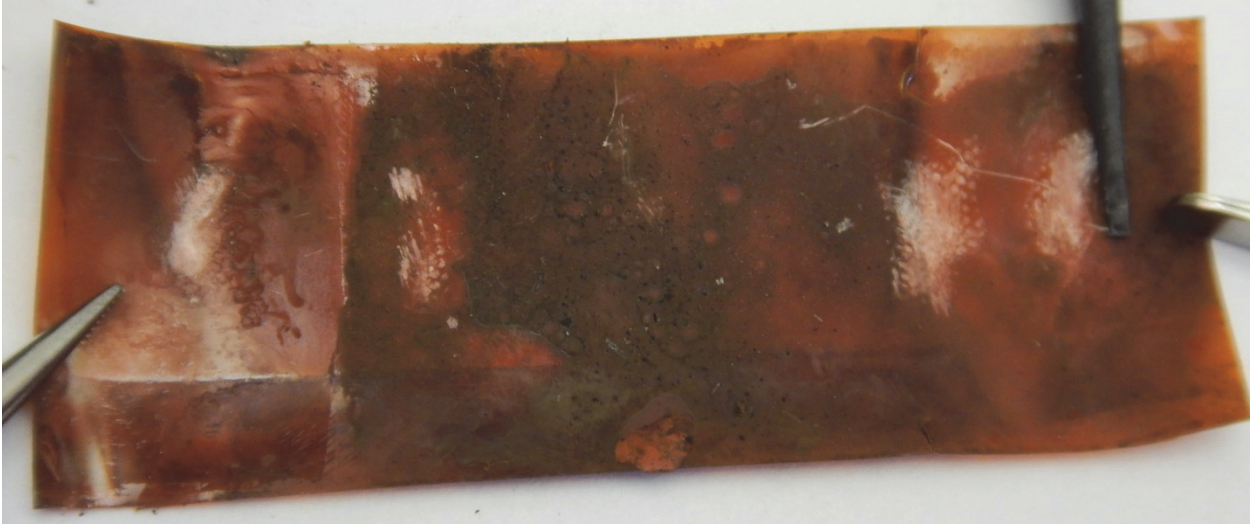
The interior surfaces of the switch body were blackened with residue. The Kapton was unrolled and found to have a split near the module end. The unrolled Kapton was translucent and exhibited a very thin layer of residue. (Figure 19)

Figure 19. Residue on unrolled Kapton liner.

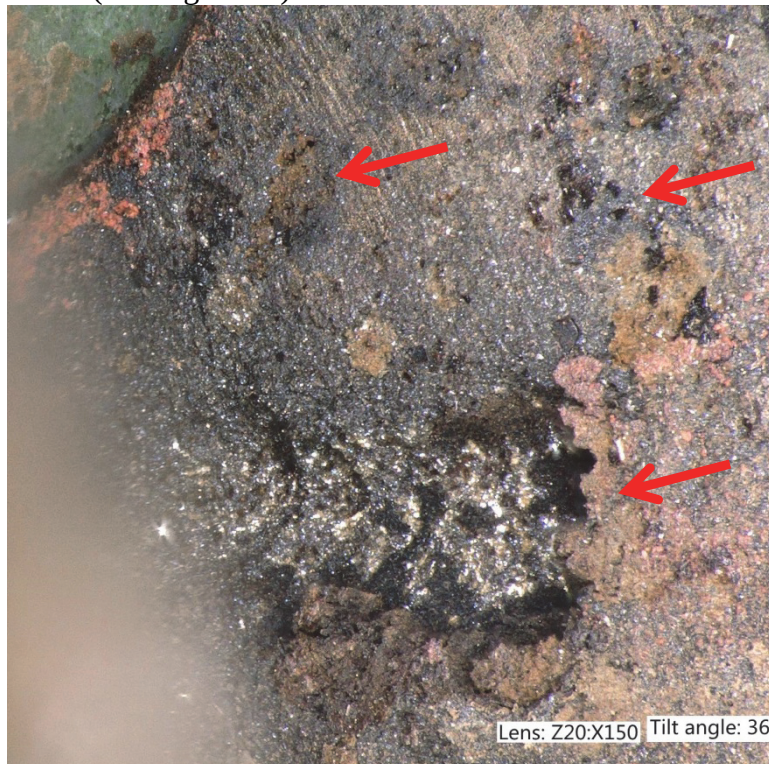
The top of the switch module, called a header, was covered in black residue. The header also had extensive surface pitting, with larger pits near the wire connectors and near a ball which sealed the module during manufacture. The two biggest pits beneath the wire terminals were 0.007 inches and 0.011 inches deep. Microscopic examination revealed no evidence of heat or molten globules and undercutting with flaking consistent with corrosion was noted. (See Figure 20)

Figure 20. Blackened surface of the switch module header, with visible pitting (upper arrows), undercutting, and flaking (lower arrow). This surface was beneath one of the terminals where a wire had been attached.

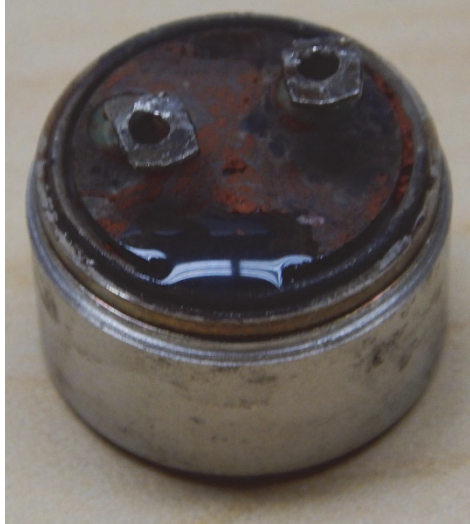
During the disassembly, the wires were intentionally broken off of the welds at the switch module terminals for examination of the module. The ball was removed from the module and pressurized water sprayed out of the module. (See Figure 21)

Figure 21. Water on surface of switch module.

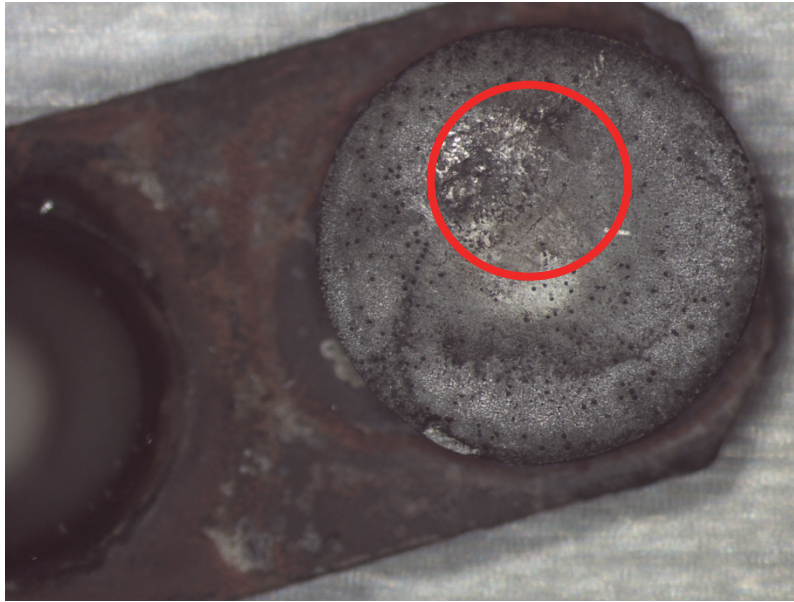
The switch contact had no weld marks. It did have pitting and material transfer. (See Figures 22 through 24)

Figure 22. Material transfer pit on contact surface denoted by circle. The armature which the contact is mounted to is normally shiny, but was coated with brown rust.

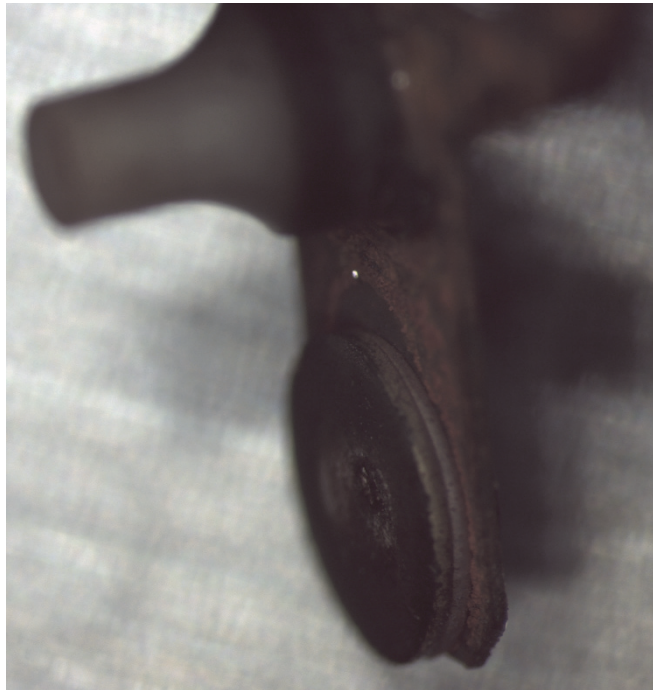
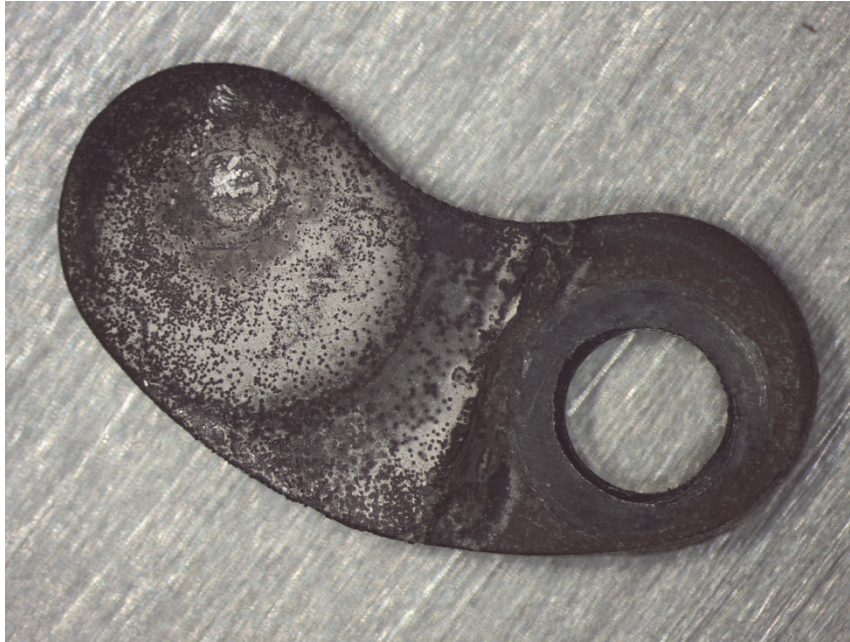
Figure 23. Contact material.

Figure 24. Contact material transferred.

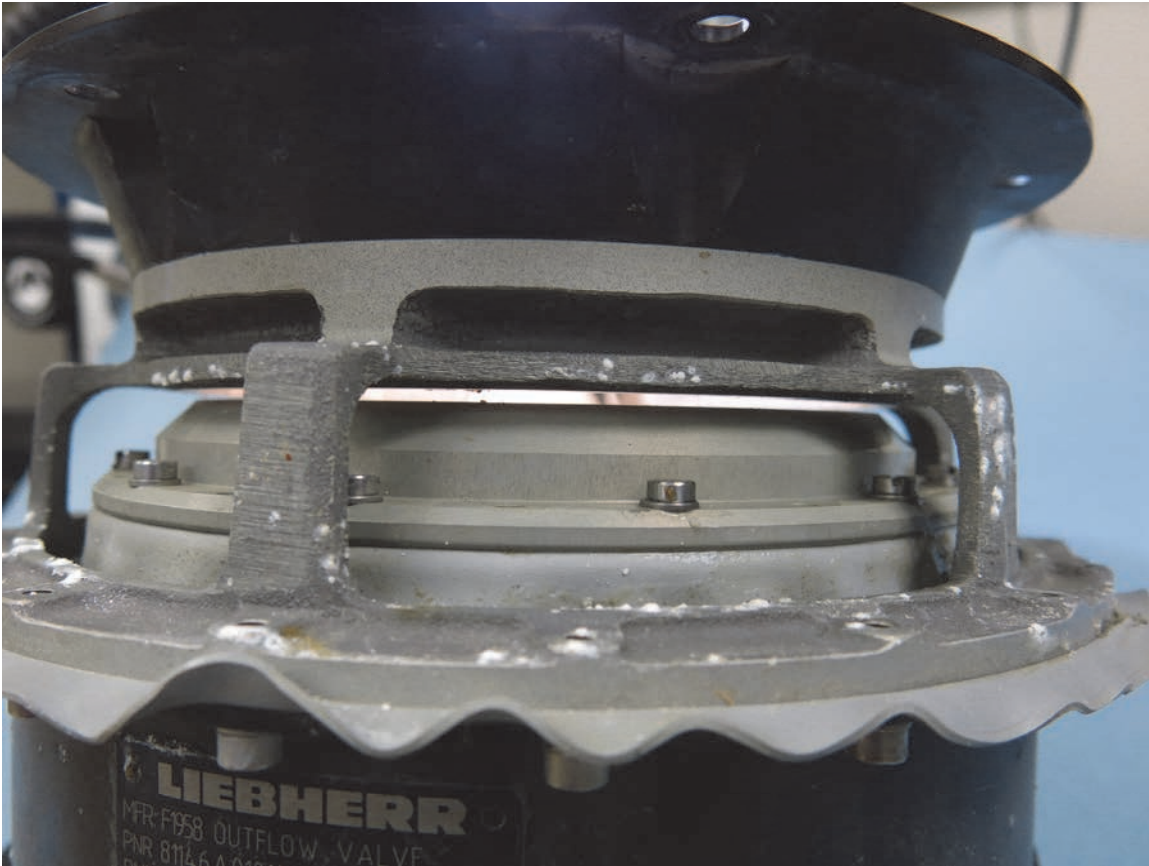
Figure 31. Close-up view of the 0.07” opening of the outflow valve main valve body when placed with the poppet resting on the internal spring. The white areas are organic ocean material and corrosion.

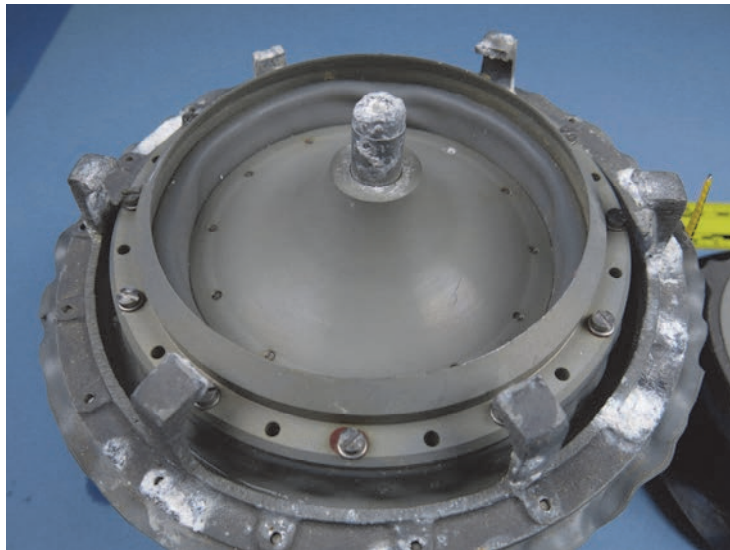
Figure 34. The main valve body on the broken central shaft. The shaft broke flush with where it had entered the mounting flange visible in the next photo.

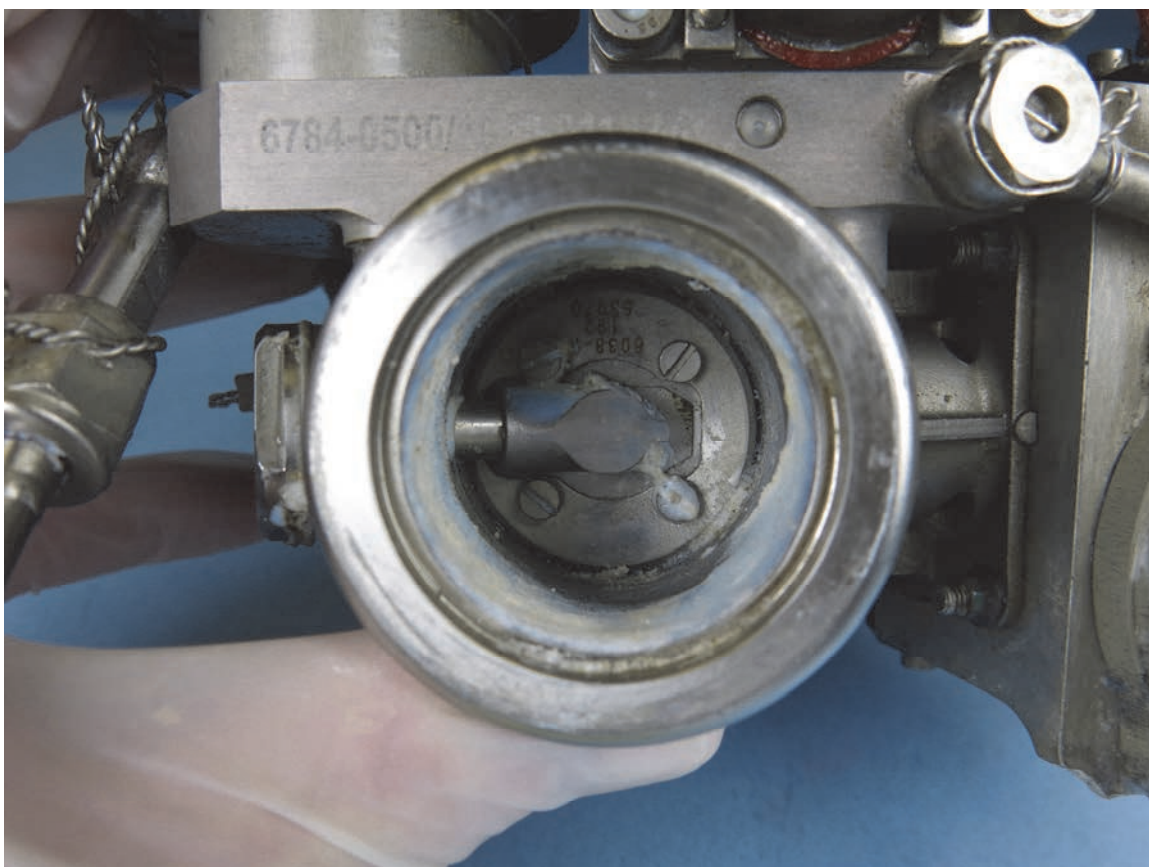
Figure 42. Butterfly valve in closed position within the FCSOV. The white deposits were found on numerous parts recovered from the ocean and the slippery surface is not visible.

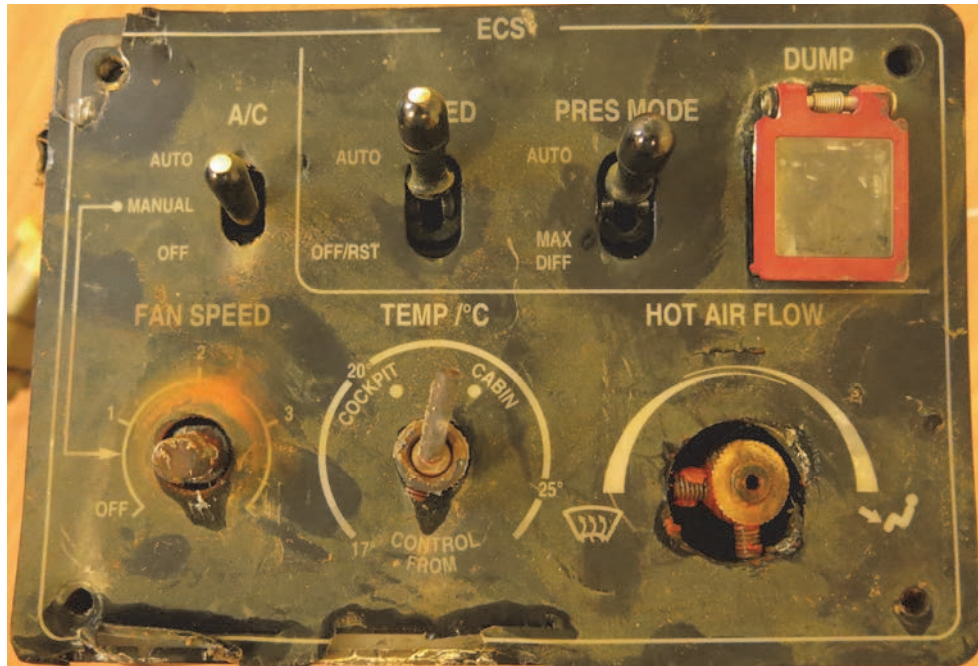
Figure 49. Face of the ECS Control Panel with brown rust deposits.

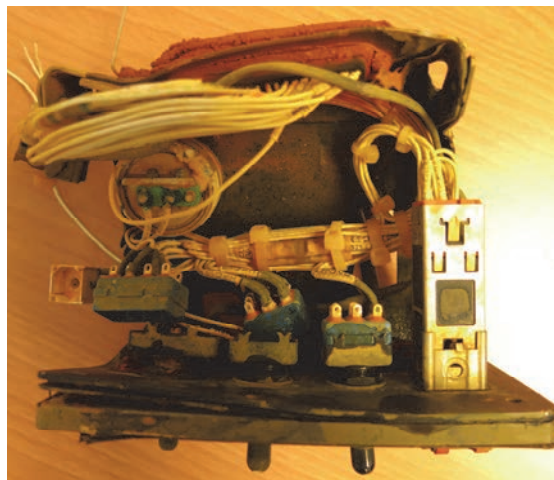
Figure 50. This view of the top of the ECS Control Panel shows the rusty connector across the top of the photo.

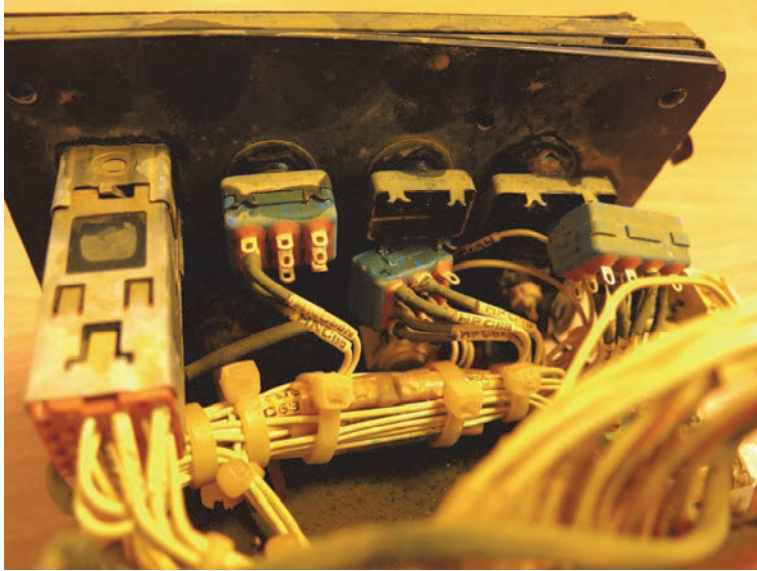
Figure 51. Broken switch bodies are visible.

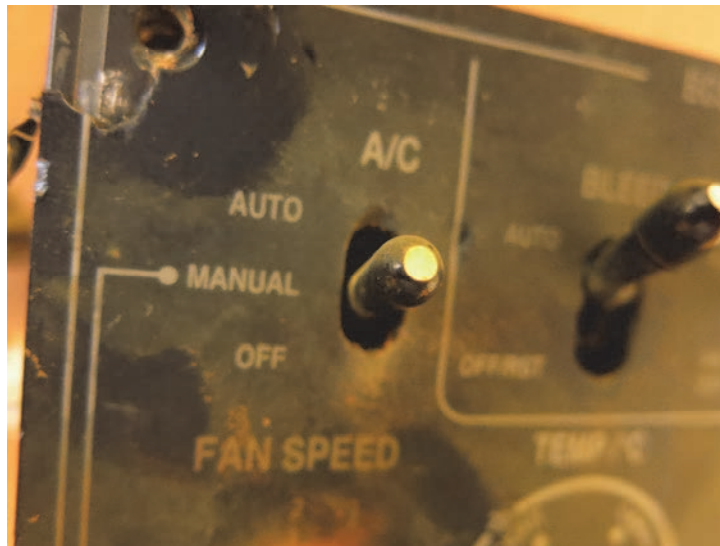
Figure 52. The AC switch toggle had recessed into the panel and was loose. The impact position was indeterminate.

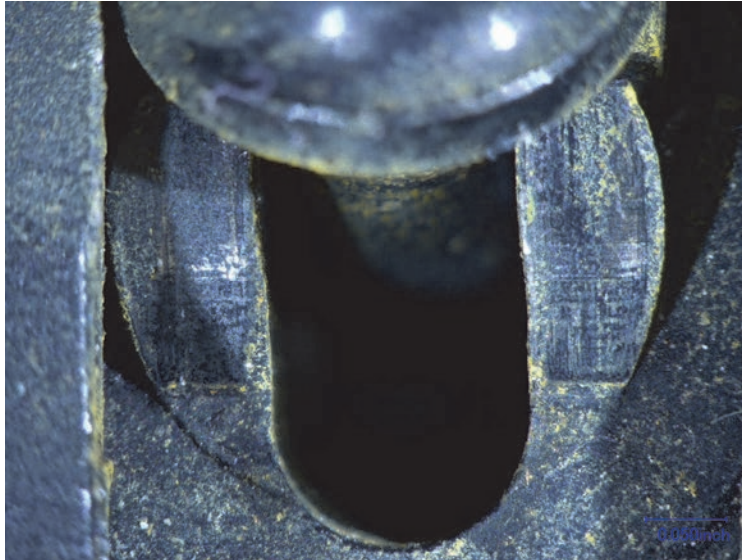
Figure 53. The BLEED switch was found in the AUTO position. The locking gate had no imprints or scars on the OFF/RST side of the lock.

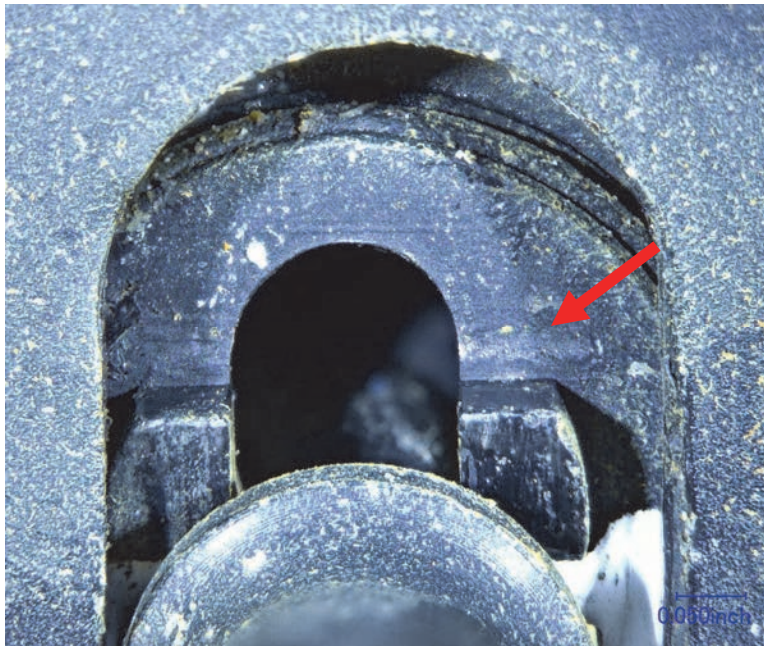
Figure 54. The BLEED switch had an imprint on the AUTO side of the locking gate.

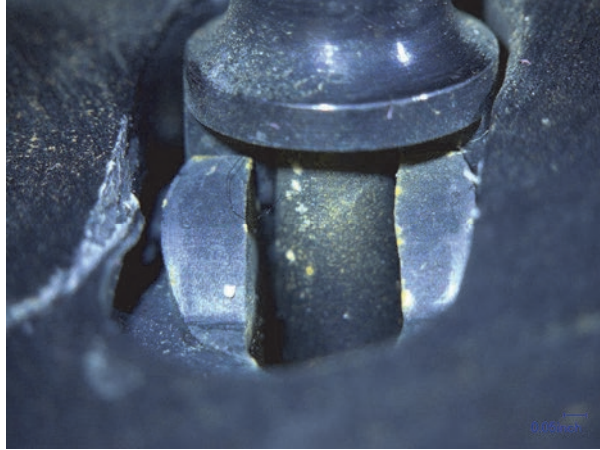
Figure 55. The PRES MODE switch was found in the AUTO position. The locking gate had no imprints or scars on the MAX DIF side of the lock shown here.

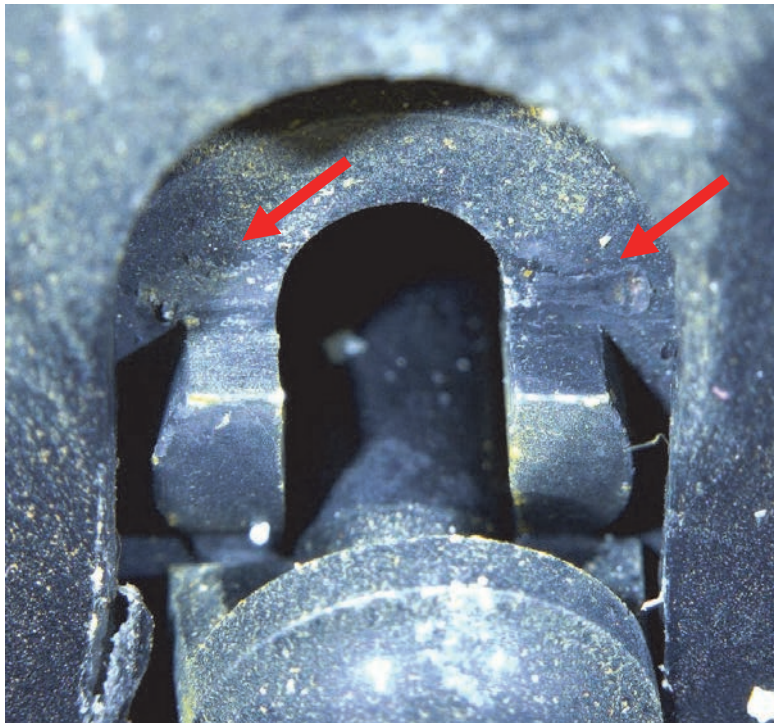
Figure 56. The PRES MODE switch had imprints on the AUTO side of the locking toggle.

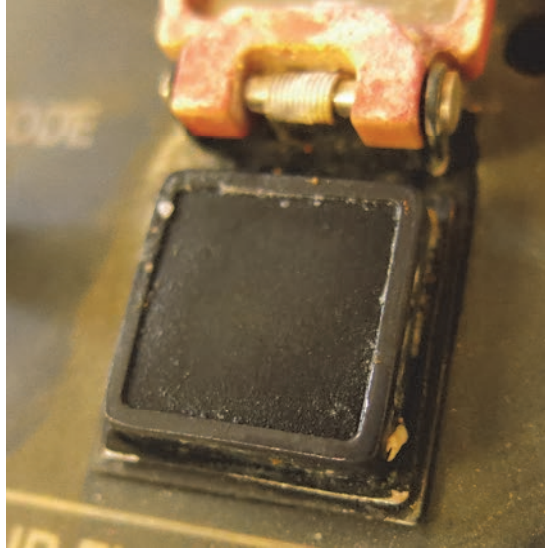
Figure 57. The DUMP switch body was intact. The button was found immobilized in the extended position and was not disassembled.

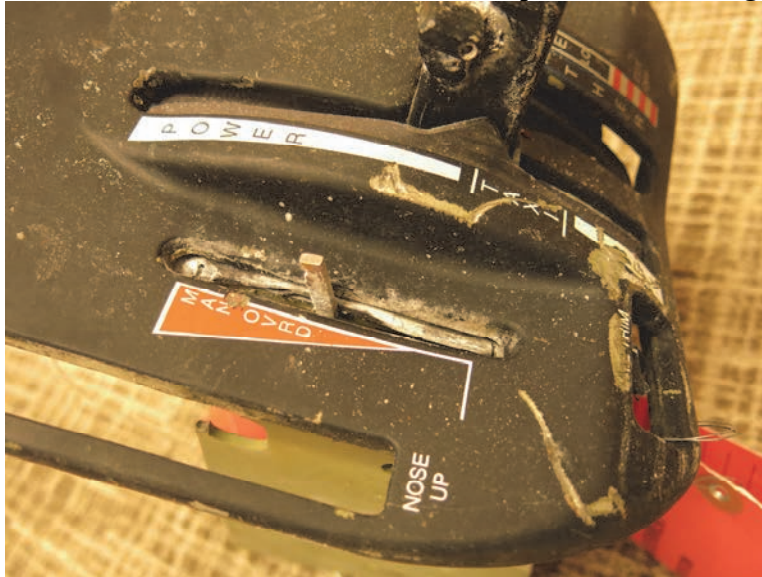
Figure 65. Throttle quadrant position of power lever, manual over-ride, and missing pitch trim indicator.

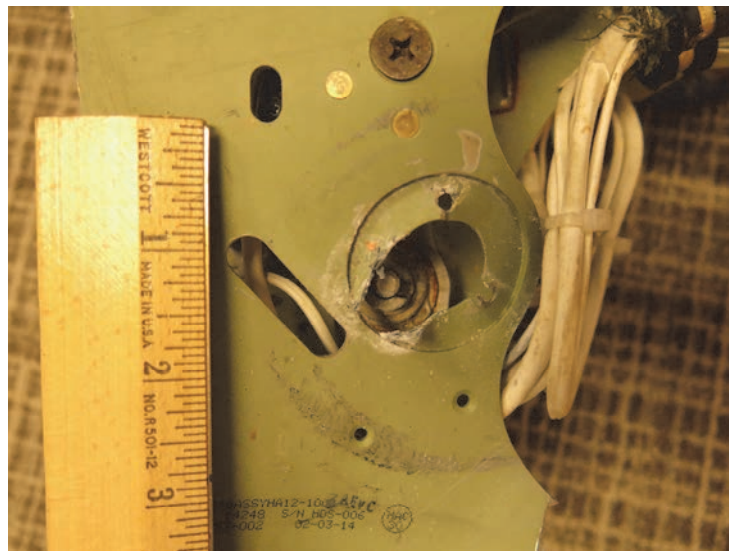
Figure 66. Tearing and displacement of throttle quadrant axle.
