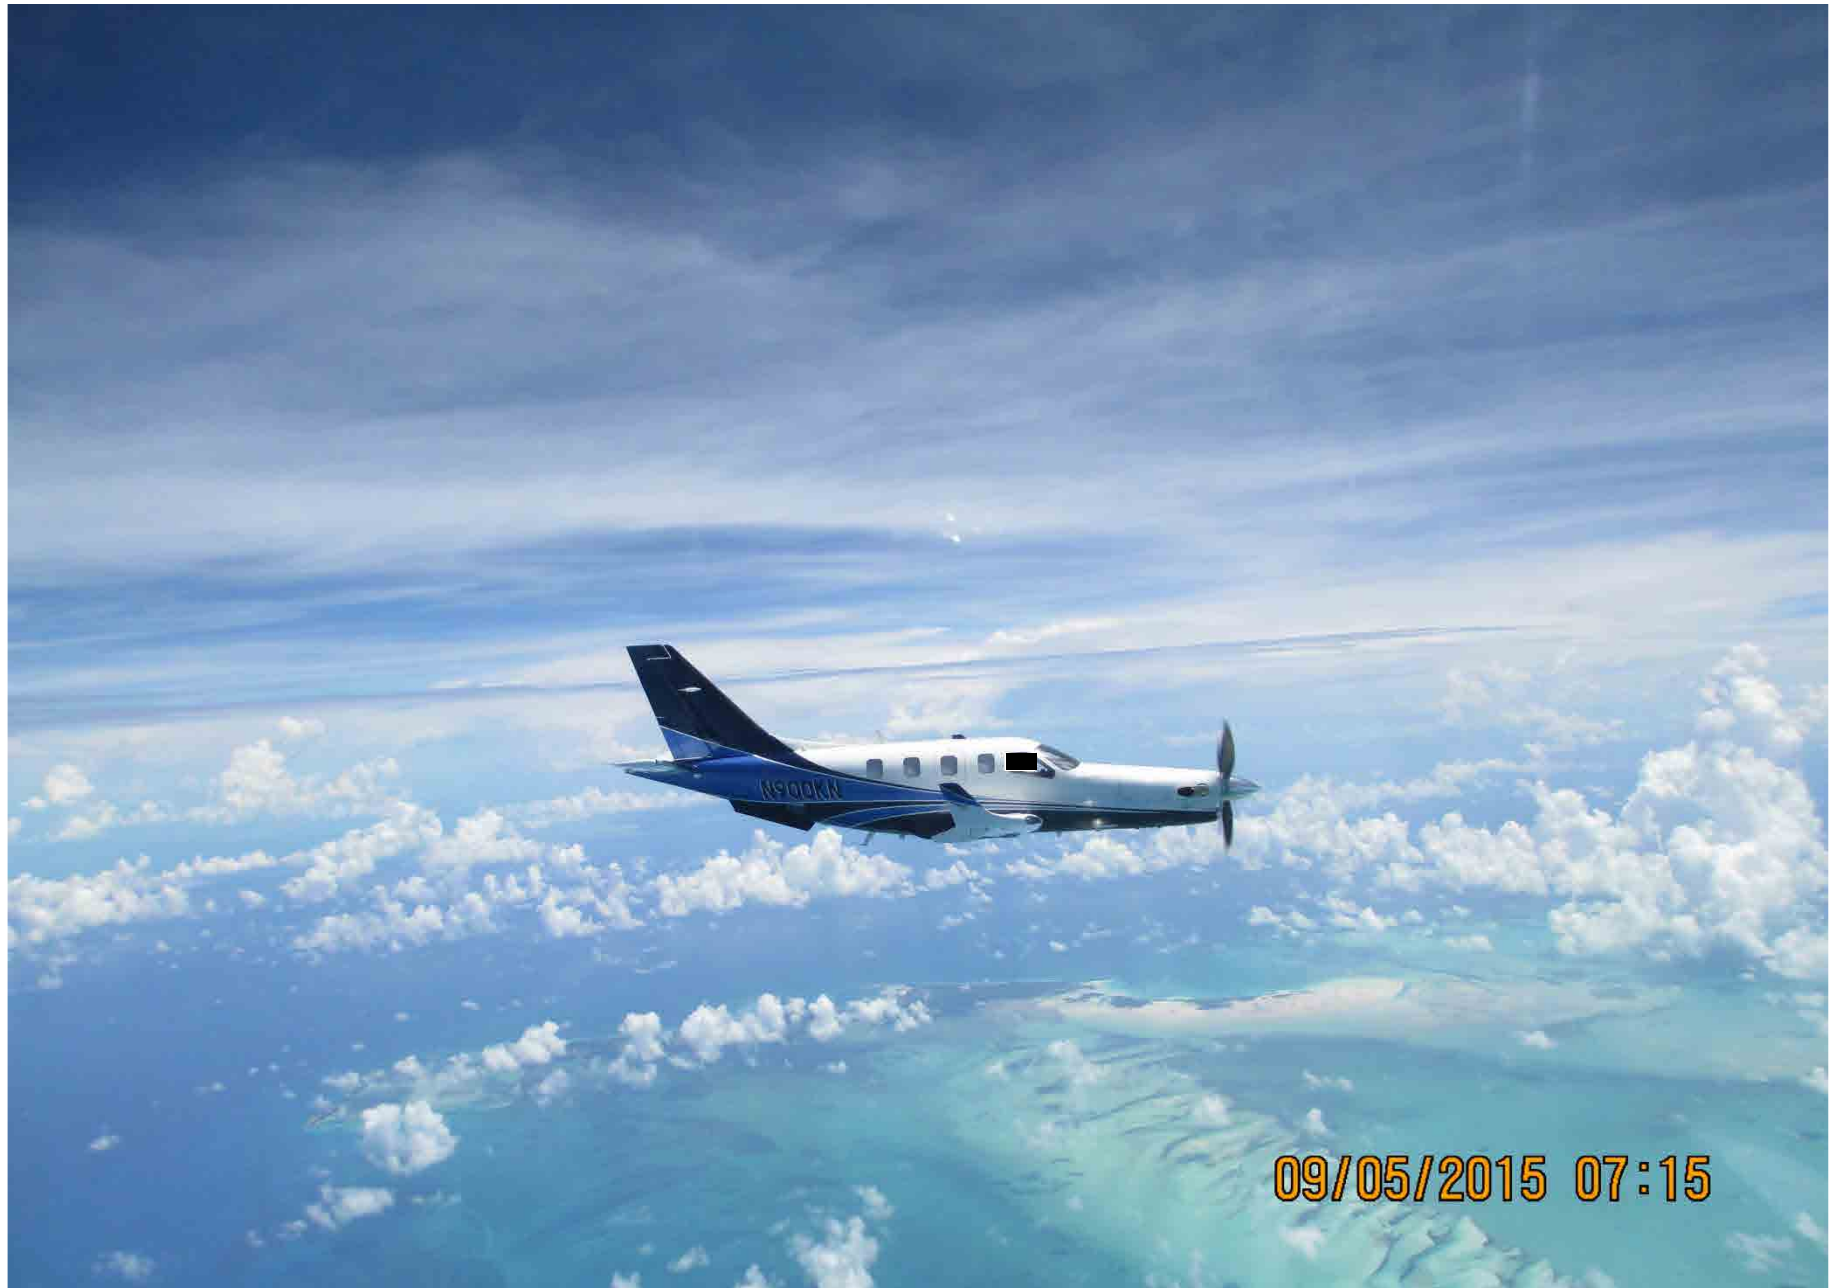
**Photo 1 – Starboard Side View of Accident Airplane at FL250 (Courtesy of United States Air Force Air National Guard)**

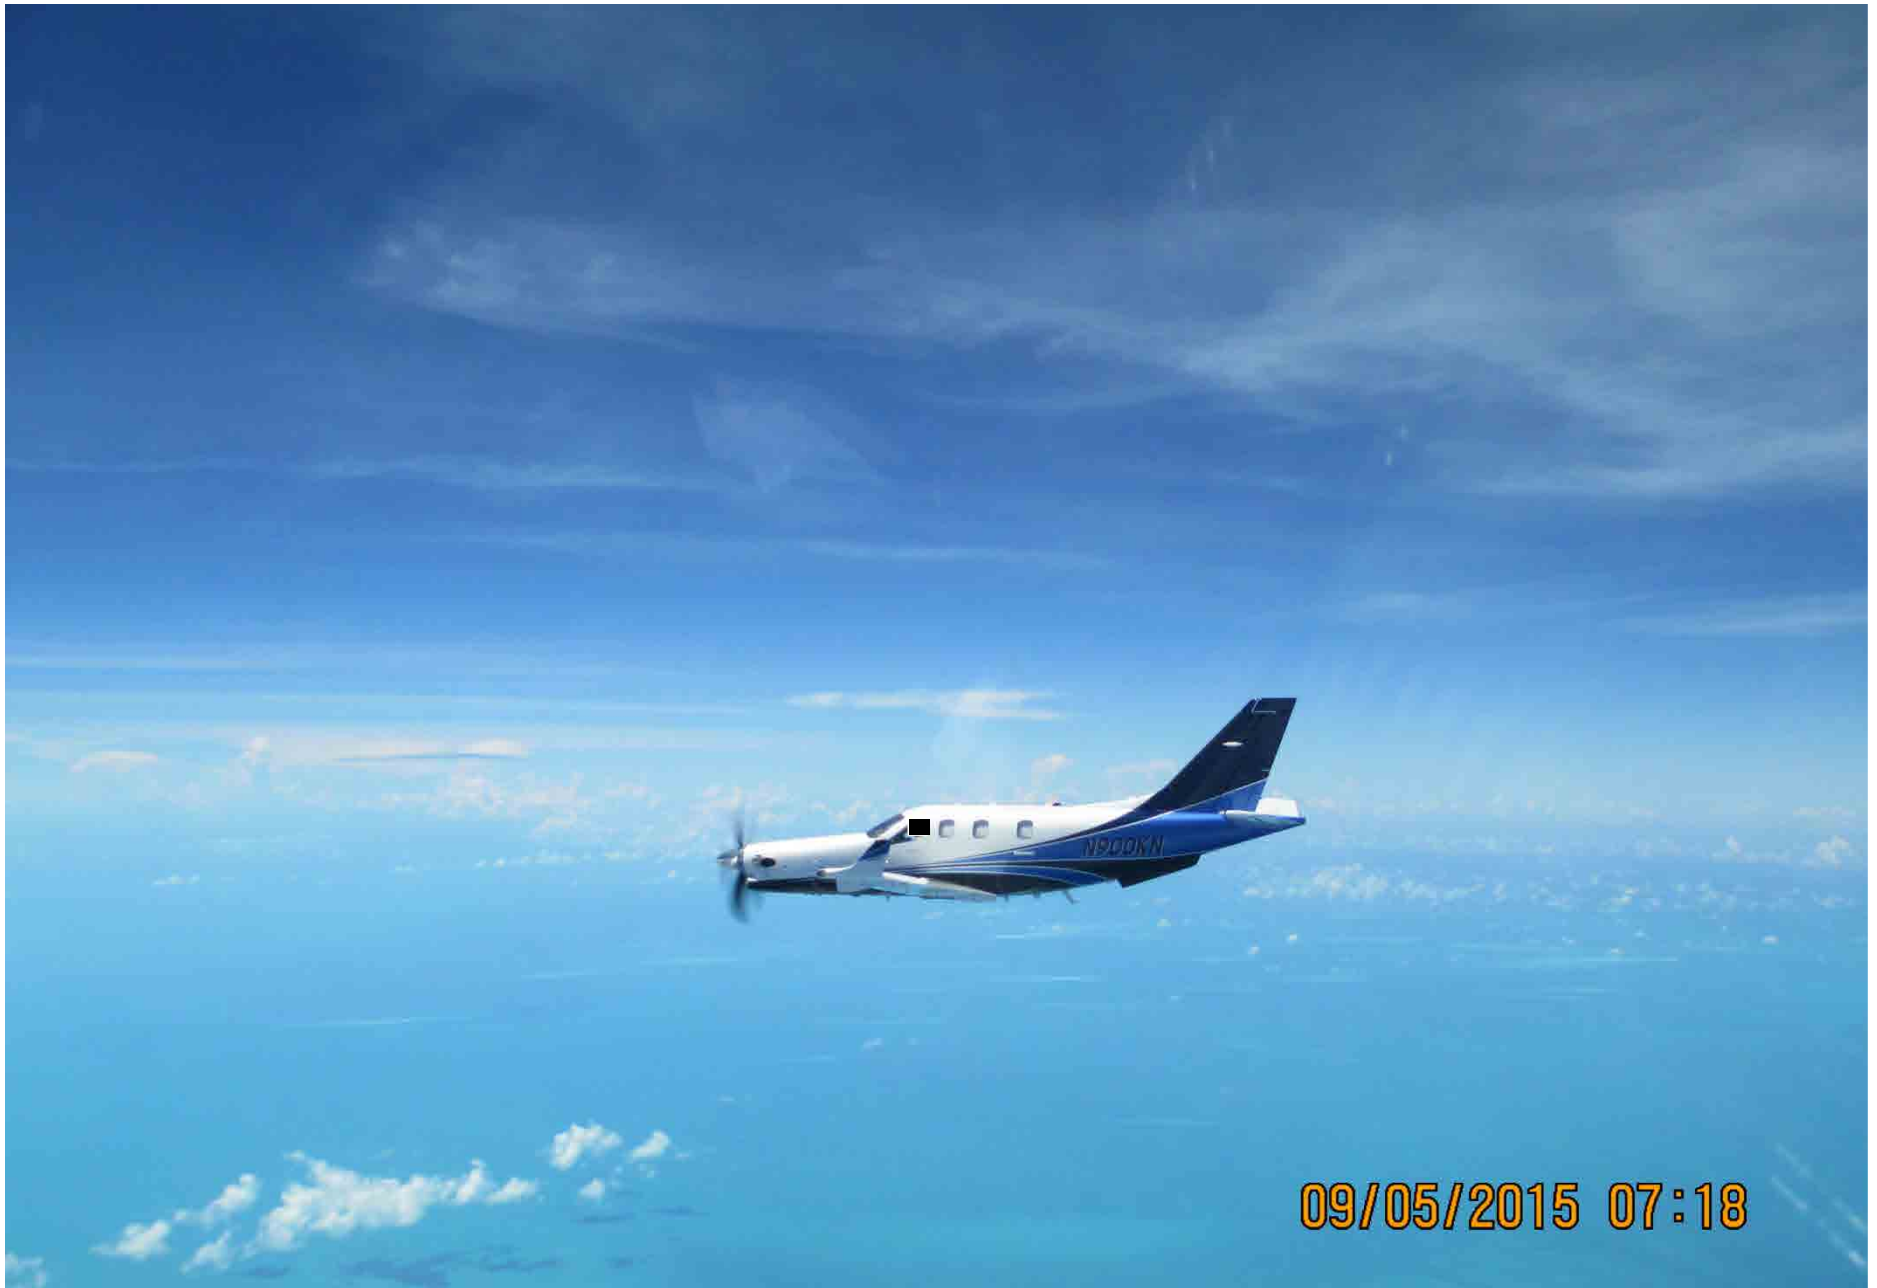
**Photo 2 – Port Side View of Accident Airplane at FL250 (Courtesy of United States Air Force Air National Guard)**

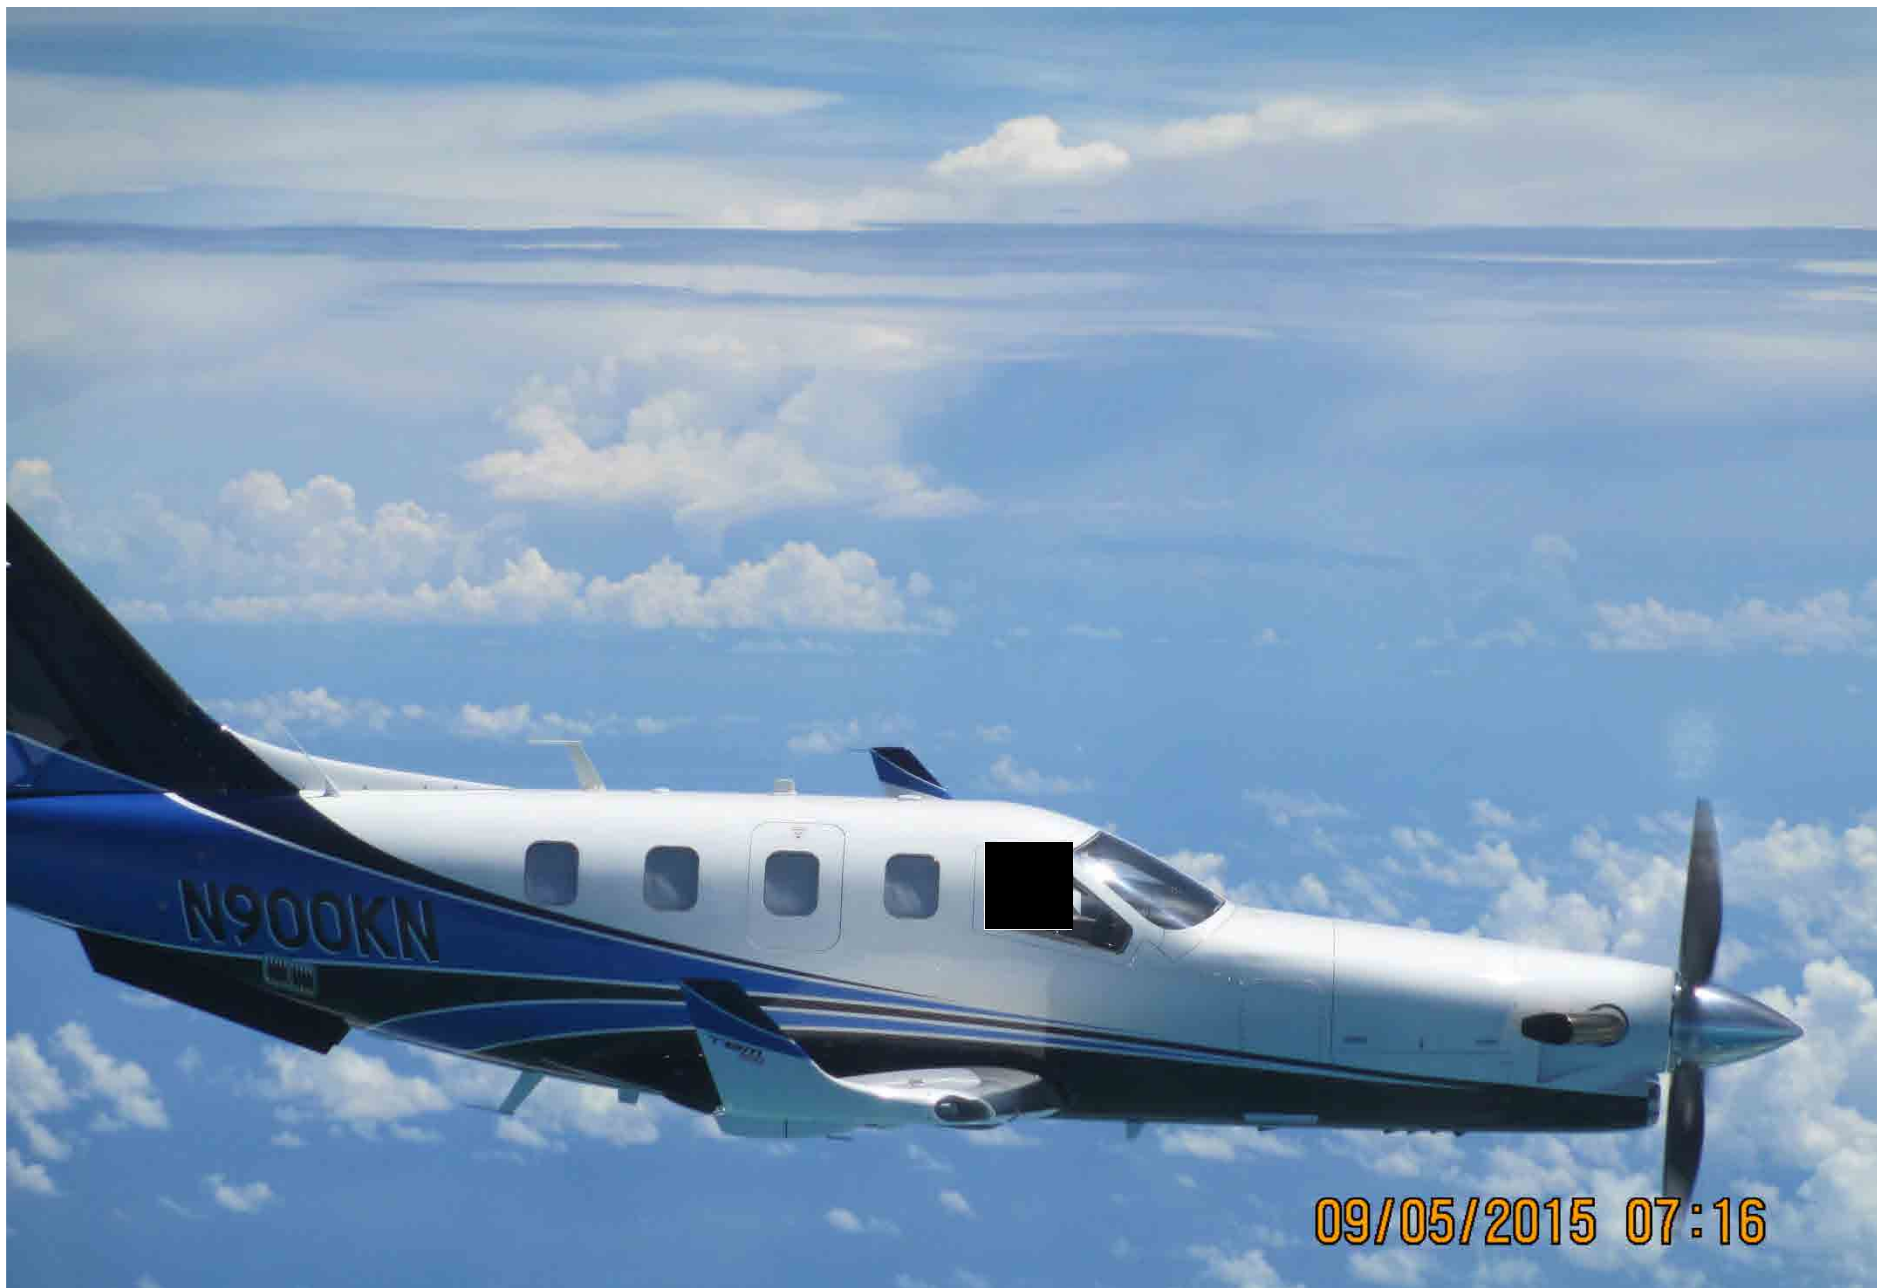
**Photo 3 – Starboard Side View of Accident Airplane at FL250 (Courtesy of United States Air Force Air National Guard)**

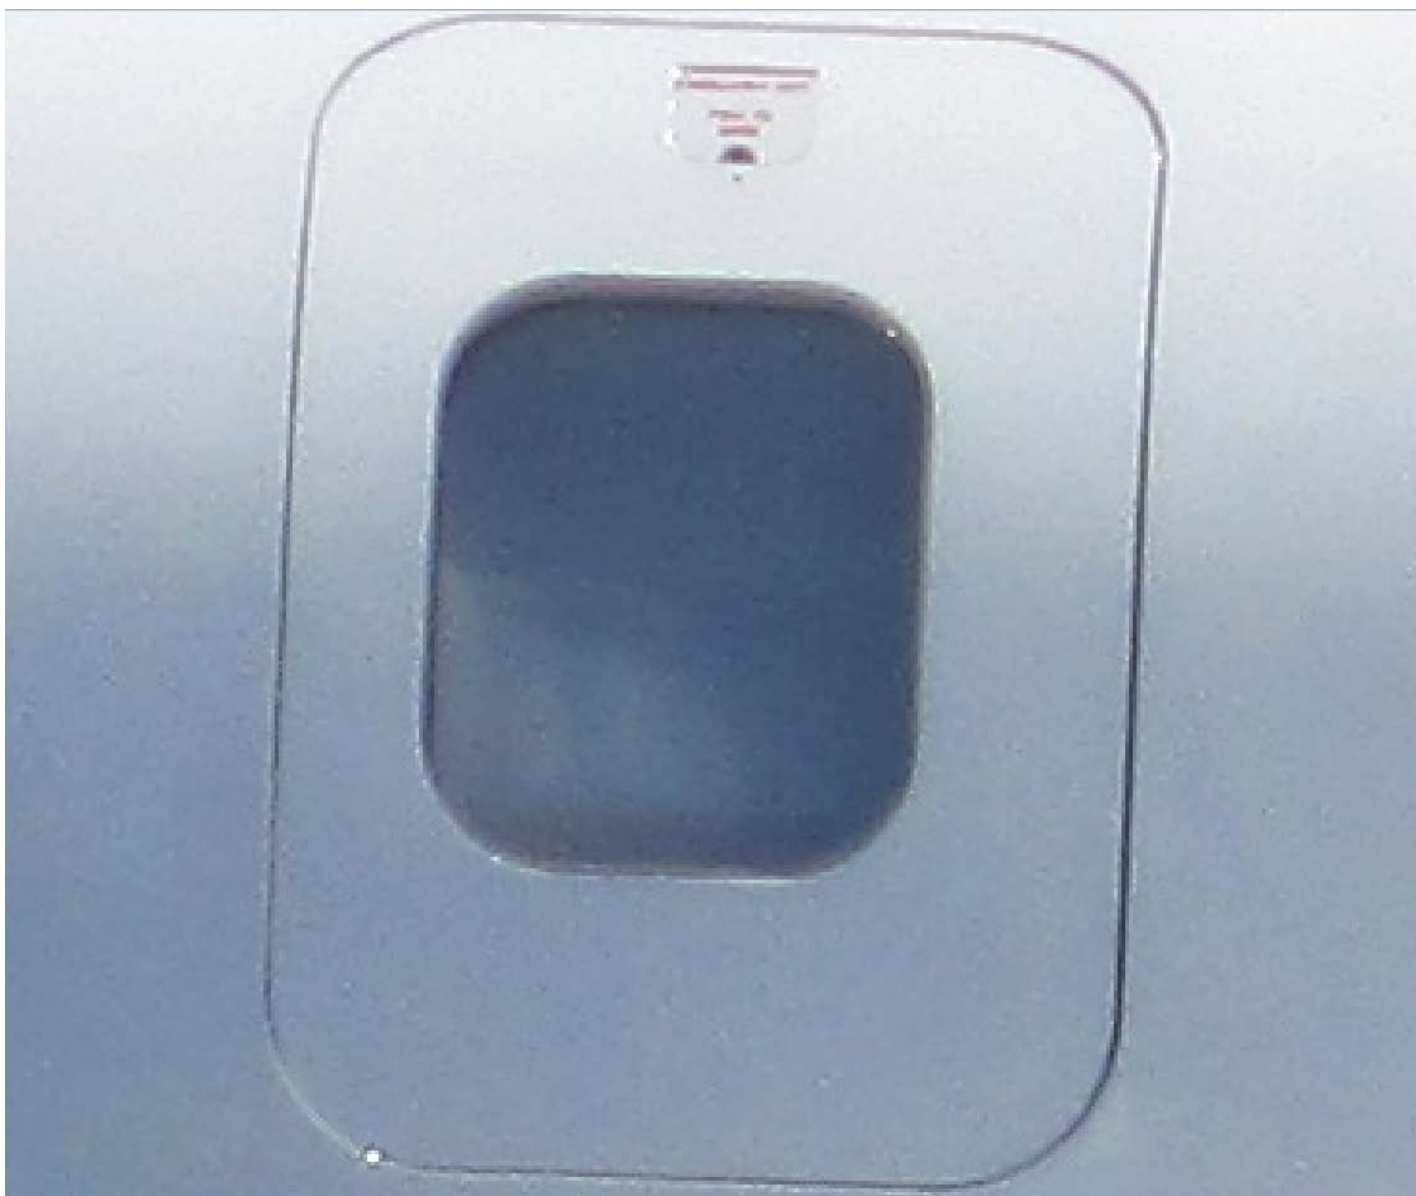
**Photo 4 – View of Accident Airplane Emergency Exit Window During Accident Flight (Courtesy of United States Air Force Air National Guard)**

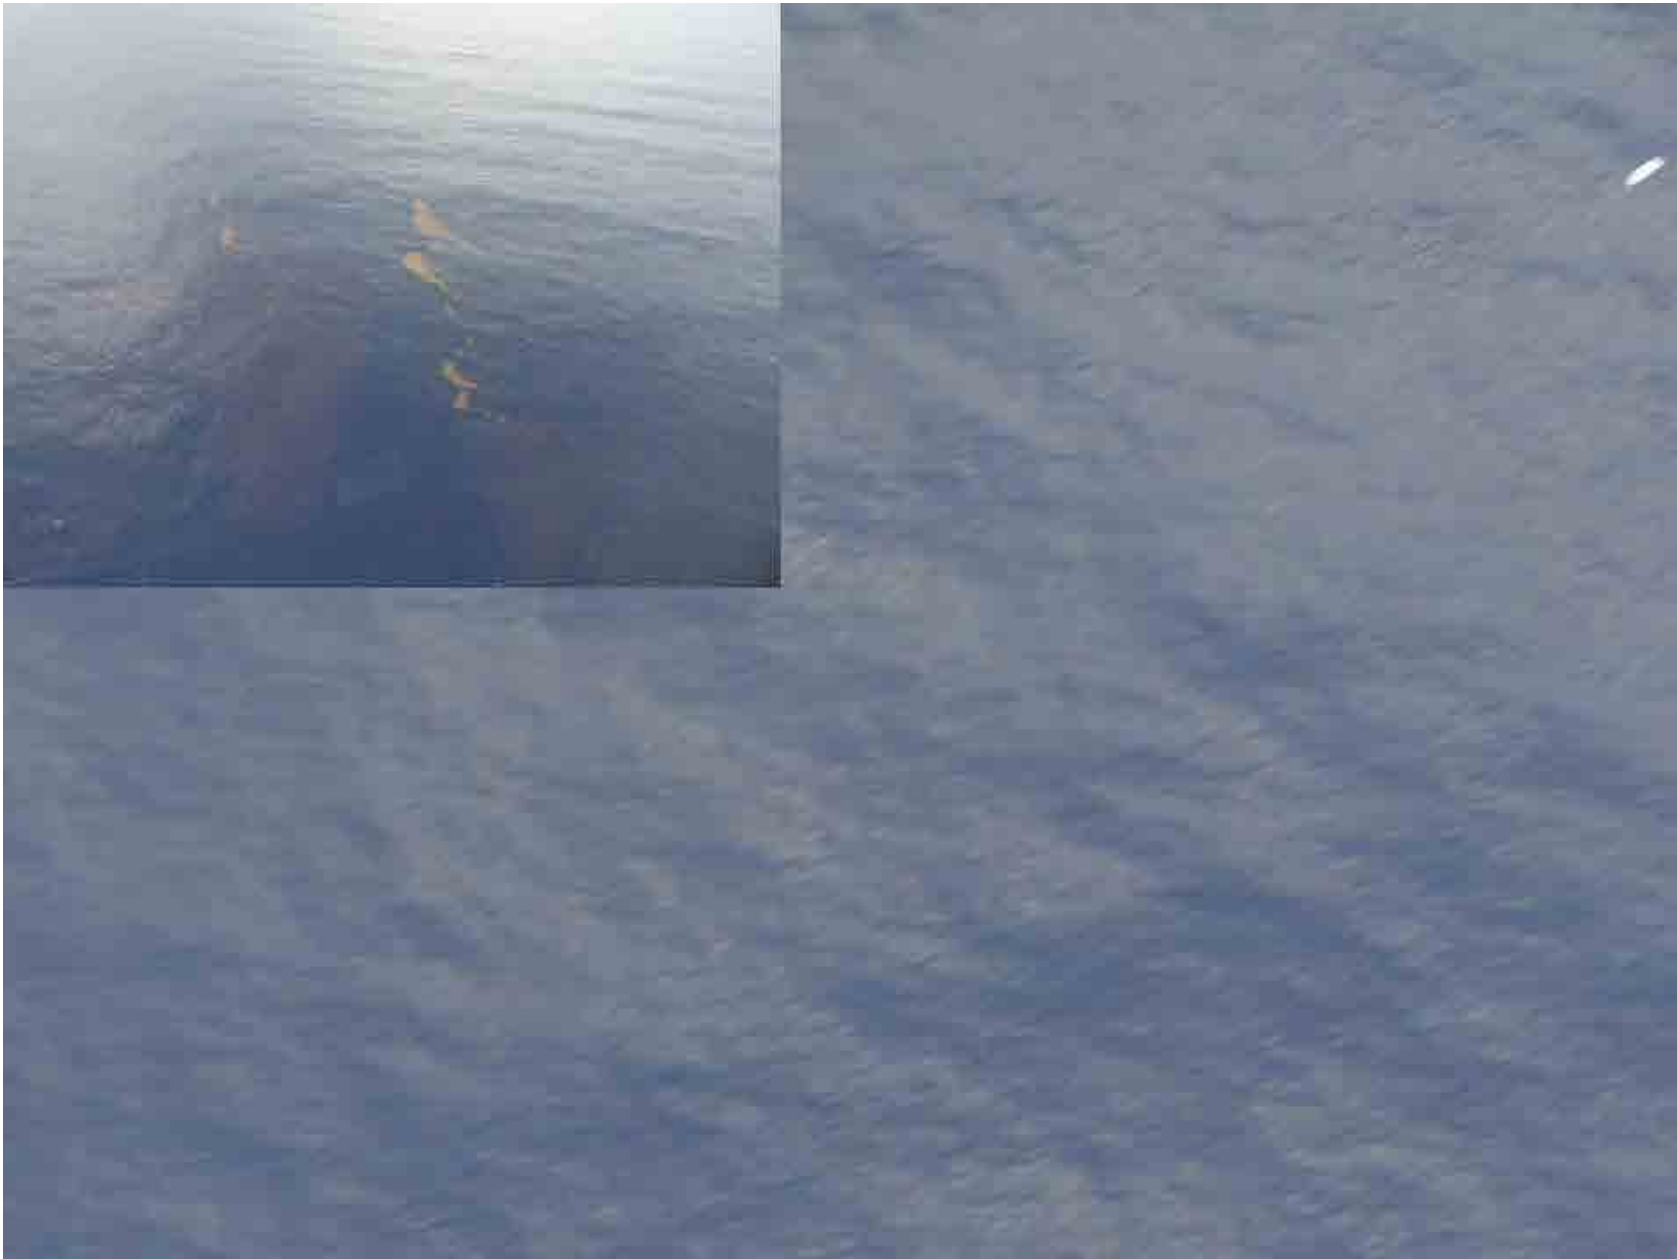
**Photo 6 – View of Oil Slick and Debris Located During Search Effort (Courtesy of Jamaican Civil Aviation Authority)**
