## ENGINE FIELD INSPECTION REPORT

| ENGINE MODEL | E-185-3 |
| AIRCRAFT REGISTRATION | N4900K |
| FILE NUMBER | 14-194 |

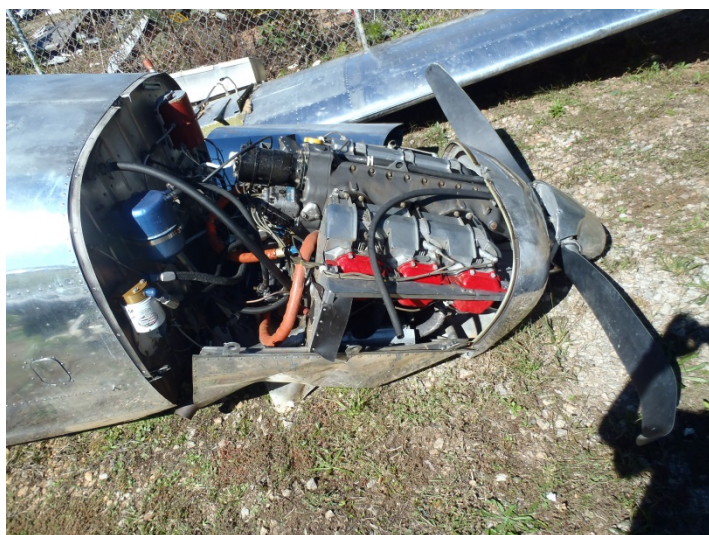
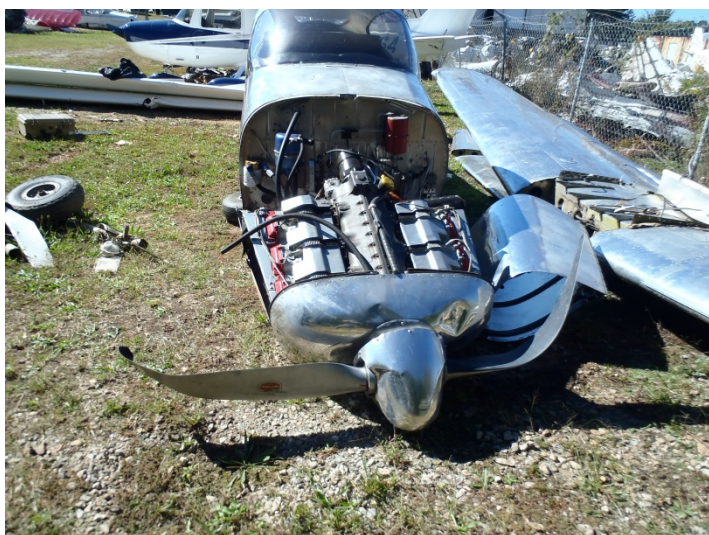
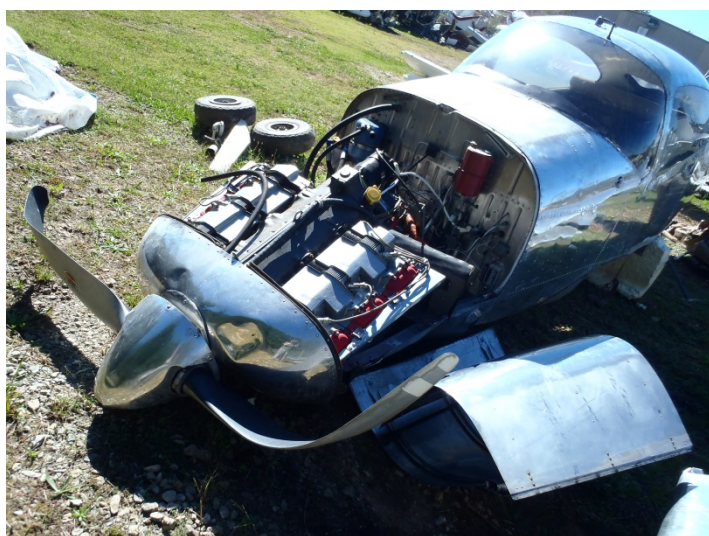
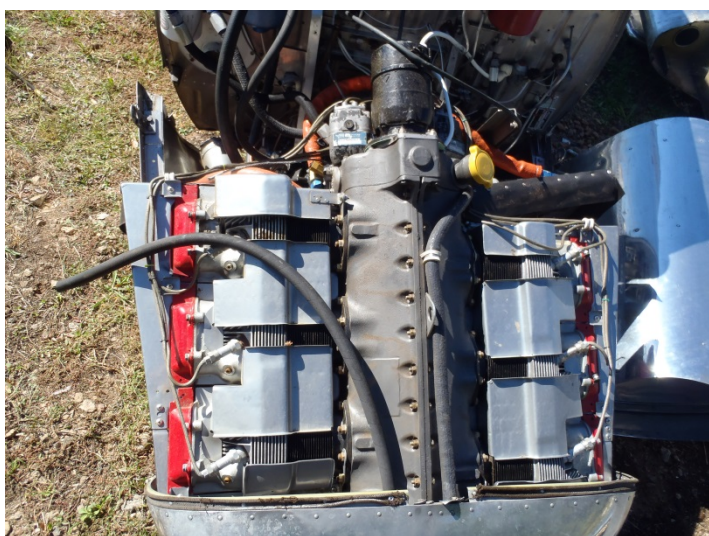
The engine remained attached to the airframe through the engine mounts, hoses, control cables and wires. The engine sustained some impact damage to the exhaust system and the oil cooler. It was noted that there was no dataplate attached to the engine crankcase. The two blade, variable pitch propeller remained attached to the crankshaft and sustained damage consistent with impact damage. One blade displayed chordwise scratches, aft bending deformation near the blade tip, and some tip curling. The other propeller blade displayed aft bending deformation, and leading edge polishing and chordwise scratches near the propeller tip. All six cylinders remained attached to the engine and were undamaged.

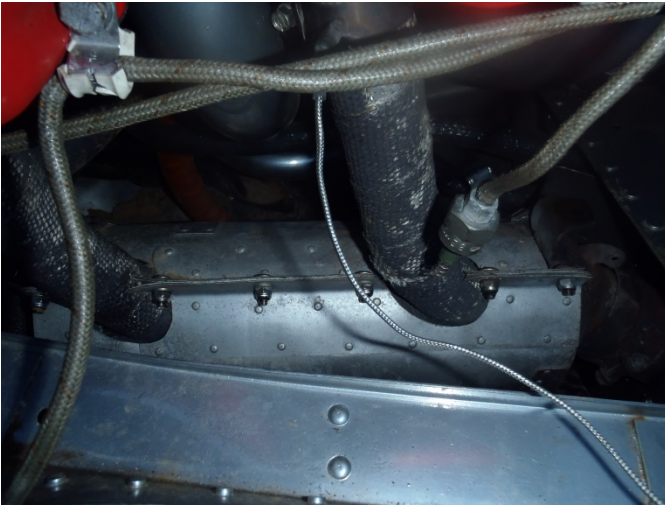
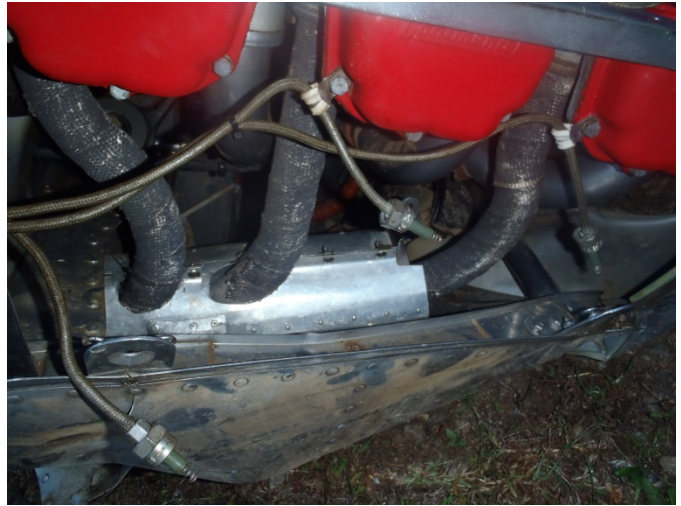
The exhaust system remained attached to the engine and sustained some damage consistent with impact damage. There were no anomalies noted with the exhaust system.

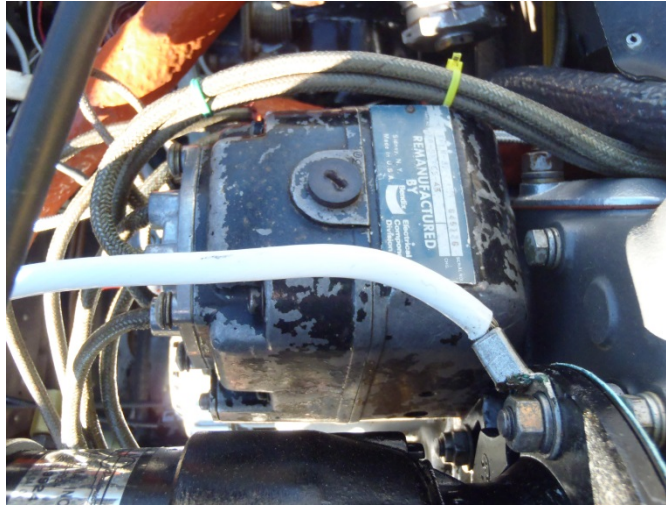
The magneto remained attached to its respective installation point and was undamaged. It was noted that during crankshaft rotation the impulse couplings engaged and the magneto was capable of producing a spark for all 6 spark plugs.

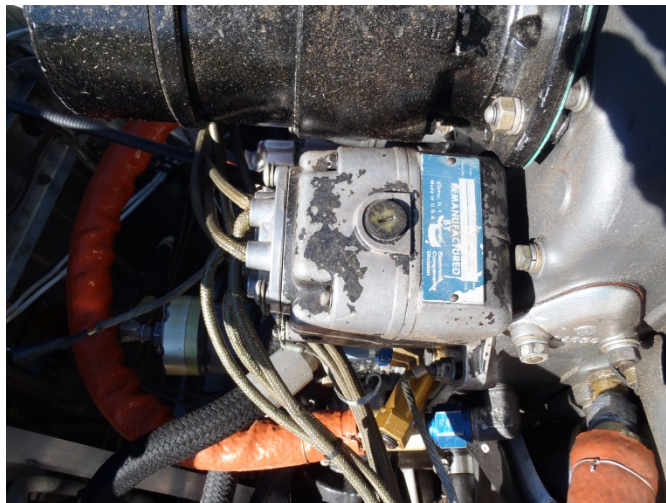
The magneto remained attached to its respective installation point and was undamaged. It was noted that during crankshaft rotation the impulse couplings engaged and the magneto was capable of producing a spark for all 6 spark plugs.

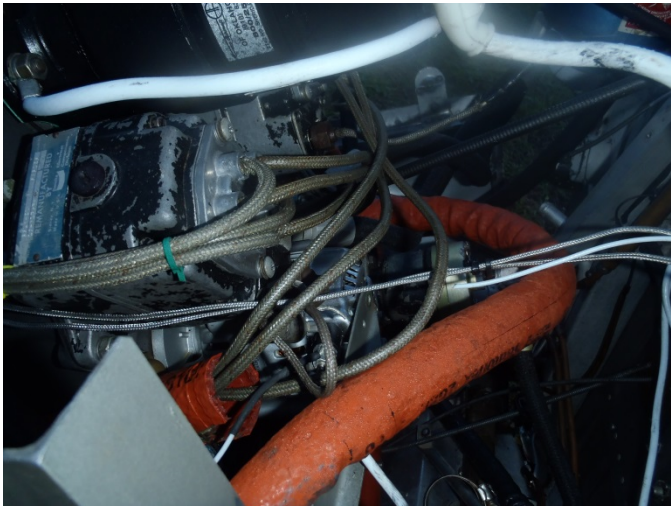
| Condition: | The ignition harness remained attached to both of the magnetos and to all of the spark plugs. The ignition harness was undamaged and it was noted that during magneto impulse coupling engagement the ignition harness was capable of conducting a spark from each magneto to all of the spark plugs. | | |

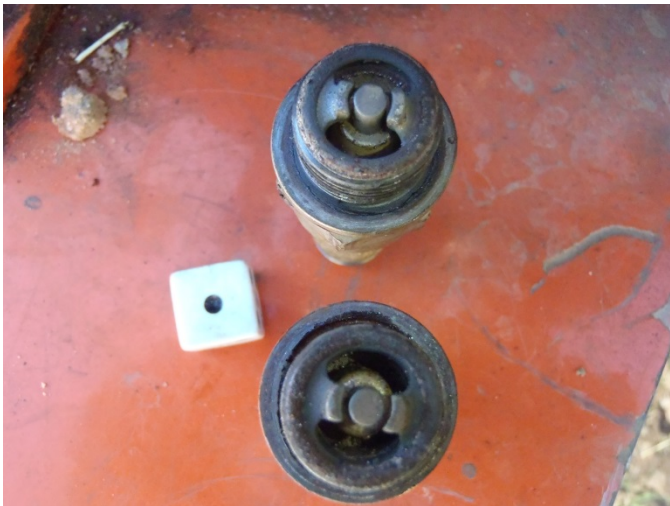
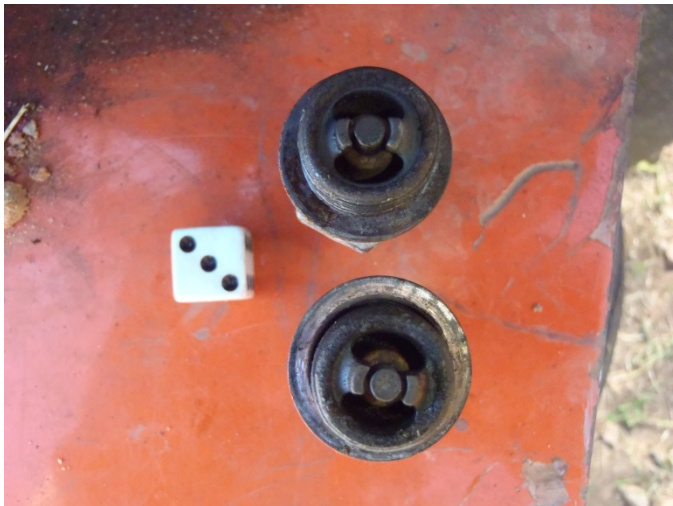
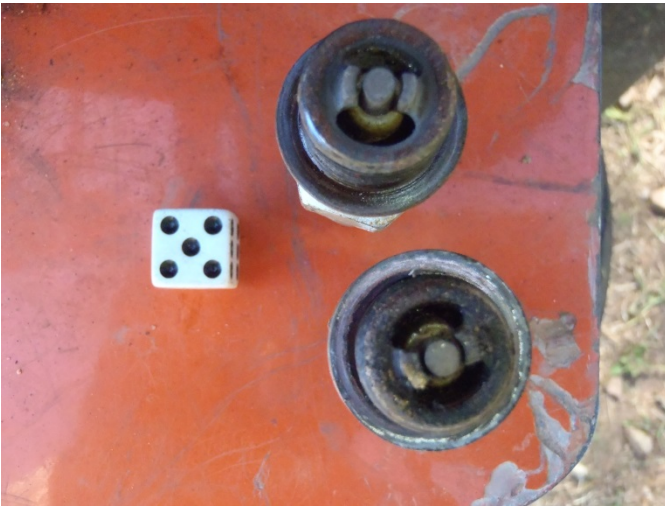
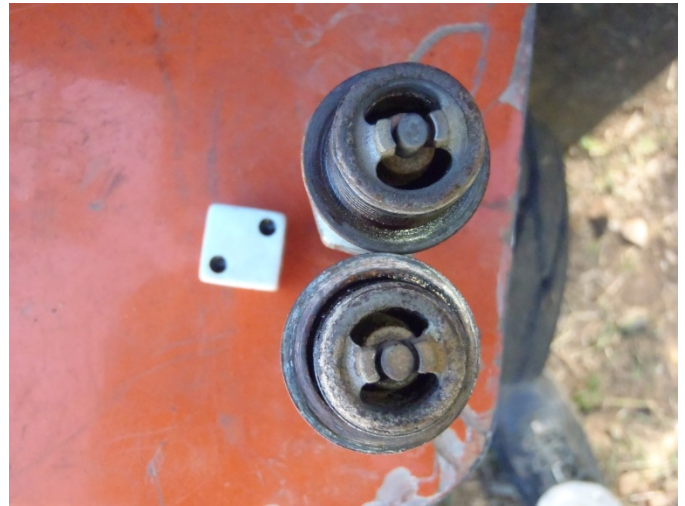
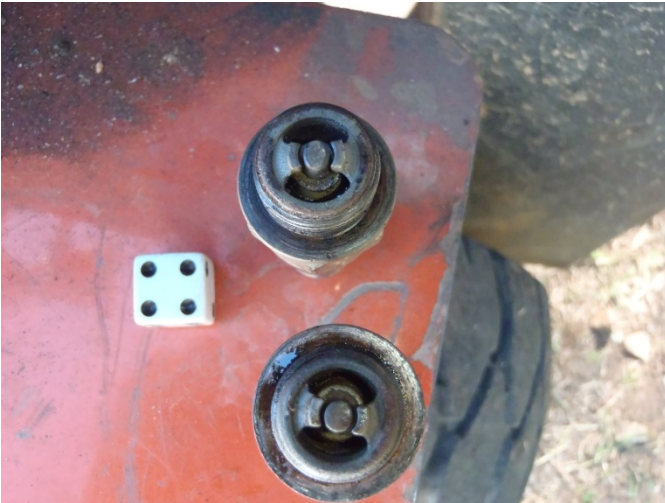
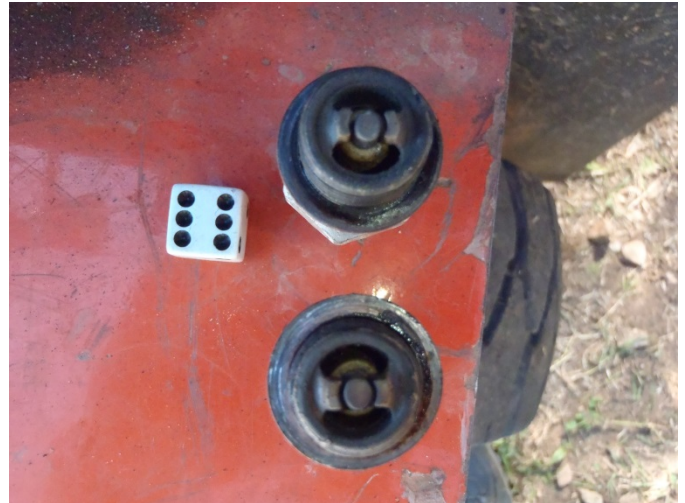
| Condition: | All of the spark plugs remained installed in their respective cylinders and were undamaged. The spark plugs were removed and all of the spark plugs displayed normal operating signatures when compared to Champion Aviation Service Manual AV6-R and Autolite L-1710A Manual. It was noted that during magneto impulse coupling engagement all of the spark plugs were capable of conducting a spark between the ground and center electrodes. | |

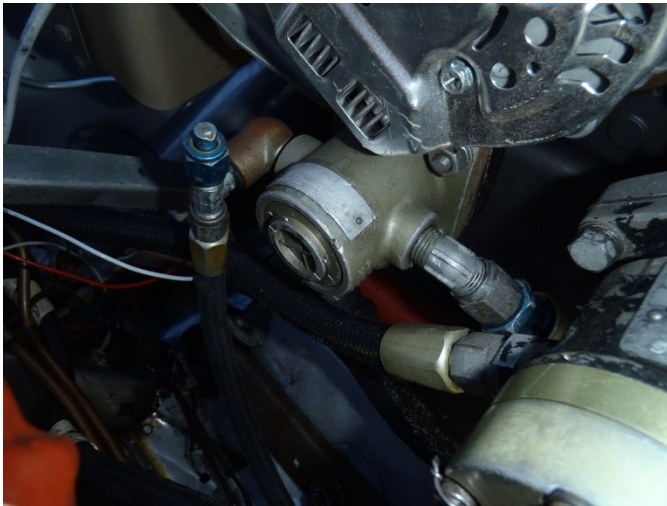
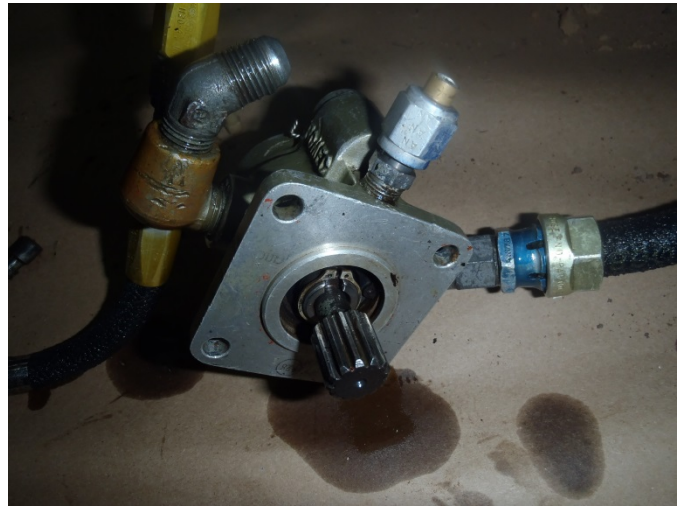
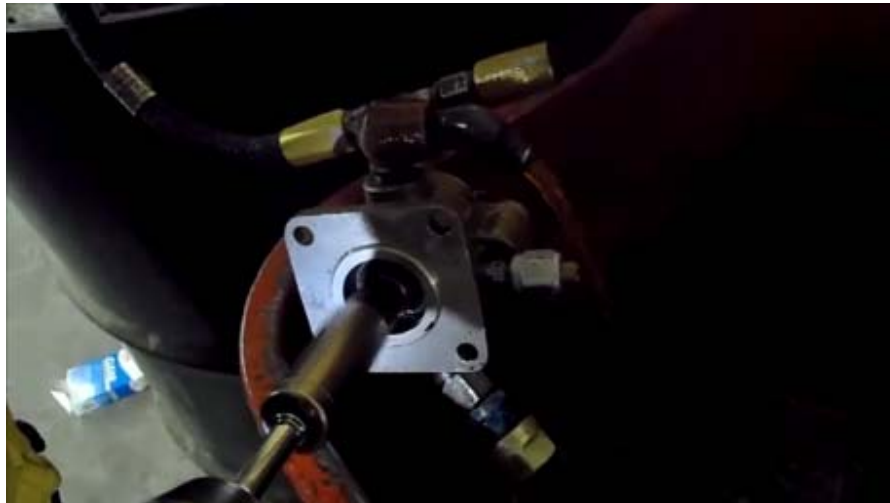
The fuel pump remained attached to its respective installation point and was undamaged. It was noted that the fuel pump inlet and fuel pressure indication fuel lines were disconnected prior to the investigator's examination. The fuel pump was removed and the fuel pump inlet line was submersed in a solvent tank; the fuel pump drive was driven by an electric drill and it was noted the fuel pump was capable of pumping the solvent. There were no anomalies noted with the fuel pump.

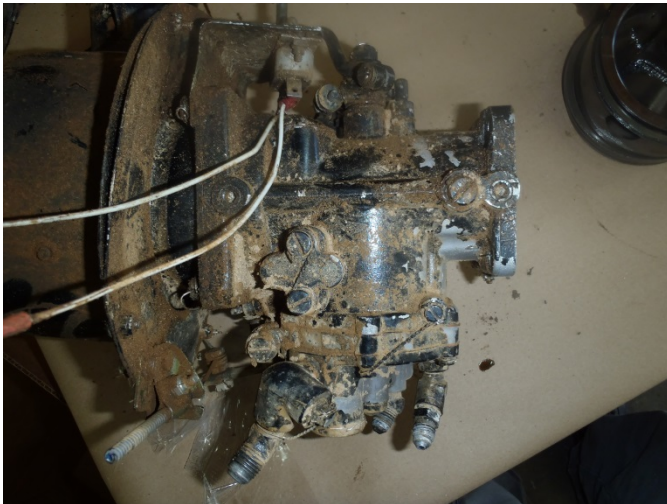
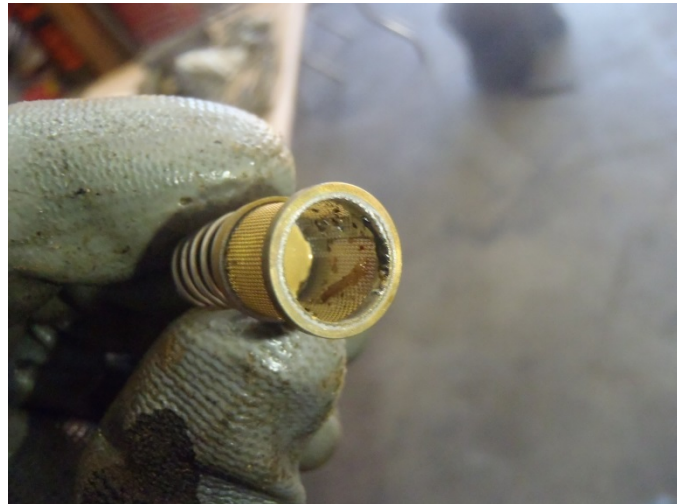
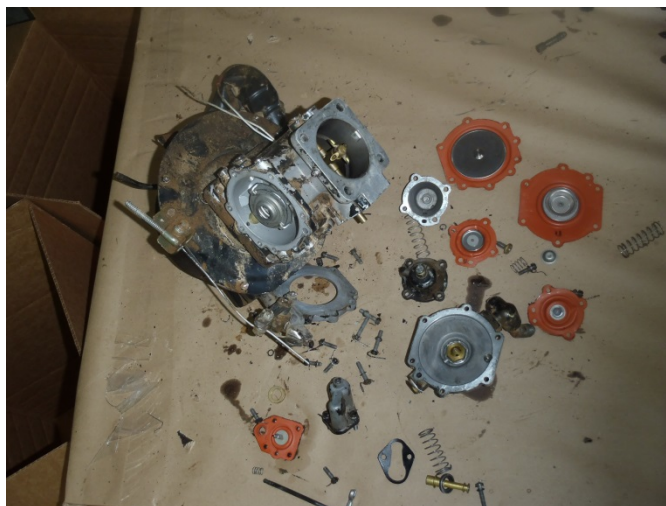
The carburetor remained attached to the intake system and sustained some damage consistent with impact damage. All of the fuel lines and control cables were noted to be secure and control cable continuity was established by moving the controls at the throttle quadrant. The carburetor was removed from the engine and disassembled for inspection. All of the internal components displayed normal operating signatures. It was noted that the fuel screen had a small amount of organic material consistent with dirt and grass contained within the screen; however, the screen was not blocked and there was no foreign material found in any of the carburetor chambers. Compressed air was blown through the final chamber of the carburetor to check the carburetor jets for blockages; there were no blockages noted. There were no further anomalies noted with the carburetor.

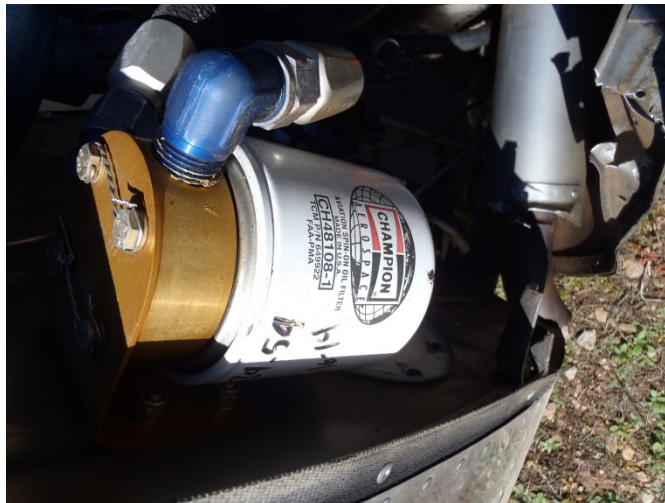
The aircraft was equipped with a remote oil filter system. The oil filter remained secure and there were no signs of leaks. Due to the type of inspection performed the filter was not removed from the aircraft.

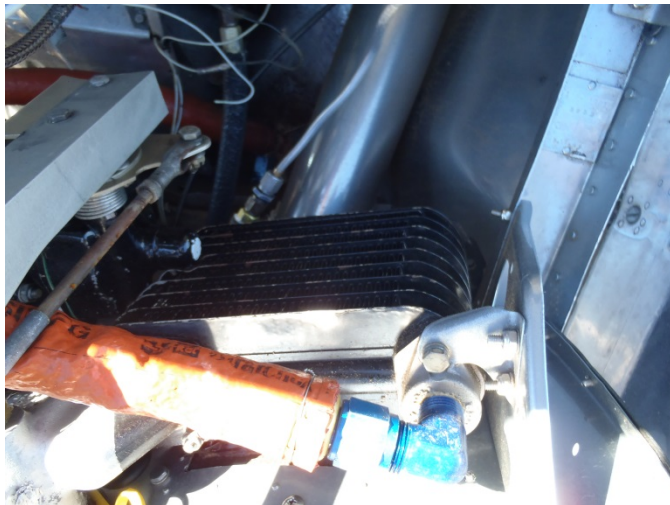
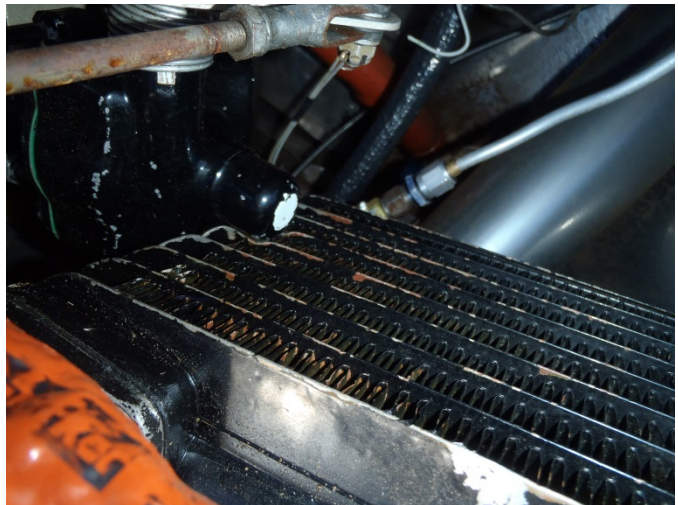
| Condition: | The oil cooler remained attached to its respective installation point and sustained damage consistent with impact damage caused by the propeller governor striking the oil cooler. There were no anomalies noted. | | |

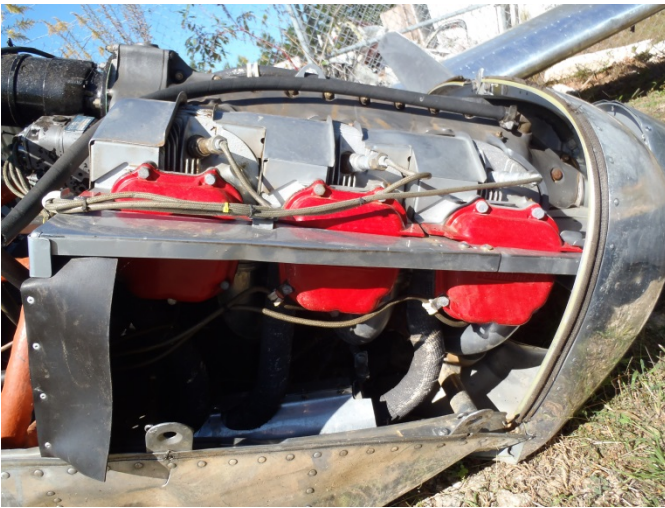
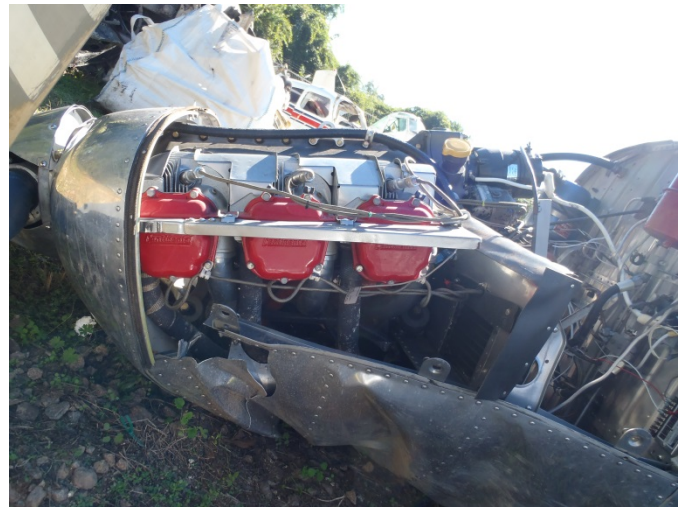
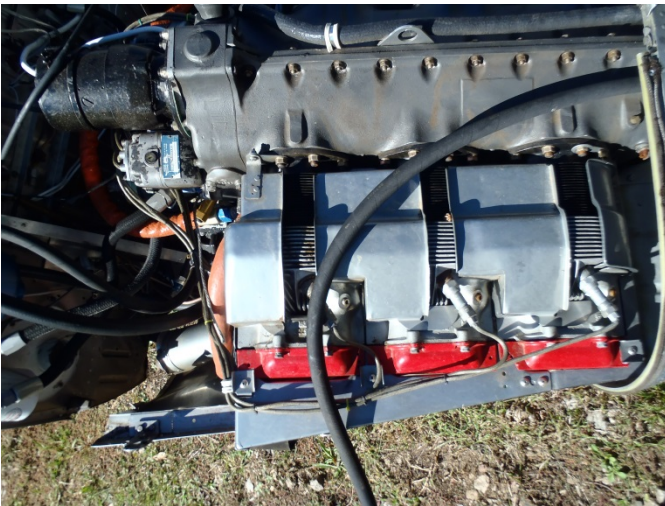
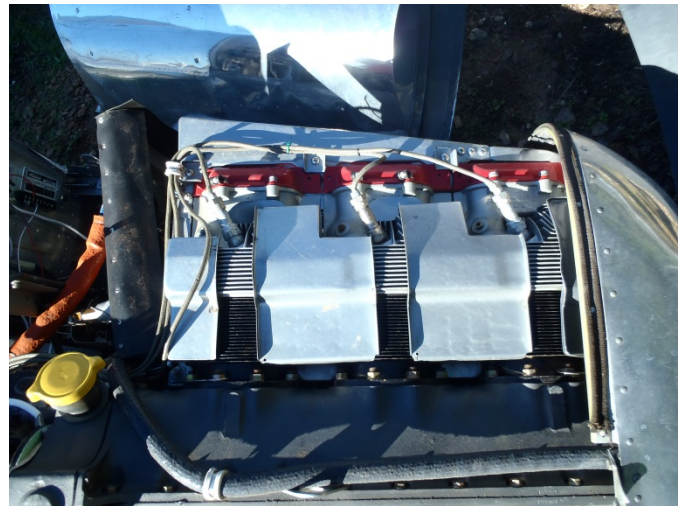
| CYLINDERS | P/N: Inaccessible | S/N: Inaccessible | |
|---|---|---|--|
| Condition: | All of the cylinders remained attached to their respective installation points and were undamaged. The cylinders were inspected using a borescope; the #1 cylinder bore displayed some corrosion, the remaining cylinder bores were free of anomalies. The valve heads and piston heads were inspected using the borescope; the components displayed normal operating and combustion signatures. The crankshaft was rotated by hand and it was noted that all of the cylinders displayed good thumb compression and suction. | | |

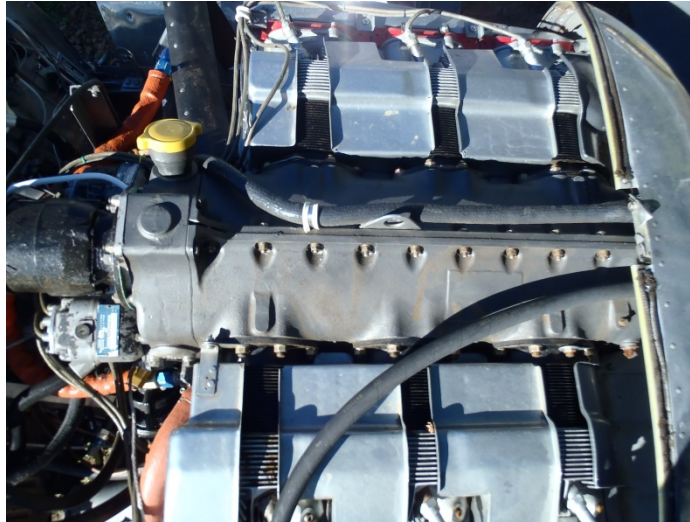
| CRANKCASE | Casting Number: | 1-3-5: Inaccessible | 2-4-6: Inaccessible | S/N: Inaccessible |
|---|---|---|---|---|
| Condition: | The crankcase was undamaged and displayed normal operating signatures. It was noted that the engine dataplate was missing from the crankcase. There were no anomalies noted that would have prevented normal operation. | | | |

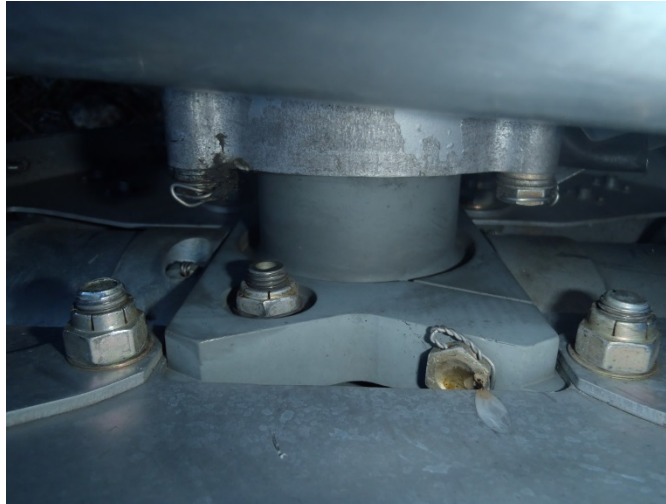
The crankshaft remained intact and was capable of normal rotation. The crankshaft was rotated by hand and continuity was established between the crankshaft, camshaft, connecting rods, and associated components. There were no anomalies noted with the crankshaft.

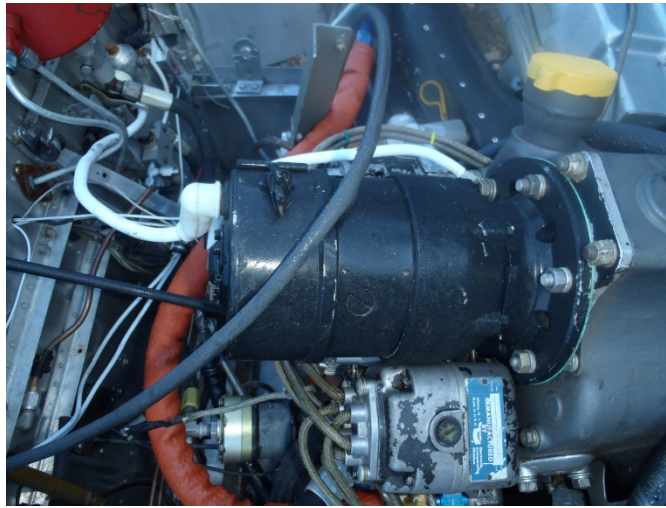
The starter remained attached to the engine and was undamaged. There were no anomalies noted with the starter.

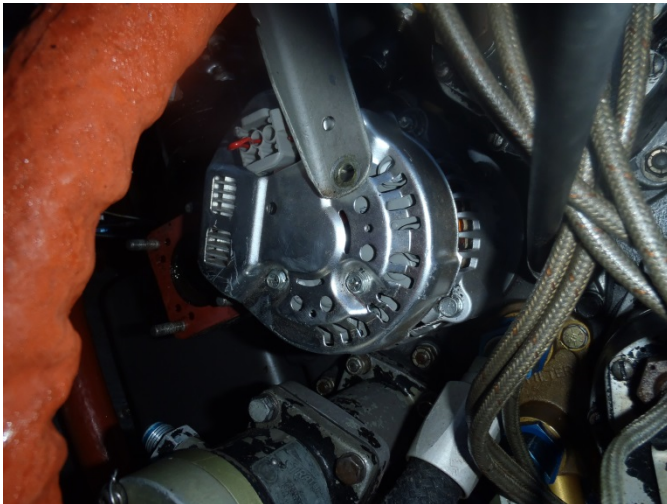
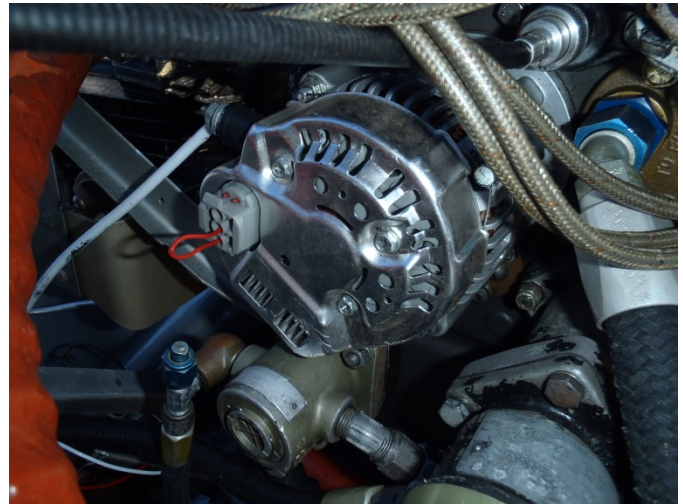
The alternator remained attached to its respective installation point and was undamaged. There were no anomalies noted with the alternator.

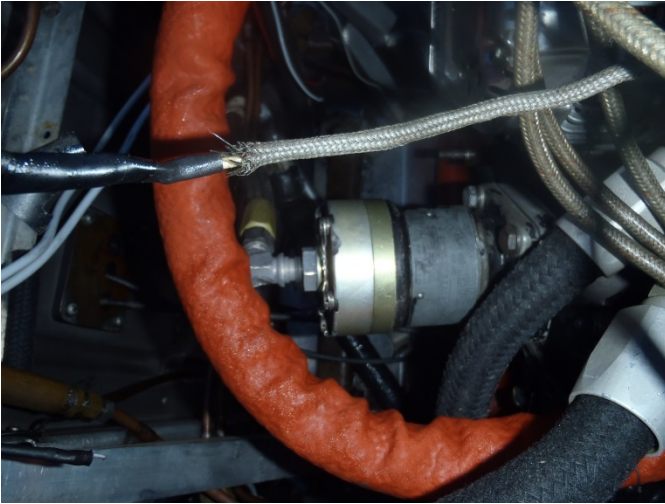
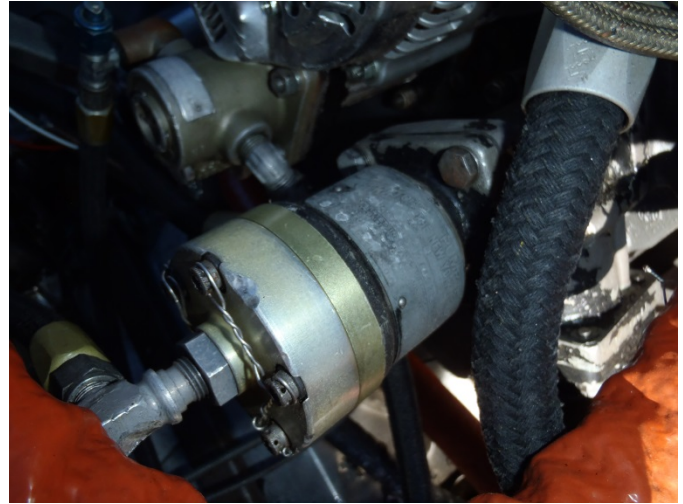
The engine driven hydraulic pump remained attached to the engine and was undamaged. There were no anomalies noted with the hydraulic pump.

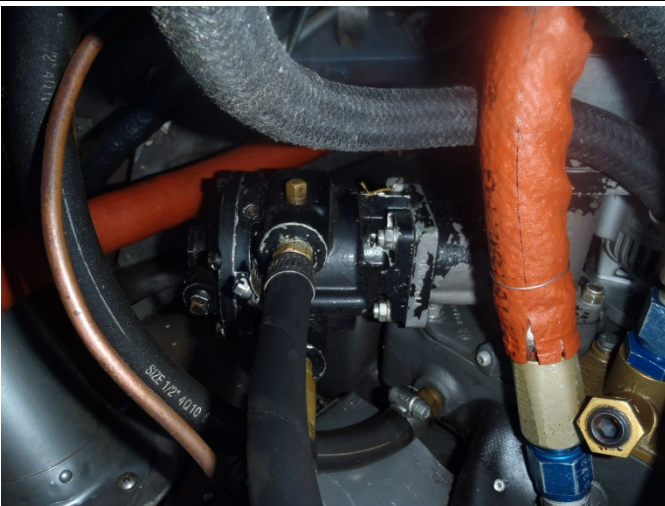
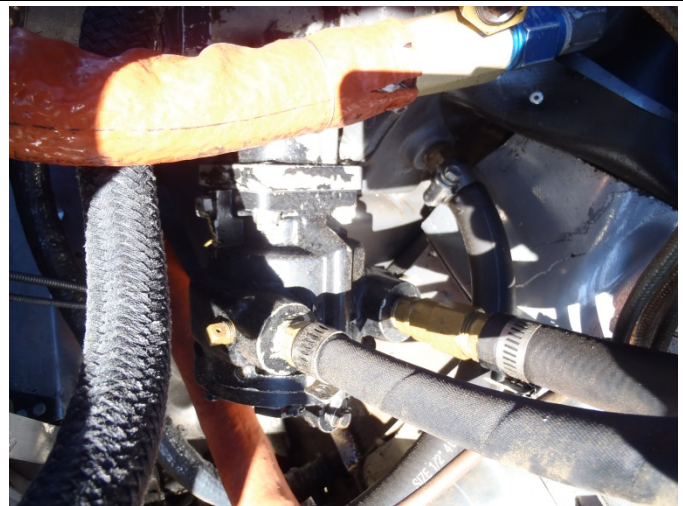
The vacuum pump remained attached to its respective installation point and was undamaged. There were no anomalies noted with the vacuum pump.

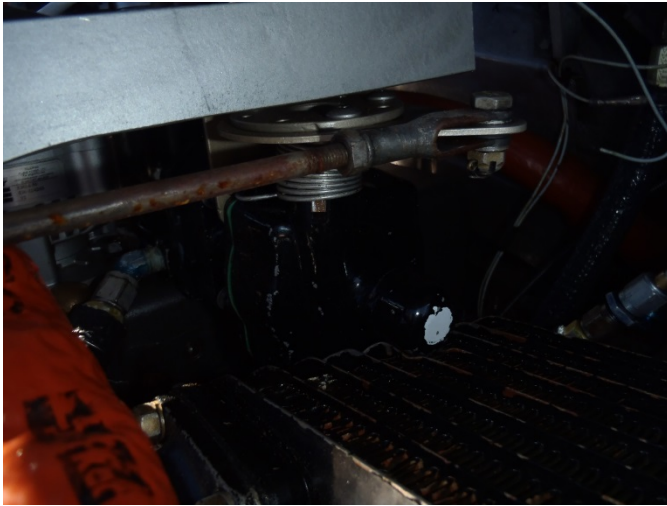
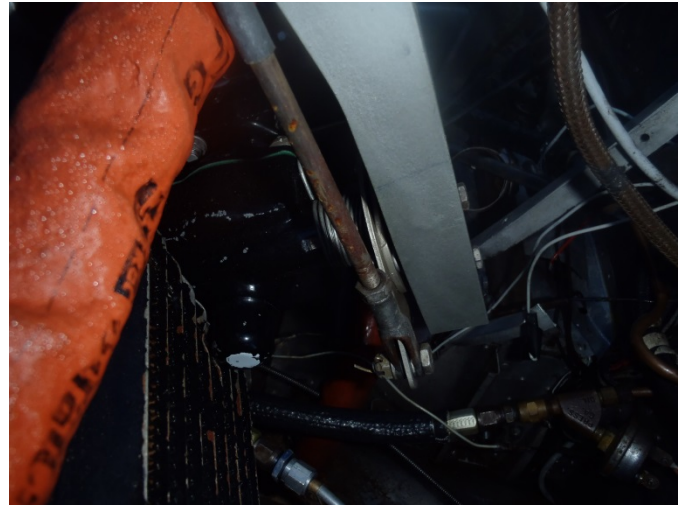
The propeller governor remained attached to its respective installation point and sustained some damage consistent with impact damage and was impinged against the oil cooler. The propeller control cable remained secured to the propeller governor. There were no anomalies noted with the governor.

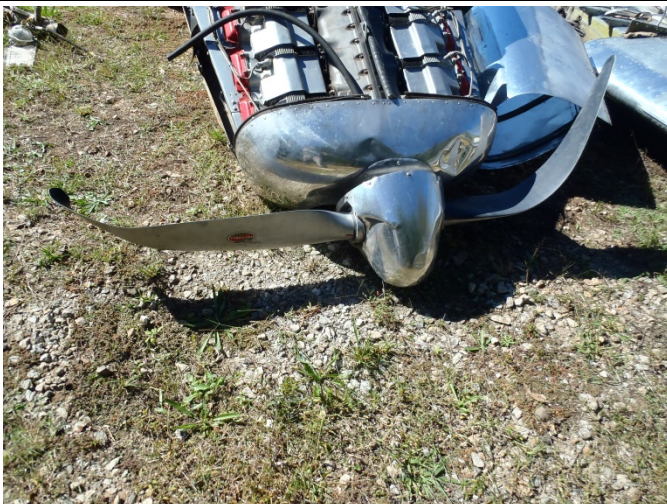
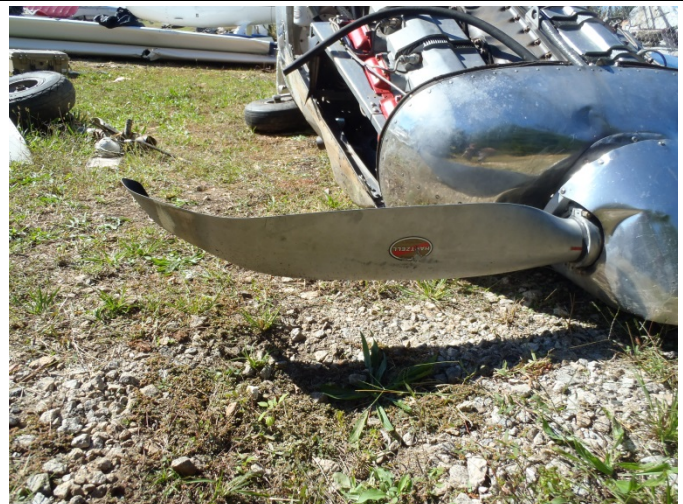
The two blade, variable pitch propeller remained attached to the crankshaft and sustained damage consistent with impact damage. One blade displayed chordwise scratches, aft bending deformation near the blade tip, and some tip curling. The other propeller blade displayed aft bending deformation, and leading edge polishing and chordwise scratches near the propeller tip.
