# NATIONAL TRANSPORTATION SAFETY BOARD

## MATERIALS LABORATORY FACTUAL REPORT

Report No. 14-062

Place : Houlton, Maine  
Date : January 17, 2014  
Vehicle : Eurocopter AS350 B3  
NTSB No. : ENG14TA096  
Investigator : Paul Cox, AS-ERA

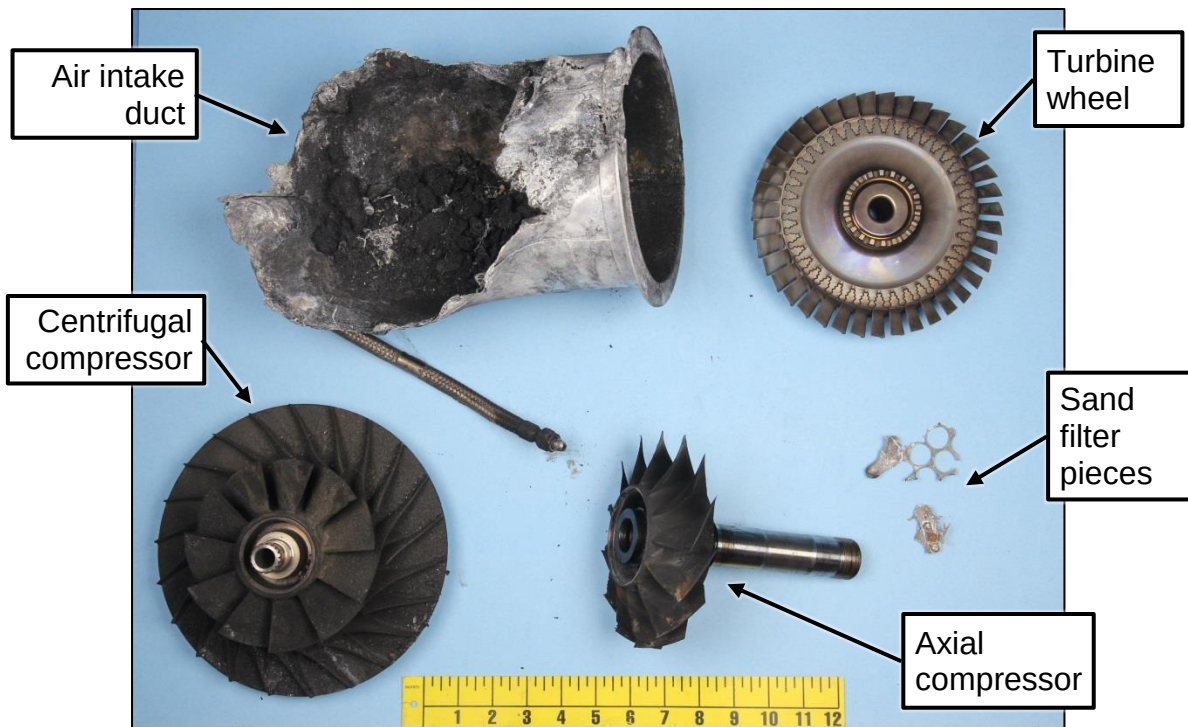
An overall view of the submitted components is shown in figure 3. The axial compressor, centrifugal compressor, and gas generator turbine wheels were intact. A large portion of the air intake duct and most of the sand filter were missing.

The air intake duct was discolored and the edges around the missing portion of the duct were wrinkled and distorted with flowing deformation consistent with exposure to high heat. The interior of the duct contained charred debris with embedded glass fibers consistent with remains of the engine cowling, which was made of glass fiber reinforced composite and honeycomb. Pieces of aluminum alloy material were also found within the duct. Most of the pieces had a flowed appearance consistent with solidification from a molten condition. Some of the pieces were pieces of sheet with a circular cut-out pattern consistent pieces of the sand filter. Additional sand filter pieces included in the submitted components are shown in figure 1. Flowed deformation from a previously molten condition was observed at the edges of several pieces identified as pieces of the sand filter.

Figure 1. Overall view of submitted components.

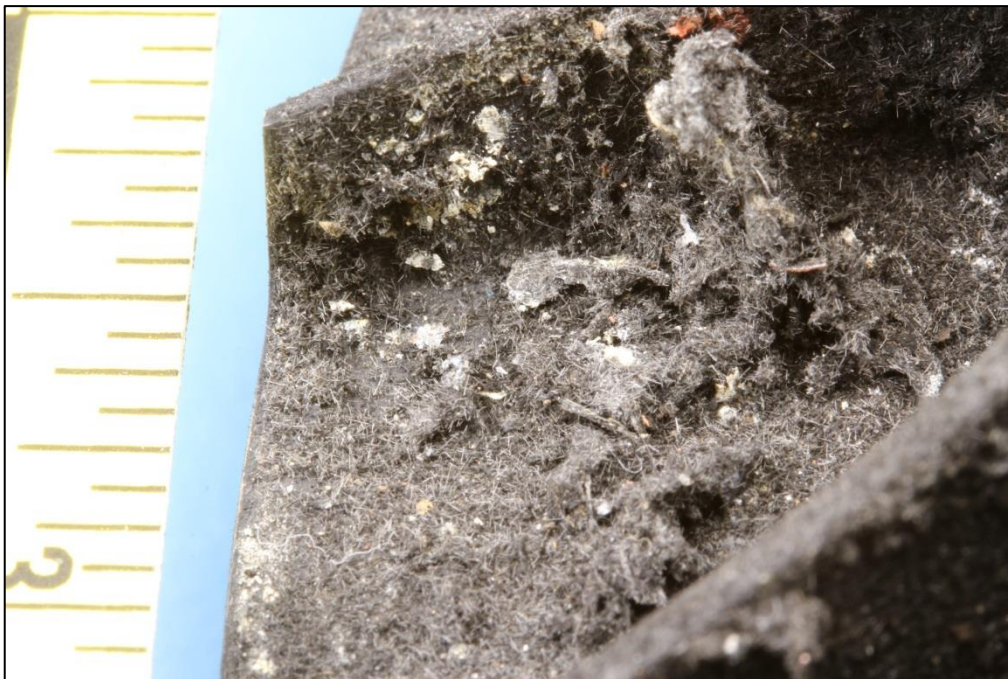
Charred debris with embedded glass fibers were observed on both the axial and centrifugal compressor wheels. A view of an area where this debris accumulated in the

axial compressor is shown in figure 2. Some glass fiber segments were also observed on the gas generator turbine wheel.

Figure 2. Close view of charred debris on the centrifugal compressor.

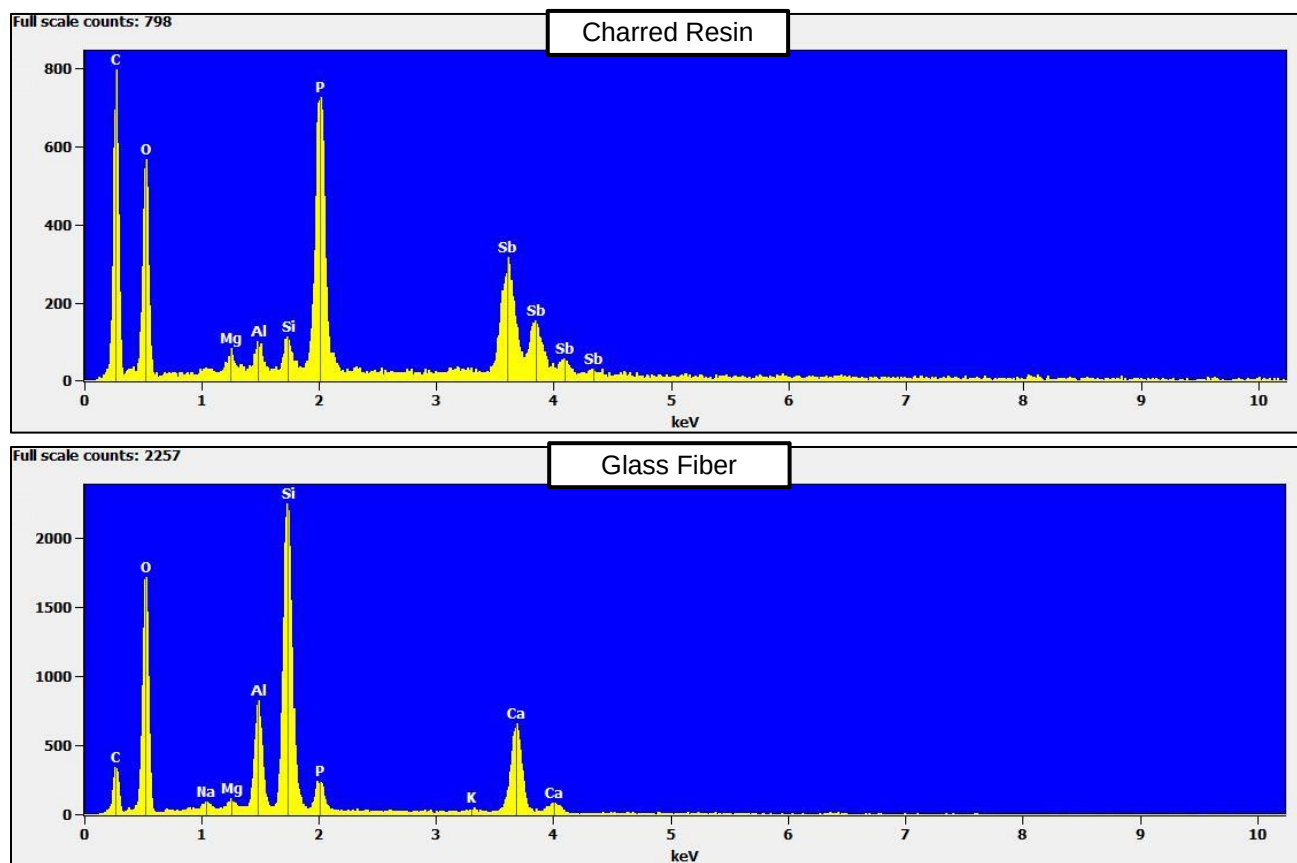
A sample of the charred debris with embedded fibers was removed from the air intake duct and analyzed using energy dispersive x-ray spectroscopy (EDS) in a scanning electron microscope (SEM). The EDS spectra of the charred resin material and the fiber remnants are shown in figure 3.

Figure 3. EDS spectra for the charred resin debris (upper spectrum) and fiber remnants (lower spectrum) collected from inside the air intake duct.

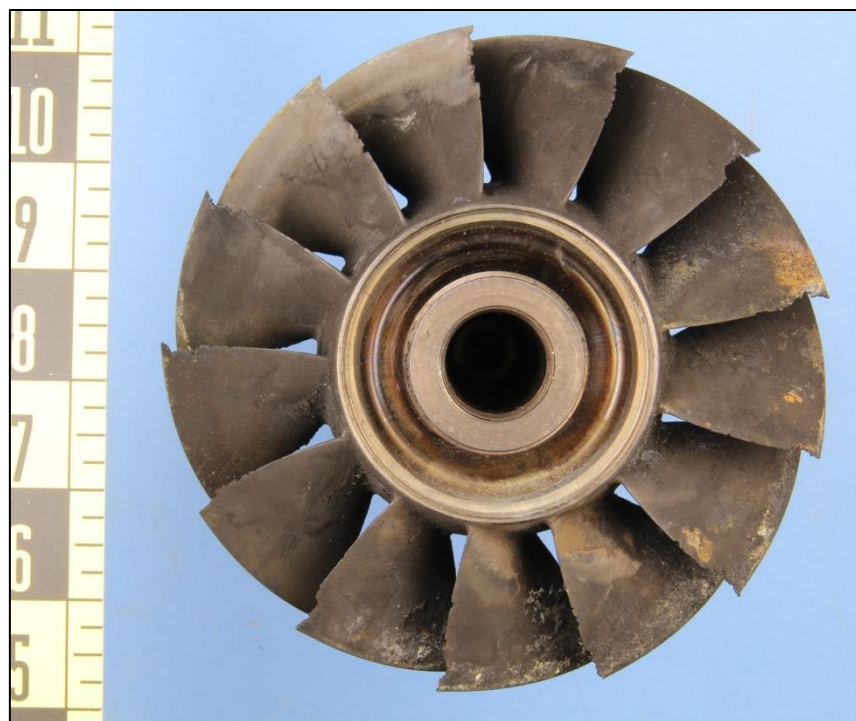
An overall view of the axial compressor wheel is shown in figure 4. Deposits of varying color including black, gray, and orange were observed on the airfoil surfaces. Charred deposits with embedded fibers were observed mostly near the base and pressure sides of the blades. All of the blades showed impact damage at their leading edges near the blade tips. Close views of impacts on two of the blades is shown in figure 5. Deposits of varying colors are shown in the upper image in figure 5. A lip of material as indicated in the lower image in figure 5 was observed at the edges of many of the impact areas.

Figure 4. Overall view of the upstream side of the axial compressor.

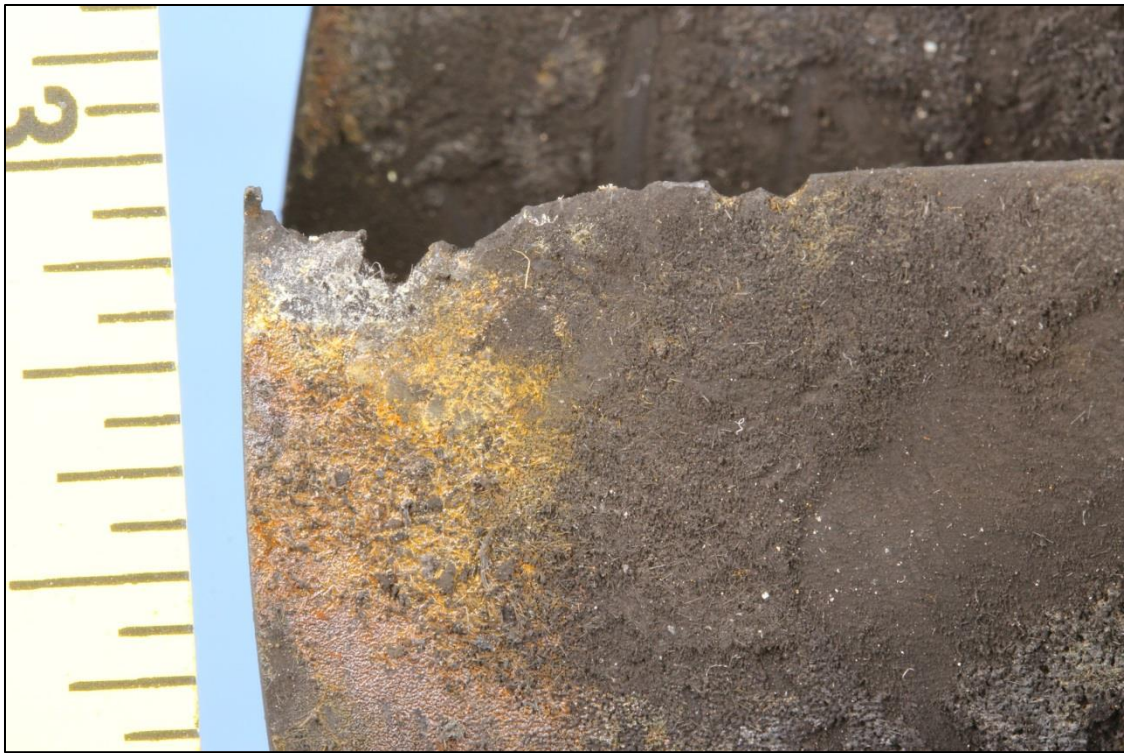
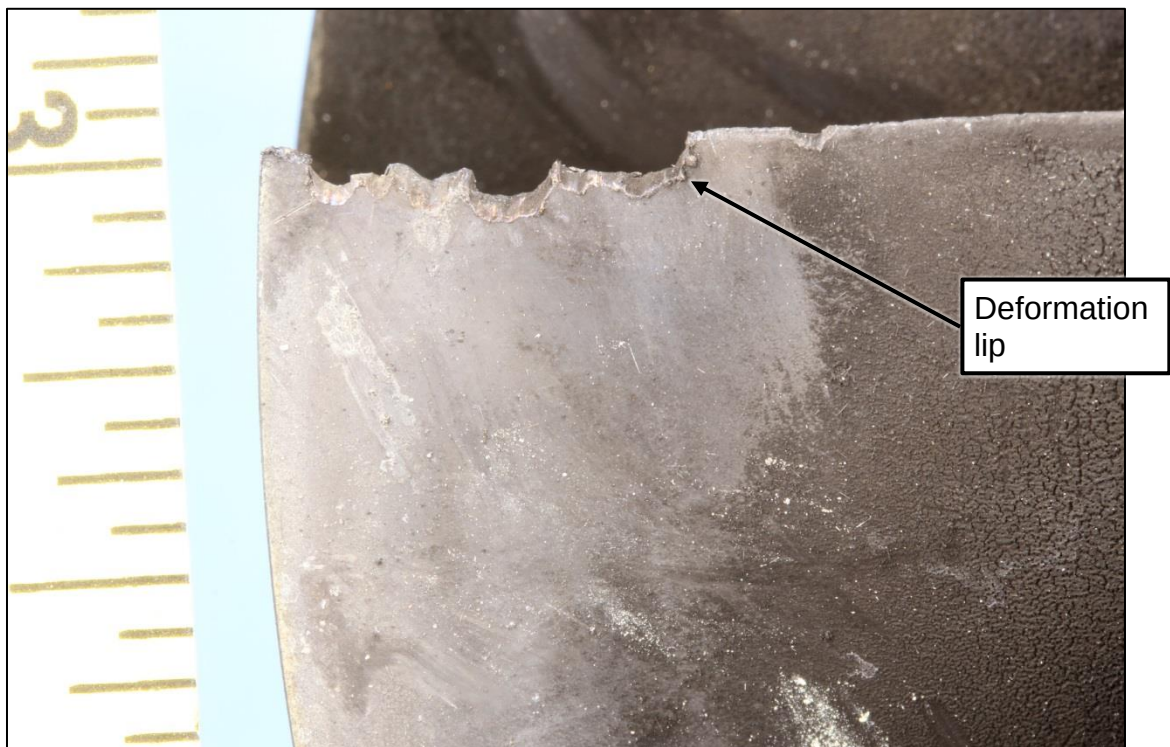
Figure 5. Close views of impact damage near the tips of axial compressor blades.

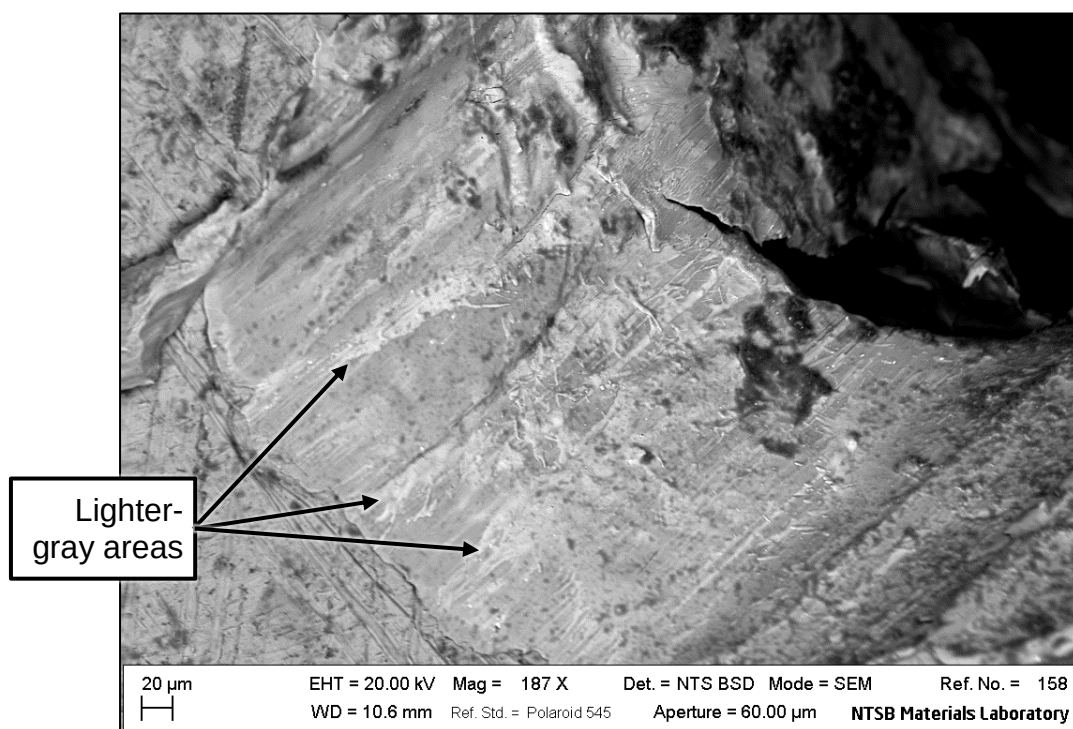
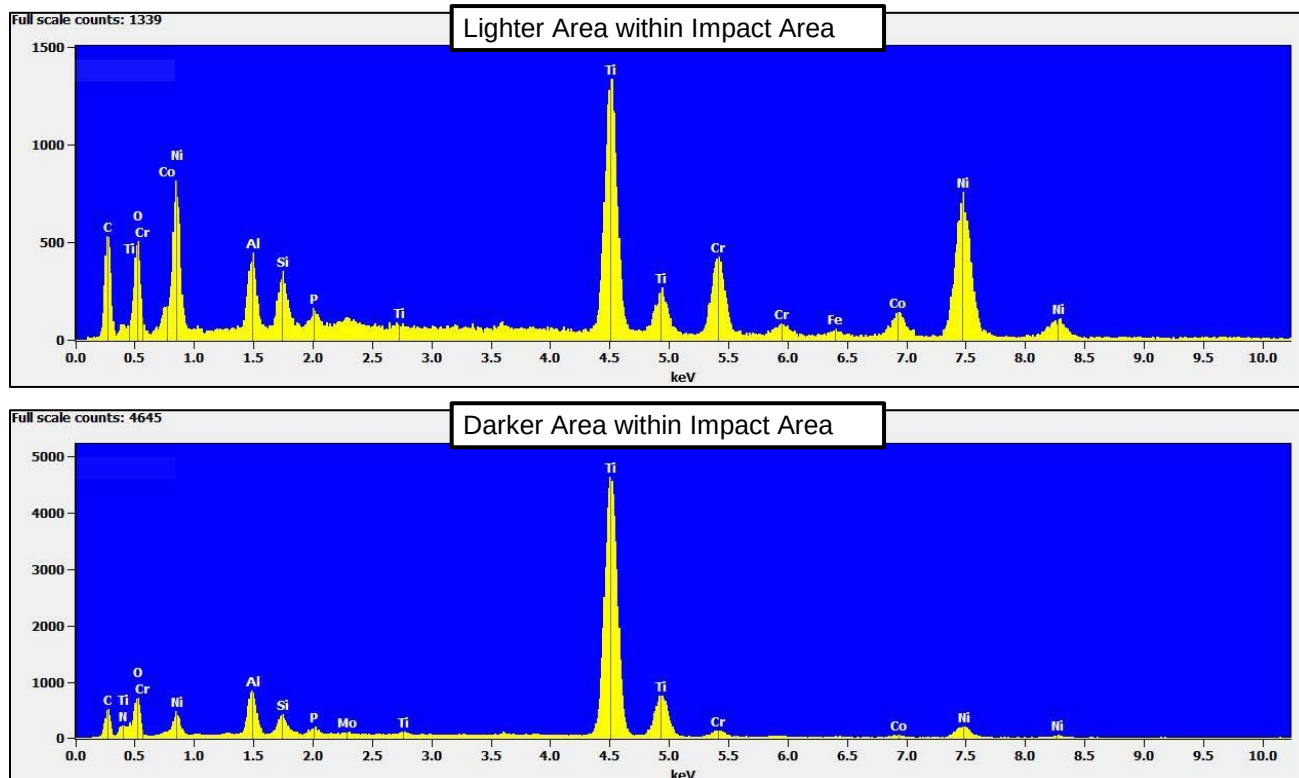
A pie-shaped section of the axial compressor wheel was cut to facilitate examination of the impact damage at the leading edge of one of the blades. An image of the impact area on the sectioned blade as viewed in the SEM using a backscatter detector in composition mode<sup>1</sup> is shown in figure 6. The area showed smearing and deformation consistent with sliding contact. Streaks of areas with a relatively lighter shade of gray were observed as indicated in the image in figure 6. The EDS spectrum of the lighter gray areas are shown in the upper spectrum in figure 6, and results for darker gray areas within the impact region are shown in the lower spectrum in figure 6. Higher peaks of nickel, cobalt, iron, and chromium were observed in the lighter shaded areas relative to the darker shaded areas.

Figure 6. SEM image of an area of impact on an axial compressor blade as viewed using backscattered electrons (upper image) and EDS spectra of areas within the SEM image showing compositional differences between the lighter gray areas indicated in the image (upper spectrum) versus the darker gray areas (lower spectrum) within the impact area.

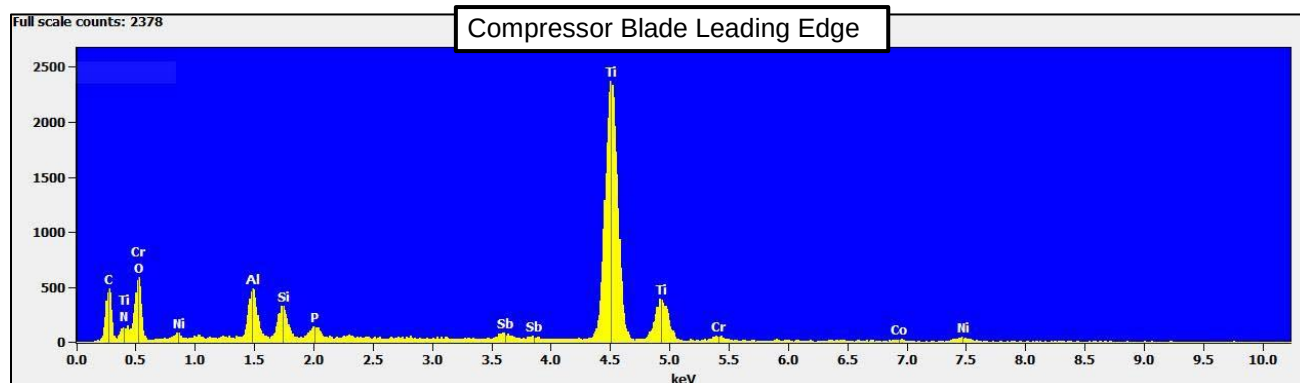
Areas of the axial compressor blade away from the impact area were also analyzed using EDS. Figure 7 shows a typical EDS spectrum of the blade leading edge surface away from the area of impact. For comparison, the EDS spectrum on the cut surface representing the bulk composition of the titanium alloy axial compressor is shown in figure 8.

Figure 7. Typical EDS spectrum of the axial compressor blade leading edge surface at midspan (away from the area of impact).

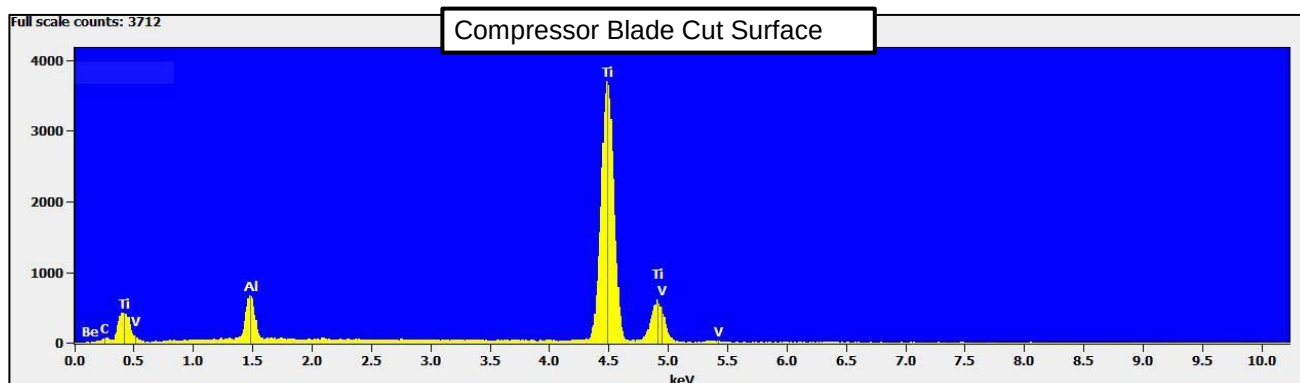
Figure 8. EDS spectrum of the axial compressor blade as collected from the surface of a cut through the blade made to facilitate the SEM examination and EDS analysis of the axial compressor.

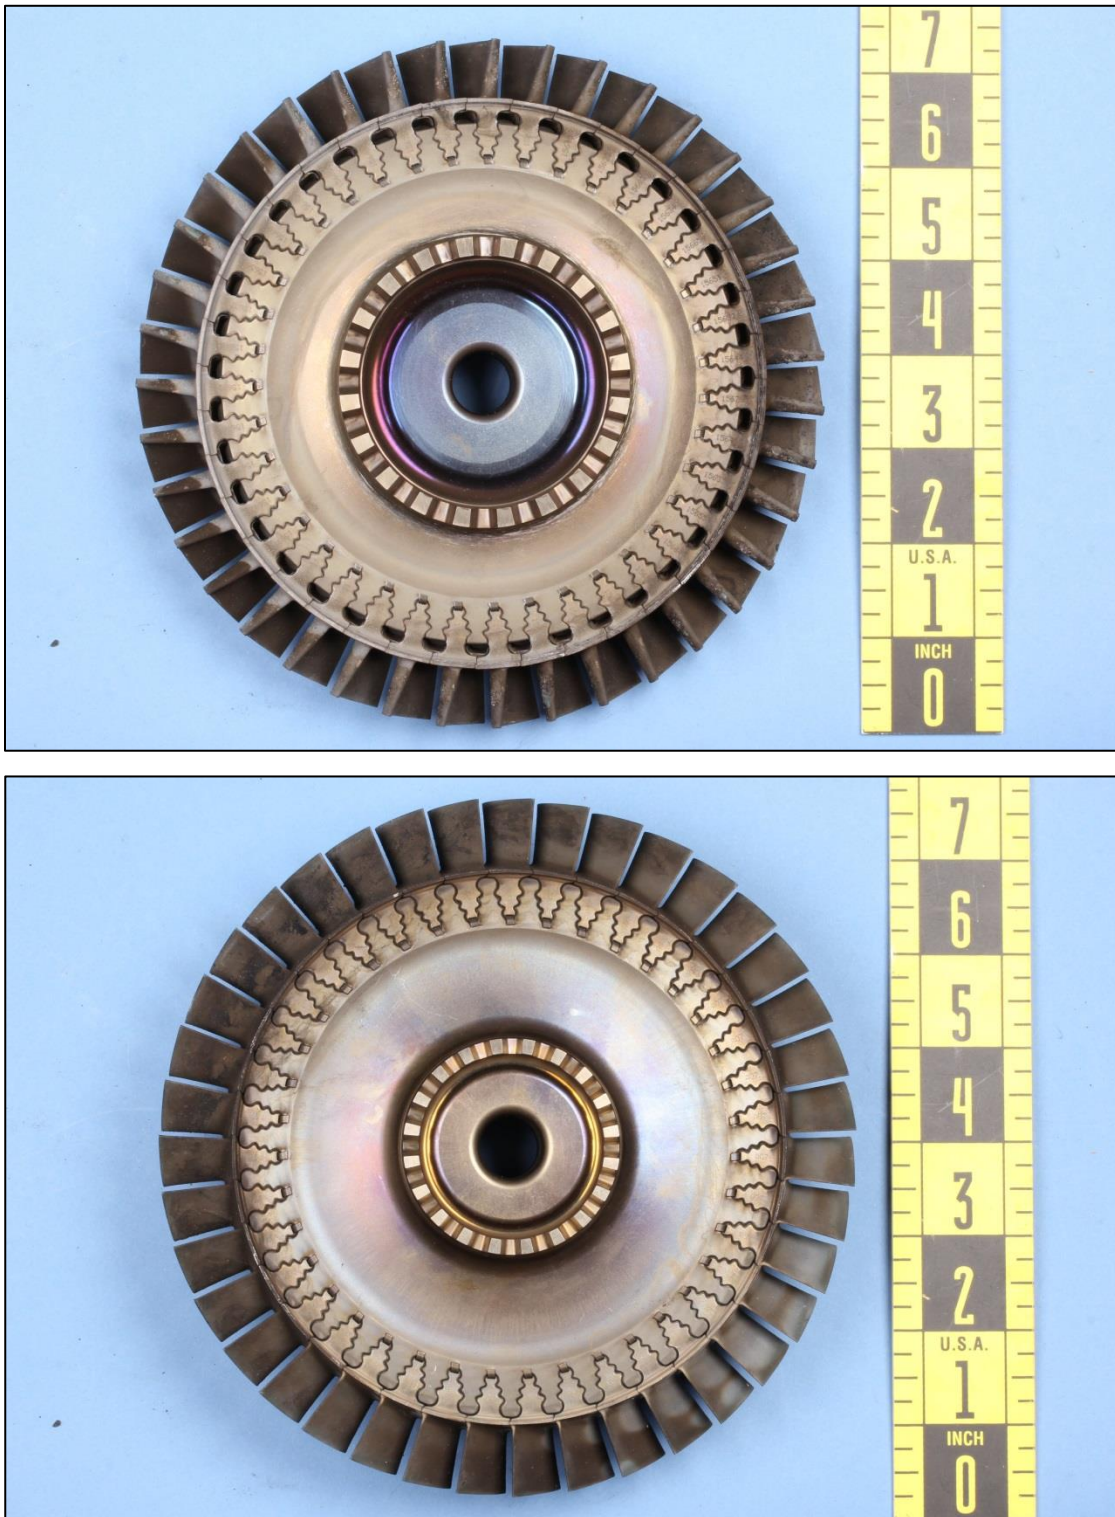
Overall views of the gas generator turbine wheel are shown in figure 9 showing the upstream and downstream sides of the wheel. The blades were generally brown in color with areas of some blades appearing light gray. Light gray and black deposits were observed mostly at the leading edge and on the convex face of the blades. Some

shallow spalled areas with green oxides were observed on the leading edges of some blades.

Figure 9. Overall views of the upstream (upper image) and downstream (lower image) sides of the gas generator turbine wheel.

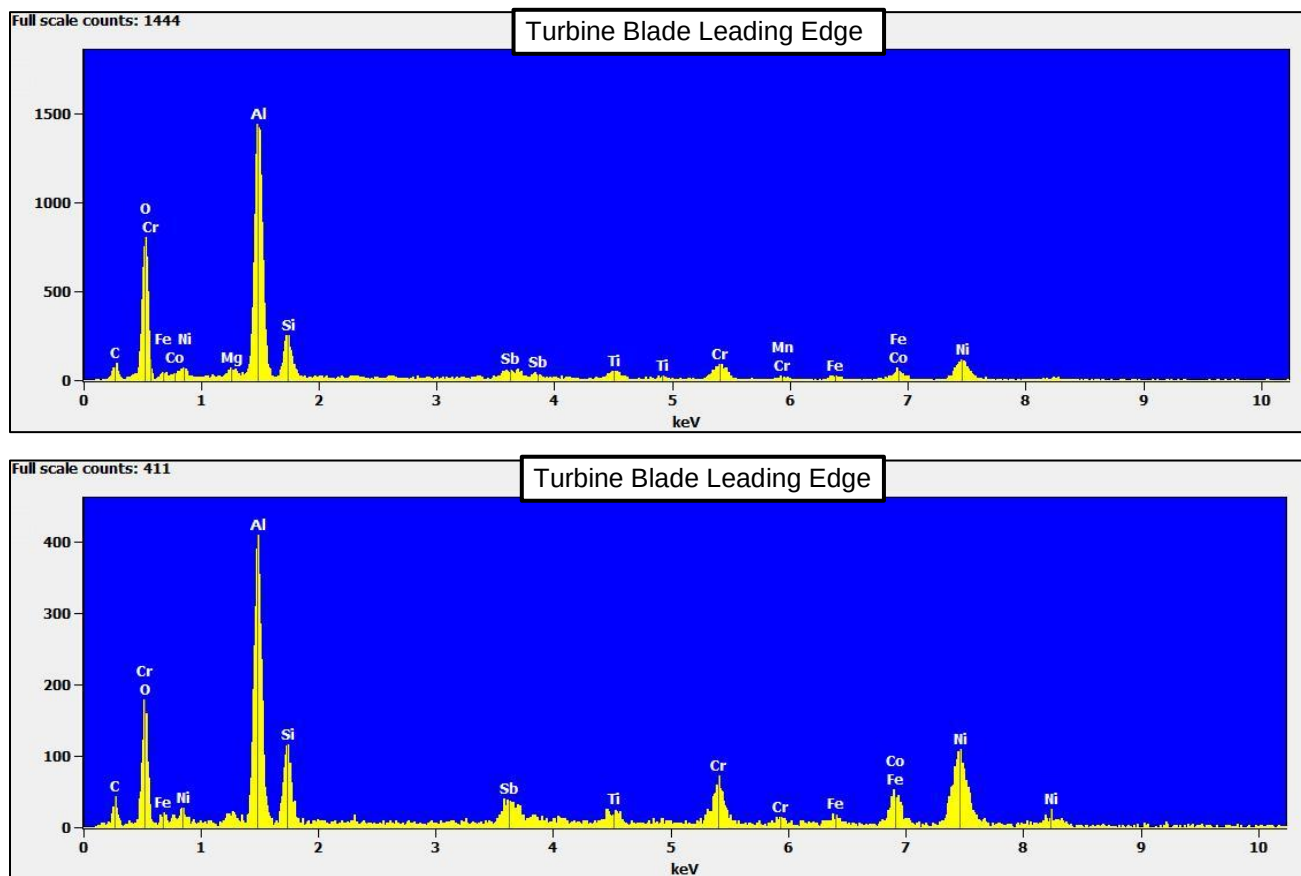
One of the blades showing a typical deposit pattern on the leading edge was removed from the gas producer turbine for SEM examination and EDS analysis. Typical EDS spectra covering relatively large areas of the leading edge deposits are shown in figure 10. Some areas of the deposits appeared relatively thicker when viewed using the secondary electron detector and appeared relatively darker when viewed using the backscatter detector. EDS analysis showing typical spectra for these thicker deposits that appeared darker when viewed using the backscatter detector is presented in figure 11. The convex side of the blade was analyzed using EDS at several locations along the midchord, and typical spectra for these areas are presented in figure 12.

Figure 10. Typical EDS spectra of areas of the surface of the removed gas generator turbine blade at the leading edge near midspan.

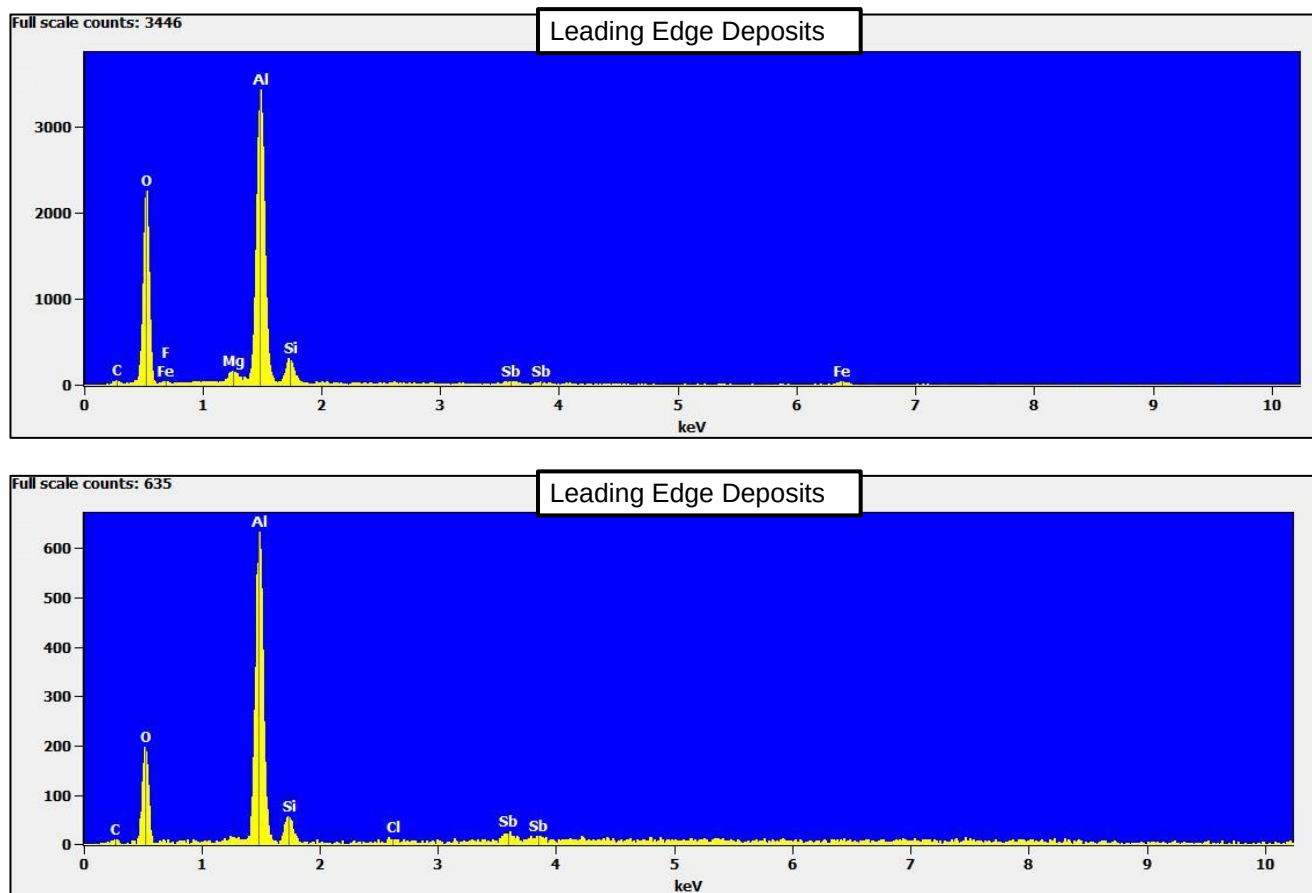
Figure 11. Spot EDS spectra of the leading edge deposits on the removed gas generator turbine blade showing results for deposit areas that appeared to be thicker on the surface when imaged using secondary electrons and appeared darker than the surroundings when imaged using backscattered electrons.

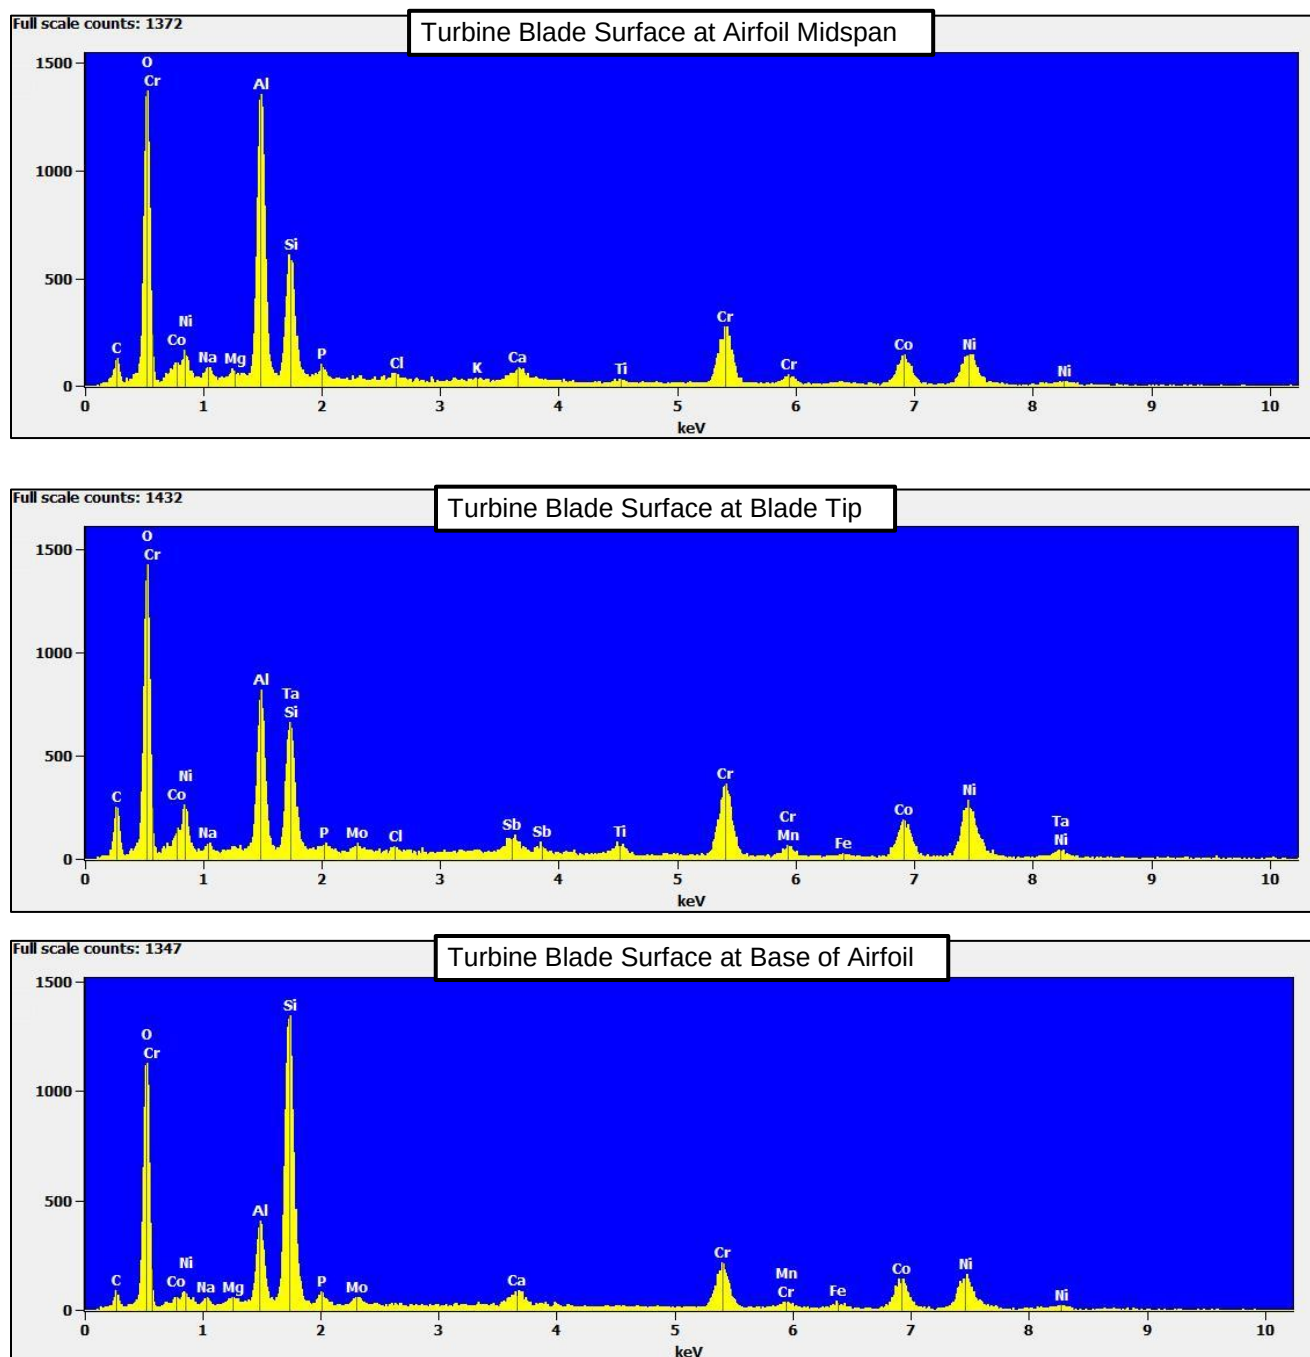
Figure 12. EDS spectra for areas of the removed gas generator turbine blade surface at the trailing edge near midspan (upper spectrum) and at the tip (middle spectrum) and the base (lower spectrum) of the airfoil near midchord.

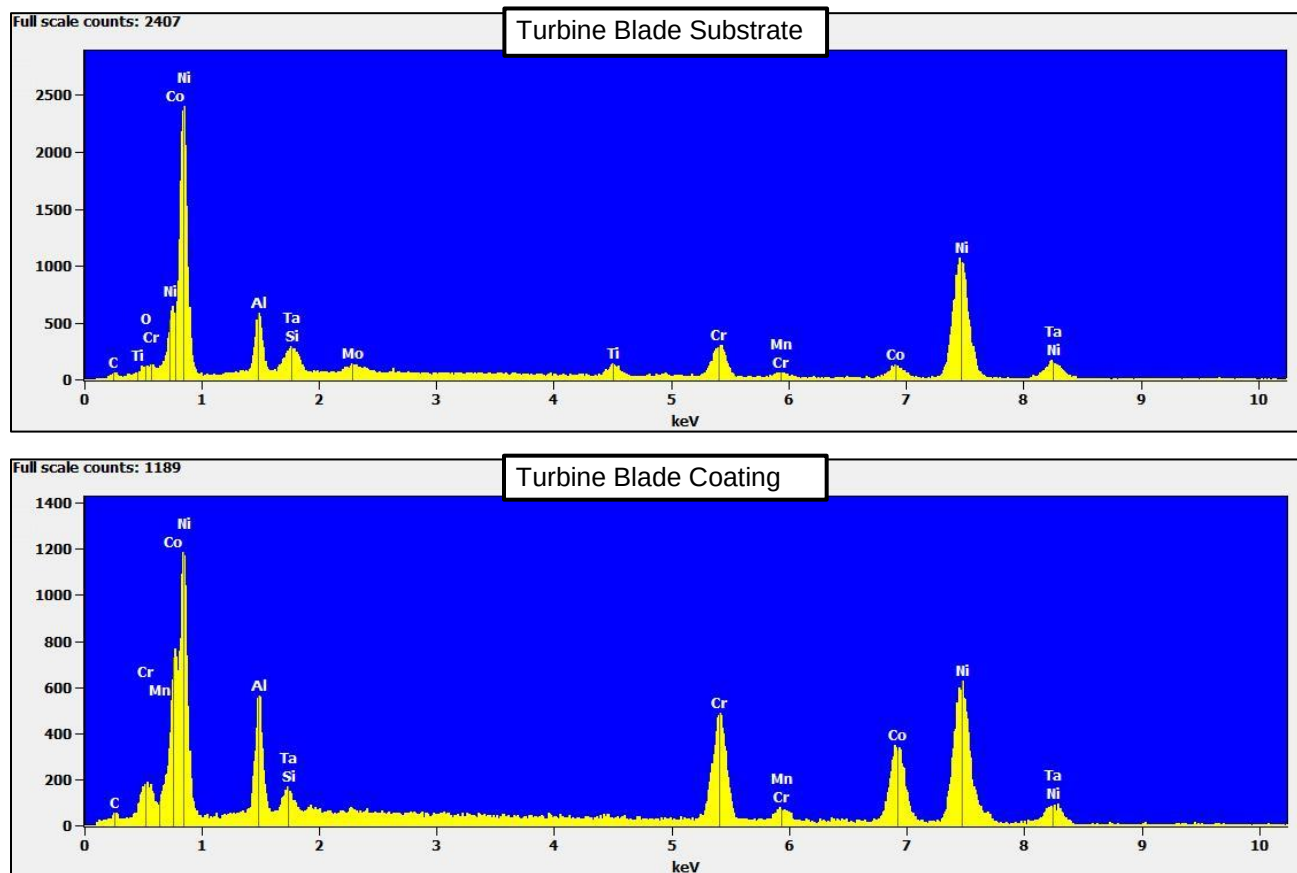
Next, the turbine blade was sectioned spanwise, and the cut surface was rough ground to a 600 grit finish. The sectioned piece was examined using SEM and EDS. AS viewed using backscattered electrons, the cross-section near the blade surface was a different shade of gray than the rest of the blade, consistent with a surface coating. Typical EDS spectra for the bulk of the blade cross-section (the substrate) and for the surface coating as analyzed on the cut surface of the blade are shown in figure 13.

Figure 13. EDS spectra from the surface of a cut through the removed gas generator turbine blade showing a typical spectrum for the substrate (upper spectrum) and a spot in the middle of the surface coating (lower spectrum).
