## VEMD, DECU and Harness examination

Document ID: **BEA\_n-ae140118\_tec01**  
Date of occurrence: 18/01/2014  
Place of occurrence: Houlton (United States)  
Aircraft type: AS 350 B3  
Registration number: **N578AE**  
Equipments examined:

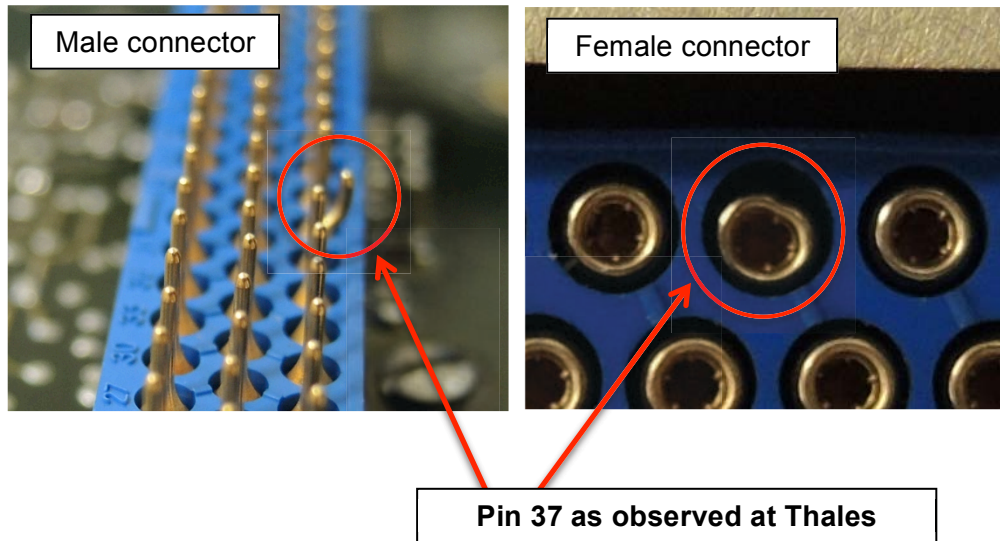
Picture taken during the visual inspection performed at Thales on 06/23/2014

An internal visual inspection of the DECU was performed by Thales after the ATP tests. It showed that the pin 37 of J11 male connector was bent as a “bayonet”.

The pin 37 of J11 connector is connected to the red light which indicates a red GOV signal.

The pins 37 of the male and female connector were found more damaged during the visual inspection at Thales than it was during the visual inspection performed at BEA. That indicates that the fact that the pin 37 of J11 male connector was bent as a "bayonet" directly resulted from the reassembly performed at BEA after the visual inspection.

According to the manufacturers (Turbomeca and Thales), pin 37 was initially correctly installed and that all the damages probably resulted from the BEA visual inspection.

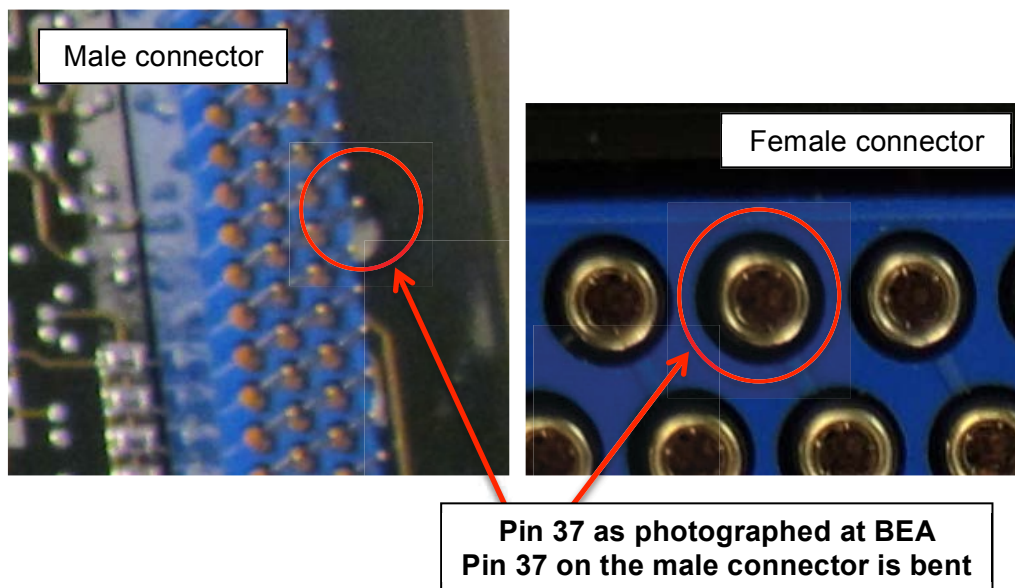
Pictures taken during visual inspection at BEA on 03/28/2014

During the boards inspection at the BEA, some photos of these connectors were taken. The condition of the pin 37 had not been initially observed. A review of the pictures was done by BEA after the visual inspection at Thales.
