# Inspector Statement

**Description:** N461MM Accident Investigation, Jacksonville, Florida, October 17, 2014  
NTSB # ERA-15-S-A-003

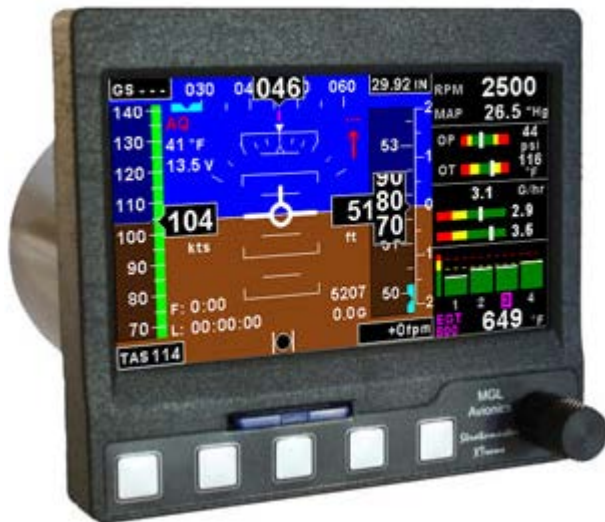
*Aircraft remains were inspected and could not locate the ignition system components. Remain only the back engine adapter plate that houses the ignition system. The starter was found in several pieces and the starter attach mount was heavily damaged. A search was conducted and found the gas tank, (recovery team stated it was half full of gasoline,) the carburetor with fuel hose assembly attached and inline valve in the open position, intake tubes and intake engine adapters. These components looked as being in good working condition at time of impact. Found an FL-760 VHF Transceiver Comm radio heavily damage; an MGL Avionics Stratomaster face plate but no memory card and the separated body of the Stratomaster XTreme. Also found an RT-359A Transponder, also heavily damaged and still attached to a small piece of the instrument panel with 6 circuit breakers and the ignition switch.*

Back View of XTreme Instrument

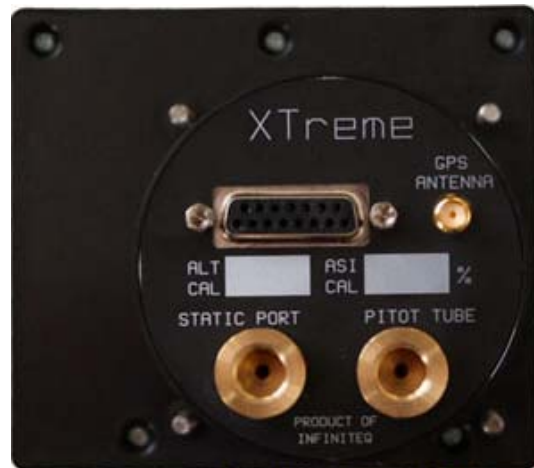
Stratomaster XTreme (New)

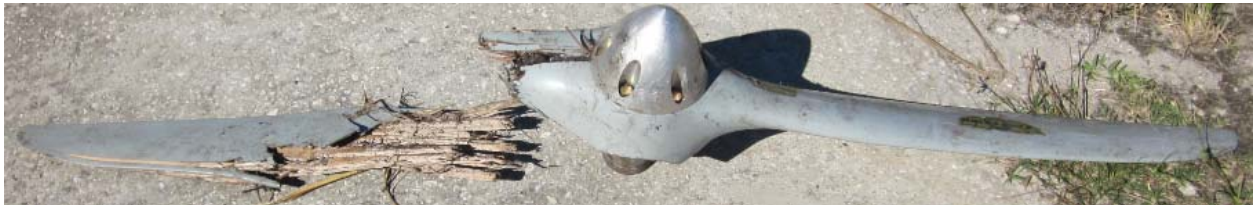
*The propeller was separated from the engine. It showed indications of not being rotating at time of impact. One blade was attached to the main hub with no visible damage. The second blade was sheared at about 90% of the blade length from the tip. This blade showed indications of being separated at impact. The back of the hub was connected to the engine adapter. The engine prop mount adapter showed indication of shear from side impact and the connecting bolt was sheared inside the adapter.*

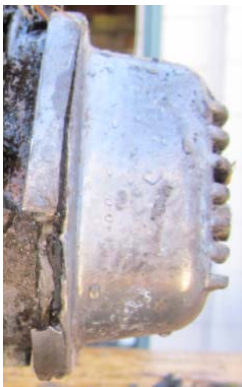
*A visual inspection of the engine indicated damage to the front of both valve covers flanges. These damages are consistent with impact damage. The exhaust tubes were bent back and had crushed the engine valve connecting rods tubes. The engine propeller mount adapter was separated and broken off at the engine crankshaft connection; damage was consistent with the indications of the rear of the propeller. Spark plugs ignition leads were cut by recovery team during salvage operation. A small piece of engine baffle was still attached to engine and oil tube was bent and damaged. Intake tubes were damaged but still connected to the engine.*

*Engine Valve Covers*

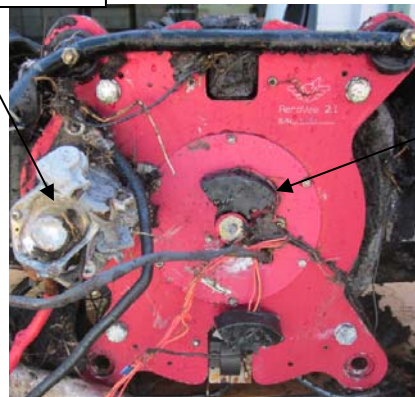
Ignition System

*Ignition system and starter mount*

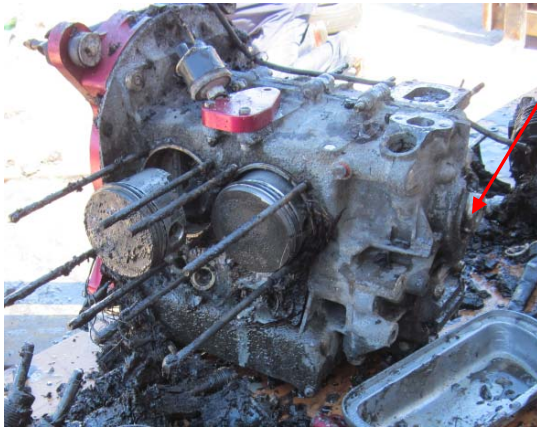
*Right side engine (N461MM)*

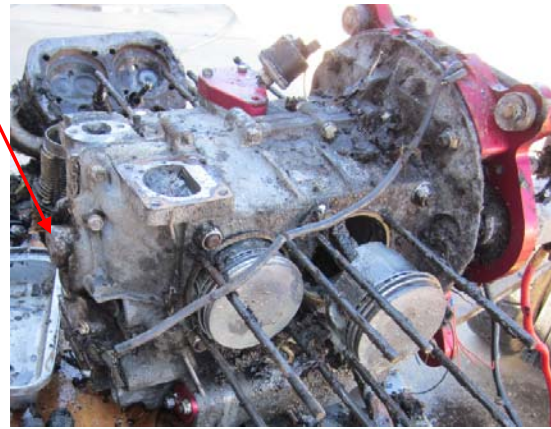
*Left side engine (N461MM)*

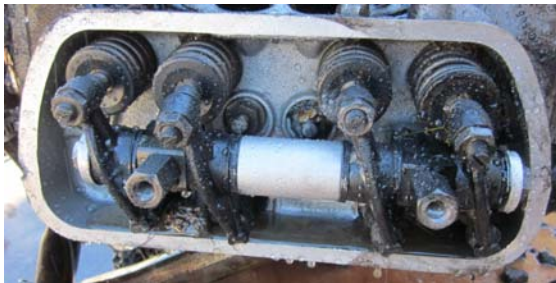
Valve rocker arms and springs (N461MM)

*Engine spark plugs were removed and showed gap was present and no indication of being fouled. The intake manifolds, access cover plates and valve covers were removed. Inside of engine was full of mud from the time spent immersed in the water. After cleaning up the mud from the valve areas, inspection revealed to be in good condition, clearance, condition and movement. The valve springs tension was good and not damaged and the valves were closing and opening with no hesitation. Removed valve assemblies and inspected cylinders with good results of not being damaged. Removed the cylinder jugs and cylinders showed to have good clearance with no excessive play between the rings and the jugs.*

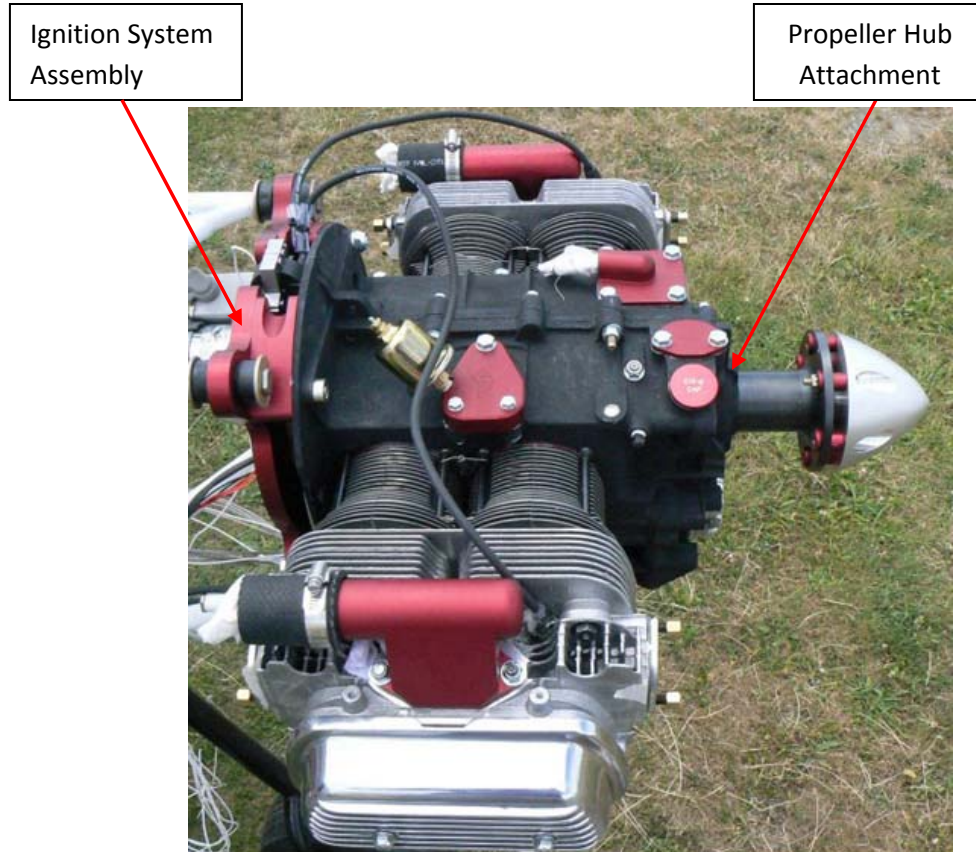
*Complete engine with ignition system located at rear of engine inside red mount area. (New)*
