# Continental Motors

## ENGINE RUN REPORT

| ENGINE MODEL | LTSIO360EB3B |
| FILE NUMBER | 14-369 |

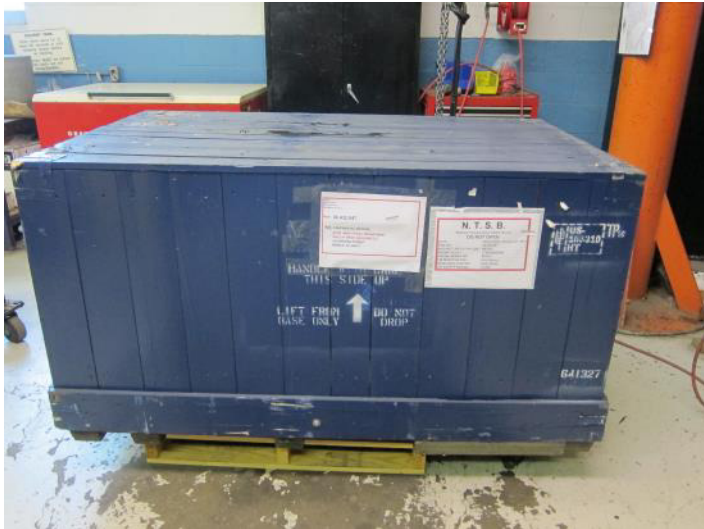
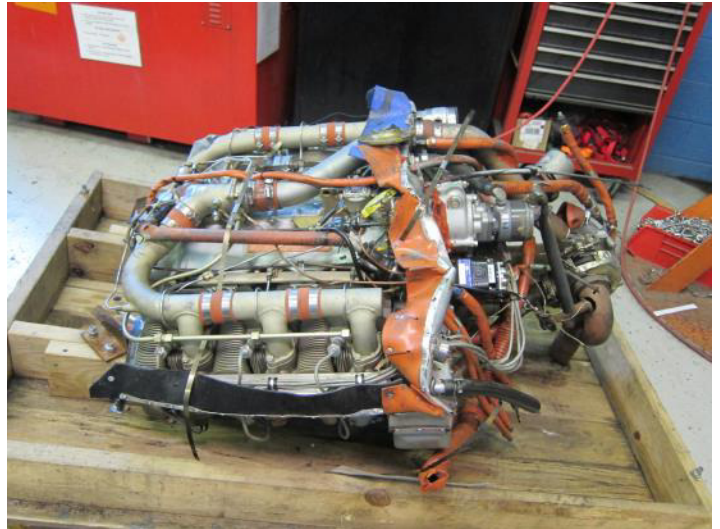
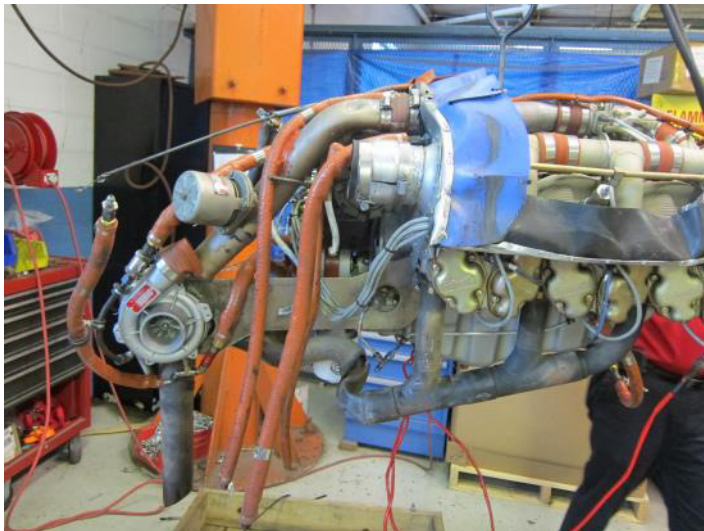
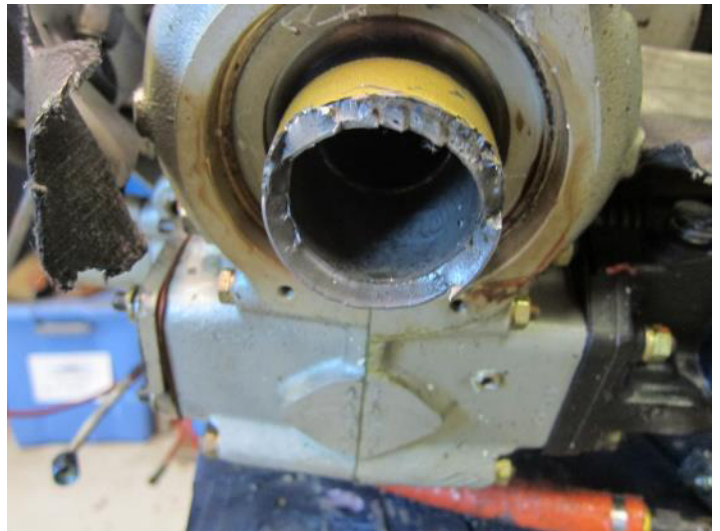
### EXTERNAL INSPECTION OF ENGINE

The engine was returned to CMI with the Crankshaft flange fractured from impact forces. The flange was weld repaired for the test run. The fuel pump was fractured from impact. Portions of the induction system and exhaust system were impact damaged and replaced for the engine test. There were no pre-impact anomalies noted that would have prevented engine operation to rated power.

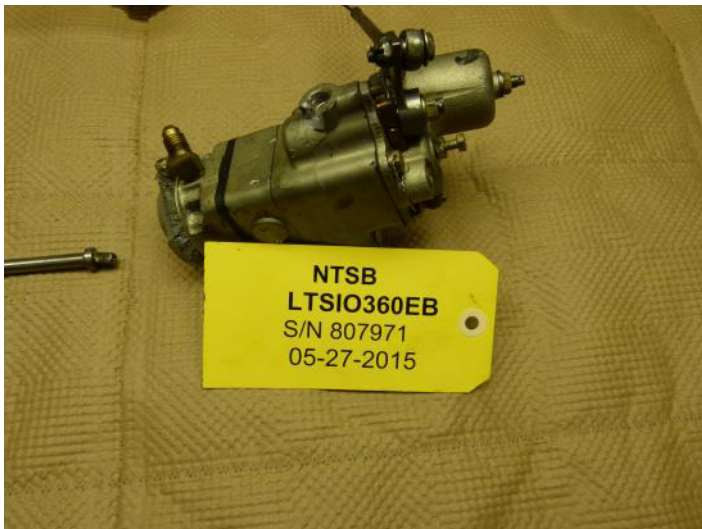
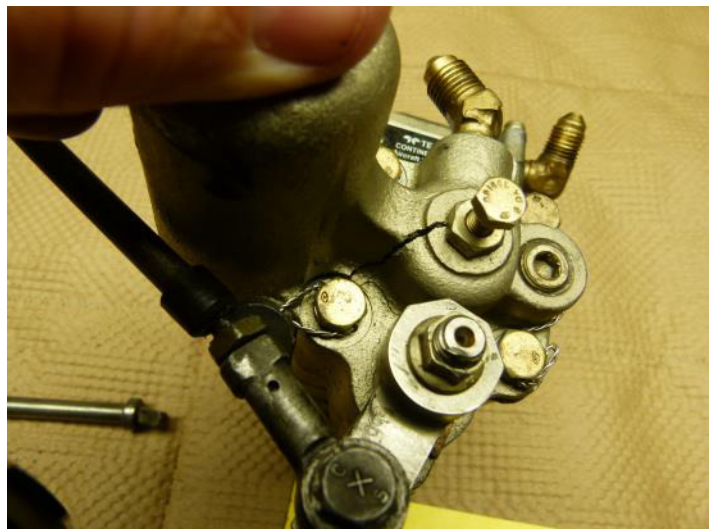
## FUEL PUMP REPAIR PRIOR TO RUN:

The fuel pump exhibited impact damage to the mounting flange, rear aneroid housing, and the fuel outlet boss. The mounting flange and the rear aneroid housing were replaced with serviceable units. The outlet fitting was replaced and epoxied to seal the damaged boss. The pump adjustments were measured and reset to the same extension of the as received fuel pump. The remainder of the fuel pump components was reused for the engine test.
