Aircraft Accident/Incident report No.: 150102

**NTSB File No.:** ERA15FA088

**Aircraft:** Piper PA-34-200T

Aircraft Accident/Incident report No.: 150102**Propeller Teardown Report****Date of Investigation:** March 5, 2015**Location:** AMF, Springfield, TN**Propeller Model:** HC-C2YF-2UF with FJC8459-8R blades

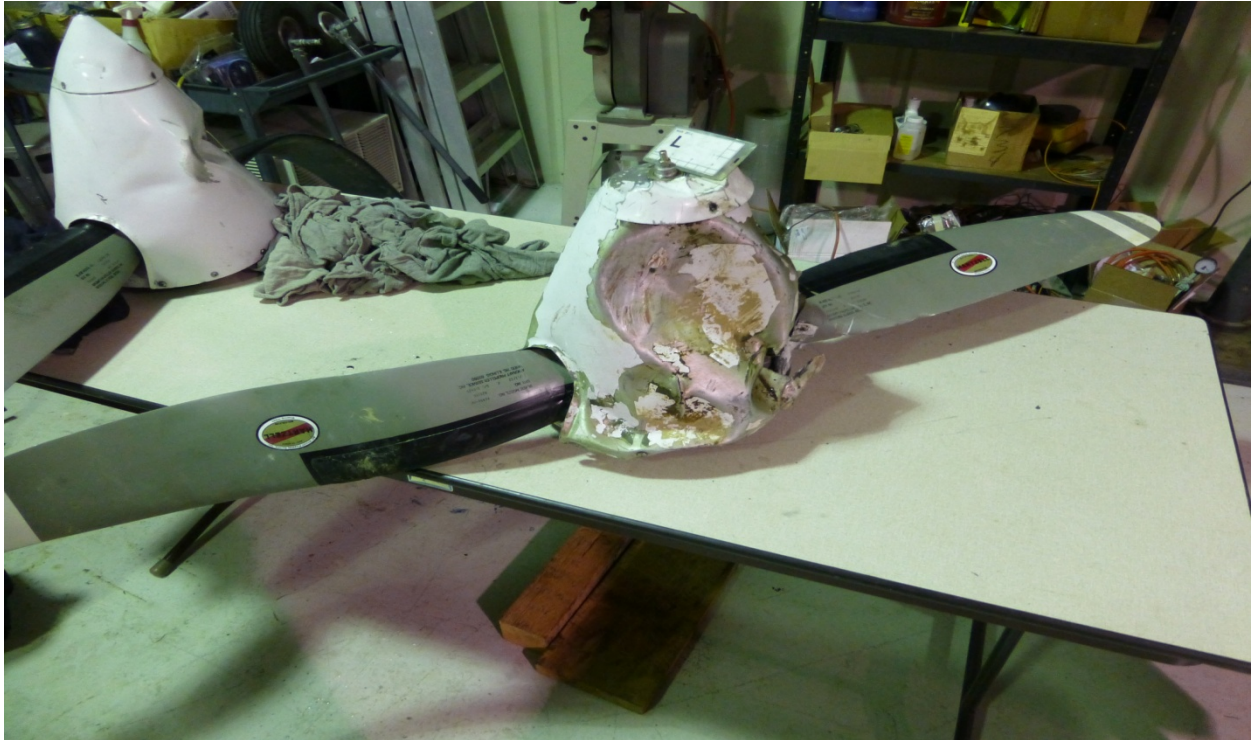
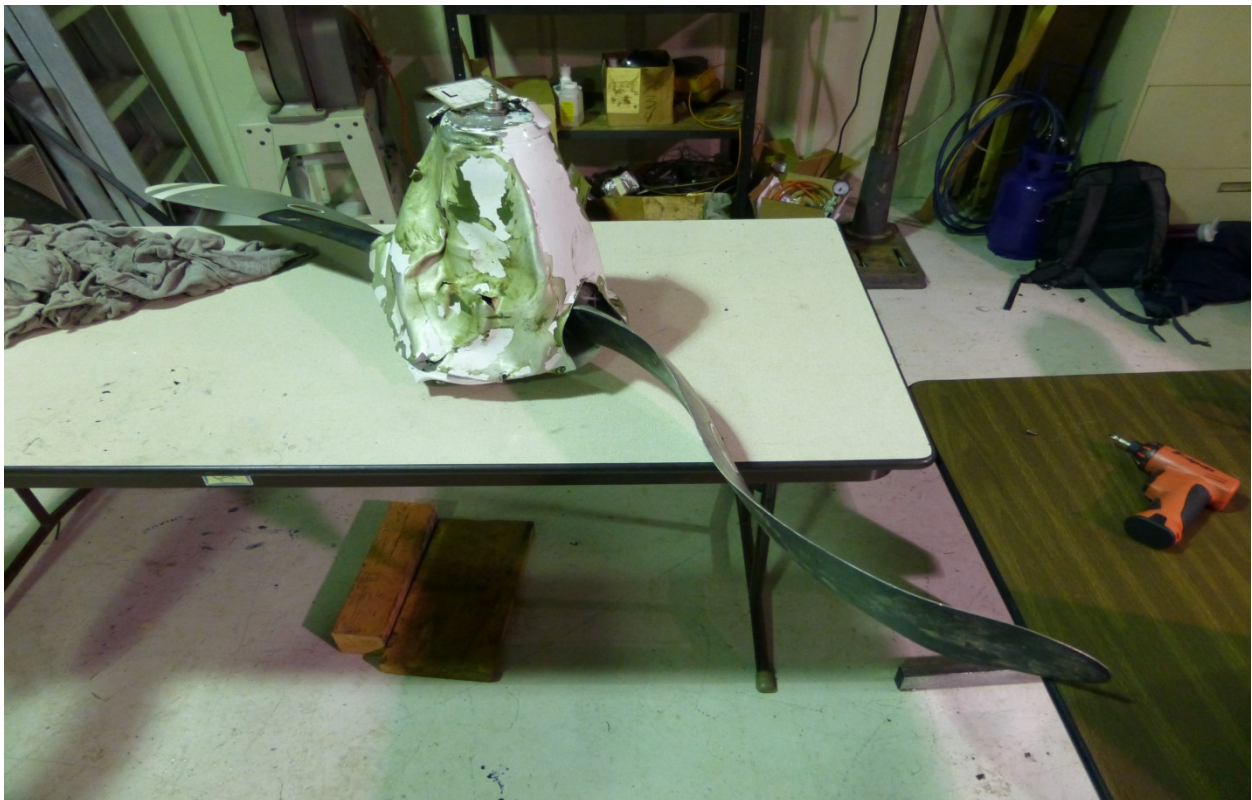
The propeller was fractured off the engine at the engine shaft. An AMF salvage technician removed the engine shaft for shipping purposes. The spinner dome was crushed on all sides. The spinner dome cap was fractured and the air valve was missing the valve stem. The cylinder was stripped off the hub but remained attached to the pitch control rod.

The spinner dome was crushed on all side with the cap fractured and only a small piece remained attached to the dome.

The spinner bulkhead was bent around the edges.

Propeller cycling was not possible due to impact damage and the cylinder being stripped off the hub.

The air valve was missing the valve stem.

Photo #1, left propeller as received.

Photo #2, left propeller as received.

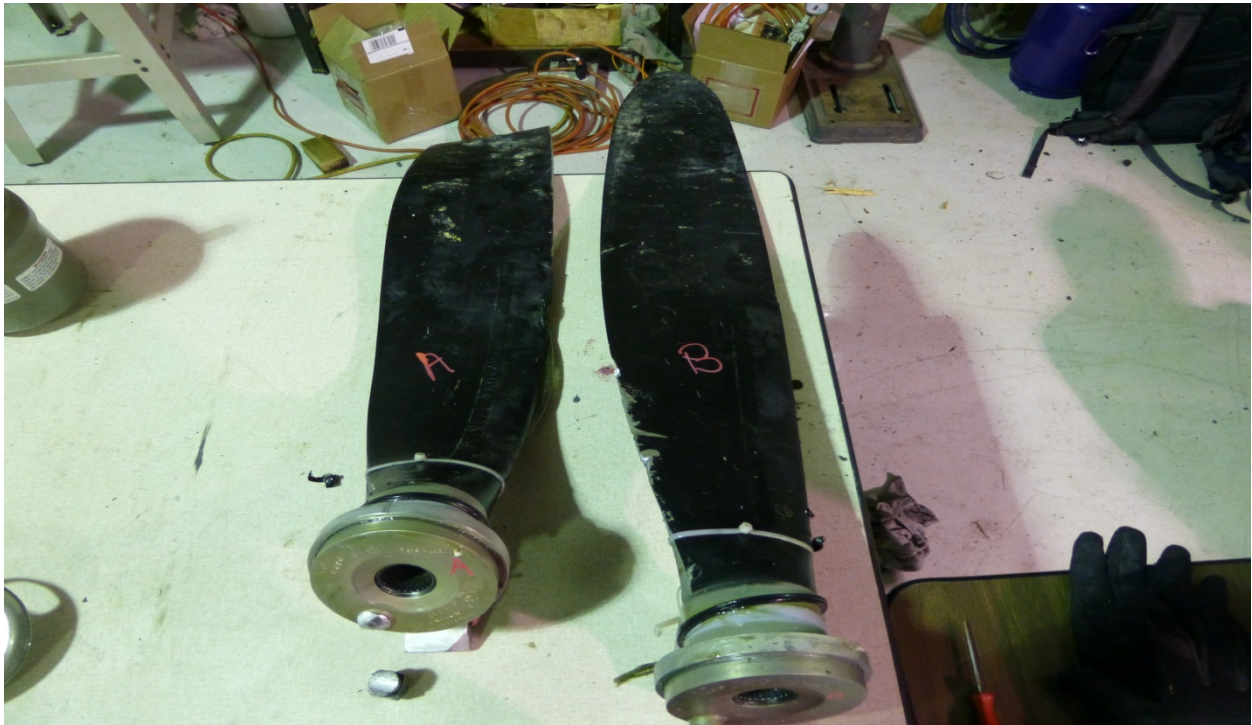
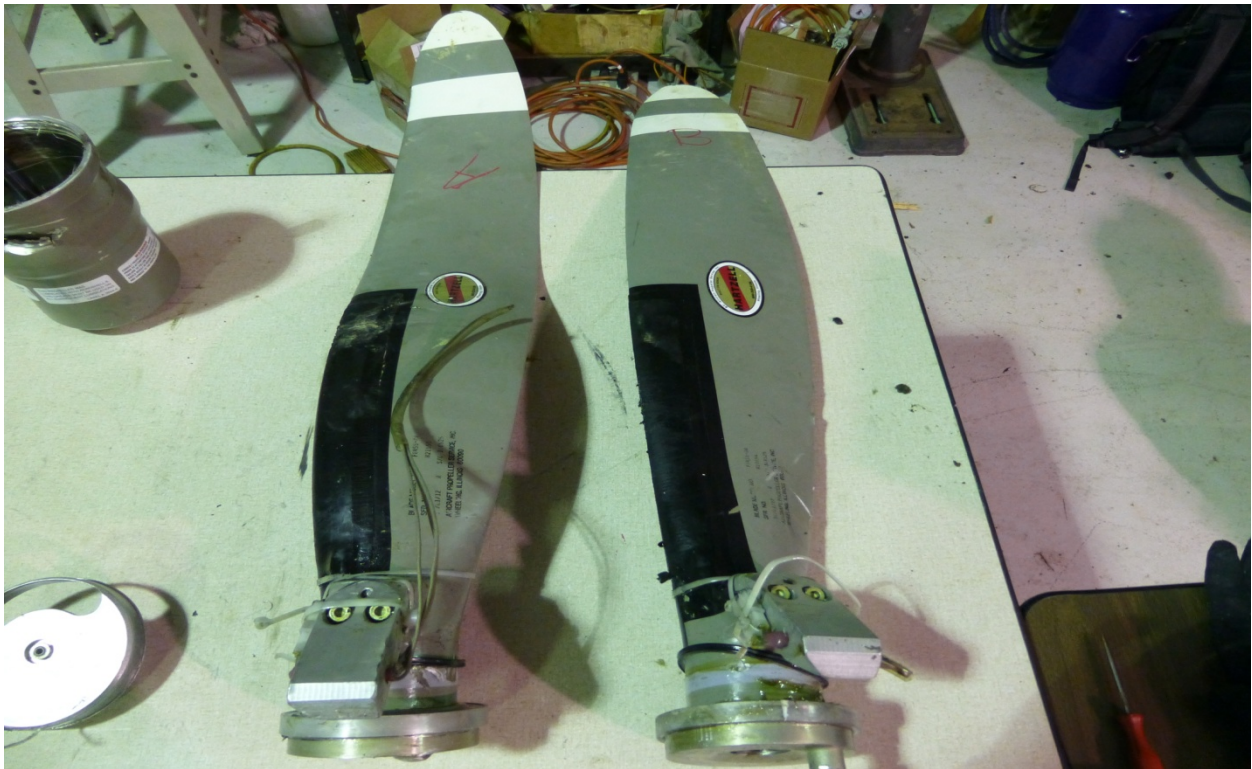
paint, camber side - Intact.  
paint, flat side - Intact.  
bend - forward and aft.  
twist - none.  
lead edge damage - none.  
trail edge damage - none.  
knob condition - fractured off.  
counterweight - Intact and unremarkable.

paint, camber side - Intact.  
paint, flat side - Intact.  
bend - aft.  
twist - none.  
lead edge damage - none.  
trail edge damage - gouges and nicks near base.  
knob condition - intact and unremarkable.  
counterweight - intact and unremarkable.

Photo #3, left propellers blades.

Photo #4, left propeller blades.

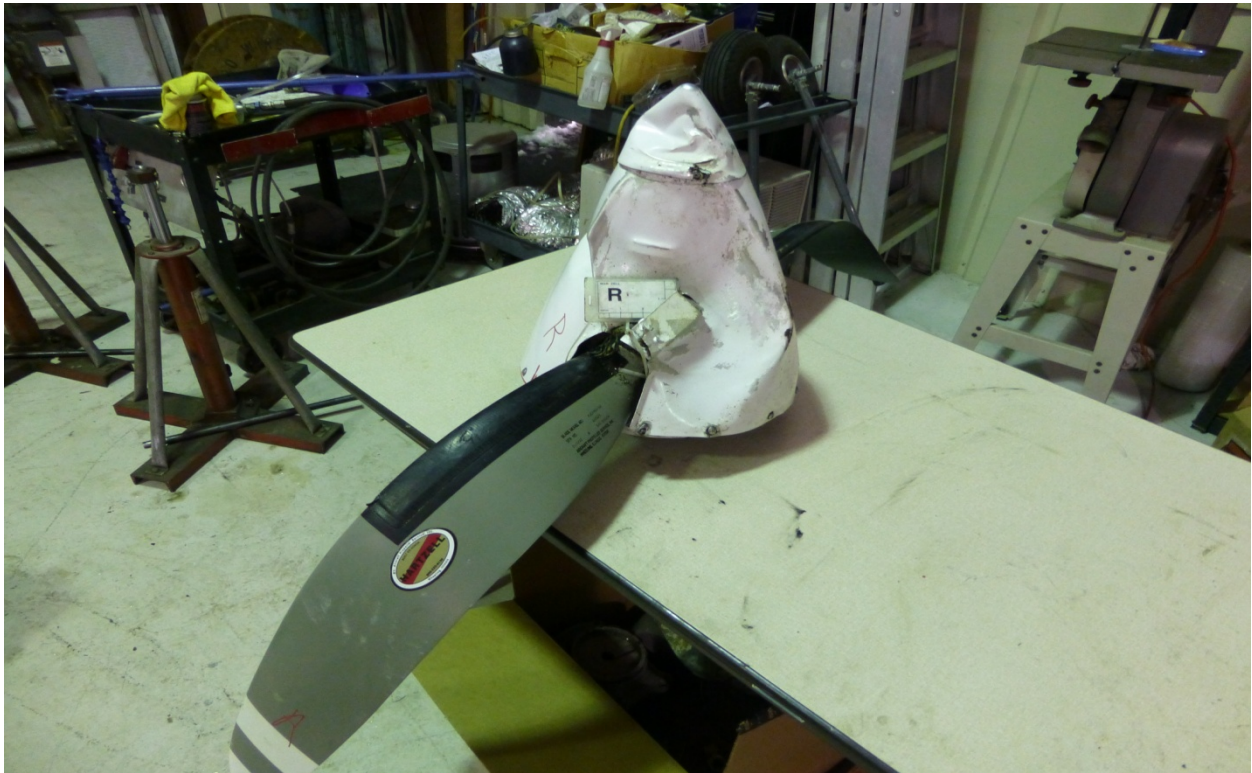
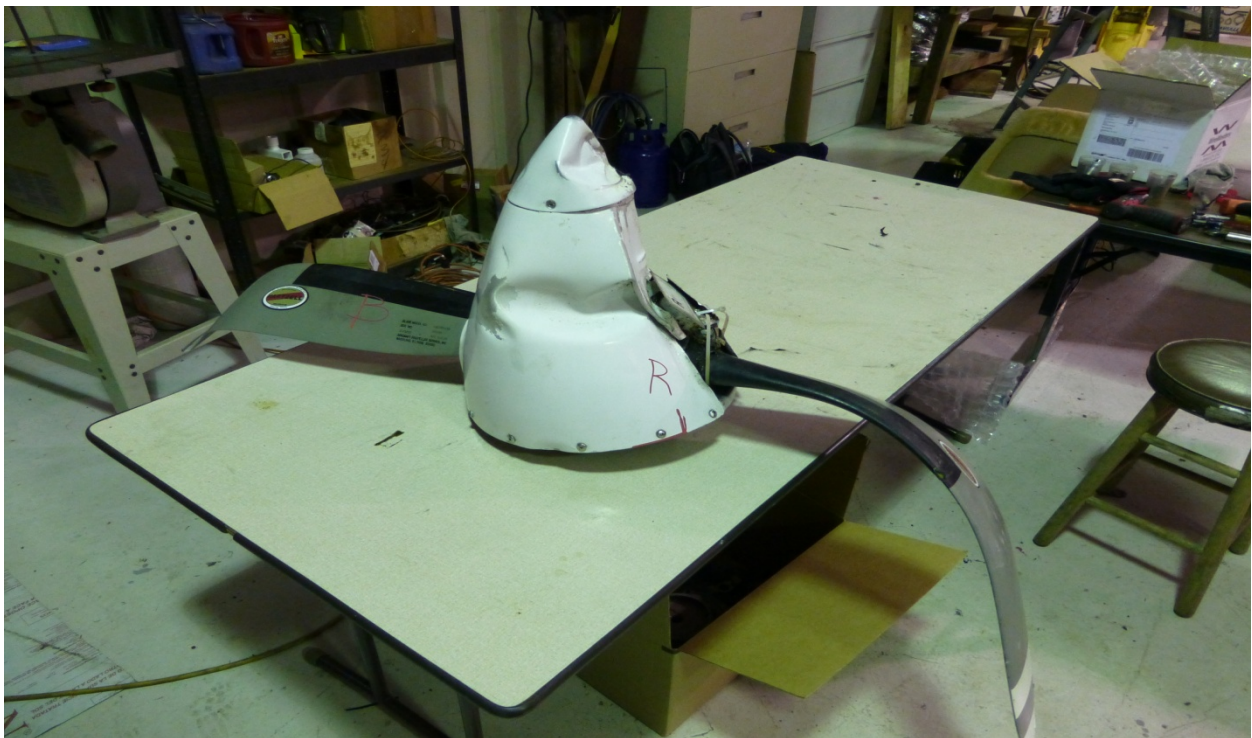
The propeller was fractured off the engine at the engine shaft. An AMF salvage technician removed the engine shaft for shipping purposes. The spinner dome was crushed on one side. The cylinder was fractured off the hub, however it was still attached to the pitch change rod. Both blades were bent aft midblade. There was an impression mark in the spinner dome from a counterweight that shows the propeller in a low blade angle setting at impact.

The spinner dome was crushed on one side. A counterweight made an impression mark in the dome that shows the propeller in a low blade angle setting at impact.

The spinner bulkhead was intact and bent around the edges.

Propeller cycling was not possible due to impact damage.

Photo #5, right propeller as received.

Photo #6, right propeller as received.

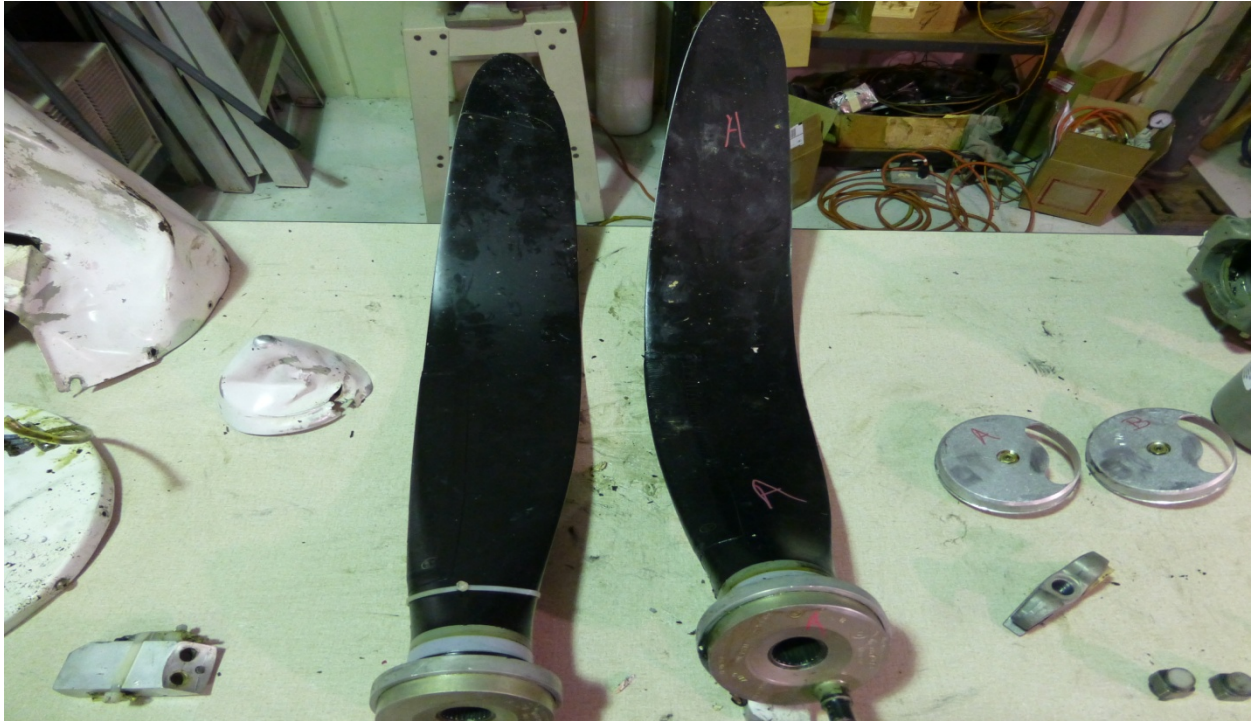
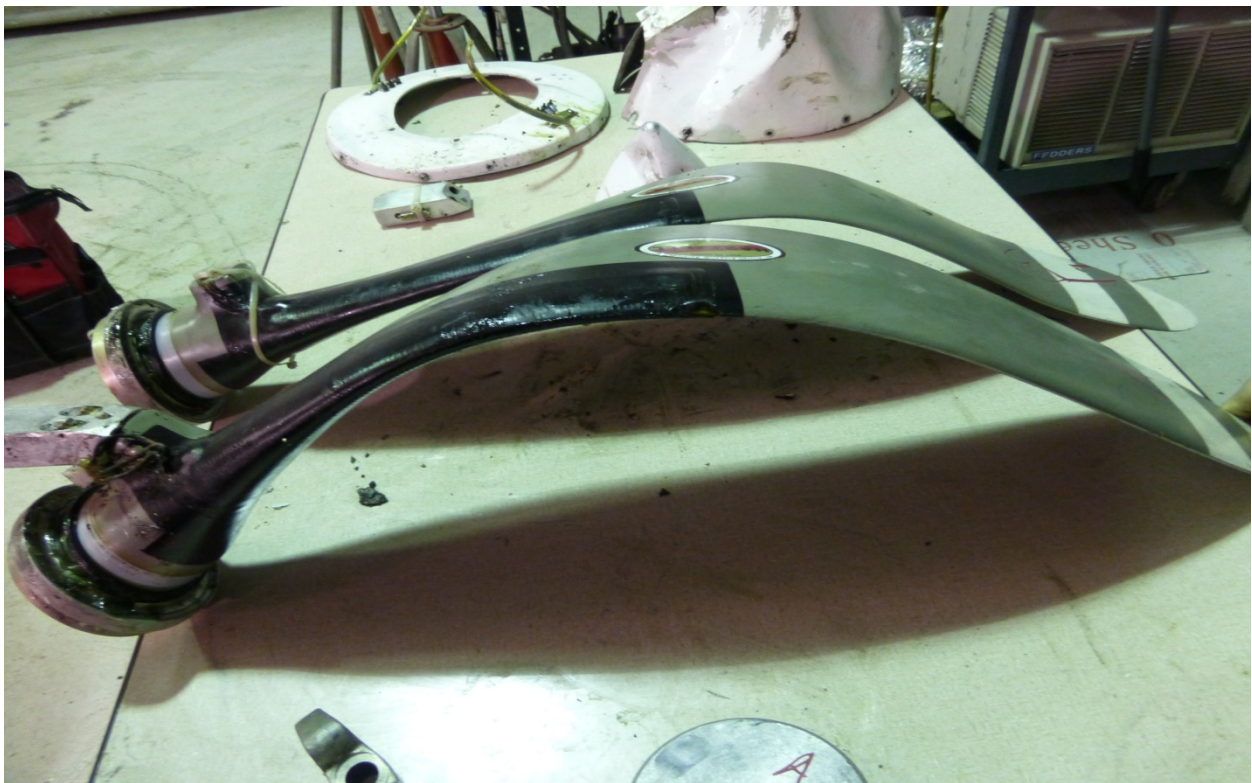
paint, camber side - intact.  
paint, flat side - intact.  
bend - aft.  
twist - none.  
lead edge damage - none.  
trail edge damage - none.  
knob condition - intact and unremarkable.  
counterweight - intact and unremarkable.

paint, camber side - intact.  
paint, flat side - intact.  
bend - aft.  
twist - none.  
lead edge damage - none.  
trail edge damage - none.  
knob condition - intact and unremarkable.  
counterweight - bents towards hub.

Photo #7, right propeller blades.

Photo #8, right propeller blades.
