# NATIONAL TRANSPORTATION SAFETY BOARD

## MATERIALS LABORATORY FACTUAL REPORT

Report No. 15-017

Place : Sebring, Florida  
Date : January 16, 2015  
Vehicle : Aventura II, N511DS  
NTSB No. : ERA15FA102  
Investigator : Shawn Etcher, AS-ERA

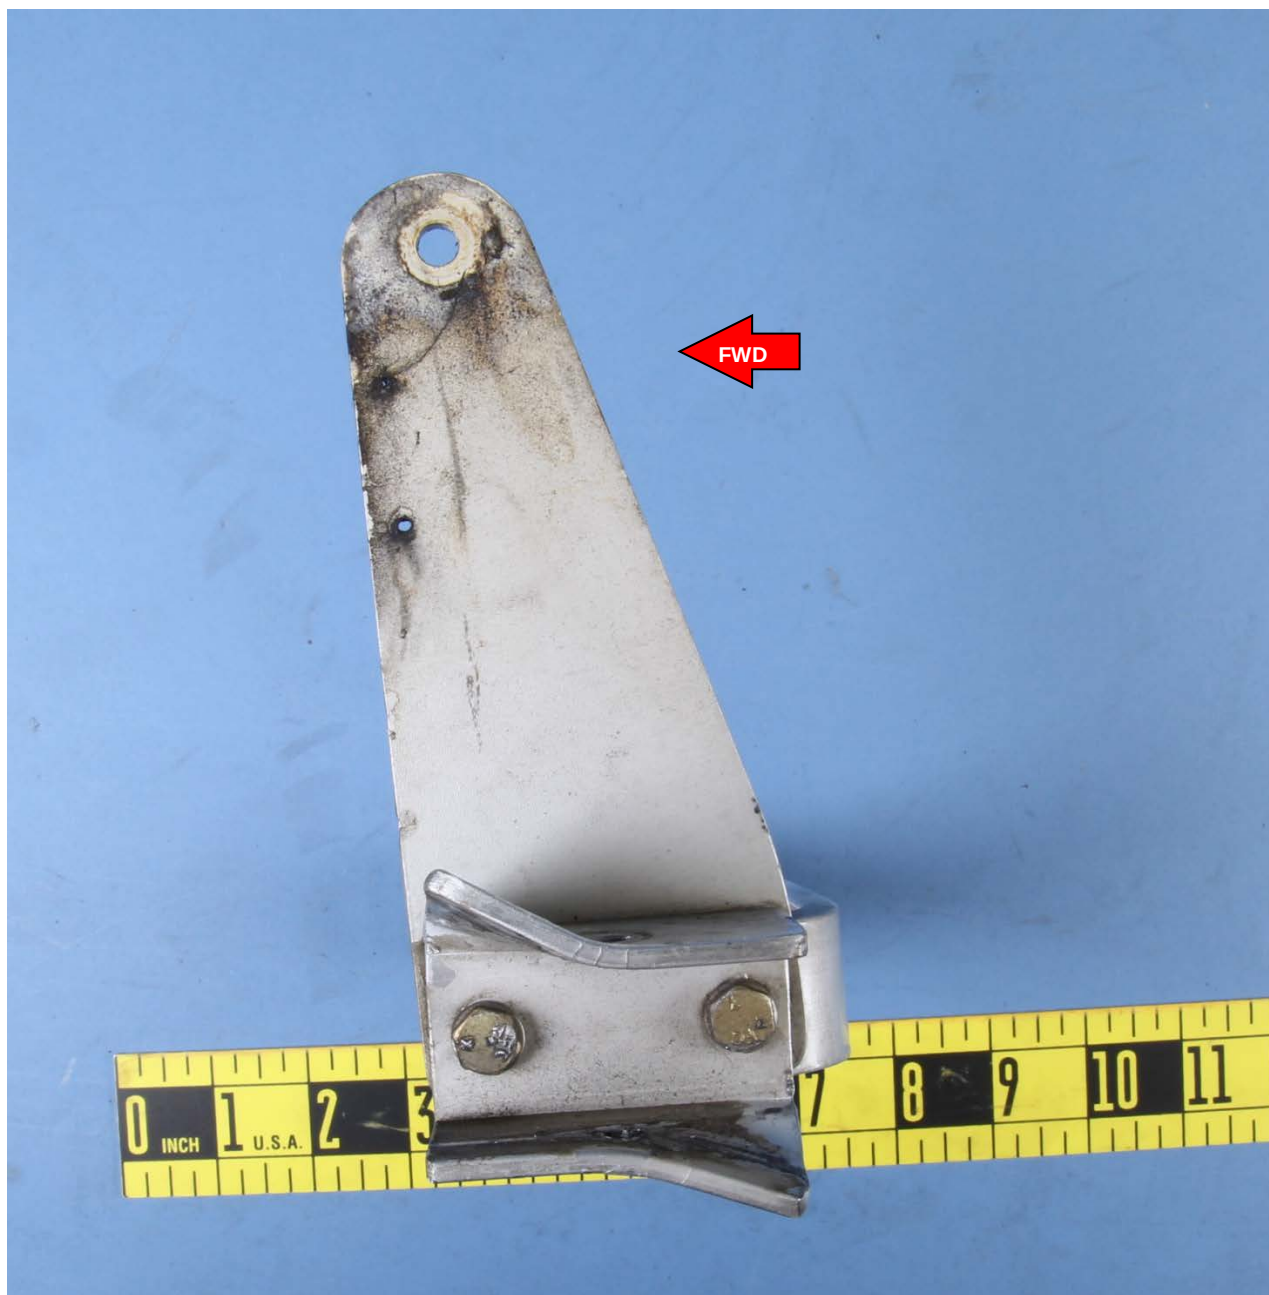
The elevator horn was intact and appeared undamaged except for distortion of the left elevator attachment channel shown in figure 2. The forward portion of the upper flange of the channel was deformed upward and the aft portion of the lower flange was deformed downward as shown in figure 2. The respective deformations were forward and aft of the left elevator attachment bolt as indicated and were consistent with the elevator pivoting rear downward about the attaching bolt.

Figure 2. View of the left side of the elevator horn showing the deformation of the left elevator attachment channel.

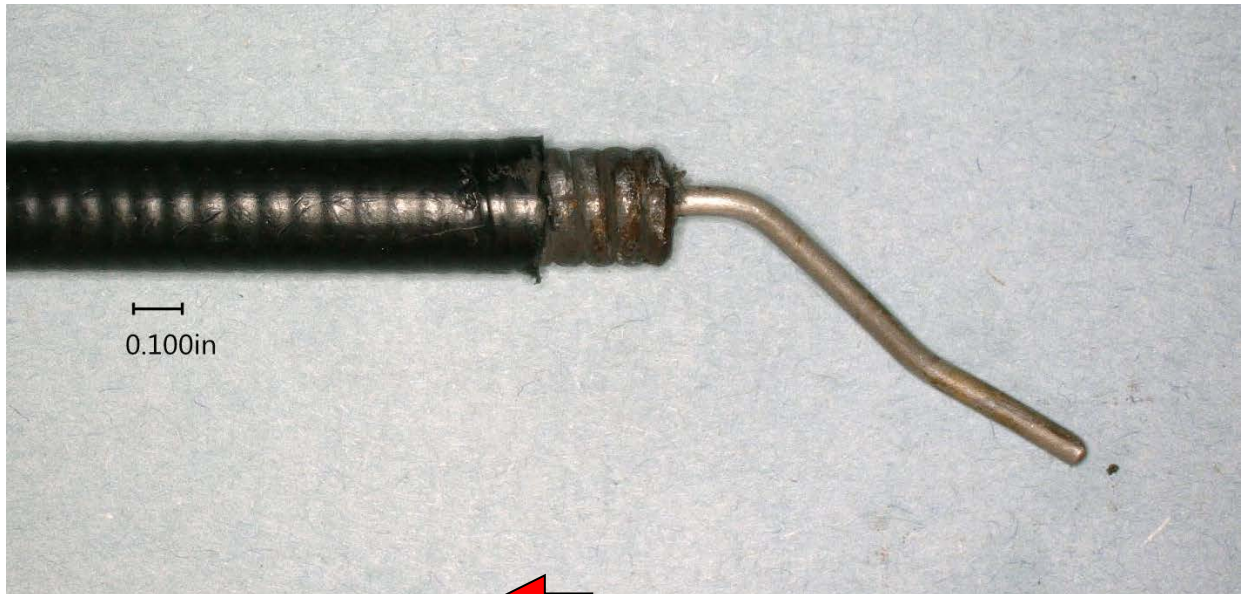
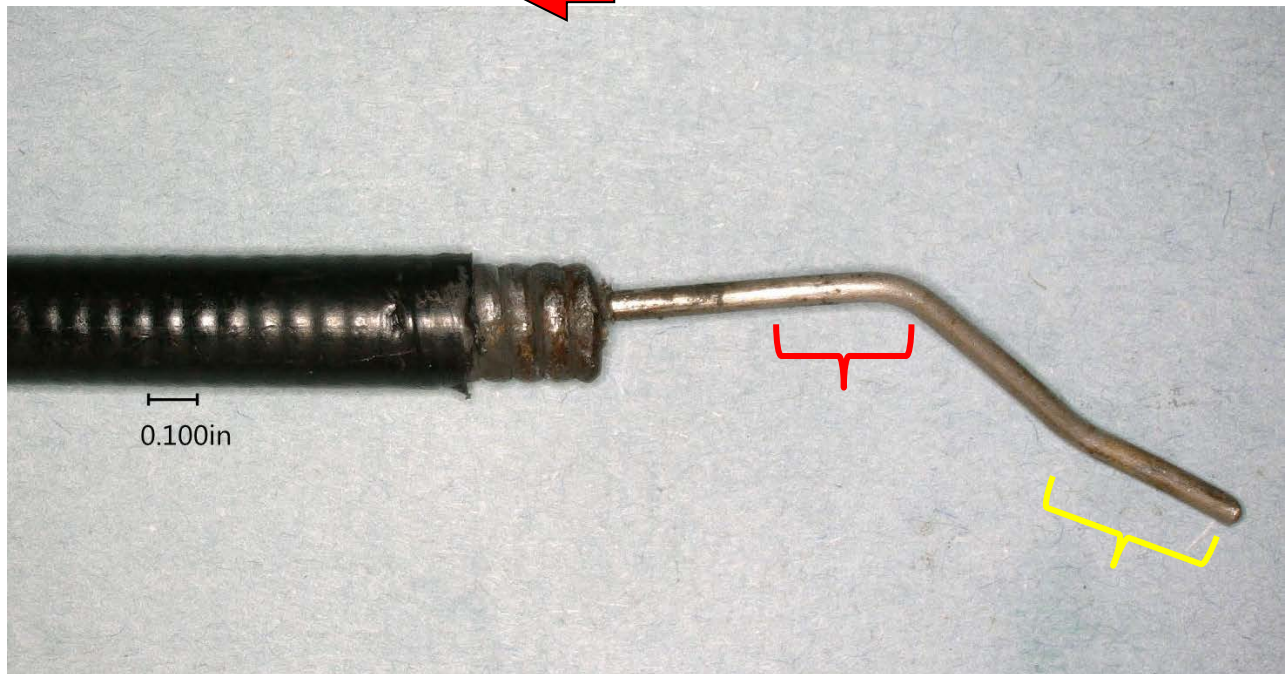
The elevator trim cable section is displayed in figure 3 with the solid inner cable wire in both retracted and extended positions. In the extended position a longitudinal wear area was visible on the inside of the forward bend, as denoted by the red bracket. The wear area extended into the bend as shown in the upper view of figure 4. Further, the inner diameter of the sheath of the trim cable was worn into the shape of the inner wire as shown in the lower view of figure 4. The wear had penetrated the plastic inner sheath liner and was into the metal outer layer of the sheath. The wear on the inner wire and sheath were consistent with side loading of the cable.

Figure 3. view of the trim cable with the inner wire retracted (top) and extended (below). The wear area is denoted by the red bracket. The yellow bracket highlights the area of the inner wire shown in figure 5.

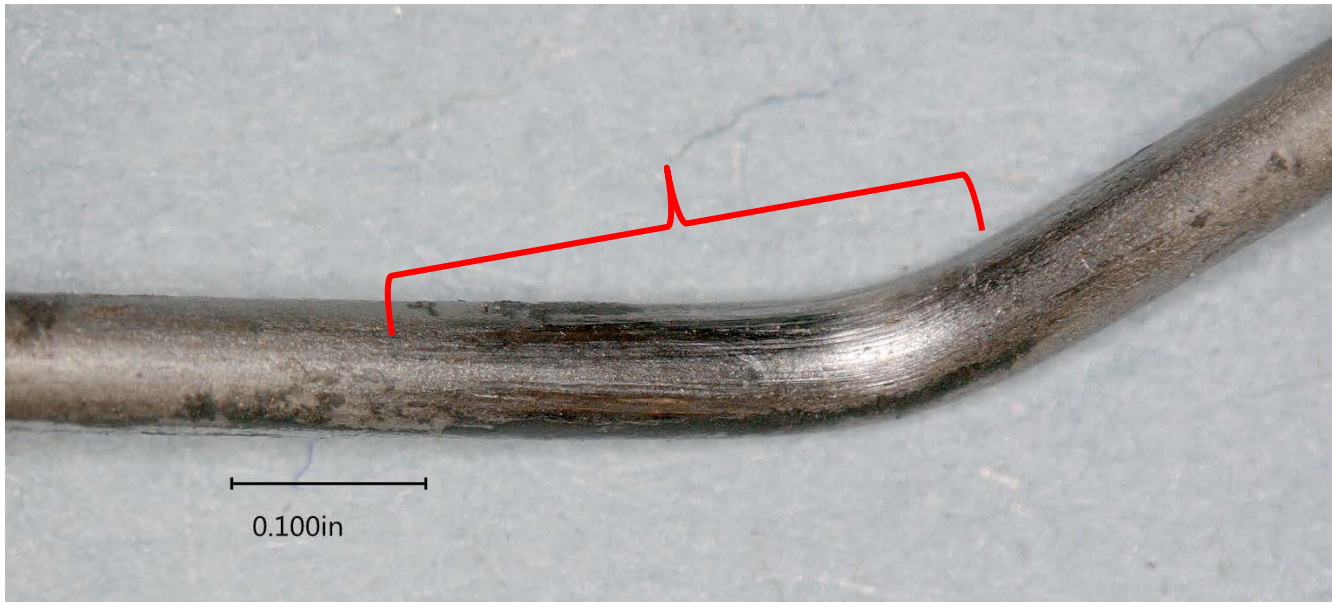
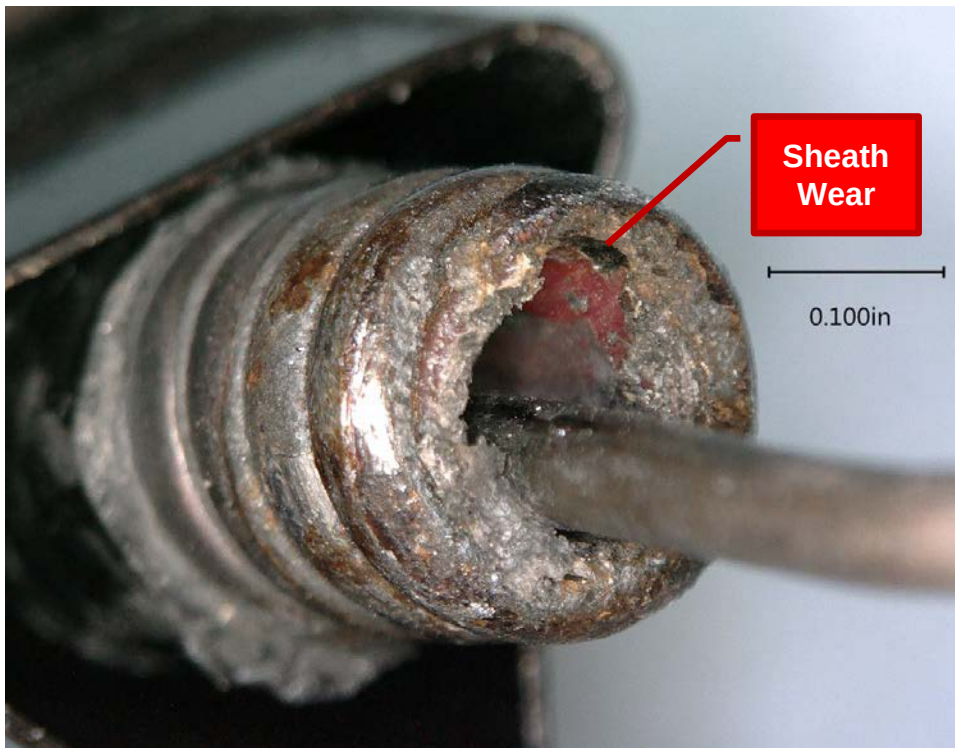
Figure 4. Upper view shows a closer view of the wear (red bracket) on the inner wire. Lower view shows the wear to the inner diameter of the cable sheath in the shape of the inner wire.

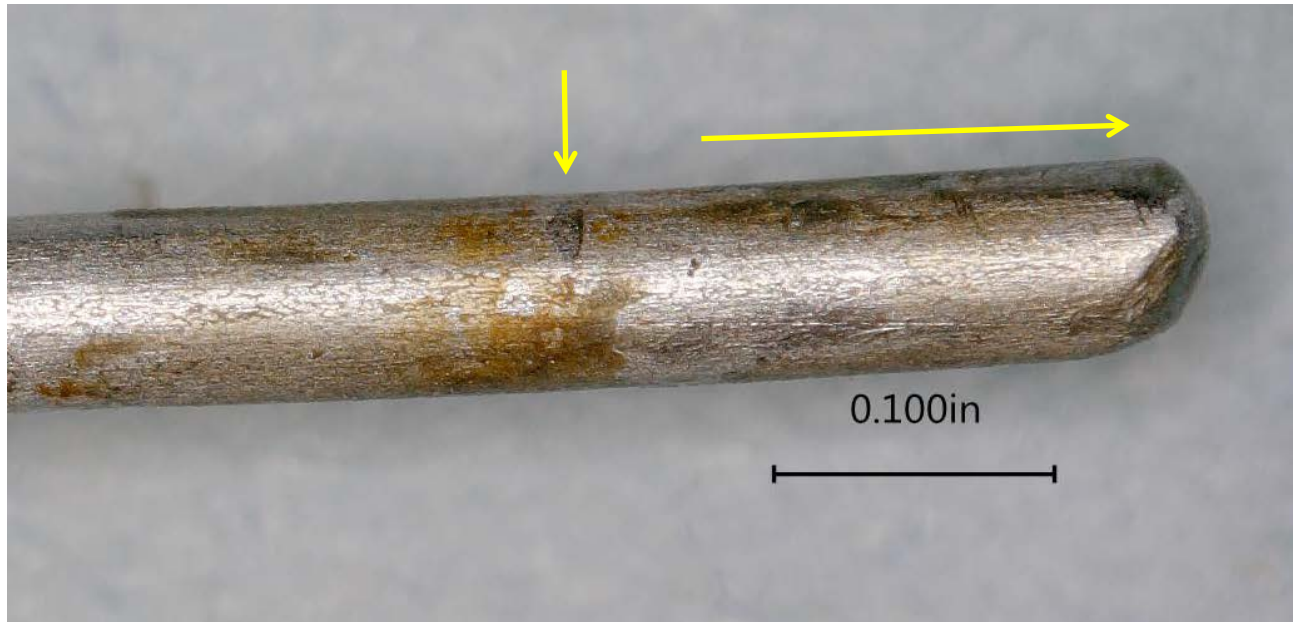
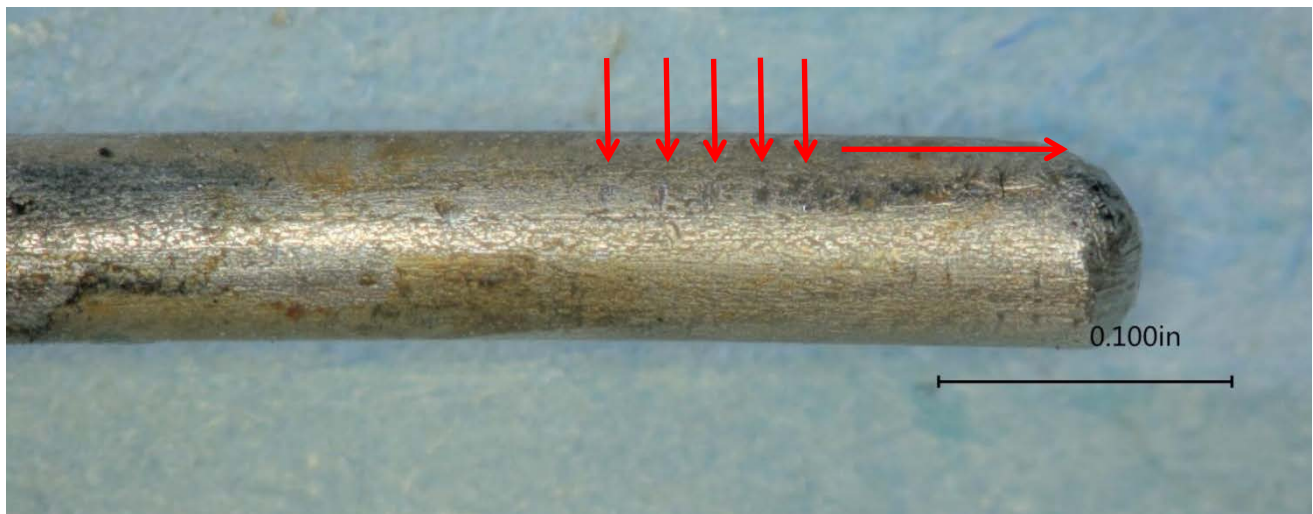
The extreme end on the inner wire (denoted by the yellow bracket in figure 4) was partially covered in a thin layer of translucent yellow brown material consistent with cable lubricant compound. The surface also showed diametrically opposed marks consistent with a screw type pinch clamp that were not covered by the lubricant compound. Other marks on the wire were covered.

On one side, a single crescent shaped mark (yellow arrow) was visible consistent with the edge of the clamp hole. A continuous sliding scrub mark (long red arrow) extended to the end of the wire.

Diametrically opposite the crescent mark, the surface of the wire contained a series of very light marks (red arrows) suggestive of the edge of the clamping screw in multiple positions with a continuous scrub (long red arrow) to the end of the wire.

Figure 5. Views of the inner wire surface showing contact marks consistent with a screw type cable clamp. Upper view shows a crescent mark (yellow arrow) followed by a sliding scrub mark (long arrow). The lower view show a series of light marks (red arrows) diametrically opposed to the crescent mark followed by a continuous scrub mark (long arrow).
