# **National Transportation Safety Board**

## **Performance Study**

### **Specialist Report**

| NTSB Number: | ERA15FA109 |

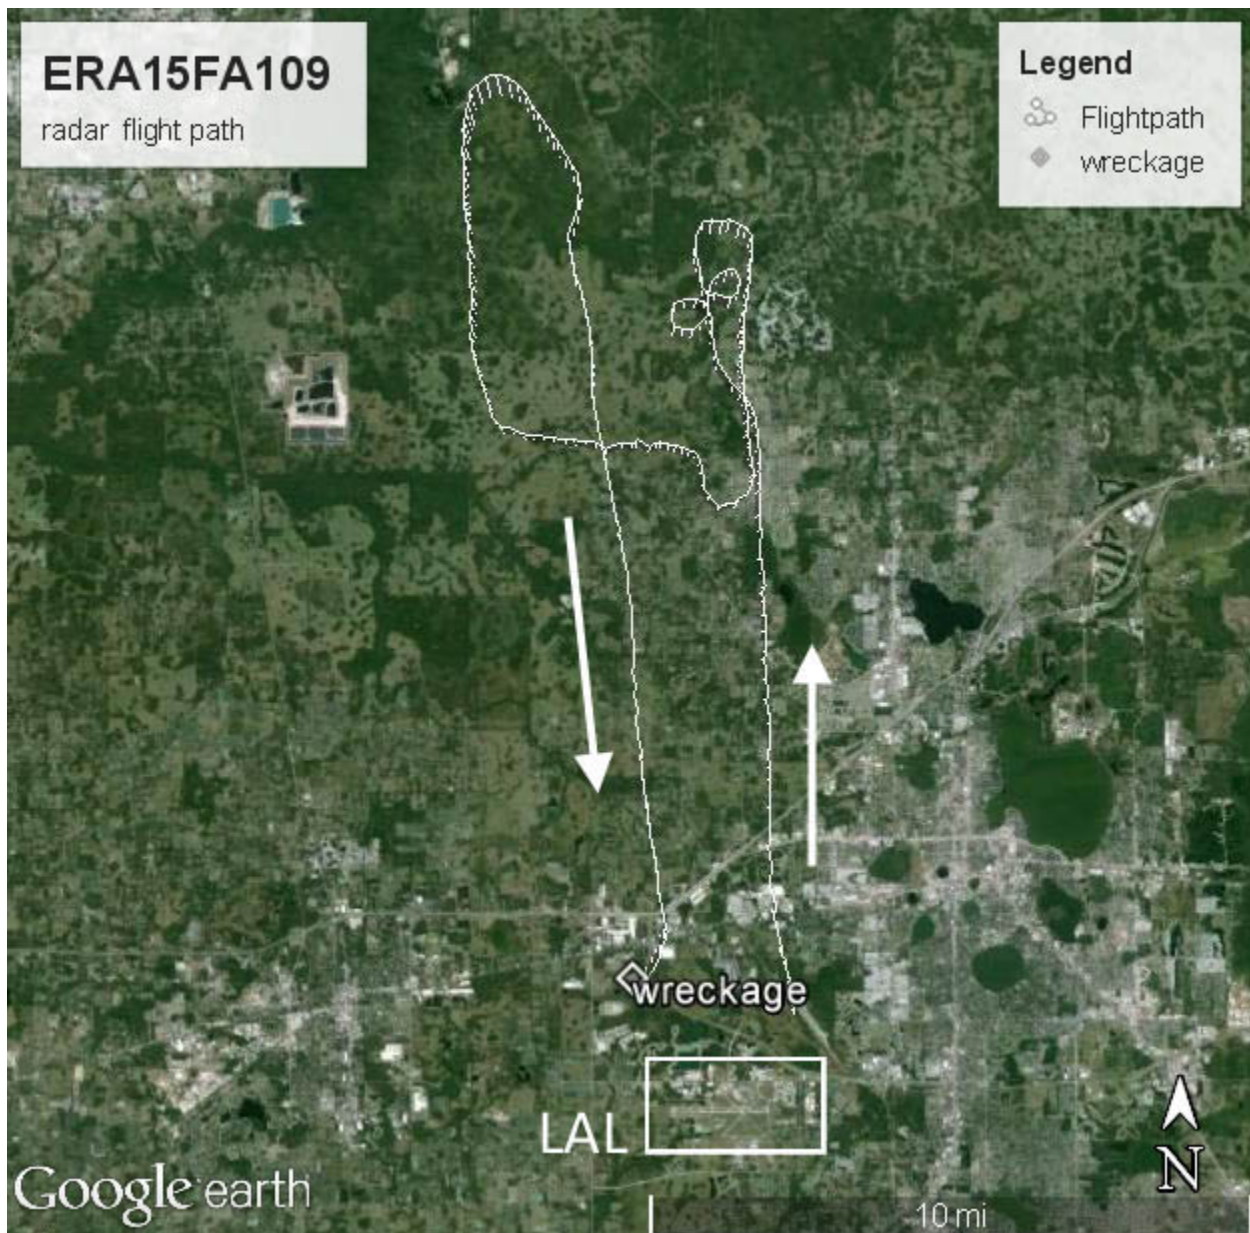
The MCO radar picked up the aircraft north of LAL at 849:50 EST as it climbed above 1200 ft mean sea level (MSL) or about 1100 ft above ground level (AGL). The flight recorded by radar was approximately 40 NM long and lasted 22 minutes and is shown in Figure 1. The last radar return was recorded at 0912:58 EST.

**Figure 1.** Aircraft flight path from MCO radar and wreckage location. Lakeland Linder Region Airport (LAL) is shown at the bottom of the figure.

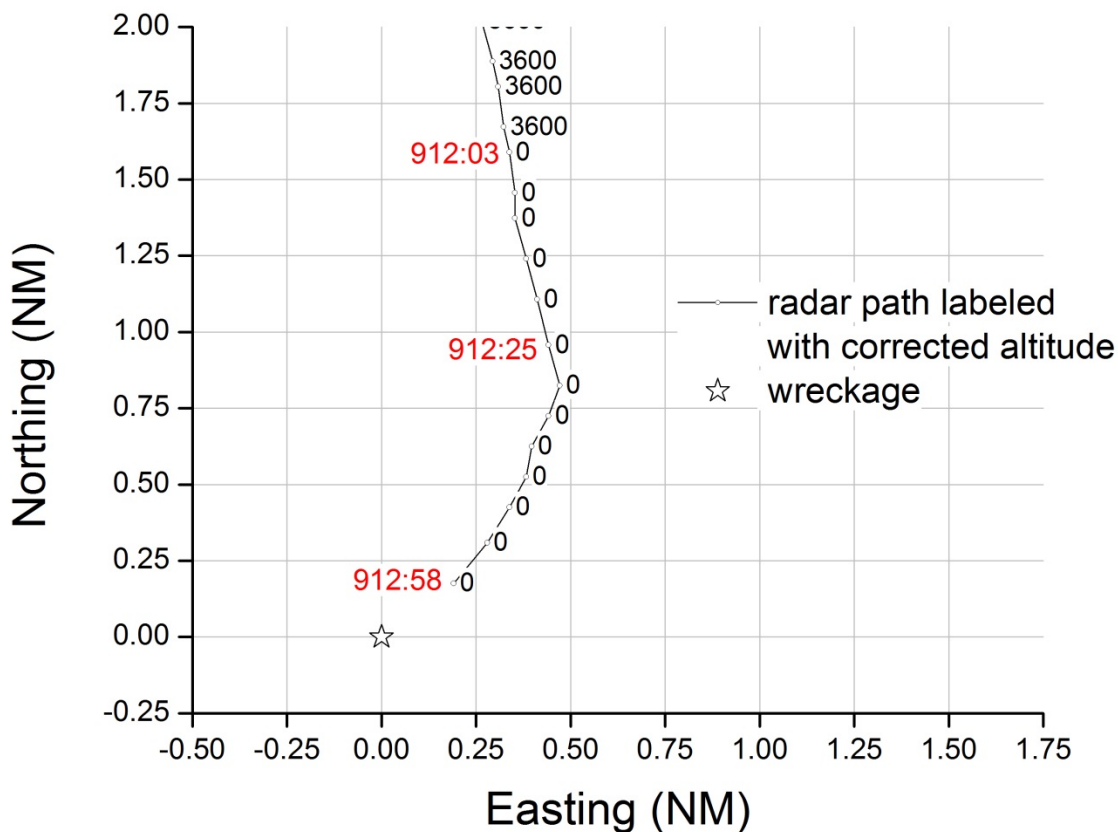
The last maneuver of the aircraft recorded by radar was a right turn and is shown in Figure 2. The wreckage location lay along the final track of the aircraft and was about 1500 ft (0.3 miles)

from the last radar return. The data points in Figure 2 are labeled with the aircraft's corrected altitude and selected times (in red) as recorded by radar. The final 13 points have no altitude associated with them and the reason for this is unknown. Rate of climb calculations could not be completed due to lack of altitude data for the critical portion of the recorded flight.

**Figure 2.** Flight path for final right turn. The 0,0 point of northing and easting is the wreckage location. Times for selected data points are shown in red.

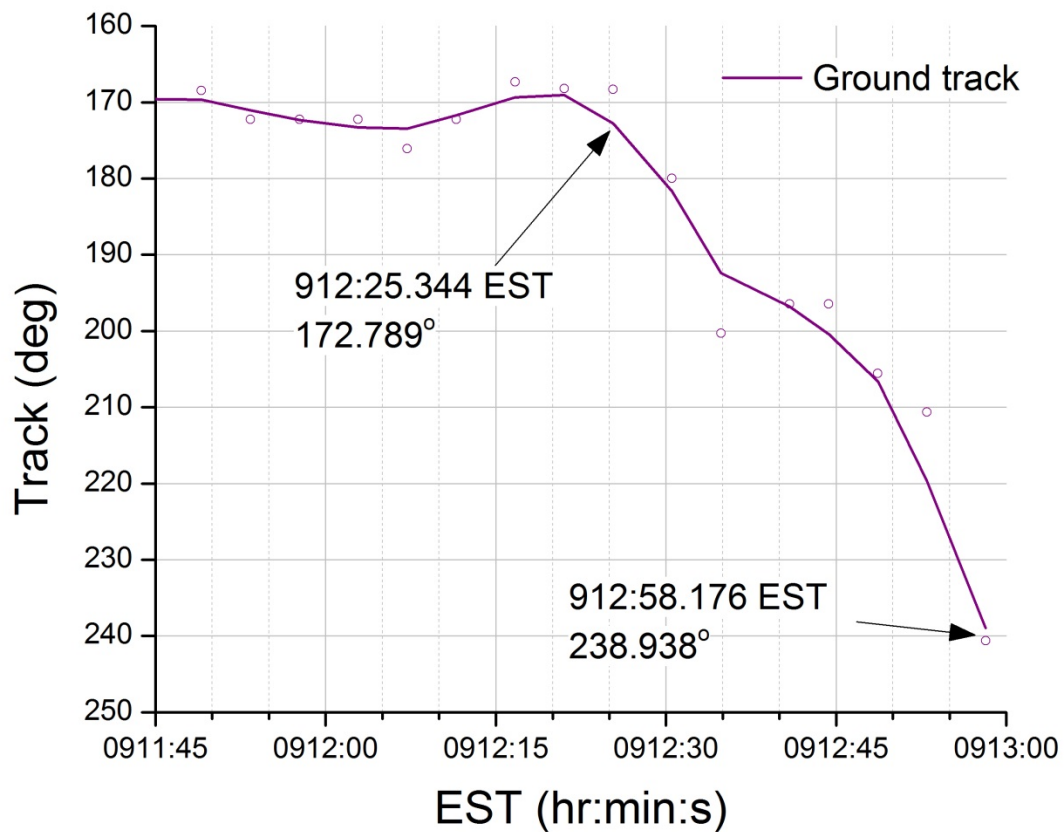
Figure 3, below, shows the flight track of the aircraft for the final minute of flight. If the beginning of the final right turn was at 912:25.344 and a track of 172°, the rate of turn to the final radar point at 912:58.175 on track 239° was approximately 2 degrees/s.

**Figure 3.** Flight track for final right turn.

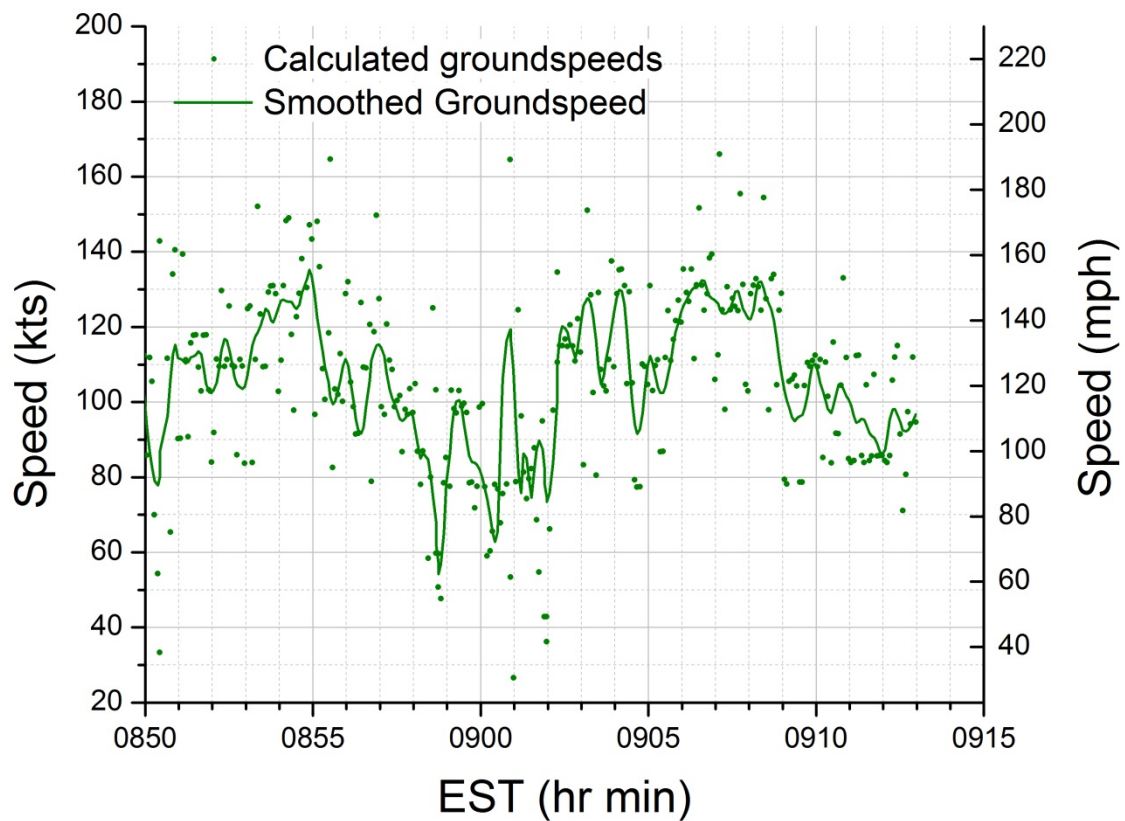
The aircraft's groundspeed was calculated using the radar locations and is shown in Figure 4. Groundspeeds calculated from radar have uncertainties associated with timing and the number of significant digits of the recorded latitude and longitude. The aircraft's groundspeed varied between 70 kts and 130 kts (80 mph and 150 mph) during the flight. The aircraft's reported stall speed is 57 kts (66 mph) for gear and flaps up configuration [1].

**Figure 4.** Aircraft's calculated ground speed.

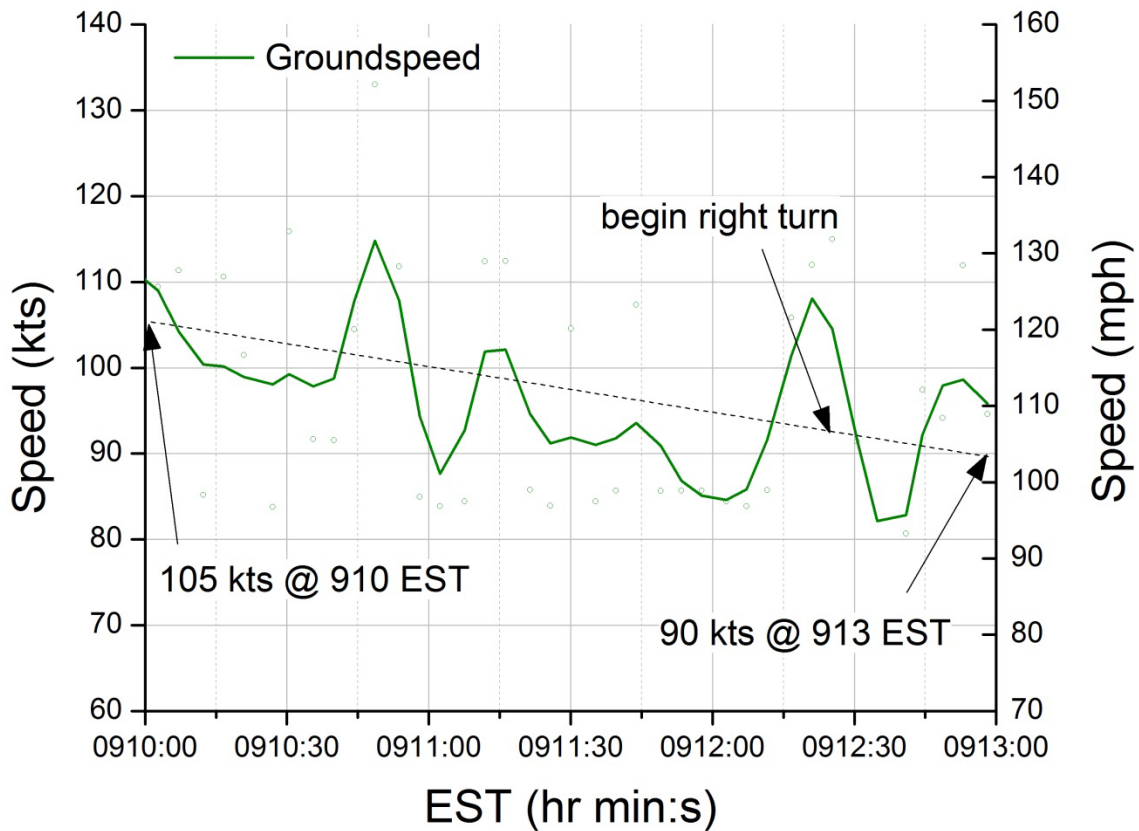
Figure 5 shows the groundspeed for the final three minutes of recorded flight. If the ground speed at 910 was estimated to be 105 kts (121 mph) and the final speed to be 90 kts (103 mph) at 913, the aircraft was slowing at 5 kts/min (5.75 mph/min) as it entered and continued through the final right turn.

**Figure 5.** Aircraft's ground speed for final three minutes of flight. Points are the raw calculated data, and the green line shows a somewhat smoothed version. The dotted line is a straight line fit through the data in the figure.

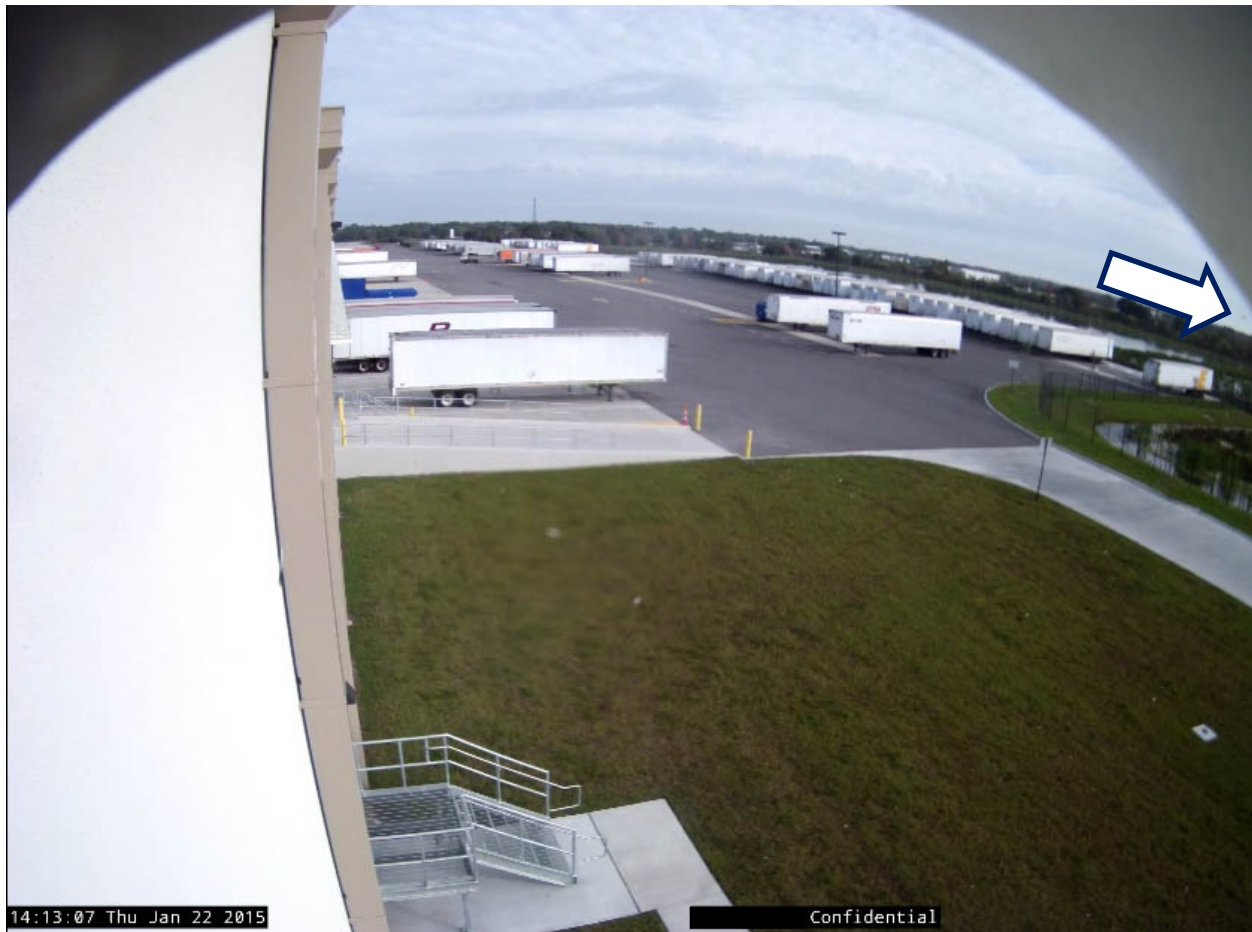
Video from a nearby security camera recorded the aircraft descending into the building and the resulting fire. The security camera was at a facility about a half a mile west of the wreckage and recorded at a rate of 10 frames per second. The aircraft could just be seen in the far right side of the video image (example in Figure 6) for five frames.

**Figure 6.** Second frame of aircraft descent from security camera video. The white arrow points to the aircraft.

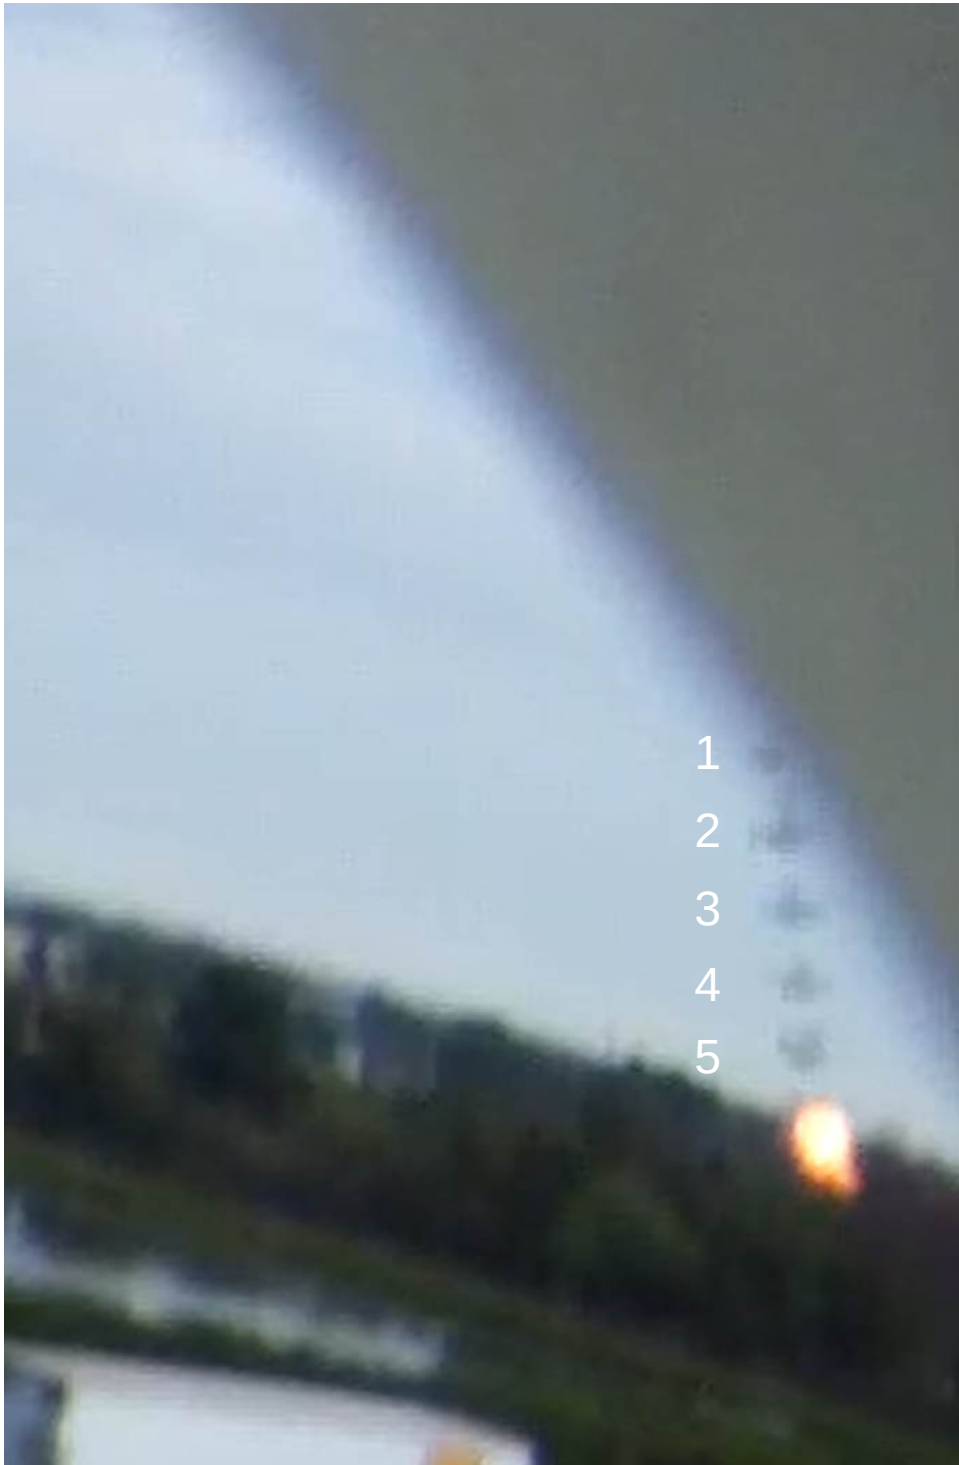
The image of the aircraft was quite small in the video and distorted by the curvature of the lens since it was at the edge of the camera's field of view. Figure 7 shows a zoomed-in overlay of the five sequential frames of the aircraft's descent and one frame of the resulting fireball. The fireball image was from 9 frames after the last aircraft frame, or 9/10<sup>th</sup> of a second later. The image labeled '2' in Figure 7 appears to show the fuselage of the aircraft aligned vertically and the wings on the horizontal axis.

**Figure 7.** Overlay of five frames of the aircraft's descent (numbered) into the building and a single frame of the resulting fireball. The fireball image was from 9 frames after the last aircraft frame.

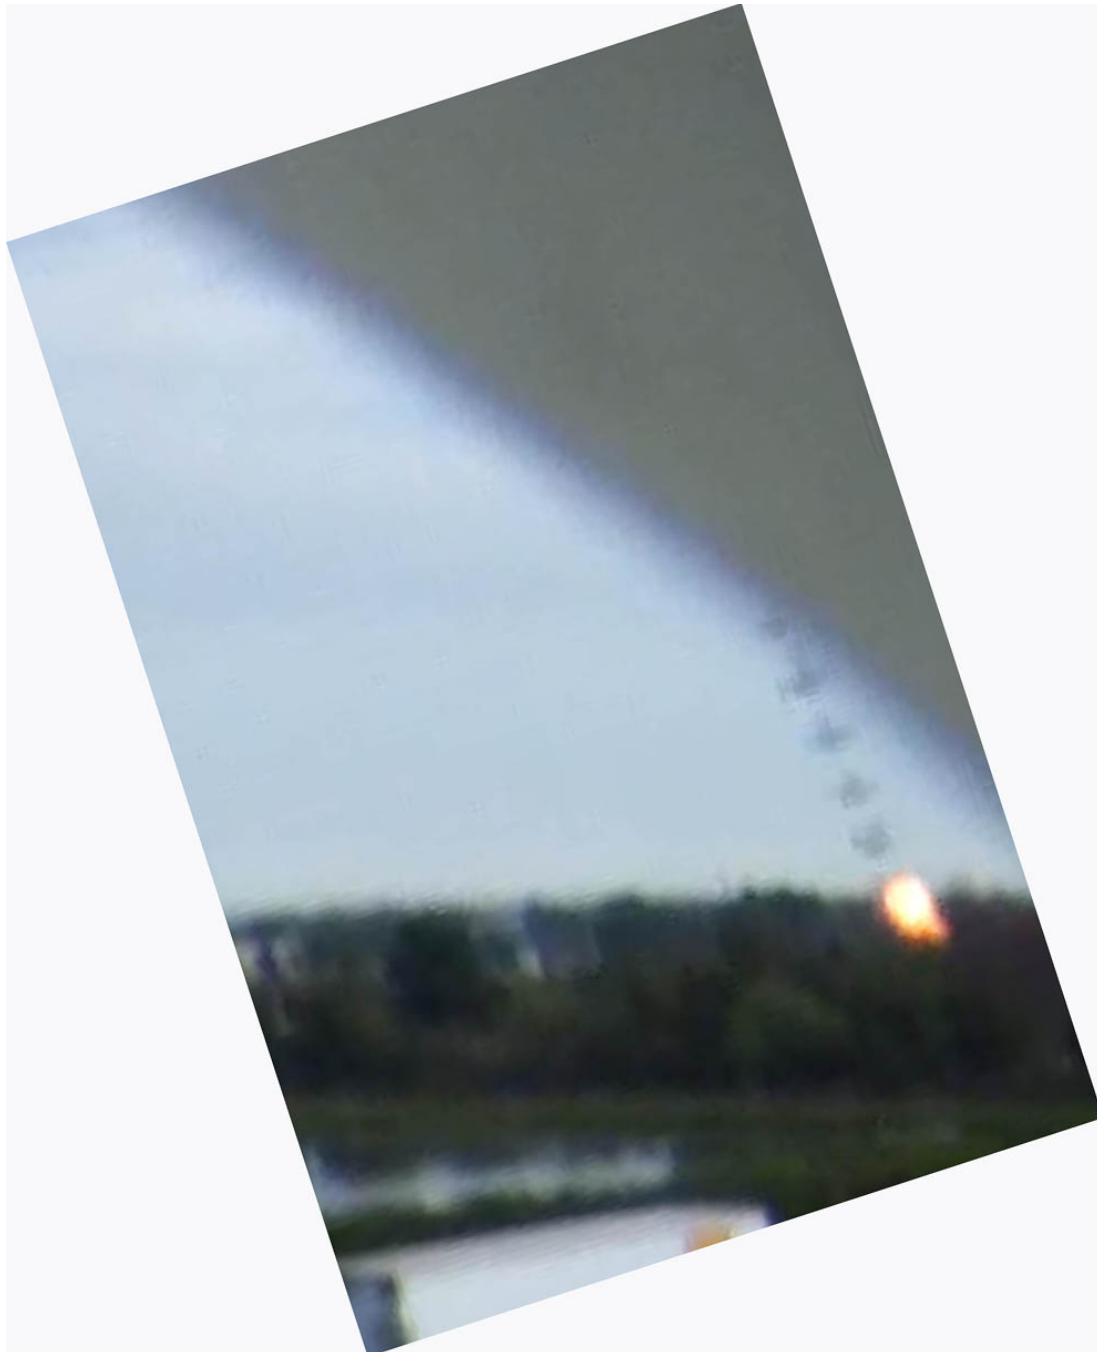
ground level beneath the aircraft was obscured by trees and distorted by the edge of the lens. Figure 8 shows the image in Figure 7 rotated 18° to the left so that the horizon line is approximately horizontal. This rotation shows that the aircraft descended at a steep angle into the building, but was not coming straight down. Since the camera was west of the wreckage location, the aircraft was descending along a generally southerly heading. However, the quality of the image was not good enough to determine if the heading was due south, southeasterly, or southwesterly. The wreckage was southwest of the final radar return (refer back to Figure 2).

**Figure 8.** Overlay of five frames of the aircraft's descent into the building rotated 18° to the left.

Video analysis of the security video showed the aircraft descending quickly along a steep angle from the north into the building. The projection of the aircraft changes in the sequential video images indicating it may have been tumbling or spinning as it fell.
