# NATIONAL TRANSPORTATION SAFETY BOARD

MATERIALS LABORATORY FACTUAL REPORT

Report No. 15-098

Place : Lakeland, Florida  
Date : January 22, 2015  
Vehicle : Piper PA-23, N465JA  
NTSB No. : ERA15FA109  
Investigator : Timothy W. Monville, AS-ERA

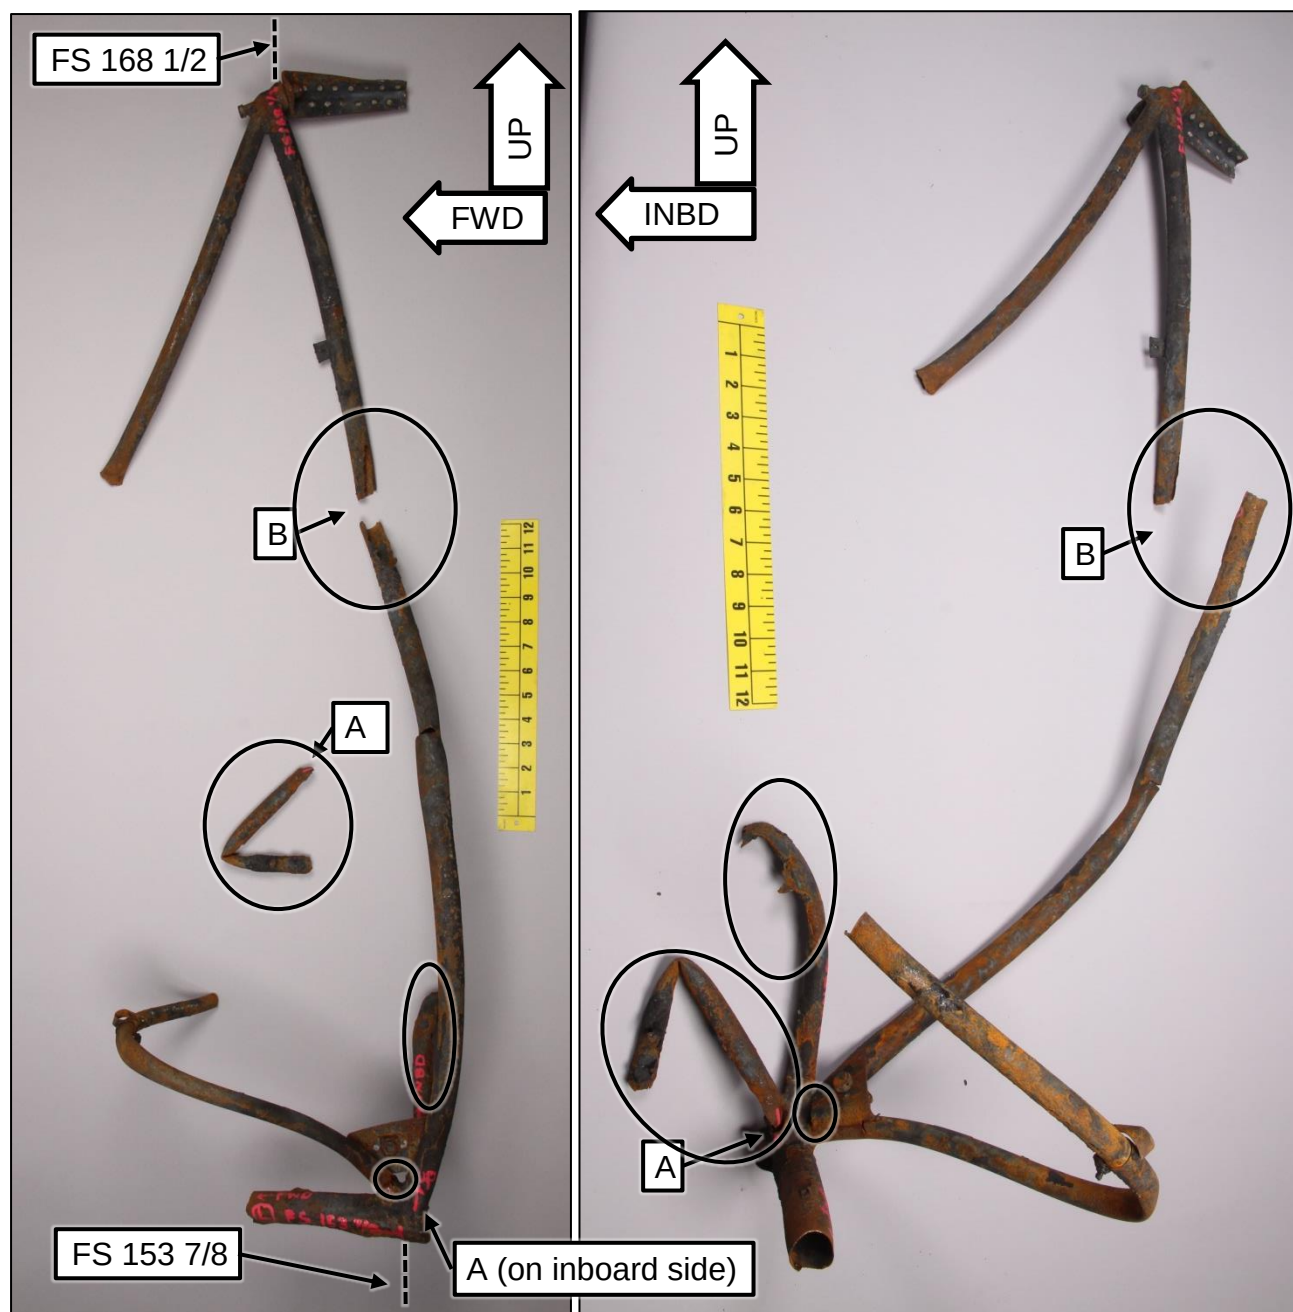
Overall views of the submitted tubular frame pieces are shown in figure 1. Two fracture locations with mating sides of the fracture are labeled A and B. The frame pieces were located from the left side of the airplane and include welded clusters at fuselage stations (FS) 153  $\frac{7}{8}$  and 168  $\frac{1}{2}$ .

Overall, the components showed black scale and orange oxidation consistent with exposure to high heat. In some areas, black bubbled remnants of paint were observed. In areas shown circled in figure 1, metal loss through the thickness of the tube walls was observed.

Figure 1. Overall views of the submitted frame pieces looking inboard (left image) and to the aft (right image). Fractures labeled A and B are indicated. In the aft view, mating fracture faces for fracture A are shown in close proximity. In the lateral view looking inboard, the outboard face of fracture A is not visible since it faced away from the camera. Circled areas in each image indicate areas on the structure where through-wall metal loss was observed.

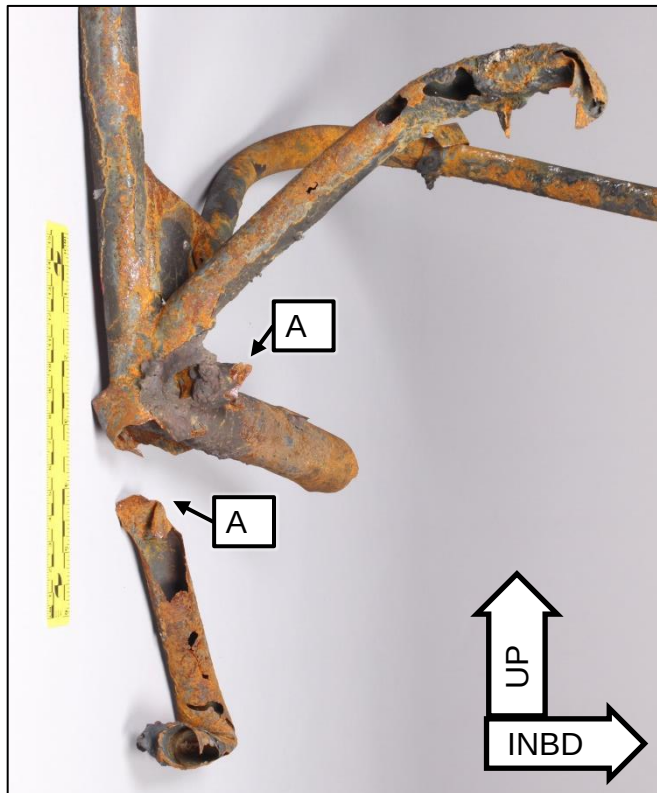
Views of the inboard side of the cluster at FS 153  $\frac{7}{8}$  are shown in figures 2 and 3 where mating sides of fracture A are indicated. Fracture surfaces of fracture A were covered with orange oxides. Metal loss through the wall was observed in the tube piece above and inboard of the fracture. Areas adjacent to the fracture showed deformation of the wall where the wall was folded toward the forward direction, features consistent with contact with another object moving forward relative to the cluster. In figure 3, the mating sides of fracture A are shown in close proximity, and unlabeled arrows indicate the deformed tube walls adjacent to the fracture.

Figure 2. View of the cluster at FS 153 7/8 looking forward showing fracture A.

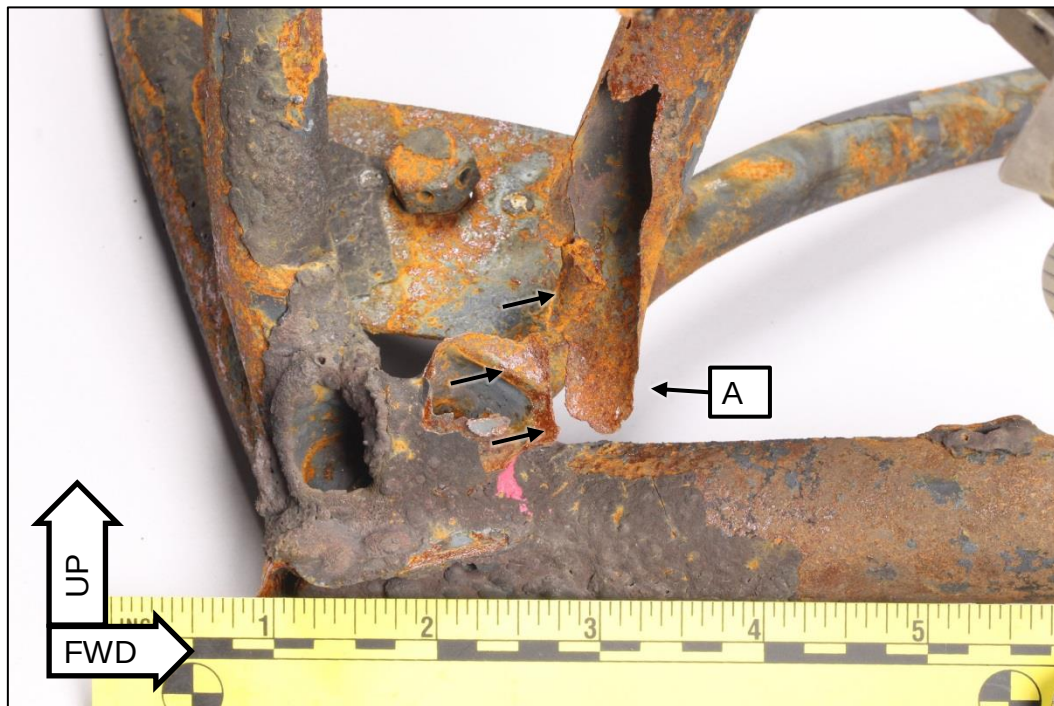
Figure 3. Closer view of fracture A. Arrows indicate deformation of the tube wall adjacent to the fracture consistent with contact with another object moving forward relative to the frame.

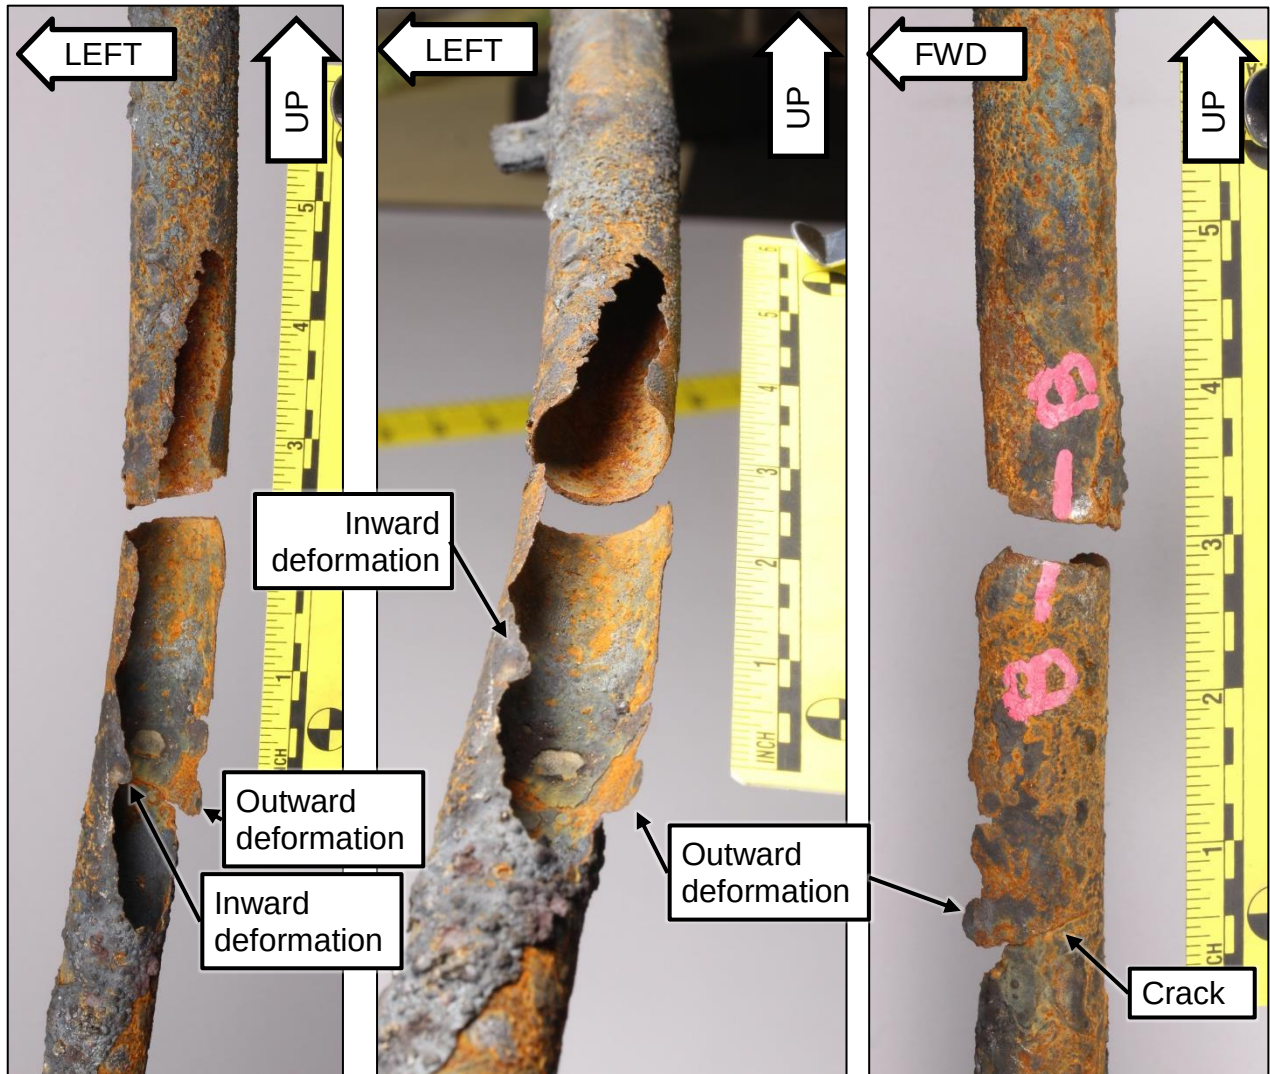
Views of fracture B from several perspectives are shown in figure 4. The surfaces of fracture B were covered with orange oxides. Metal loss through the thickness of the tube wall was observed on the aft side of the tube up to approximately 2 inches above the fracture and 3.5 inches below the fracture as shown in the left and middle images in figure 4. The tube wall was deformed inward at the left edge of the

metal loss approximately 2.25 inches below fracture B, and the wall was deformed outward at the opposite edge of the area of metal loss approximately 2.5 inches below fracture B (see figure 4). A crack extended from the edge of the metal loss at a location adjacent to and just below the outward deformation as indicated in the right image in figure 4. The crack extended at an angle relative to the circumferential plane. The crack fracture surfaces were covered with orange oxide.

Figure 4. Views of fracture B looking forward (left image), upward and forward (middle image), and right (right image).

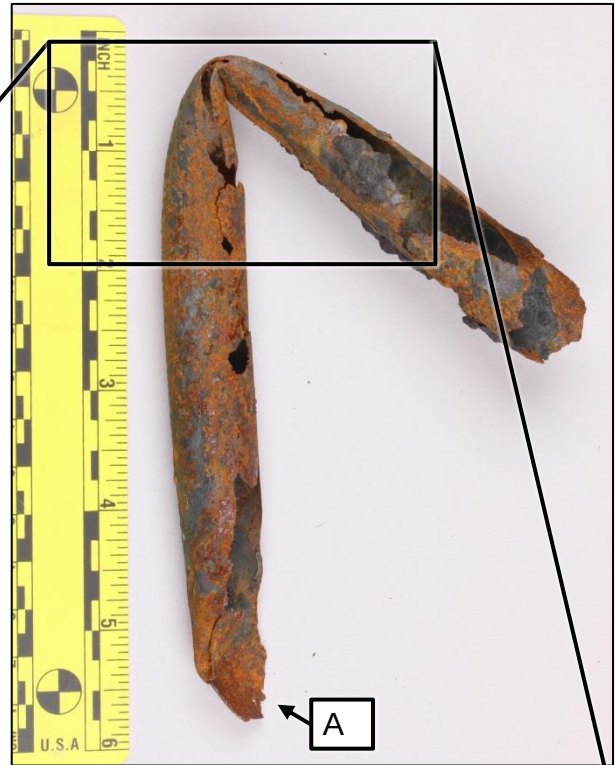
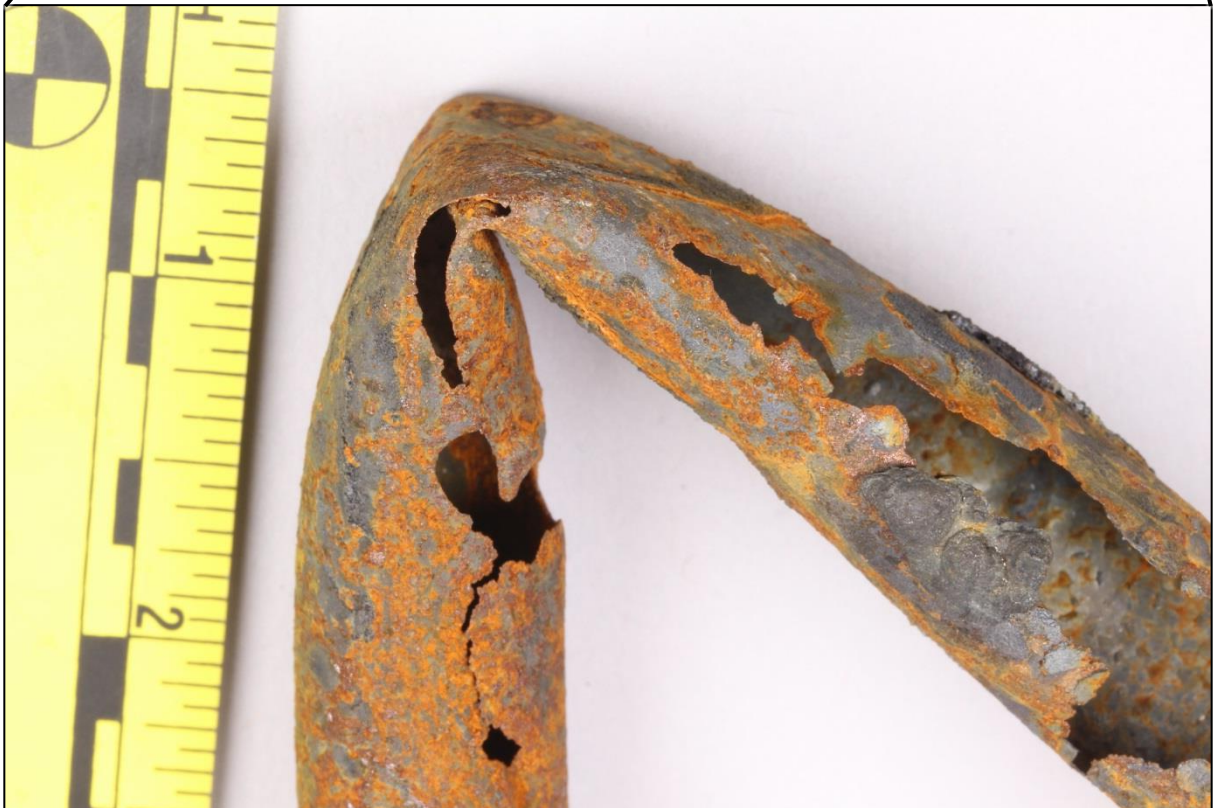
Closer views of the tube piece inboard of fracture A are shown in figure 5. As shown in the upper image, the tube was bent near the middle of the segment, and a closer view of the bend is shown in the lower image. Within the bend itself, metal loss through the wall was located only at the edge of the crease viewed in figure 5. However, other areas within several inches of the bend showed much larger areas of through-thickness metal loss, including sides of the tube longitudinally in line with the inside and outside surfaces of the bend.

Figure 5. Tube piece inboard of fracture A with a close view of the location of the bend.

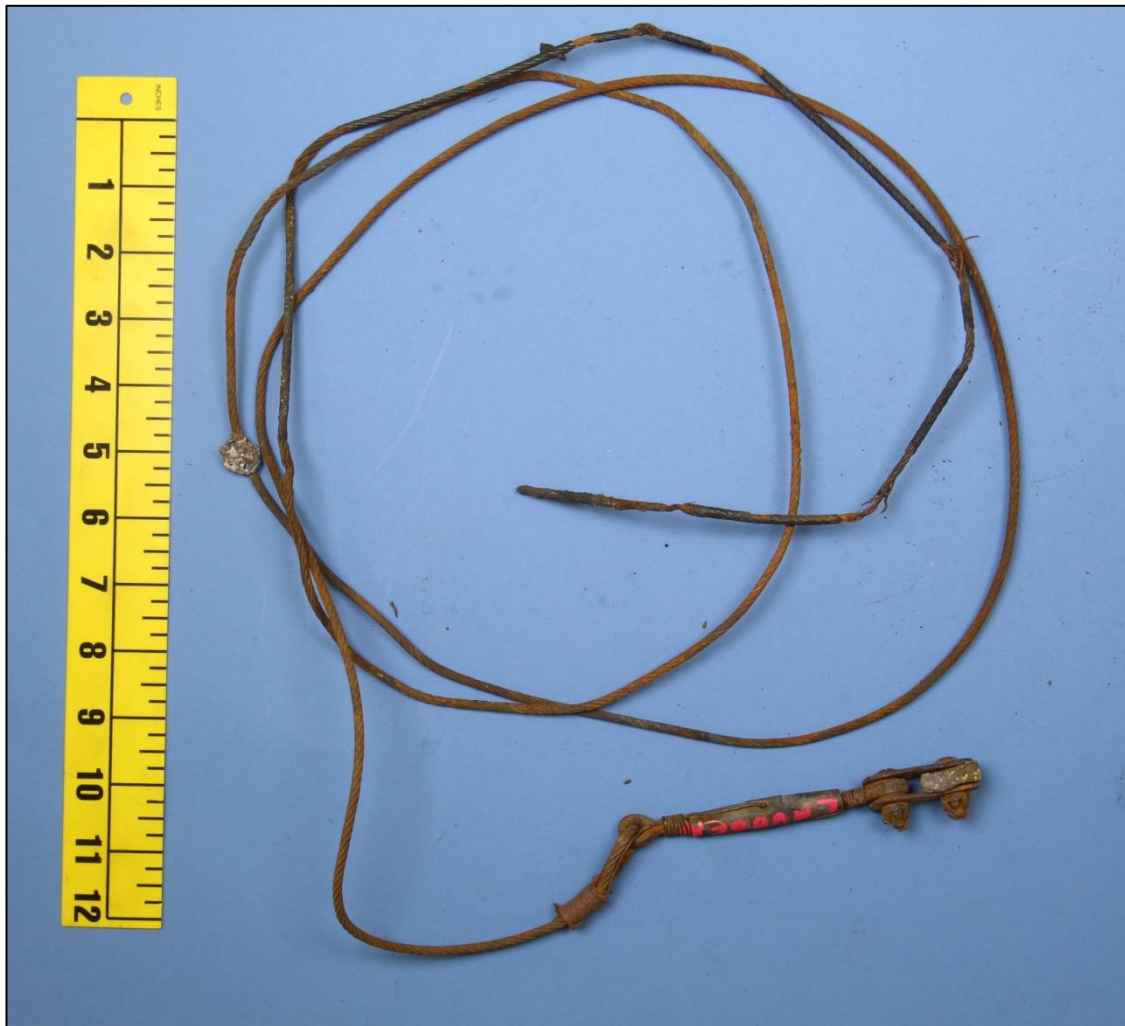
An overall view of the left rudder control cable is shown in figure 6. The cable was fractured at one end, and at the other end, the cable connection was fractured through an attachment lug. The total length of the cable from the fractured lug to the fractured cable end was 8 feet 9 inches. Most of the length of the cable showed exposed wires generally covered with orange oxide. Near the fractured end of the cable, a black material was observed covering segments of the cable. In several locations, the cable was bent and partially fractured through many of the wires comprising the cable. The cable fracture was covered in black material and orange oxides. The wires at the fractured end were together and did not show any splaying or broomstraw fracture appearance. However, fracture features were mostly covered by the black material, and where visible, fracture features were obliterated by oxidation. At the other end of the cable piece, the fracture through the attachment lug showed rough fracture features consistent with overstress fracture.

Figure 6. Overall image of the rudder cable as-received.
