**SPECIALIST'S REPORT OF INVESTIGATION  
SOUND SPECTRUM STUDY  
ERA15FA129**

Location: Miami, Florida  
Date: February 11, 2015 1439 Eastern Standard Time (EST)  
Aircraft: Beechcraft 1900C, VY1674  
Operator: Aeropanamericano, C.A  
NTSB Number: ERA15FA129

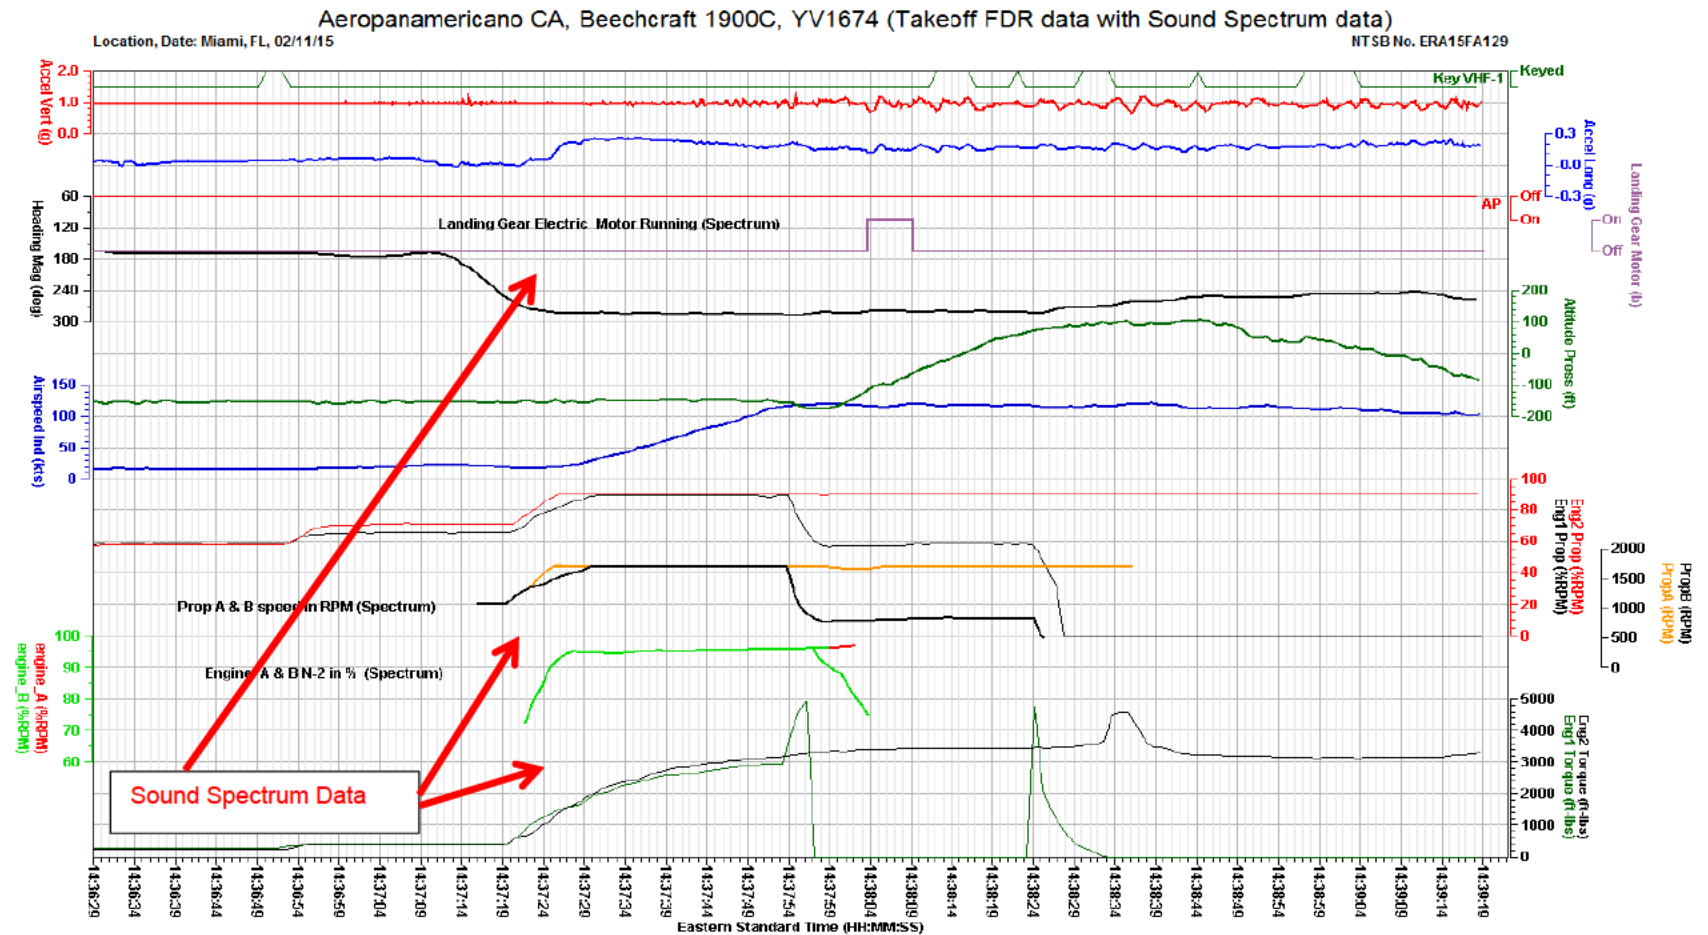
# CHART-3

The data shown on Chart-3 is select parameters recovered from the aircraft's flight data recorder <sup>1</sup> along with information obtained from the sound spectrum study. The additional sound spectrum study data is highlighted with red arrows on the chart.

Additionally a sound trace that is associated with the aircraft's landing gear retraction/extension electric motor running was audible on channel 3 of the cockpit voice recorder. This data is also included on Chart 3.
