# NATIONAL TRANSPORTATION SAFETY BOARD

MATERIALS LABORATORY FACTUAL REPORT

Report No. 15-080

Place : Miami, Florida  
Date : February 11, 2015  
Vehicle : Beech 1900C  
NTSB No. : ERA15FA129  
Investigator : Robert Gretz, AS-ERA

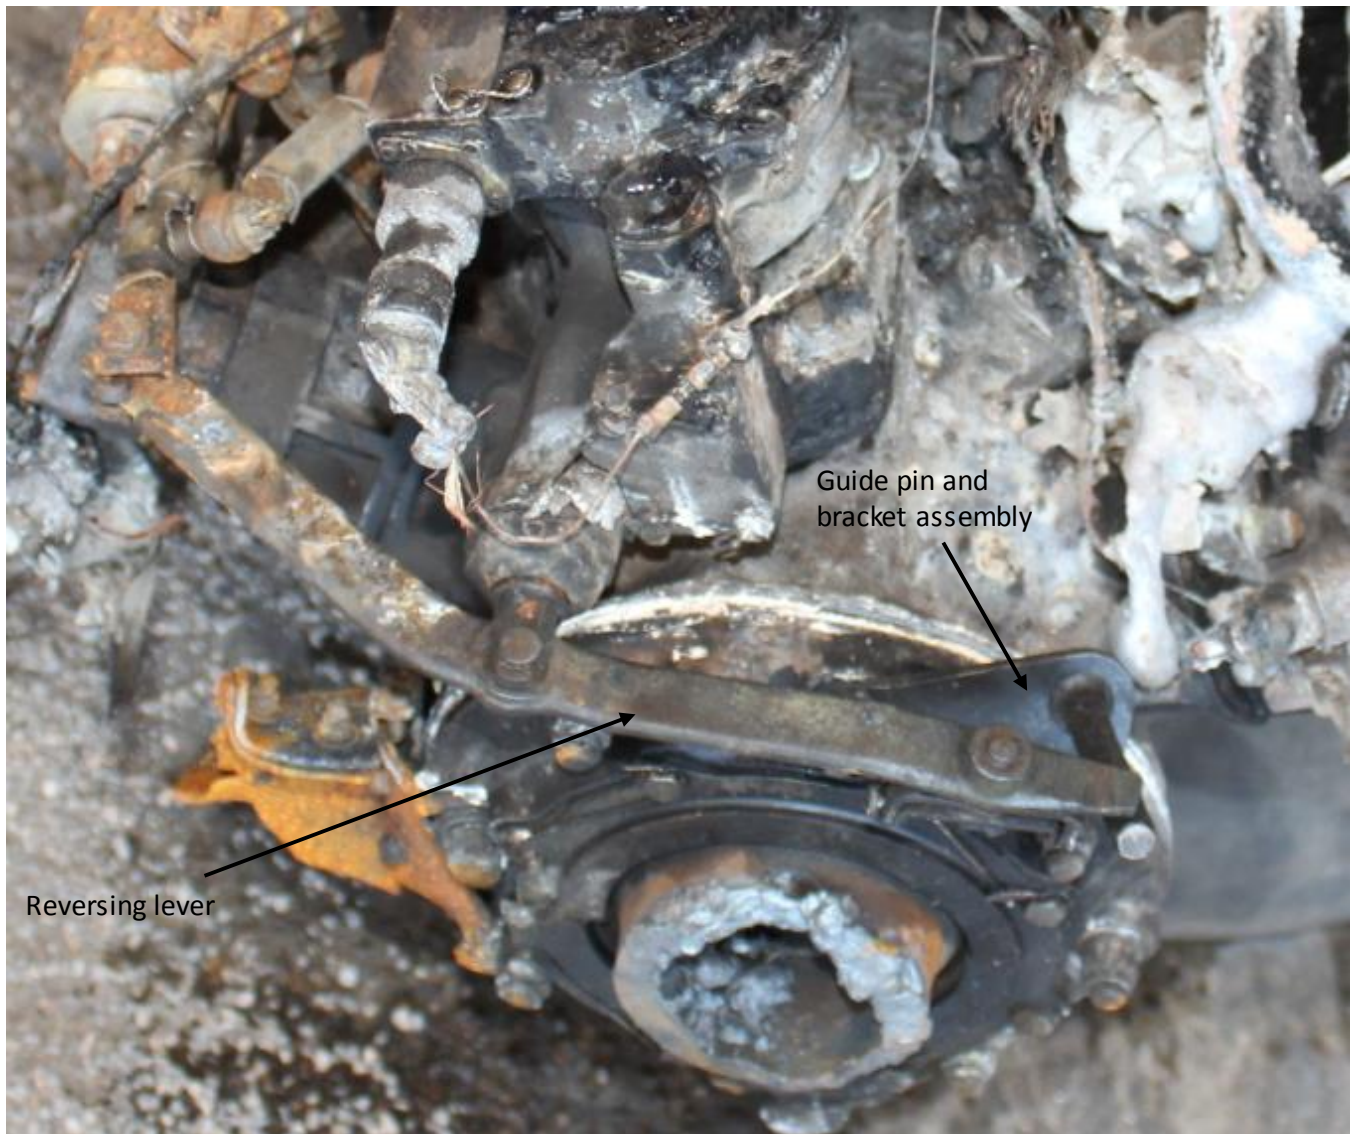
An accident-scene view of the reversing lever and guide pin installation on the aircraft engine is shown in Figures 1, 2, and 3. Closer views of the position of the reversing lever tip and the guide pin are shown in Figure 2, and 3. In Figure 3a, an isometric engineering drawing shows the as-designed position of the reversing lever tip relative to the guide pin. Figure 3b, shows the position of the reversing lever tip relative to the guide pin after the accident.

Figure 1 Image of side A (see Figure 3) of the reversing lever and guide pin and bracket assembly as-installed on the engine after the accident.

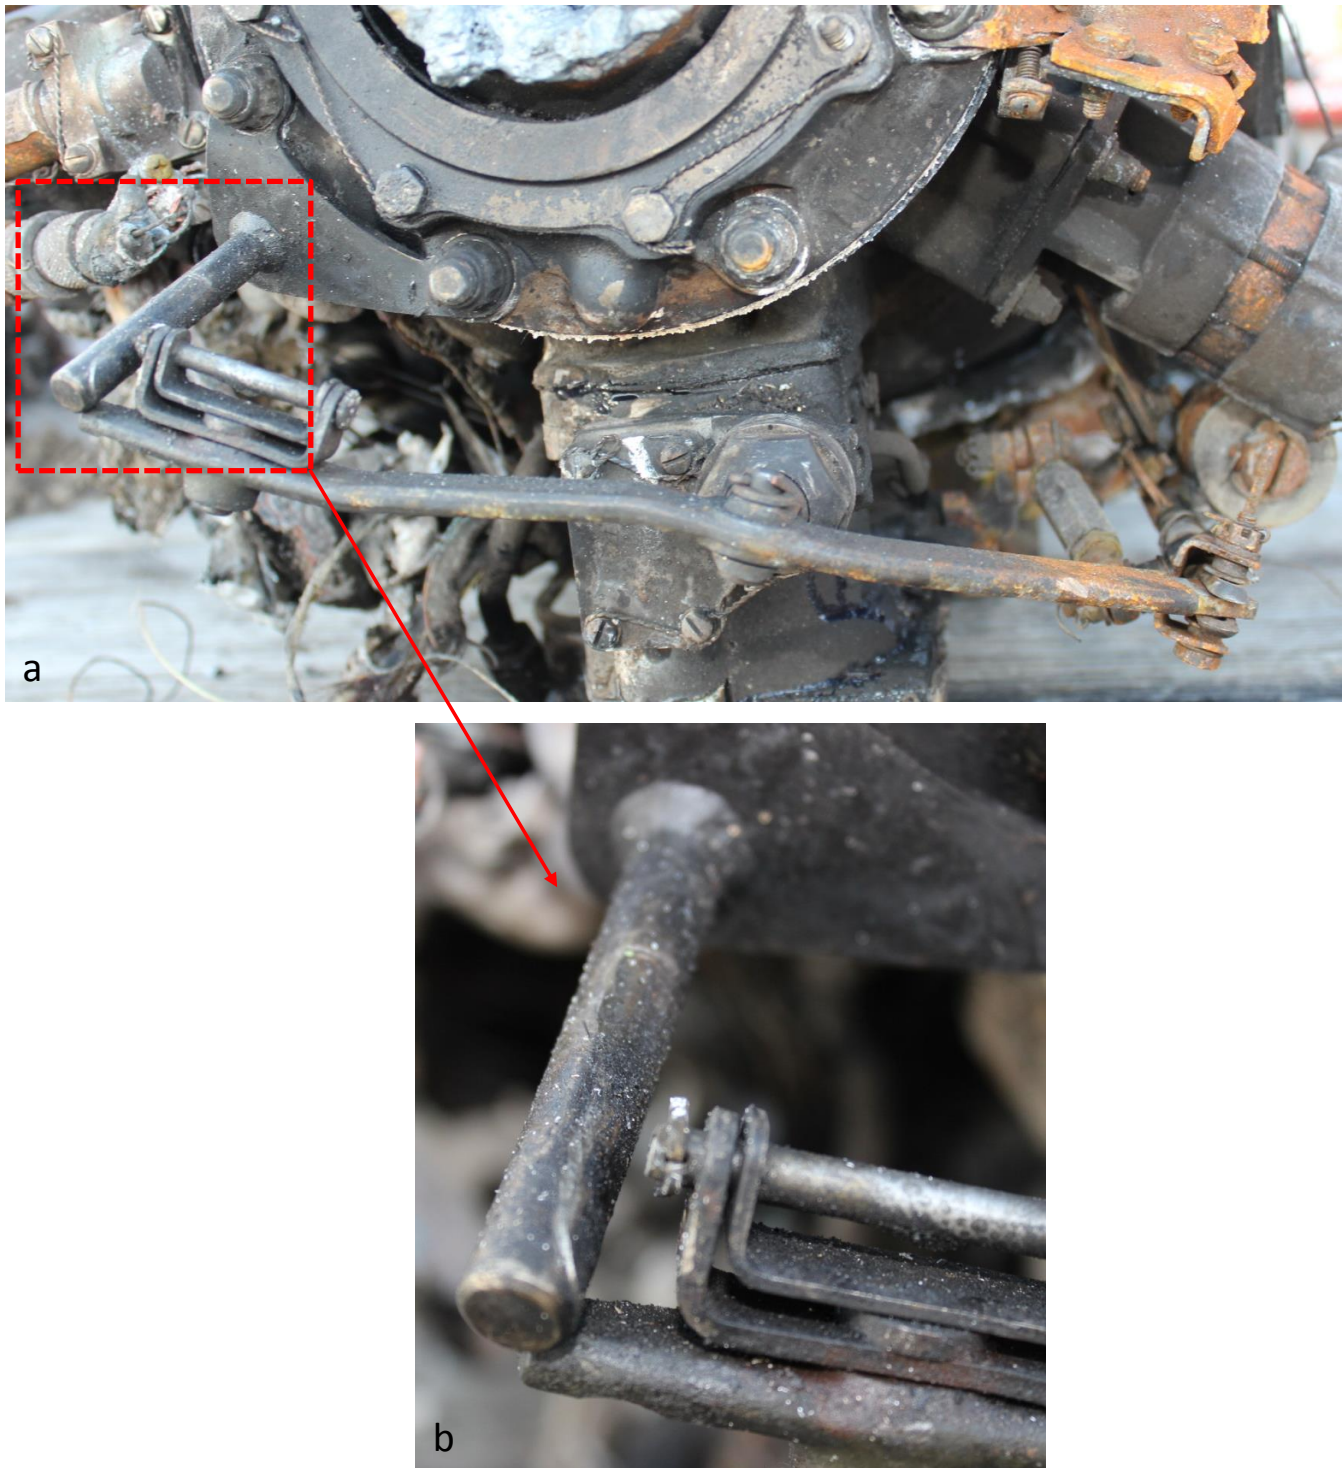
Figure 2 Images of side B (see figure 3) of the reversing lever and guide pin and bracket assembly as-installed on the engine after the accident. View b is a closer view of the mechanical interface between the tip of the reversing lever and the guide pin.

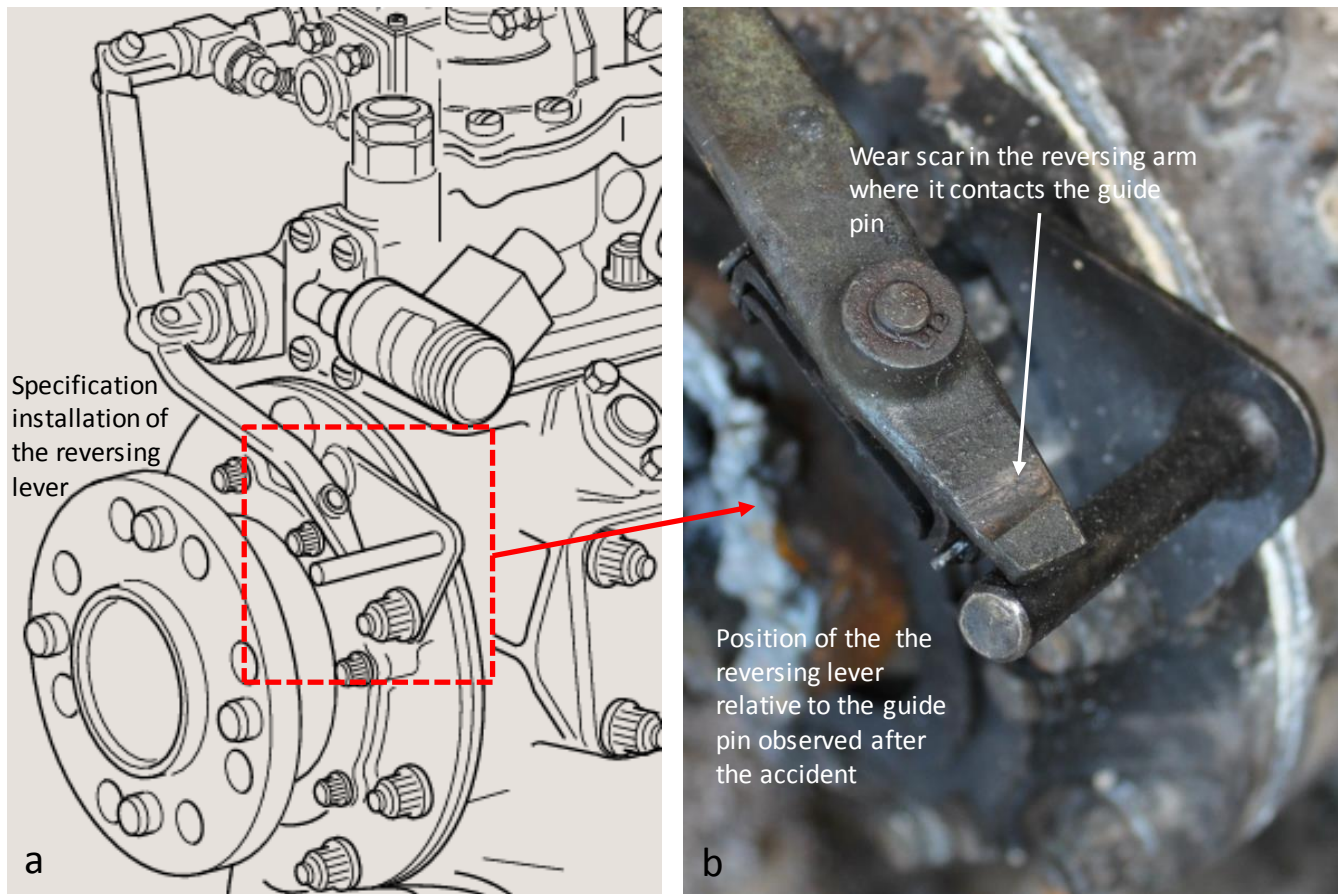
Figure 3 View a is an isometric engineering image of the reversing lever and guide pin mechanical interface. View b is a similar image of the reversing lever and guide pin mechanical interface after the accident. As indicated in view b, the tip of the reversing lever has been displaced from the specification position shown in view a. View b also shows a wear scar across the width of the reversing lever tip where normally contact with guide pin.

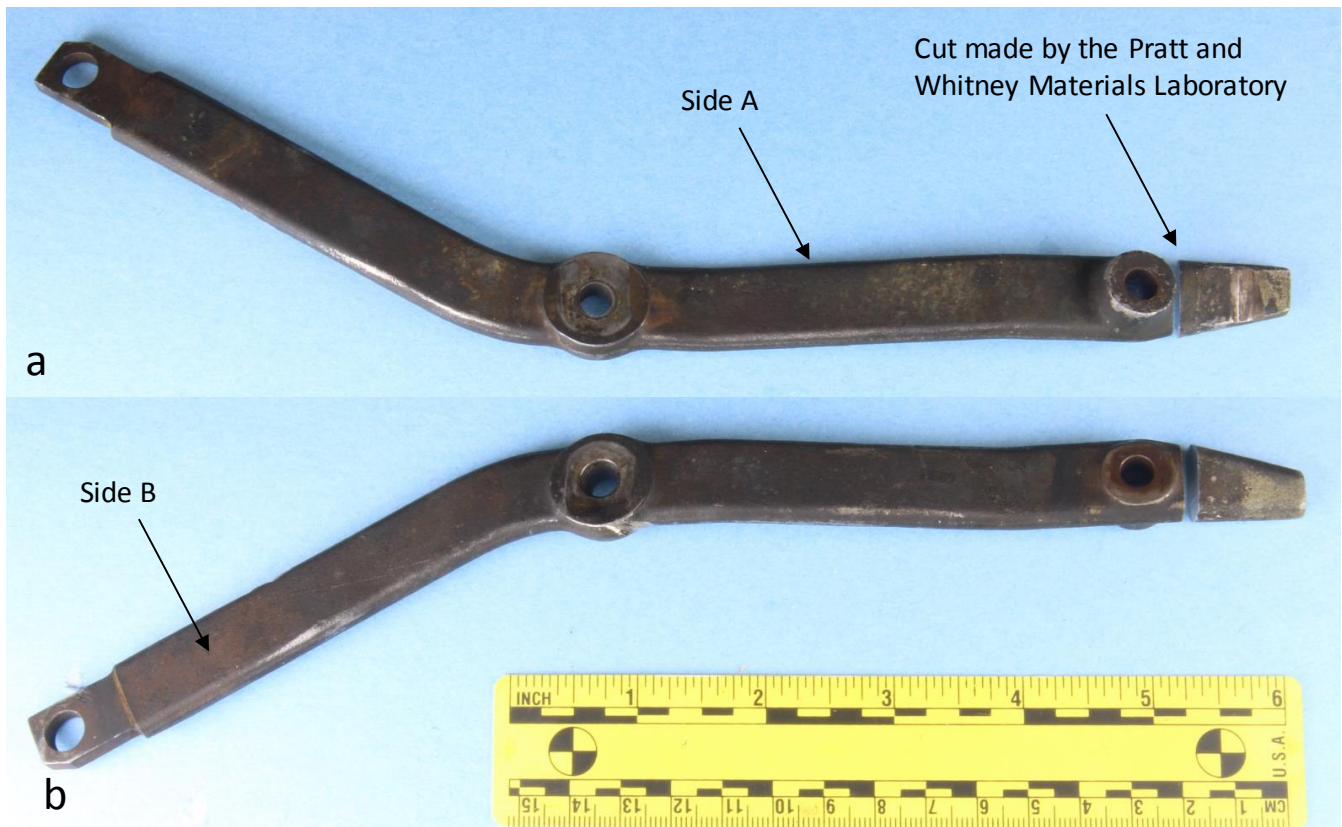
Images of the reversing lever are showing in Figure 4. The tip of the reversing lever had been previously cut during an exam at Pratt & Whitney Canada. The flat sides of the lever arm are arbitrarily labeled A and B as shown in the figure. Closer views of the tip of the lever arm are shown in Figure 5. As indicated in the figure, a wear scar was observed on side A of the tip which is consistent with as-designed contact with the guide pin. The guide pin exhibits a complimentary wear scar where it contacts the reversing lever tip as shown in Figure 6a. No wear scars or contact marks were present on side B of the reversing lever tip as indicated in the figure.

Figure 4 Images of the reversing lever after removal from the engine. The tip has been sectioned during previous work conducted by the Pratt and Whitney Materials Laboratory. In these images, the tip has been placed close to its pre-sectioning position.

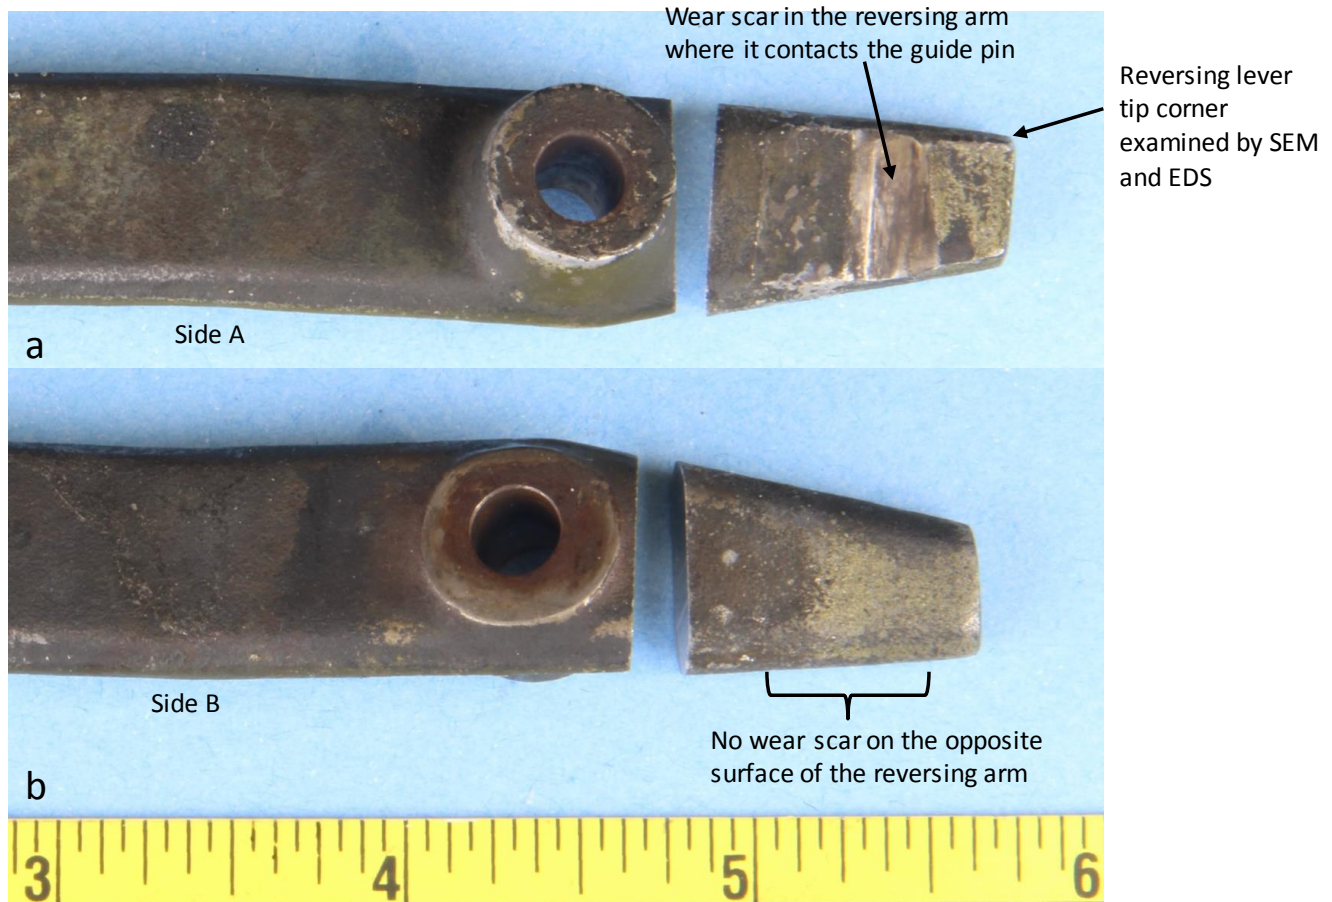
Figure 5 Closer images of the reversing lever tip after removal from the engine. The tip has been sectioned during previous work conducted by the Pratt and Whitney Materials Laboratory. In these images, the tip has been placed close to its pre-sectioning position. Wear scars are indicated in view a. In view b, side b of the tip was examined for wear scars in the region identified, but no scars were identified.

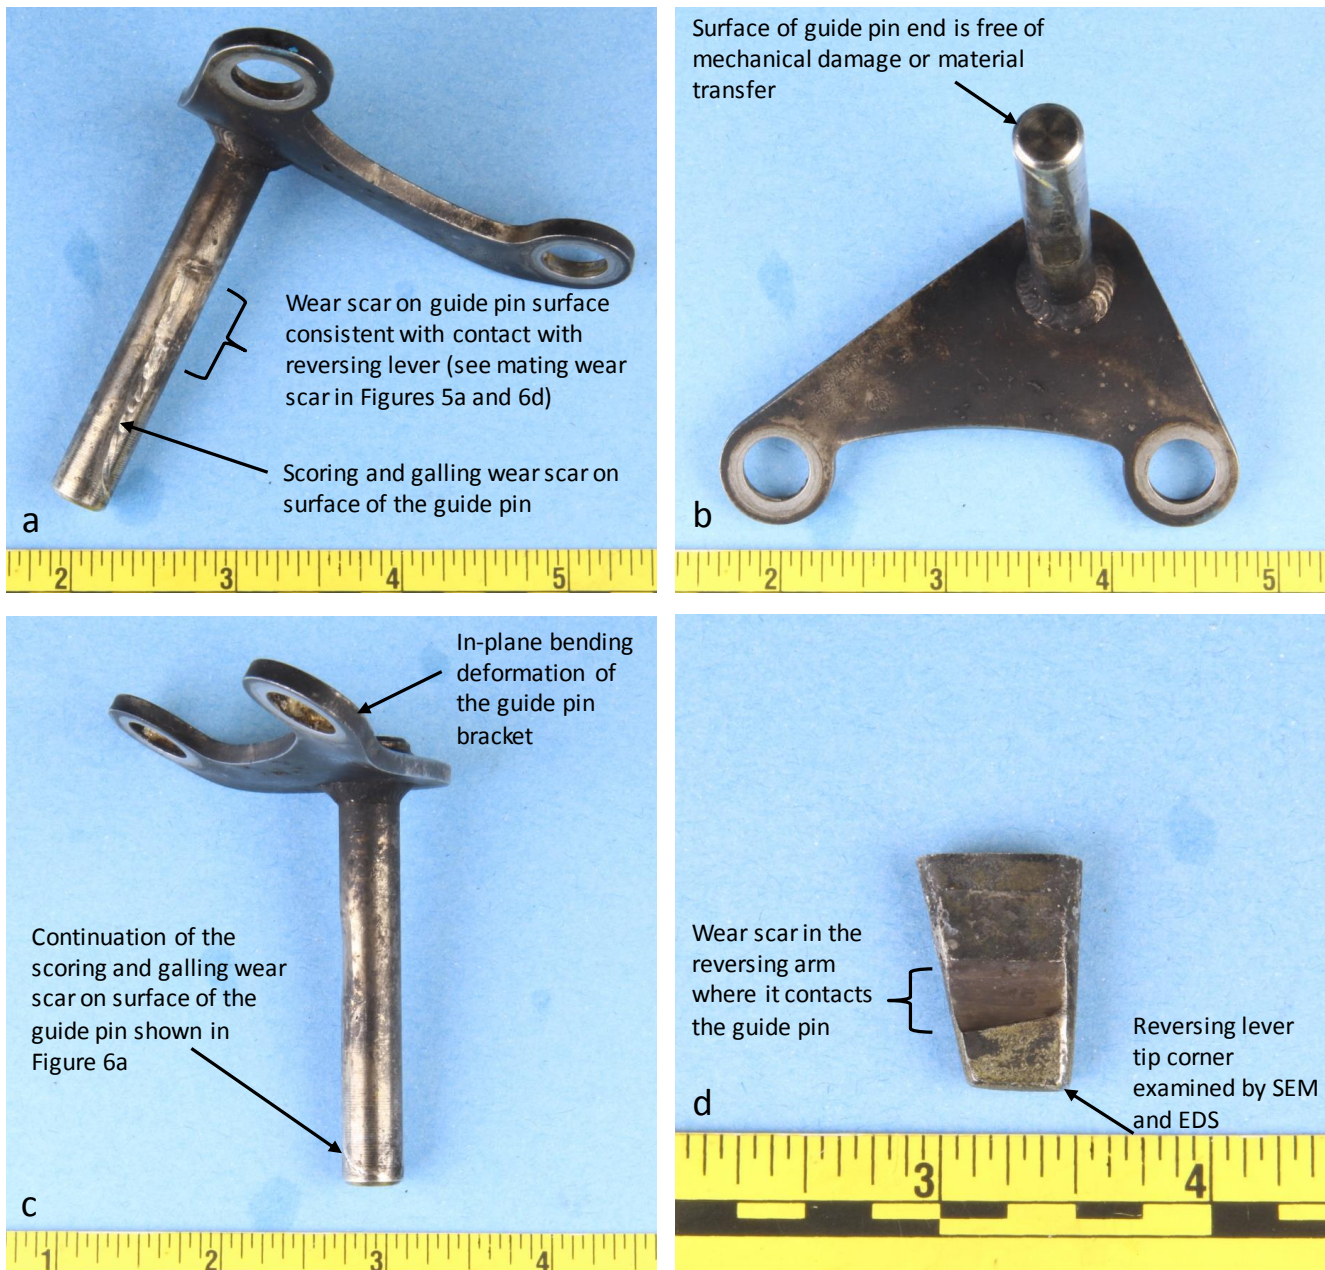
Views of the guide pin and bracket assembly are shown in Figure 6. The bracket exhibited in-plane bending deformation such that as-installed it is no longer perpendicular to the axis of the propeller (see Figure 6b). The guide pin surface exhibited a wear scar consistent with contact with reversing lever as shown in Figure 6a. Extending from the reversing-lever contact-wear scar is an axially-oriented scoring wear scar that also exhibits galling wear features as identified in Figures 6a and 6c. The scoring and galling wear scar transitions to a radial path as it approaches the tip of the guide pin (see Figure 6c). For reference, the complimentary guide-pin contact-wear scar on the reversing lever tip is shown in Figure 6d.

Figure 6 Images of the reversing arm tip and the guide pin and bracket assembly.

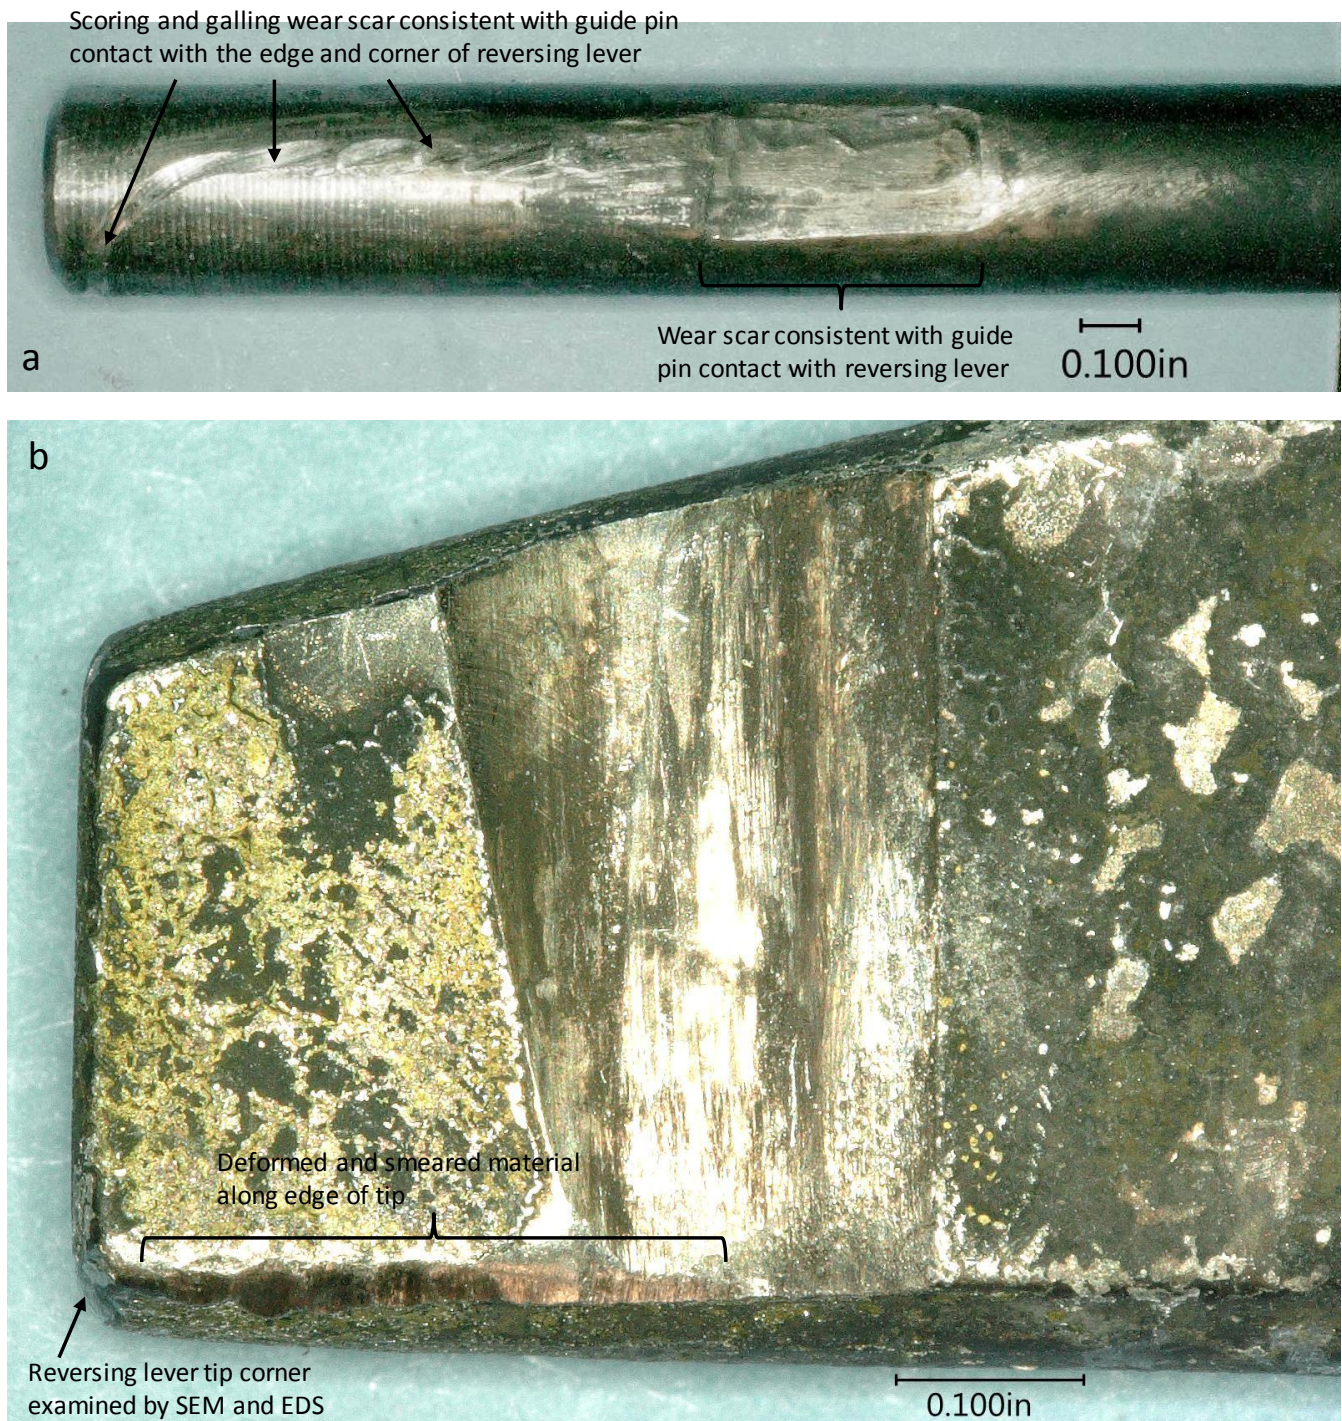
A closer view of the guide pin wear scars is shown in Figure 7a. As indicated, a scoring and galling wear scar extends from the lever arm contact wear scar to the tip of the guide pin. There is deformed and smeared material along edge of reversing lever tip as identified in Figure 7b—consistent with contact with the guide pin.

Figure 7 Images of the reversing lever tip (view b) and the guide pin surface (view a) showing the mating wear contact surfaces.

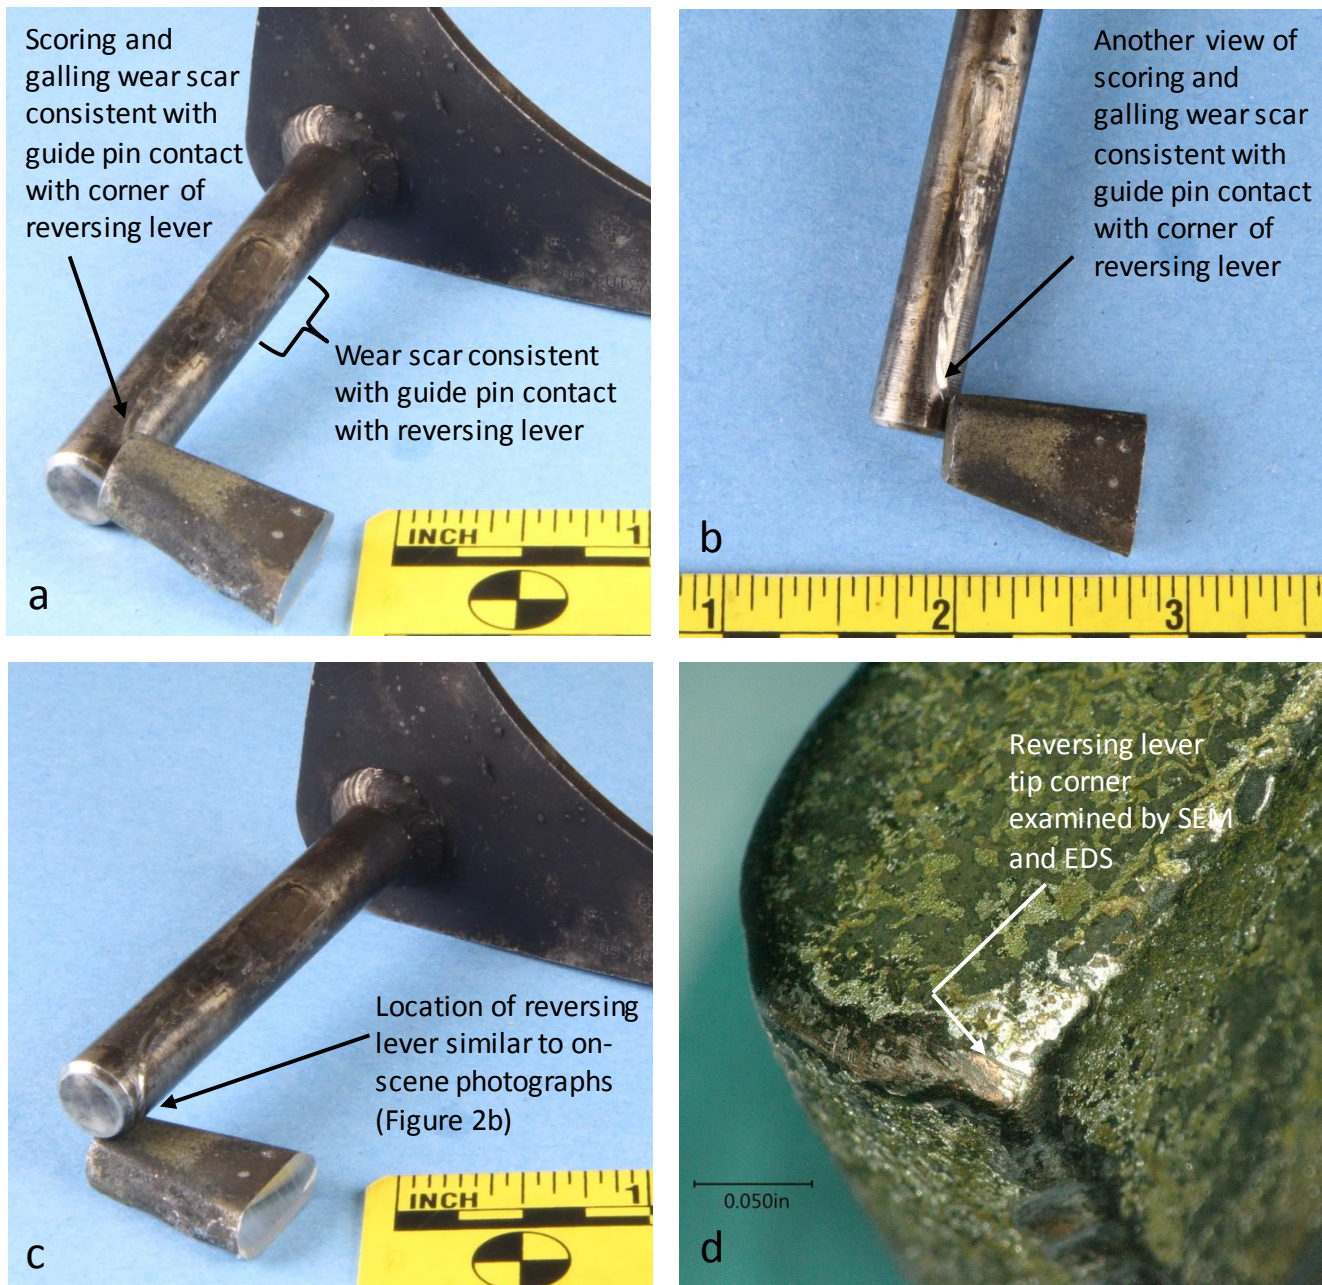
In Figure 8a, the scoring and galling wear scar is consistent with guide pin contact with the corner of the reversing lever tip. The tip of the reversing lever is placed near the wear track for exemplar purposes. Other exemplar views of the sliding of the reversing lever tip corner along the length of the guide pin are shown in Figures 8b and 8c. As indicated in Figures 8d, 7a, 6d, and 5a, the corner of the reversing lever tip exhibited galling wear signatures and was examined by scanning electron microscopy (SEM) and chemically surveyed by energy dispersive spectroscopy (EDS) for material transfer.

Figure 8 Images of the reversing lever tip and the guide pin demonstrating the sliding path of the reversing lever tip relative to the guide pin.

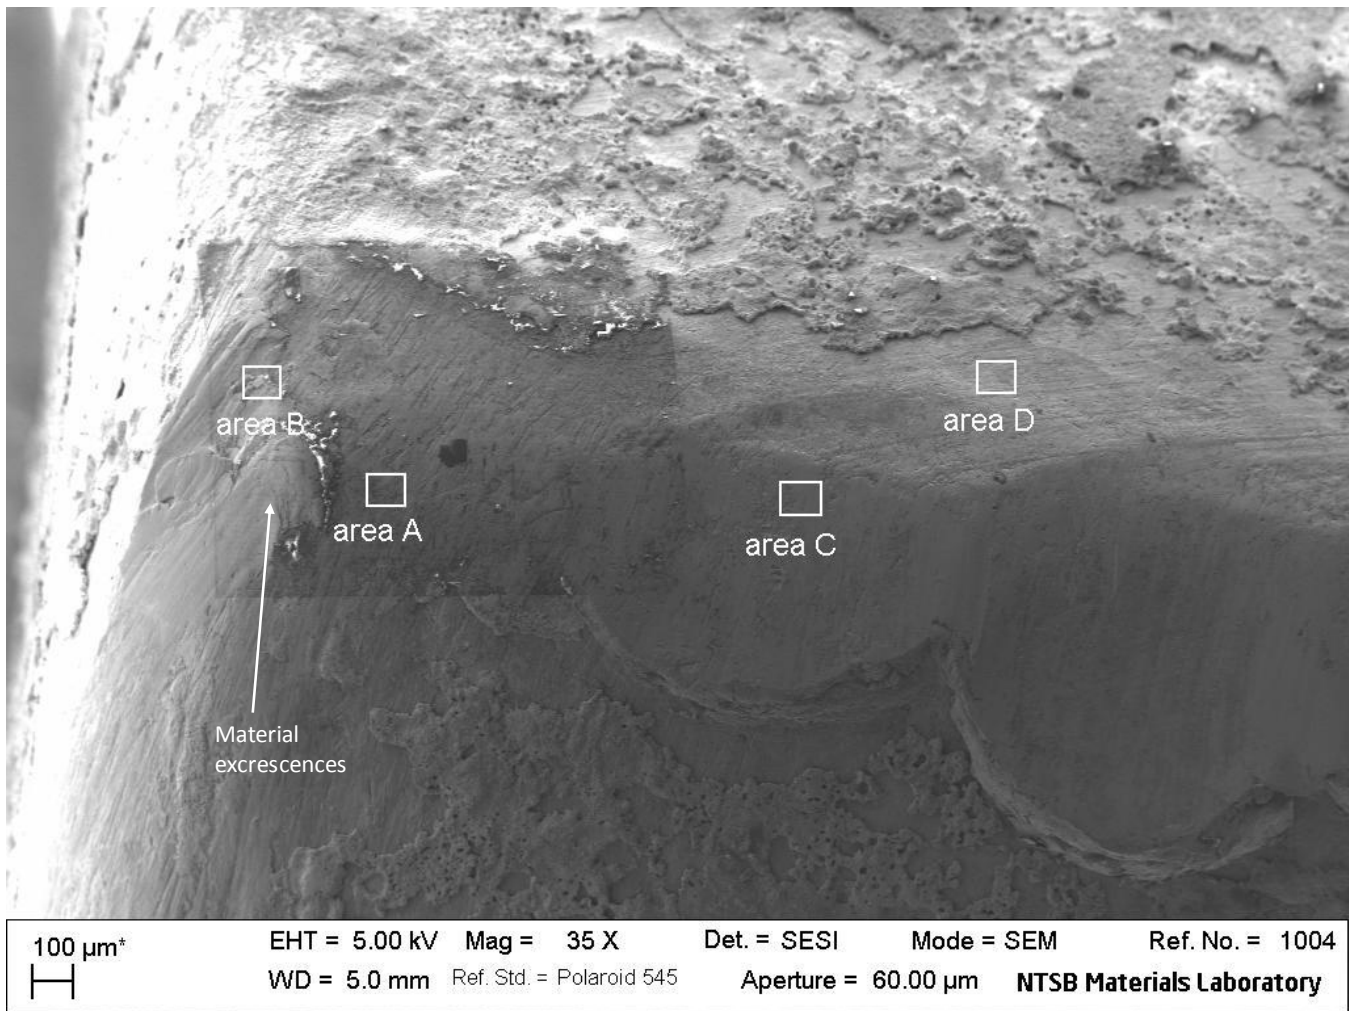
A scanning electron micrograph of the reversing lever tip corner is shown in Figure 9. The white rectangular boxes indicate regions of EDS composition analysis. EDS spectra for the boxes labeled 1 through 4 are shown in Figures 10 and 11. An EDS spectra for the lever arm base material (taken on the cut surface of the tip) is shown in Figure 12. The guide pin is fabricated from type 304 stainless steel (as confirmed by EDS). The reversing lever is fabricated from cadmium-electroplated type 410 stainless steel. The EDS spectra for areas 1 and 2, reveal elevated nickel peaks which are consistent with tribo-transfer of type 304 stainless steel to the surface of the reversing lever tip corner. In the region near areas A and B in Figure 9, material excrescences are present at the tip corner consistent with galling wear.

Figure 9 Scanning electron micrograph of the reversing lever tip corner (see Figure 6d, 7a, and 8d). A region exhibiting material excrescences is shown. Four areas are identified where energy dispersive spectroscopy was conducted.

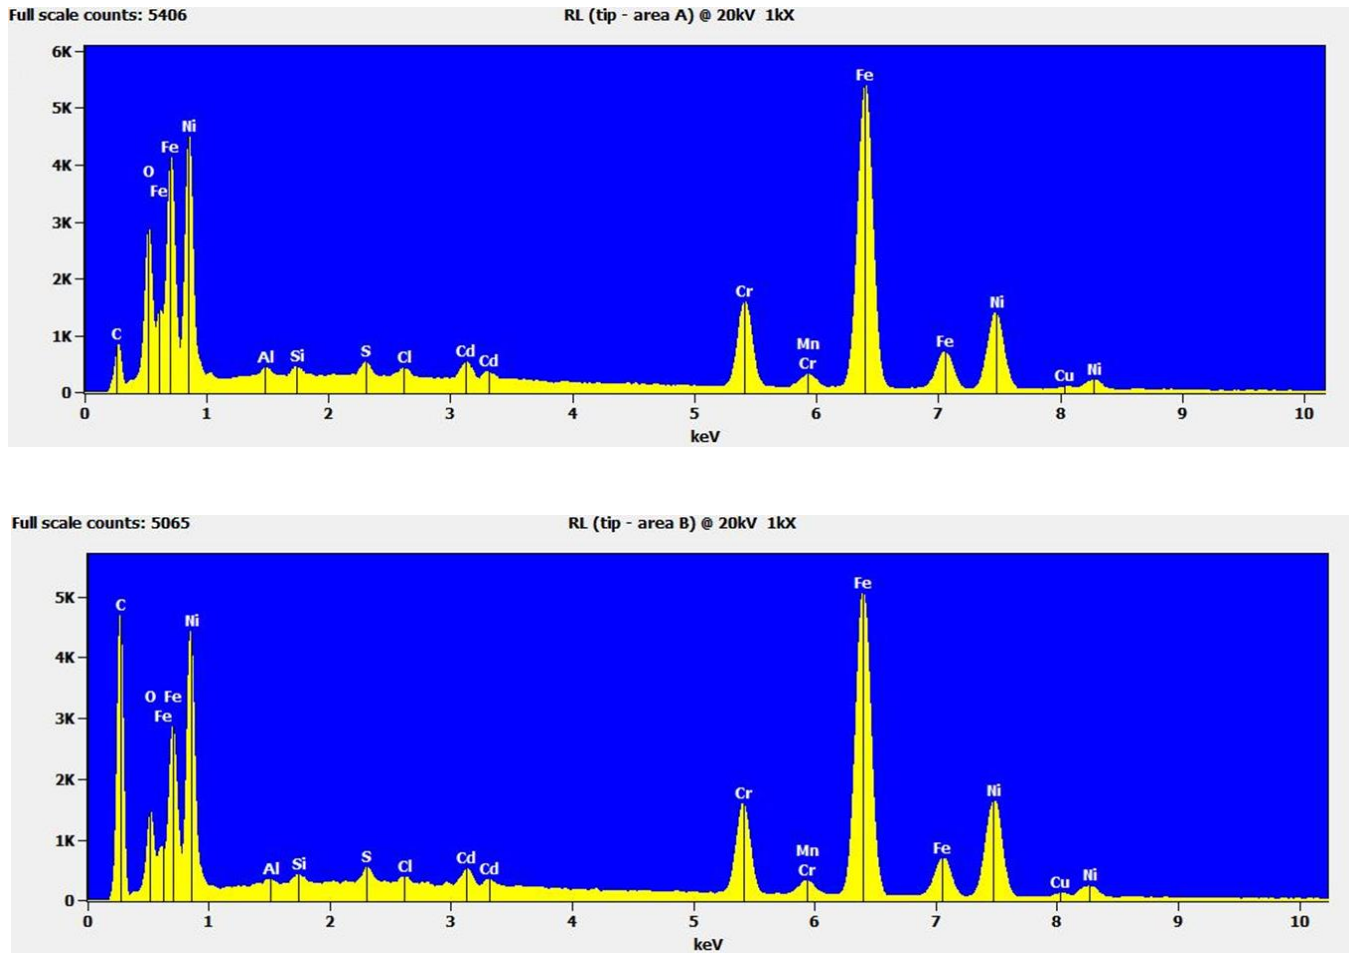
Figure 10 Energy dispersive spectra for the reversing lever tip areas a and b.

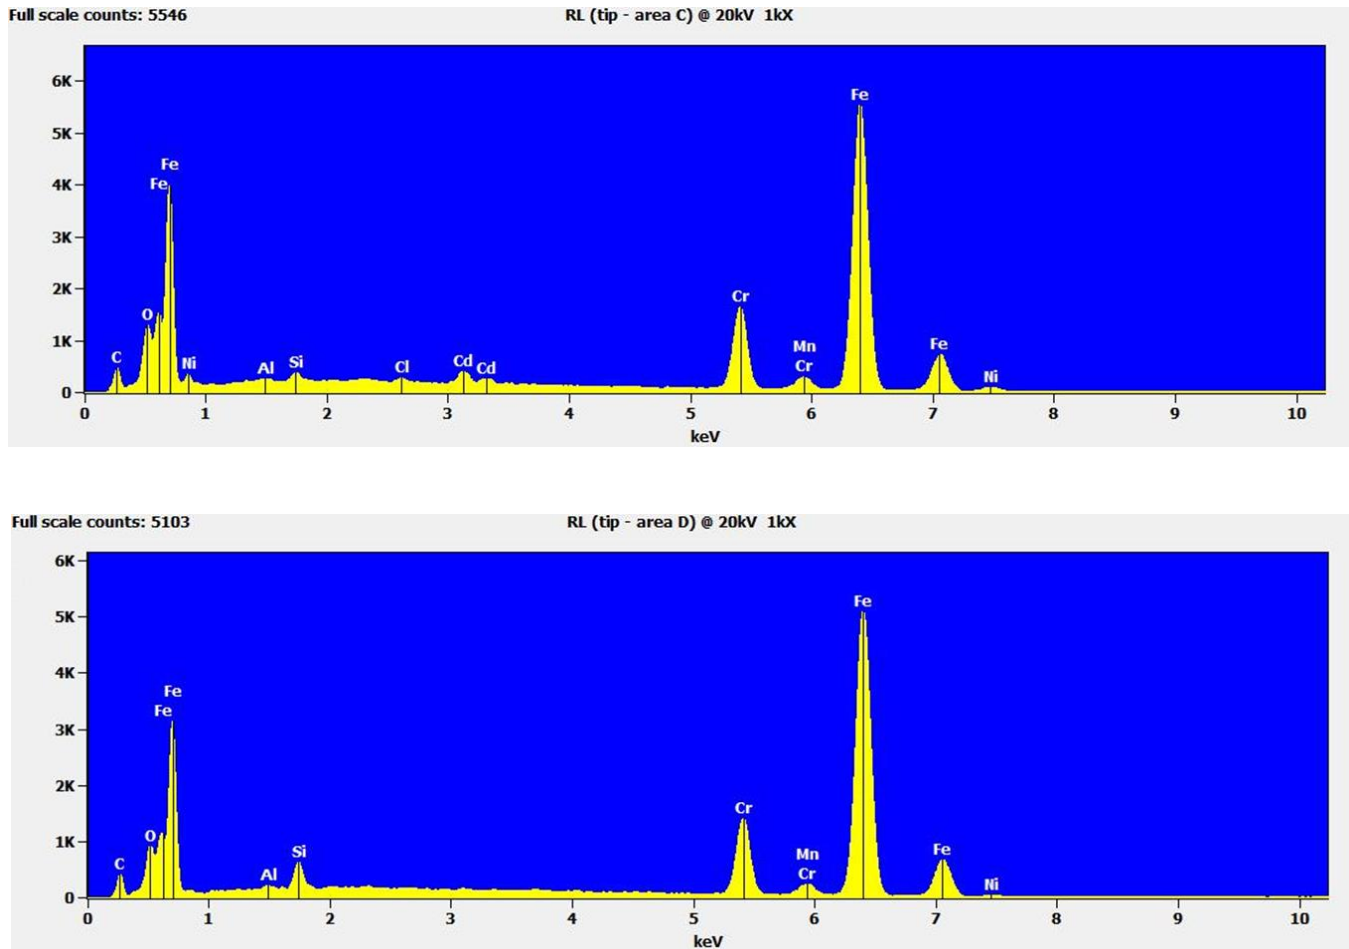
Figure 11 Energy dispersive spectra for the reversing lever tip areas c and d.

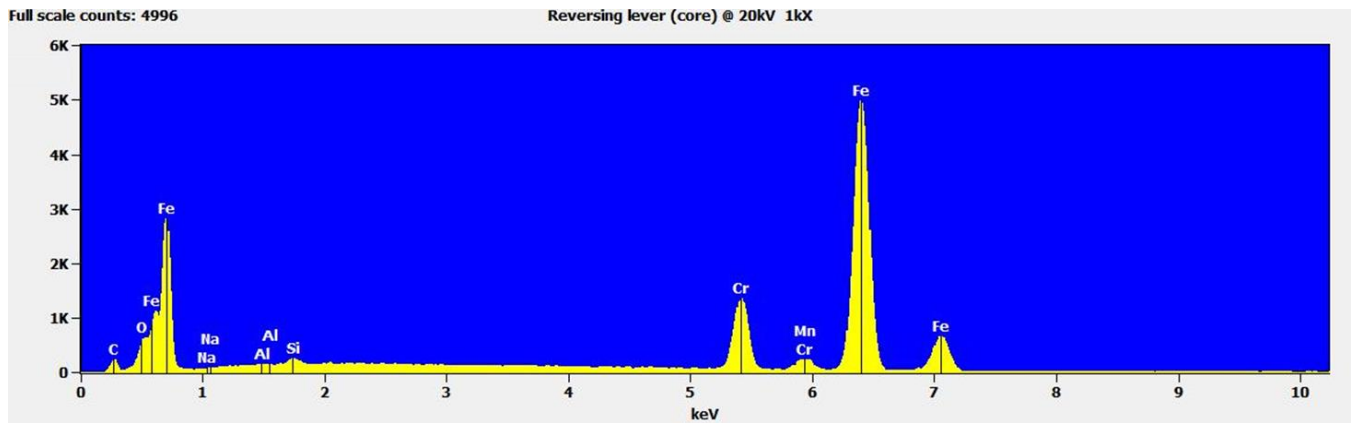
Figure 12 Energy dispersive spectra for base material for the reversing lever tip.
