**Accident / Incident Report**

**Report No.: 15-012**

**Brinks Inc.  
Beech 1900C, Aircraft Reg. No. YV1674  
Miami, Florida, USA  
February 11, 2015  
PT6A-65B  
L/H S/N 32138  
R/H S/N G/G 32040 P/S 32065**

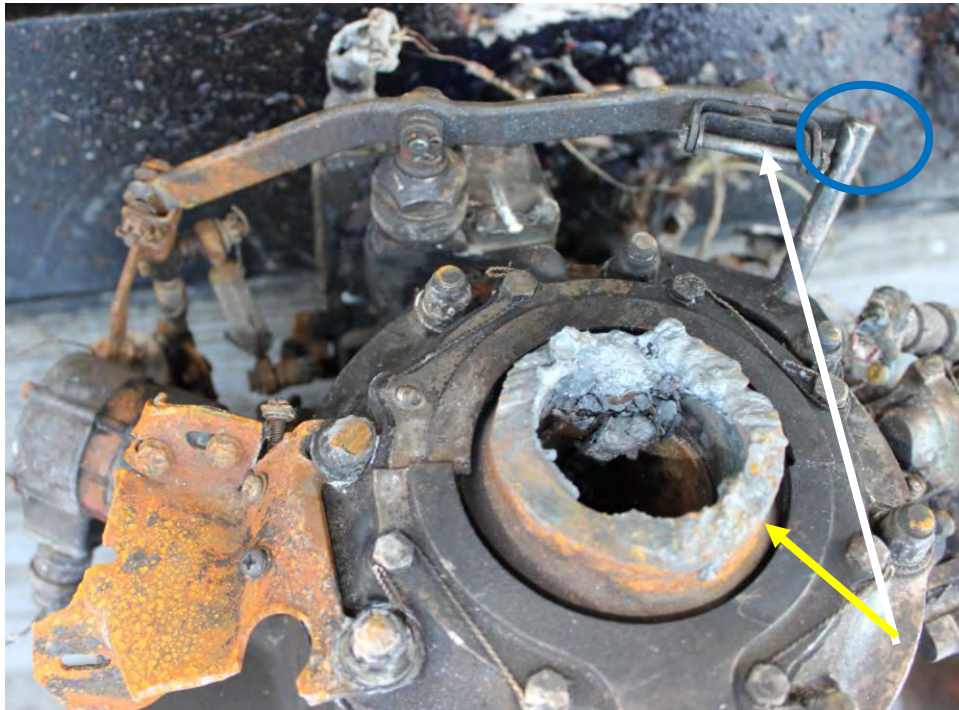
- 3.1 **External Condition:** The propeller shaft had been sectioned at the accident site to remove the propeller for examination (Ref. Photo No. 1). The propeller reversing lever was found above its respective guide pin that keeps the carbon block in the beta ring (Ref. Photos 1 to 3). There was a wear mark noted on the guide pin (Ref. Photo No. 2, red arrow). The four aircraft mounts were attached to their respective mount pads on the gas generator case but the rubber grommets were deteriorated from exposure to the post flight fire. The left hand exhaust stack was bent and the right hand exhaust stack and exhaust port flange were missing. The engine exhibited staining and some burnt regions from exposure to the post flight fire (Ref. Photos No. 4 to 7). The engine data plate showed the serial number was PC-E 32138 (Ref. Photo No. 8). The power section data plate showed the serial number was 32138 (Ref. Photo No. 9). Photo No. 10 shows an overview of the removed propeller.

Photo No. 1, The carbon block is missing (white arrow). The propeller reversing lever is above its respective guide pin (blue oval). Sectioned end of the propeller shaft (yellow arrow).

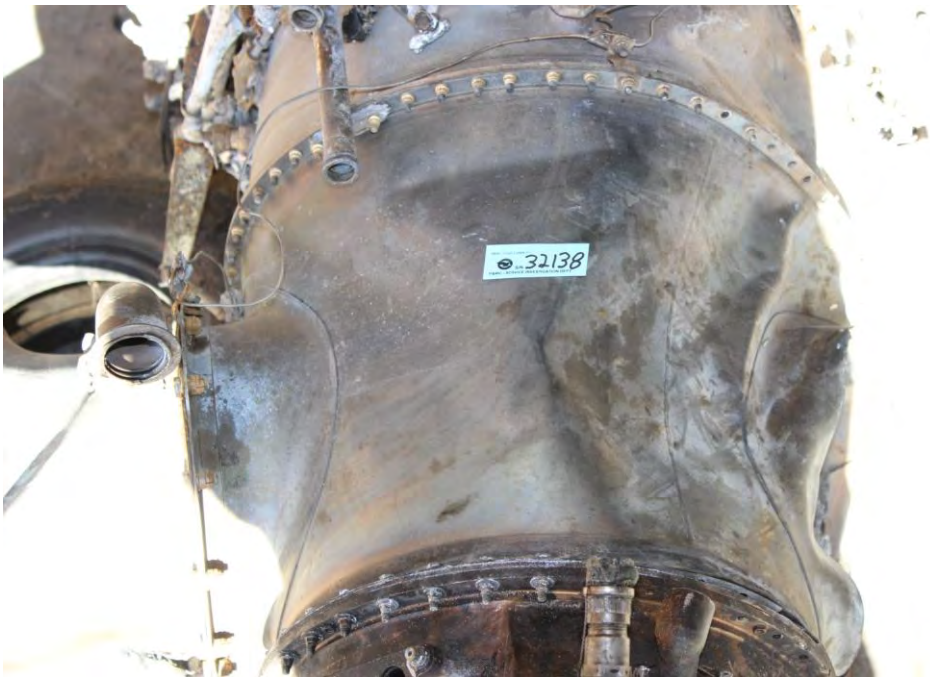
Photo No. 13

**Exhaust Duct:** The duct was bent and buckled mainly adjacent to the right exhaust port (Ref. Photo No. 13). The left exhaust stack was bent and buckled and the flange for the right hand exhaust stack was missing (Ref. Photos No. 14 & 15). Several of the exhaust duct to the gas generator mating flange bolts were missing (Ref. Photo No. 15, red oval).

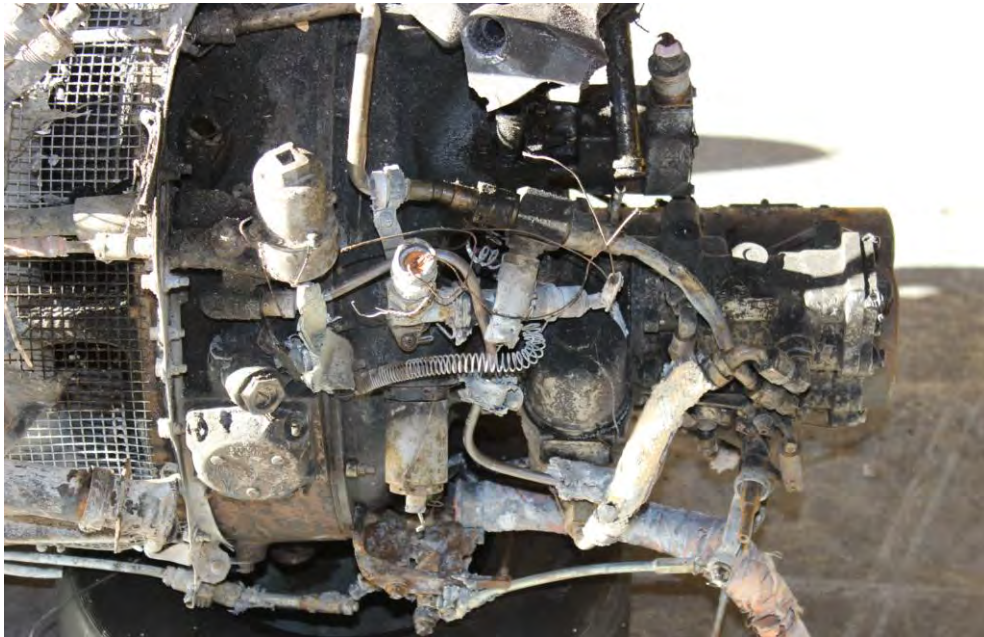
Photo No. 18

**Accessory Gearbox:** The exterior of the gearbox was blackened (Ref. Photos No. 18 & 19) and the inlet case exhibited some localized burning from exposure to the post flight fire (Ref. Photo No. 20).

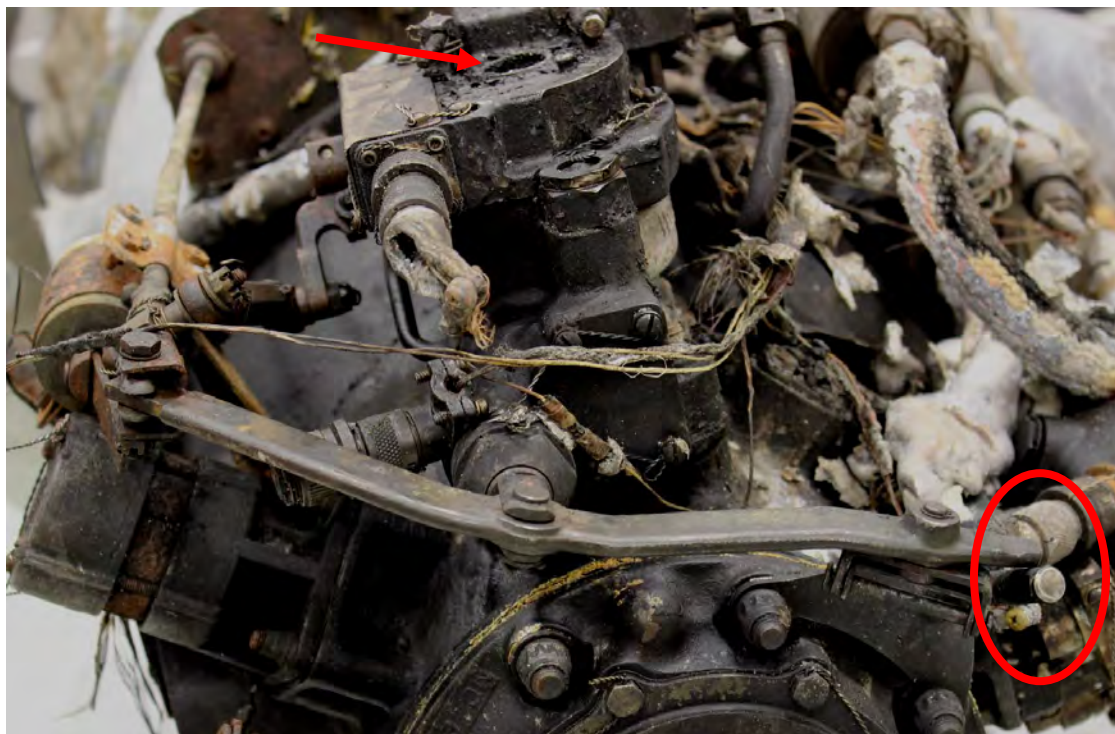
Photo No. 21

- 3.1.2 **Power Control and Reversing Linkage:** The propeller speed control actuating arm was missing from the propeller governor (Ref. Photo No. 21, red arrow). The front linkage was complete and secure (Ref. Photo No. 21). The propeller reversing lever was above the guide pin (Ref. Photo No. 21, red oval). The correct orientation for the guide pin and reversing lever is shown in Figure 1. The lever sustained some cutting damage during the sectioning of the propeller shaft. The guide pin and reversing lever were forwarded to P&WC Accessories Investigation and Material Laboratory for additional analysis.

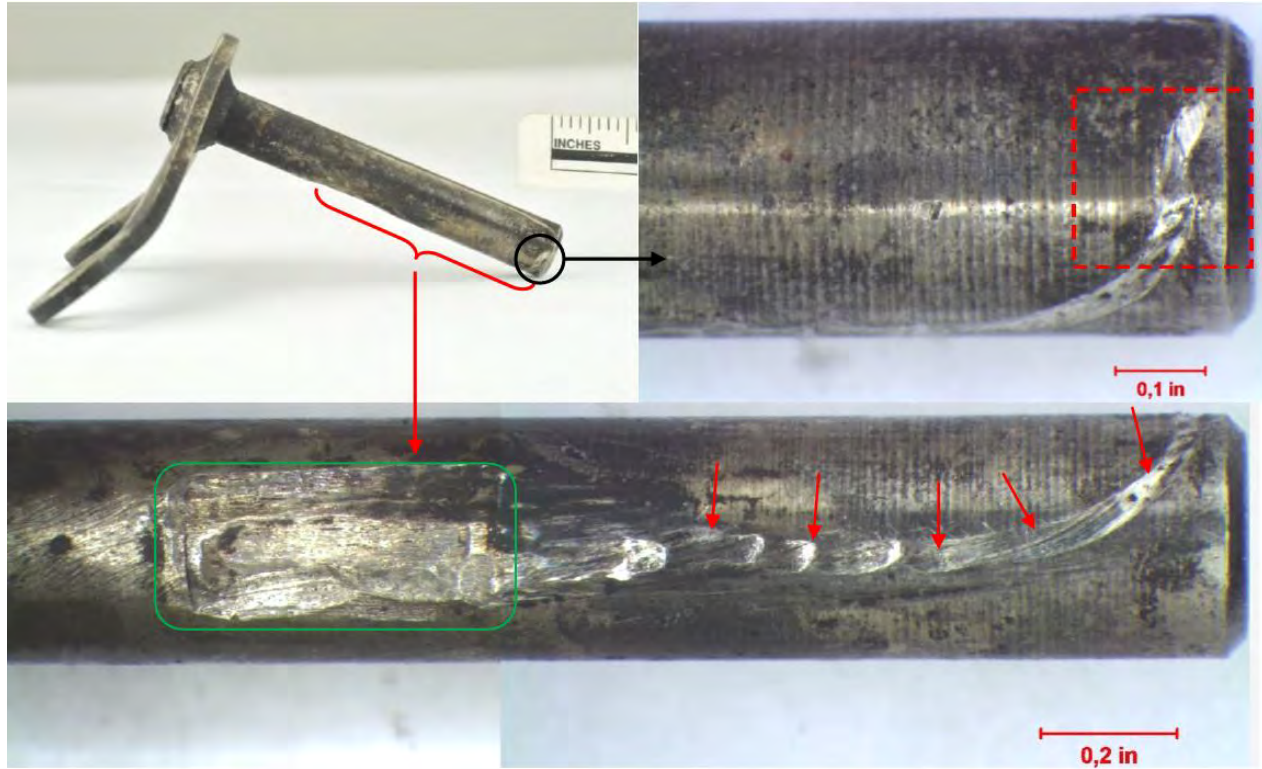
Photo No. 22 shows an overview of the propeller reversing lever and guide pin. The guide pin exhibited a shiny contact wear area indicating the propeller reversing lever had recently been properly seated against the underside of the pin (Ref. Photo No. 23, green rectangle). The width of the worn area corresponds to the width of the lever. An intermittent wear mark extending from the normal contact area to the forward tip of the pin indicating that the lever slid forcefully in a non-continuous manner from the underside of the pin across to its top side (Ref. Photo No. 23, red arrows). Scanning Electron Microscope (SEM)-Energy Dispersive X-Ray Spectrometry (EDS) analysis of debris recovered from the red dash outlined region in Photo No. 23 were Cadmium which suggest the debris originated from the Cadmium plated lever. A magnified view of the top side of the pin shows a continuous wear mark suggesting a continuous sliding movement (Ref. Photo No. 24, red arrows).

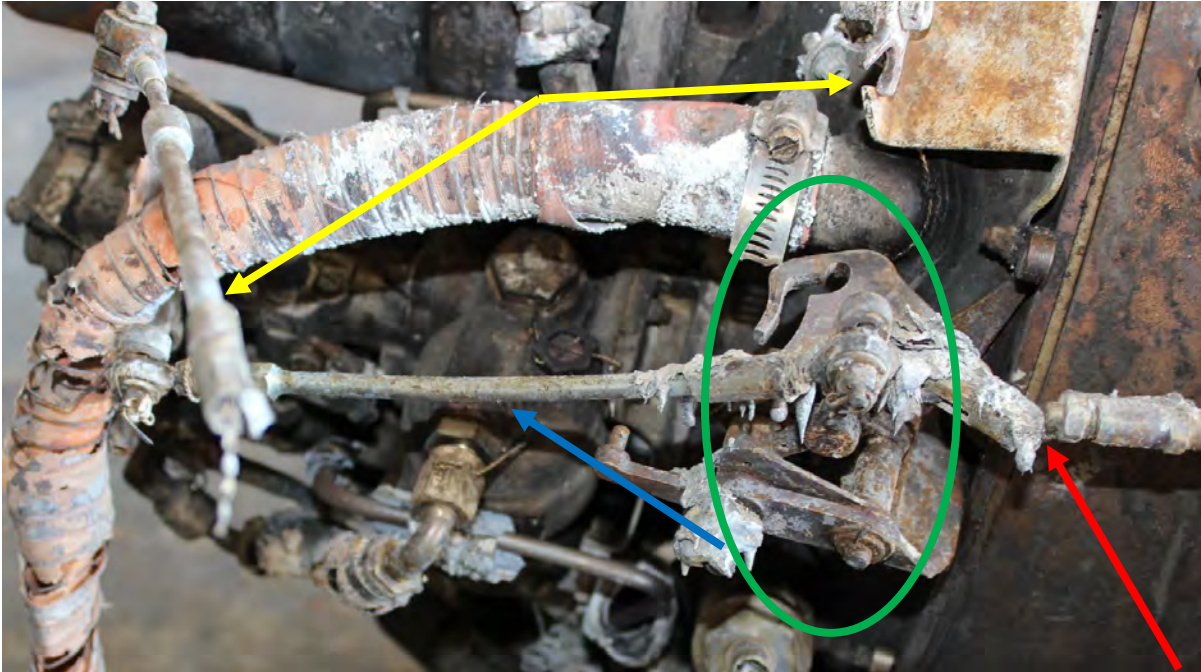
Photo No. 27

The wire rope casing was bent at several locations. The sleeve nut that connects to the clevis was fractured, adjacent to the CAM box (Ref. Photo No. 27, red arrow). The CAM box was fractured (Ref. Photo No. 27, green oval) and the connecting rod between the fuel control and the CAM box was bent (Ref. Photo No. 27, blue arrow). The aircraft cable to the fuel condition lever was connected but was pulled from its mounting bracket (Ref. Photo No. 27, yellow arrows). The CAM box input lever and airframe power lever cable were missing.

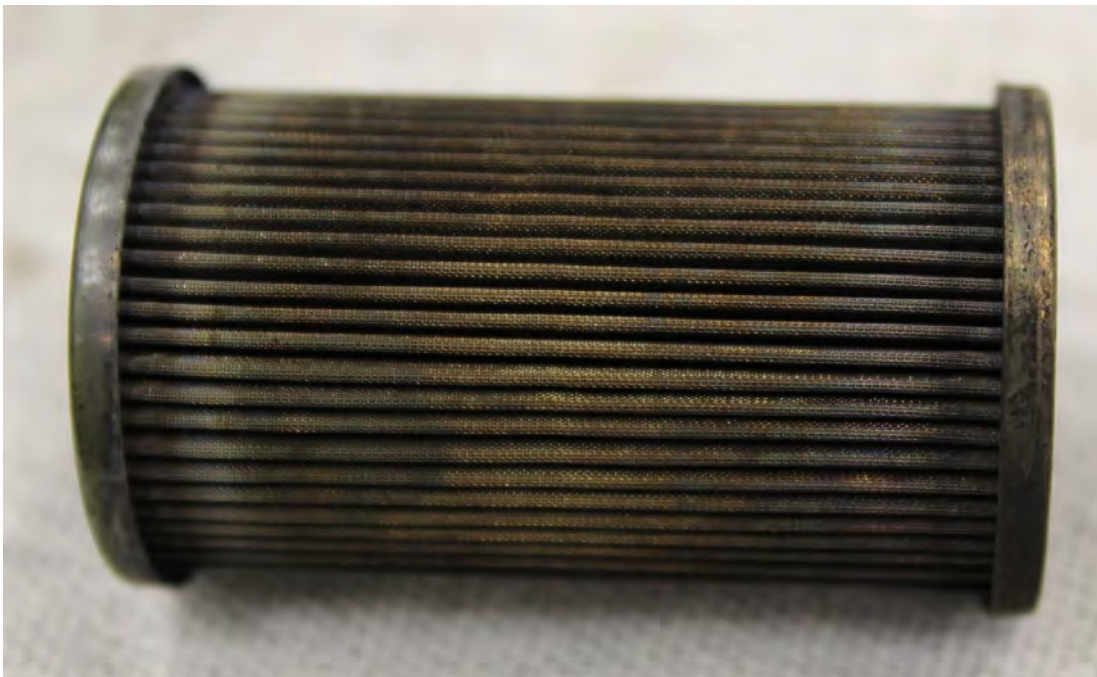
Photo No. 29

**Compressor Discharge Air (P3):** The tubes and filter housing were in place and secure. The thermal insulation was deteriorated from heat exposure from the post flight fire (Ref. Photo No. 28, red arrow). The P-3 air filter was discoloured, most likely due to heat exposure from the post flight fire (Ref. Photo No. 29).

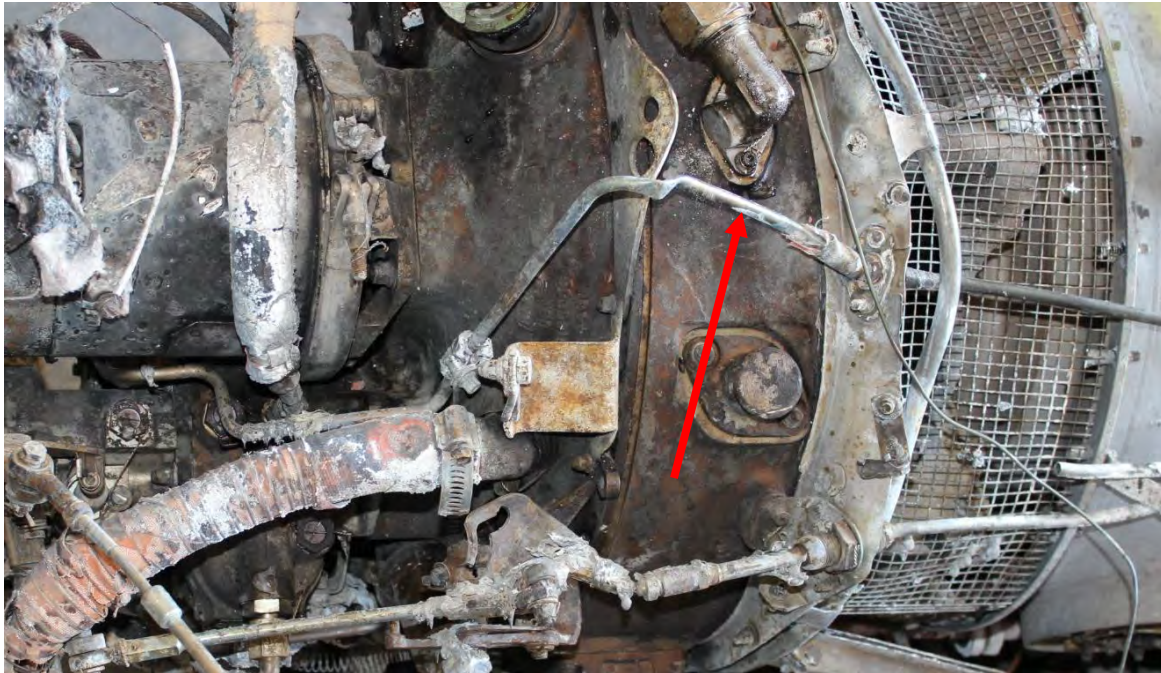
Photo No. 30

**Power Turbine Control (Py):** The line was in place and secure. The line was bent adjacent to the accessory gearbox and the inlet case (Ref. Photo No. 30, red arrow).

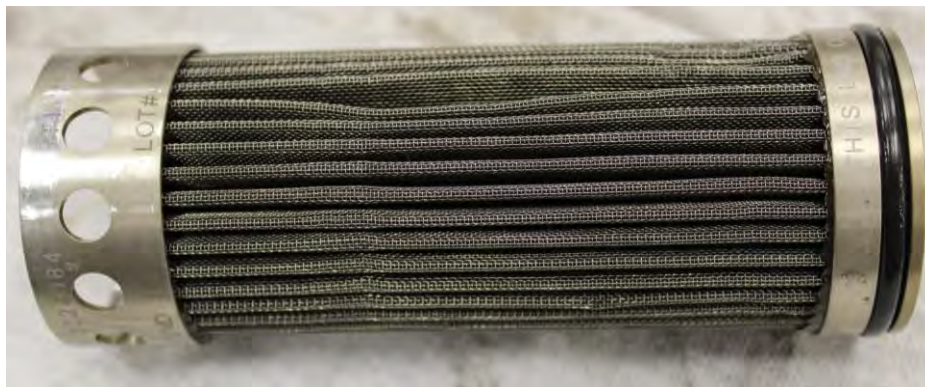
Photo No. 32

**Oil Filter:** The filter was clean but emitted an acrid smell (Ref. Photo No. 32).

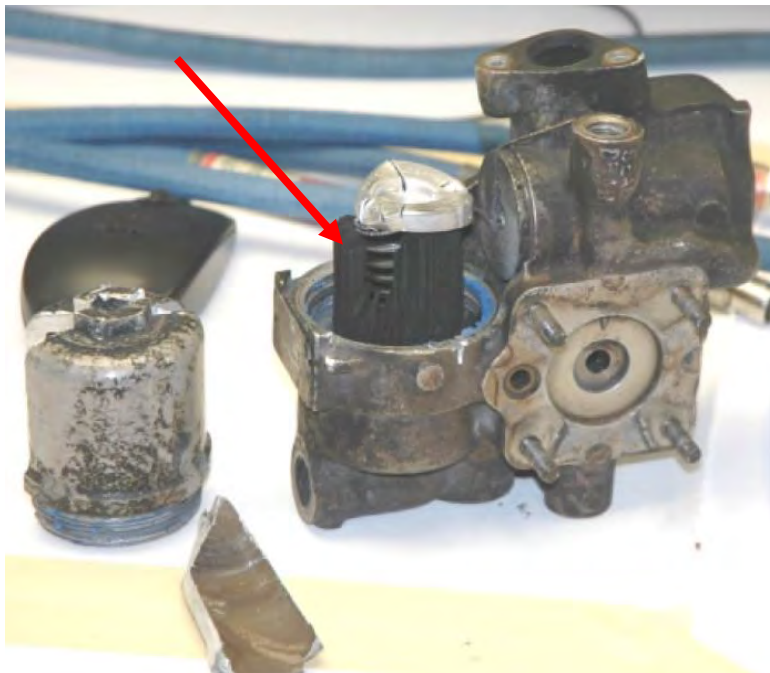
Photo No. 33

**Fuel Filter:** The filter was burned, blackened, and deteriorating due to heat exposure from the post flight fire (Ref. Photo No. 33, red arrow).

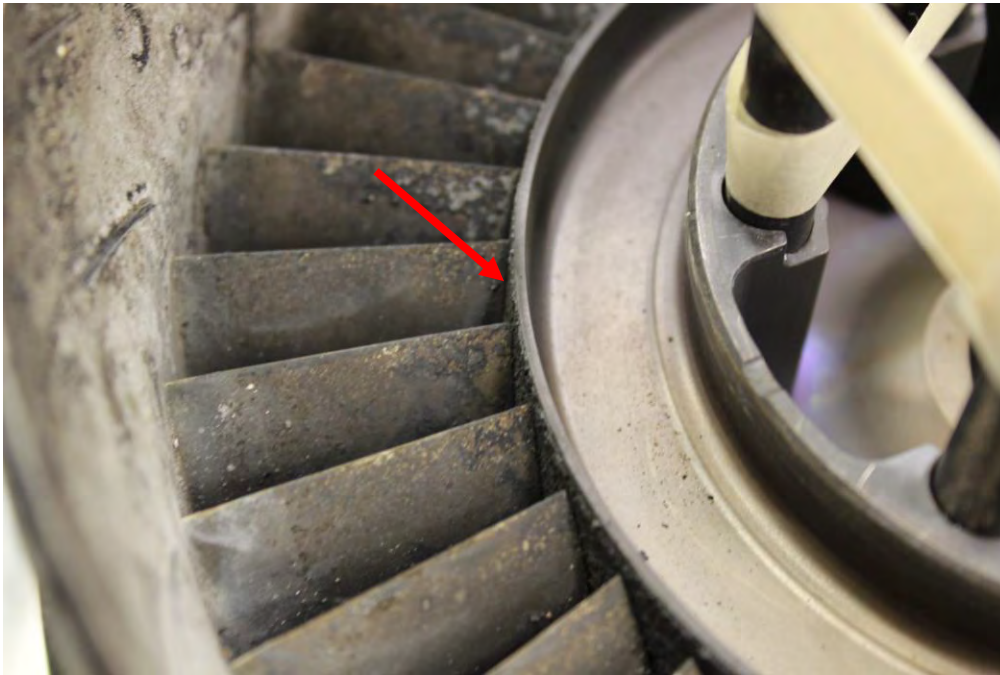
Photo No. 41

**Compressor 1<sup>st</sup>, 2<sup>nd</sup>, 3<sup>rd</sup>, and 4<sup>th</sup> Stage Spacers:** The gas path surface of the 1<sup>st</sup> stage spacer was coated with soot and debris (Ref. Photo No. 41, red arrow). The spacers were not removed for the purposes of this investigation.

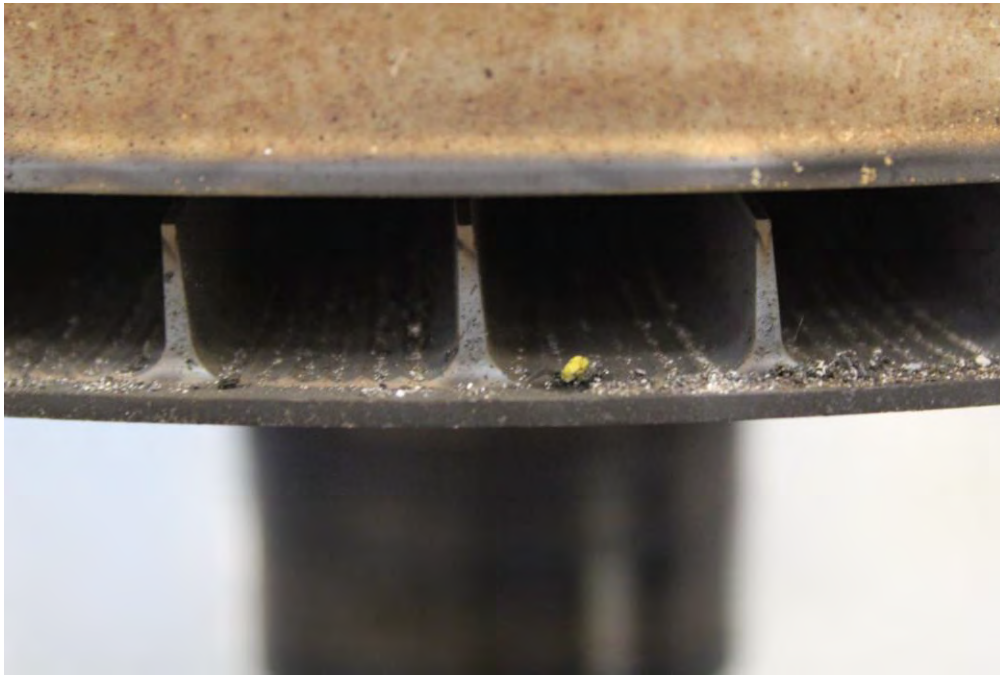
Photo No. 42

**Centrifugal Impeller:** Light debris was noted on the upstream side of the impeller (Ref. Photo No. 42). No distress was noted on the visible portions of the impeller. The impeller was not removed for the purposes of this investigation.

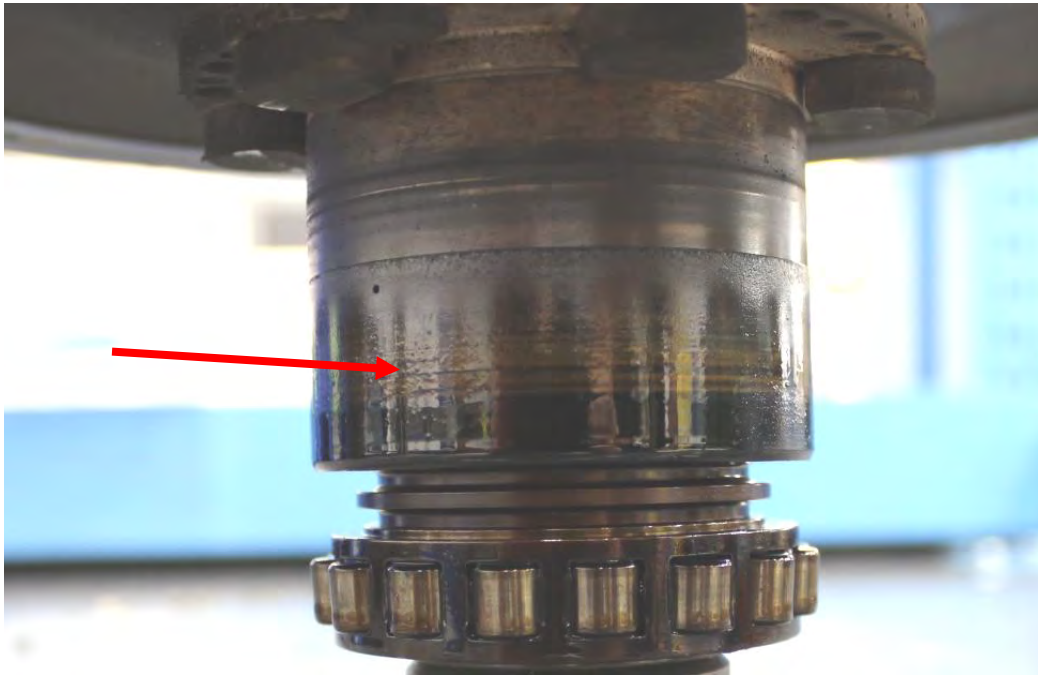
Photo No. 45

**No. 2 Bearing and Airseals:** The bearing was oil wetted and rotated freely. The airseals exhibited light rotation scoring (Ref. Photo No. 45, red arrow).

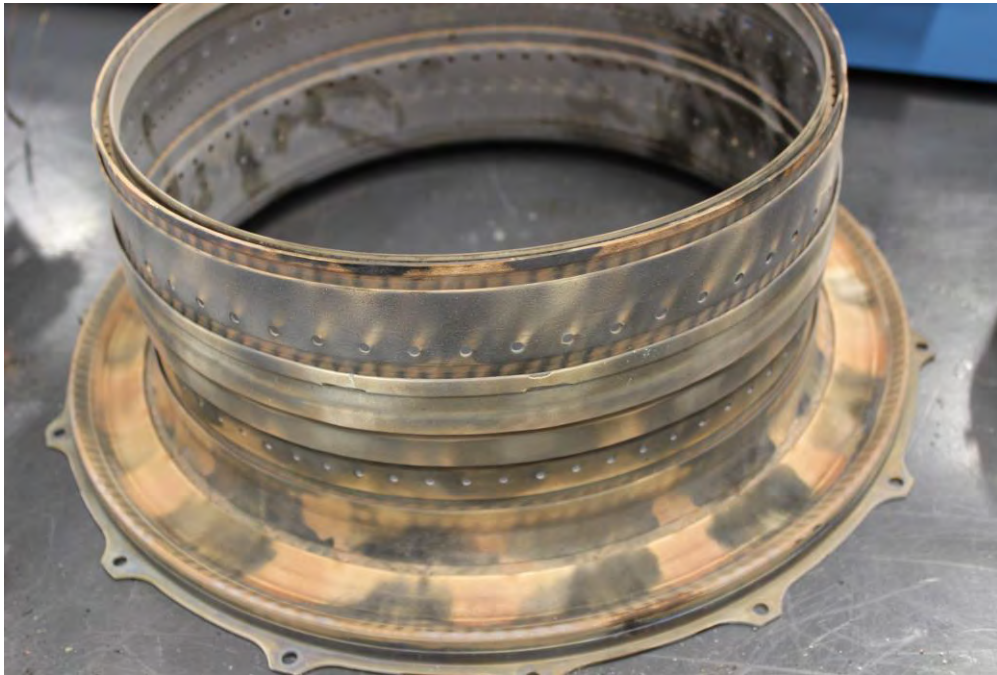
Photo No. 46

**Combustion Chamber Liner:** The liners exhibited some operational staining but did not exhibit any anomalies (Ref. Photo No. 46, inner liner & 47, outer liner). The outer liner was not removed for the purposes of this investigation.

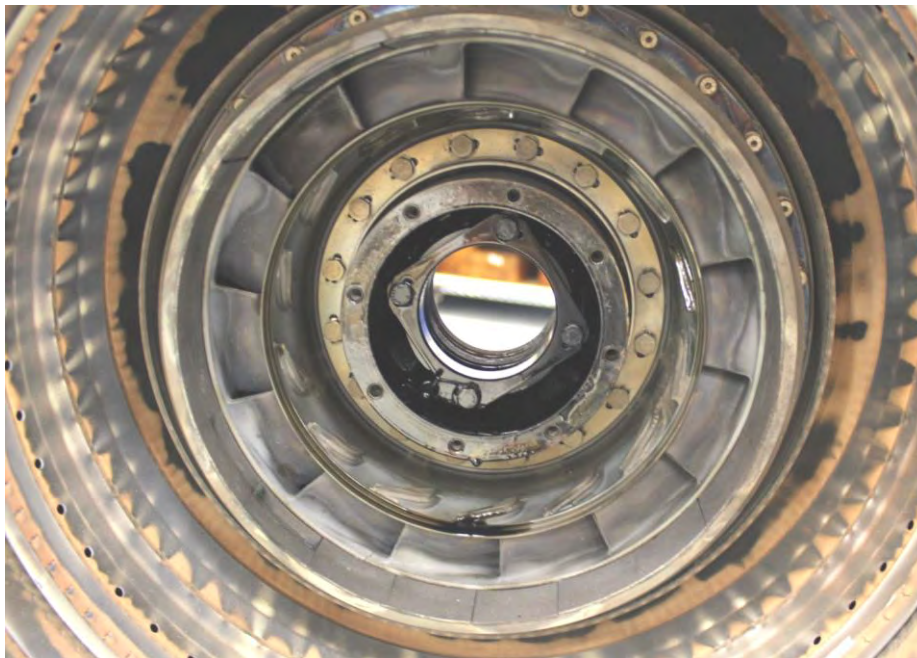
Photo No. 48, downstream side

**Compressor Turbine Guide Vane Ring:** The visible portion of the vane did not exhibit any distress but some staining was evident on the airfoils (Ref. Photos No. 48 & 49). The staining was most likely residue from incomplete fuel combustion.

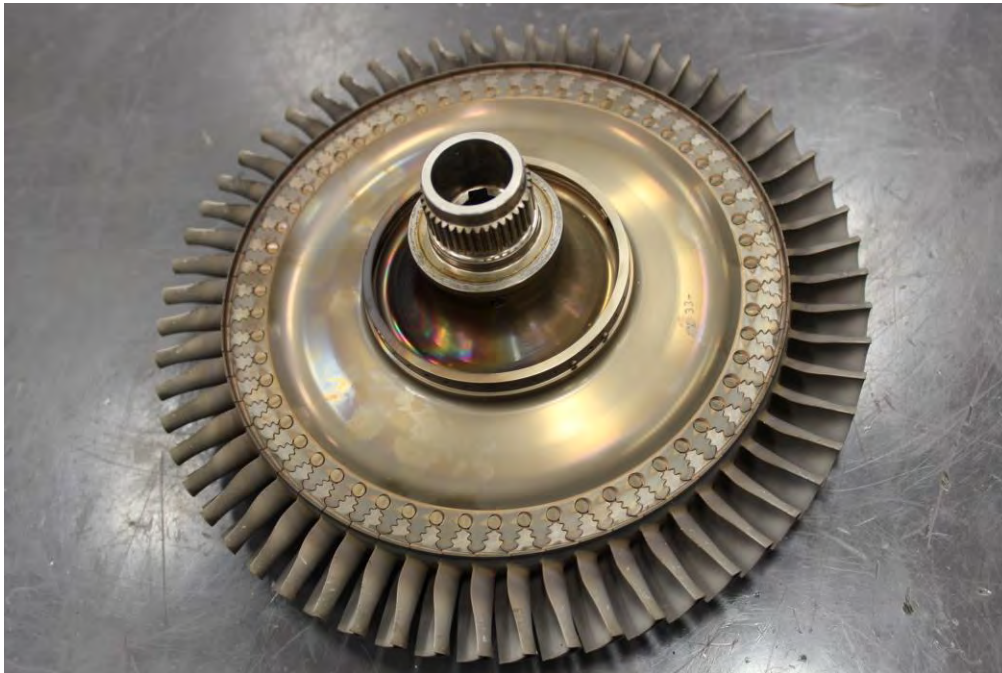
Photo No. 52, upstream side

**Compressor Turbine:** The upstream side of the disc exhibited a stained region from a post impact oil leak from the turbine air seals (Ref. Photo No. 52 & 53). Some staining was evident on the upstream side of the blades (Ref. Photo No. 54). Several of the rivet flares and blade root firtrrees exhibited rub marks on the downstream side from contact the 1<sup>st</sup> stage power turbine vane and baffle (Ref. Photo's No. 55 to 57, red ovals). Staining was also evident on the downstream side of the blades (Ref. Photo No. 58). The blade tips were rubbed from contact with the compressor turbine shroud (Ref. Photo No. 59).

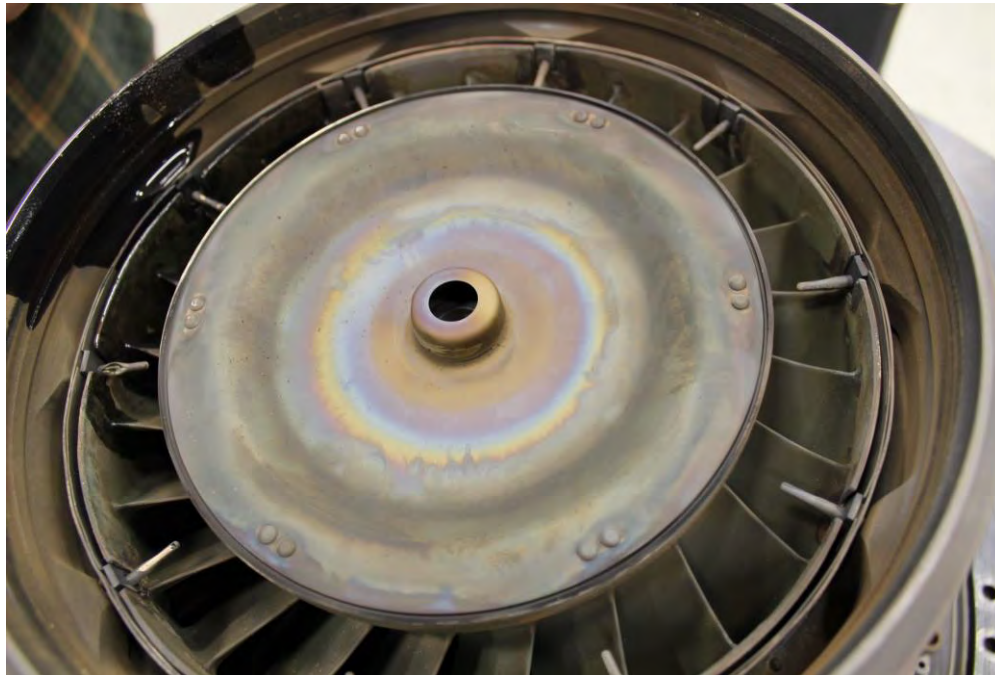
Photo No. 60

**ITT Probes, Busbar, and Harness:** All of the probes were in place and secure (Ref. Photo No. 60). One probe exhibited a burned region, most likely from operation (Ref. Photos No. 61, red arrow). The harness and busbar were in place and secure.

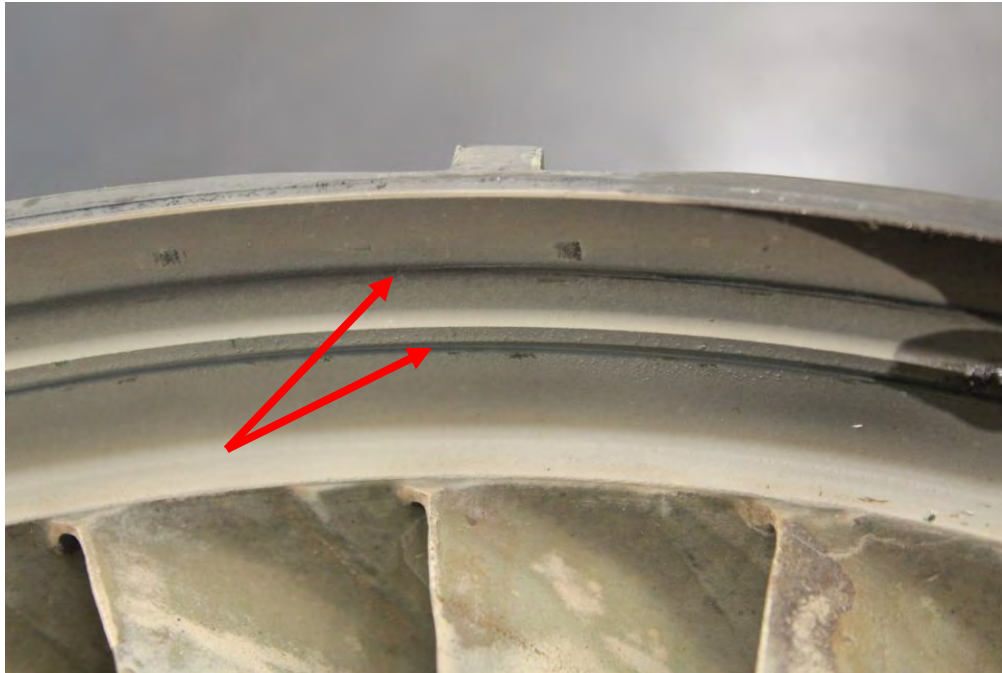
Photo No. 69

**1<sup>st</sup> Stage Power Turbine Shroud:** The 1<sup>st</sup> stage shroud exhibited rubs from contact with 1<sup>st</sup> stage power turbine blades (Ref. Photo No. 69, red arrows).

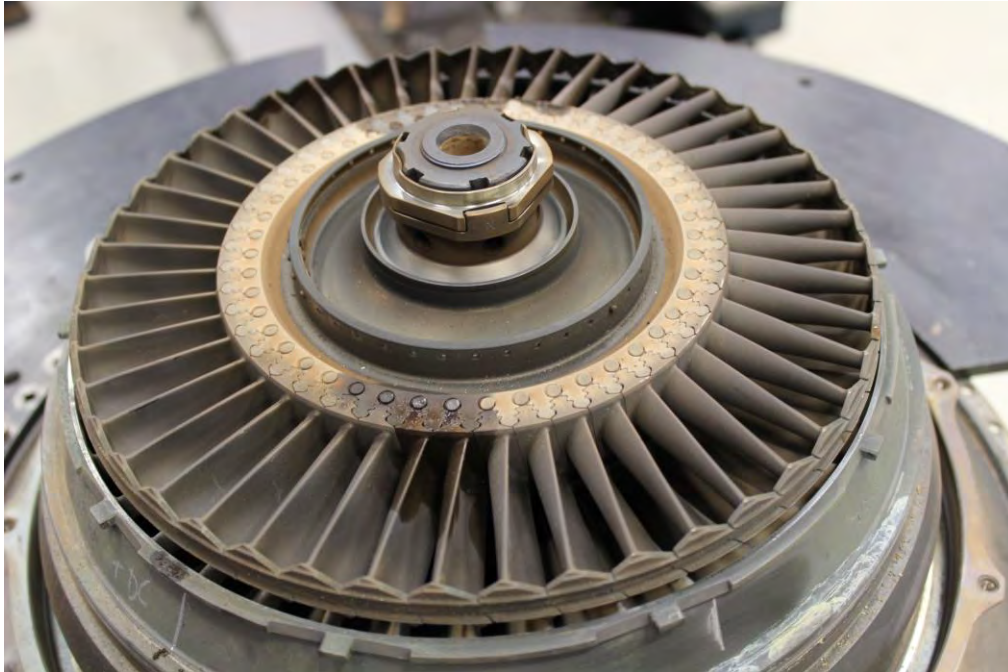
Photo No. 70, upstream side

**1<sup>st</sup> Stage Power Turbine:** The turbine was oil wetted in two regions, covered with soot and debris (Ref. Photos No. 70 & 72). A light rub was noted on upstream side of a few of the blade roots (Ref. Photo No. 71, red arrow). The blade tips exhibited rubs from contact with their respective shroud (Ref. Photo No. 73).

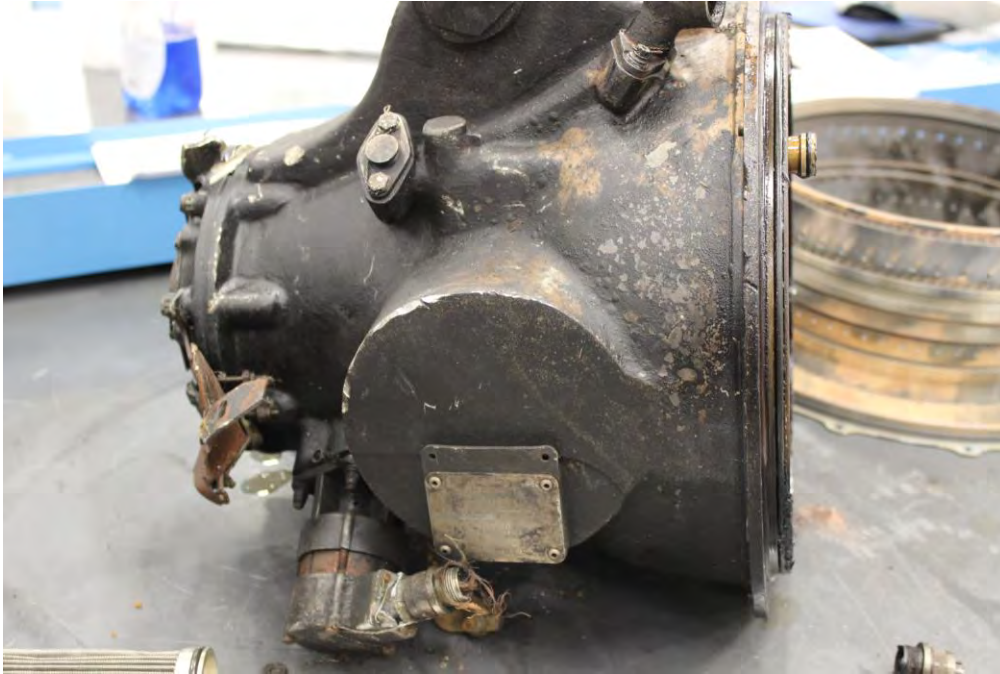
Photo No. 80

**Rear Housing:** The housing was coated with soot from exposure to the post flight fire (Ref. Photo No. 80). The rear reduction gearbox was not disassembled for the purposes of this investigation. The No. 6, No. 7, propeller shaft, and 2<sup>nd</sup> stage carrier were not capable of rotation in the gearbox housing. The visible section of the interior of the housing that was above the residual oil level was stained (Ref. Photo No. 82).

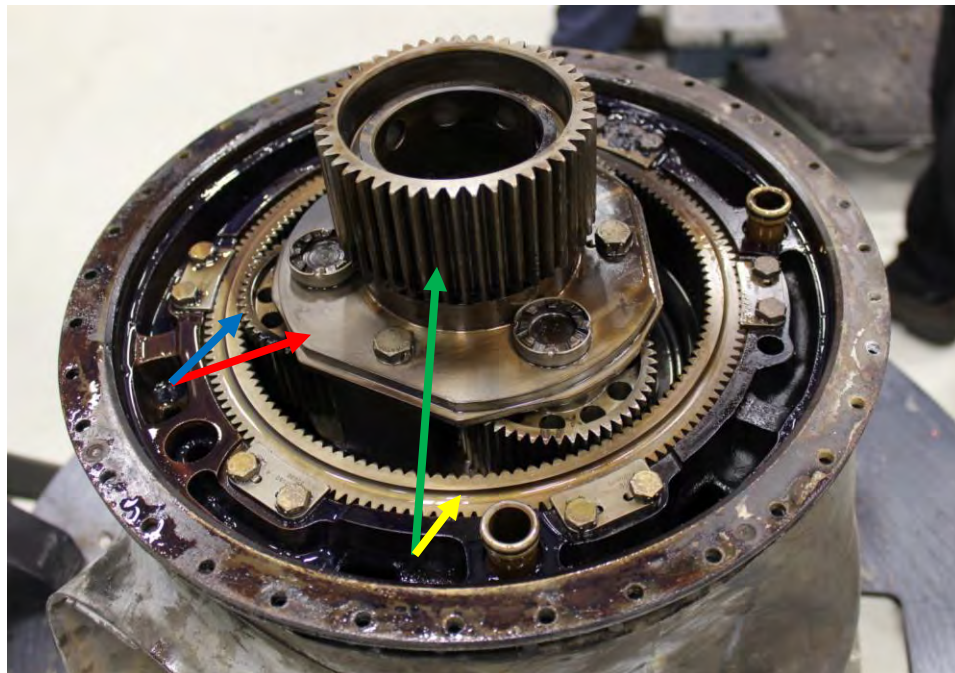
Photo No. 81

**1<sup>st</sup> Stage Planet Gear Carrier:** The visible portions of the carrier were in good condition (Ref. Photo No. 81, red arrow). Some staining was evident on the region of the carrier that was above the residual oil level in the gearbox. The staining is a residue from the heated residual oil during the post flight fire.

**1<sup>st</sup> Stage Planet Gears:** The visible portions of the gears were in good condition (Ref. Photo No. 81, blue arrow). The gears were capable of manual rotation with the ring gear.

**1<sup>st</sup> Stage Ring Gear:** The visible portion of the gear was in good condition (Ref. Photo No. 81, yellow arrow). Some staining was evident on the region of the gear that was above the residual oil level in the gearbox. The staining is a residue from the heated residual oil during the post flight fire.

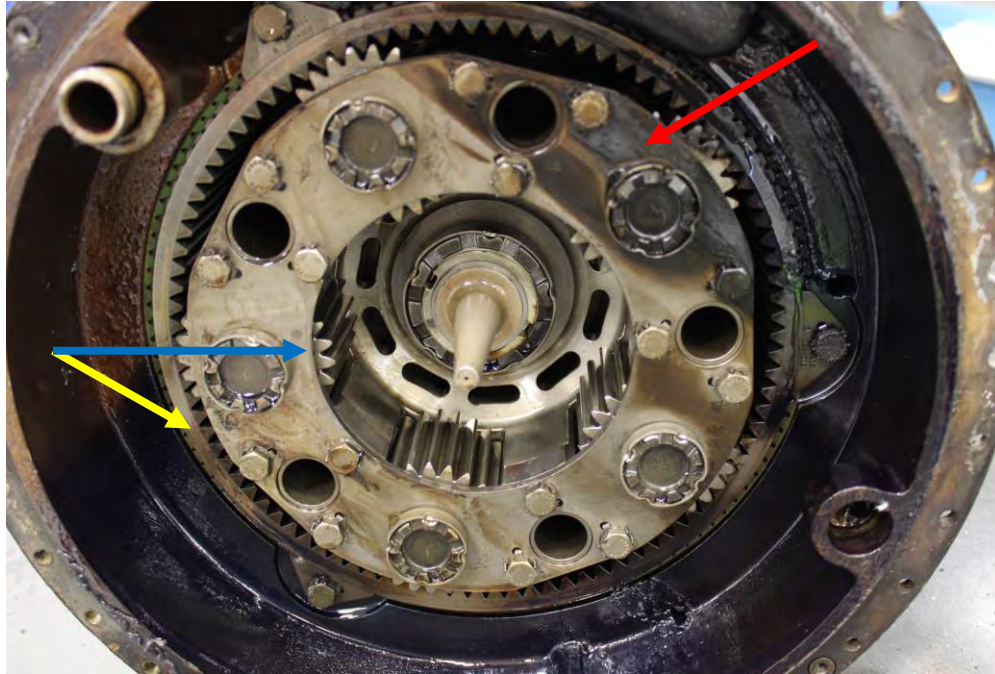
Photo No. 82

**2<sup>nd</sup> Stage Planet Gears:** The visible portions of the gears were in good condition (Ref. Photo No. 82, blue arrow). Staining was evident on the gears that were above the residual oil level in the gearbox. The staining is a residue from the heated residual oil during the post flight fire.

**2<sup>nd</sup> Stage Ring Gear:** The gear was not removed for the purposes of this investigation. The portion of the gear that was above the residual oil level in the gearbox exhibited staining (Ref. Photo No. 82, yellow arrow). The staining is a residue from the heated residual oil during the post flight fire.

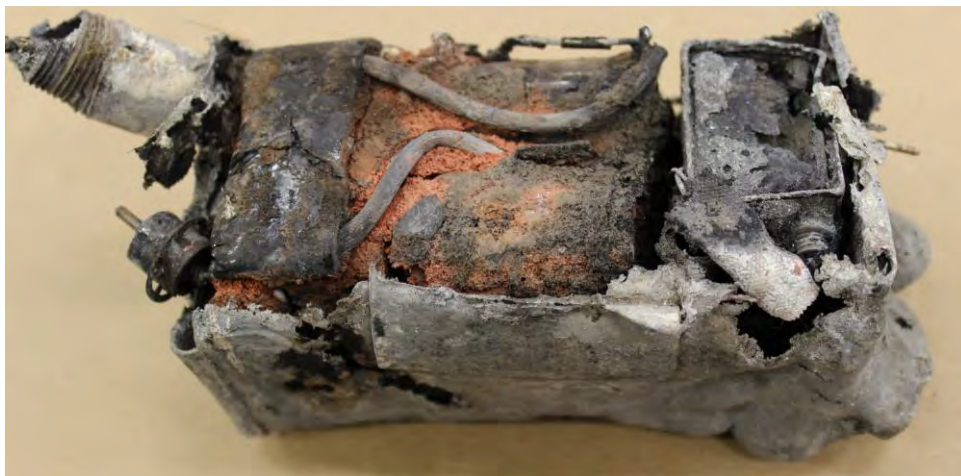
Photo No. 85

**Exciter Box:** The post flight fire had burnt the exterior of the box housing exposing the internal components (Ref. Photo No. 85).

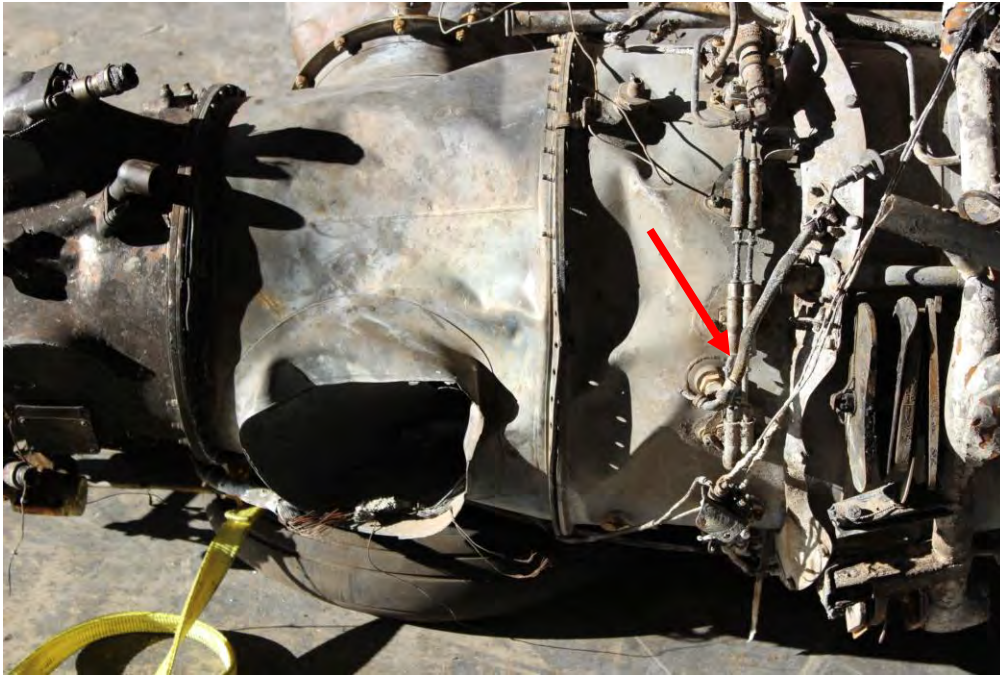
Photo No. 86

**Ignition Leads:** One of the leads was fractured at the connection to the ignition plug (Ref. Photo No. 86, red arrow). The leads were in place and attached to the ignition box and the other plug.

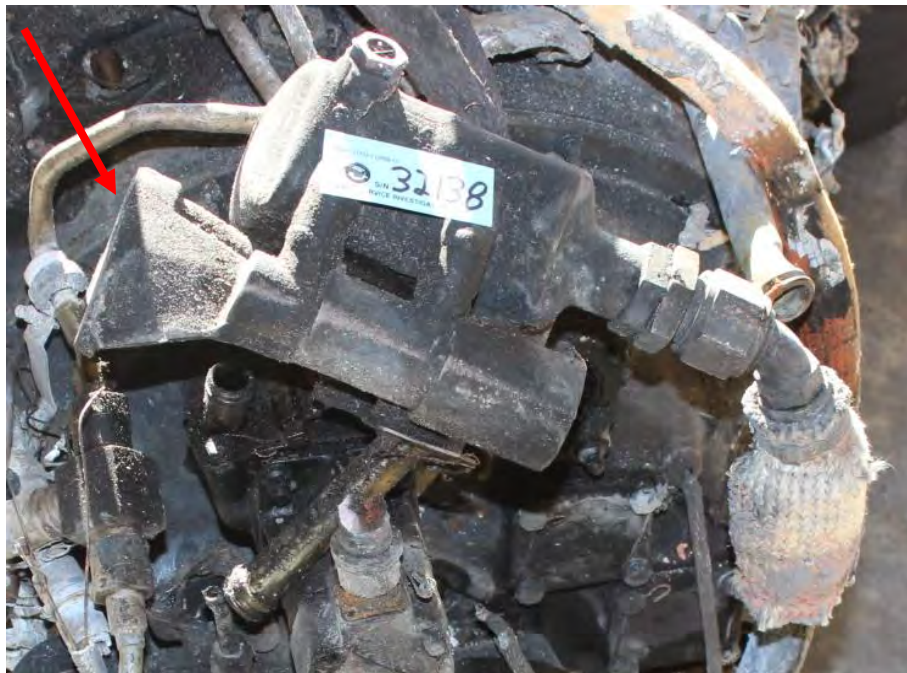
Photo No. 87

**Fuel Heater:** The heater mounting bracket to the accessory gear box was fractured (Ref. Photo No. 87, red arrow). The exterior of the heater was coated with soot.

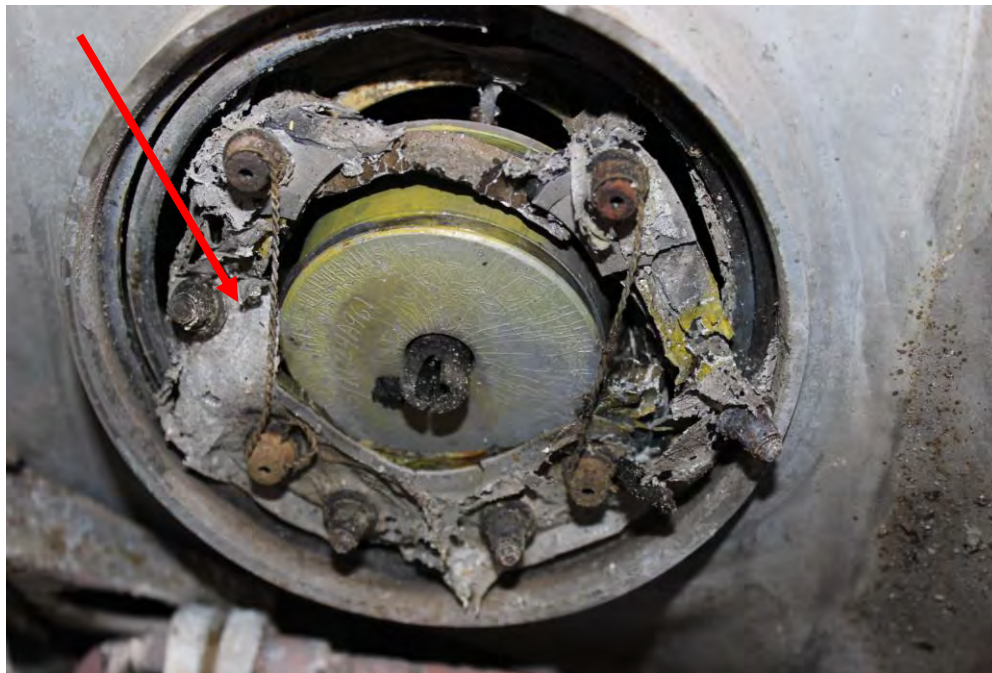
Photo No. 91

**Compressor Bleed Valve:** The majority of the bleed valve housing was melted and burnt (Ref. Photo No. 91, red arrow).

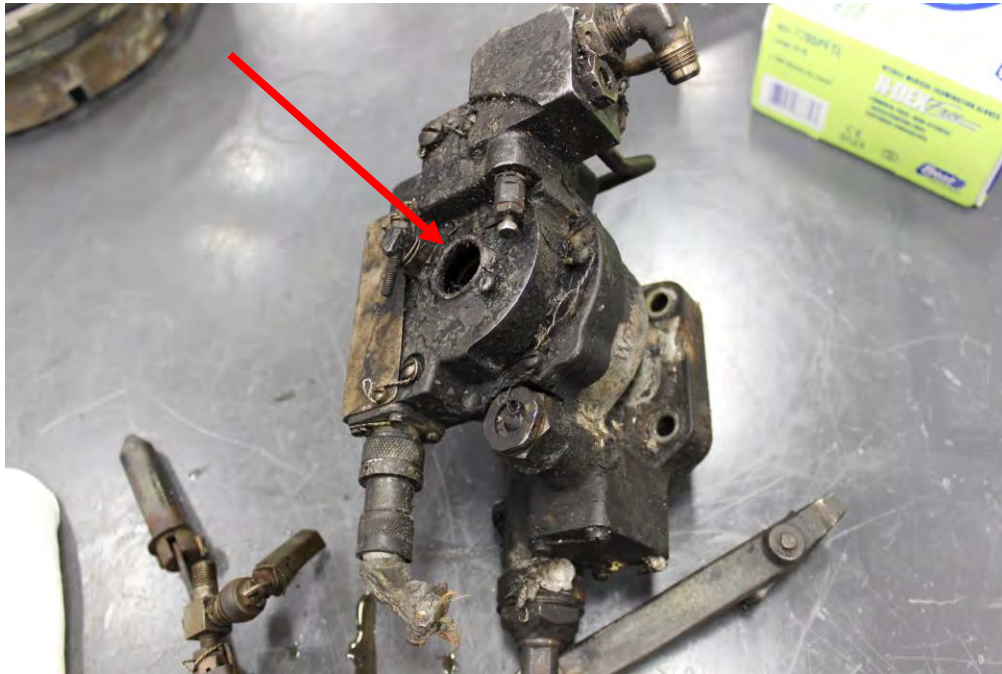
Photo No. 92

**Propeller Governor:** The governor was in place and secure. The propeller speed control lever was missing (Ref. Photo No. 92, red arrow). The exterior of the governor was discoloured from exposure to the post flight fire. The beta valve clevis sustained some cutting damage during the sectioning of the propeller shaft. The governor was forwarded to P&WC's Accessories Investigation for additional analysis. Due to the damage to the governor a functional test could not be performed. The governor was disassembled. The reset lever and the beta valve were stuck. The internal components of the governor section were covered with burnt oil. The pump gears and housing appeared normal. There were no defects or damage evident that would have prevented normal operation of the governor prior to the event.

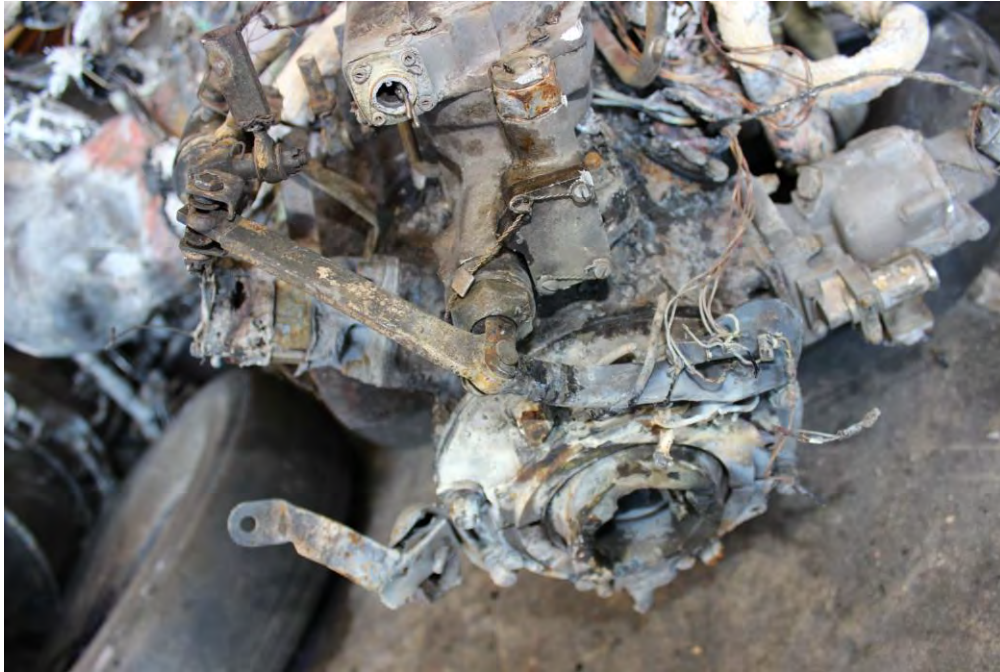
- 5.1 **External Condition:** The propeller shaft had been sectioned at the accident site to remove the propeller for examination (Ref. Photo No. 94). The four aircraft mounts were attached to their respective mount pads on the gas generator case. Both of the exhaust stacks were bent and buckled. The right hand exhaust port was filled with dirt. The engine exhibited staining and some burnt regions from exposure to the post flight fire (Ref. Photos No. 95 to 97). The engine data plate showed the serial number was PC-E 32040 (Ref. Photo No. 98). The power section data plate showed the serial number was 32065 (Ref. Photo No. 99). Photos No. 100 and 101 show an overview of the removed propeller with chain link fencing from the accident site adhered to the mating flange of the propeller shaft.

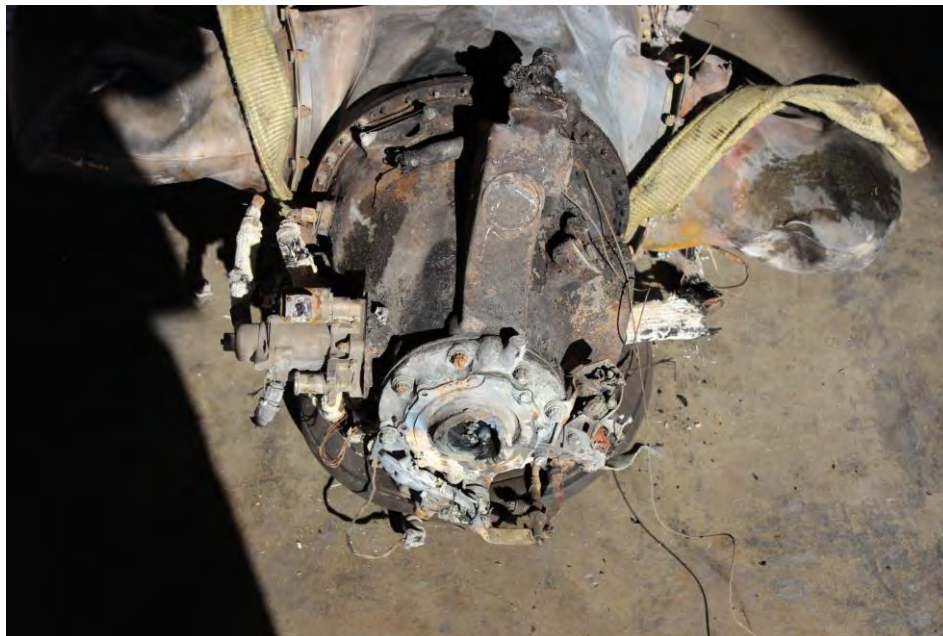
Photo No. 102

**Reduction Gearbox:** The exterior of the front reduction gearbox housing was discoloured from exposure to the post flight fire. (Ref. Photo No. 102). The scavenge and the pressure oil tube adapters were missing.
