**Accident / Incident Report**

**Report No.: 15-012**

**Brinks Inc.  
Beech 1900C, Aircraft Reg. No. YV1674  
Miami, Florida, USA  
February 11, 2015  
PT6A-65B  
L/H S/N 32138  
R/H S/N G/G 32040 P/S 32065**

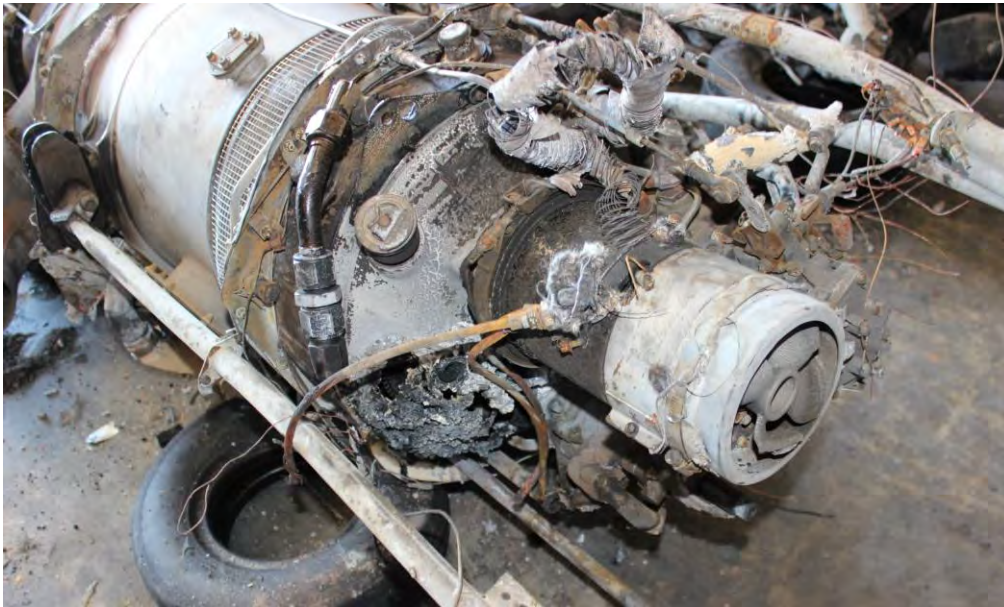
Photo No. 105

**Accessory Gearbox:** The paint on the gearbox was burnt off and the housing exhibited a burnt through area adjacent to a spur gear from exposure to the post flight fire (Ref. Photos No. 105 & 106).

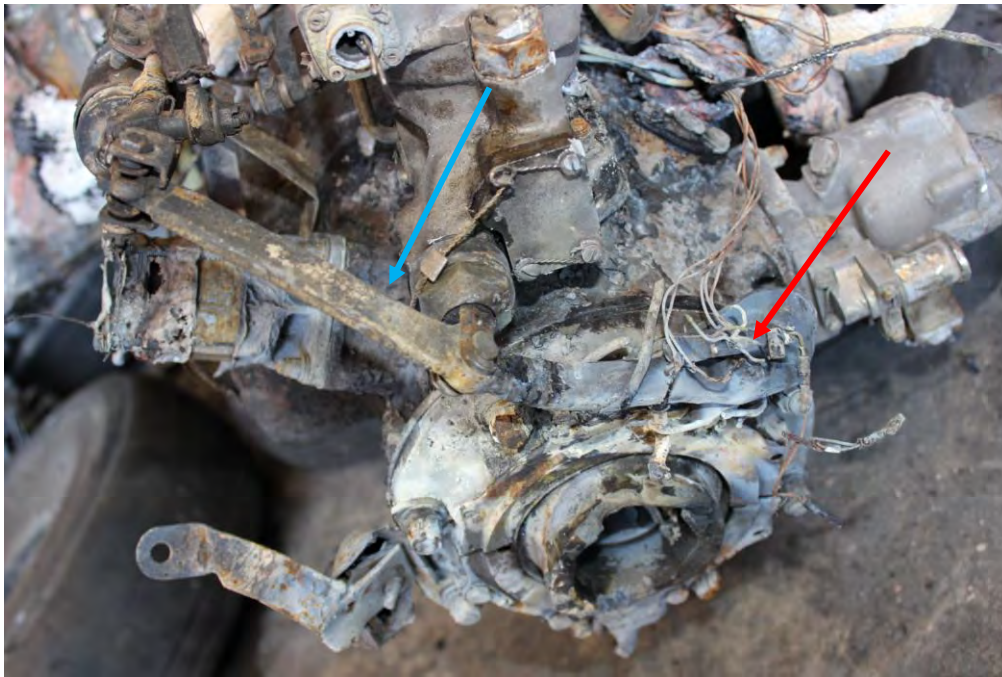
Photo No. 107

**5.1.2 Power Control and Reversing Linkage:** The propeller reversing lever guide pin was in place and bent (Ref. Photo No. 107, red arrow). The pin sustained some damage during the sectioning of the propeller shaft. The propeller reversing lever was bent but was in place and secure (Ref. Photo No. 107, blue arrow). The lever sustained some cutting damage during the sectioning of the propeller shaft. The propeller speed control lever was missing from the governor (Ref. Photo No. 108, blue arrow). The reset interconnect rod was in place and secure but was uncoupled at the slip joint (Ref. Photo No. 108, red arrows). The linkage was complete and secure from the propeller reversing lever connection to the CAM box connection. The CAM box was in place and all of the engine connections were in place and secure (Ref. Photo No. 109). The CAM box input lever and airframe power lever cable were missing. The interconnect rod between the CAM box and the fuel control unit (FCU) was in place and secure (Ref. Photo No. 109). The arm and connection hardware to the FCU was bent. The aircraft cable to the fuel condition lever was in place and connected (Ref. Photo No. 110, red arrow). The cable was severed adjacent to its respective mount connected to the accessory gearbox flange.

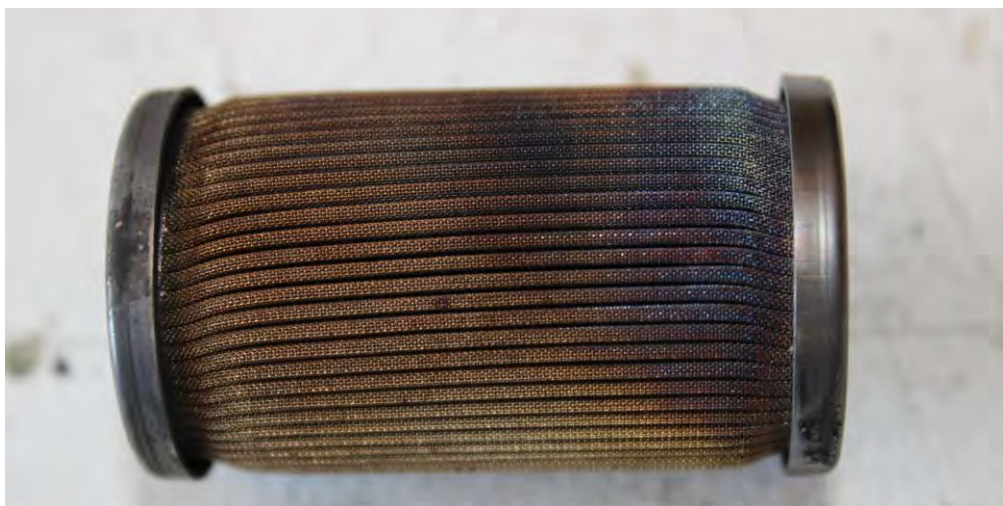
Photo No. 111

**Compressor Discharge Air (P3):** The tube from the gas generator case to the filter housing was in place and secure. The tube from the filter housing to the FCU was in place and secure. The tubes exhibited a loss of their external insulation from exposure to the post flight fire. The P-3 filter was removed. The filter exhibited some discoloration and staining from exposure to the post flight fire (Photo No. 111).

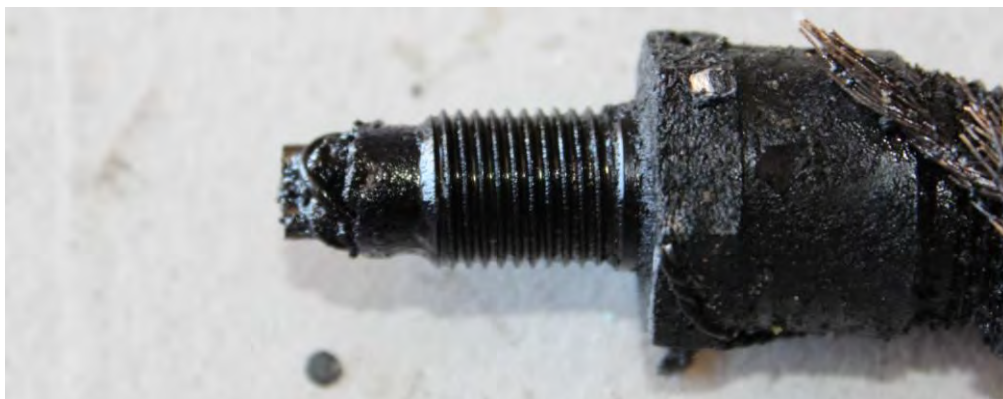
Photo No. 112

**Reduction Gearbox Chip Detector:** The chip detector was in place and secure. The detector was removed. Some carbon debris was noted on the magnetic poles. The rubber insulation around the poles was thermally expanded due to heat exposure from the post flight fire (Ref. Photo No. 112).

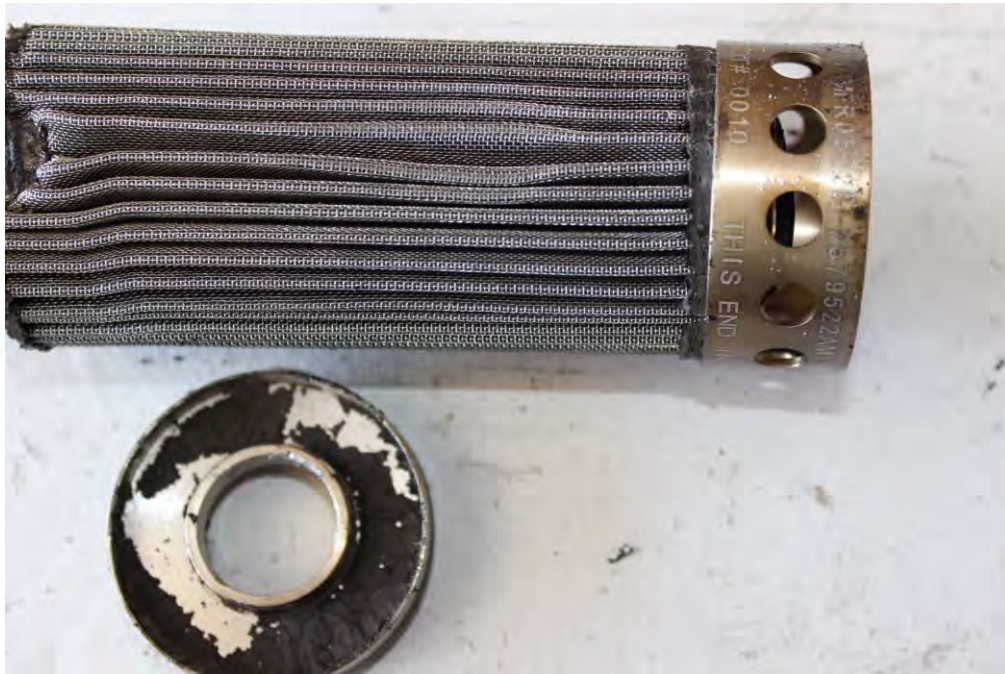
Photo No. 113

**Oil Filter:** The filter element exhibited no apparent contamination (Ref. Photo No. 113). The ends of the filter were loose due to heat exposure from the post flight fire affecting the adhesion compound. Partially solidified oil was adhered to the oil filter housing cover (Ref. Photo No. 114).

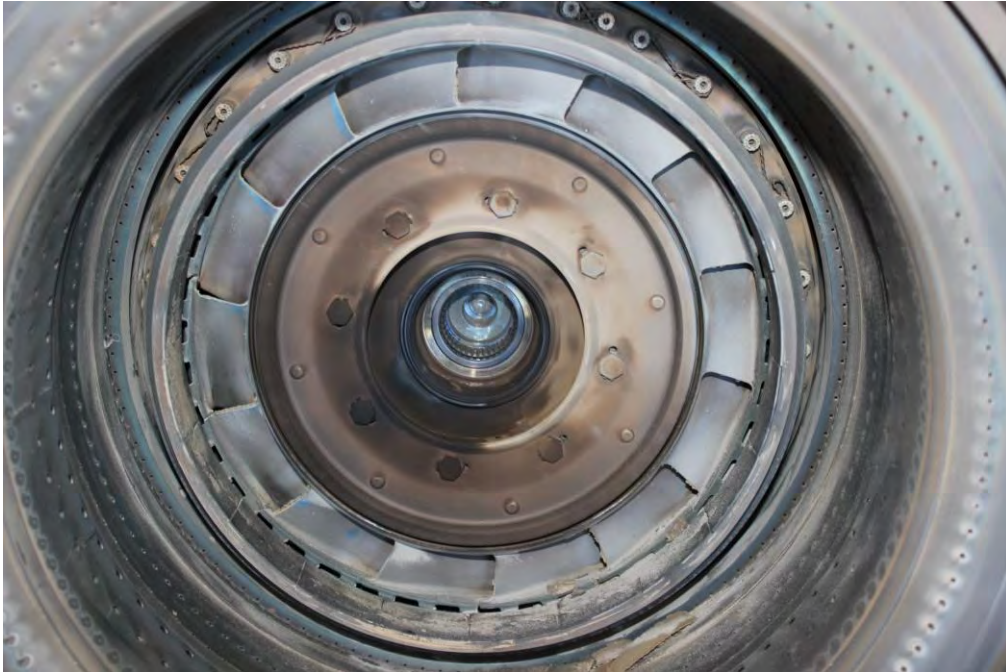
Photo No. 115

**Compressor Turbine Guide Vane Ring:** The downstream side of the vane airfoils were in good condition (Ref. Photo No. 115). The outer wall of the vane was cracked adjacent to the trailing edge of most of the airfoils (Ref. Photo No. 116, red arrows).

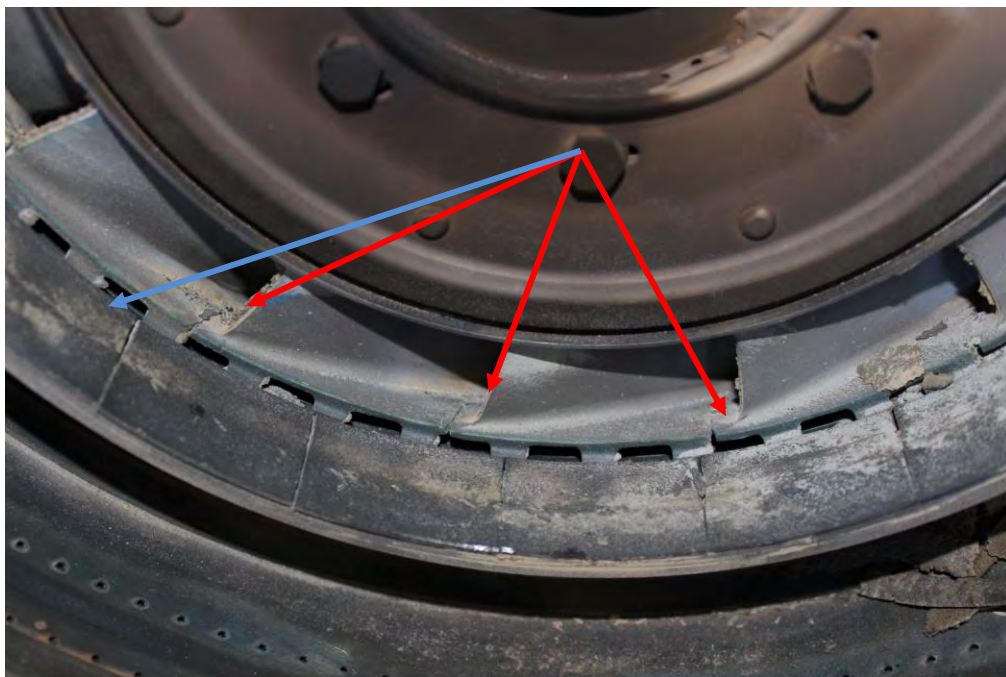
Photo No. 116

**Compressor Turbine Shroud:** The shroud was in good condition (Ref. Photo No. 116, blue arrow). Some debris that appeared to be partially melted sand had built up on the shroud (Ref. Photo No. 116).

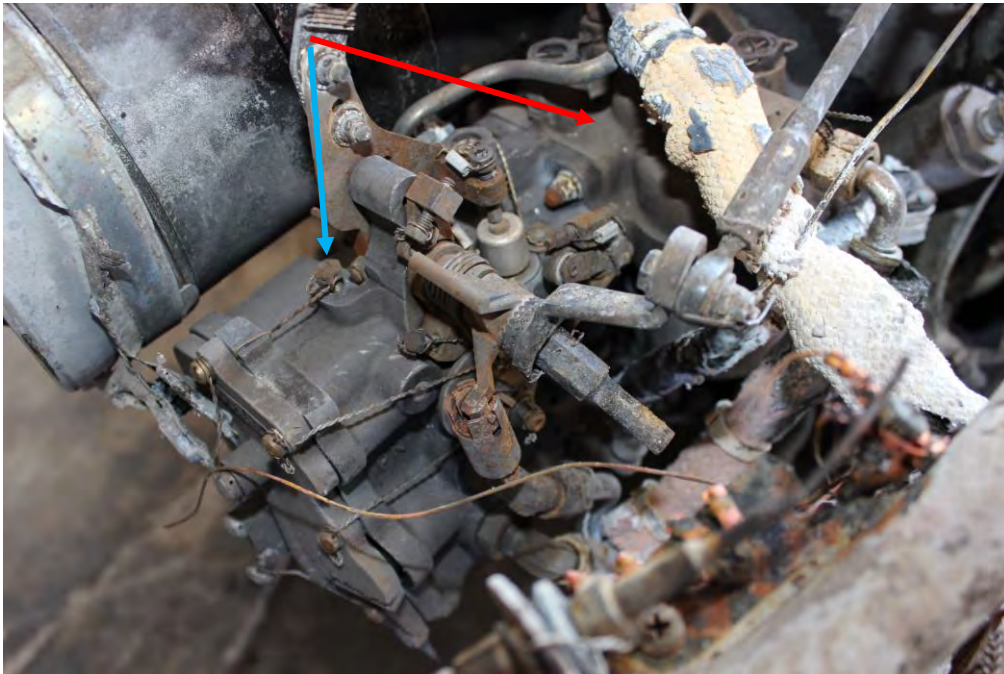
Photo No. 135

**Fuel Control Unit:** The unit was in place and secure. The rear cover exhibited heat distress from exposure to the post flight fire (Ref. Photo No. 135, blue arrow).

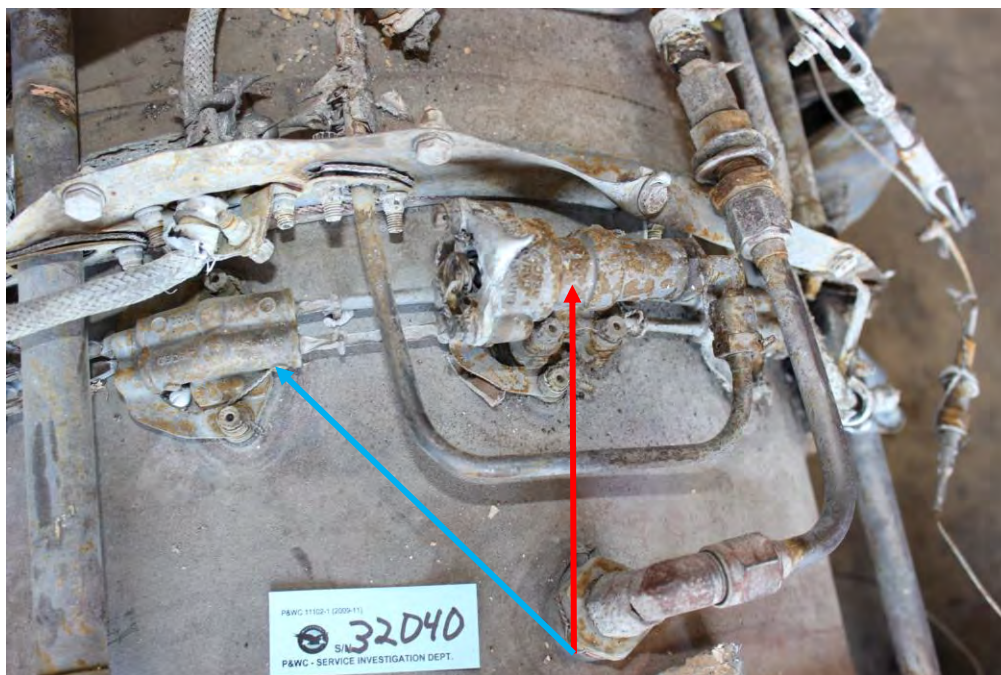
Photo No. 136

**Flow Divider:** The divider was in place and secure. The divider was burned and discoloured from exposure to the post flight fire (Ref. Photo No. 136, red arrow).

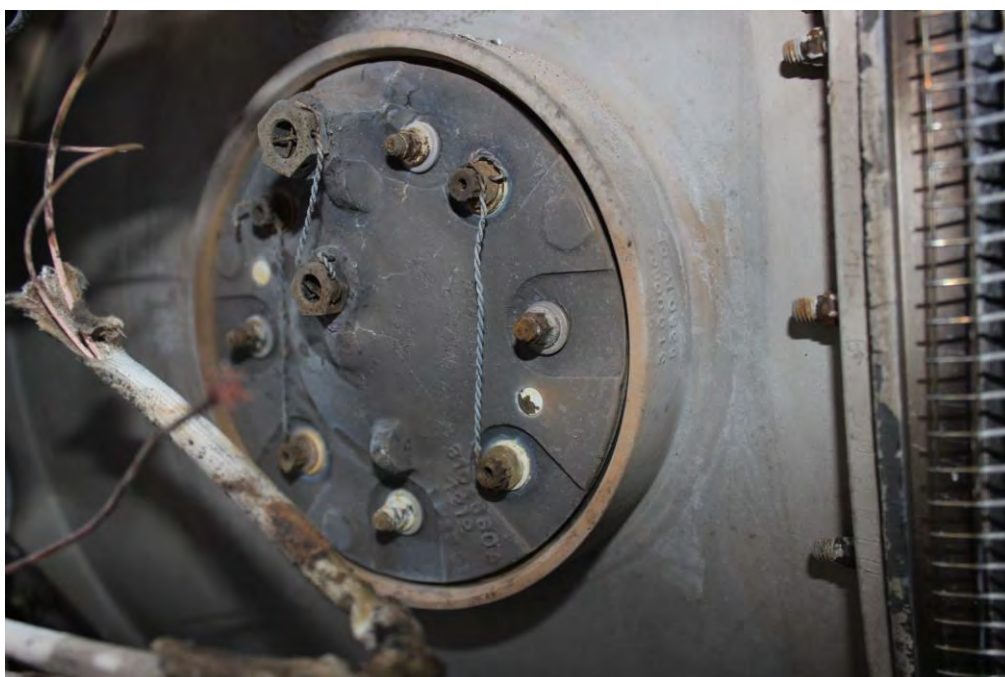
Photo No. 137

**Compressor Bleed Valve:** The valve was in place and secure. The valve was discoloured from exposure to the post flight fire (Ref. Photo No. 137).

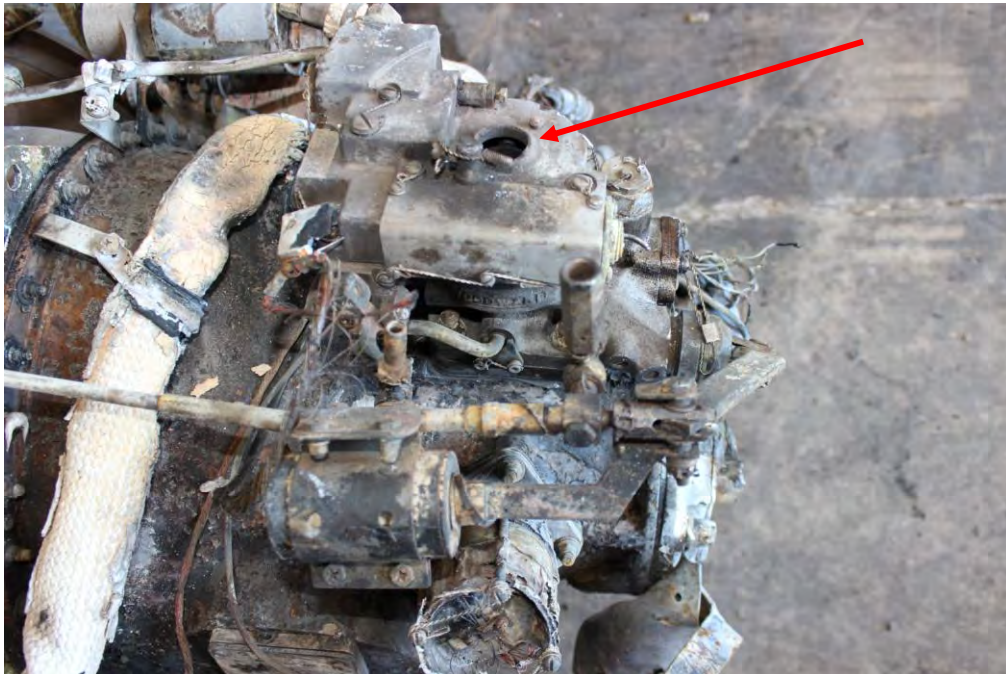
Photo No. 138

**Propeller Governor:** The governor was in place and secure. The governor was discoloured from exposure to the post flight fire. The propeller speed control lever was missing from the governor (Ref. Photo No. 138, red arrow).

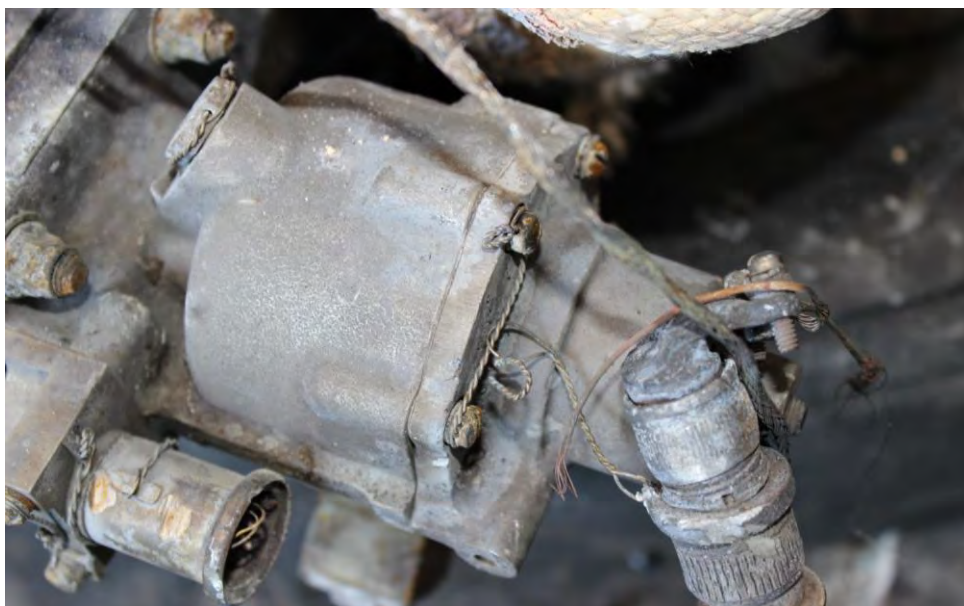
Photo No. 139

**Overspeed Governor:** The governor was in place and secure. The electrical connection was fractured. The governor was discoloured from exposure to the post flight fire (Ref. Photo No. 139).
