**HARTZELL PROPELLER INC.**

**Aircraft Accident/Incident Report No.: 150211**  
**Revision 1 – 5/3/16**

**Aircraft:** Beech 1900C

**PROPELLER TEARDOWN REPORT**

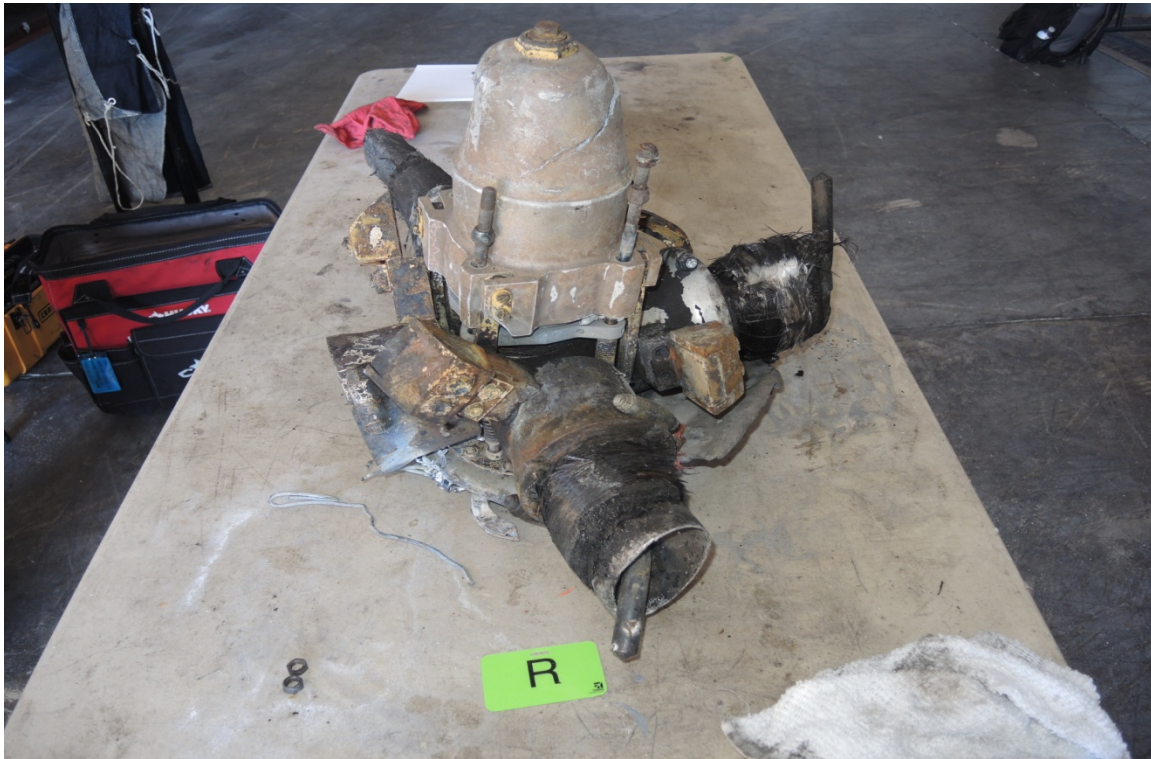
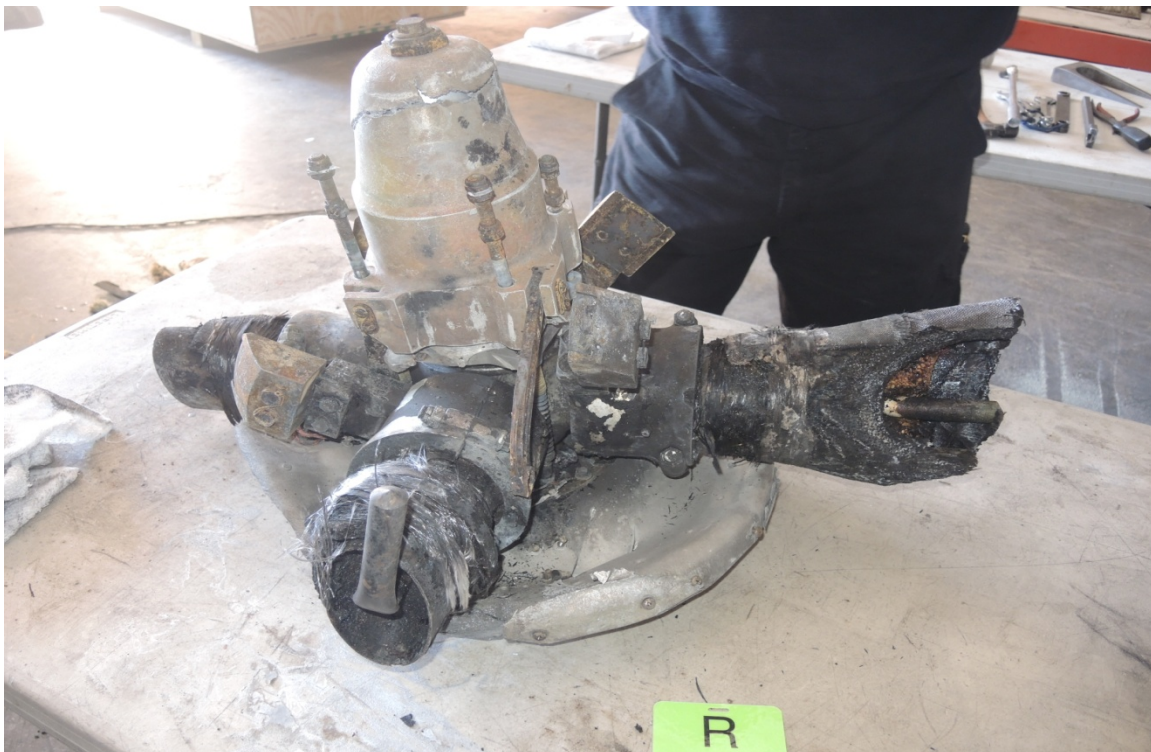
The propeller had several yards of fencing wrapped around the engine shaft and blade shanks when received. Blow torches were used to cut off the tightly wound fencing from the propeller and engine shaft. The propeller was still attached to the engine and had to be cut off the engine due to impact damage. The propeller had extreme thermal damage. The blades were broken and burnt away. One blade was missing. The propeller was in a normal operating range when received. The piston and cylinder was stripped off the hub and being held in place by the guide rods only.

Photo #1, right propeller as received.

Photo #2, right propeller as received.

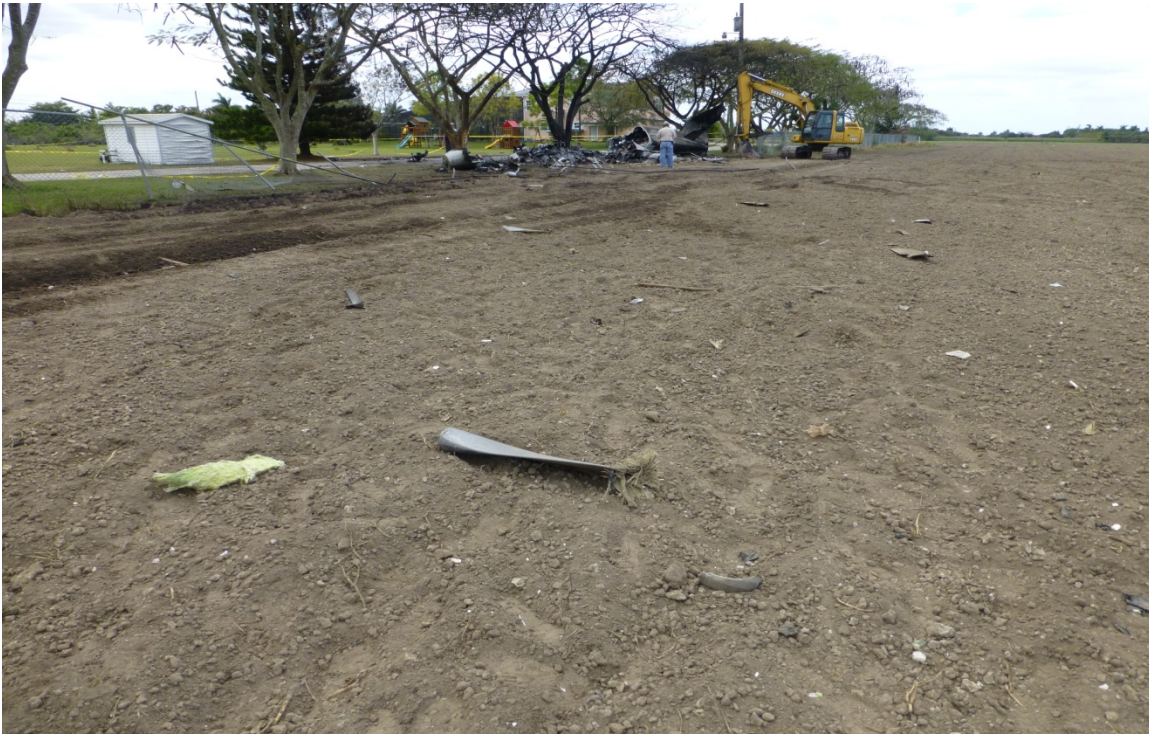
All four blades were made of composite. The four blades were fractured off at the blade butts. Fragmented pieces of propeller blades were picked up in the field but it could not be determined what propeller they were from.

Photo #3, fragmented propeller blades.

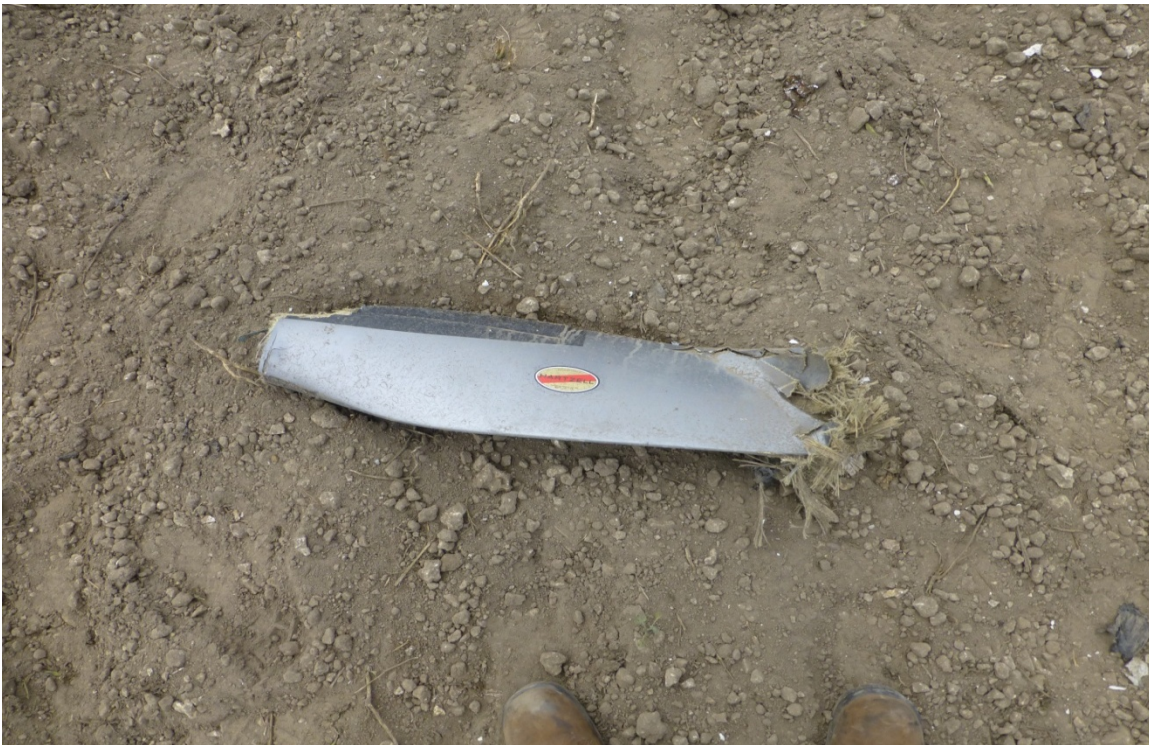
Photo #4, fragmented propeller blade.

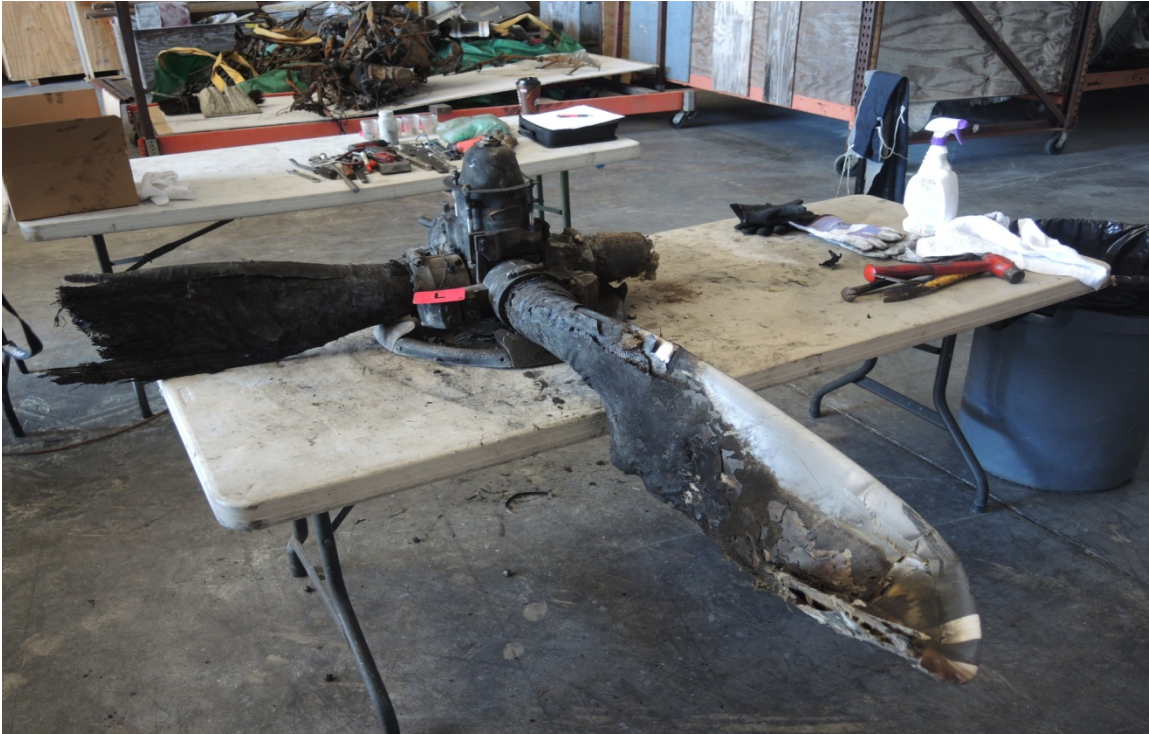
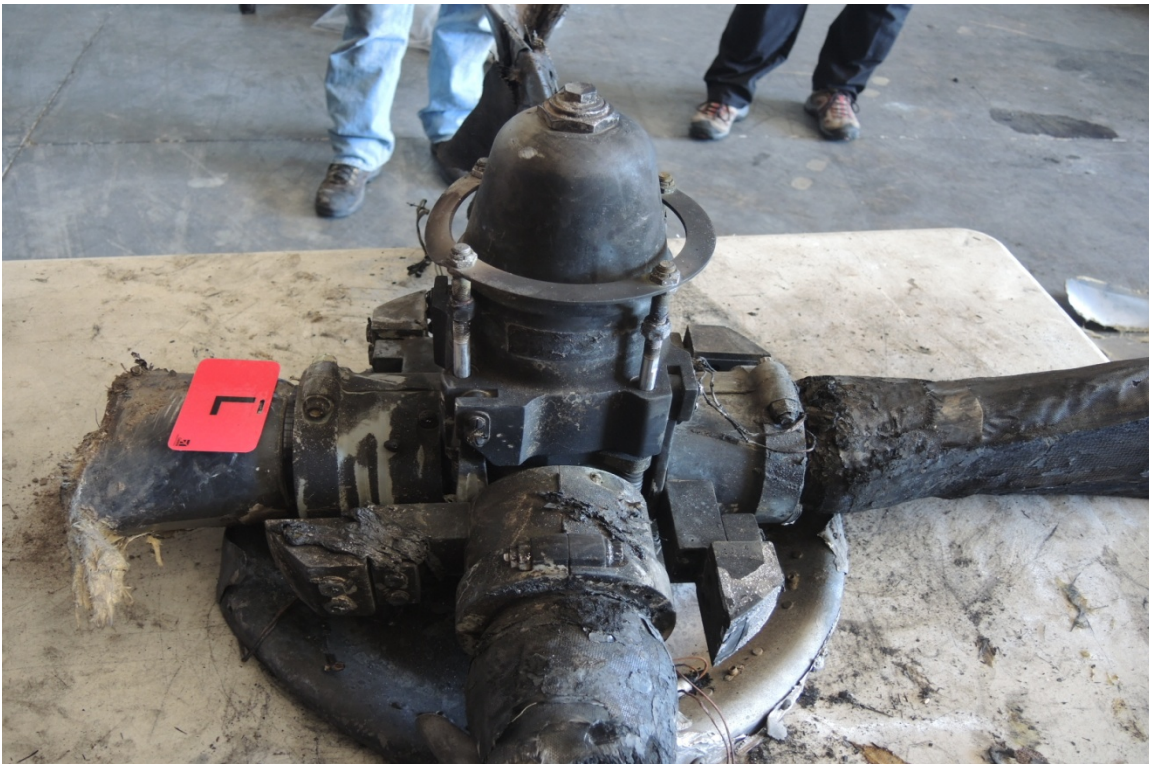
The propeller was still attached to the engine and had to be cut off the engine due to impact damage. The propeller had extreme thermal damage. Three of the four blades were broken and burnt away. One counterweight was punched through the spinner dome and moving into a feather position. Once the spinner dome was moved slightly, the propeller moved into the feather position. Half of the spinner dome was melted away.

Photo #5, left propeller as received.

Photo #6, left propeller as received.

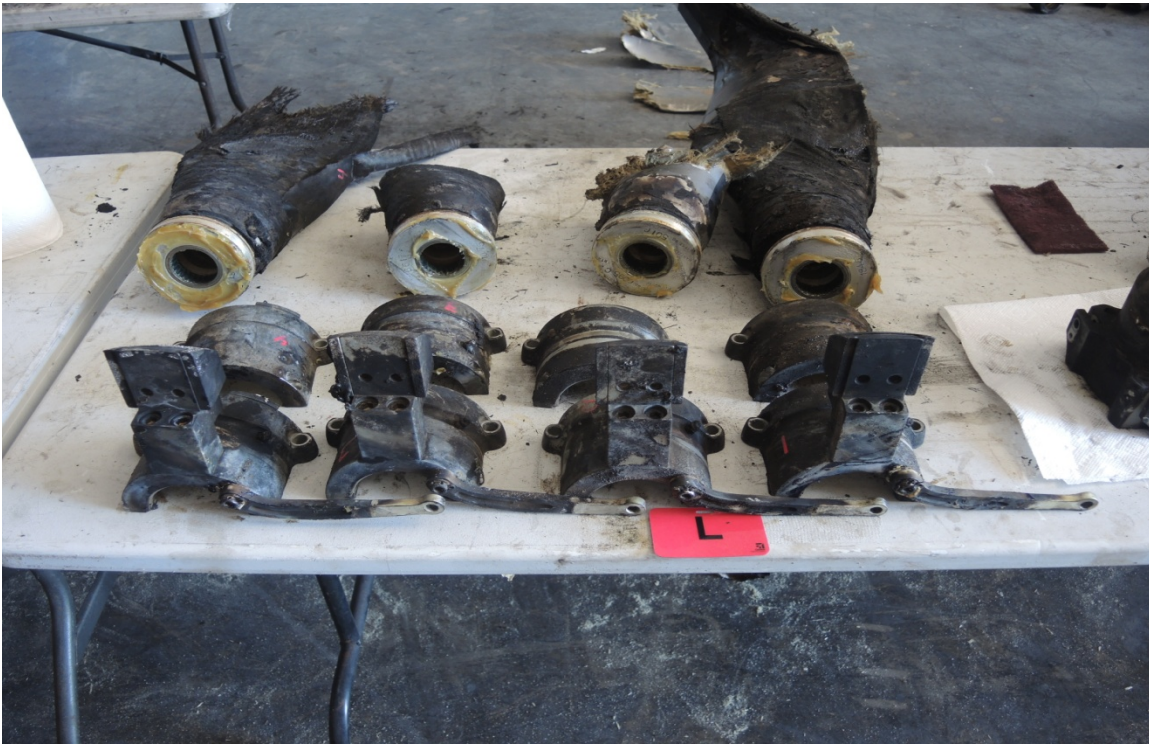
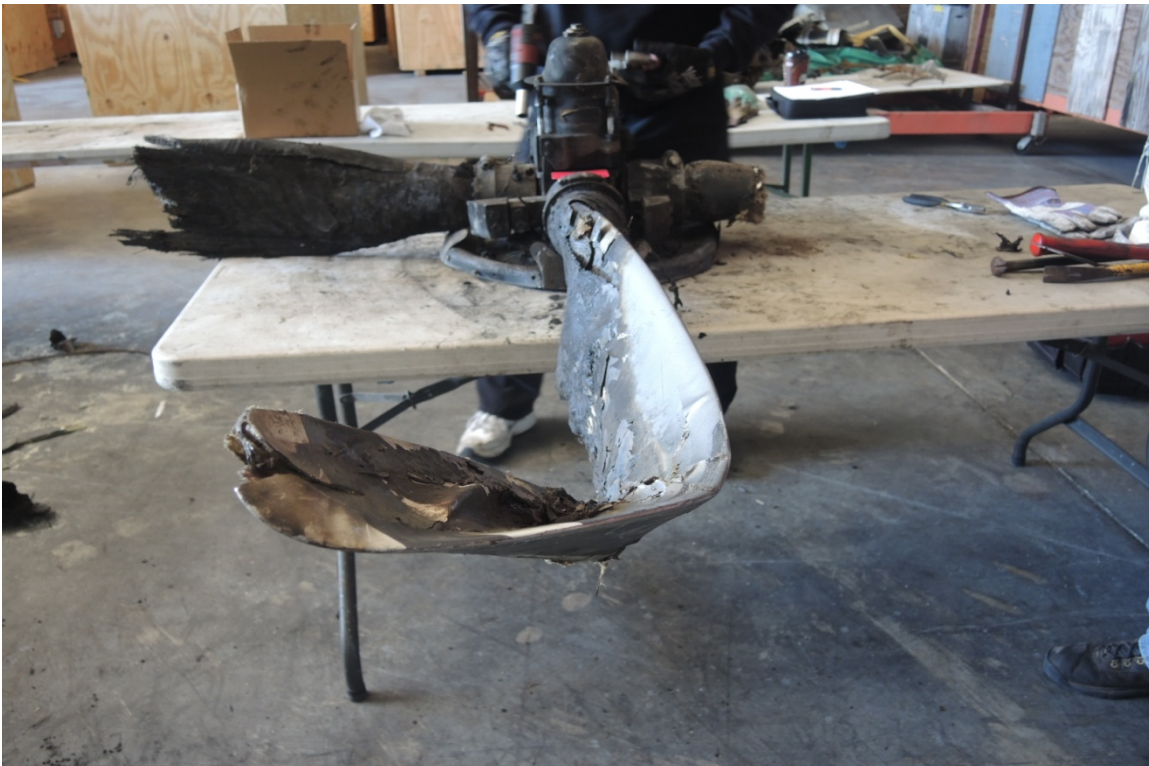
The blades are made of composite. Three blades were fractured off outboard of the blade butts. The fourth blade was burnt and twisted. Fragmented pieces of propeller blades were picked up in the field but it could not be determined what propeller they were from.

Photo #7, left propeller blades.

Photo #8, left propeller blades.

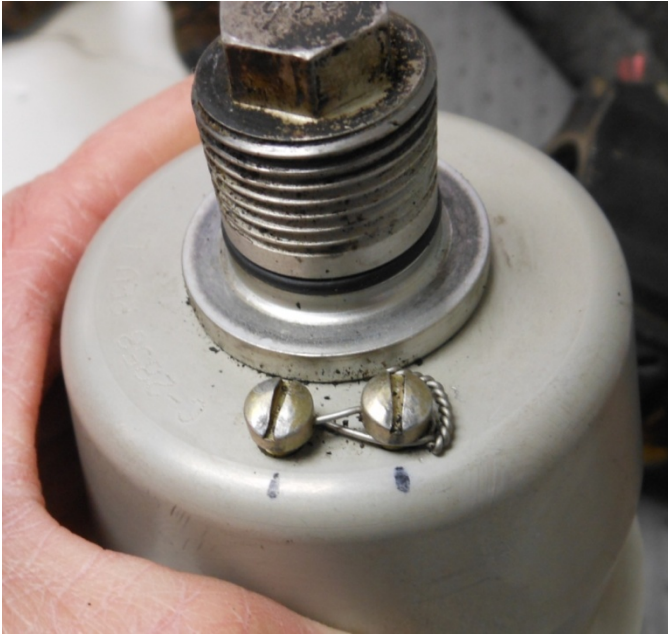
**Feather Stop:** The feather stop screws were bent on one side implying forceful contact with piston during the impact sequence (see Photo #9).

Photo #9, damaged feather stop screws.

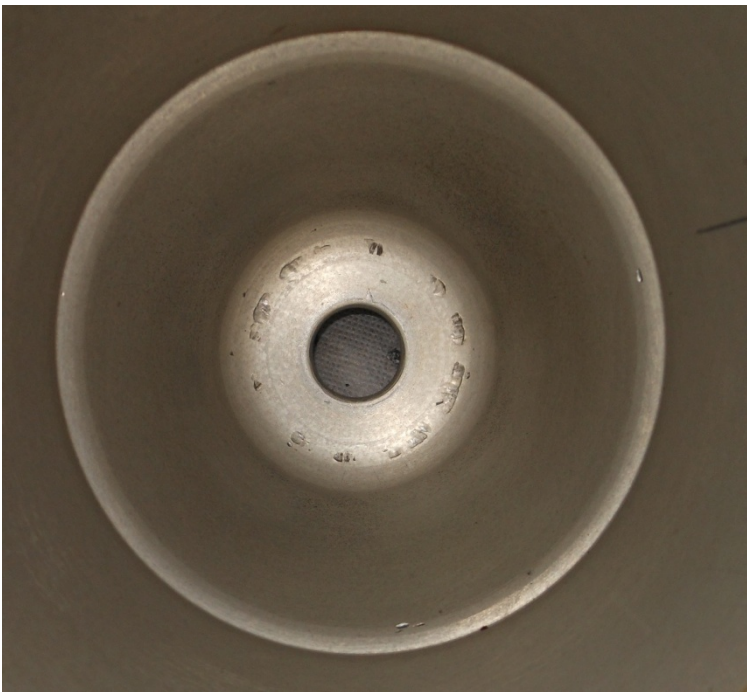
The piston was thermally damaged but intact. The top, internal surface of the piston showed evidence of several impact marks with the feather stop screws (see Photo #10).

Photo #10, top, internal surface of piston.

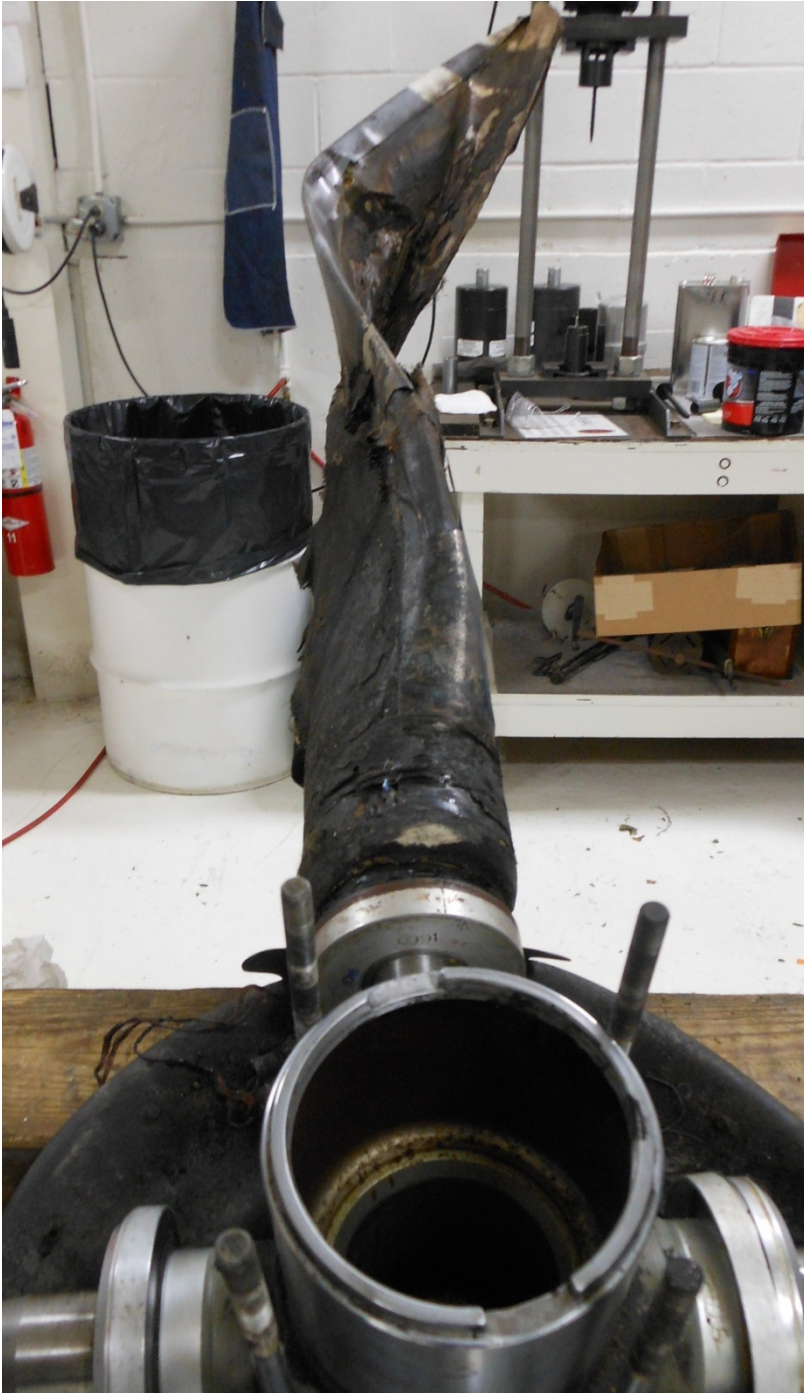
The hub unit was thermally damaged. The hub mounting was intact. There were impression marks from the blade butts on blade arm flanges #1, #2 and #3. When blade #1 was aligned with the hub impression marks, the blade was in near-feathered position (see Photo #11).

Photo #11, Blade #1 with impact marks aligned.
