**NATIONAL TRANSPORTATION SAFETY BOARD**  
**Office of Aviation Safety**  
**Washington, D.C. 20594**

**POWERPLANT GROUP CHAIRMAN'S FACTUAL REPORT**

**NTSB No: ERA15FA129**

Aircraft: Beechcraft 1900C, Venezuelan Registration Number YV1674

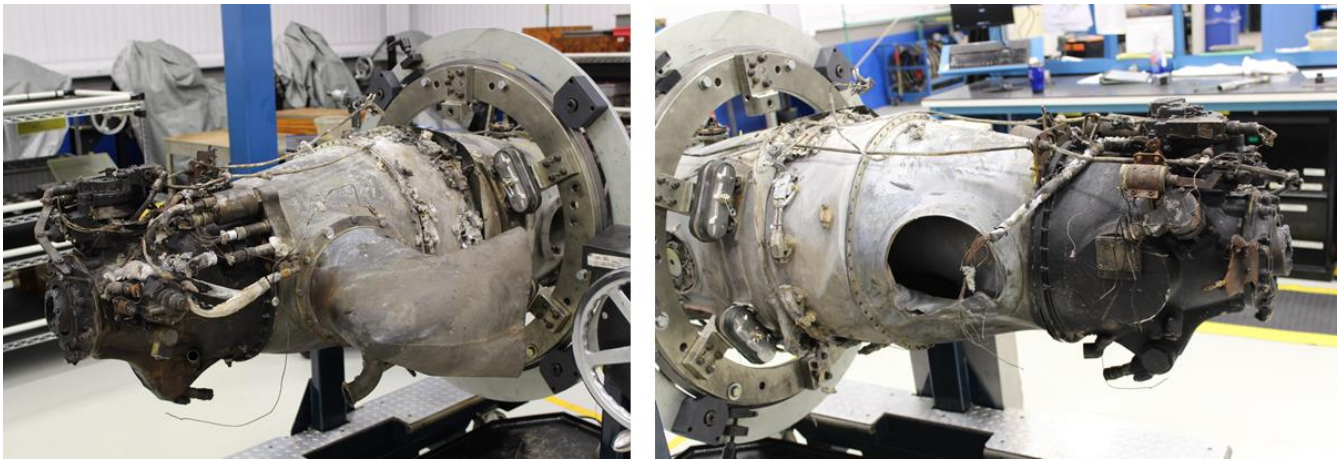
Engine serial number PC-E 32138 was received at PWC on a large pallet wrapped in plastic. Multiple airframe components were still attached to the engine and were removed in order to allow installation into a work stand (**Photos 1 and 2**). A visual examination of the engine was conducted beginning at the propeller gearbox (forward end) proceeding in the clockwise direction around the engine. All external engine surfaces were sooted from exposure to the post-crash fire.

**Photo 1- (L) Left Side of Engine (R) Ride Side of Engine, as Received**

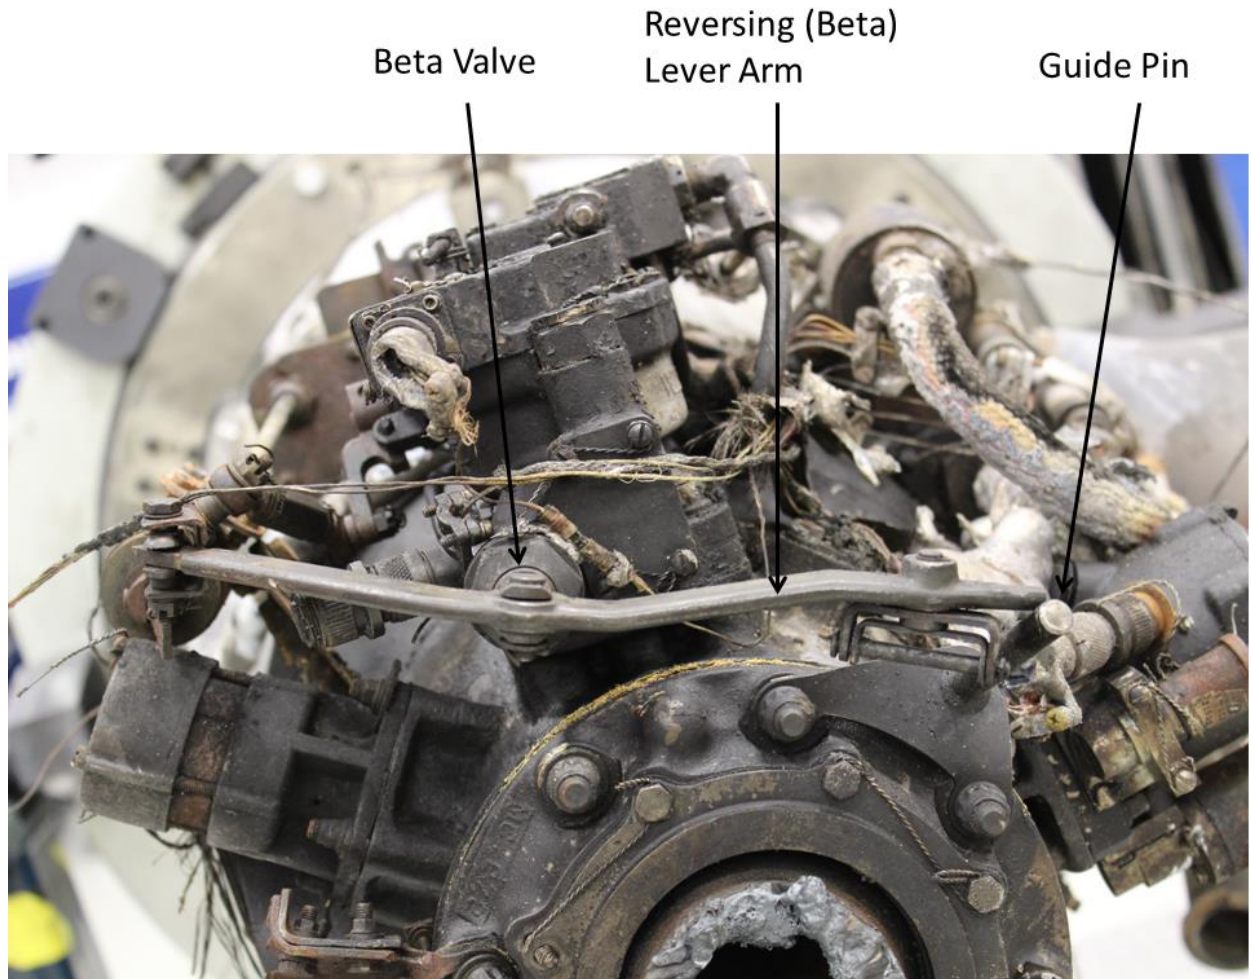
The propeller governor was present but the  $N_p$  (propeller) speed control lever was separated and missing. The propeller governor reversing (beta) lever arm was found above the guide pin and the beta carbon block was separated/broken and missing (**Photo 3**). The propeller governor cable rigging was attached but the sleeve nut that connects to the clevis was fractured, adjacent to the cambox. The cambox was fractured and the connecting rod between the fuel control and the cambox was bent. The  $P_y$  pressure sensing line from the propeller governor to the fuel control was intact. The propeller overspeed governor was in place but its cannon plug was severed. The exhaust case was missing the right side exhaust port and stack sections and the case exhibited impact deformation (crushing) on the lower right side between the 3 and 6 o'clock positions (**Photo 4**). The fuel nozzles were all present but the fuel transfer tubes were thermally damaged (melted). The flow divider was present but was thermally damaged on the left side. The exciter box was separated and resting loosely on the engine with both

**Photo 3- Propeller Governor, Guide Pin Position**

As noted earlier in this report, the propeller governor guide pin was found under the reversing lever arm as opposed above the reversing lever arm as called out in the aircraft maintenance manual. The guide pin acts as a mechanical stop that holds the beta carbon block in place and restricts motion of the lever arm for proper feedback of the propeller control system (**Photo 15**). By placing the guide pin below the lever arm the mechanical stop is no longer present and the linkage and carbon block could move in the radial direction. This radial movement could cause the beta valve to stroke outward (forward) and reduce propeller oil pressure and moves the propeller blades toward the feather position.

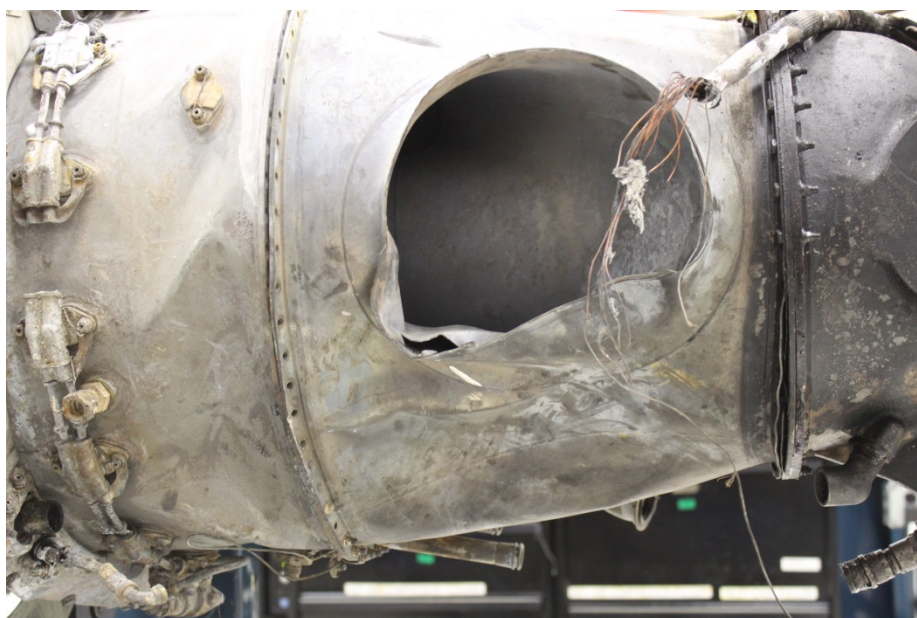
**Photo 4- Right Side Exhaust Port and Stack Separated, Exhaust Case Impact Deformation**

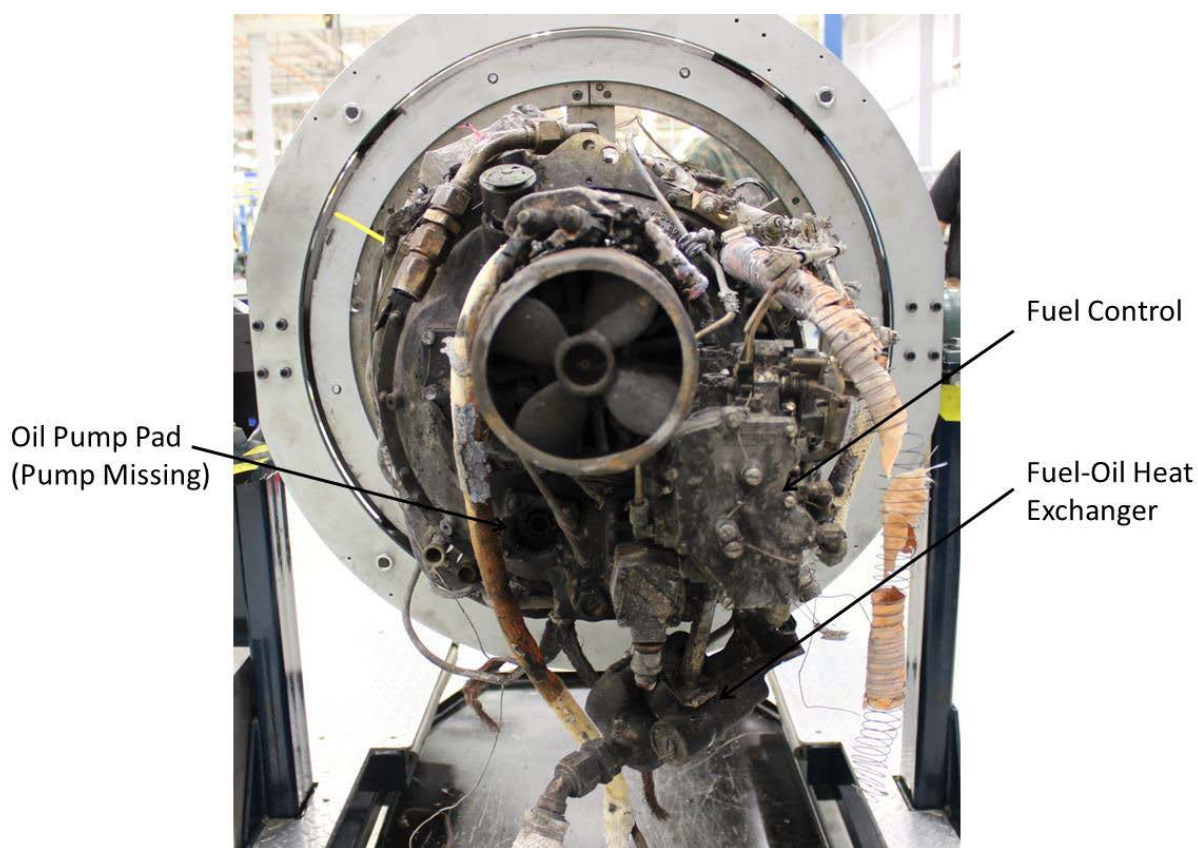
leads attached. The right exciter lead was severed at the gas generator case exciter plug port. The gas generator case exhibited impact deformation at the 1 o'clock position near the bleed valve. When viewed through the inlet screen, the inlet case was melted from the 12 to 3 o'clock positions. The inlet screen was loose around the inlet and the screen connection flange was separated. The oil pump was missing and not shipped with the engine. The fuel control and fuel pump were intact and in position. The P3 pressure sensing line from the fuel control to the gas generator case port was intact. The fuel-oil heat exchanger was separated from its mount and hanging from the engine (**Photo 5**).

**Photo 5- Aft End of Engine, Components Labeled**

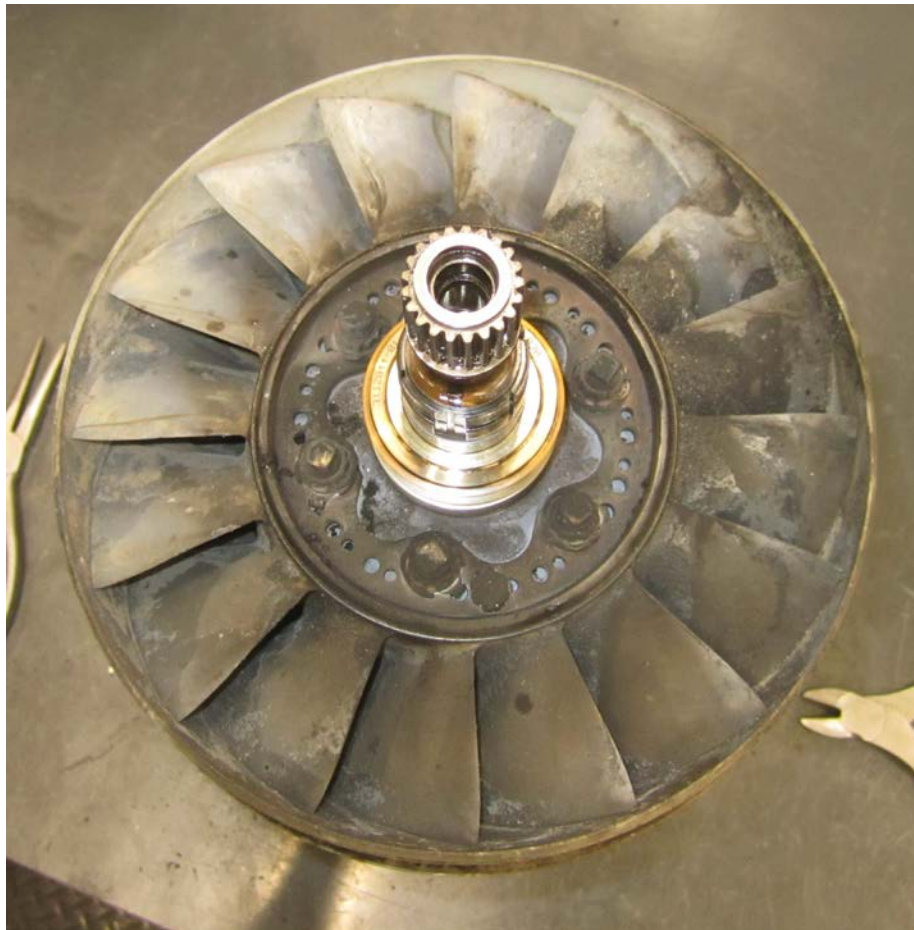
The compressor assembly was separated from the accessory gearbox (AGB). Both the No. 1 and No. 2 bearings were oil wetted and spun freely. The first stage compressor rotor blades were discolored and covered in a layer of soot and dirt debris. All first stage blades were intact and did not exhibit indications of deformation or thermal damage (**Photo 6**). After removal of the first stage rotor the second stage nozzle was exposed and it was also coated with dirt and debris, intact and otherwise unremarkable. The compressor assembly was initially seized, but after some manipulation to force the stator assembly off the compressor lands, the compressor stators was spun while the rotor was held stationary. The remaining three axial compressor stages and single centrifugal compressor stage were not disassembled because there were no indications of internal damage.

**Photo 6- First Stage Axial Compressor**

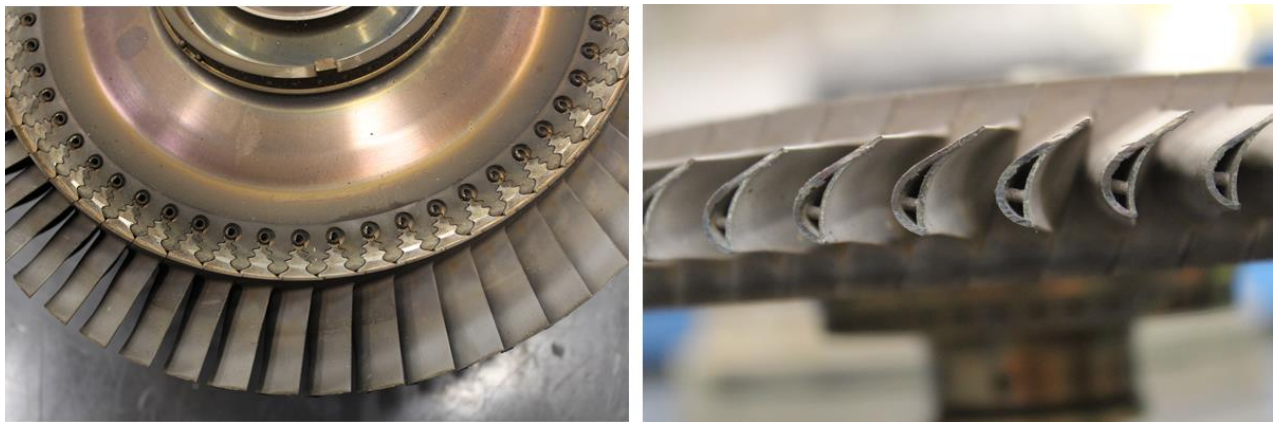
The compressor turbine (CT) disk downstream (forward) face exhibited some light rub along the blade tips and on the blade fir trees over a 90 degree section (**Photo 7**). The CT disk center bore had light rub marks 360 degrees around the circumference. A coincident rub mark was found on the turbine baffle shroud center dome between the 12 and 6 o'clock positions (**Photo 8**). The compressor turbine nozzle assembly was intact but sooted and superficial rub marks were identified between the 3 to 6 o'clock and the 10 to 11 o'clock positions on the CT shroud.

**Photo 7- CT Disk Rub (L) Fir Tree Rub, (R) Tip Rub**

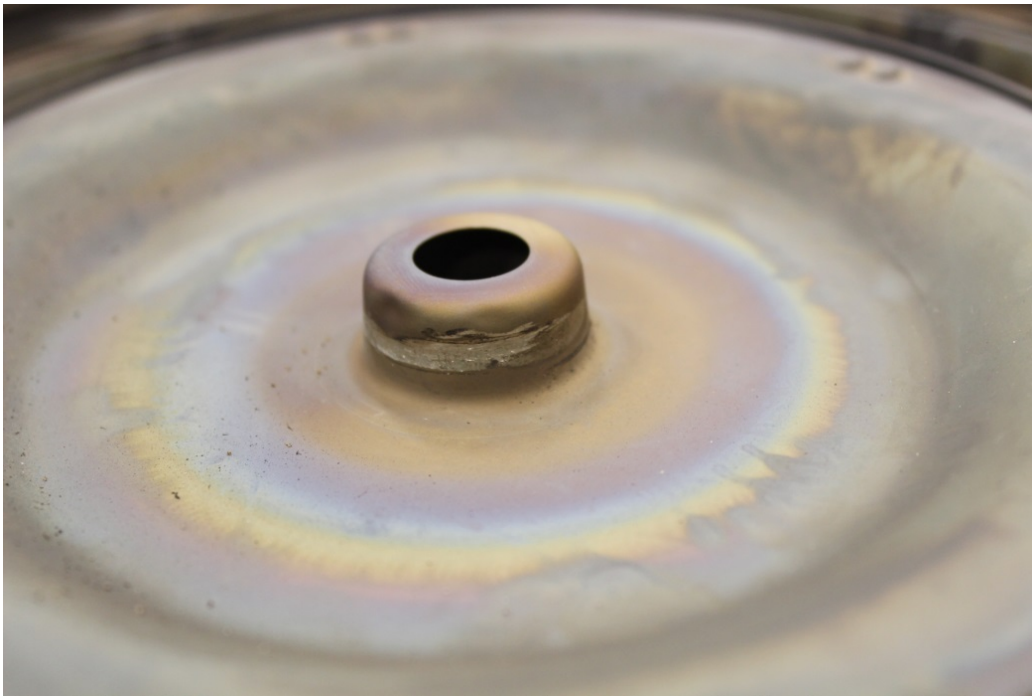
**Photo 8- Turbine Baffle Center Bore Rub**

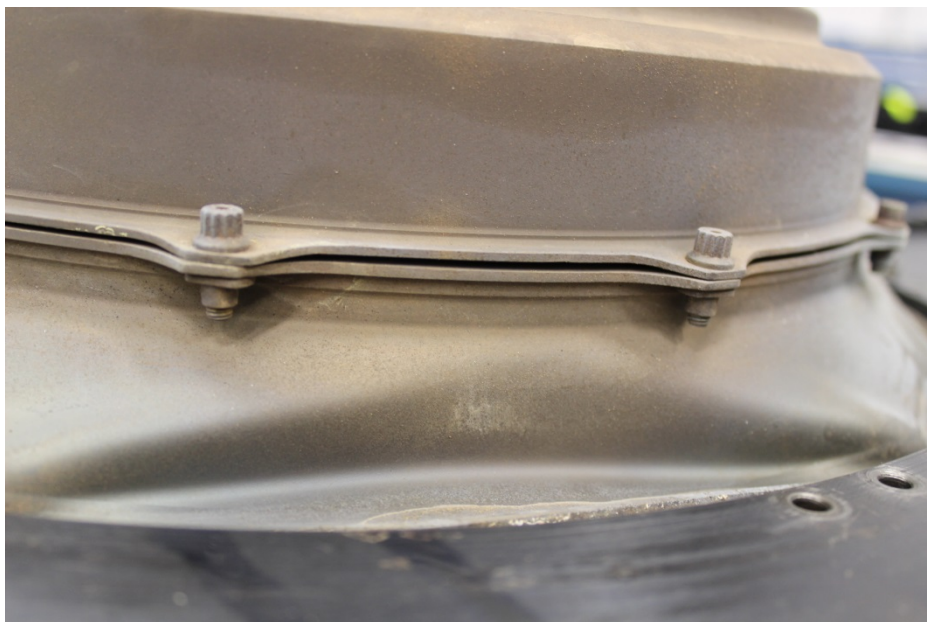
The power turbine case was axially displaced from the exhaust duct leaving a gap at the mating flange (**Photo 9**). The power turbine assembly was separated and all components were covered in soot and dirt debris but both turbine disks and nozzles were intact and in good condition. The first stage disk exhibited some light blade shroud tip rub 360 degrees around (**Photo 10**).

**Photo 9- Power Turbine Case to Exhaust Duct Mating Flange Separation**

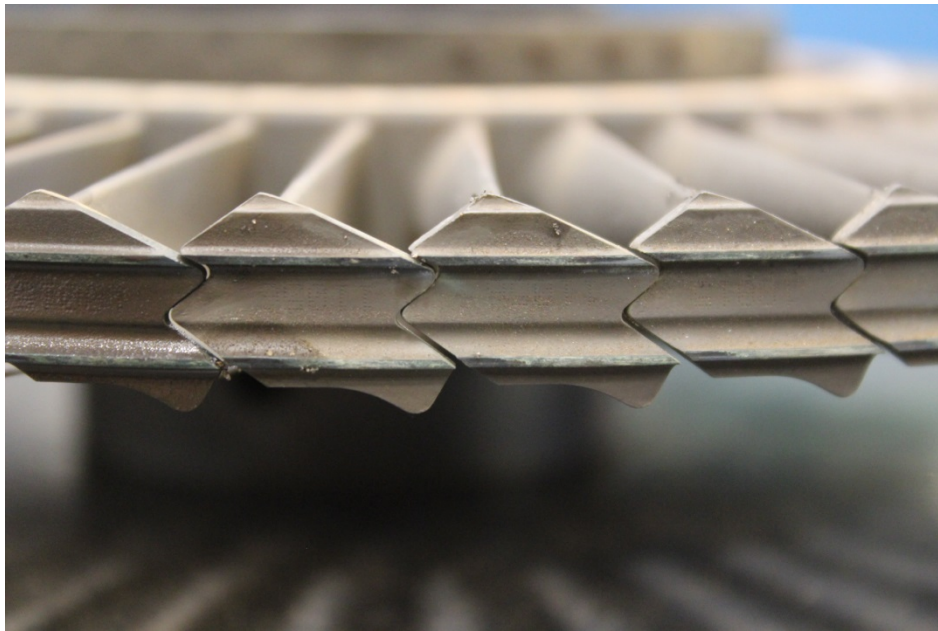
**Photo 10- First Stage Power Turbine Shroud Rub**

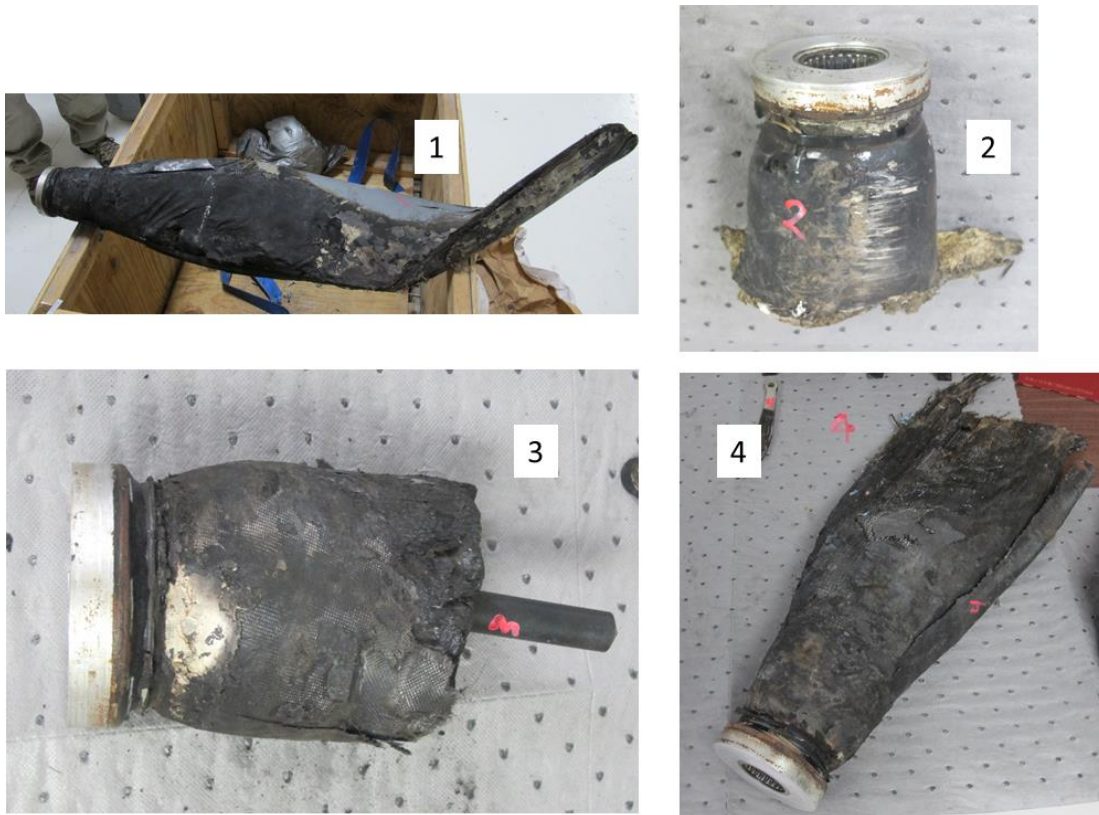
The propeller blades were separated from the hub during the field teardown and the blade numbering established in the Hartzell report was retained during the second examination (**Photo 11**). Three of the four blades had fractured airfoils, with two of the blades fractured near the blade butt (blades 2 and 3) and one blade fractured at about quarter span (blade 4). There was one complete blade (blade 1) that was twisted. All blades were sooted and thermally damaged. The blade butts were labeled to identify the face and camber surfaces and examined for witness marks to help identify blade pitch angle at the time of impact (**Photo 12**). Two blade butts (blades 2 and 3) exhibited witness marks consistent with contact with the hub. The witness marks on the butt of blade 2 were consistent with the blade impacting the ground at about 180 degrees from the normal operating pitch range. The witness

**Photo 11- Left Propeller Blades, as Received at Hartzell Propeller**

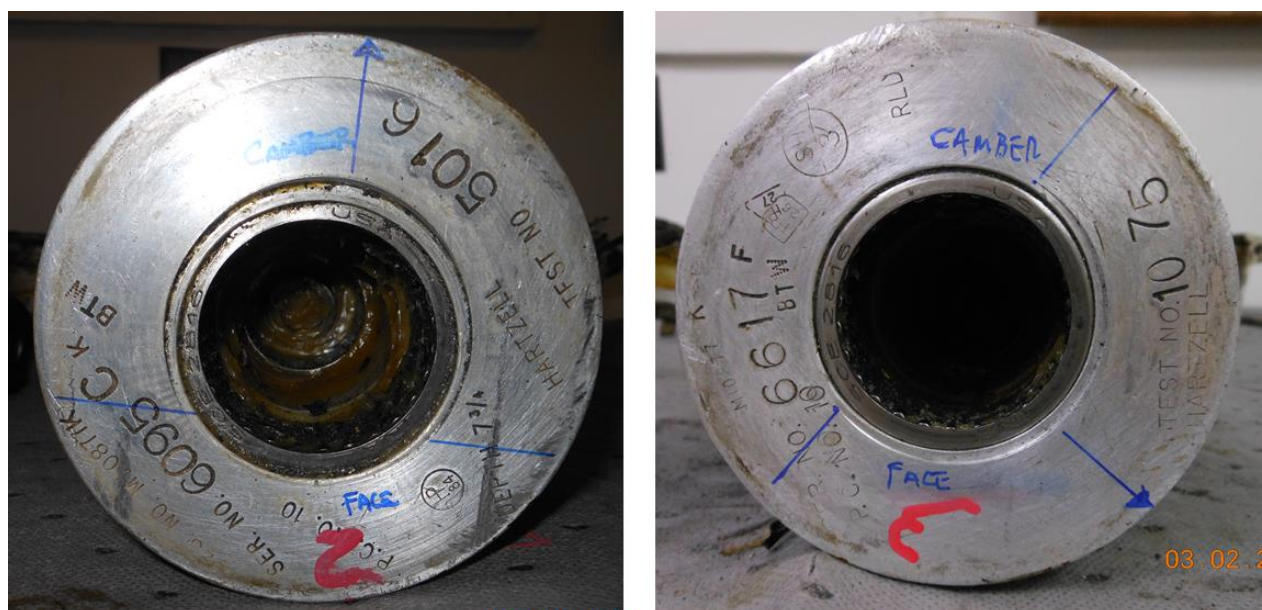
marks on the butt of blade 3 were consistent with the blade impacting the ground at or near feather pitch. The other two blades (blades 1 and 4) did not have witness marks on their respective blade butts. No anomalies were noted to the pilot tubes, blade clamps, or blade butt surfaces.

**Photo 12- Labeled Blade Butts**

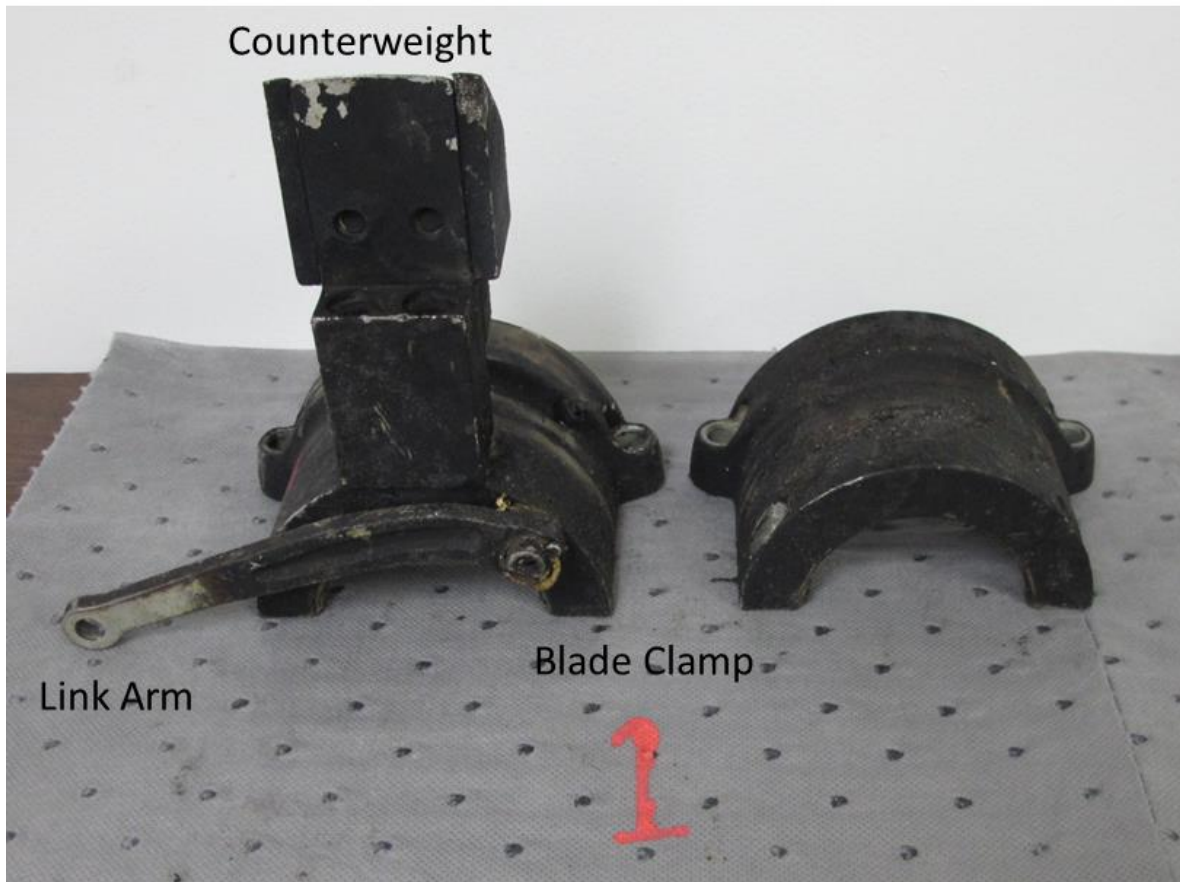
All four propeller blade clamps were intact but appeared to be thermally distressed. The link arms were all securely fixed to the link pins and did not exhibit deformation consistent with low or no propeller rotation at the time of impact (**Photo 13**).<sup>2</sup> The blade counterweights were present and intact but were sooted.

**Photo 13- Blade Clamp, Counterweight, and Link Arm**

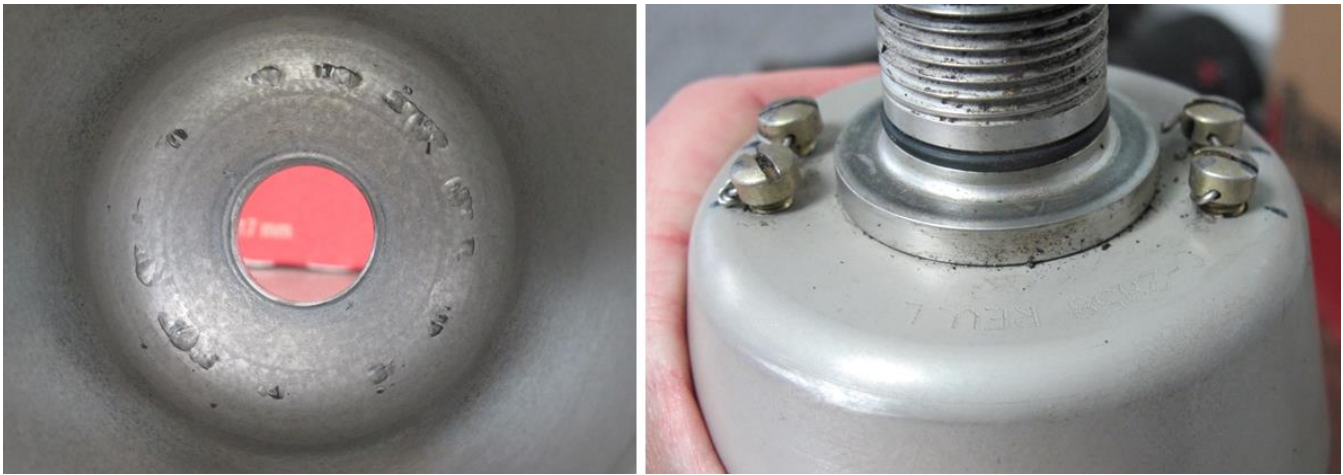
The propeller piston assembly was intact and in good condition. When the piston housing was removed impact marks were observed at the top internal surface of the piston consistent with contact with the feather stop screws (**Photo 14**). The spring assembly extends and moves closer to the piston as the blades move to feather and contact between the two components can only occur when the blades are at or near feather. The hydraulic effect of oil prevents contact between the piston and feather stop screws when the blades are at pitch angles other than feather. The piston nut was removed and the spring and cylinder were visually examined and in good condition.

**Photo 14- Piston Damage and Coincident Feather Stop Screw Deformation**

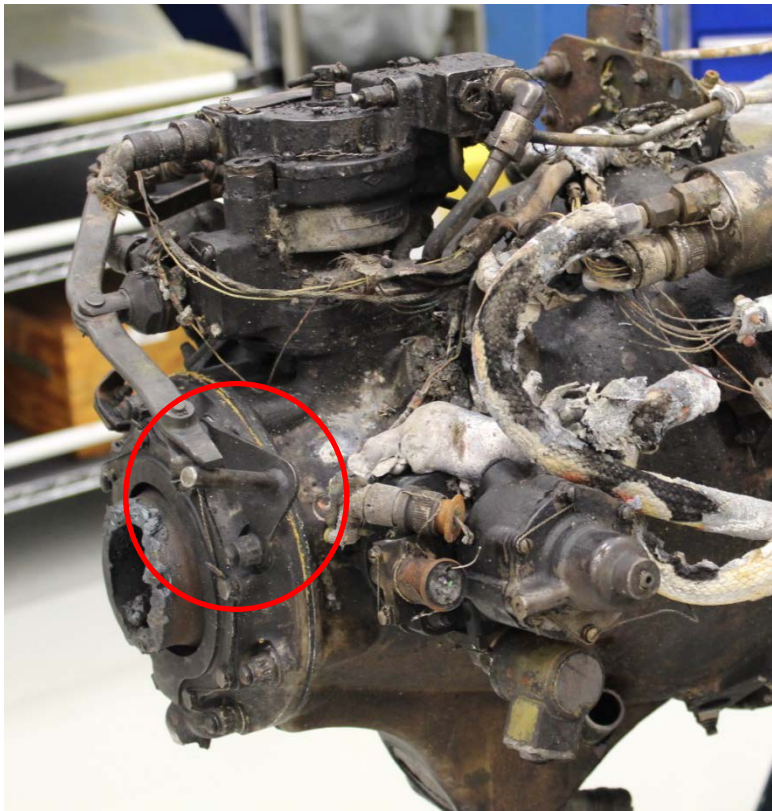
The guide pin mounting plate was bent aft toward the overspeed governor (**Photo 16**). The bottom surface of the guide pin exhibited curl shaped galling from about the mid-length of the pin to the free end. The upper side of the reversing (beta) arm had indications of material wear that changed the contour of the arm surface (**Photo 17**). The bottom surface of the beta arm was unremarkable.

**Photo 16- Guide Pin Mounting Plate, Bent Aft**

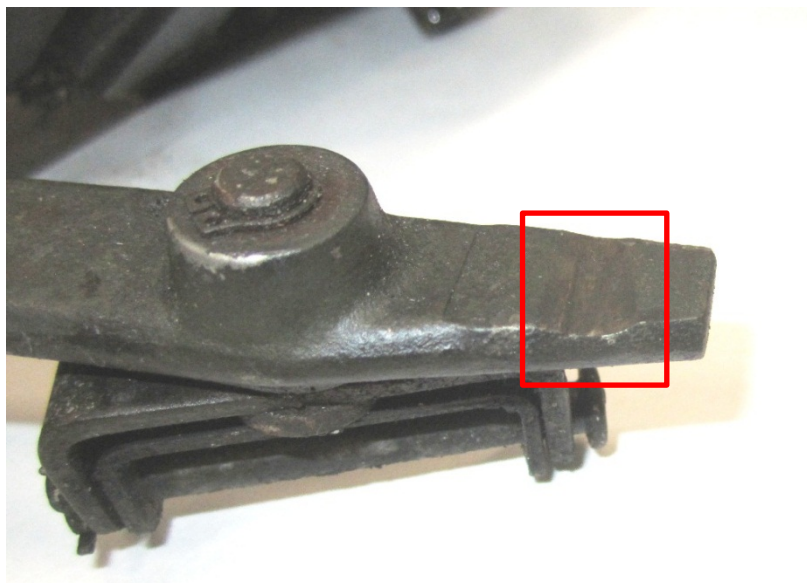
**Photo 17- Reversing (Beta) Arm Top Surface Contact Wear**

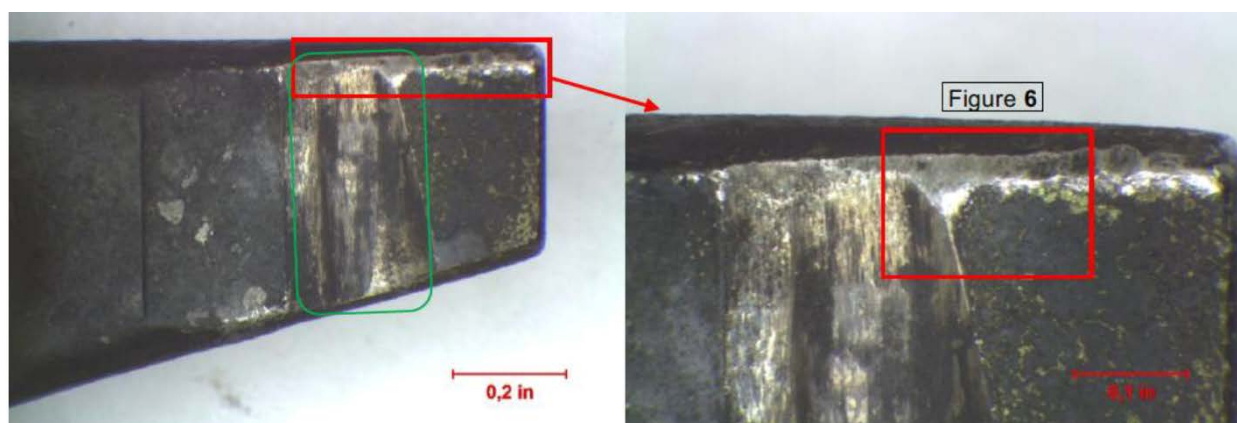
The flat area on the top side of the reversing lever was shiny indicating that material was recently worn away due to contact. Additional contact rubs were noted along the top edge of the reversing lever between the guide pin contact groove and the tip (**Photo 18**).

**Photo 18- Reversing Lever Top Surface**

The guide pin had a curl shaped wear mark on the underside of the pin. The mark was examined using scanning electron microscope (SEM)- electron dispersive spectroscopy (EDS) and a piece of debris within the groove was found to be rich in cadmium which is consistent with the plating material on the reversing lever. According to PWC, the material findings were consistent with the reversing lever arm being installed in the correct position, below the guide pin at the time of impact. The PWC Materials Laboratory findings were reviewed and corroborated by the NTSB Materials Laboratory and a full report titled: "Materials Laboratory Factual Report" is available in the docket.

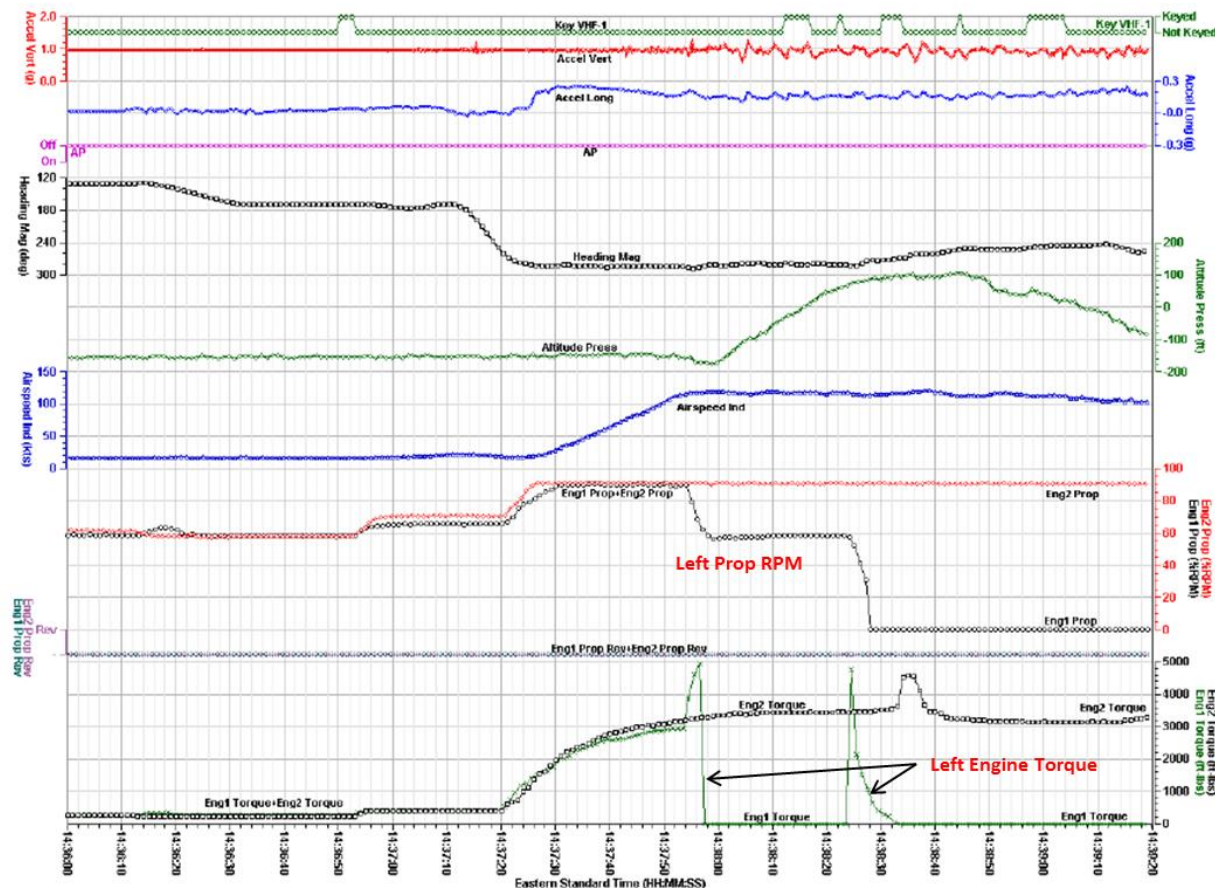
**Figure 3- FDR Plot of Accident Flight at Takeoff**

During takeoff, the torque and propeller rpm readings climbed normally as the airplane accelerated on the runway. When the plane rotated for takeoff the left propeller rpm decreased to about 60% and the left engine torque spiked to the maximum recordable value (5,000 ft-lbs). The left engine torque value then abruptly drops to zero, consistent with an exceedance of the maximum recordable value. A left engine torque reading near the maximum value does not appear again for about 27 seconds at which point both the left engine torque value and left propeller rpm dropped to zero.
