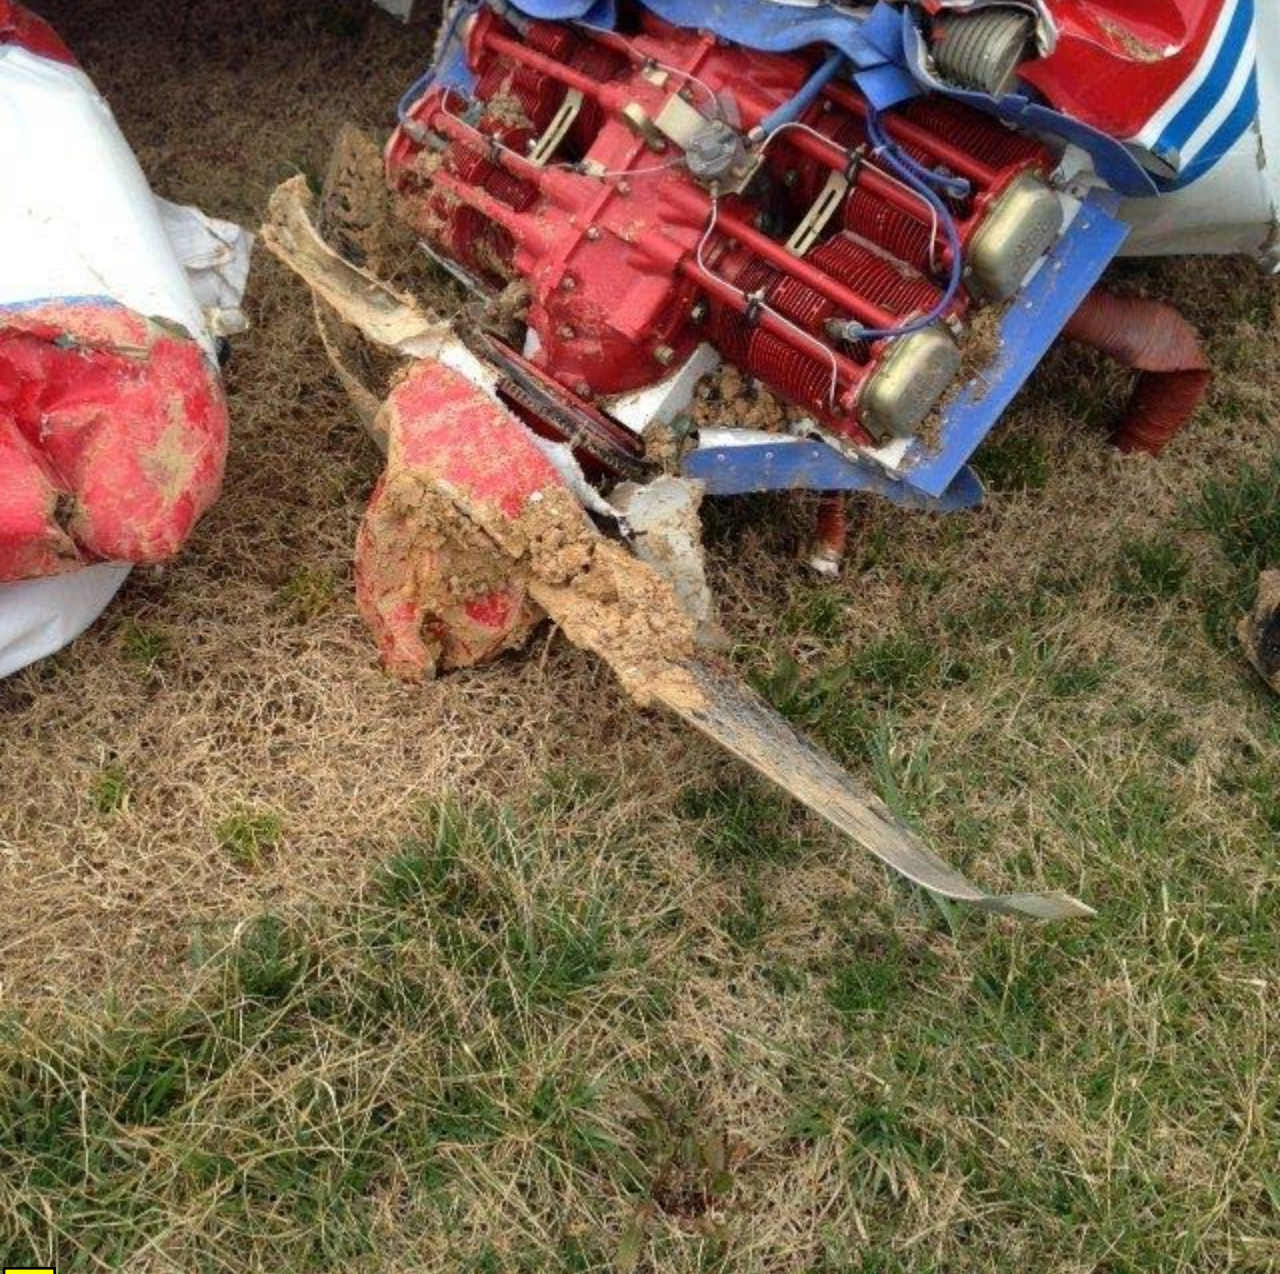
Photo 4 View of engine and propeller post recovery (Phoenix Aviation)
